BETA LAB NO. M10198, TESORO LS2 AND LS2/CS2 TEE FINDINGS PART: 6600-E HEAT EXCHANGER, LS2 22 IN, 36.5 IN MOUNTS, LS2 T2L SEM FRACTOGRAPHY AND PART 22 LS2-CS2 TEE FINDINGS PARTS 16-1 AND 22	TESORO REFINING AND MARKETING COMPANY ANACORTES REFINERY 10200 W. MARCH POINT ROAD T91WA4428 ANACORTES, WA 98221	CUSTOMER P.O. No.: 4501667904
		DATE: OCTOBER 13, 2010
		PAGE 1 OF 56

LABORATORY REPORT

This report is the tenth of a series of the reports on the failed parts of the 6600E heat exchanger. The LS# and CS# refer to longitudinal and circumferential weld seams respectively, while the part number refers to the chain of custody number. Below is the list of the previously issued reports:

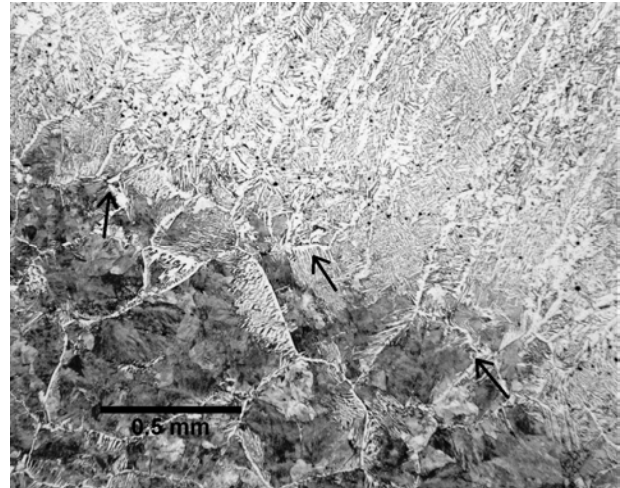
A. HAZ-Weld metal interface 3.28 mm down from ID. Un-etched

B. Same as at left. Etched

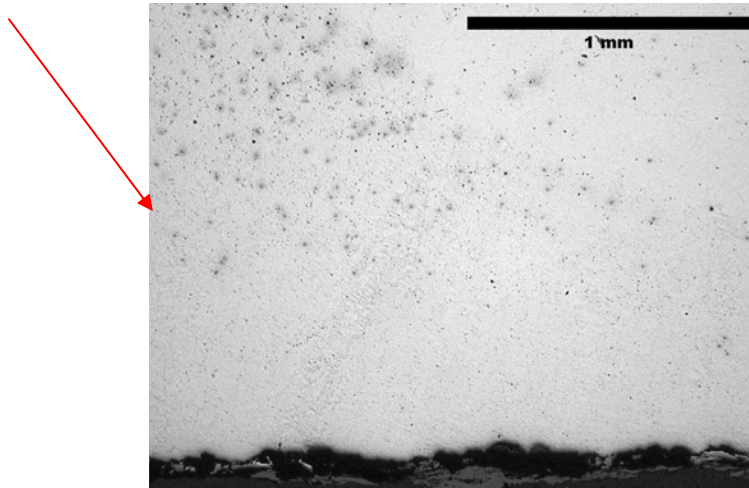
Figure 30

Toe of the weld. No damage found on CS2-A mount. Typical. Un-etched
