U.S. CHEMICAL SAFETY AND HAZARD INVESTIGATION BOARD

DUST EXPLOSION

**WEST PHARMACEUTICAL
SERVICES, INC.**

KINSTON, NORTH CAROLINA
JANUARY 29, 2003

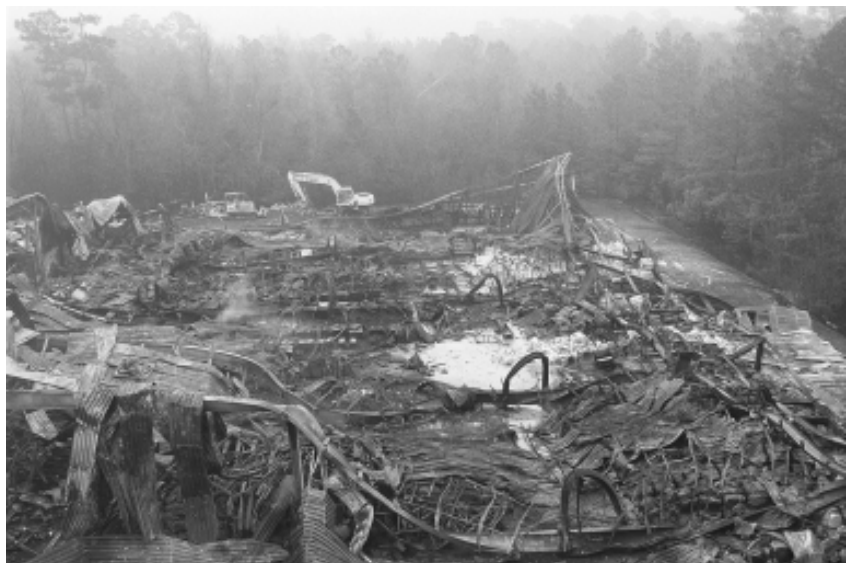
Figure 7. Remains of ACS warehouse viewed from compounding area.

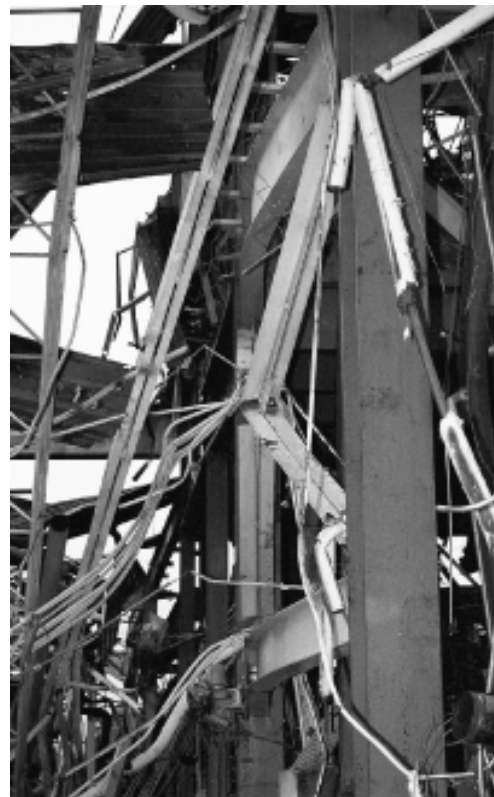
In examining the damage to structural steel and masonry block walls, CSB determined that the most severe forces—which emanated with a blast pattern of 360°—were on the first level of the plant in the area southeast of mill #1.

Figure B-1. Beam and cross bracing deflected southeastward toward warehouse.

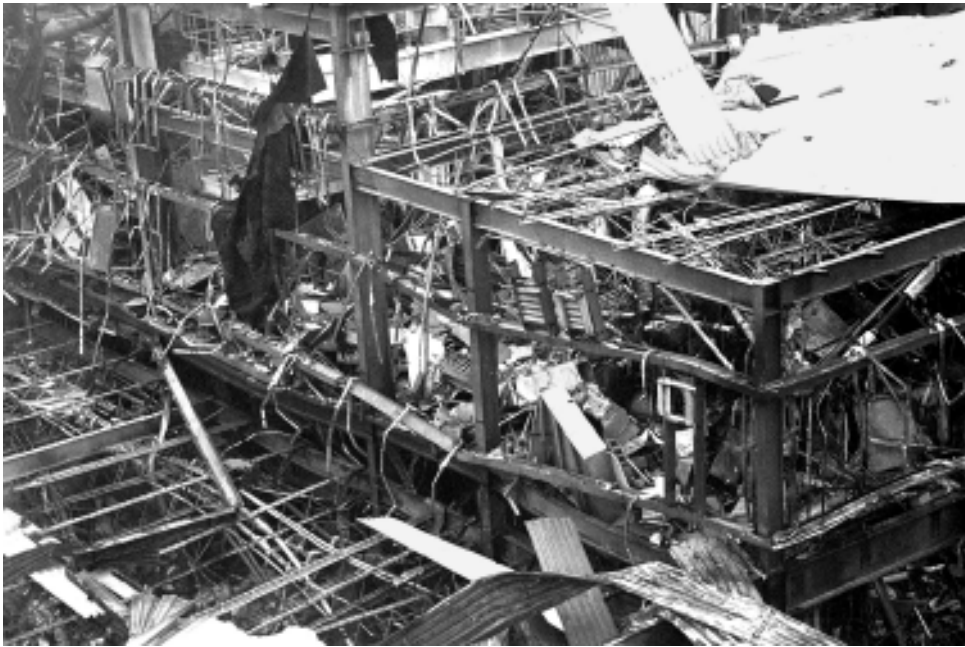
- The force of the blast displaced batchoff #1—a machine that weighs several tons—several feet to the southwest.
- To the immediate east of this area, the two masonry walls of a hallway used to conduct tours of the facility were blown northeastward into the kitchen. Structural steel in this area was deflected in the same direction.
- To the southeast, masonry walls for an elevator shaft and stairwell were blown southeastward toward the warehouse. Structural steel and cross bracing were deflected in the same direction (Figure B-1).
- The upper-level concrete slab flooring directly over the mill #1 and batchoff #1 areas was heaved upward. The floor to the northwest between the two mixers was also heaved (Figure B-2).
- Structural steel for the wall adjacent to batchoff #1 was deflected to the southwest (Figure B-3).

Figure B-3. Southwest wall of compounding area deflected outward.
