U.S. CHEMICAL SAFETY AND HAZARD INVESTIGATION BOARD

# INVESTIGATION REPORT

## EXPLOSIVES MANUFACTURING INCIDENT

### SIERRA CHEMICAL COMPANY

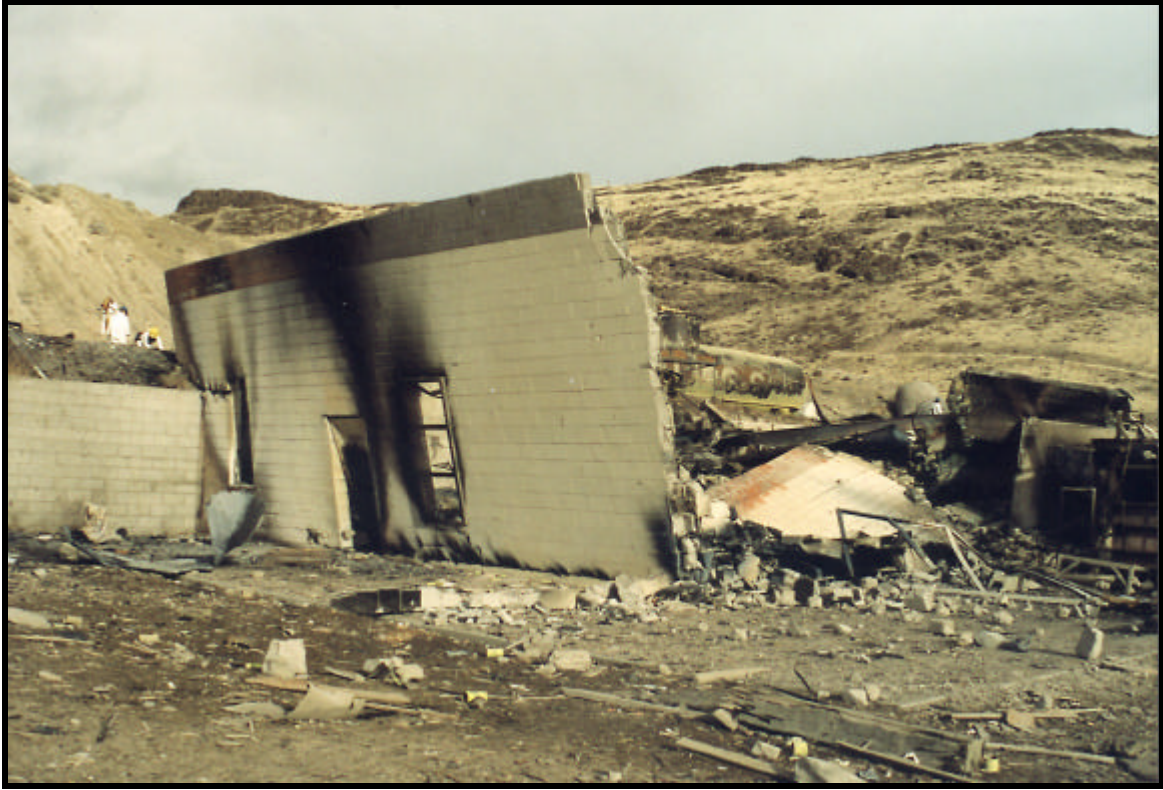
Figure 7. Booster Room 1 After Explosion

The blast effects of the explosions leveled the site and threw structural materials, manufacturing equipment, raw materials from the booster and flux operations, and other fragmentation up to 1,000 yards away. Figure 7 shows Booster Room 1 and Figure 8 shows Booster Room 2 following the explosions. The legs and cross bracing from an empty tank, which previously stood at the corner of the change room, were imbedded in a motor home located 900 feet from the production building. The doors of one of the large magazines and a portable magazine located west of the production facility were sprung open by the negative pressure pulse; however, large quantities of explosive materials that were stored inside did not detonate. Many undetonated boosters had been scattered throughout the site by the explosion. Other hazards at this time included fires, toxic chemicals, and potential detonation of the explosives in Booster Room 1 as the fire progressed.

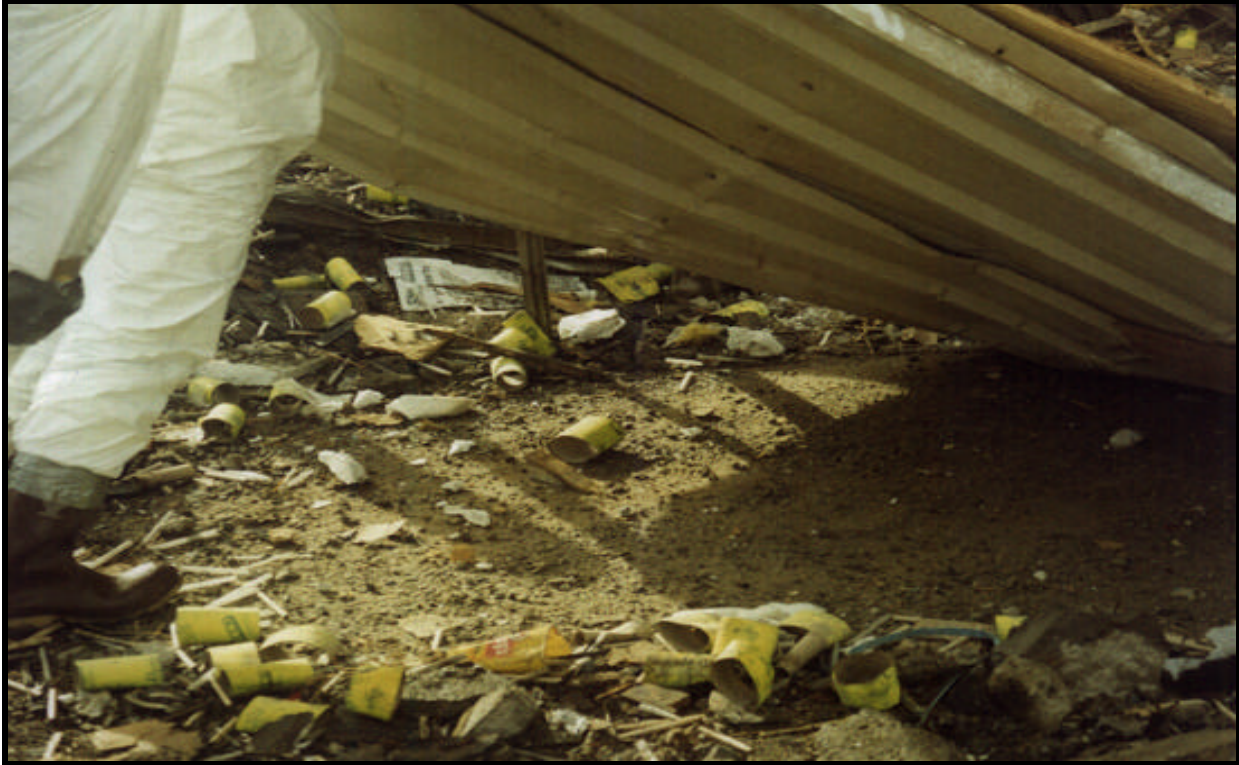
**Figure 9. Lifting the Sliding Door**

Layering of debris further demonstrated the sequence of the explosions. The concrete roof of the Boiler Building fell on top of pieces of its walls. (The Boiler Building is labeled "Main Electrical Panel and Boiler" in Figure 3.) These were in turn located on top of a corner and pinned down a seven- by ten-foot sheet-metal sliding door from the east side of Booster Room 1. A small tank, previously located outside the Boiler Building, also came to rest on this door. When the sliding door was finally lifted (see Figure 9), no debris was under it, even though it was surrounded by debris from the concrete Boiler Building. This layering, like archeological strata, indicated that the blast from Booster Room 2, which knocked down the wall between the warehouse and Booster Room 1, blew out the sliding door to the raised platform in Mixing Room 1. The second blast from the PETN building destroyed the Boiler Building and its concrete roof fell down on top of pieces of the wall.

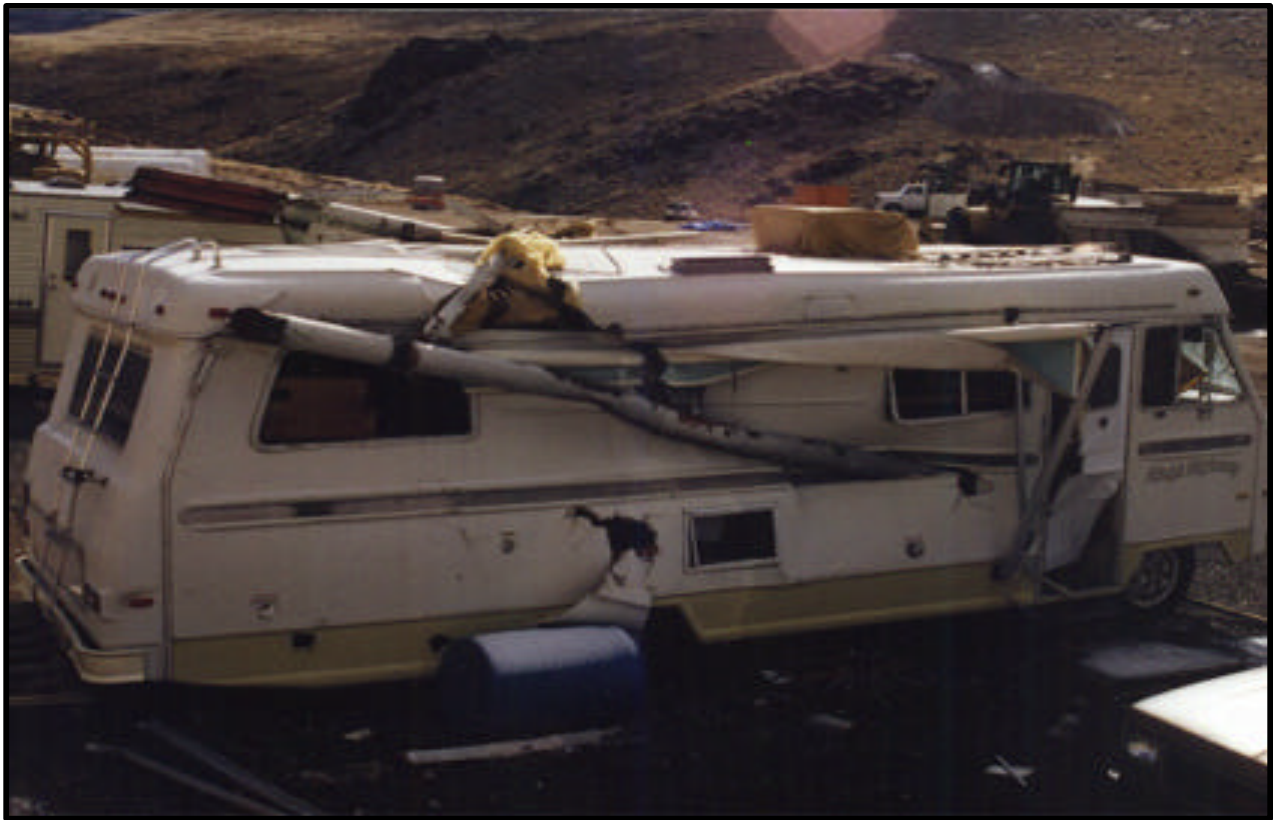
**Figure 10. Mobile Home Hit by Legs of Tank and Cross Bracing**

The main body of a 12-foot-diameter tank with a conical lower portion, that was previously located near the southeast corner of the change room south of Booster Room 2, was blown directly south approximately 850 feet. It landed on the north entrance road to the Frehner Construction Company truck parking lot. The steel-pipe stand on which this vertical tank had been elevated was found along the east side of the entrance road to the plant, where two of its large legs and cross bracing struck the mobile home (Figure 10) which housed the guard for the Frehner Construction Company. The top of the tank landed across the road northwest of the PETN building. Because this tank had been elevated, it was fully exposed to blast effects from the PETN building. Had the PETN building exploded first, this tank would have toppled toward Booster Room 2 and the adjacent flux mixing room. The tank and its support legs, however, were found on the side of the PETN building furthest from Booster Room 2. This indicated that Booster Room 2 exploded before the PETN building exploded.

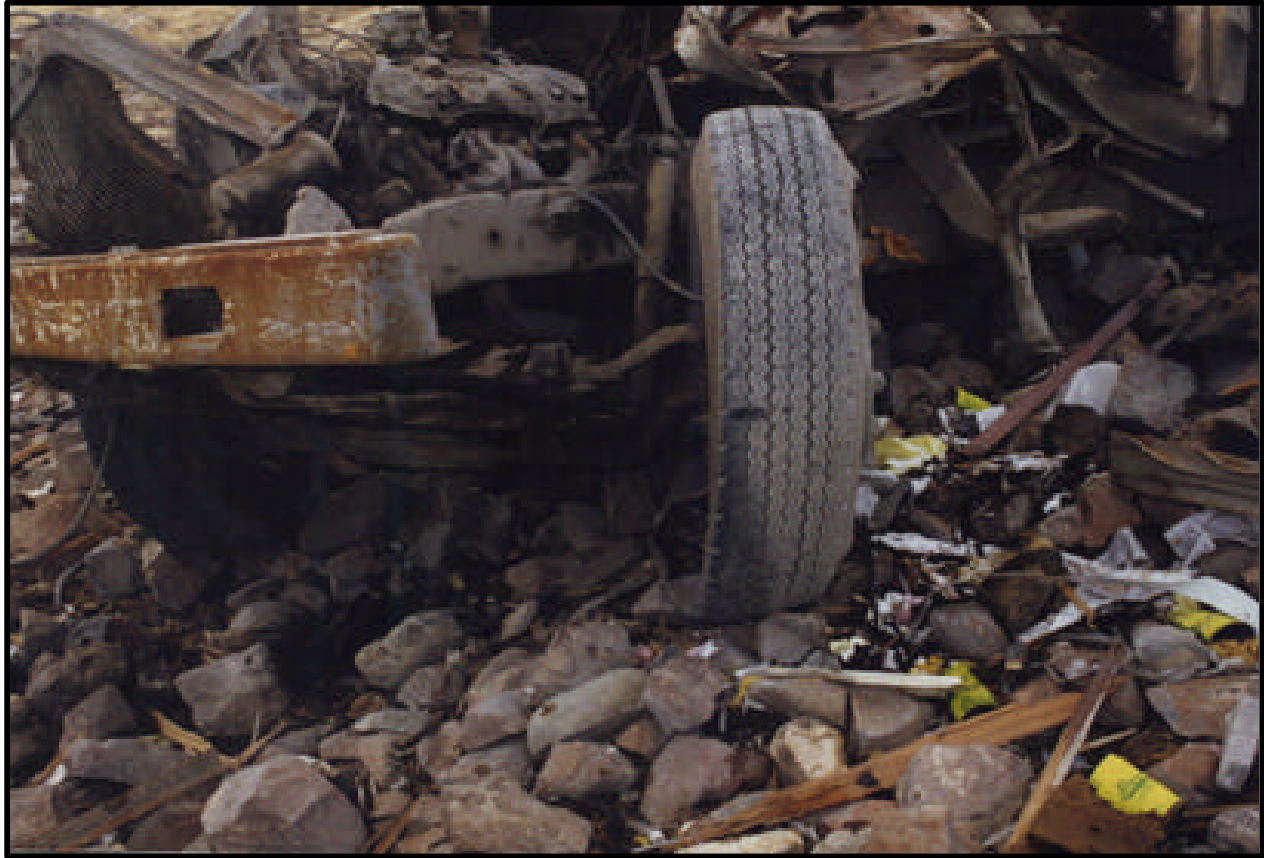
**Figure 11. Flatbed Truck Showing Riprap Against Tire**

A flatbed truck, which had been parked facing east on the terrace, south of the tanks outside of the change room/office, came to rest after the explosions facing southeast, with the cab diagonally hanging over the edge of the riprapped slope between terraces. The driver side of the engine and cab of the truck showed multiple fragment penetrations. A mixing pot fragment was found lodged on the driver's side of the truck. The passenger side of the truck showed blast damage that lifted the front of the cab off of the chassis. A pile of riprap was found on the uphill side of the driver-side front tire, with a path cleared in the riprap on the other side of the tire (see Figure 11). There was less riprap material on the uphill side of the passenger-side front tire. A steel cargo rack, which had been welded to the front of the truck bed behind the driver, was found hanging from the bed on the driver side on top of other blast debris from the vicinity of Booster Room 2.

The investigation team determined that the front of the truck was struck by the blast from Booster Room 2, and the blast propelled the truck partially over the slope, with the undercarriage resting on the brow of the slope. The axis of the truck was nearly perpendicular to the brow of the slope. The blast from the PETN building then struck the passenger side of the truck, which rotated the front of the truck back uphill about six feet, with upward damage to the cab. The second blast also tore the cargo rack from the front of the truck bed and deposited it on the uphill side of the truck on top of debris from Booster Room 2, including part of the stand from pot 4. This second blast lifted the passenger side of the vehicle, which resulted in more riprap being pushed uphill by the driver-side tire. Because the last movement of the truck was uphill, away from the PETN building, observations of the final truck position and condition supports the conclusion that the first explosion occurred in Booster Room 2.

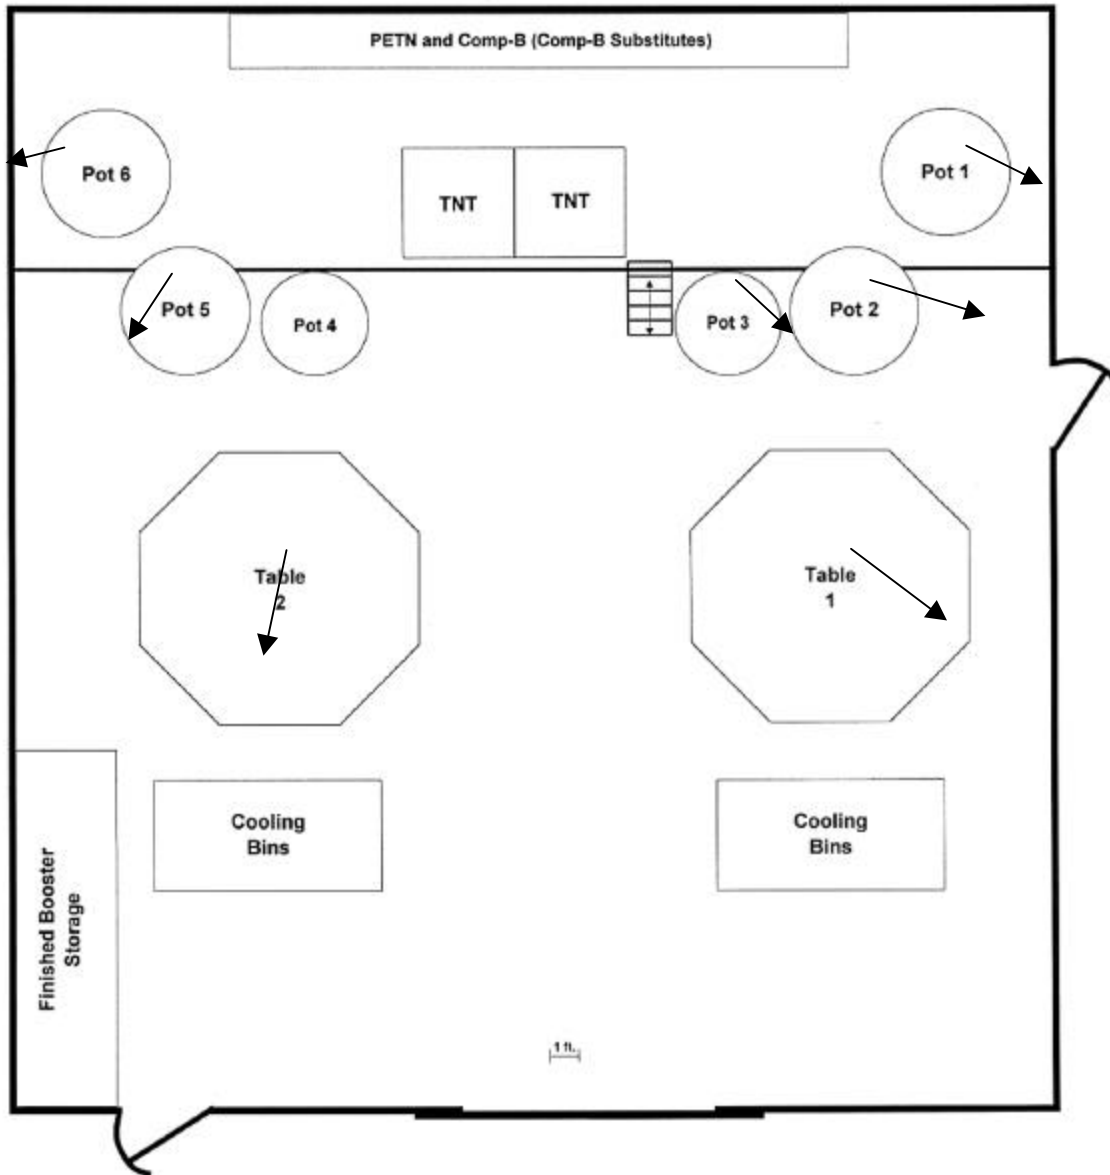
Figure 12. Details Regarding Trajectories of Booster Room 2 Equipment

The investigation team found a number of identifiable components from Booster Room 2, including table bases and several mixing-pot shafts. Figure 12 shows the original location of these items in the room and the direction (indicated by an arrow) that each traveled following the explosion. The presence of pot fragments and components in virtually all directions indicates that mixing pot 5 exploded before the staged explosives on the platform did. Figure 12 also shows that the blast was concentrated in the areas where these explosives were staged.

ILLUSTRATED ITEM	DISTANCE TRAVELED
Pot 1 with shaft intact	240 feet
Full shaft assembly, less mixing blades, and lid from pot 2	675 feet
Shaft from small mixing pot, less mixing blades, believed to be from pot 3	1250 feet
Approximately 18" piece of shaft from pot 5	450 feet
Pot 6 lid with shaft assembly, less mixing blades	480 feet
Table 1 base	455 feet
Table 2 base	380 feet

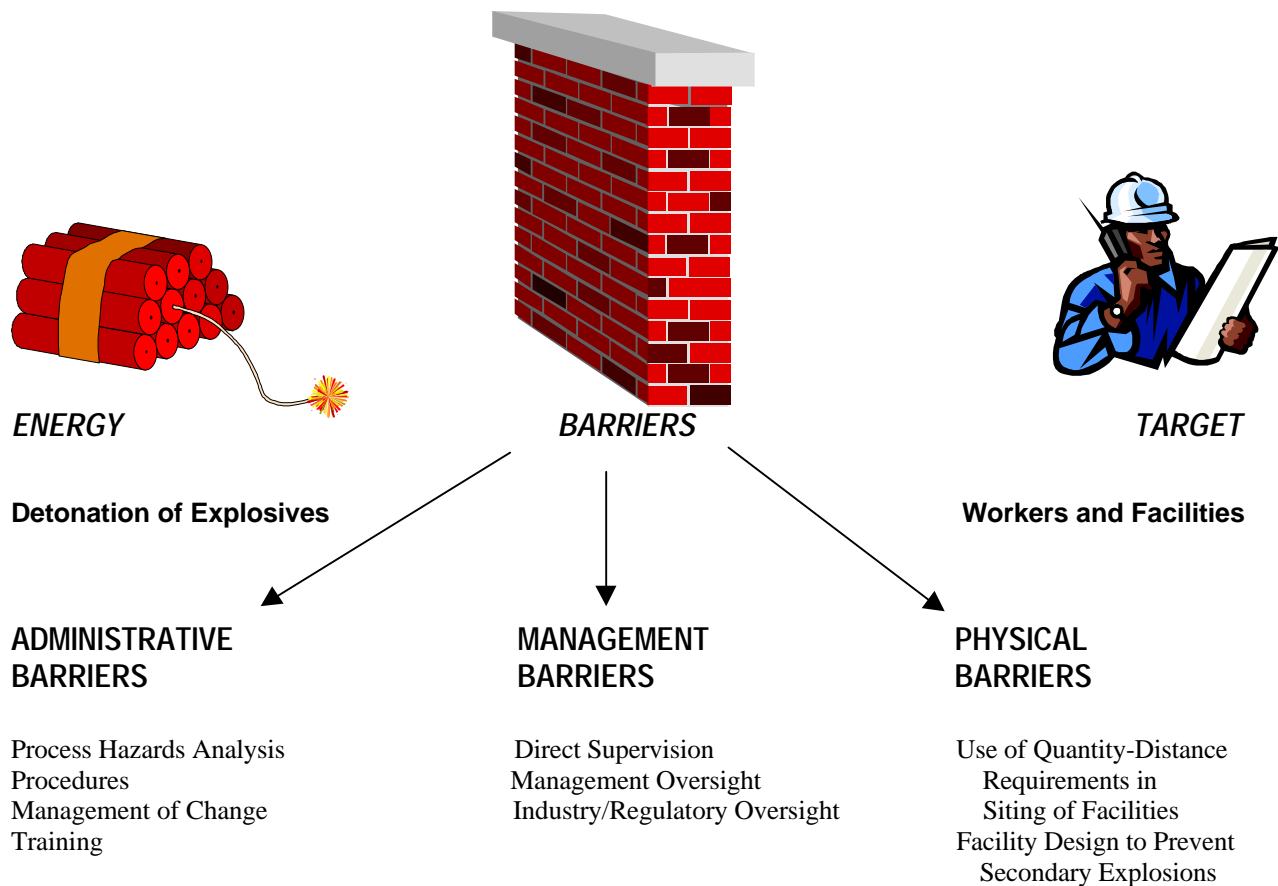
**Figure 13. Barrier Failure Analysis**

Barrier analysis is used to identify administrative, management, and physical barriers that could prevent, control, or reduce energy flows such as explosions to targets such as people or objects. This barrier analysis was concerned with those barriers that could have prevented or mitigated the impact of explosions but that either failed or were missing. The summary of this analysis, in Figure 13, shows barriers associated with all four credible initiating events.

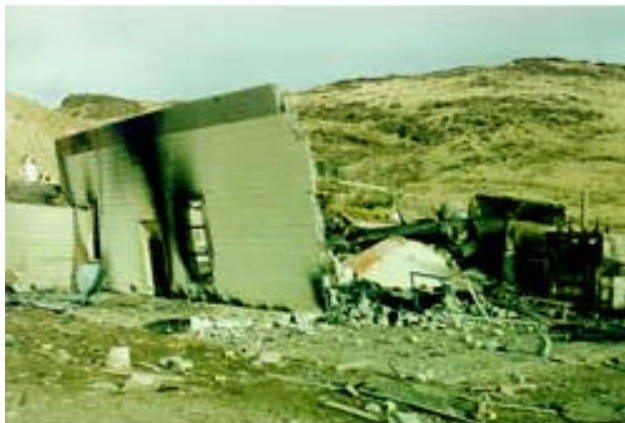
View of booster room 1 following the explosion, with west wall still standing. The five workers in this room survived.
