METALLURGICAL EVALUATION OF SAMPLES FROM THE CHEVRON U.S.A. INC., RICHMOND #4 CRUDE UNIT 8-INCH AND 12-INCH 4-SIDECUT PIPING INVOLVED IN THE AUGUST 6, 2012, HYDROCARBON RELEASE AND FIRE

Prepared for: The Chemical Safety and Hazard Investigation Board (CSB)

Report No. 5004.7920 B

February 11, 2013

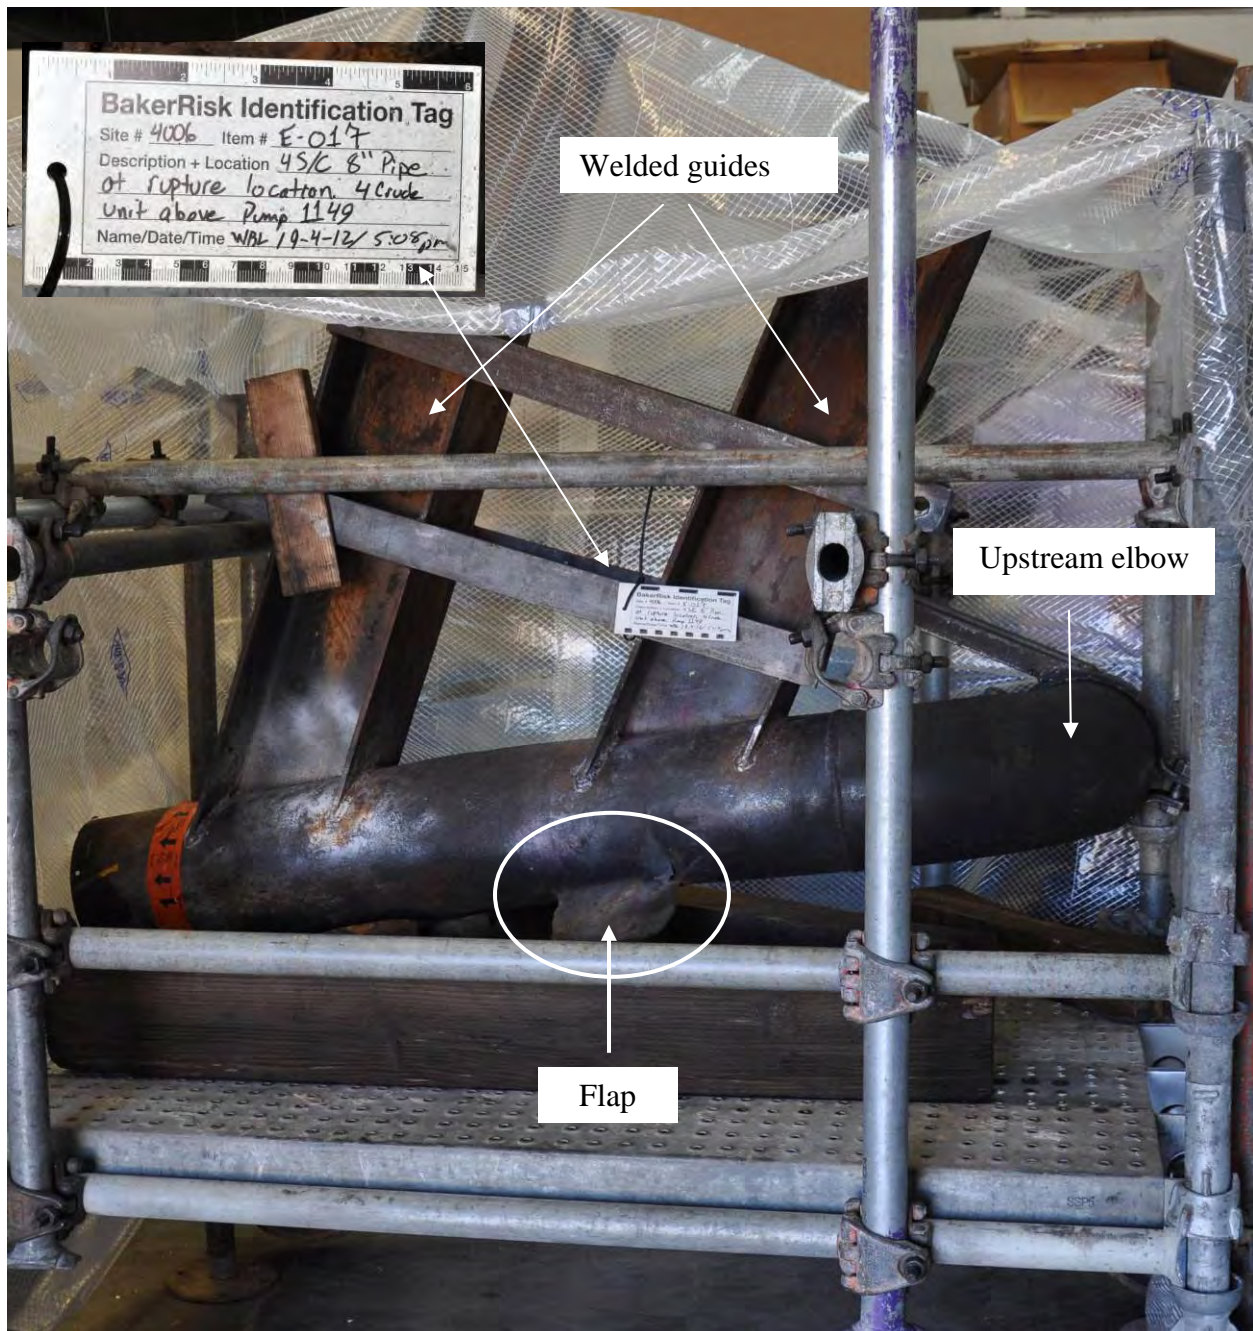
The ruptured section of the 8-inch 4-sidecut is shown as-received in Figure 1. This sample, E-017, consisted of an upstream elbow and the ruptured pipe. The downstream end of the ruptured pipe was sectioned about 8-inches from a circumferential weld that joined the pipe to a 30° elbow. In service, the welded pipe guides were vertical and the ruptured pipe was inclined about 30° from horizontal. The sample is shown in Figure 2 after being rotated 90° to provide better access to the rupture. A combination of flaky, rust colored and dark adherent scale was present on the outside surface of the sample, consistent with exposure of carbon steel pipe to heat and water from the fire and fire suppression efforts. Dark gray to black scale was present on the inside surfaces. Within the elbow, the dark colored scale was generally thicker and more friable

Figure 1 Photograph of the ruptured section of the 8-inch 4-sidecut sample E-017. The rupture location is circled. The flap projecting from the bottom is pipe wall forced outward at the location of the rupture. In service, the welded guides were vertical.

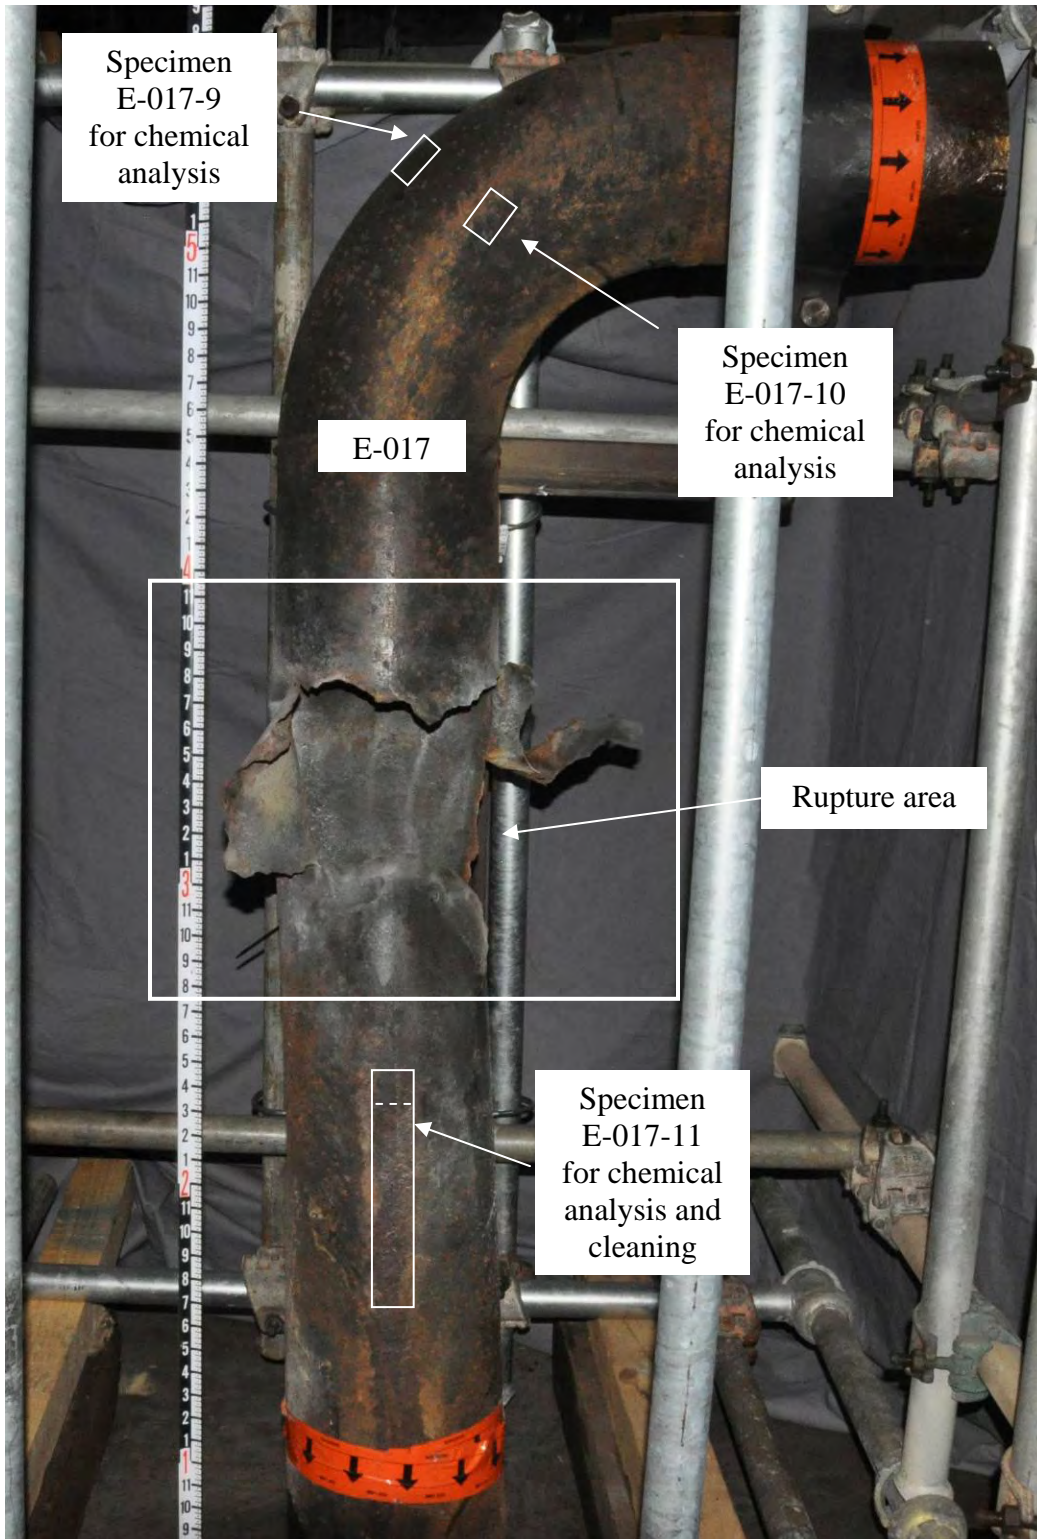
Figure 2 The ruptured sample E-017 and scaffold were rotated 90° to provide better access to the rupture area.

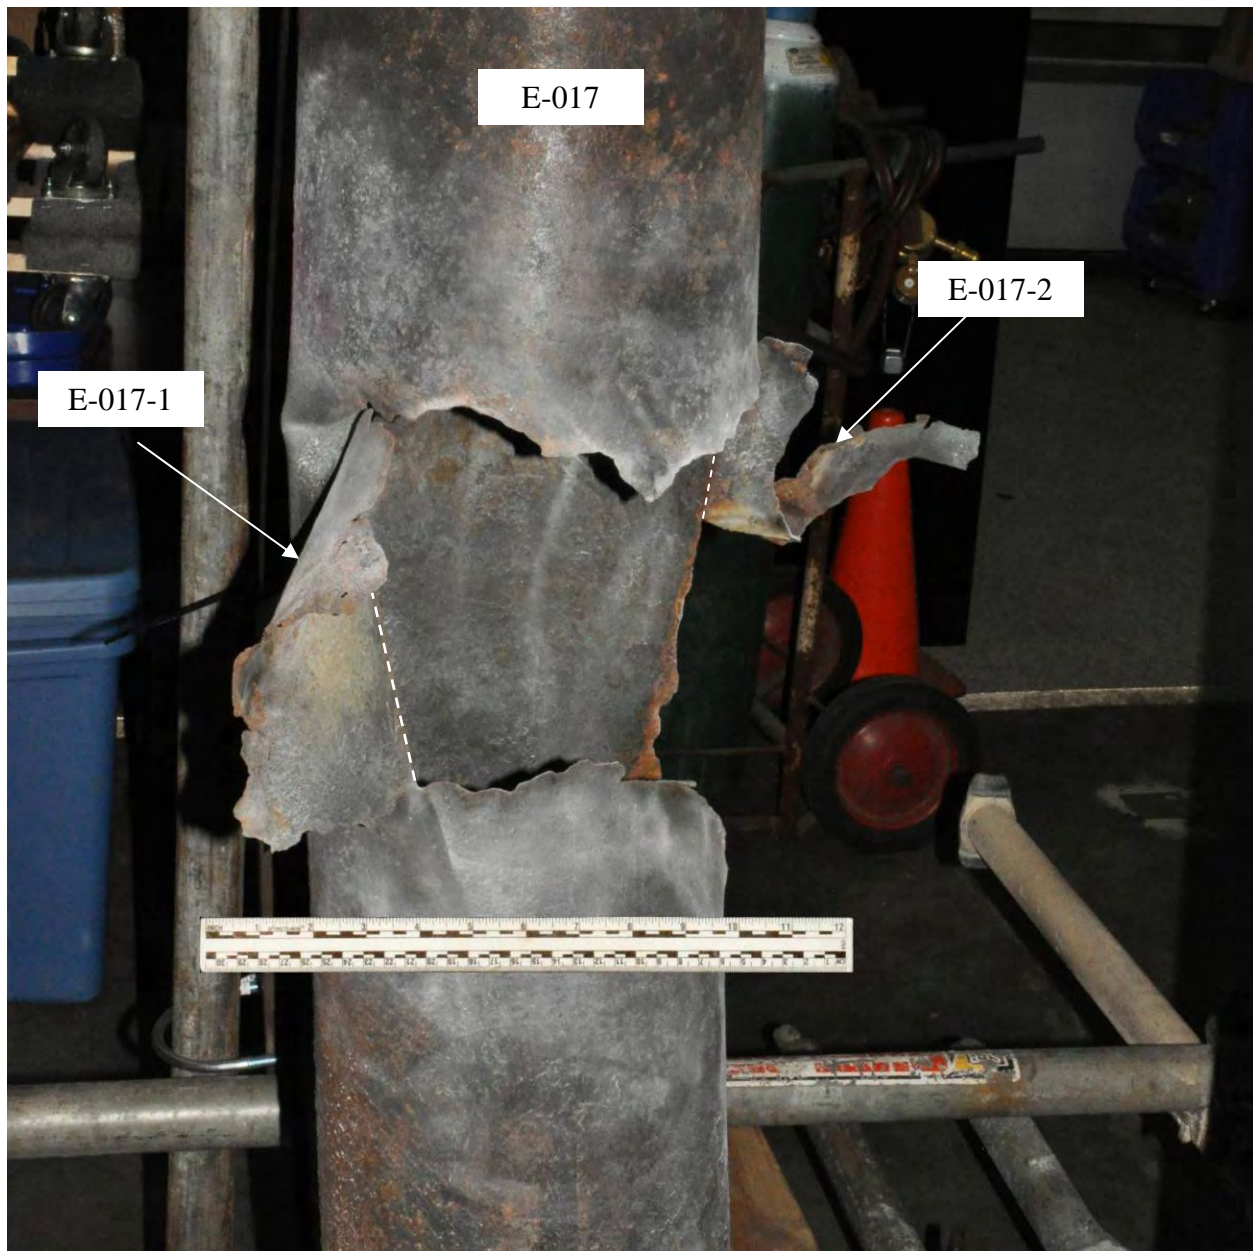
The rupture is shown from different perspectives in Figure 3 and Figure 4. A three dimensional model of the rupture was recorded by an outside contractor, 3D Scan Services, LLC, under agreement with the CSB, and a view of the model is shown in Appendix C.

Figure 3 Photograph of the rupture. Talcum powder had been applied around the rupture to aid laser scanning used to construct a three dimensional record of the rupture geometry. The dashed lines indicate where the rupture flaps, assigned the identification numbers E-017-1 and E-017-2, were sectioned.

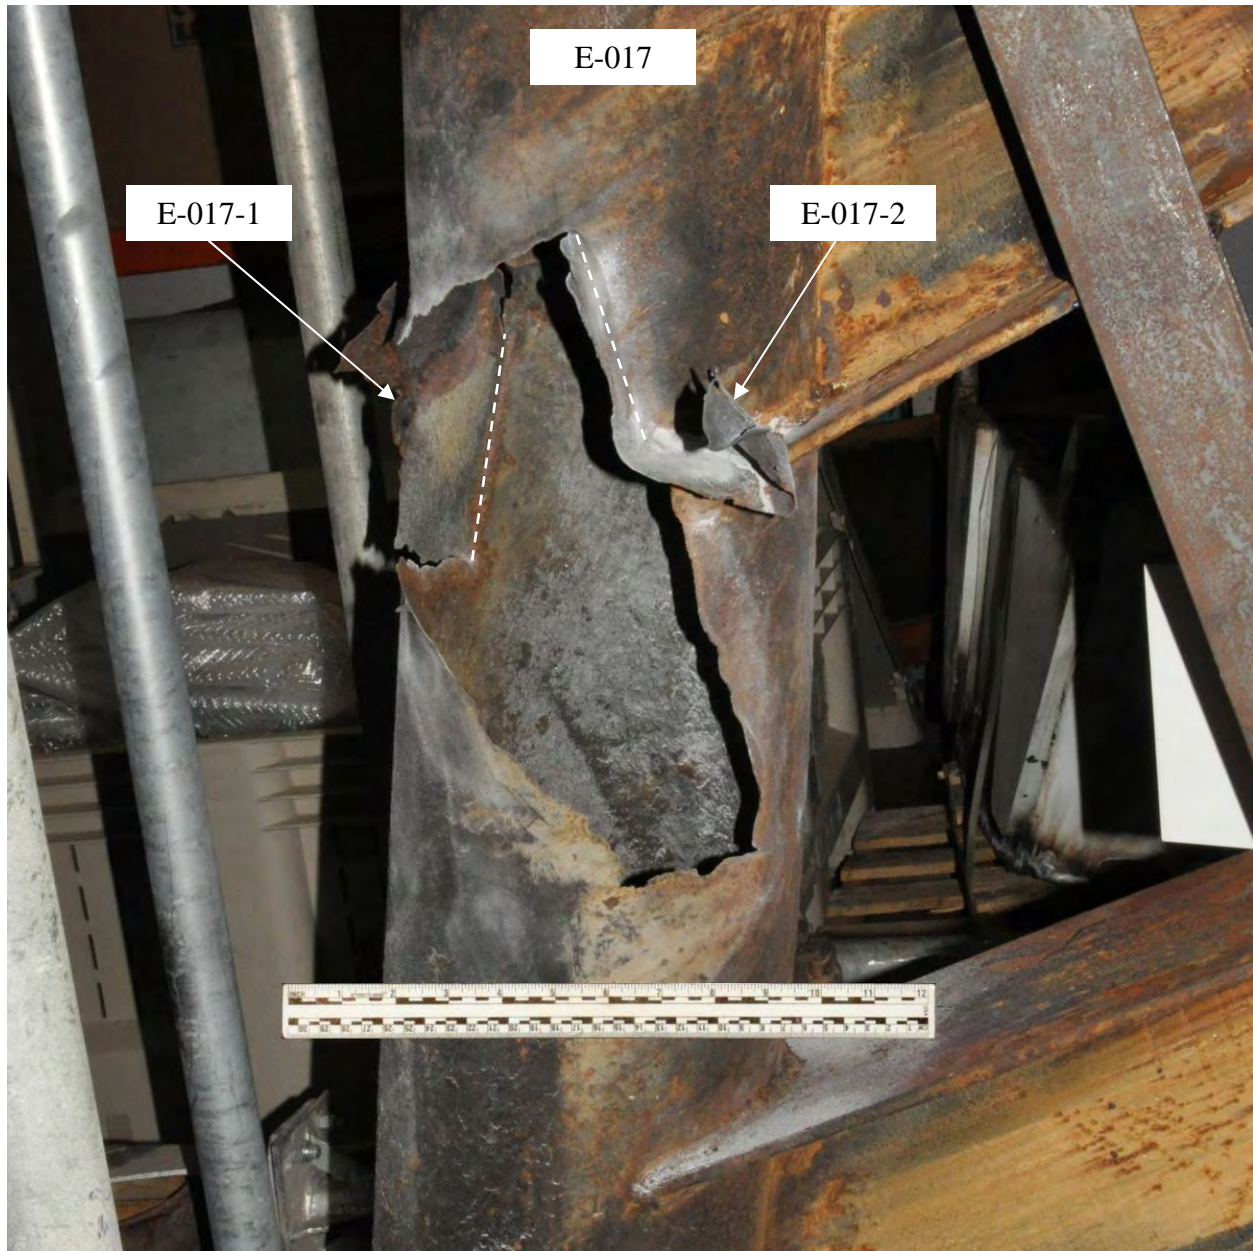
Figure 4 Photograph of the rupture from a different perspective than that shown in Figure 3. Talcum powder had been applied around the rupture to aid laser scanning to construct a three dimensional record of the rupture geometry. The dashed lines indicate where the rupture flaps, assigned the identification numbers E-017-1 and E-017-B, were sectioned.

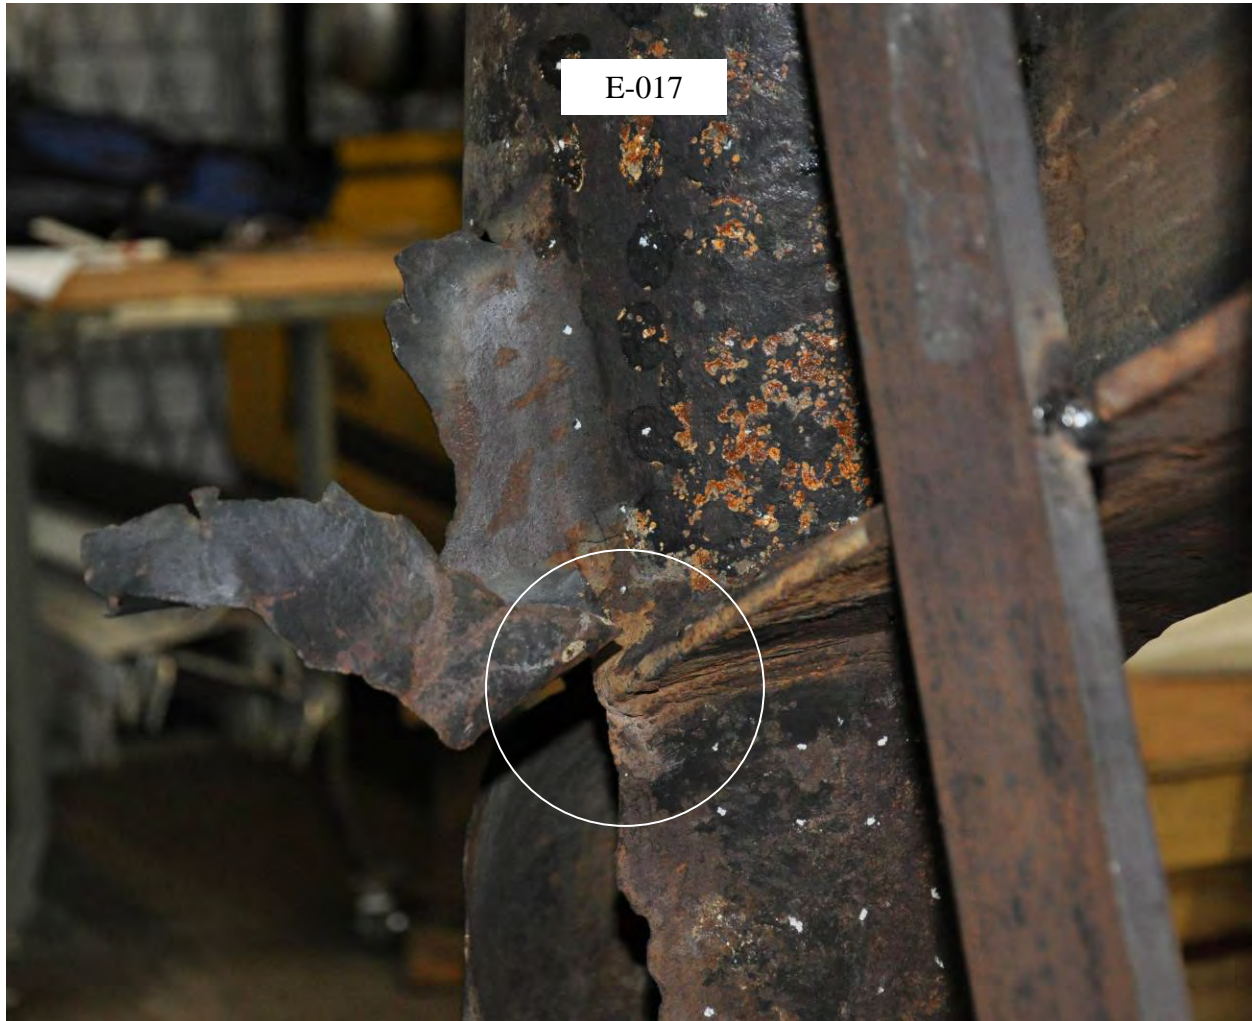
No evidence of localized thinning or rupture initiation related to the welded pipe guides was detected. In one case, the rupture intersected the toe of one of the guide welds, as shown in Figure 5. All other pipe guide welds ended 3 to 4-inches from the rupture edge. A small degree of pipe buckling near one side of the upstream welded guide was visible, as shown in Figure 6.

Figure 5 Photograph of the closest approach between the rupture and welded pipe guides of sample E-017. All other guide welds ended 4 to 6-inches from the rupture edge.

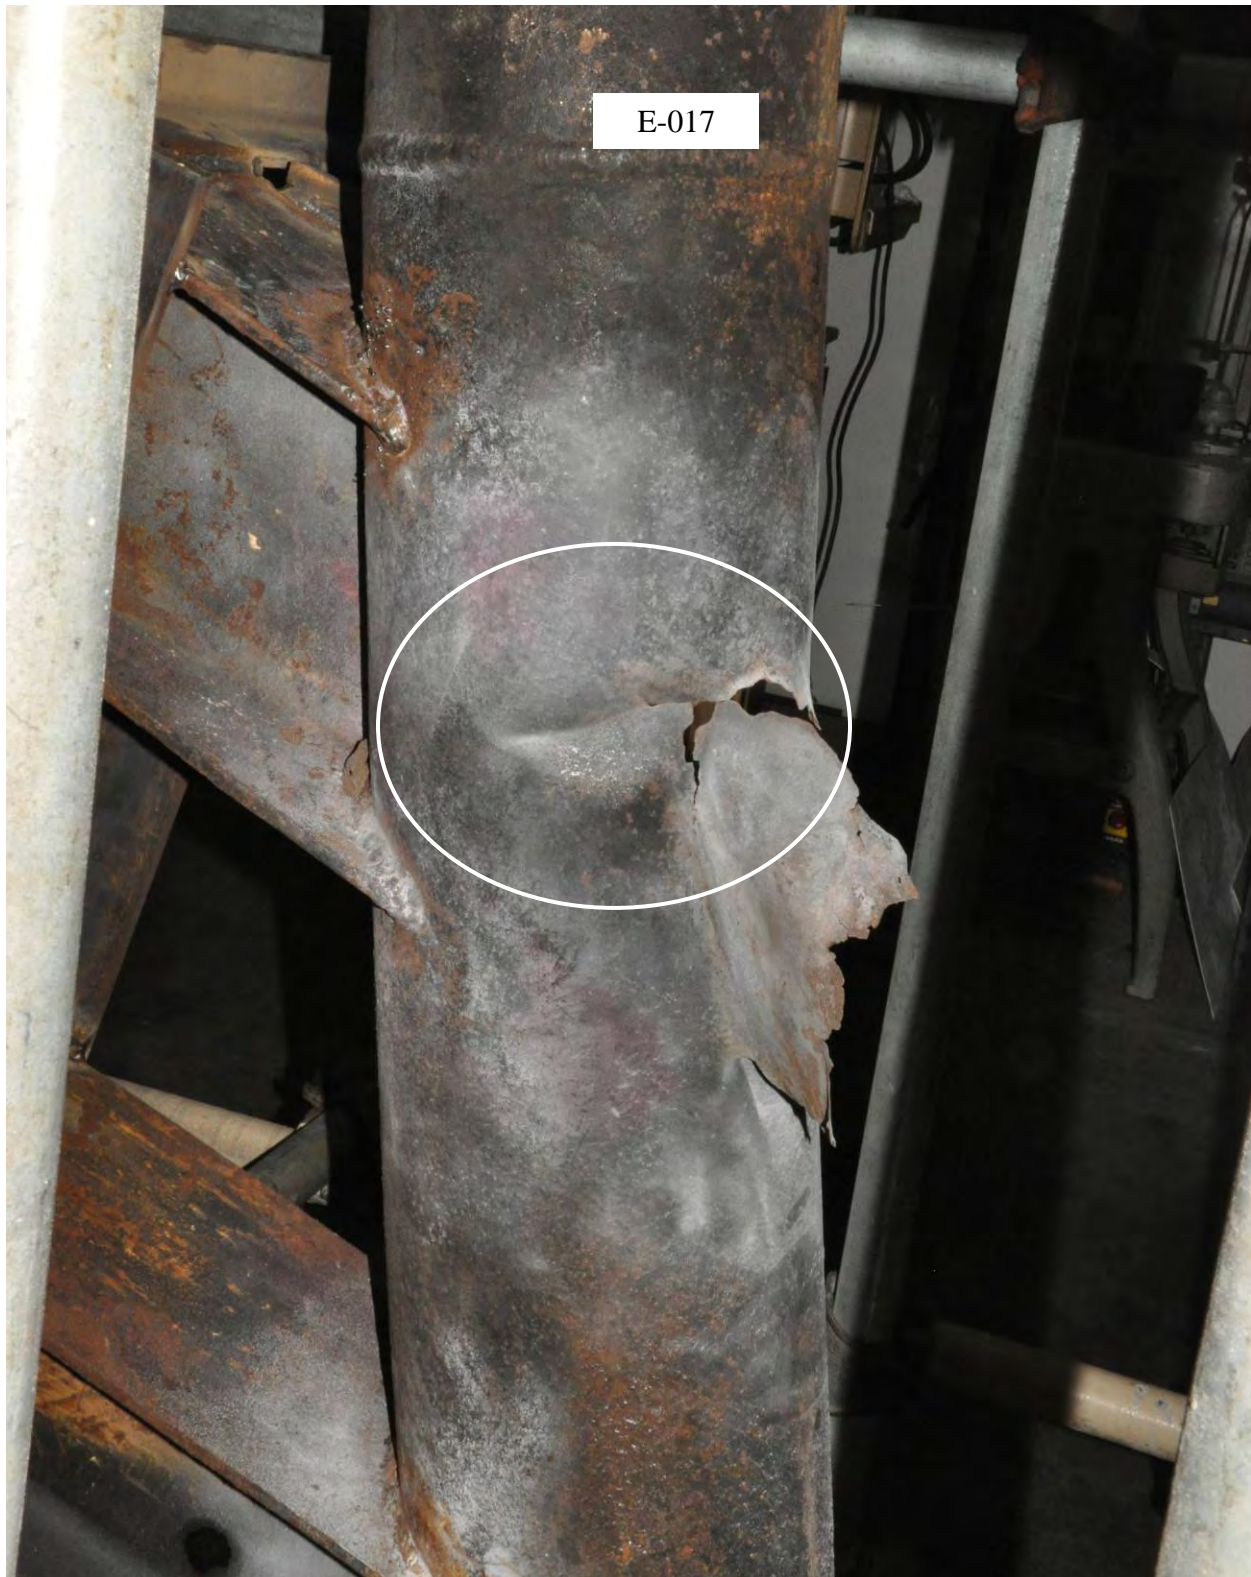
Figure 6 Photograph of the ruptured section of sample E-017. A small degree of buckling was present near the upstream welded pipe guide.

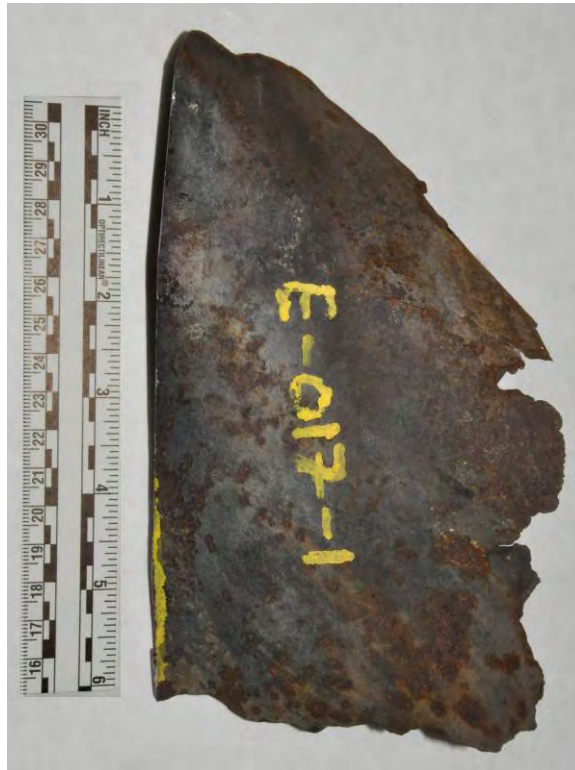
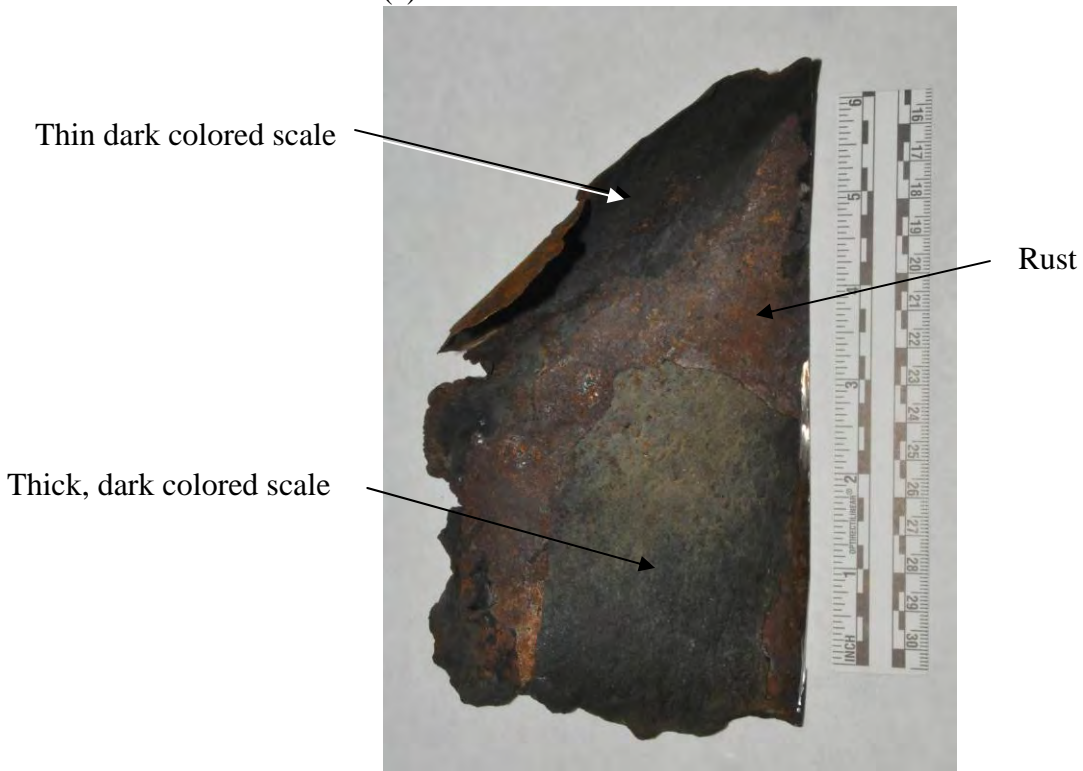
Figure 7 Rupture area flap sectioned from the pipe and assigned the number E-017-1.

Flaps E-017-1 and E-017-2 are shown after sectioning in Figure 7 through Figure 10. Following examination in the as-sectioned condition, the bends and curvature of the flaps were straightened by hand so their shape and area could be recorded. Thickness measurements were taken within 0.100-inch of the edges of the specimens at the locations indicated in Figure 8 and Figure 10 using a pointed anvil micrometer. The maximum thickness measured was 0.070-inch and the minimum thickness measured was 0.012-inch. It was reported that the 4-sidecut piping had been made from Schedule 40 pipe, which means that the original thickness of the 8-inch (NPS 8) line had been 0.322-inches. The thickness measurements indicate that extensive wall loss had occurred. In Figure 8, small perforations inside of the specimen edges were visible, which suggest that through-wall leaks were likely present prior to rupture.

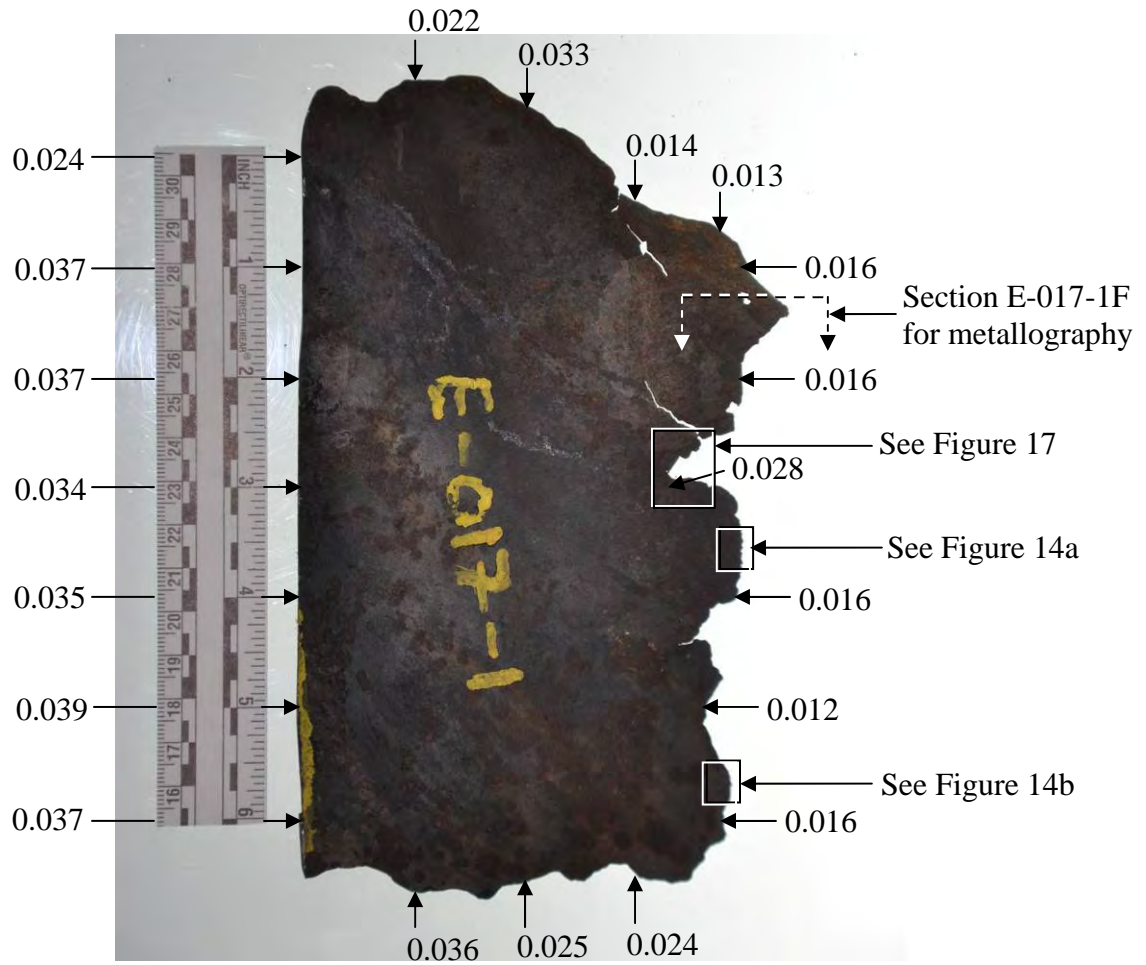
Figure 8 Section E-017-1 after flattening. Thickness measurements were made with a pointed anvil micrometer within 0.100-inch of the edge at the locations indicated before cleaning.

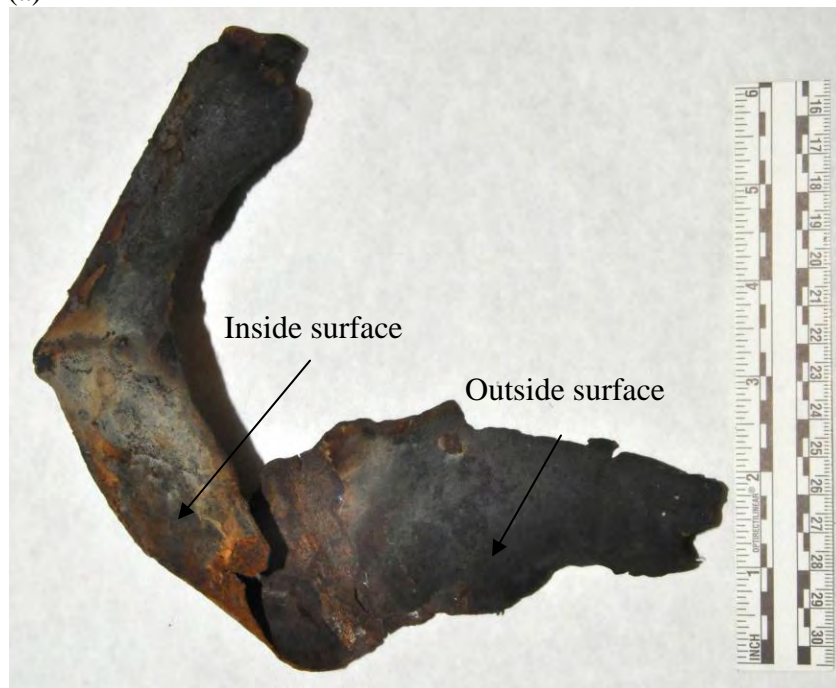
Figure 9 Rupture area flap sectioned from the pipe and assigned the number E-017-2.

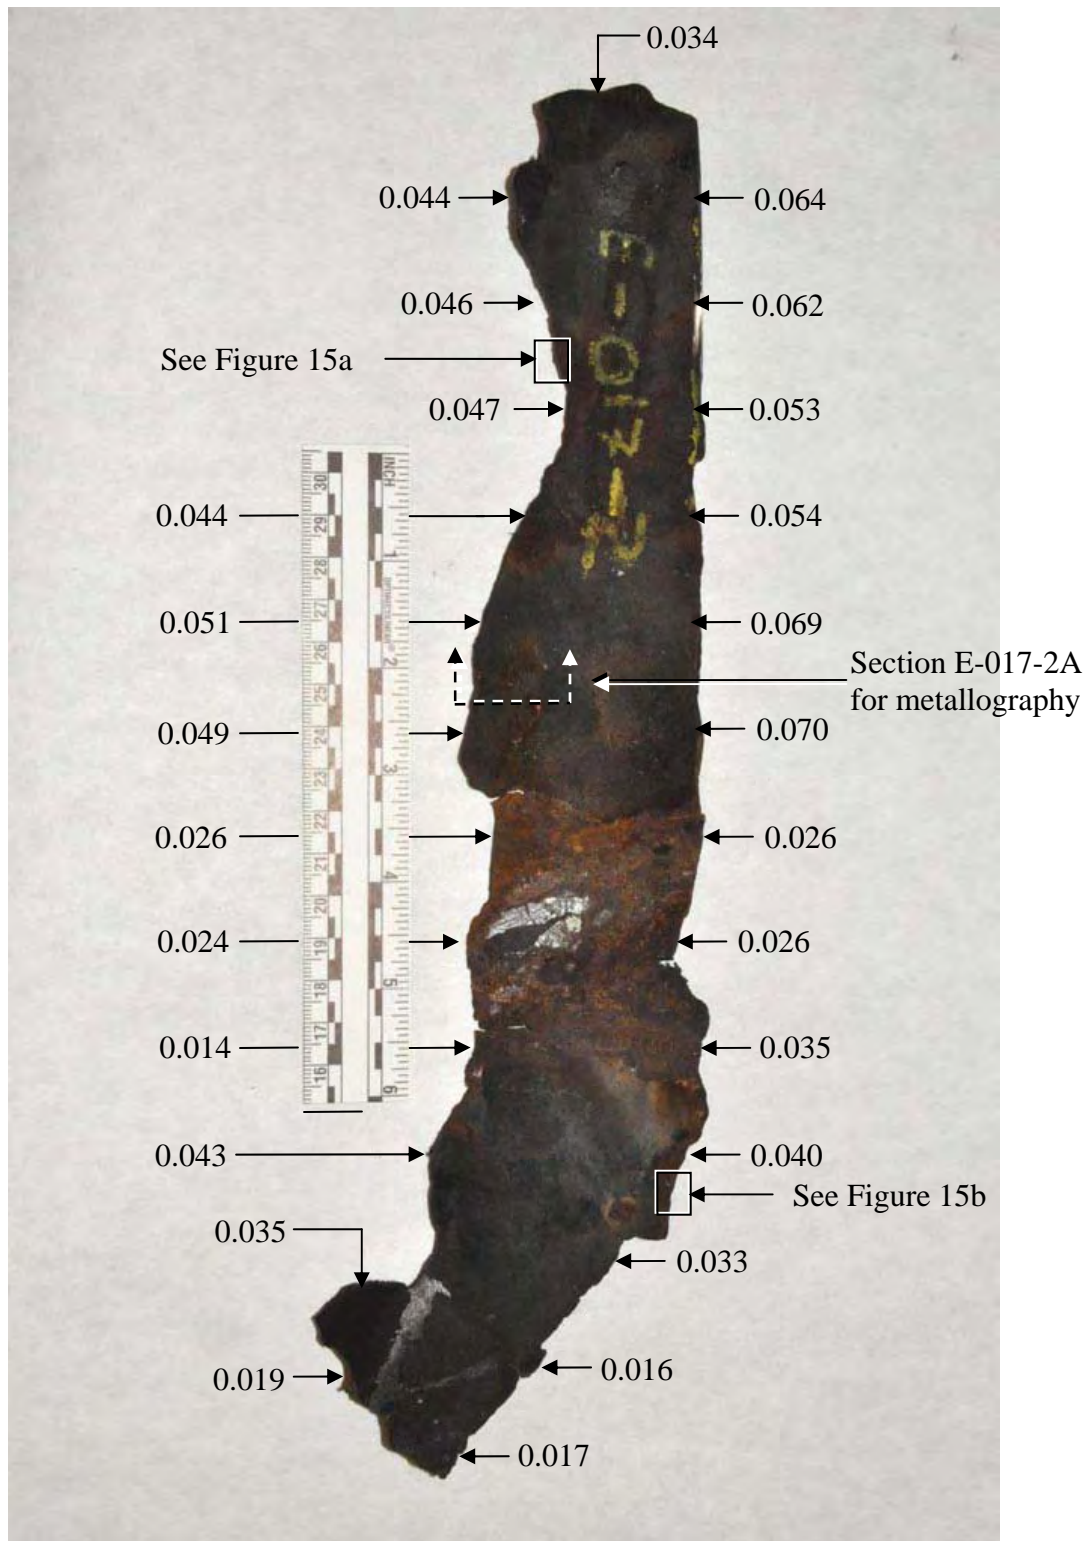
Figure 10 Section E-017-2 after flattening. Thickness measurements were made with a pointed anvil micrometer within 0.100-inch of the edge at the locations indicated before cleaning.

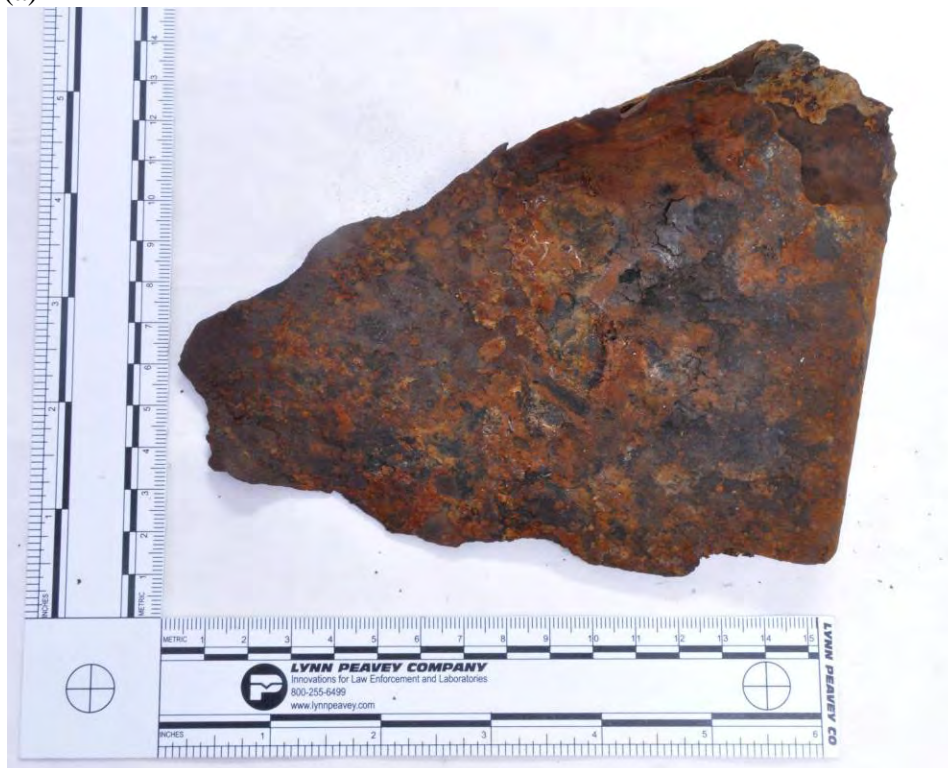
Sample E-014 was recovered from the ground beneath the rupture after the incident. As shown in Figure 11, E-014 was folded over and covered with rust, but the general thickness was similar to that of the ruptured area, and the sample was attracted to a magnet, which indicated that it could be carbon steel. The sample was straightened out and thickness measurements were taken along the edges at the locations indicated in Figure 12 in the same manner as for E-017-1 and E-017-2, before cleaning. The maximum thickness measured was 0.056-inch and the minimum thickness measured was 0.023-inch.

Figure 11 Fragment E-014 recovered from the ground beneath the rupture.

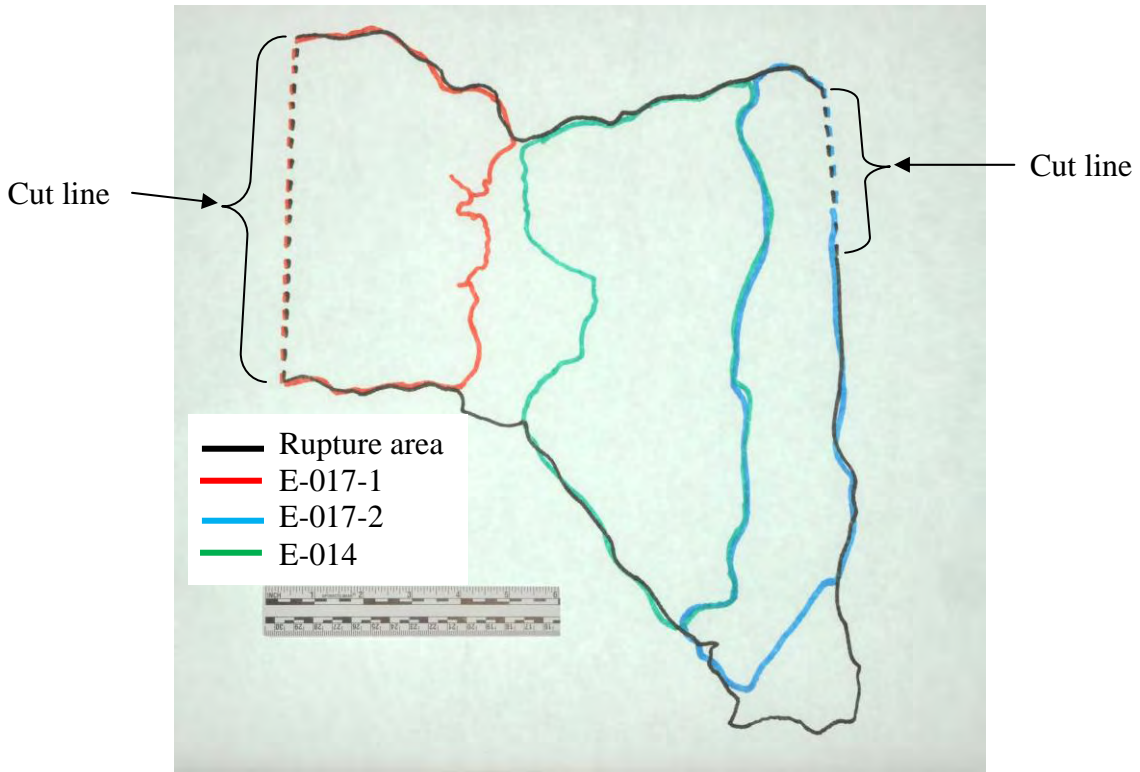
Figure 13

The total rupture area was determined from the tracing to be between 94 and 106-square inches. The smaller number was obtained directly from the tracing and the larger number was determined from the tracing adjusted slightly so that E-017-1, E-017-2, and E-014 did not overlap the traced lines in the longitudinal direction. Some of the overlap can be accounted for by a slight buckle in the pipe, indicated in Figure 6. Two areas of the ruptured pipe wall that were not accounted for, one between E-017-1 and E-014, and one at the downstream end of E-017-2, measured 8.8 and 2.4-square inches, respectively, indicated in Figure 13b.

Geometric relationship between the rupture area, flaps E-017-1, E-017-2, and sample E-014. In (a) the total rupture area is shown in black and the shapes of E-017-1, E-017-2, and E-014 are shown in red, blue, and green, respectively. In (b) flaps E-017-1, E-017-2, and sample E-014 are shown on top of the tracing.

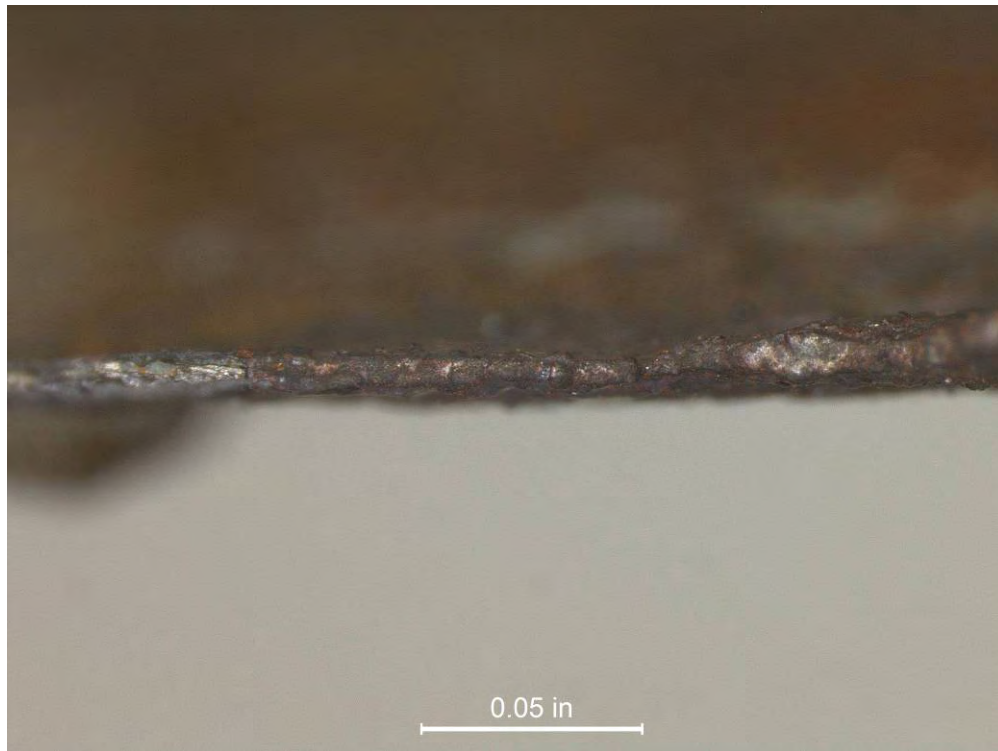
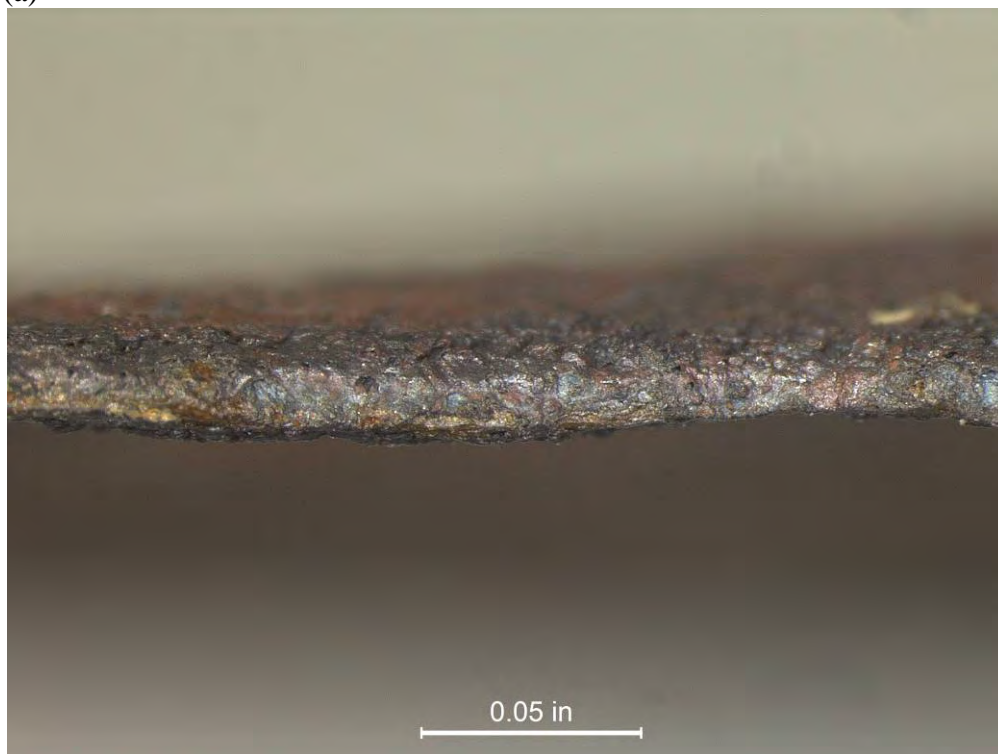
Edges of E-017-1, E-017-2, and E-014 were examined using an optical stereomicroscope. The edges were covered with rust and dark colored scale, consistent with having been exposed to the fire and water from the fire suppression efforts. Two general edge morphologies were present. In the thinnest areas, the edges tapered to a rounded edge. In the thicker areas, the edges were relatively flat with steps and facets. Representative macrographs are shown in Figure 14 through Figure 16. As described in Section 2.5, corrosion of the rupture edges destroyed evidence of the fracture origin. However, rupture likely originated in the thinnest region and initially followed a longitudinal path driven by the hoop stress. Therefore, the location of the initial leak and rupture origin was likely within the circled area in Figure 13b.

Figure 14 Representative optical macrographs of tapered edges on the rupture edge of specimen E-017-1. The locations from which these macrographs were recorded are indicated in Figure 8.

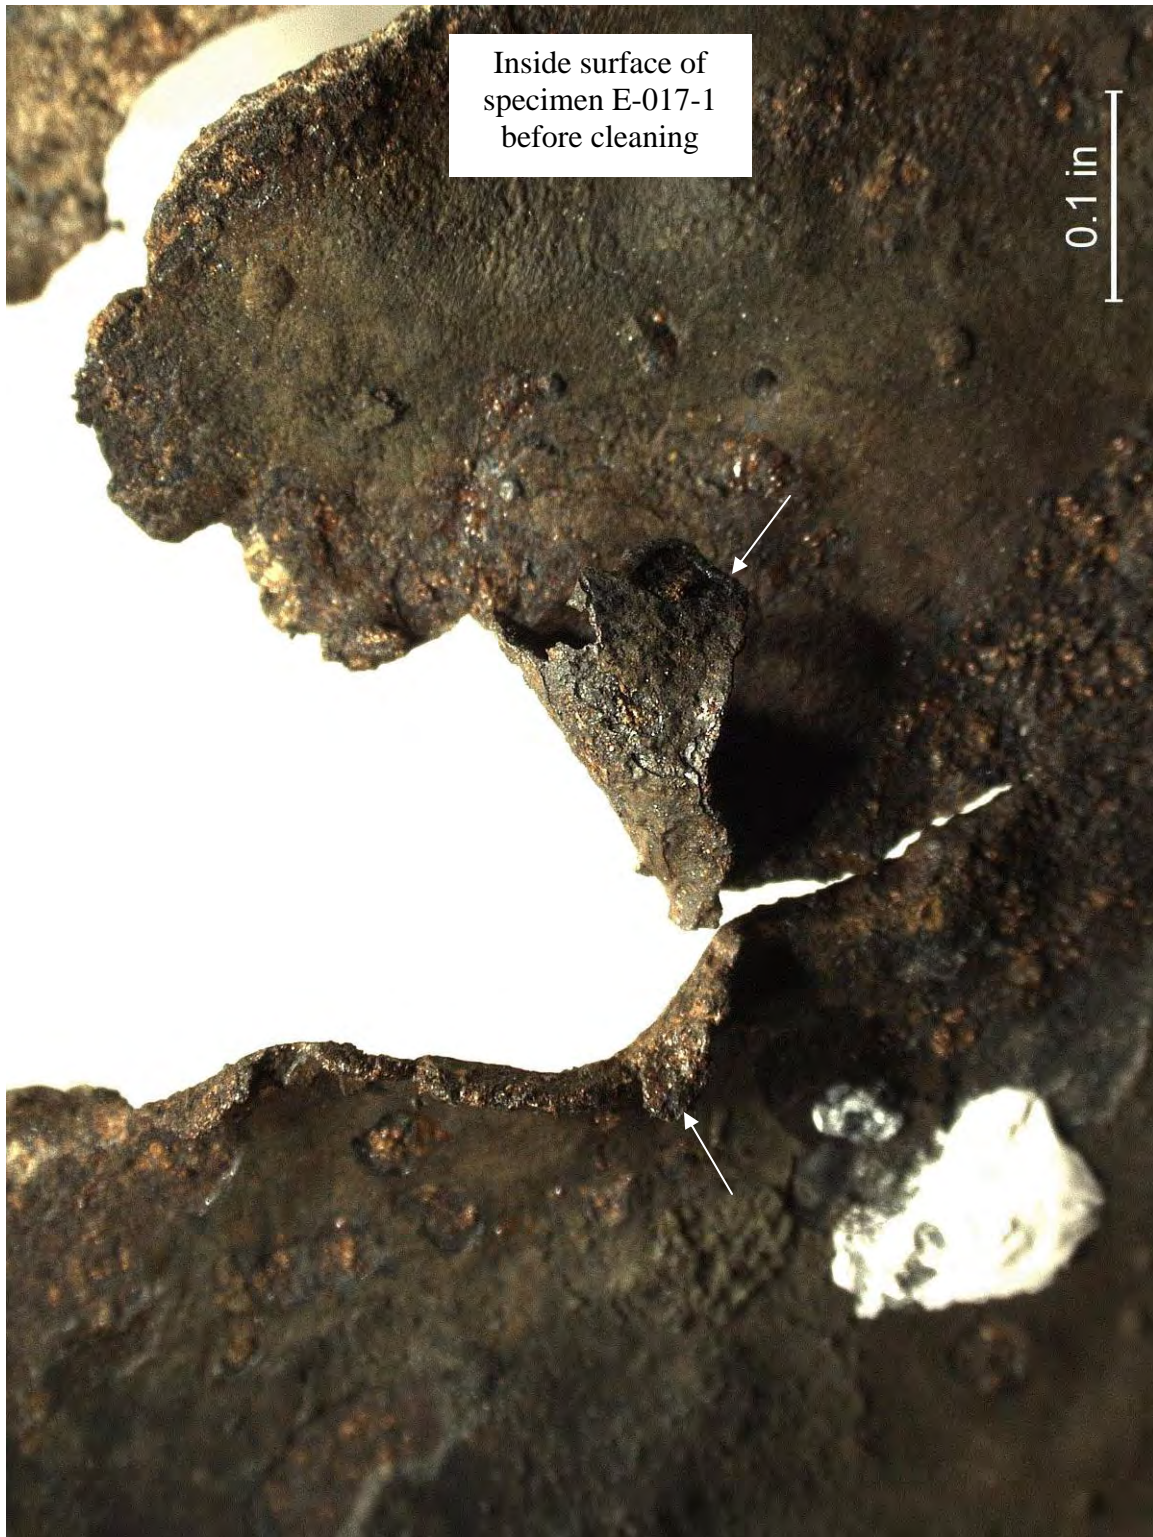
A region of ruptured edge deformation toward the inside surface of the pipe on specimen E-017-1 is shown in Figure 17. The deformation, located at the 6 o'clock position or bottom side of the pipe, was consistent with mechanical force applied to the outside surface of the pipe. The CSB requested that the morphology of the deformation be compared to the shape of two tools, referred to here as fire pikes, recovered from the post incident scene. Photographs of the fire pike samples E-099 and E-082-2 are shown in Figure 18 through Figure 21. Both pike tips had essentially the same geometry. The deformed region of specimen E-017-1 was compared to the tip of both fire pikes and a good physical fit between the pike tips and the inward deformation of the specimen was found, as shown in Figure 22. The orientation of the fire pike, with respect to the ruptured section, that would have been required to produce the observed fit between the tip and the inward deformation of the rupture edge is shown in Figure 23.

Figure 17 Macrograph of the inside surface of specimen E-017-1 taken from the region indicated in Figure 8 before cleaning. Deformation of the specimen edge, indicated by arrows, was consistent with mechanical force applied from the outside.

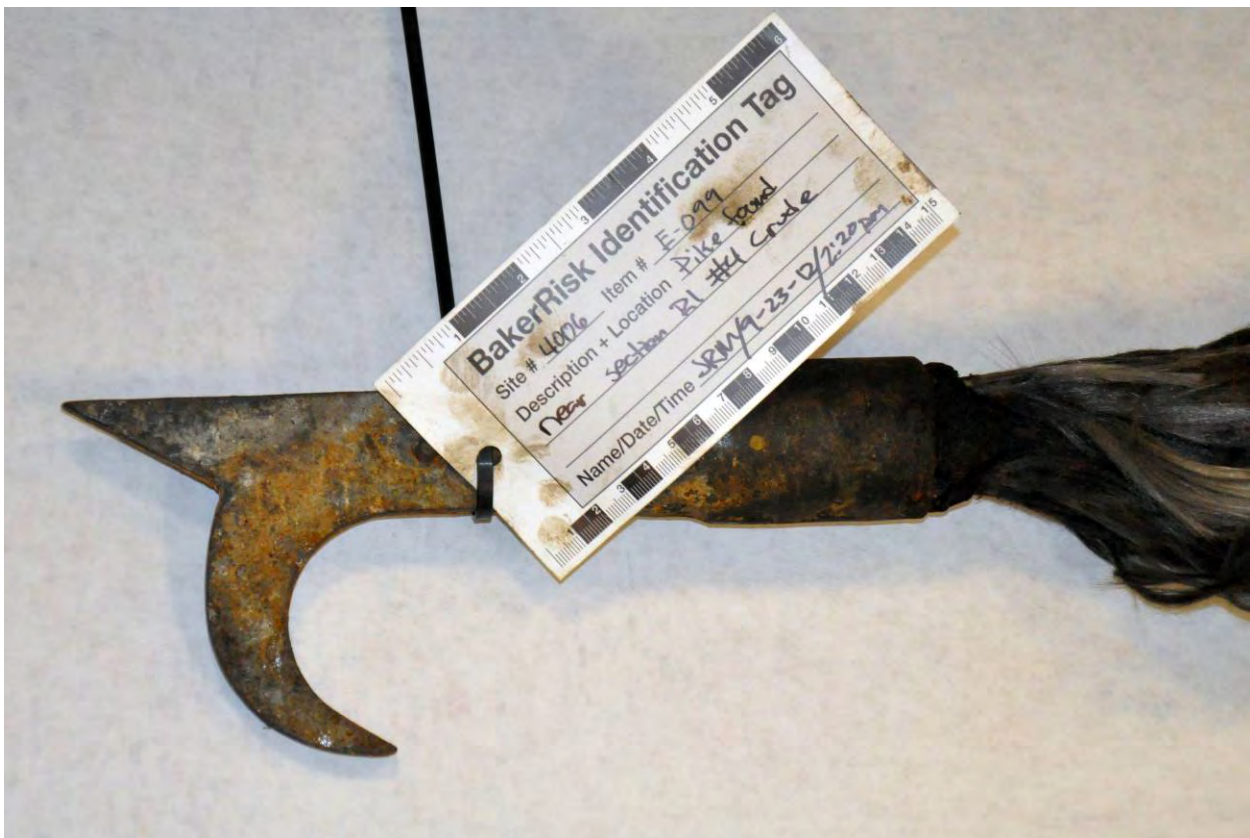
Figure 18 Photographs of pike pole sample E-099 recovered from the site of the ruptured 4-sidecut. The pole was made from glass fiber reinforced polymer, and much of the polymer was burned away in the fire. A tangle of exposed glass fibers remained.
