METALLURGICAL EVALUATION OF SAMPLES FROM THE CHEVRON U.S.A. INC., RICHMOND #4 CRUDE UNIT 8-INCH AND 12-INCH 4-SIDECUT PIPING INVOLVED IN THE AUGUST 6, 2012, HYDROCARBON RELEASE AND FIRE

Prepared for: The Chemical Safety and Hazard Investigation Board (CSB)

Report No. 5004.7920 B

February 11, 2013

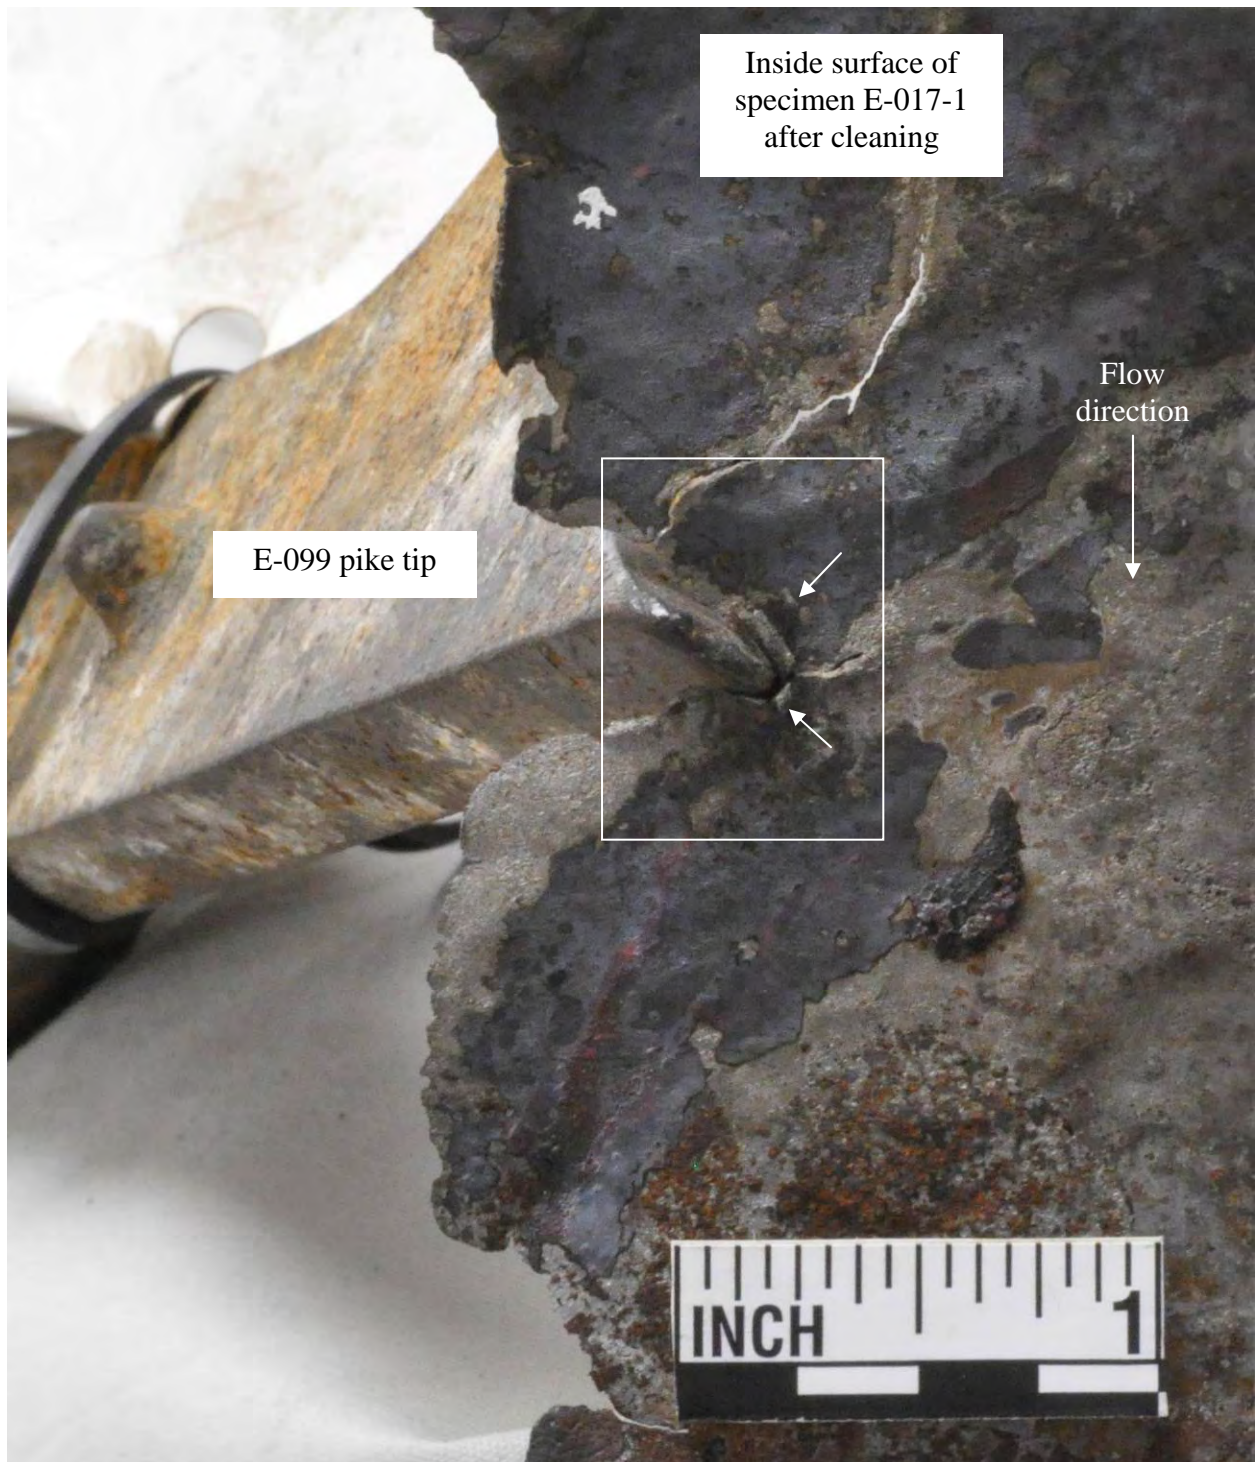
Figure 22 Photograph of the fire pike pole tip and the inside surface of specimen E-017-1. The boxed area is shown without the pike pole in Figure 17. The pike tip fit the region of inward deformation.

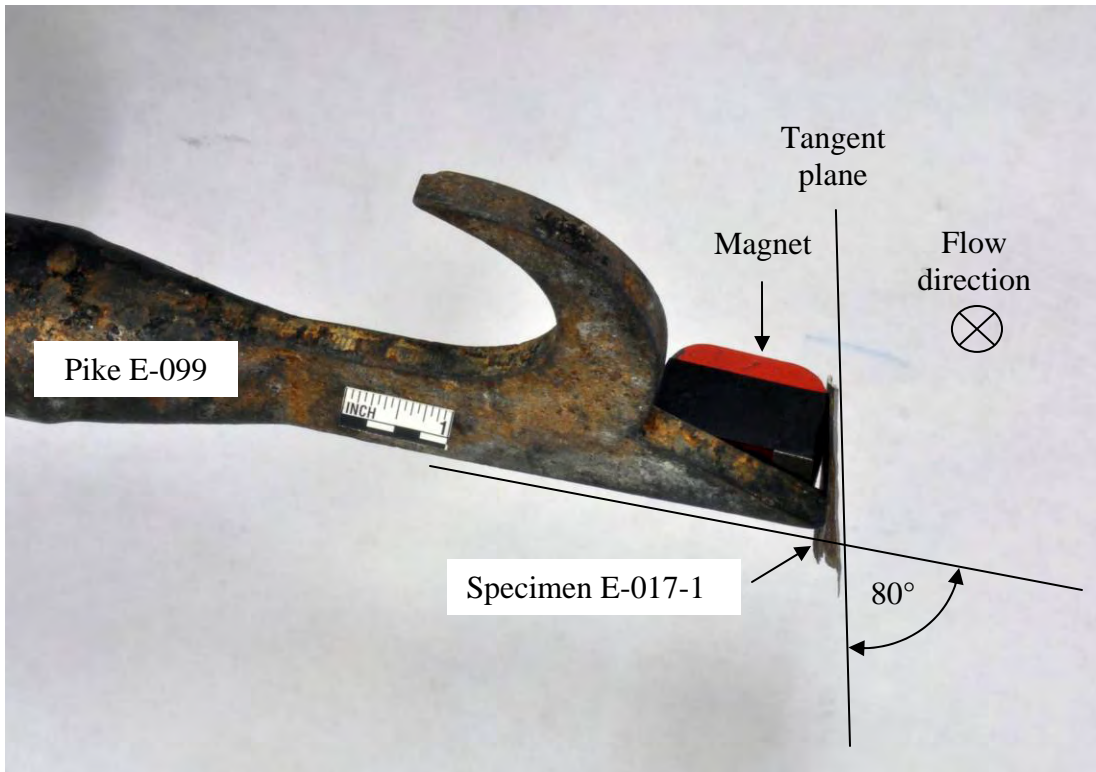
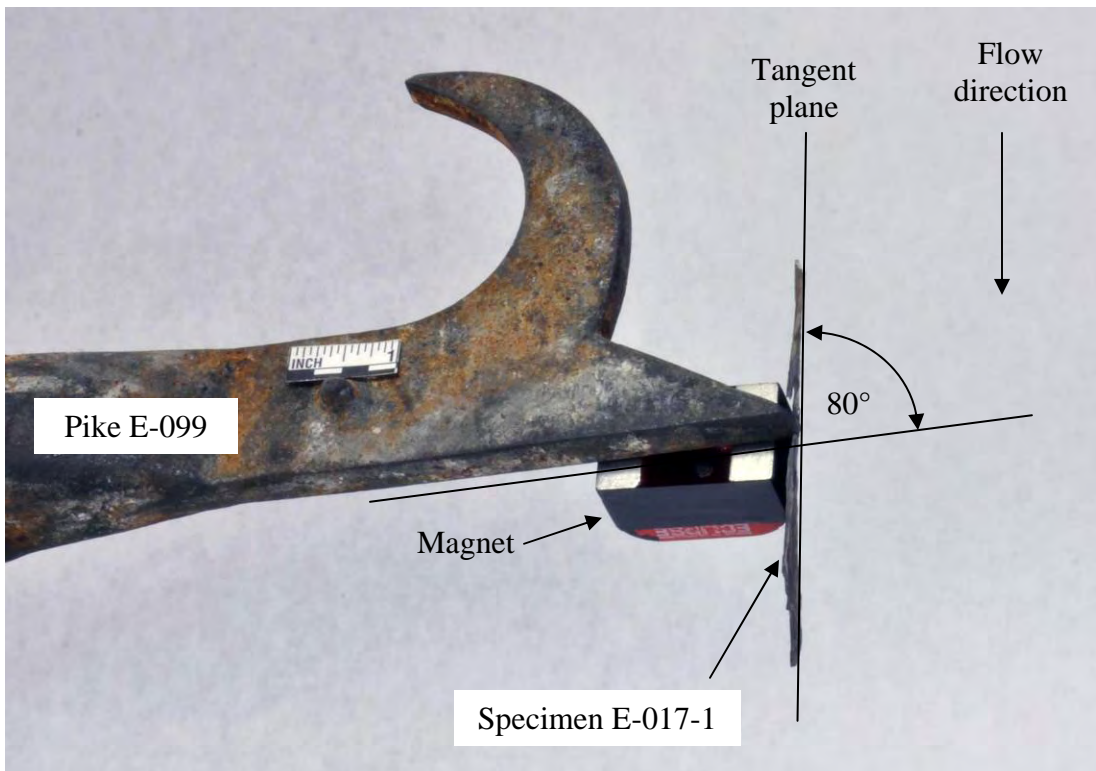
Figure 23 Two orthogonal views of the fire pike E-099 fit to the location on specimen E-017-1 shown in Figure 22. The magnet served to hold specimen E-017-1 in place.

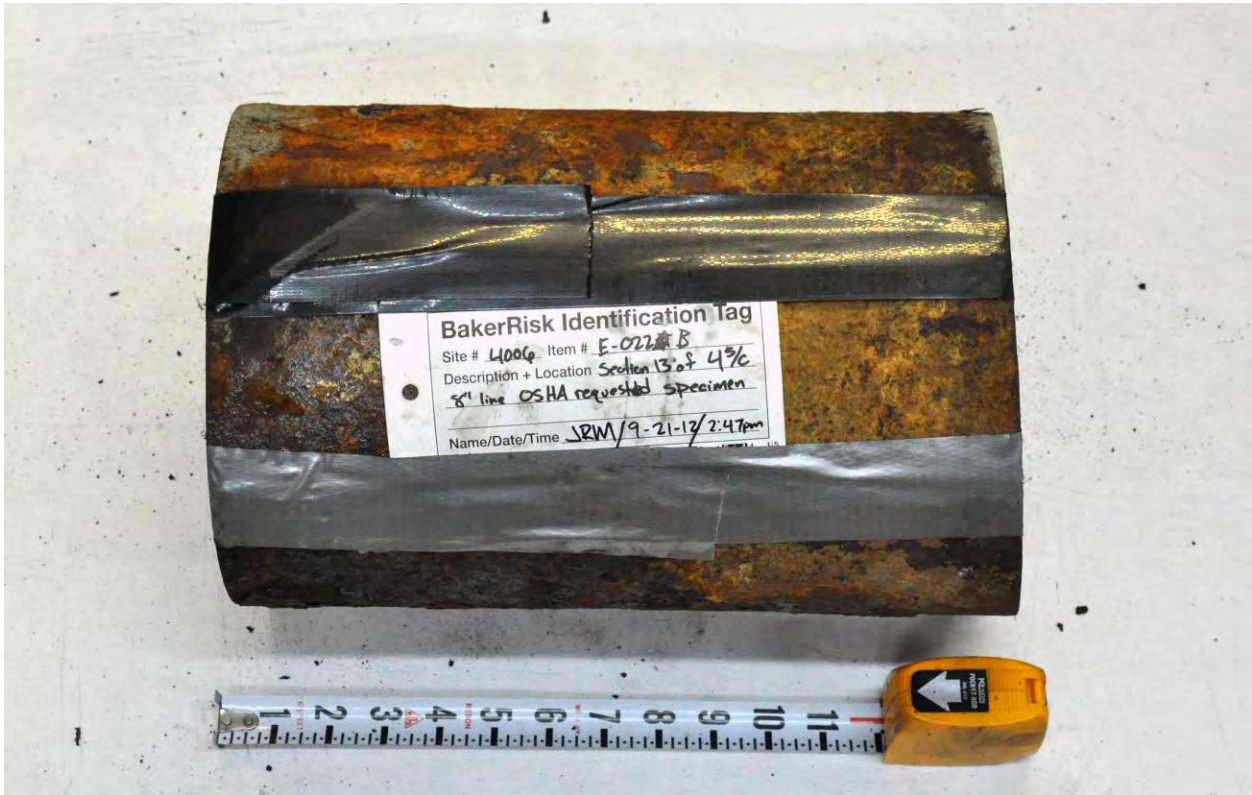
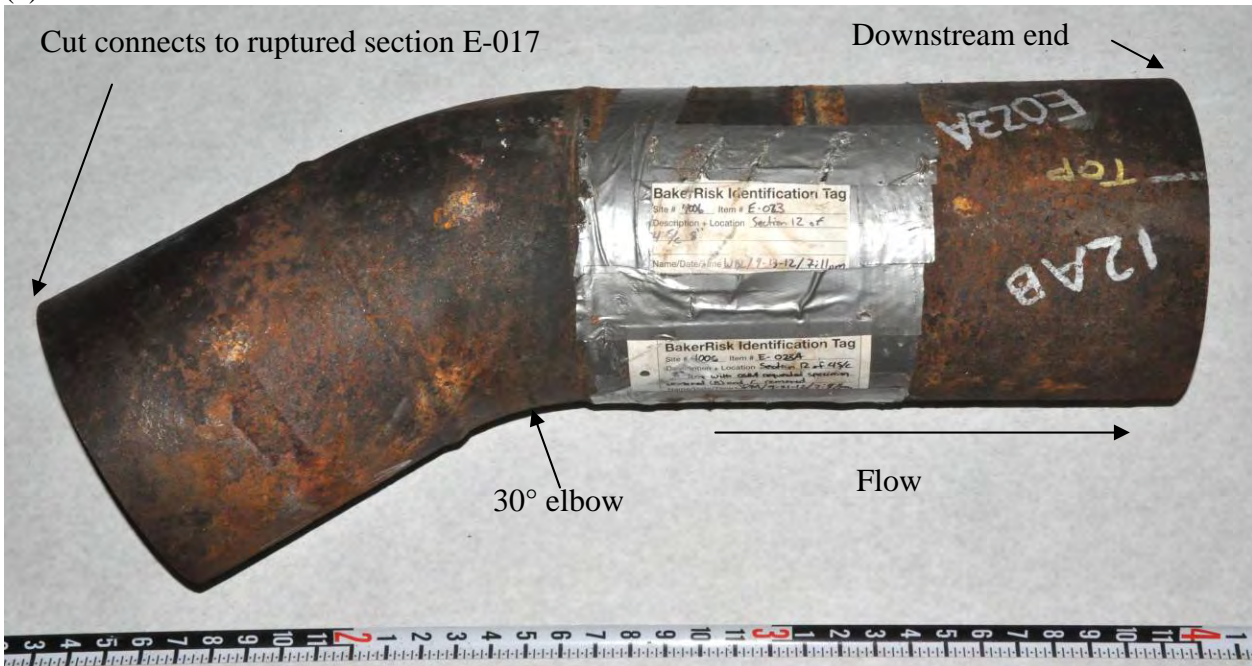
Segments of the 8-inch 4-sidecut sampled from various locations in the line under the combined direction of Cal/OSHA, CUSA, and the CSB are shown in Figure 24 through Figure 27a. Sample E-023A consisted of an 8-inch section of the ruptured pipe, a 30° elbow, and a 15-inch section of pipe downstream from the elbow. Sample E-023C consisted of a 15-inch section of pipe, 90° elbow, and 3-inch section of downstream pipe. With the exception of sample E-017, described in Section 2.1.1, all other 8-inch pipe samples consisted of short lengths of pipe without welds.

Figure 24 Photographs of 8-inch 4-sidecut samples E-022B and E-023A as-received.

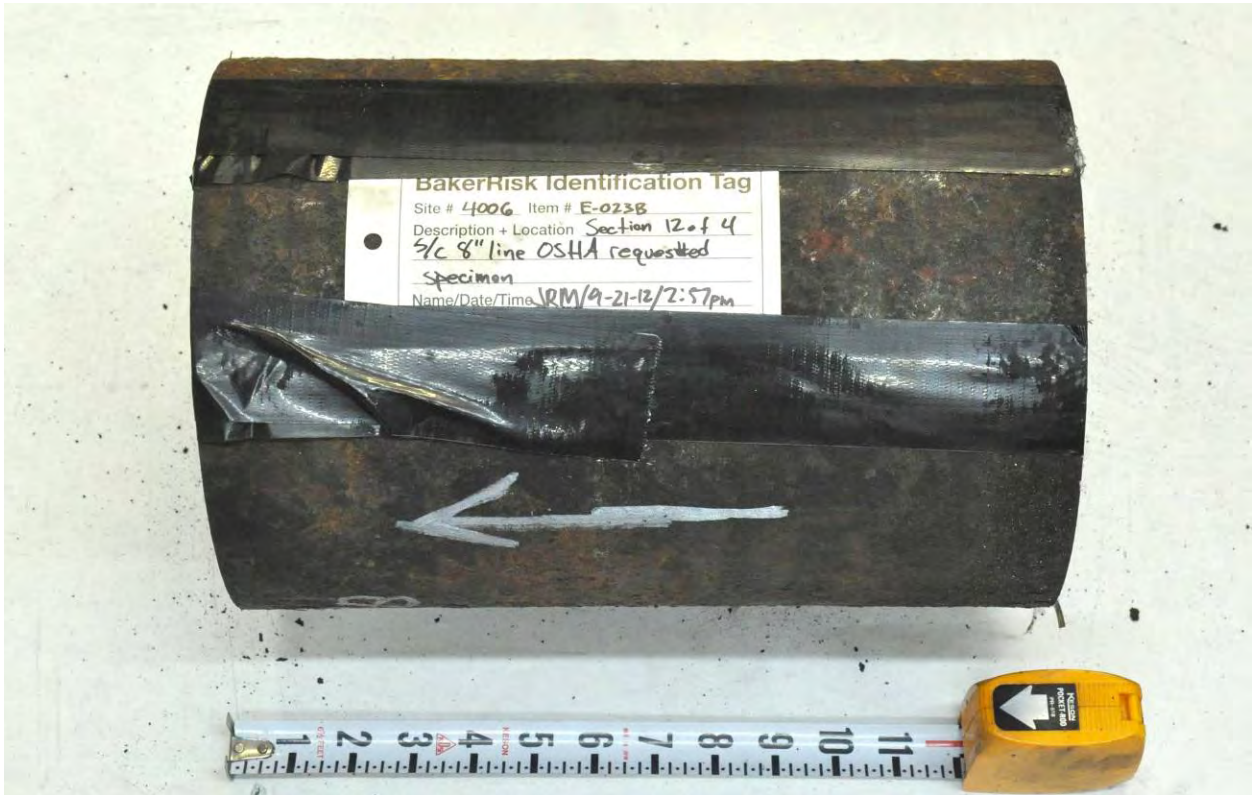
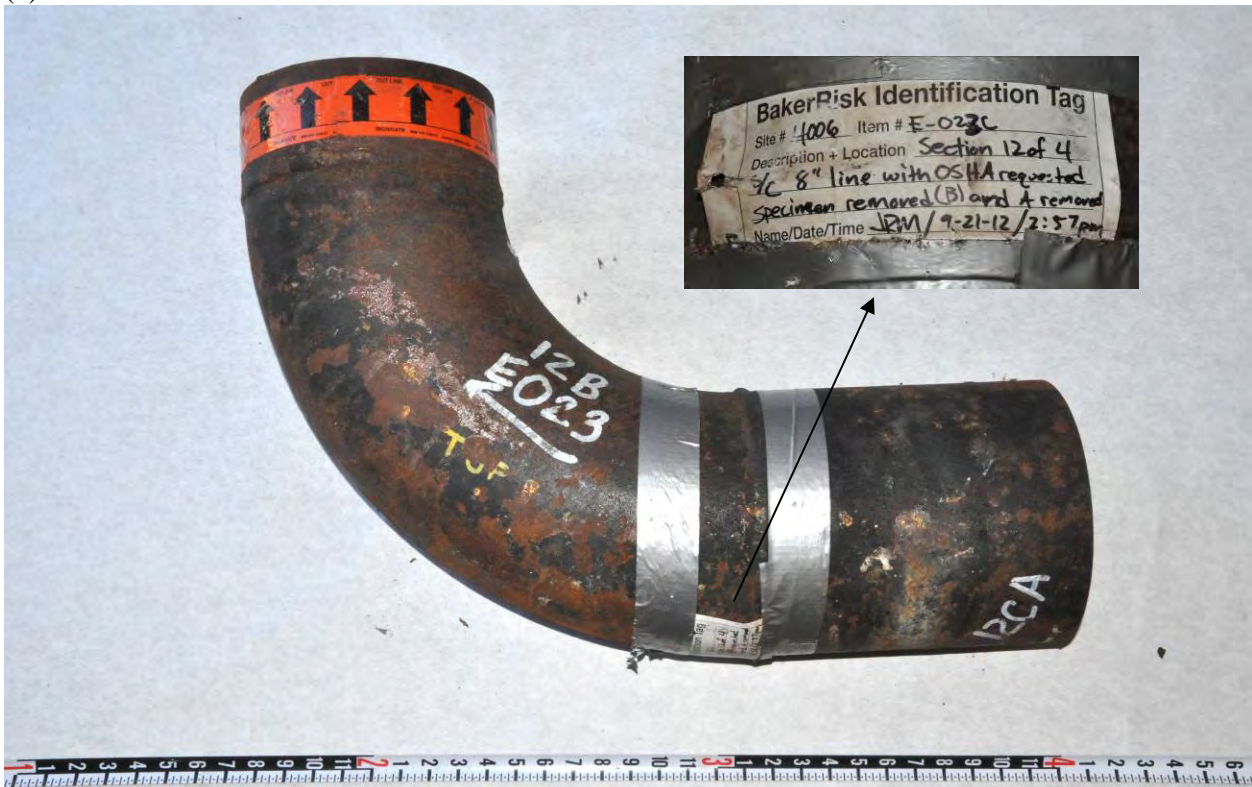
Various combinations of flaky rust and dark colored adherent scale were present on the outside surface of the 8-inch samples. Sample E-023B had the most flaky, rust colored scale, and sample E-034B had the most dark colored, adherent scale. Dark gray to black scale was present on the inside surfaces of all the samples. The inside scale was friable at the surface, and adherent under the surface, where it had a shiny metallic appearance when scraped with a metal spatula. All of these characteristics are consistent with sulfidation corrosion product.

Figure 25 Photographs of 8-inch 4-sidecut samples E-023B and E-023C as-received.

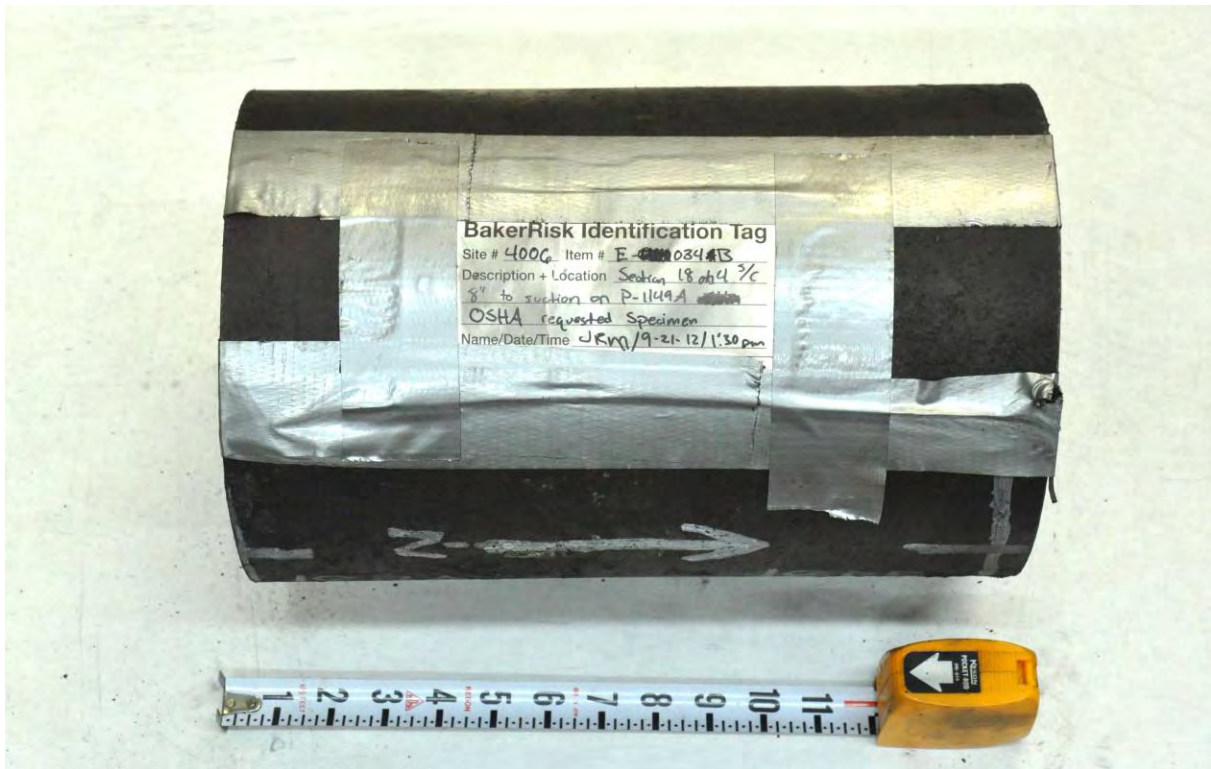
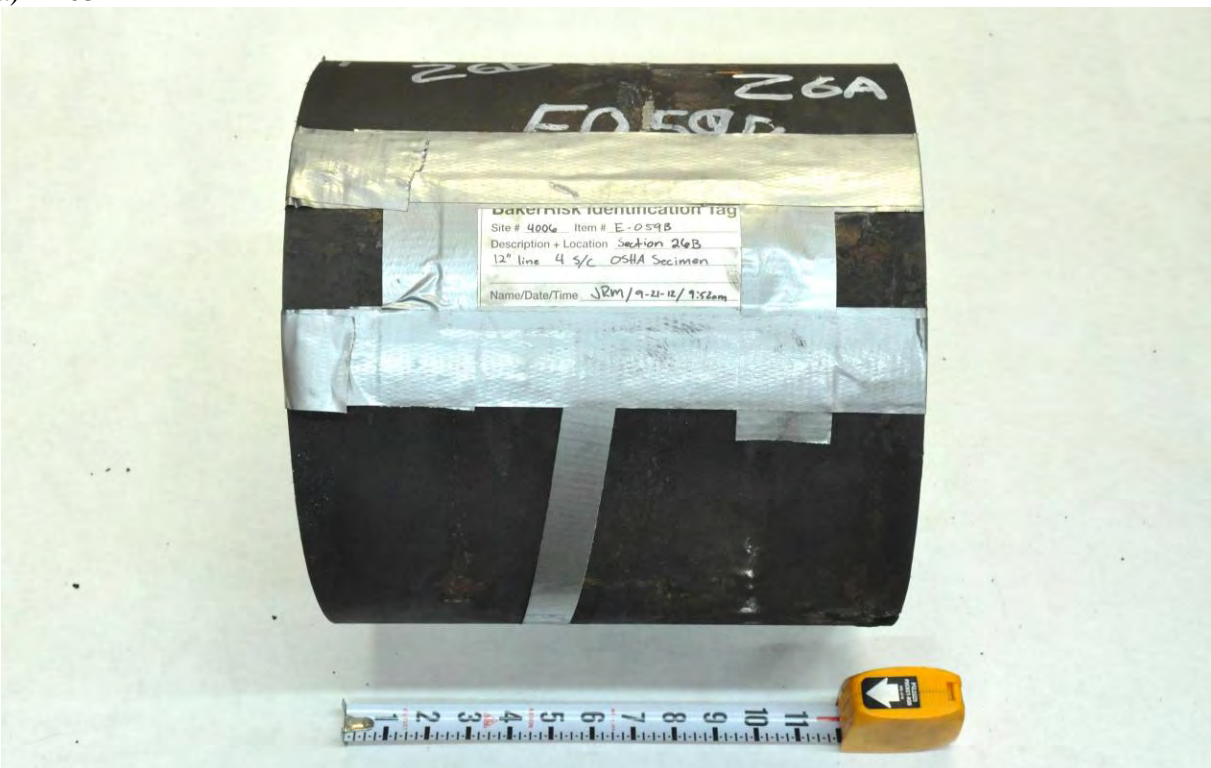
A thick, black, easily disturbed deposit was present on top of the scale in sample E-034B. The appearance and consistency suggested the deposit was soot. X-ray diffraction, described in Section 2.6, identified amorphous carbon in the scale specimen taken from the inside surface of this sample. Rust was present on the inside surfaces of some of the samples, and some, including E-030B, had rusty liquid level lines consistent with collection of water within the line during the 23 days that water was applied to the scene.

Figure 27 Photographs of 8-inch 4-sidecut sample E-034B and 12-inch 4-sidecut sample E-059B as-received.

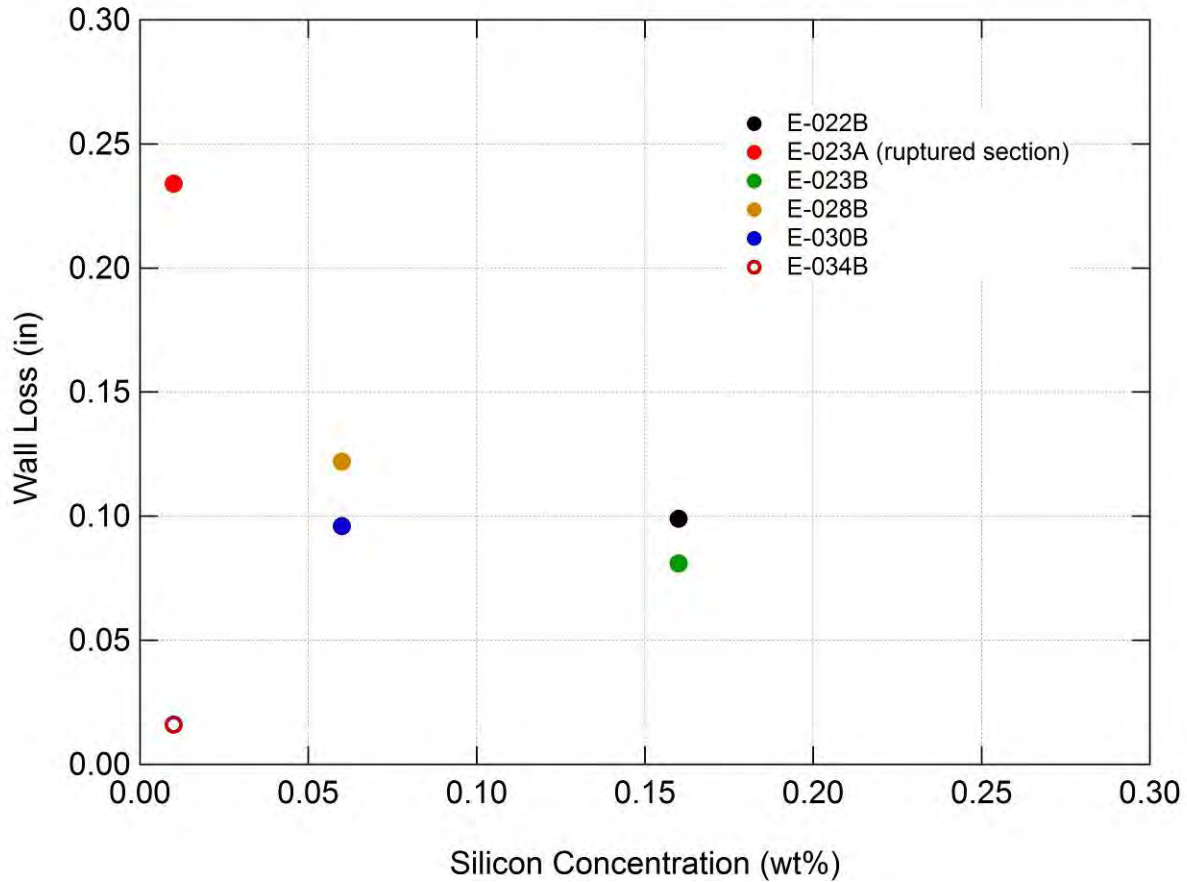
Silicon concentration in carbon steels can have an important effect on sulfidation corrosion rate². Sulfidation rates are generally greater for carbon steels with silicon concentration below 0.1-wt% than for steels containing more than 0.1-wt% silicon. A plot of wall loss and silicon concentration for samples of the 8-inch 4-sidecut is shown in Figure 37. Wall loss was calculated for each sample from the difference between the average of four thickness values listed in Table 2 and the 0.322-inch nominal thickness of 8-inch Schedule 40 pipe. The data points present an overall trend of decreasing wall loss caused by sulfidation with increasing silicon concentration, except for the data point from sample E-034B. Sample E-034B was cut out of a vertical run from the 8-inch line to a spare pump. Consequently, the flow conditions in this section were likely to have been different compared to what the other samples were exposed to.

Figure 37 Plot of wall loss and silicon concentration for samples of the 8-inch 4-sidecut. Wall loss was calculated from the average of thickness measurements listed in Table 2 subtracted from the 0.322-inch nominal wall thickness for 8-inch Schedule 40 pipe. Sample E-034B was removed from a vertical run off the main 8-inch 4-sidecut, that led to a spare pump. Consequently, the service conditions were likely different, particularly in terms of flow, compared to the rest of the 8-inch samples.

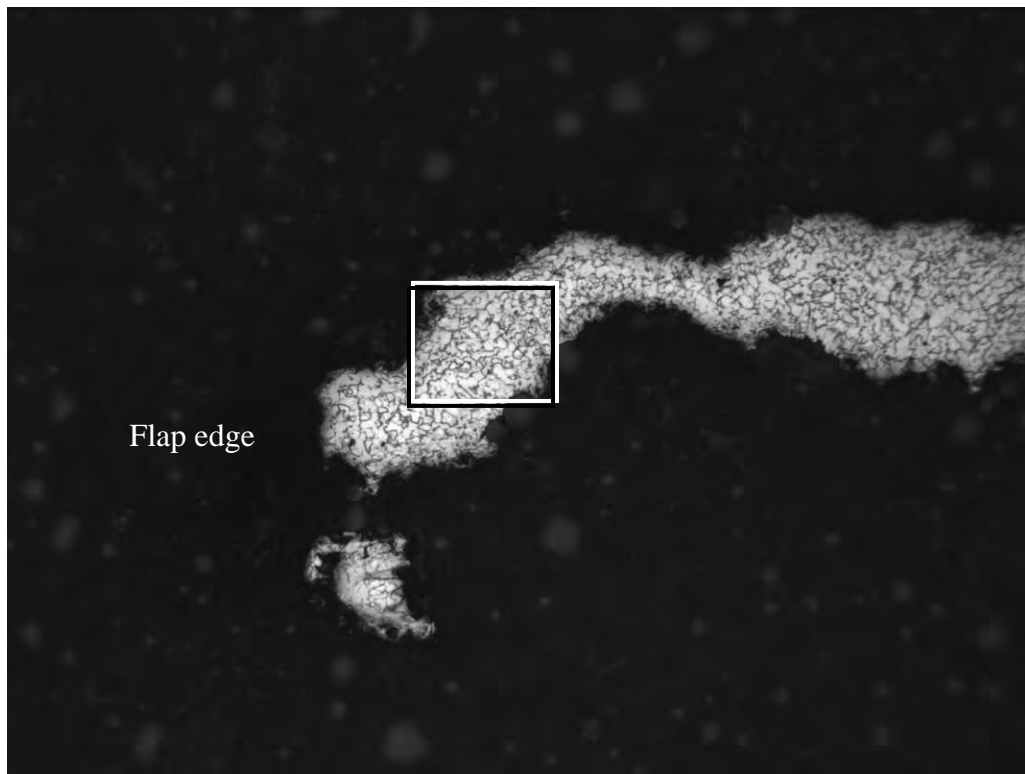
Figure 42 Optical micrographs of specimen E-017-1F, prepared from the section indicated in Figure 8 after cleaning. The entire specimen had been recrystallized by the heat of the fire.

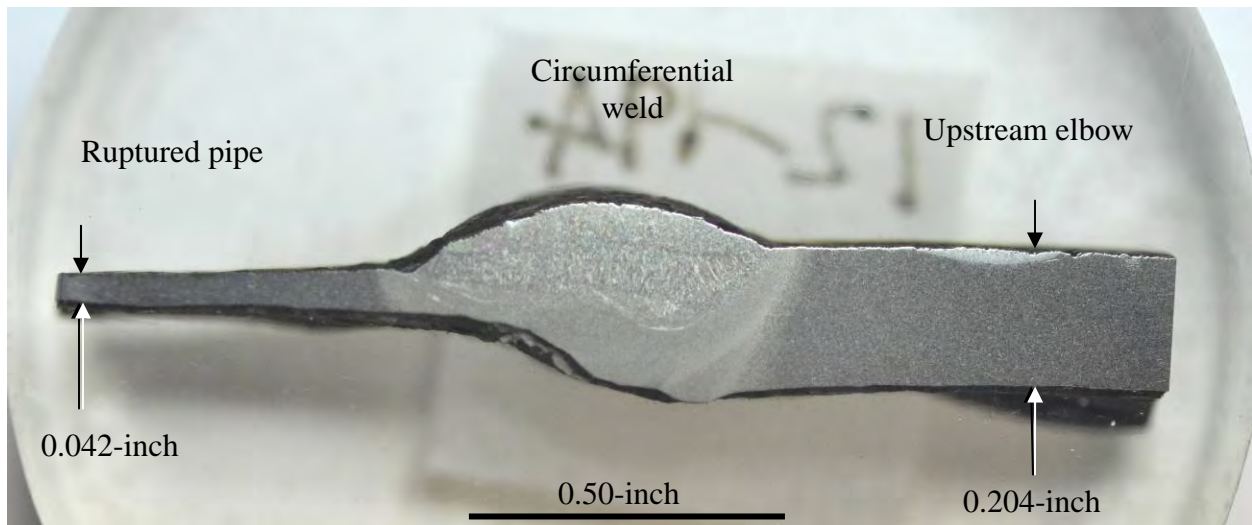
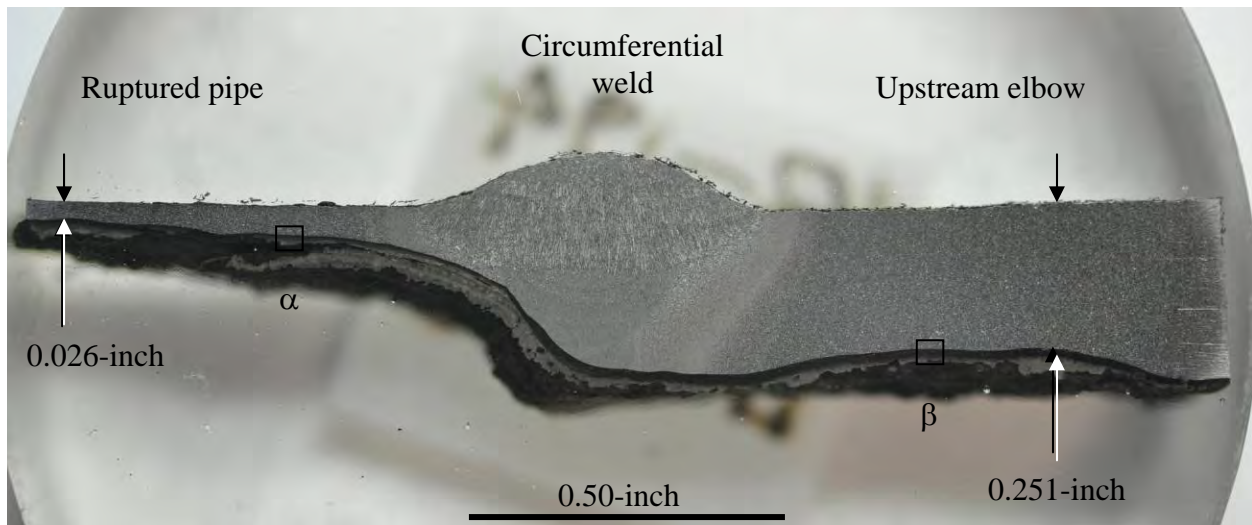
Specimens were prepared for metallography from sections through the circumferential weld that joined the ruptured straight section of pipe to the upstream elbow at the locations indicated in Figure 43 (sections E-017-7 and E-017-8). Photographs of the polished and etched specimens are shown in Figure 44. The wall thickness of the straight section was significantly more reduced than that of the elbow, both of which were reported to have been in service for the same length of time. Micrographs representative of the interface between the pipe wall and inside surface scale are shown in Figure 45. The morphology of the scale was consistent with sulfidation scale that forms from the reaction between carbon steel and sulfur bearing hydrocarbon streams.

Figure 44 Polished and etched sections through the ruptured pipe and upstream elbow taken from the locations indicated in Figure 43. The areas labeled α and β are shown in Figure 45.

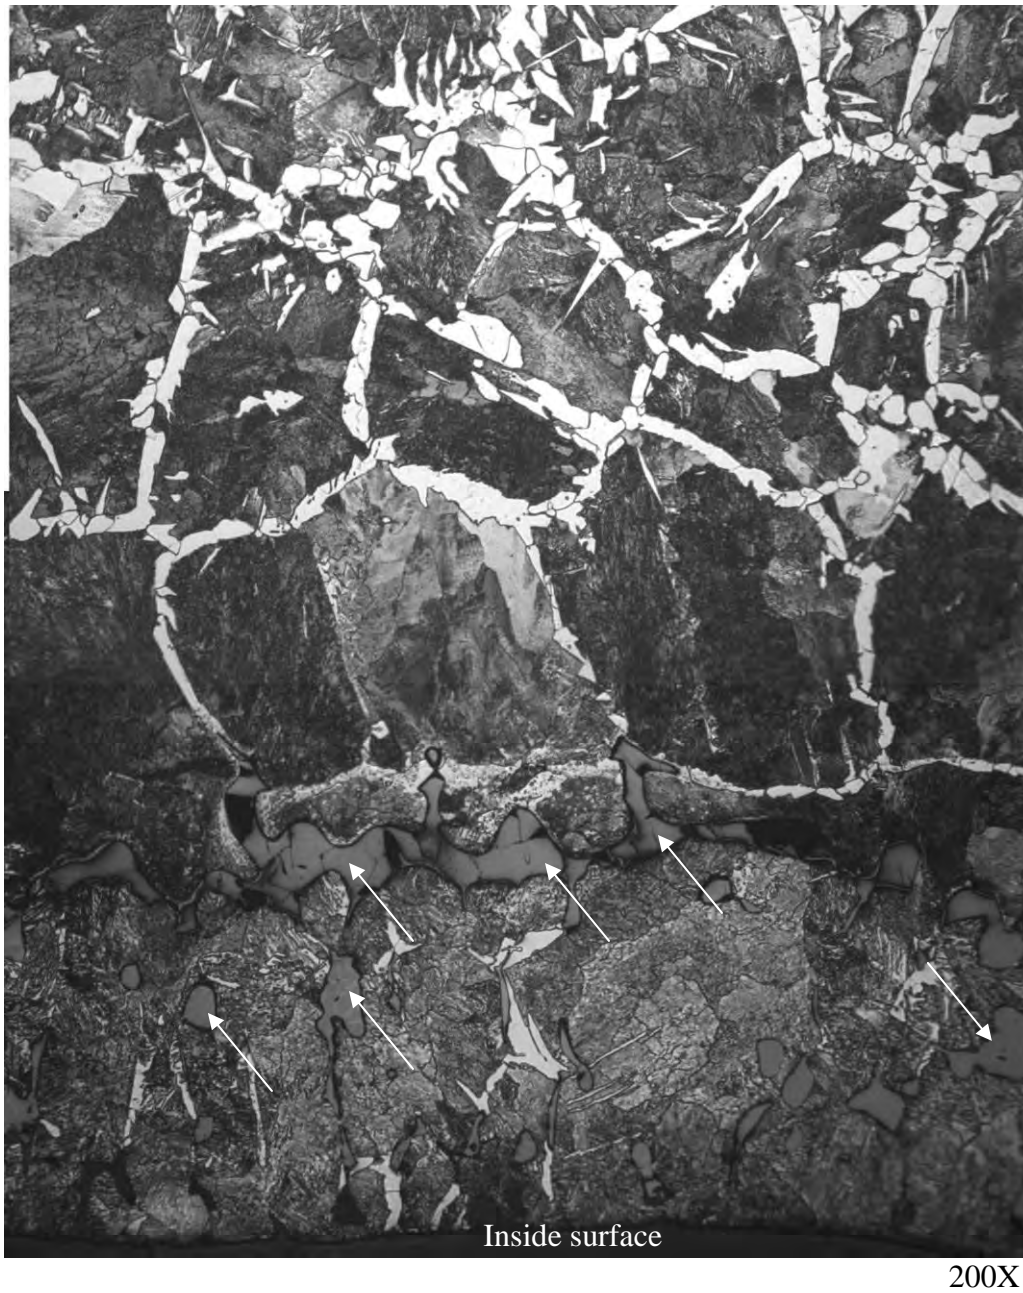
The majority of inside surface scale on sample E-034B spalled off specimens during sectioning. Microstructural evidence of recrystallization and carburization of the inside surface was present in specimens prepared from sample E-034B, as shown in Figure 52 and Figure 53. Sulfide inclusions atypical for carbon steel pipe in size, shape, and distribution were present near the inside surface of these specimens, likely caused by internal sulfidation. All of these observations are consistent with high temperature exposure during the fire.

Figure 53 Optical micrograph montage of a transverse specimen prepared from sample E-034B. Arrows point to examples of sulfide inclusions likely formed by internal sulfidation.
