**Silver Eagle Refinery
Explosion Investigation:
Metallurgical Analysis**

Dan Tillema, P.E.
Chemical Incident Investigator
U.S. Chemical Safety & Hazard Investigation Board

June 19, 2013

0907487.000 A0F0 0613 RPT1

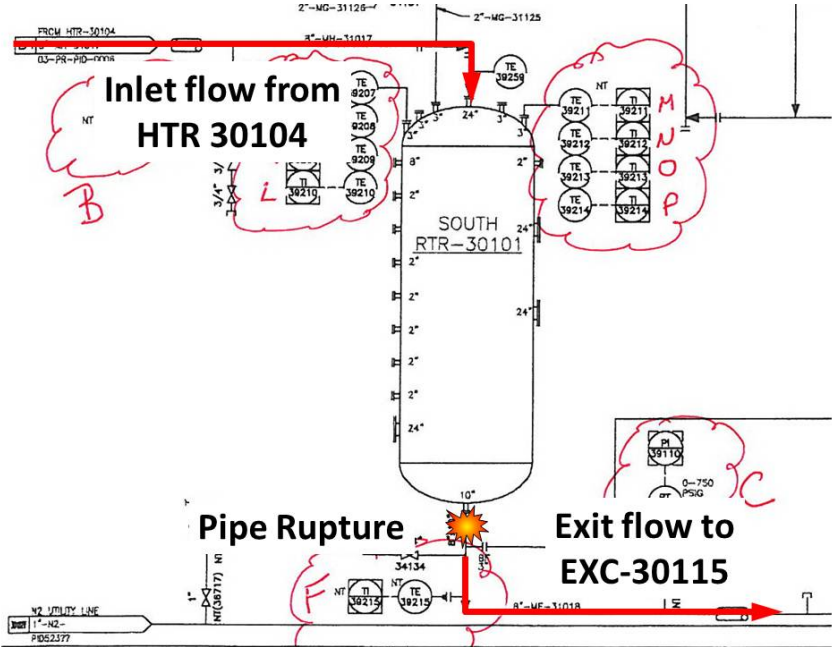
Temperature and pressure measurements were made at the discharge of the South Reactor, labeled “F” and “C” in Figure 2, respectively. Inlet and exit temperatures for the South Reactor are shown in Figure 3. The catalyst regeneration procedure began at 9:00 p.m., as seen in the initial heating of the reactor. The reactor inlet temperature rose from 680°F at 9:00 p.m. to 806°F at 3:00 a.m., and remained essentially constant for the start of a planned 24-hour catalyst regeneration cycle. At 9:11 a.m., approximately six hours into the procedure, the inlet temperature suddenly dropped, and the exit temperature increased to over 1000°F (Figure 4). This resulted from the pipe rupture between 9:11 a.m. and 9:12 a.m., causing the inlet temperature to drop as the system depressurized, and the outlet temperature to rise since the outlet thermocouple was exposed to the resulting fire. Pressure in R30101 was increased from normal operating levels just below 600 psig to about 640 psi during the catalyst regeneration process (Figure 5). At the time of the accident, the pressure was at 642 psi (Figure 6).

Figure 2. Annotated P&ID of the rupture site.

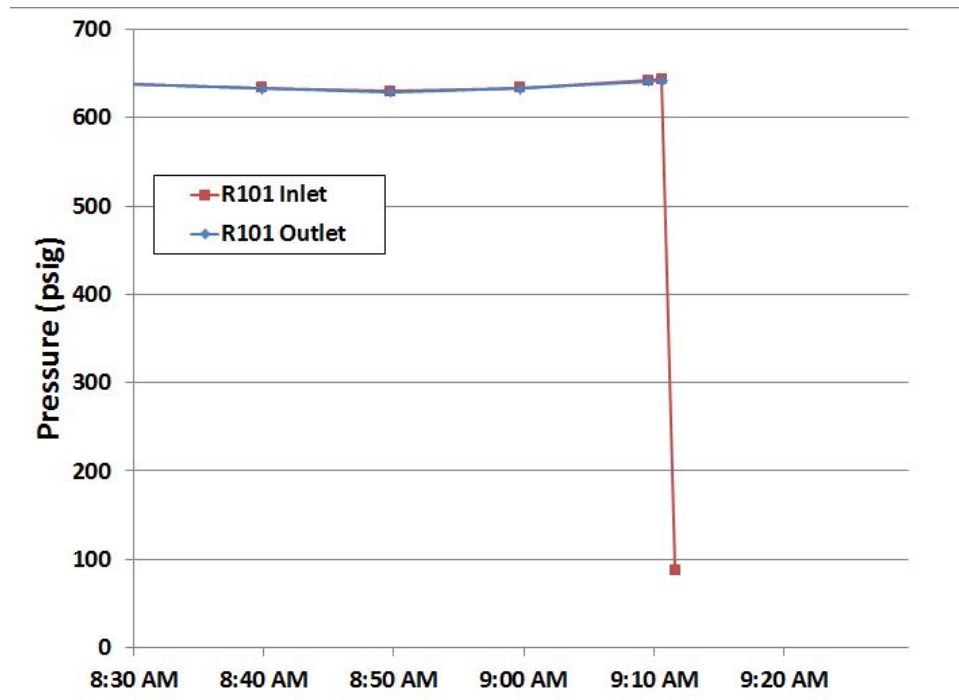
The composition of the gases is listed in Table 1 below. The primary species was hydrogen (81% by volume), followed by C1 or methane (9.5%), and small amounts of other light hydrocarbons and nitrogen. Temperature (Figure 4) and pressure measurements in the MDDW unit (Figure 6) show conditions at the discharge of R30101 were 642 psig and 785°F.

Figure 6. R30101 pressure at time of failure.

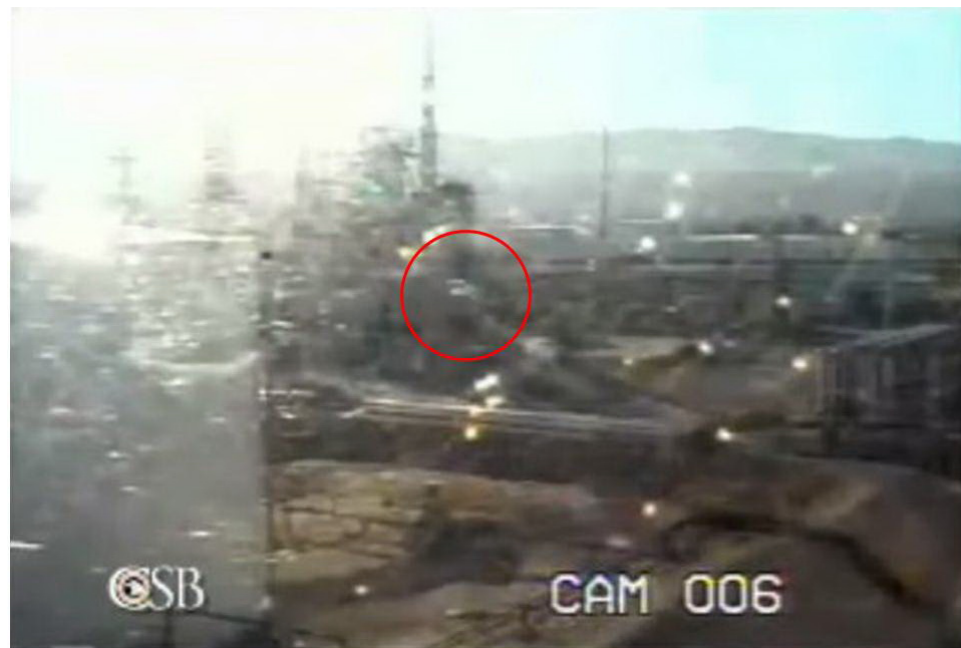
Security video of the accident covered the MDDW (Figure 7). The location of the pipe rupture is marked with a red circle. A frame from this video reveals the initial release of gas from the ruptured pipe (Figure 8). This release rapidly expanded (Figure 9), and the hot gas mixture ignited shortly after rupture (Figure 10). A shock wave from the resulting explosion expanded through the adjacent neighborhood, causing varied degrees of blast damage to residential homes.

Figure 8. Initial gas release on security video.

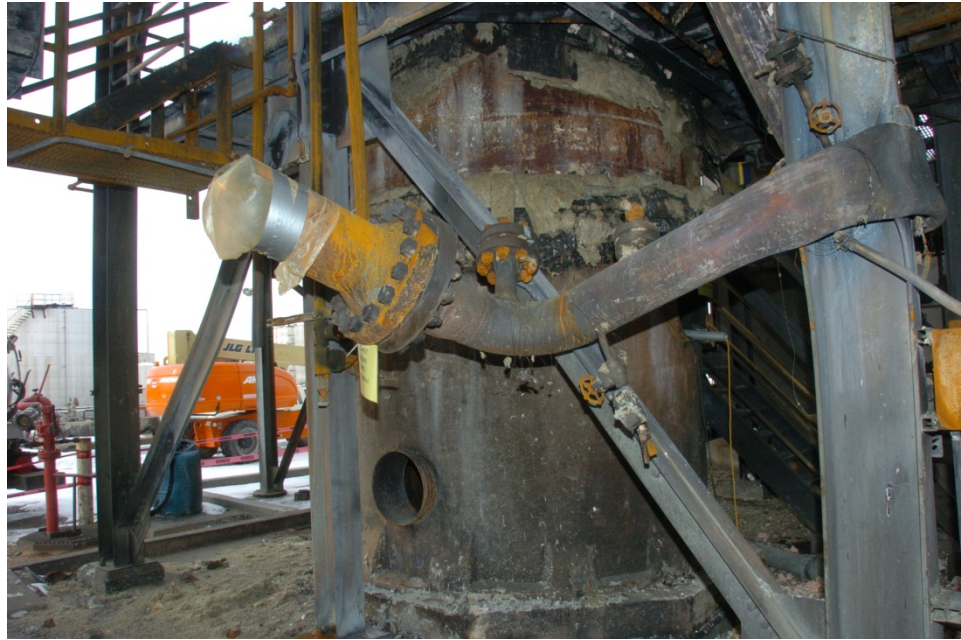
The origin of the explosion was a pipe failure at the bottom of South Reactor R30101. The 10-inch diameter discharge line ruptured in the skirt underneath the reactor. The discharge line runs from the bottom of R30101 up to Heat Exchanger EXC-30115. The resulting reaction force caused by rapidly escaping high pressure gas bent the piping around a reactor support beam (Figure 11). After rupture of the pipe, high pressure gas was escaping from both ends of the pipe failure. One end of the fractured pipe ended up wrapped around a reactor support beam (Figure 12), while the second end was attached to the bottom of the reactor (Figure 13).

Figure 11. R30101 discharge pipe bent around reactor support beam.

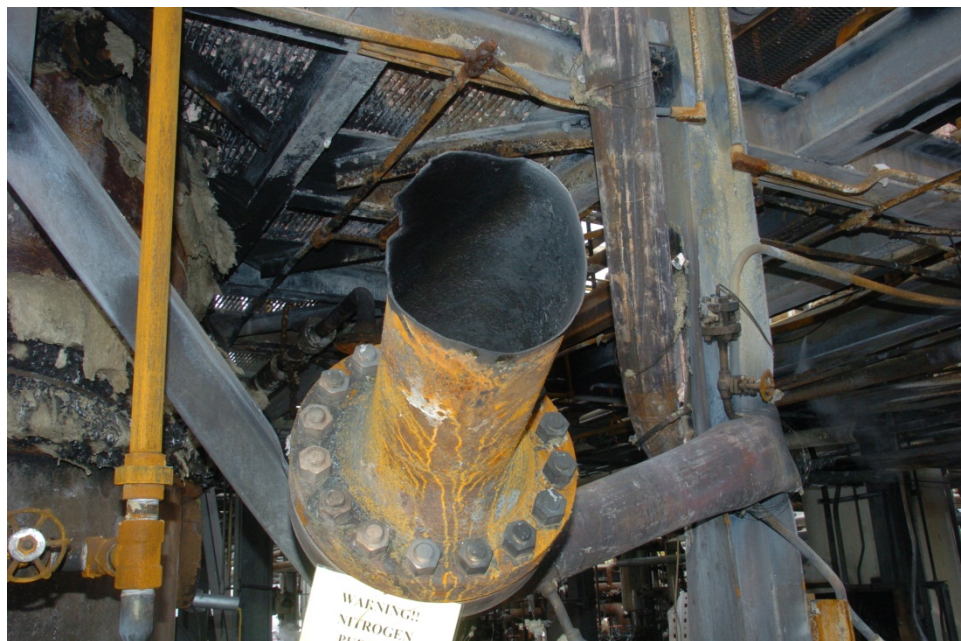
Figure 12. Ruptured end of pipe wrapped around support beam.

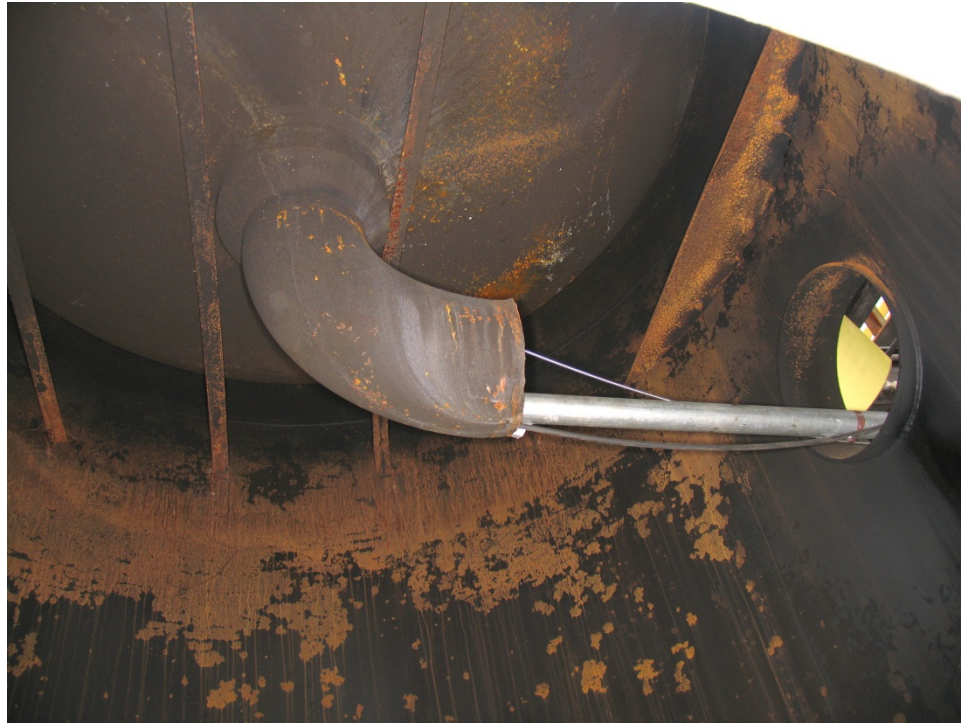
Figure 13. Ruptured end of pipe still attached to R30101.

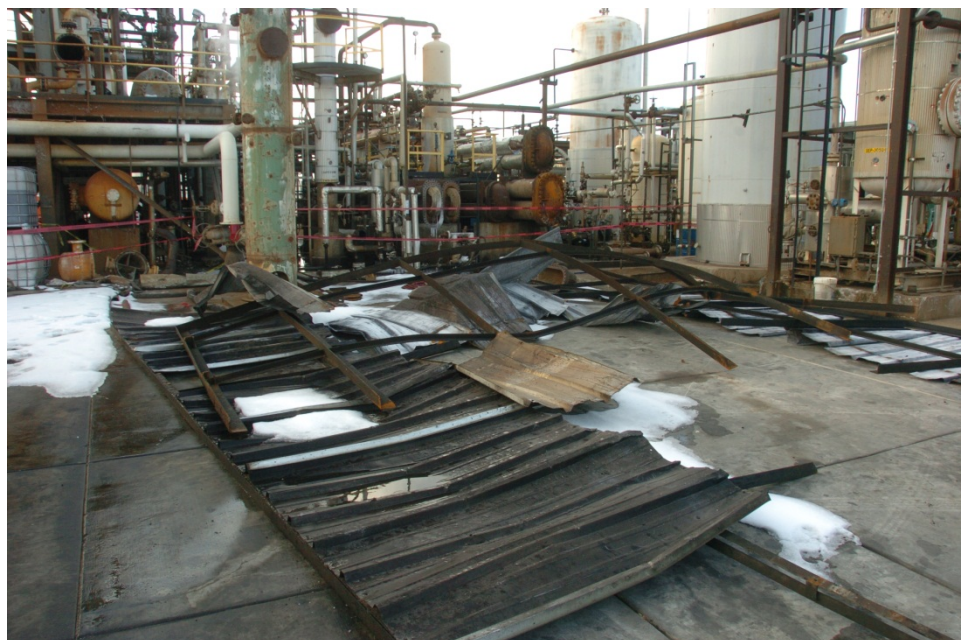
There was explosion damage to light structural elements on the adjacent "hydro pad", where water blasting/cleaning activities took place (Figure 14). A view from the hydro pad includes the surrounding residential community (Figure 15).

Figure 14. Explosion damage to light structural elements, hydro pad.

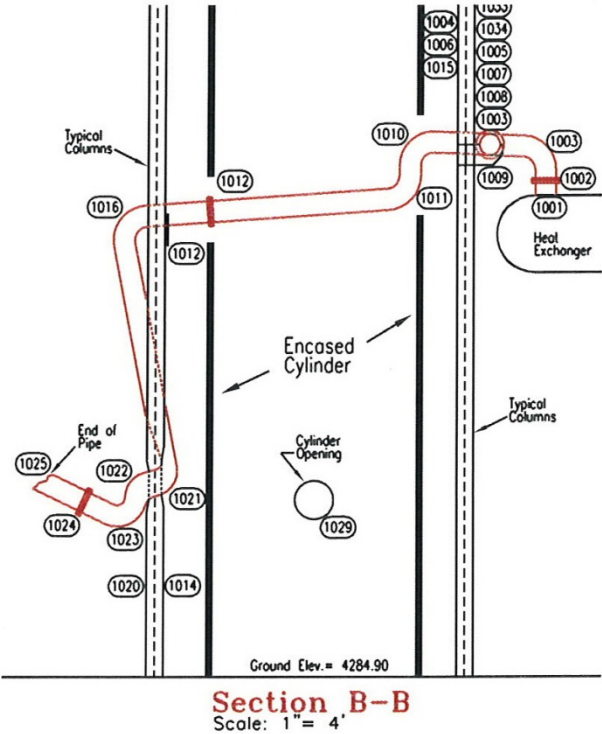
Exponent retained Balling Engineering to perform site survey activities. This included measuring the as-found geometry of the R30101 discharge piping. An elevation view is shown in Figure 16. The fractured end of the pipe is labeled as Point #1025. Before the rupture, this

pipe ran through an opening in the skirt around the base of R30101, labeled as Point #1029. The rupture occurred under the skirt around R30101. A plan (overhead) view of the pipe is shown in Figure 17.

Figure 16. Elevation view of surveyed pipe.

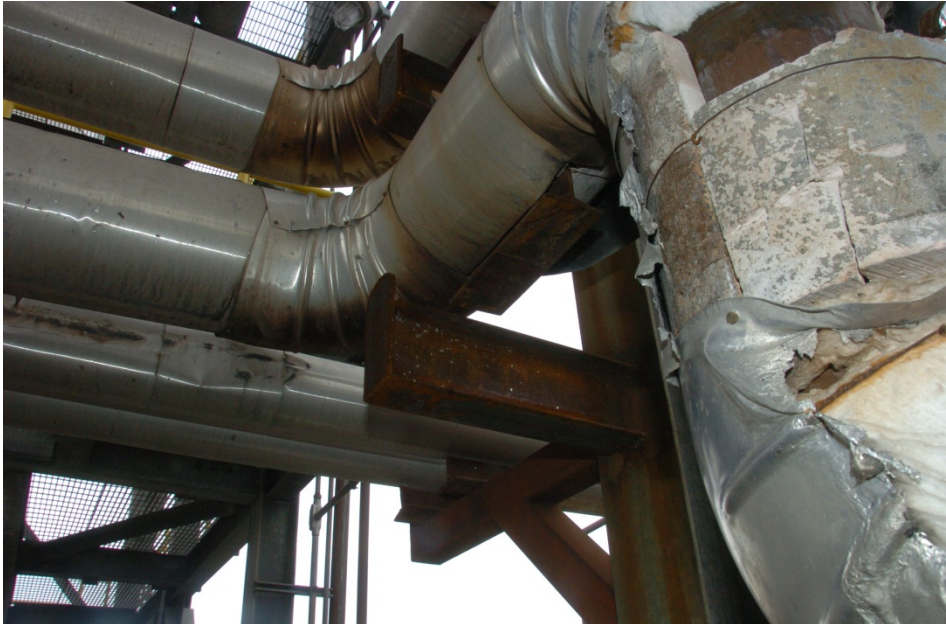
The ruptured pipe ran from the bottom discharge of South Reactor R30101 to Heat Exchanger EXC-30115. A 10-inch diameter pipe exits Reactor R30101 and reduces to eight inches in diameter at a flange connection just downstream of the fracture location outside the reactor skirt. Pipe supports underneath the pipe are illustrated in Figure 17, with the longest unsupported run of pipe measuring just less than twelve feet. A photograph of one of the pipe supports is shown in Figure 18. A sliding support was observed, with reaction forces from the pipe rupture having shifted the pipe off the support plate. Inadequate pipe support is not considered a contributing factor to this accident.

Figure 18. Pipe support location.

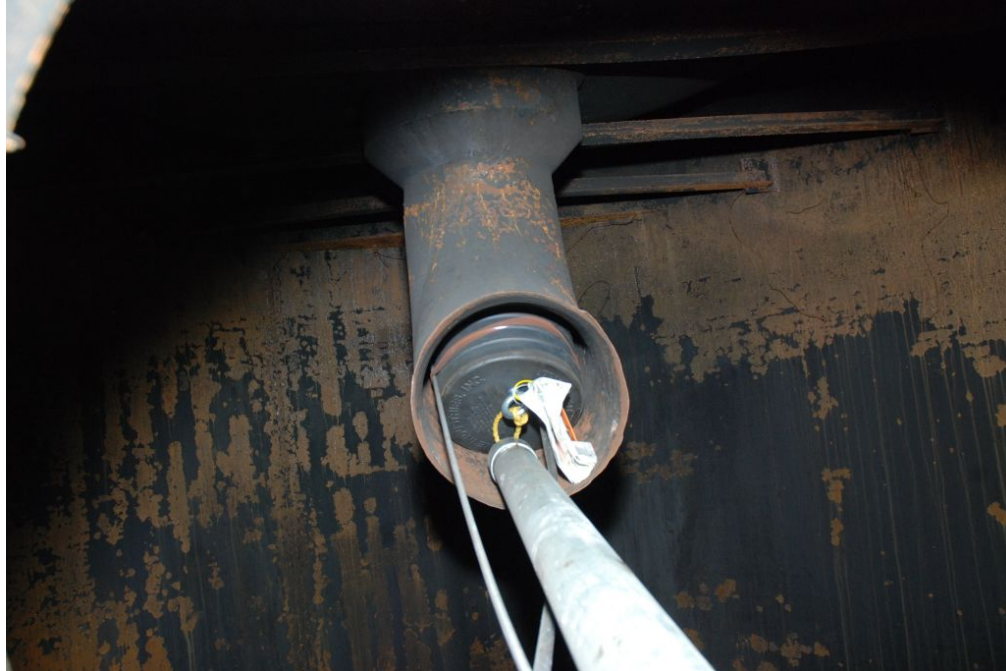
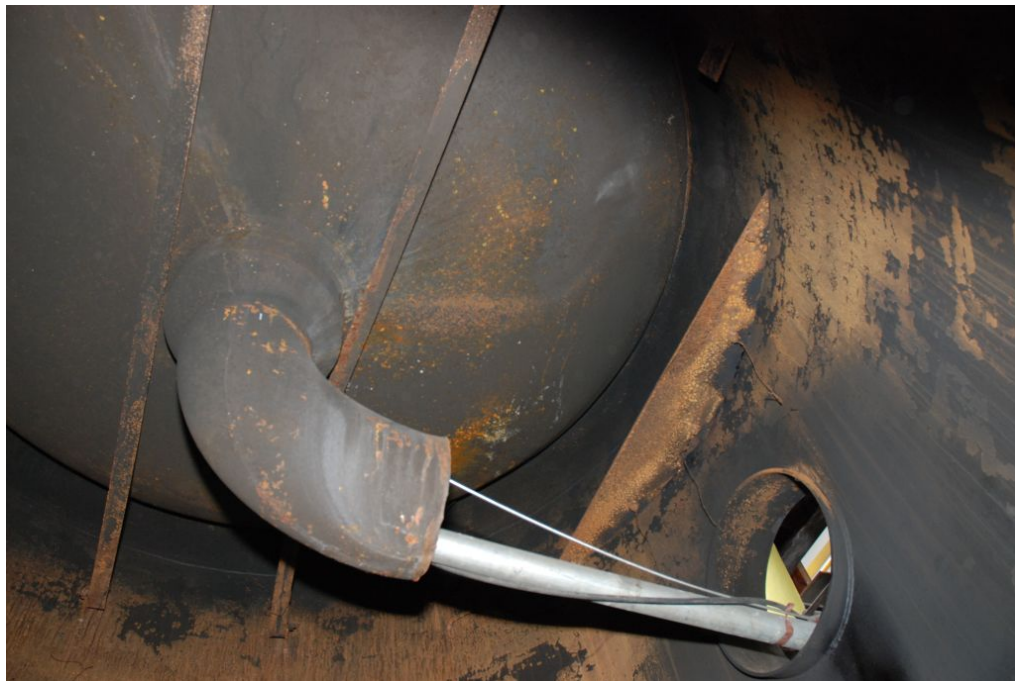
Figure 19. Images of the upstream end of the fractured pipe prior to its removal in March 2010.

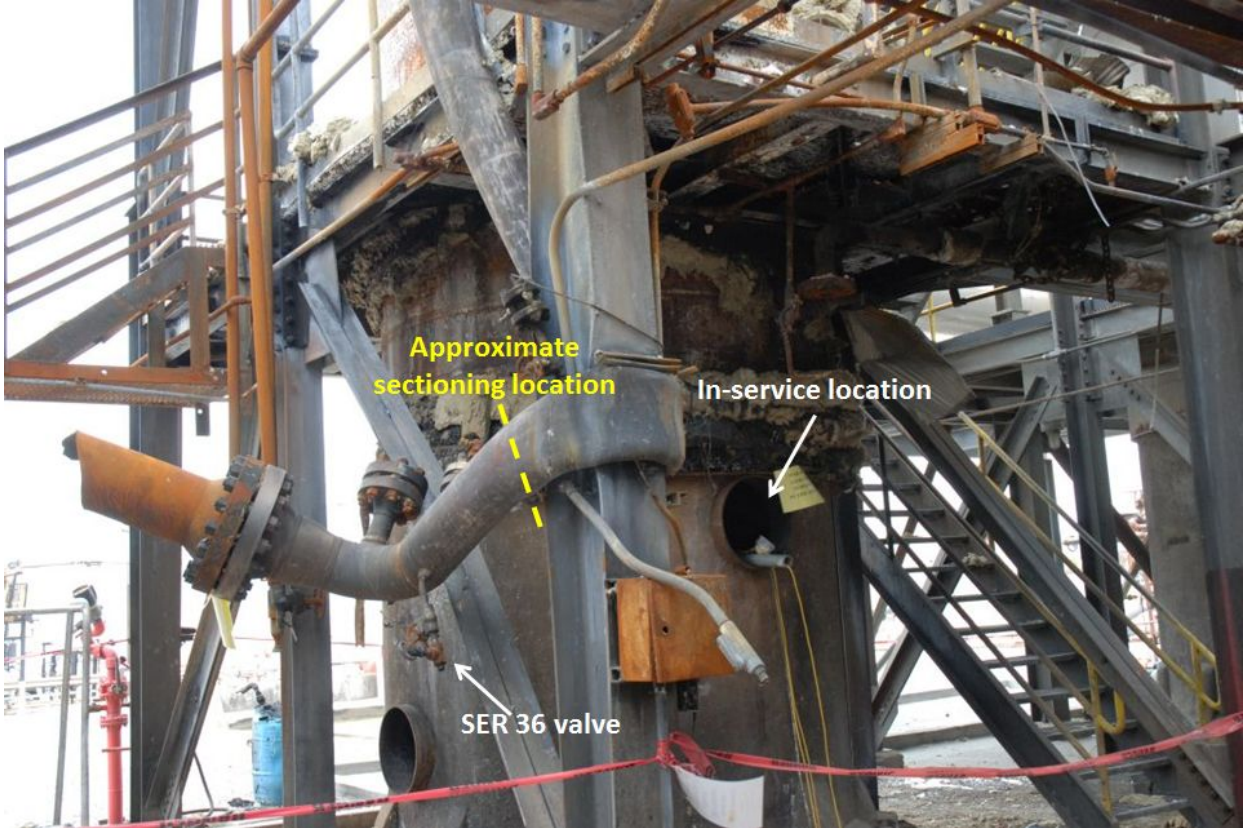
The upstream end of the fractured segment still attached to the bottom of the reactor was labeled “SER 34” and sectioned for removal from the site, as shown in Figure 19 and Figure 20. The downstream end of the fractured segment that had wrapped around a reactor support beam was labeled “SER 35” and also sectioned for removal from the site, as shown in Figure 21 with the sectioning location through the eight-inch-diameter pipe indicated. Prior to sectioning, fluid remaining in the piping was drained through the valve designated “SER 36” and stored in a glass bottle (Figure 22).

Figure 21. Image of the downstream fractured section "SER 35" prior to sectioning for removal from the site in March 2010.

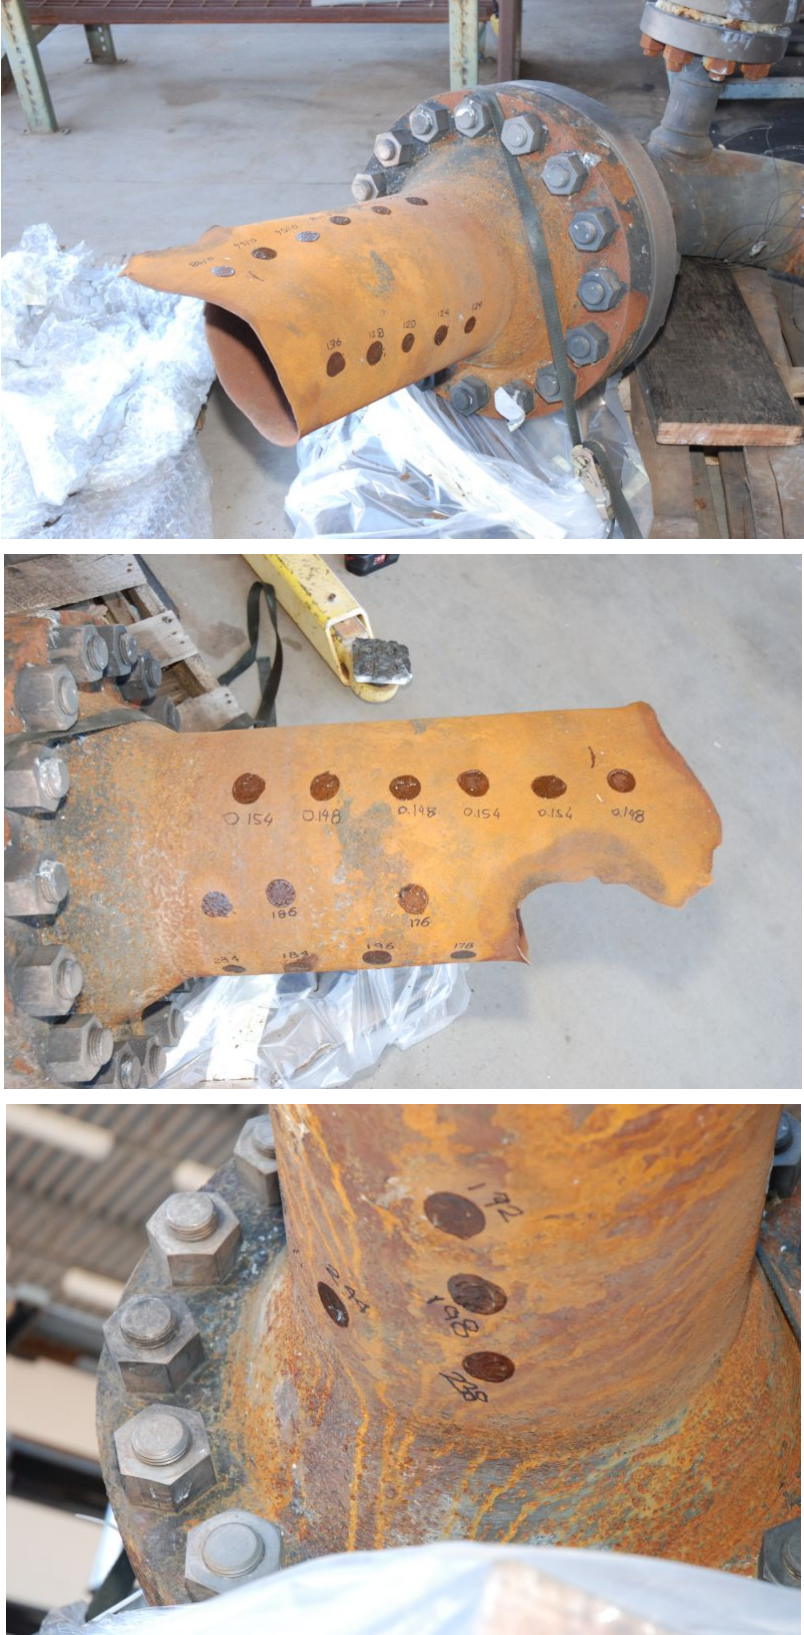
Ultrasonic thickness (UT) testing on the fractured end of the SER 35 segment was conducted at locations along the length and around the circumference of the ruptured pipe. Thickness measurements ranged from 0.120 to 0.244 inches (Figure 26). The fractured end was then sectioned from the remaining segment approximately 12 inches upstream of the flange shoulder with a handheld reciprocating saw (Figure 27).

Figure 26. Images showing UT measurements taken on the SER 35 segment in August 2010.

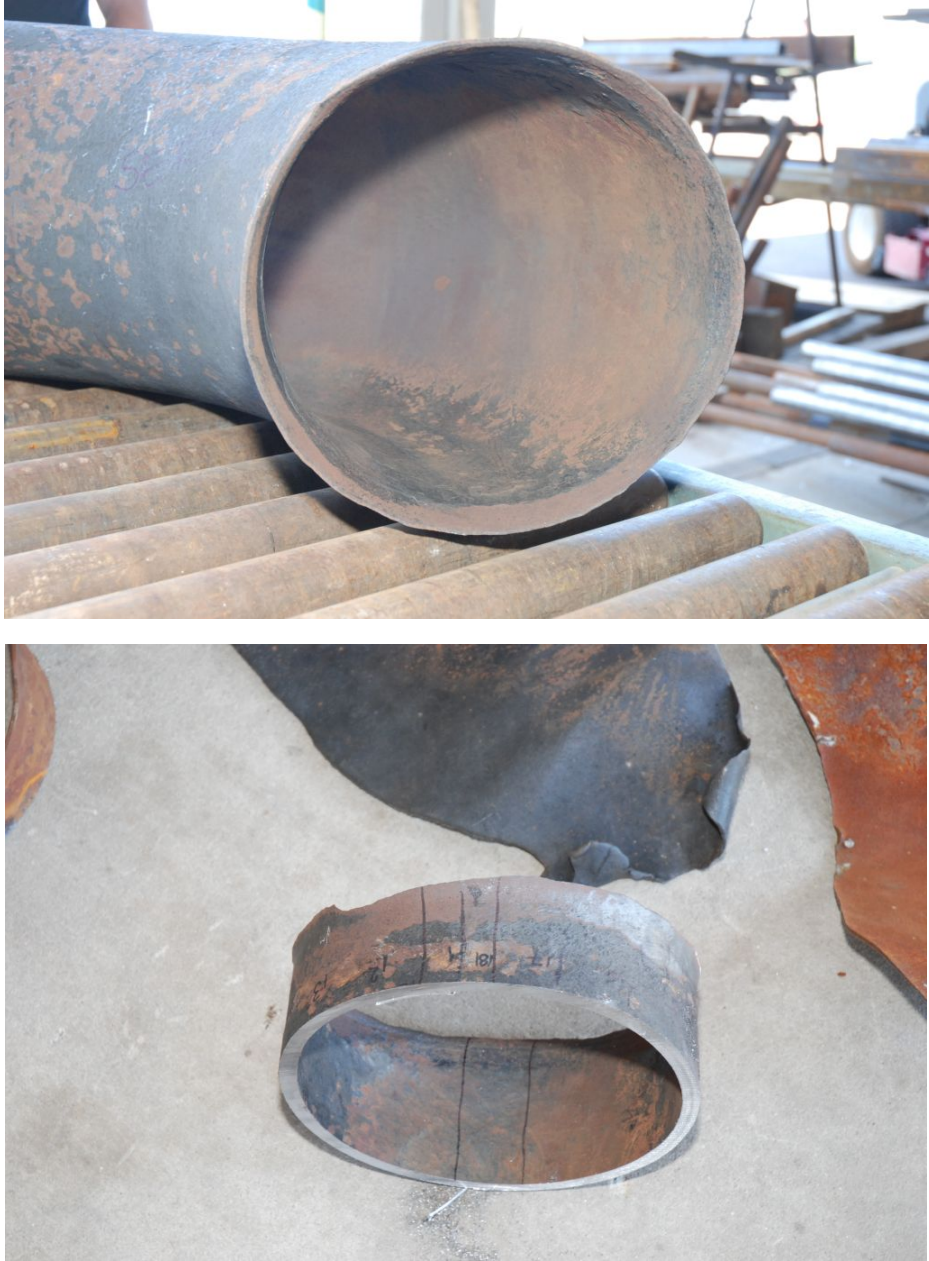
UT measurements were also conducted on the SER 34 segment, ranging from 0.522 to 0.570 inches along the elbow intrados (inner curve), and 0.372 to 0.448 inches along the elbow extrados (outer curve), with the wall thickness measurements generally decreasing with distance downstream. Wall thickness measurements near the fracture surface were taken around the circumference of the pipe, and ranged from 0.032 to 0.112 inches. At the upstream field-cut end of SER 34, thickness measurements were between 0.526 and 0.585 inches. The fractured end was then sectioned from the remaining segment approximately six inches upstream of the fracture with a band saw (Figure 28).

Figure 28. The fractured end of SER 34, before and after sectioning in August 2010.

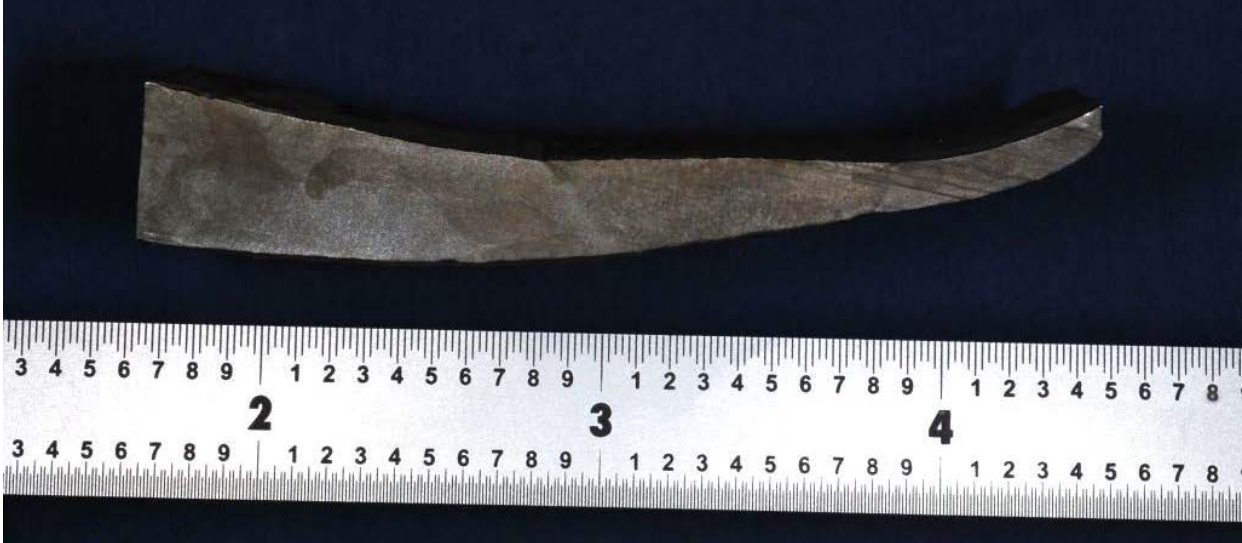
Examination of the metallographic longitudinal cross-sections that included the weld and the fracture surface clearly indicated that wall thinning had occurred through the weld metal and the base metal of the 10-inch straight segment from the inside diameter (ID), as shown in Figure 31 and Figure 32. The rupture was in the straight segment base metal.

Figure 31. Image of the metallographic longitudinal cross-section specimen from the 6-o'clock location on SER 34, showing wall thickness loss at the ID surface through the weld metal and base metal of the straight segment.

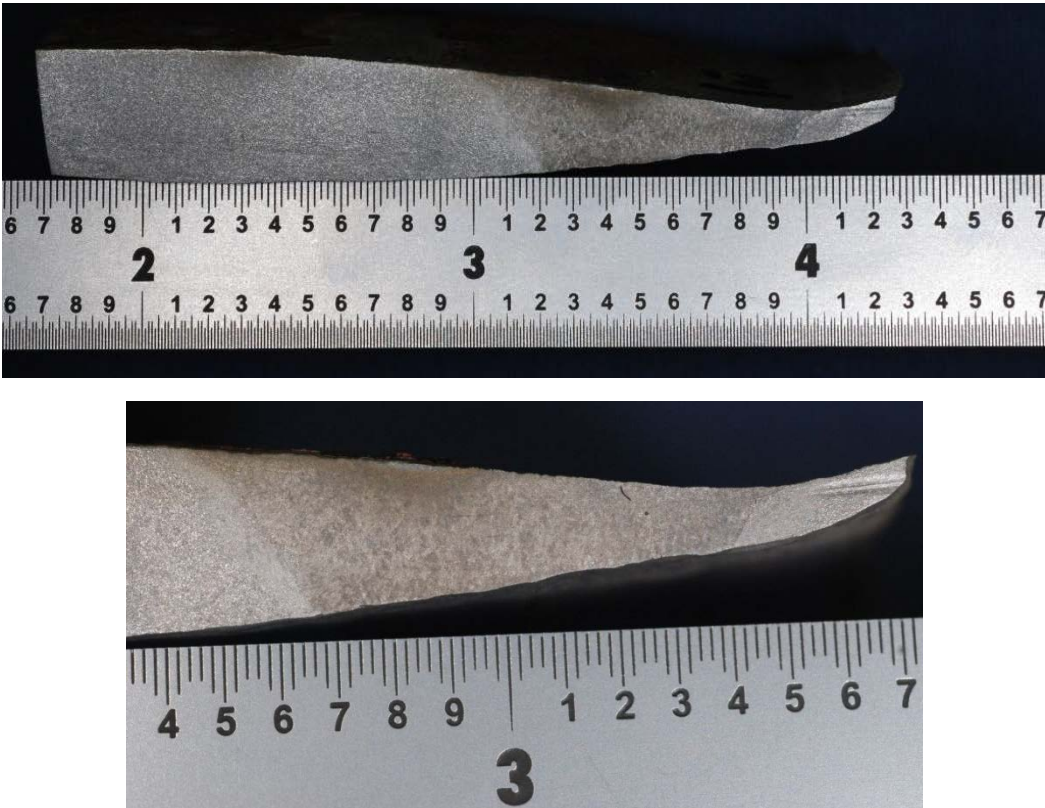
Figure 32. Images of the metallographic longitudinal cross-section specimen from the 12-o'clock location on SER 34, showing wall thickness loss at the ID surface through the weld metal and base metal of the straight segment.

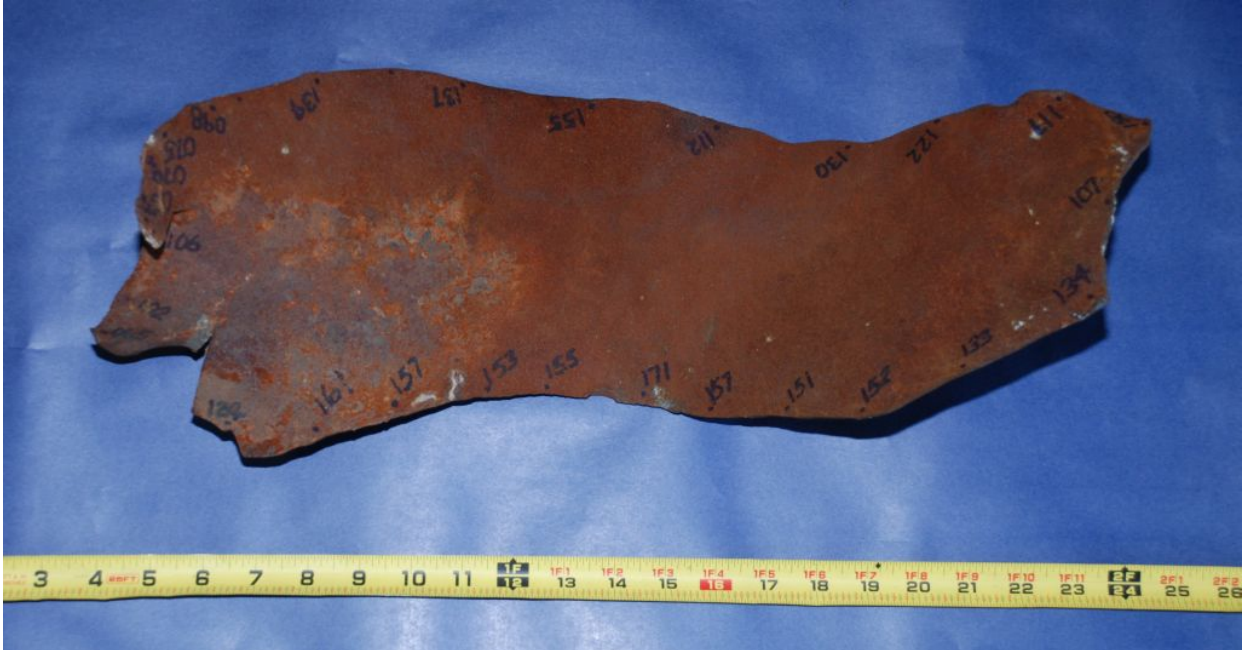
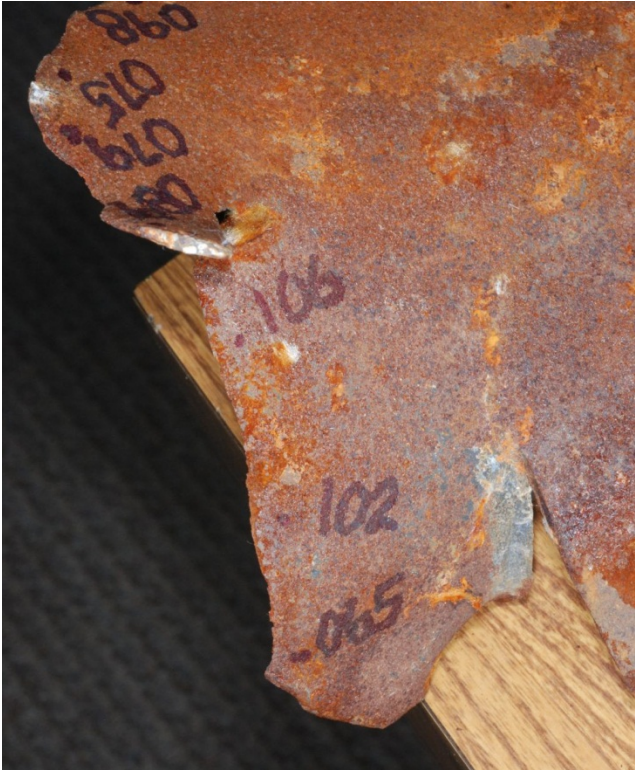
Thickness measurements were made near the edges of the fracture surfaces on the SER 27 and SER 28 pieces. On SER 27, measurements ranged between 0.065 and 0.171 inches (Figure 33). On SER 28, measurements ranged between 0.039 and 0.170 inches (Figure 34). Subsequently, SER 27 and SER 28 were aligned with the fracture surface from SER 34, with fracture surface features confirming their original in-service locations as part of the 10-inch straight segment (Figure 35).

Figure 33. Images of SER 27 showing the results of wall thickness measurements.

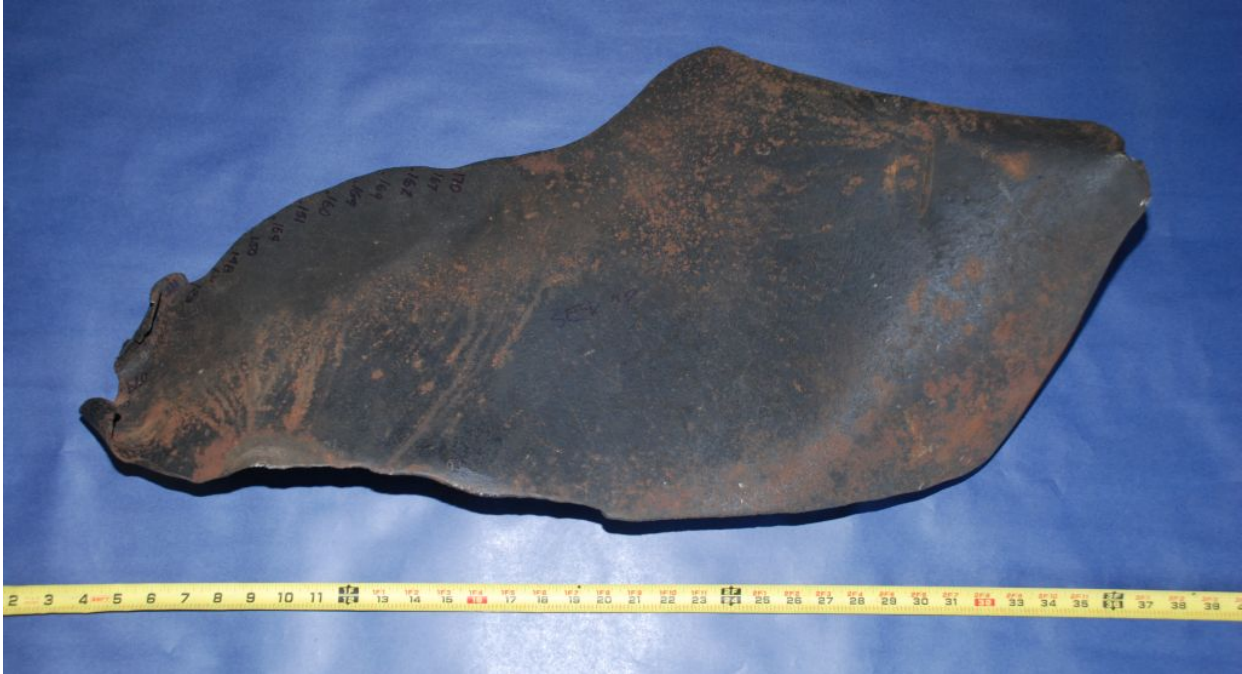
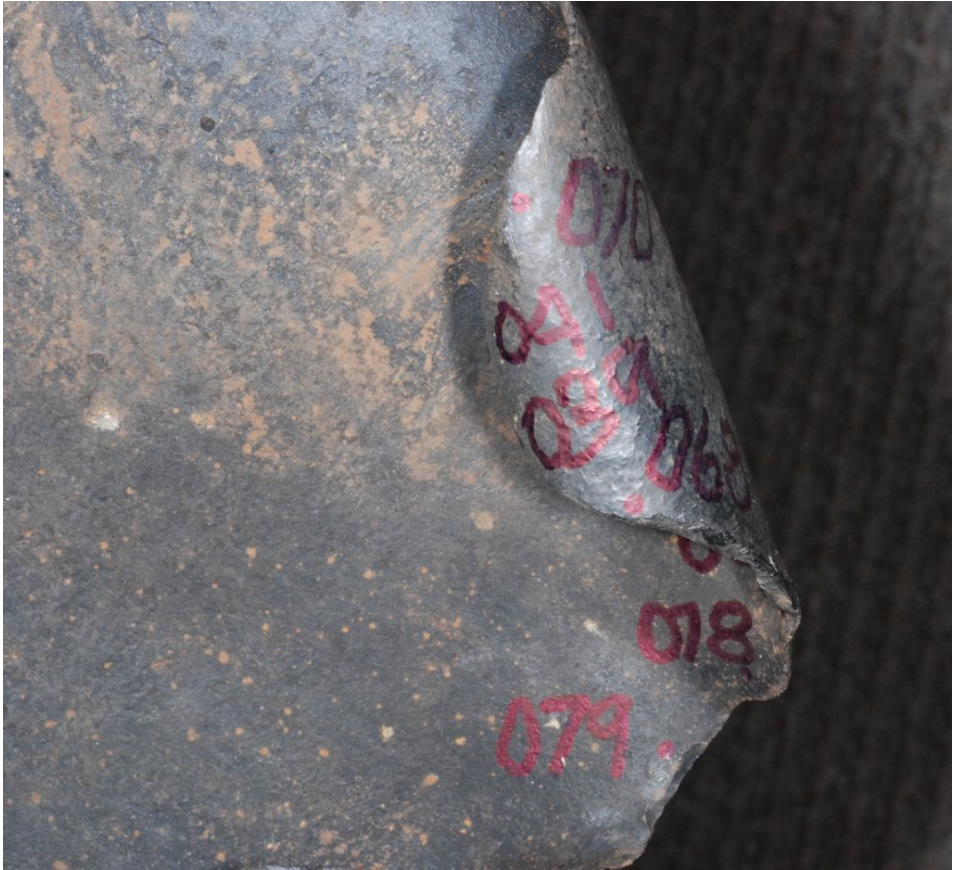
Figure 34. Images of SER 28 showing the results of wall thickness measurements.

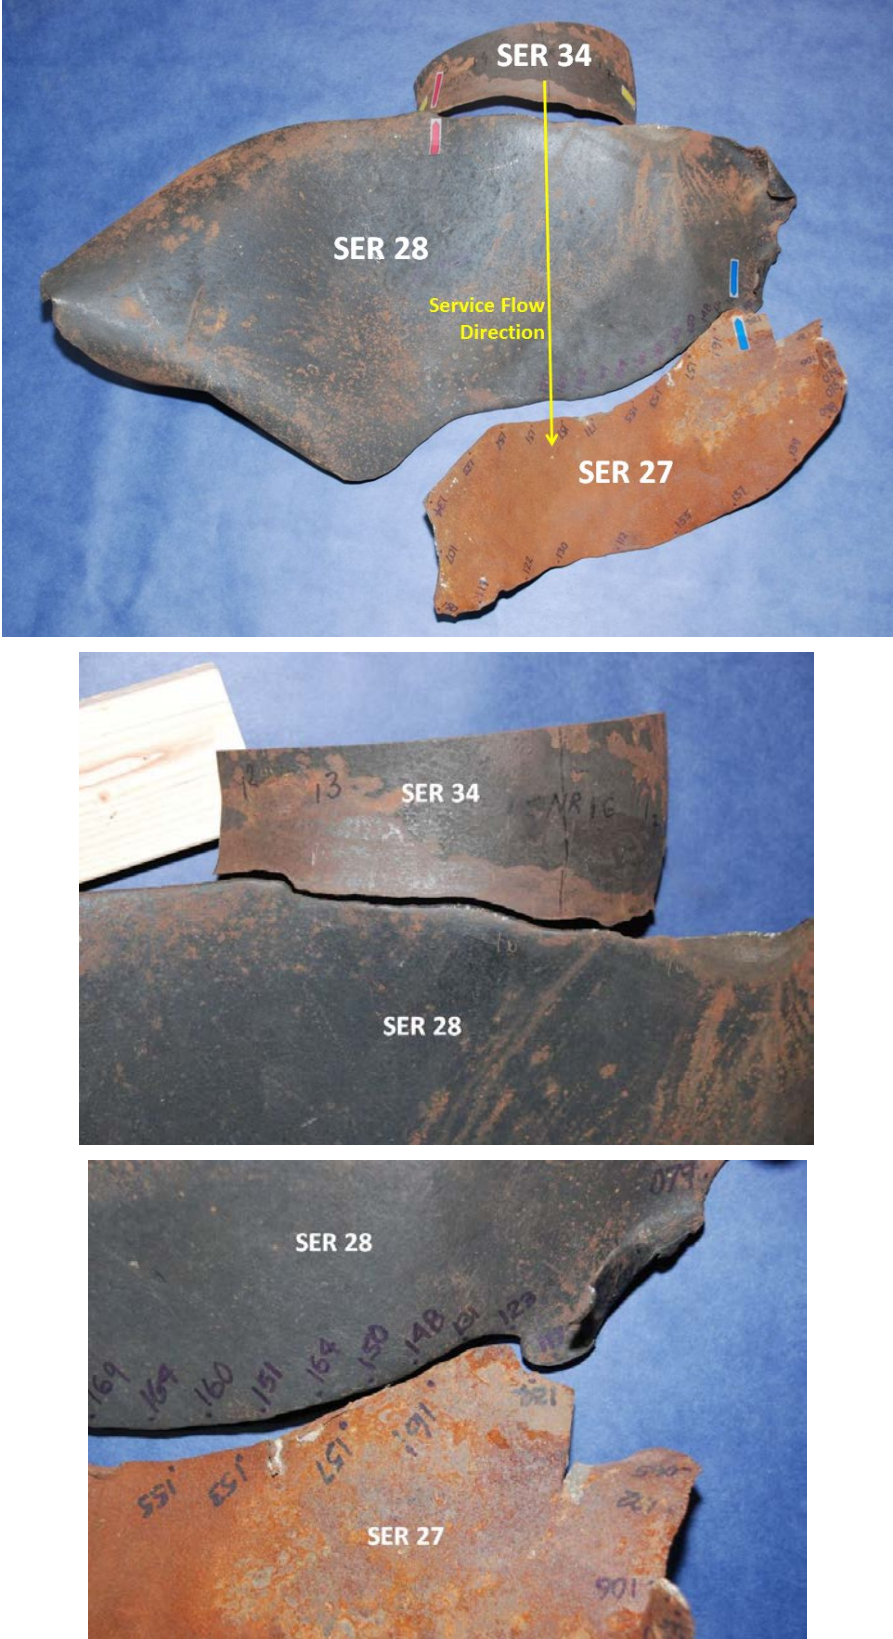
Figure 35. Images showing the in-service locations of SER 34, SER 28, and SER 27 based on alignment of fracture surface features.
