# Investigation Report

Published: December 2022

## SAFETY ISSUES:

On November 27, 2019, a series of explosions occurred at the TPC Group (TPC) Port Neches Operations (PNO) facility, located in Port Neches, Texas, after highly flammable butadiene released from the process unit. The explosions caused a process tower to propel through the air and land within the facility, other process towers to fall within the unit, extensive facility damage, and fires that burned for more than a month within the facility. The butadiene unit was destroyed, forcing the facility to cease butadiene production operations indefinitely. As of the date of this report, the butadiene production operations remain shut down. Two TPC PNO employees and a contractor reported minor injuries, and according to media reports, at least five local residents reported injuries. Officials in Jefferson County, Texas declared the county to be in a state of disaster and issued a mandatory four-mile radius evacuation order that affected people in the cities of Port Neches, Groves, Nederland, and a portion of Port Arthur. The explosion also led to reduced usage of the Sabine-Neches Waterway, the nation's third largest waterw

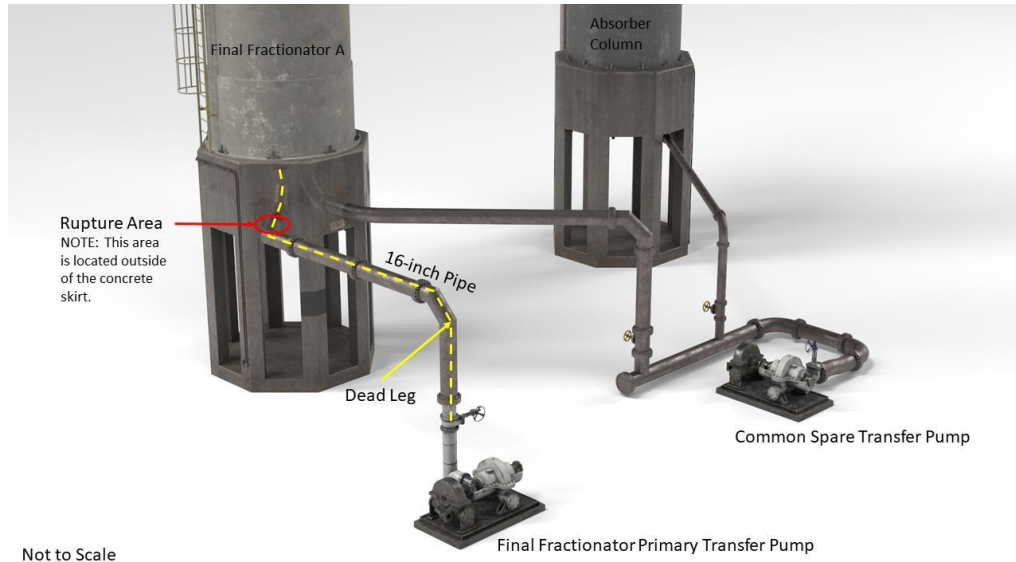
During this 114-day period, the process piping between Final Fractionator A and the manual isolation valve upstream of the Primary Pump was a dead leg, as the pump could not initiate flow through the line. The portion of dead leg piping was 16 inches in diameter and approximately 35 feet long (**Figure 9**). During this 114-day period, TPC PNO continued to experience popcorn polymer formation and plugging in the unit (see Section 4.3). The U.S. Chemical Safety and Hazard Investigation Board (CSB) did not find that anyone at the TPC PNO facility realized the potential popcorn polymer and rupture hazard in the dead leg that was created when the Primary Pump became nonoperational.

**Figure 9.** Schematic showing dead leg location when Primary Pump was nonoperational. (Credit: CSB)

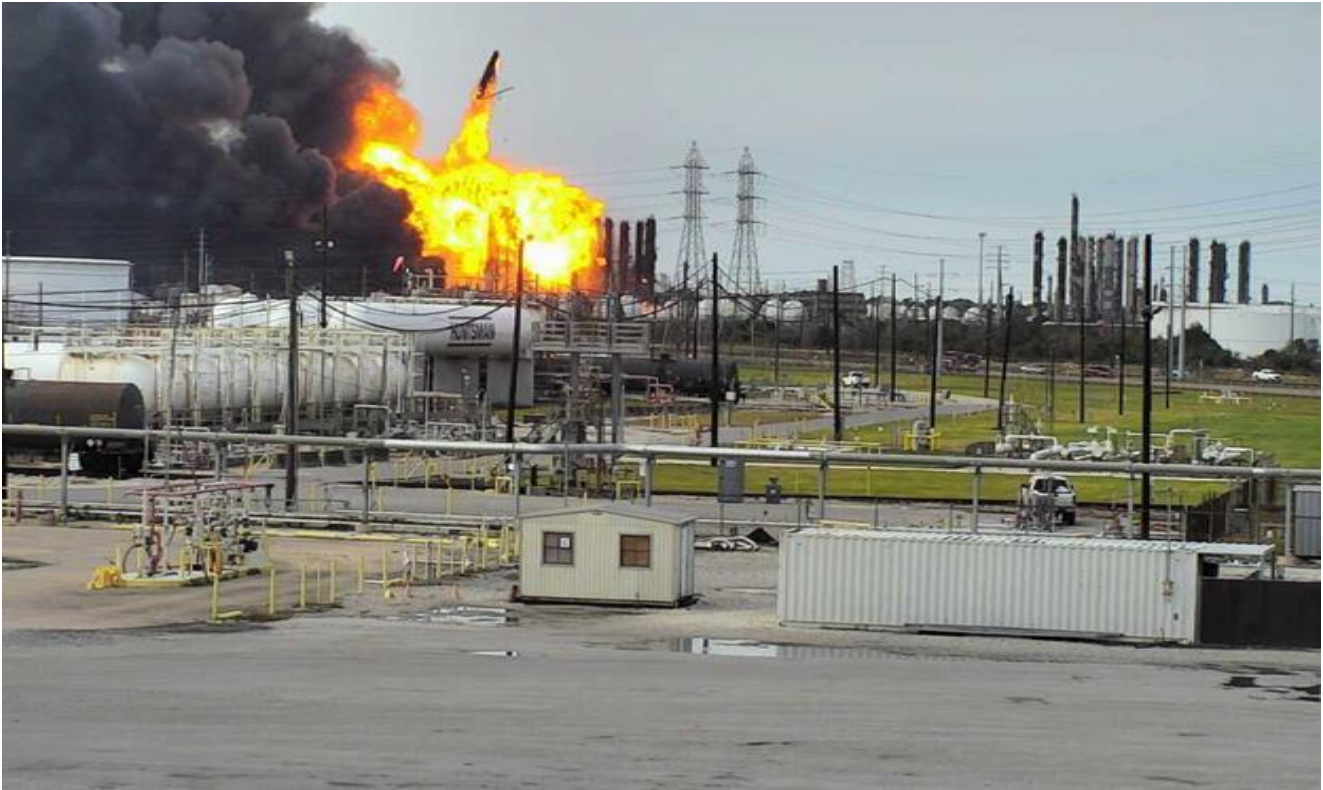
At least two additional explosions occurred following the initial blast. At 2:40 a.m., a cell phone recording captured one of the explosions (**Figure 13**). That afternoon, at 1:48 p.m., another explosion occurred, which caused one of the facility's towers to propel into the air (**Figure 14**). The tower landed within the confines of the TPC PNO facility.

**Figure 14.** Explosion at 1:48 p.m. on November 27, 2019 which propelled one of the unit towers into the air. (Credit: Huntsman Corporation)

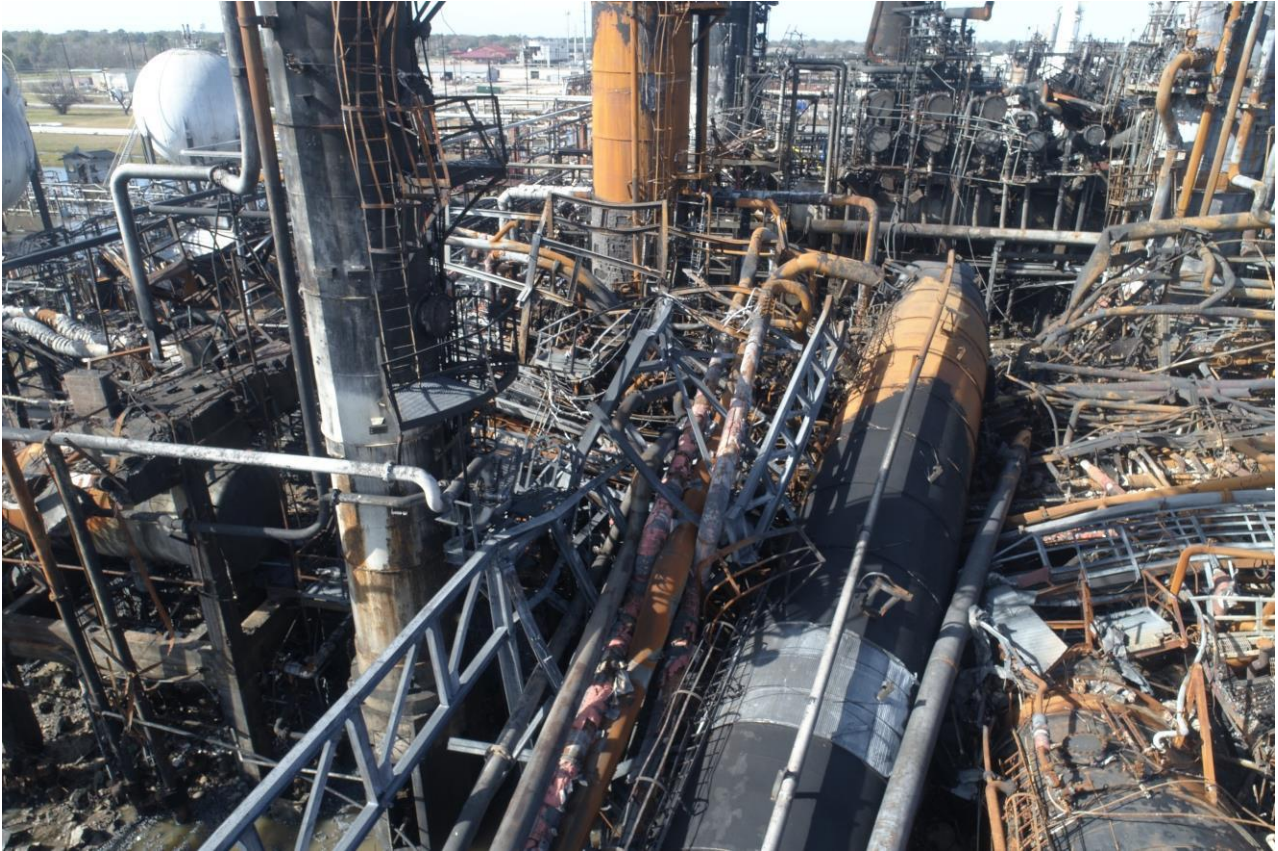
The incident caused significant damage to piping and equipment (**Figure 15**). At least four columns fell as a result of the explosions and fires: the Final Fractionator A, an extractive distillation absorber, an out-of-service water wash tower, and the depentanizer (**Figure 16**).

Figure 15. Damaged piping and equipment in the South Unit. (Credit: TPC)

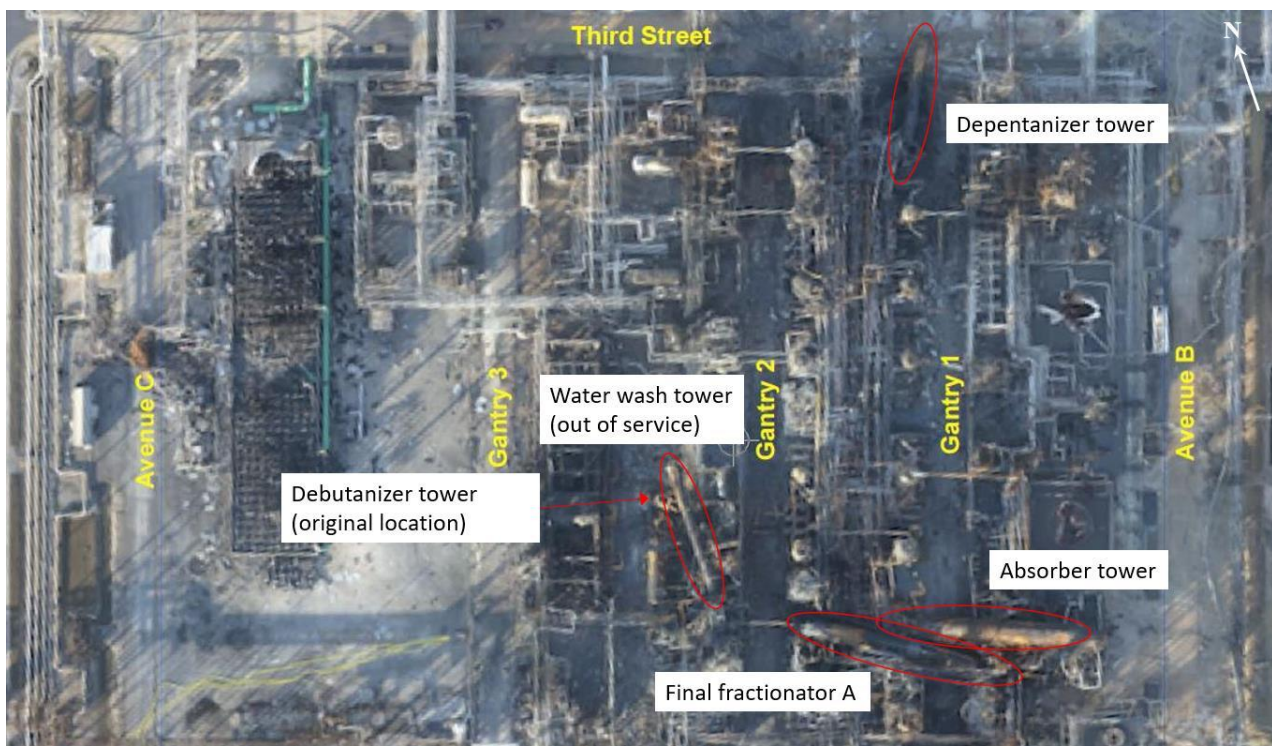
Figure 16. Overhead photograph of TPC PNO South Unit showing the locations of the fallen towers. (Credit: TPC)

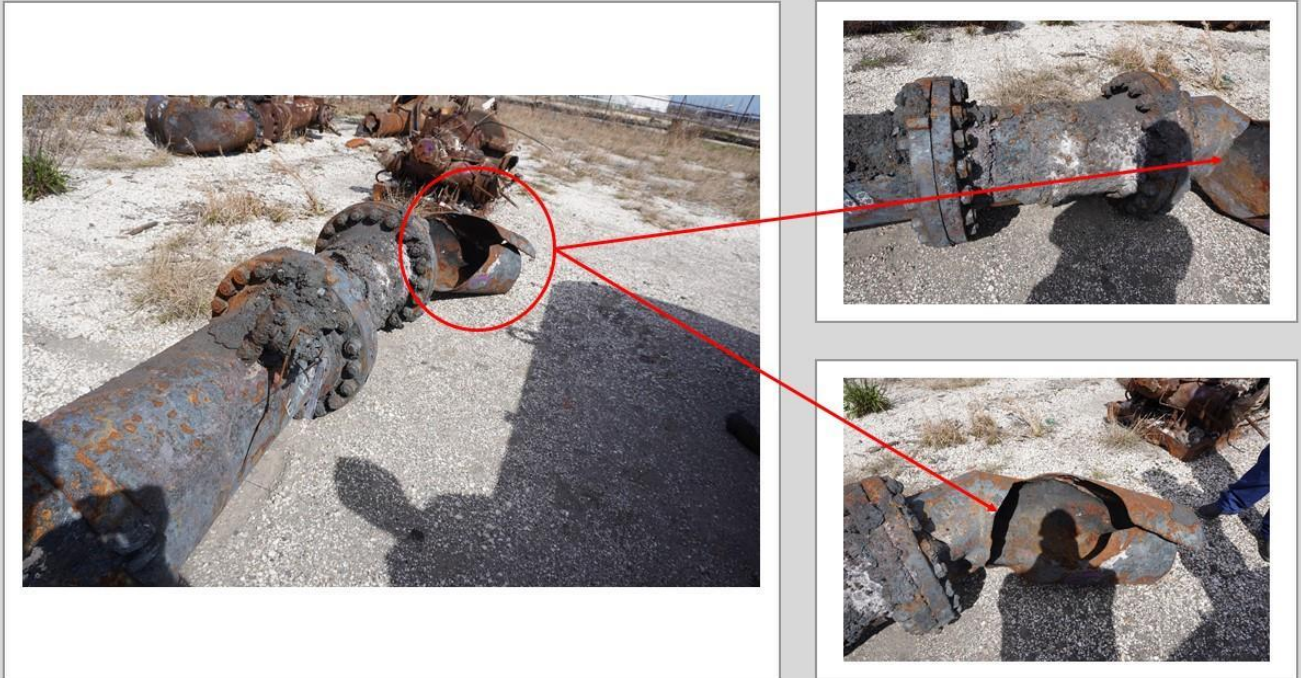
The dead leg piping between Final Fractionator A and the manual isolation valve upstream of the Primary Pump was recovered after the incident. As shown in **Figure 18**, a rupture is visible within the piping segment. A CSB-commissioned metallurgical examination of the rupture concluded that the longitudinal rupture was consistent with internal pressure that exceeded the rupture strength of the pipe.

**Figure 18.** Photos of the recovered Final Fractionator A/B Primary Pump suction piping. (Credit: CSB)

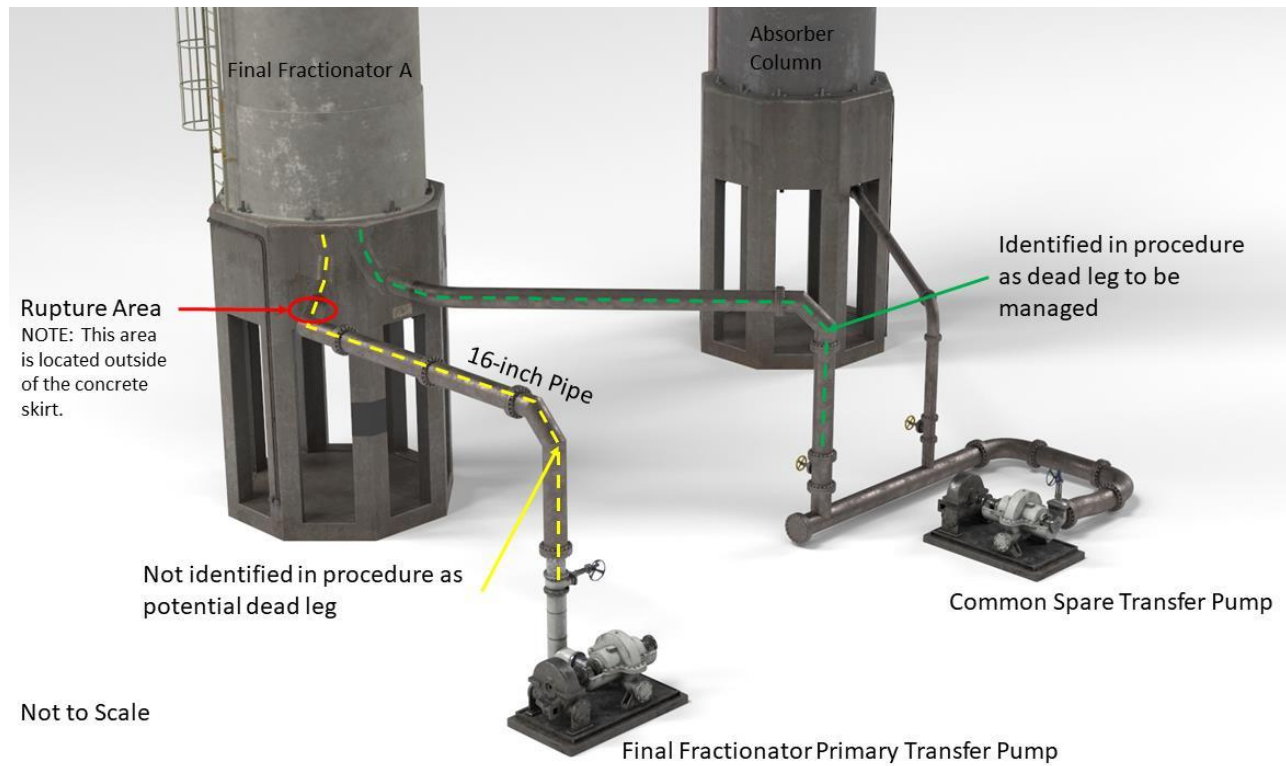
**Figure 19.** Primary Pump dead leg not identified in TPC PNO procedure. (Credit: CSB)

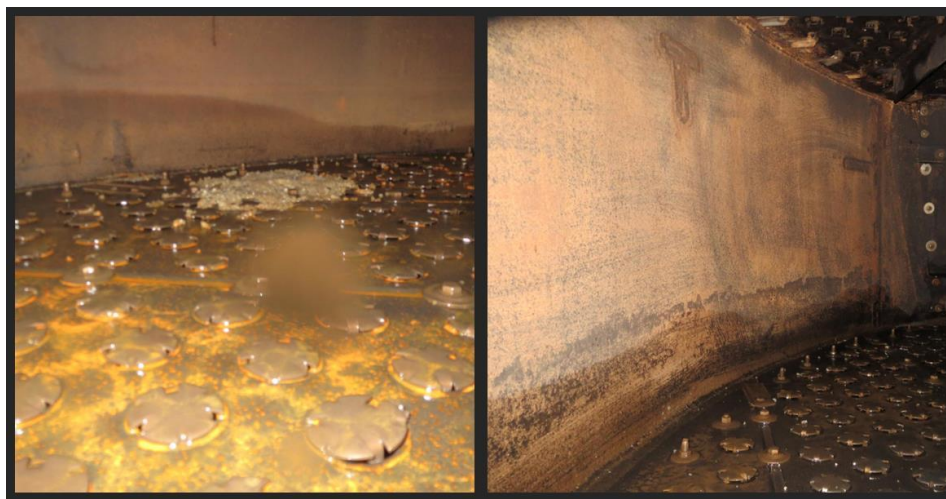
**Figure 25.** Photos of Final Fractionator A column taken during TPC PNO’s 2017 turnaround. (Credit: TPC)

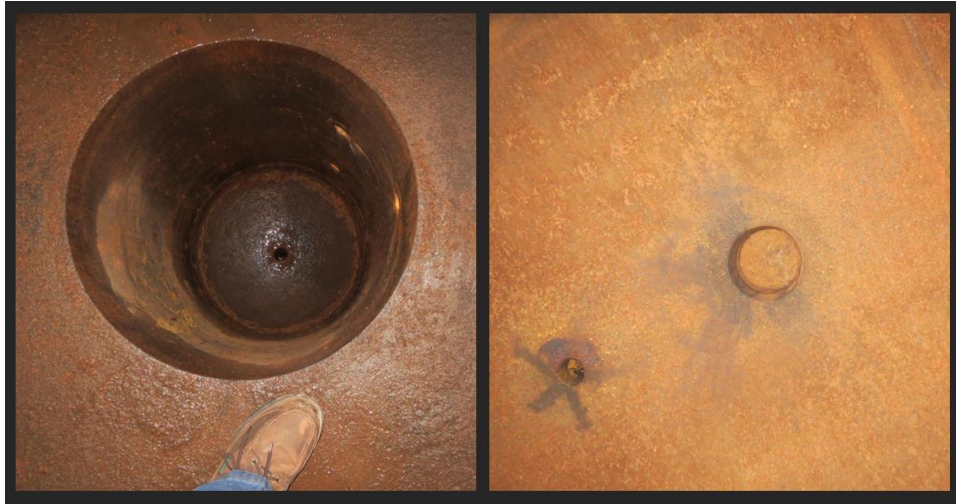
**Figure 26.** Photos of the Final Fractionator Overhead Accumulator taken during TPC PNO's 2017 turnaround. (Credit: TPC)

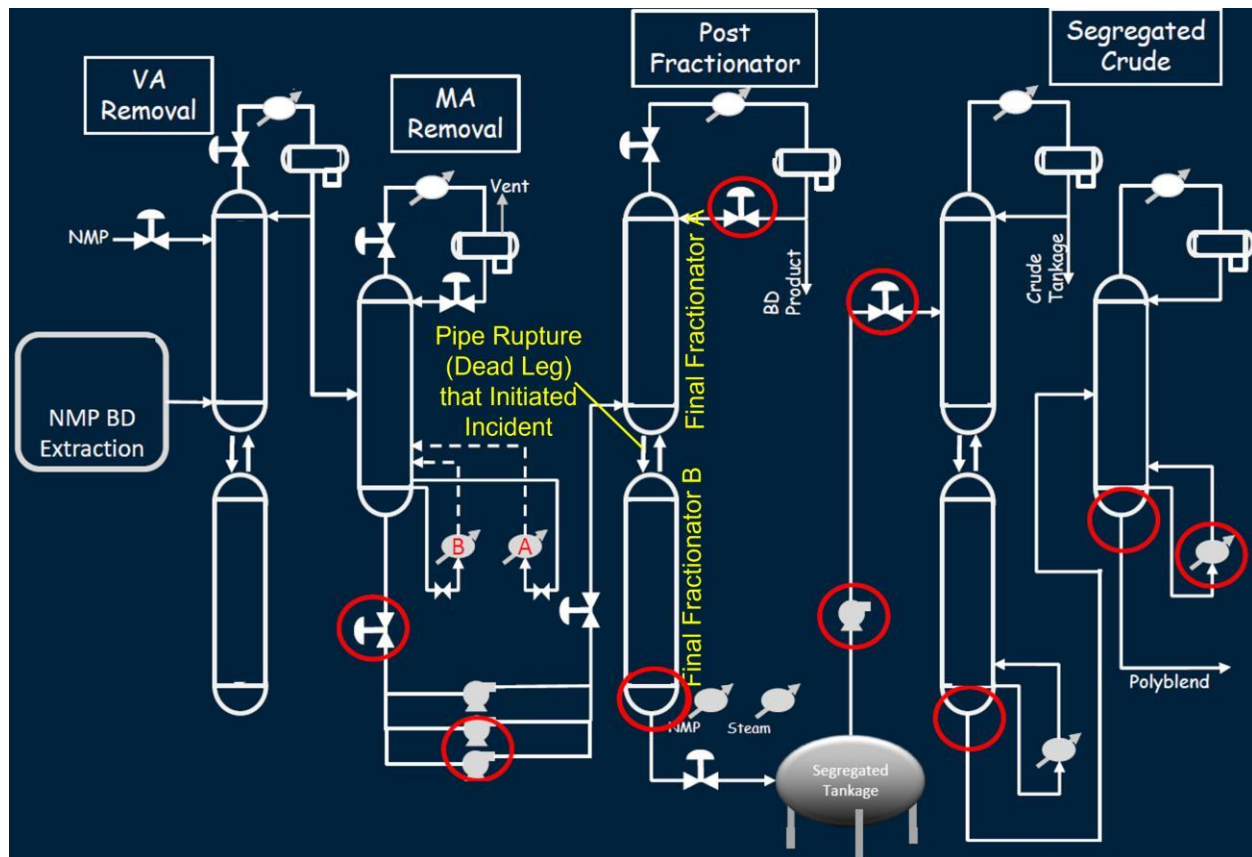
TPC PNO continued to experience popcorn polymer and equipment plugging in the butadiene process throughout the remainder of 2019. Circled in red in **Figure 34** below are locations where the TPC PNO facility had experienced popcorn polymer blockage in equipment between June and October 2019.<sup>a</sup>

**Figure 34.** Locations of popcorn polymer blockages or fouling between June and October 2019. (Credit: TPC with text added by CSB)
