| BETA LAB No.M10198- LS3 TOP | TESORO REFINING AND MARKETING COMPANY ANACORTES REFINERY 10200 W. MARCH POINT ROAD T91WA4428 ANACORTES, WA 98221 | CUSTOMER P.O. No.: 4501667904 |
| PART: 6600-E HEAT EXCHANGER LS 3 TOP PART 15 | | DATE: SEPTEMBER 20, 2010 |

LABORATORY REPORT-LS3 TOP

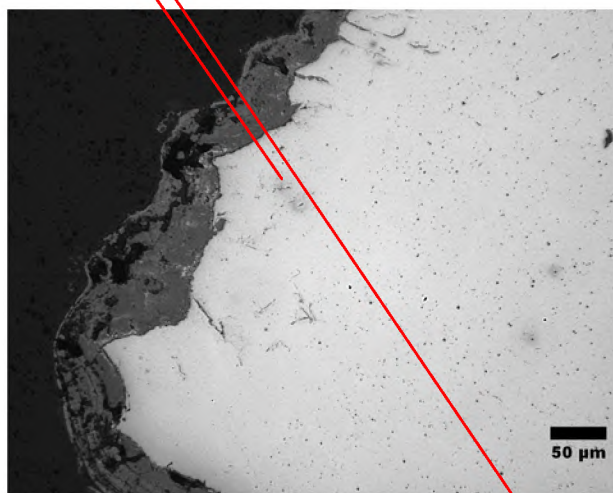
Wed toe at the weld metal side of the crack, un-etched

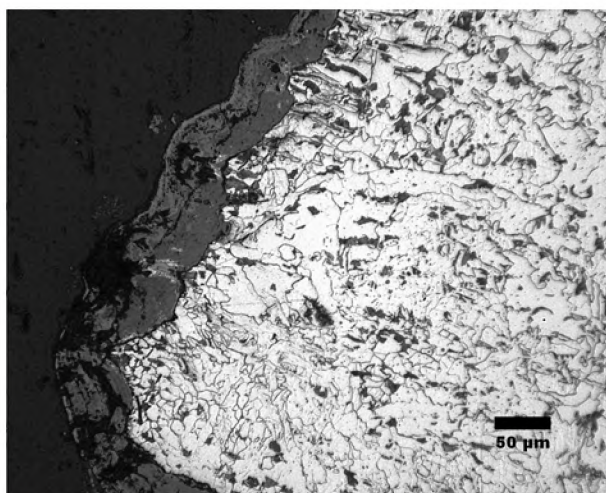
Same as at left, etched

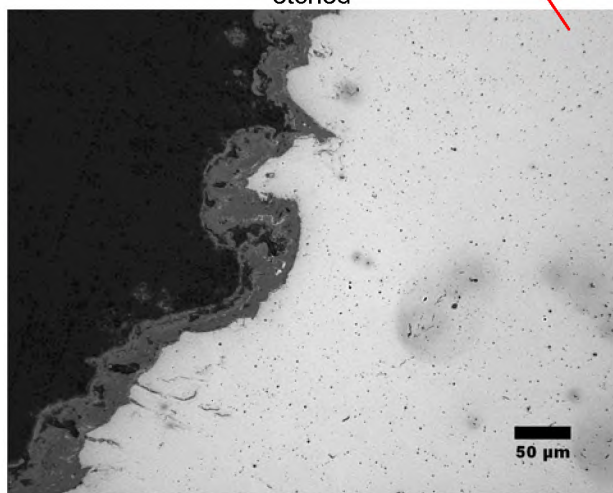
One field up along the crack edge, un-etched

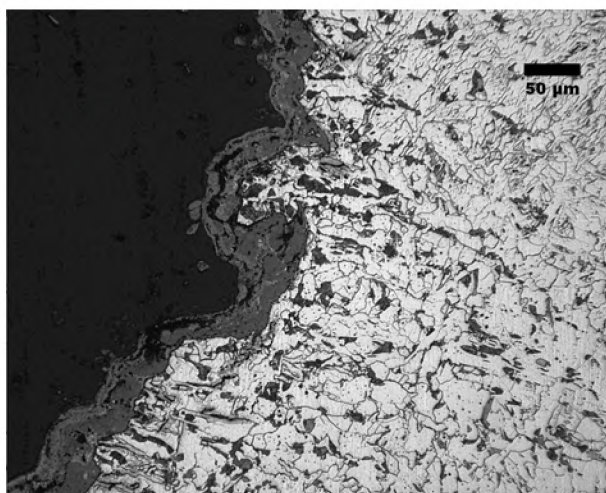
Same as at left, etched

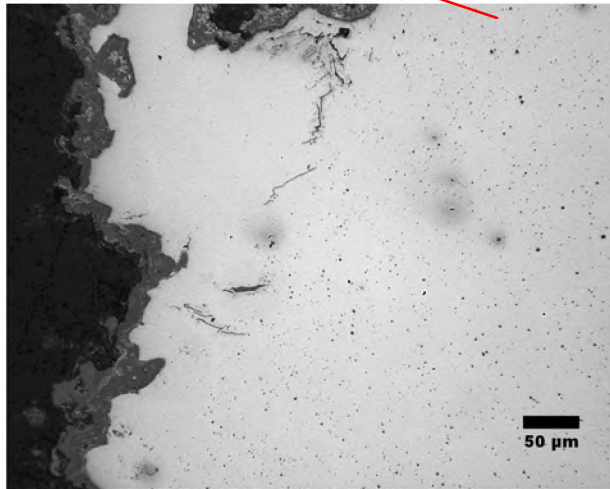
Two fields up along the crack edge, un-etched

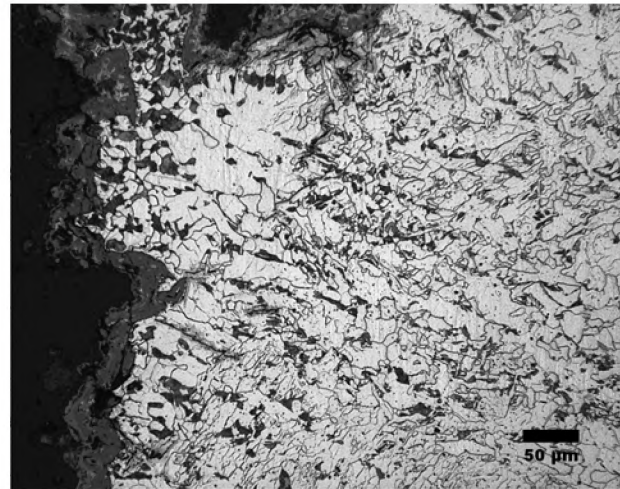
Same as at left, etched

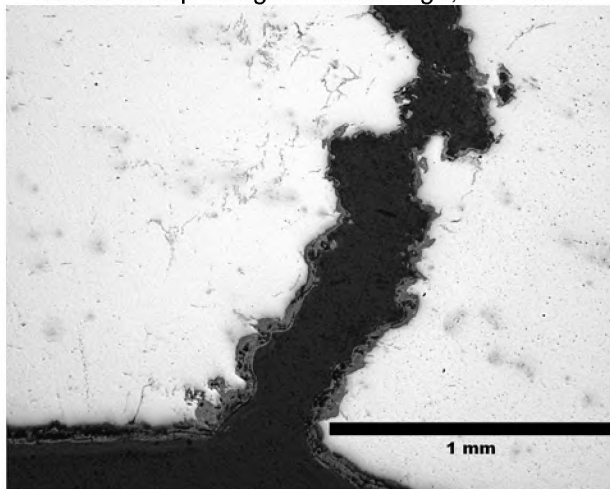
Both sides of the crack at ID. Un-etched

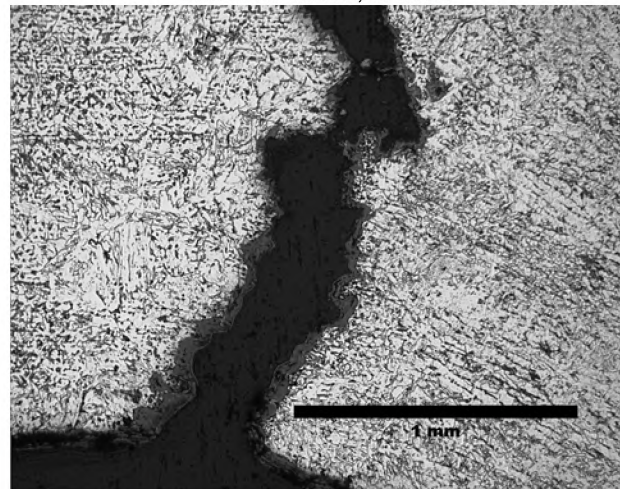
Same as at left, etched

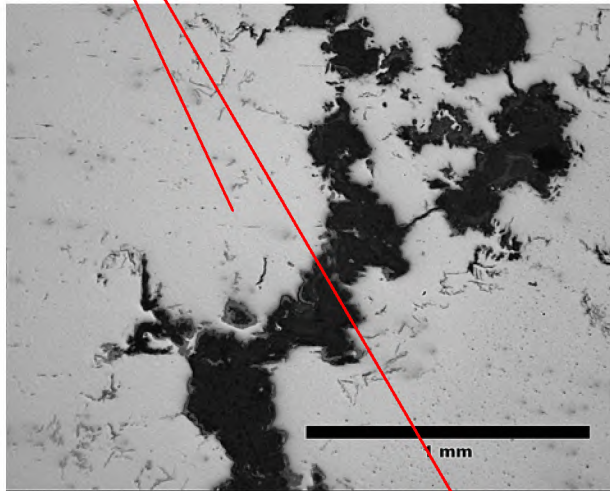
Crack, up from the ID. Un-etched

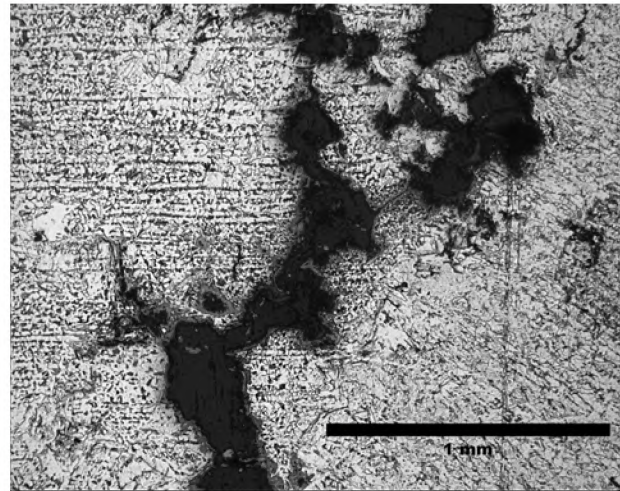
Same as at left, etched

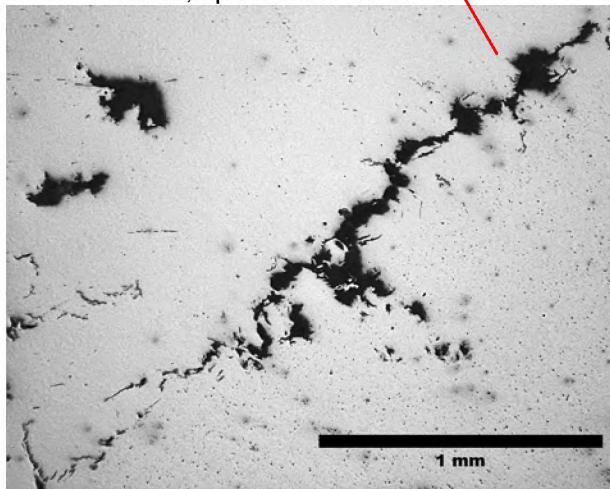
Tip of the crack along fusion line, un-etched

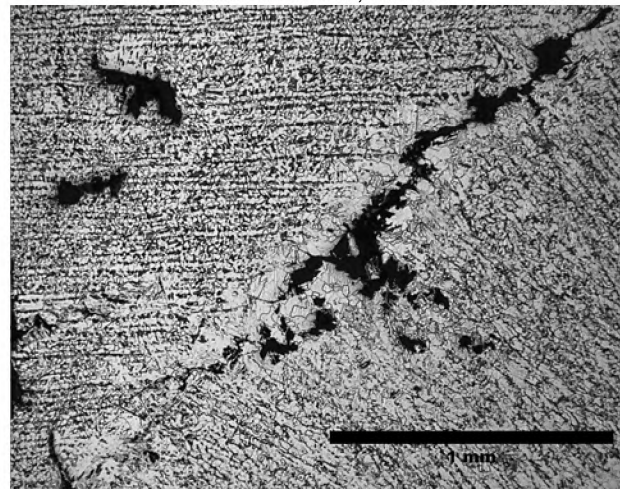
Same as at left, etched

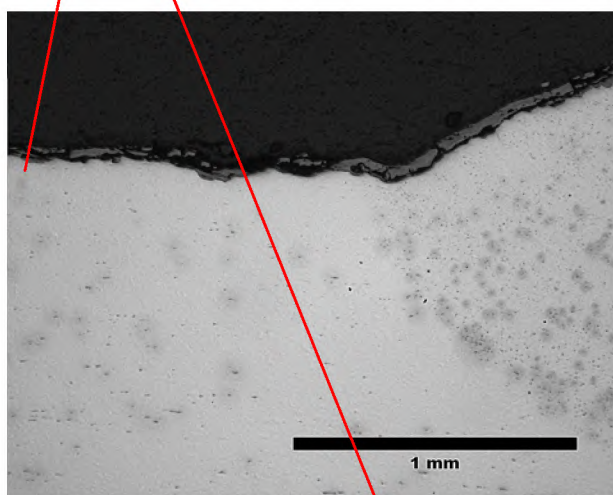
Weld toe at OD. Un-etched

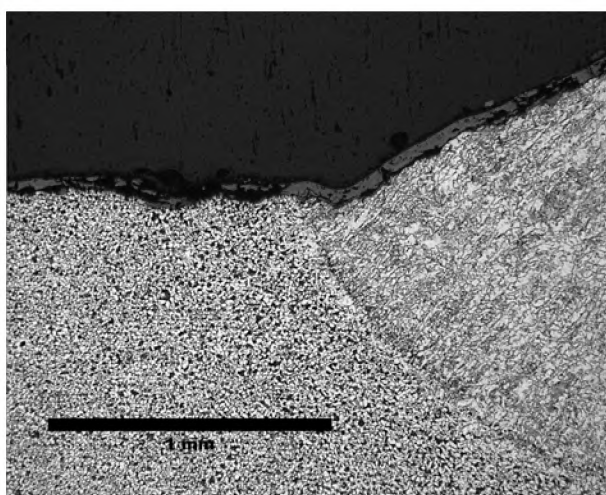
Same as at left, etched

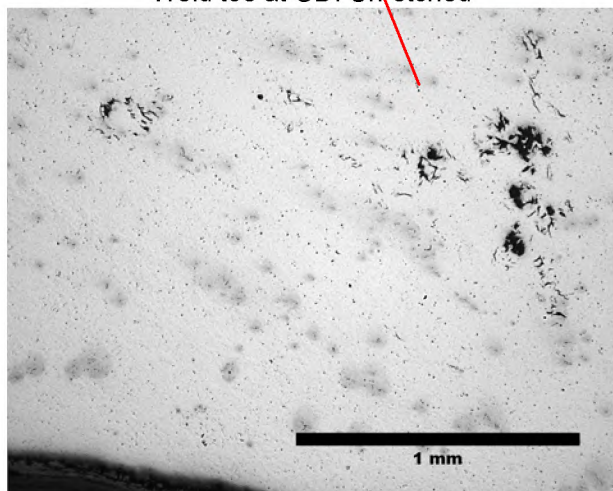
Cracks in the Weld Metal, un-etched

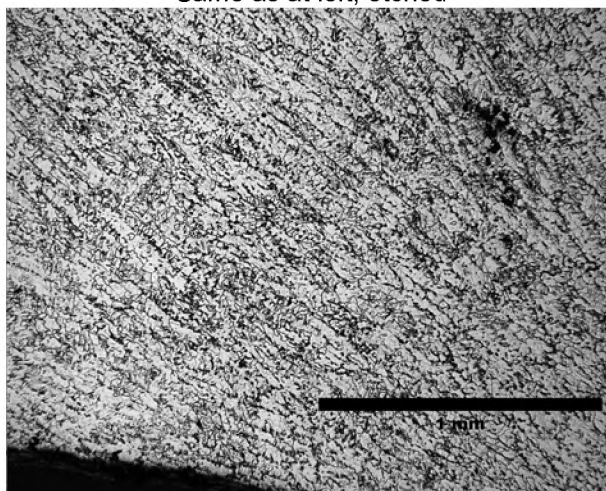
Same as at left, etched

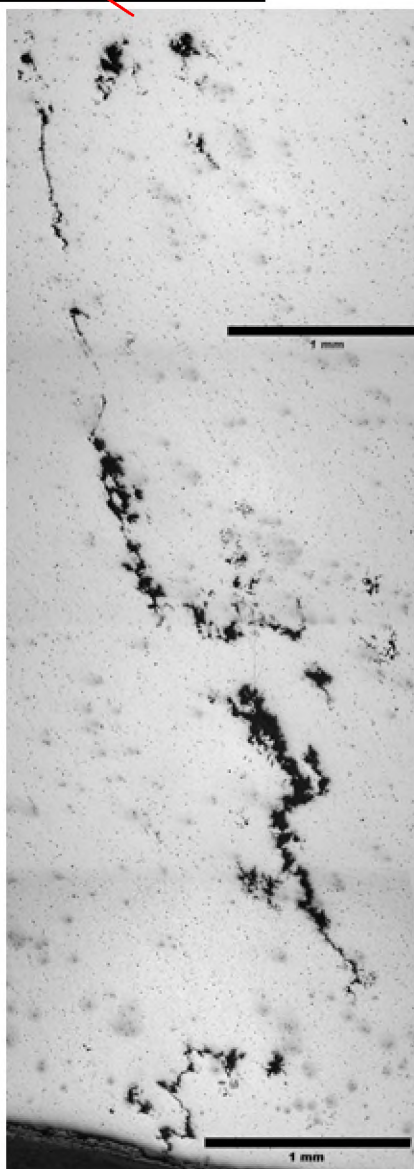
One of the cracks in the Weld Metal. Four microphotographs stitched together. Un-etched

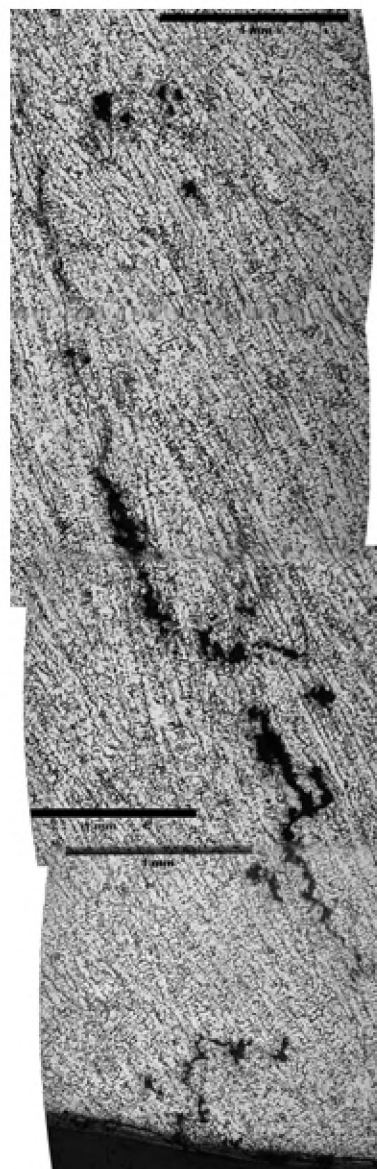
Same as at left, etched

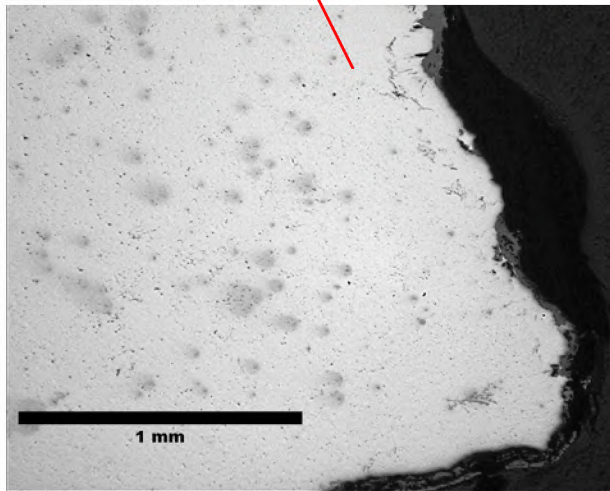
Fracture edge at ID. Un-etched

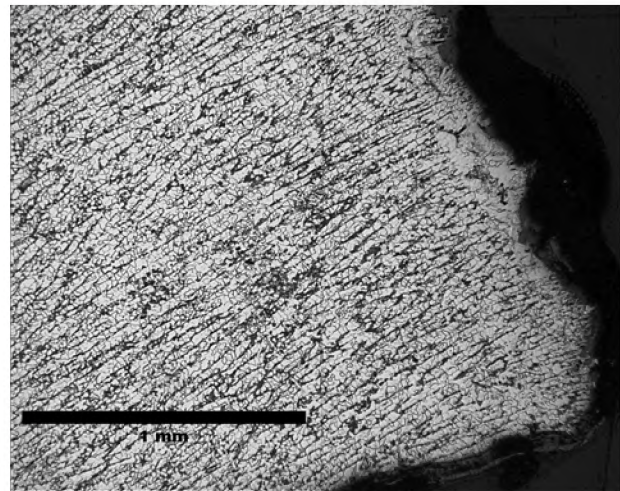
Same as at left, etched

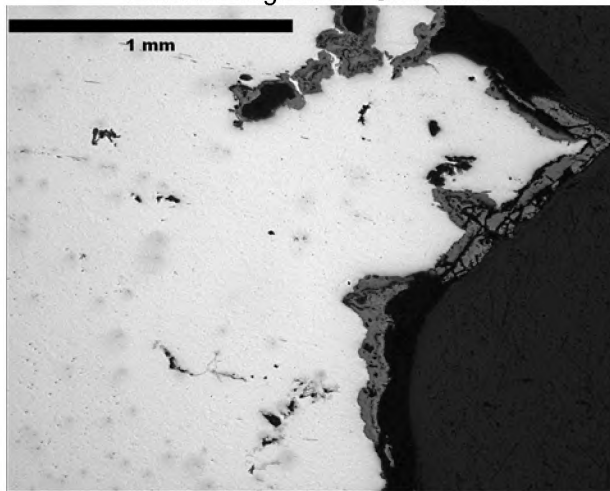
Fracture edge, four fields up from ID, un-etched

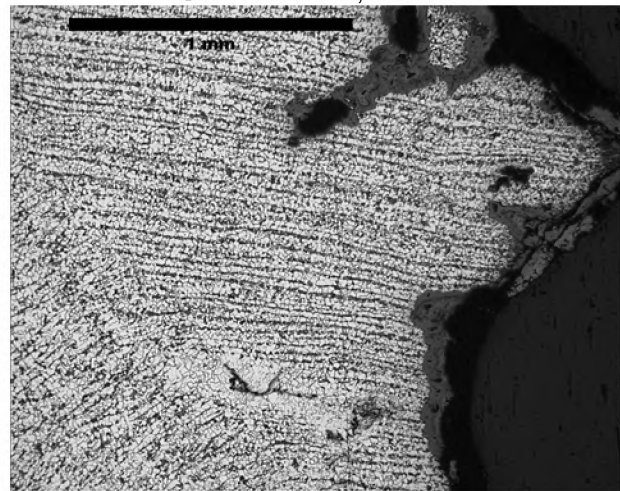
Same as at left, etched

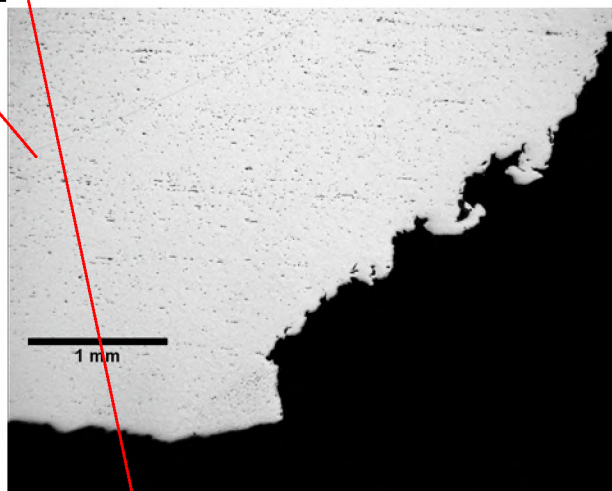
Fracture edge at OD. Un-etched

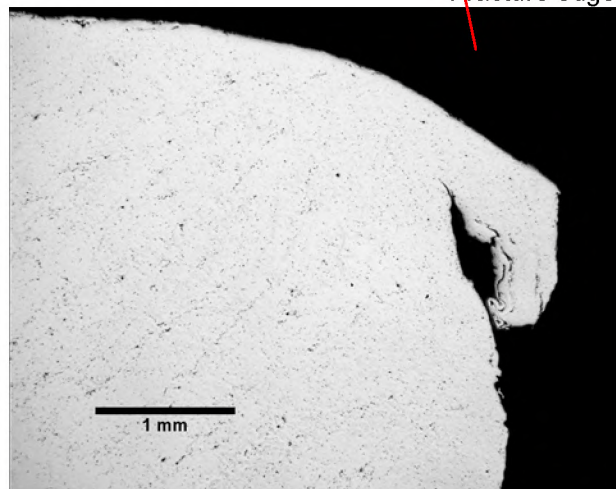
Fracture edge at ID. Un-etched

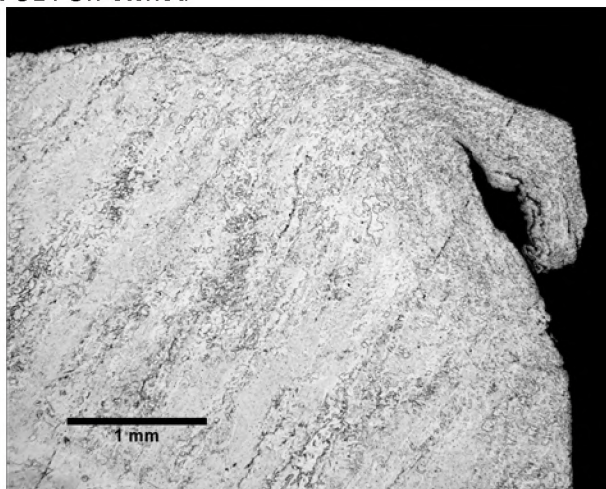
Same as at left. Etched

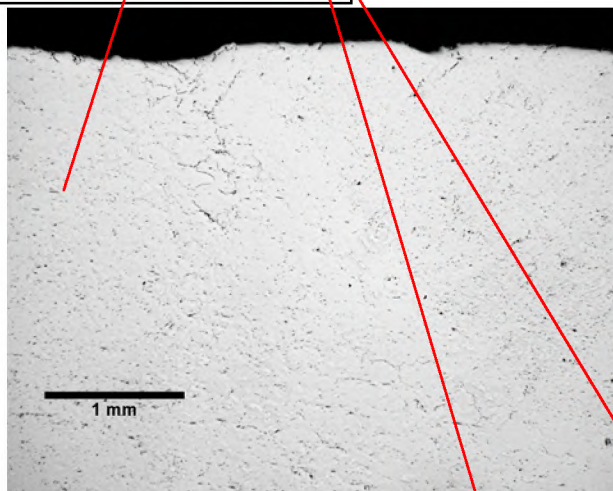
Area at the weld toe at ID

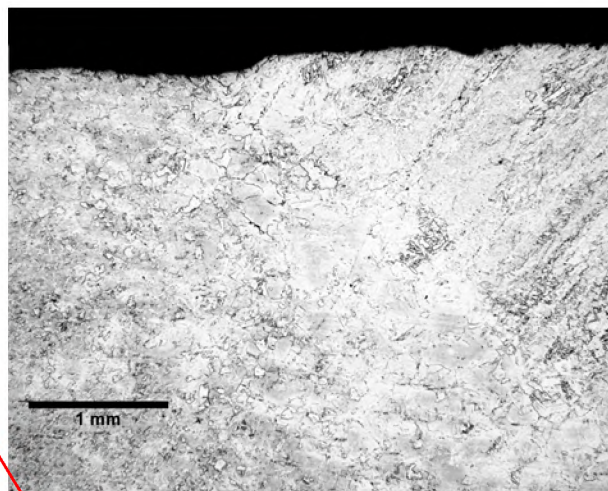
Same as at left. Etched

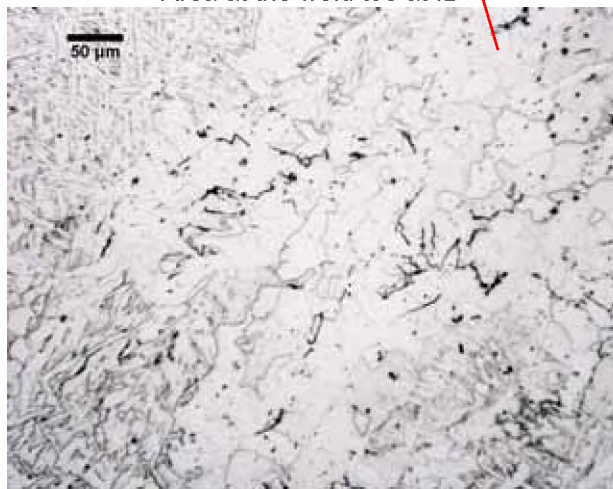
Weld metal near ID. Etched

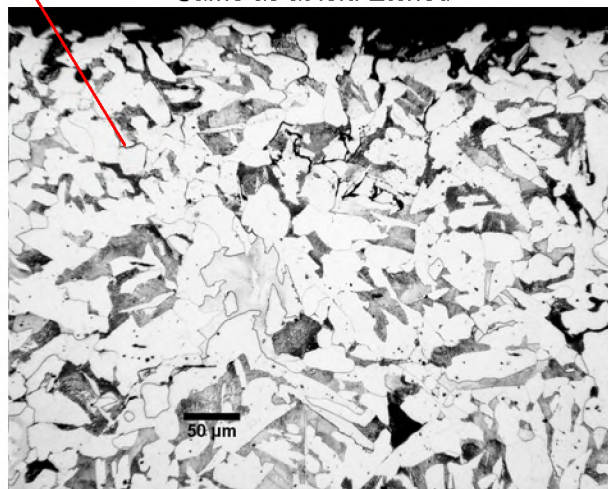
Area of the base metal 1.5 fields down from the toe of the weld. Etched.

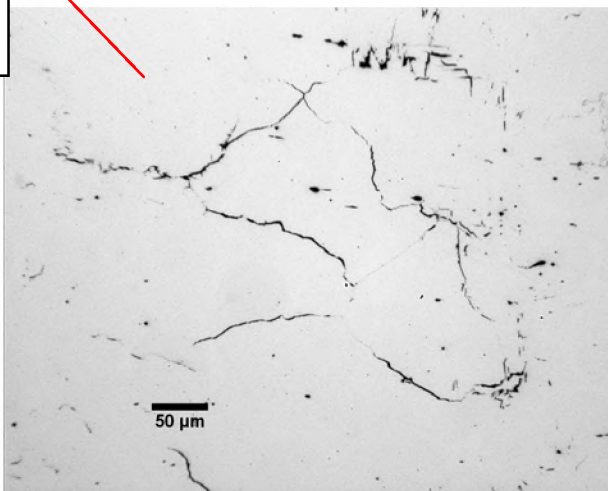
Area at weld toe near ID at higher magnification
(See Figure 18, top). Un-etched

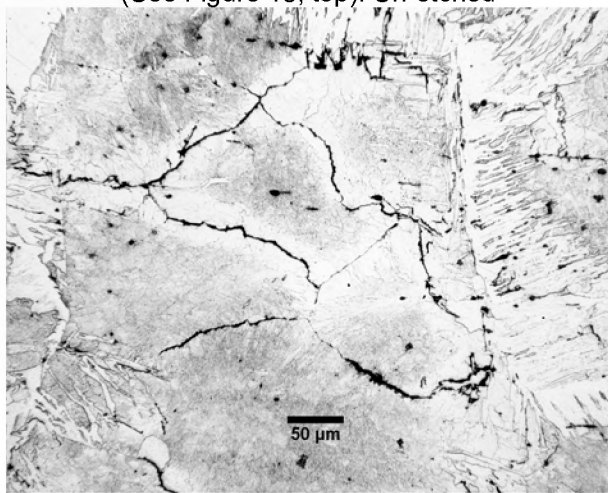
Same as above. Etched

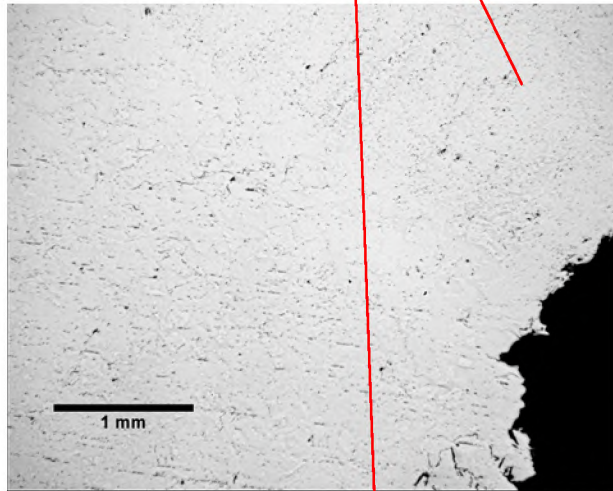
Fracture edge, one field down from ID. Un-etched

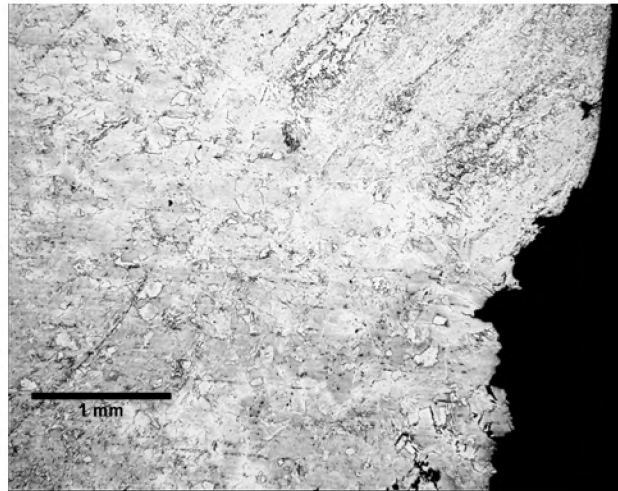
Same as at left. Etched

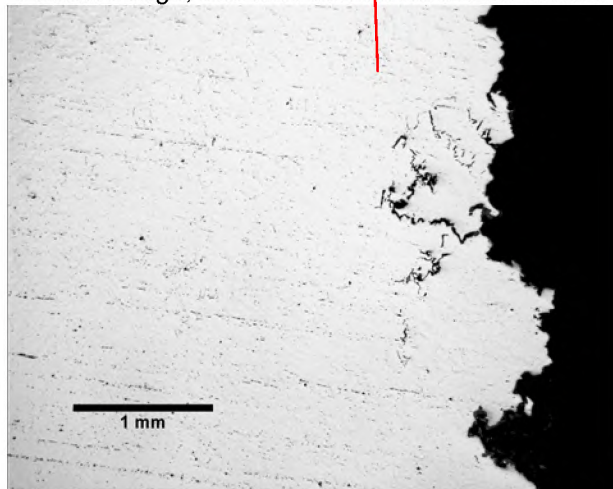
Fracture edge, two fields down from ID. Un-etched

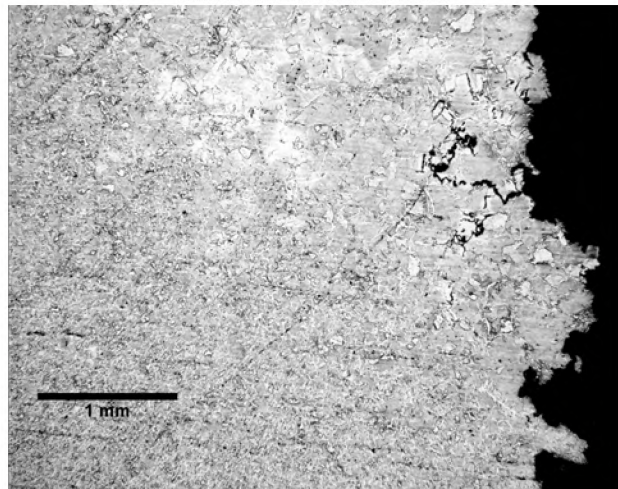
Same as at left. Etched

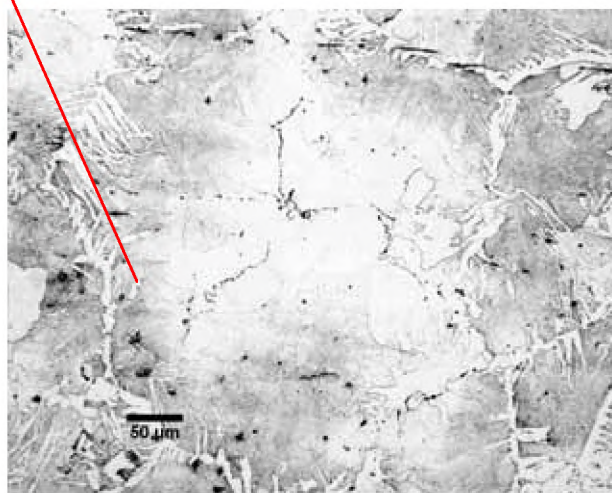
Area down one field (see picture in Figure 31 above) from the ID and near the fracture edge.
 Etched

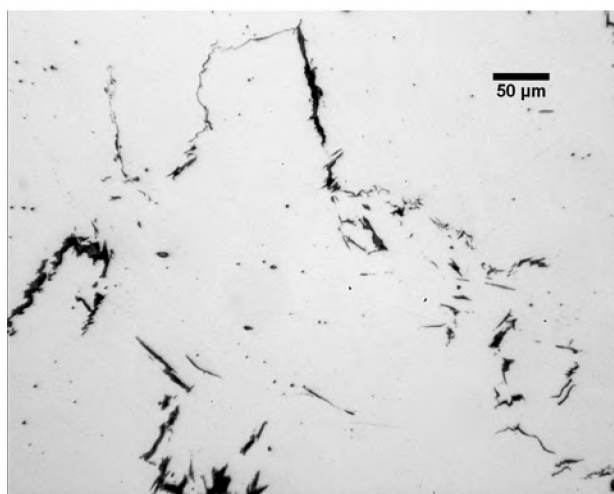
Area down two fields (see picture in Figure 31 above) from the ID and near the fracture edge.
 Un-etched

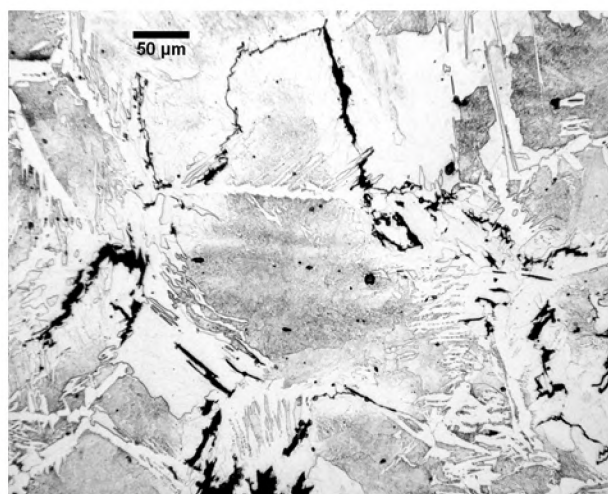
Area down two fields (see picture in Figure 31 above) from the ID and near the fracture edge.
 Etched

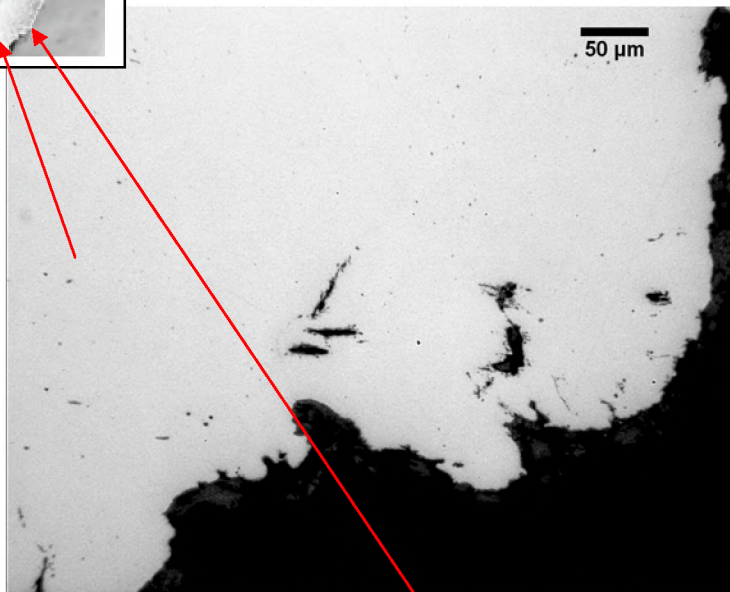
Area at fracture edge near OD-Un-etched

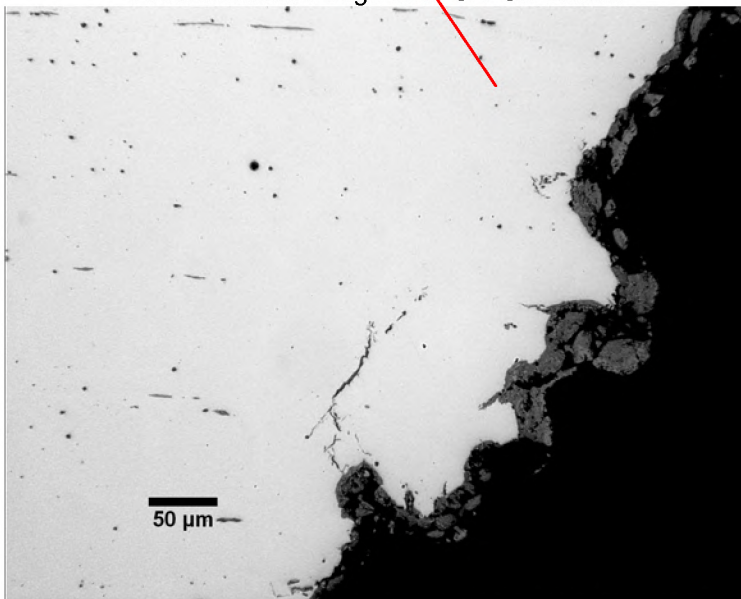
Area at the fracture edge 1.5 fields up from the OD--Un-etched
