Introduction

At approximately 11:00 PM on May 31, 2017, explosion(s)¹ at the Didion Milling (Didion) facility in Cambria, Wisconsin, resulted in 5 worker deaths and an additional 14 workers injured. Because the event occurred at night, only 19 employees were working within the facility at the time of the incident.²

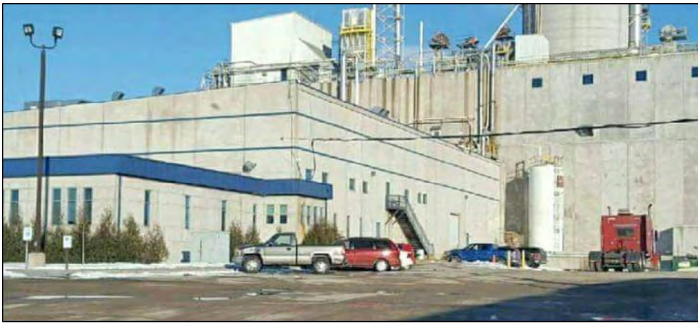
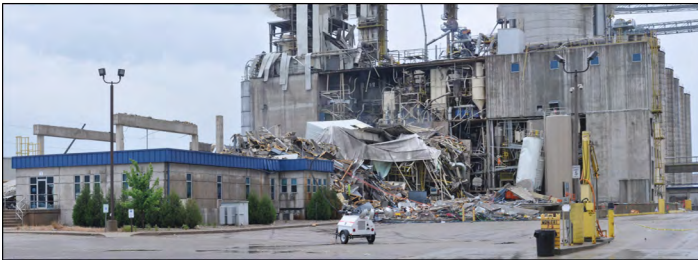
Figure 4. Pre- (top) and post-incident (bottom) photos of the west side of the Didion facility.¹³

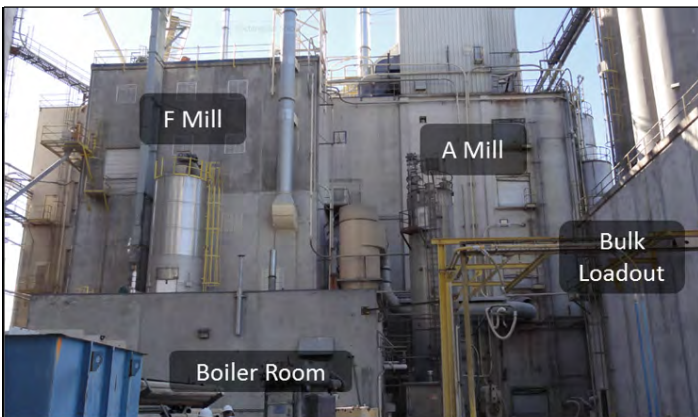
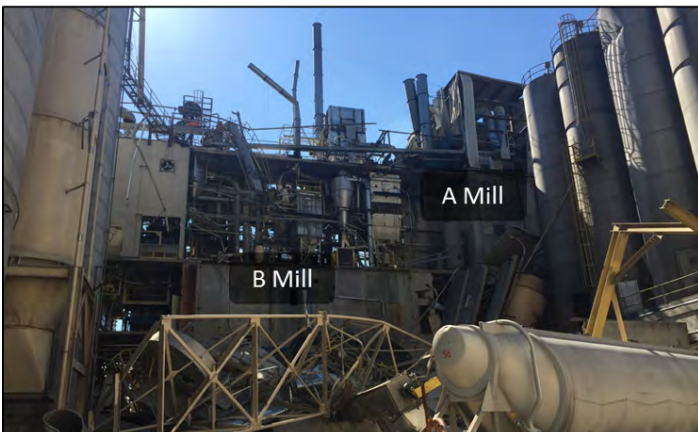
Figure 5. East side view of the Didion facility pre-incident taken during the latter part of 2010 (top) and post-incident (bottom) showing the complete collapse of F Mill and the boiler room. The pre-incident photograph shows the facility before the D Mill or the expanded bulk loadout bays were added.

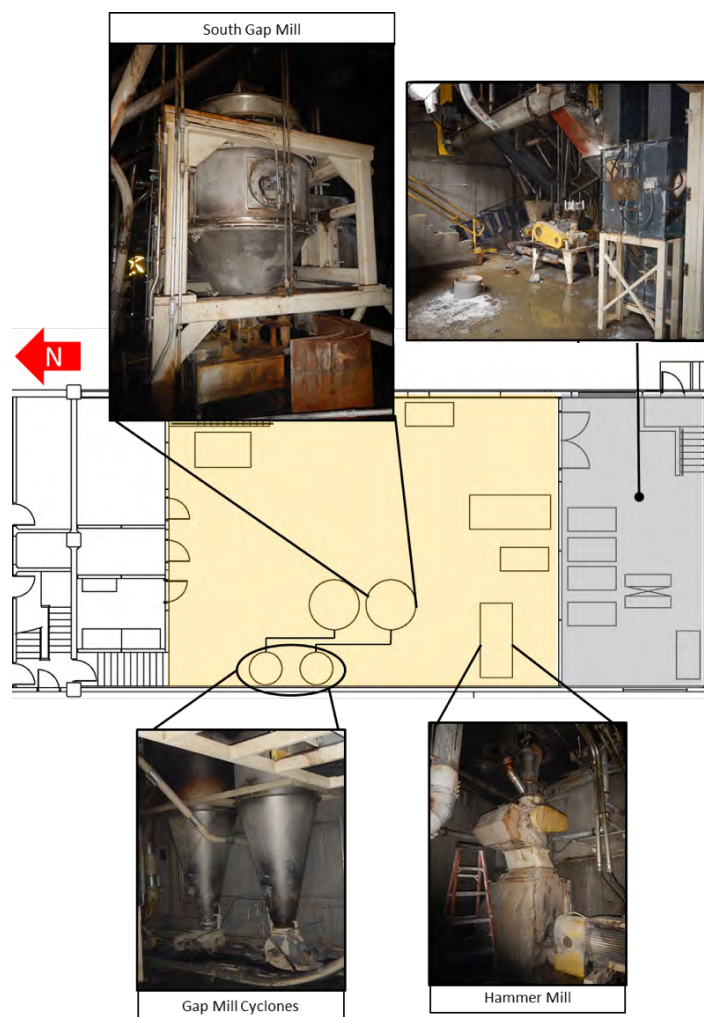
Figure 8. Partial equipment layout and photos in 1B identifying and denoting the locations of the south gap mill and a cyclone connected to gap mill’s product output stream (see Figure 10 and footnote 29 for further explanation), a hammer mill, and a room (grey) containing various pieces of equipment that Miller B inspected for burned belts or other problems.

Miller B was returning to the second floor when he noticed a small amount of smoke in another room in 1B (yellow room, Figure 8), but he could not tell where it was coming from. He and another co-worker who had come to look for the smoke source checked a hammer mill and they assessed it to be running well (Figure 8). They also visually confirmed that product was flowing well through a nearby gap mill (Figure 8) by inspecting a sight glass on a cyclone connected to the mill's product output stream (Figure 9).²⁹

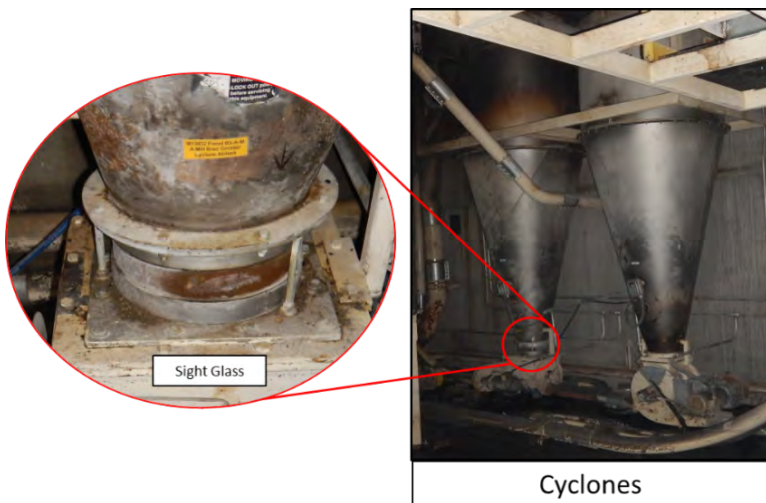
Figure 9. The cyclone highlighted here is connected to the south gap mill (Figure 8). A sight glass at the bottom of the cyclone allows workers to see if product is flowing.

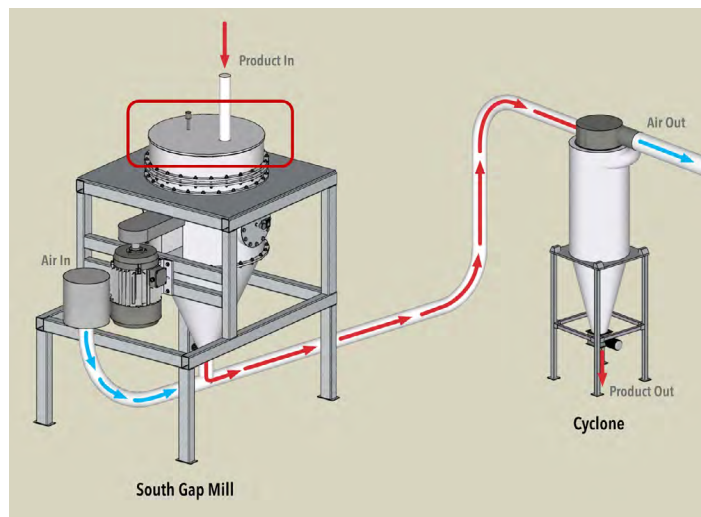
However, Miller B then saw a mixture that looked like dust or smoke being thrown out of the area near the gap mill's product inlet (Figure 10). The gap mill was designed to have product fall through the mill and exit through the bottom,³⁰ so when it happened, Miller B could not understand why product was flowing in the wrong direction (Figure 10). Miller B called over the radio to request that Miller C shut down the south gap mill through the computer system in the control room,³¹ but within seconds of the conversation, there was a loud noise and more smoke and dust came out near the area of the gap mill. At this point, the Superintendent told him it could explode and that they should run. Miller B then quickly left 1B to head toward the control room on the second floor, but while he was on the stairs between the first and second floor, there was an explosion and a large quantity of dust filled the air around him.

Figure 10. Diagram of the south gap mill. Miller B witnessed a mixture that looked like dust or smoke coming out near the top of the mill (red box). The design of this mill uses an exhaust fan to draw air through the inlet filter (blue arrows, left), product from the bottom of the mill (red arrows) through a cyclone where the product falls to the bottom of the cyclone, and the air containing fine corn dust (blue arrow, right) continues out of the top to a dust collection system.

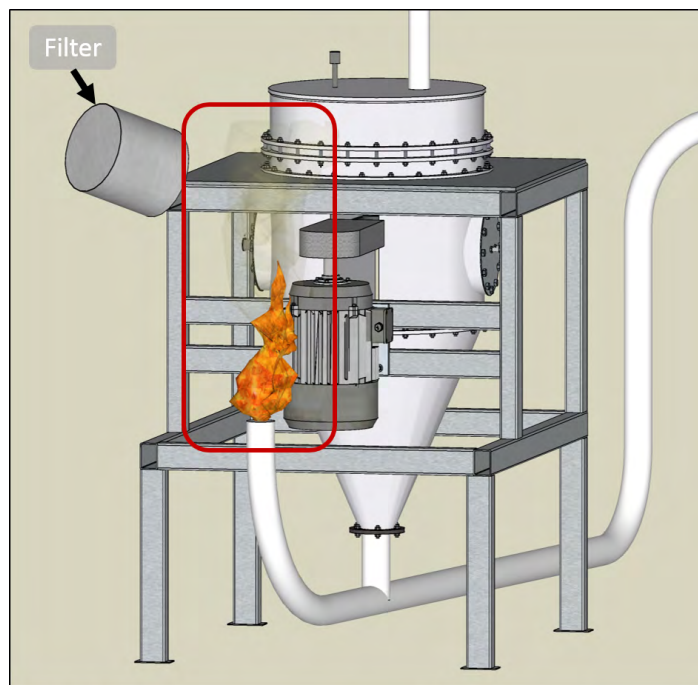
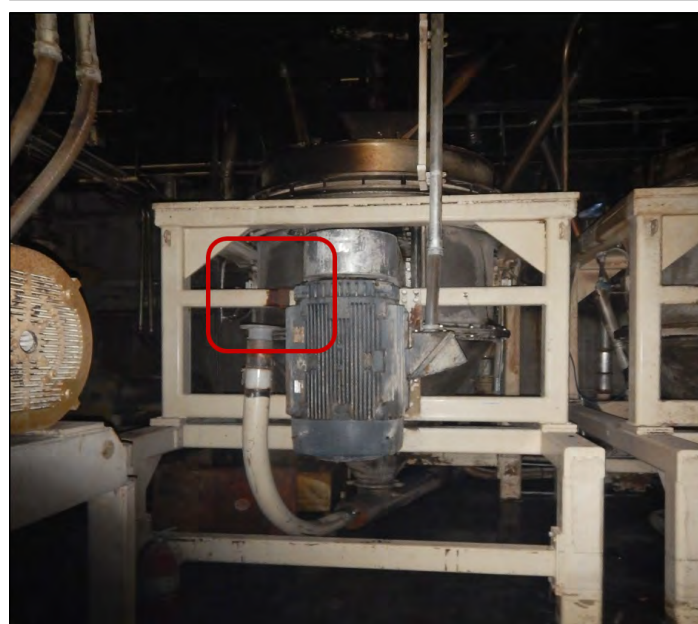
Everyone else left the room as the Superintendent and Miller B continued to inspect and find no problems with other equipment in 1B. Suddenly the Superintendent heard a “huge boom” and then a constant roar. When he looked toward the sound, he saw the filter from the south gap mill air intake line flying in the air and a three- to four-foot flame shooting out from the same line (Figure 12).³⁴ Based on what he saw, the Superintendent thought the initial boom might have knocked dust off the horizontal pipes that ran along the ceiling, which began misting down (Figure 13). The flame was visible for four to five seconds, and then it sucked back in. About five seconds later, the flame shot back out.

Figure 12. The Superintendent saw the filter from the south gap mill air intake line flying in the air and a three- to four-foot flame shooting out from the same line (red box, top image). The post-incident photograph (bottom) shows the filter missing (red box).

³⁴ Post-incident, the CSB observed that the filter from the south gap mill was missing from the intake suction line.

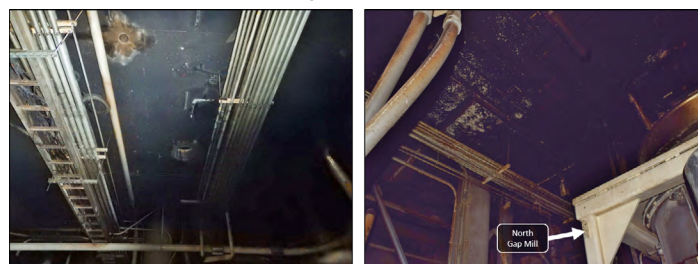
Figure 13. Example of overhead horizontal surfaces in 1B near the gap mill.

- Dust and product thrown into the air from equipment damaged by an overpressure event, like the one that caused the air intake line of the gap mill to blow off, or some other failure, and
- the lofting or knocking of fugitive dust into the air that had accumulated on floors, overhead piping, and other horizontal surfaces inside the mill.

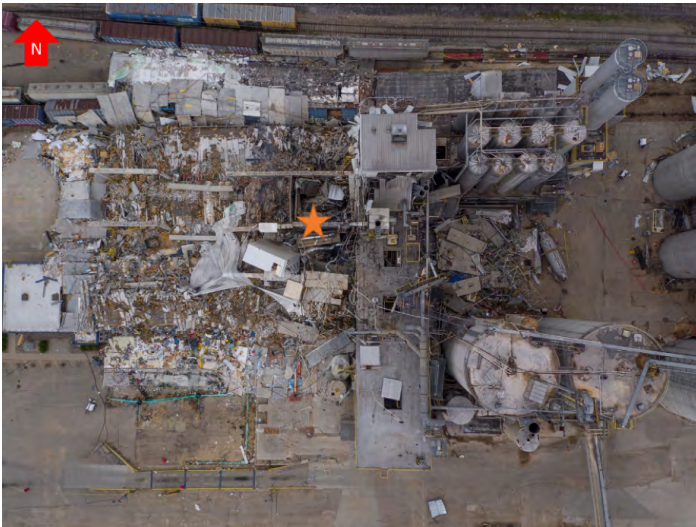
After getting away from the warehouse rubble, Tech B met up with an employee that had heard the explosion from home³⁷ and came back to the facility to help. They heard two Packers shouting for help because one of them had been pinned by a railcar in the Warehouse Railcar Loading Bay. Tech B worked with a Loader to move one of the railcars so that firefighters could get water to an area of the mill that was burning close to where the Packer was trapped. While near the railcars, he heard another explosion in the area indicated on Figure 17. After moving the railcar, he shut off the main gas line.

Figure 17. Approximate location (gold star) of the second explosion after the collapse of the mill buildings.

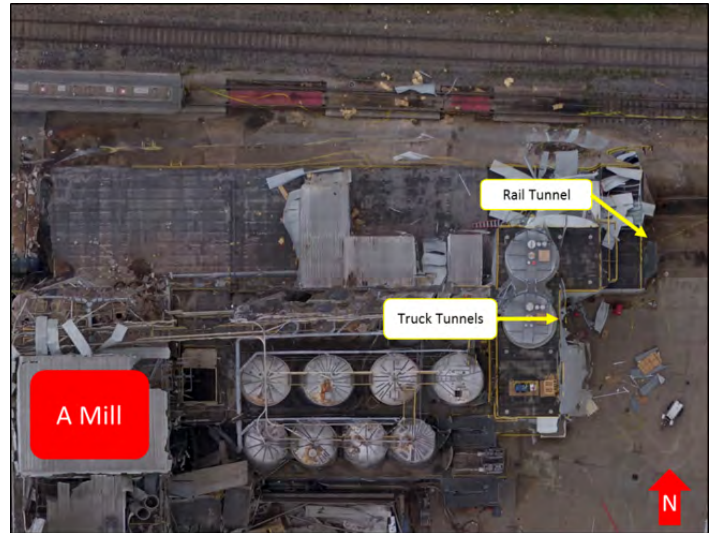
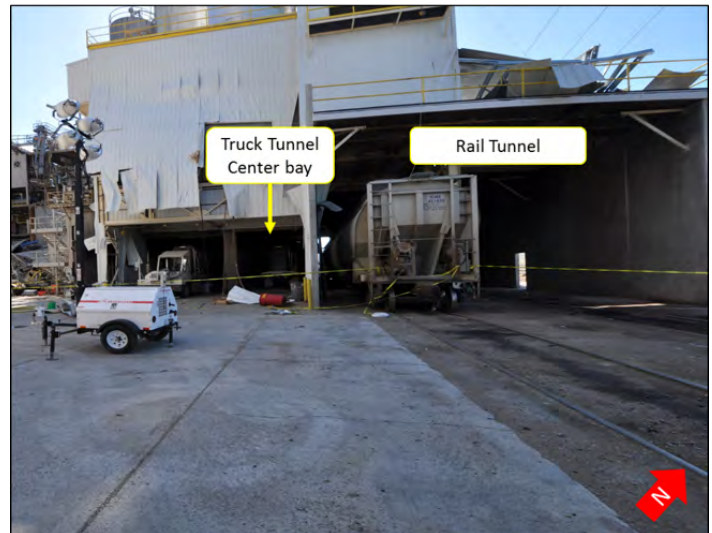
Figure 18. Post-incident images of the rail and truck loading “tunnels”. At the time of the incident, Loaders were working in the rail tunnel and witnessed fire and flames coming from the west end tunnel.
