TESORO ANACORTES REFINERY

EXCHANGER E6600B

June 24, 2010 Inspection Report

**TESORO ANACORTES REFINERY
HEAT EXCHANGER E-6600E
Unit: NHT**

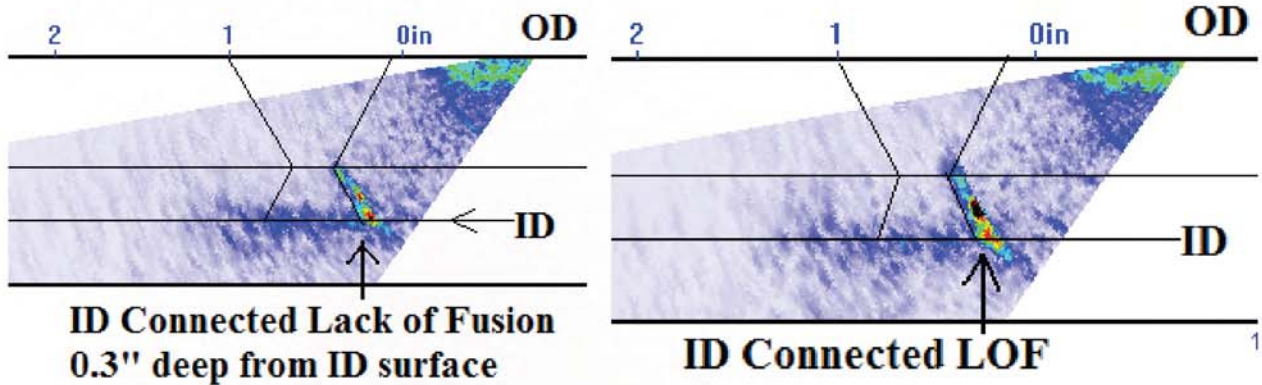
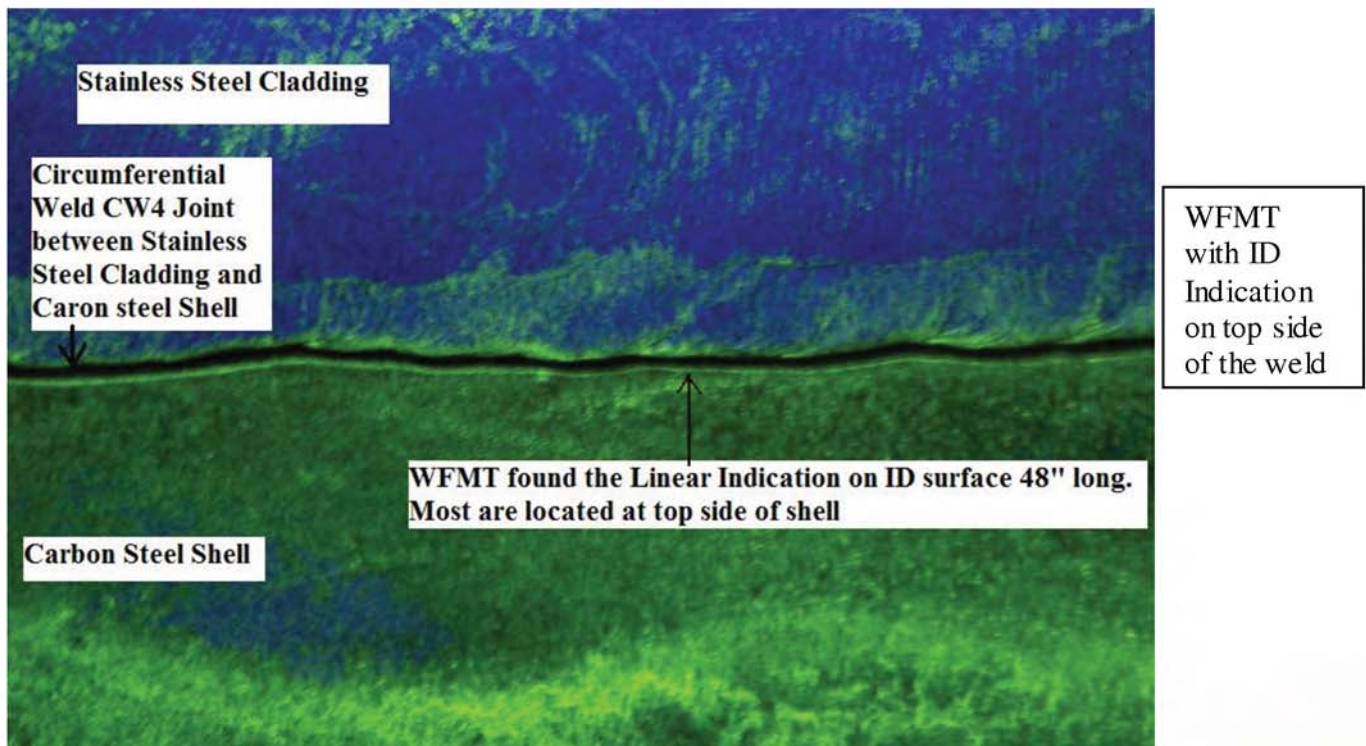
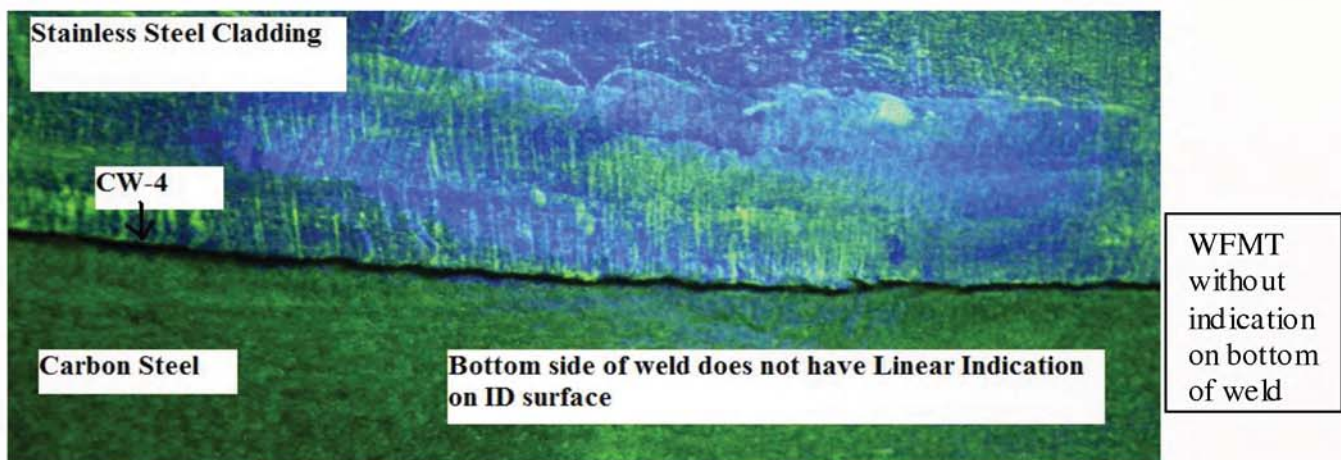
1. Phased Array inspection found ID connected Lack of fusion (0.3" deep from ID) or crack (since it is ID connected) at the edge of stainless cladding on circumferential weld CW4. Internal visual and internal WFMT confirmed the Phased Array finding and found it cover at least 50% of the weld. (48" long linear indication on ID surface).

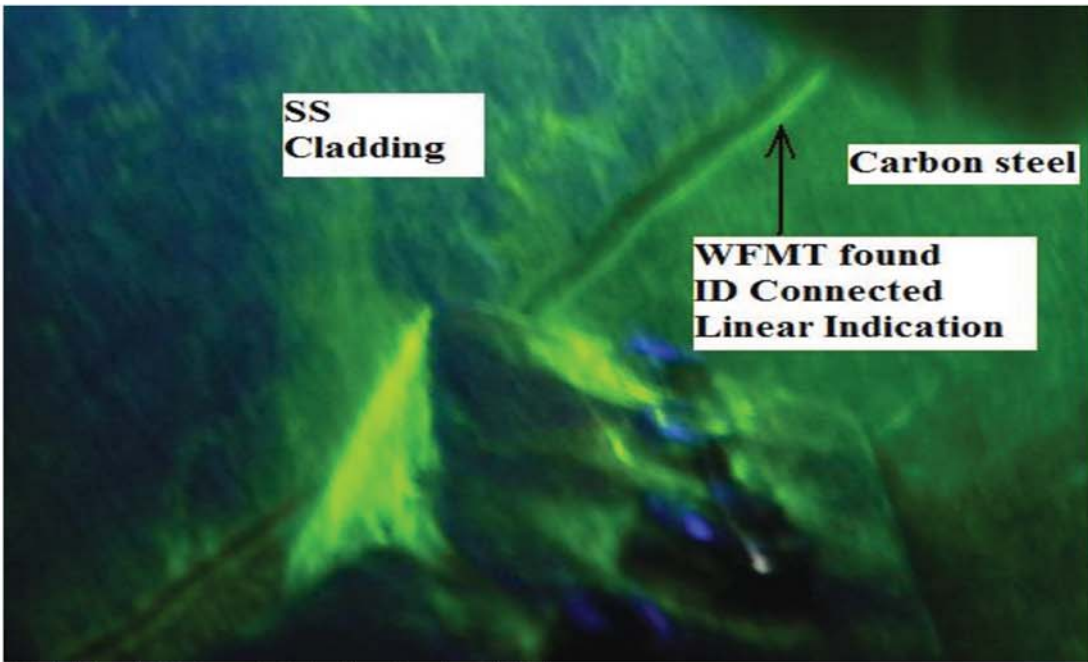
WFMT with Linear ID indication in CW-4.

Total circumference of CW4 was 76". ID connected indication ran from 0"- 31". It was also present from 64"-76".

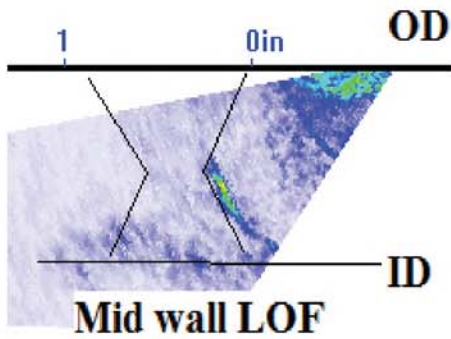
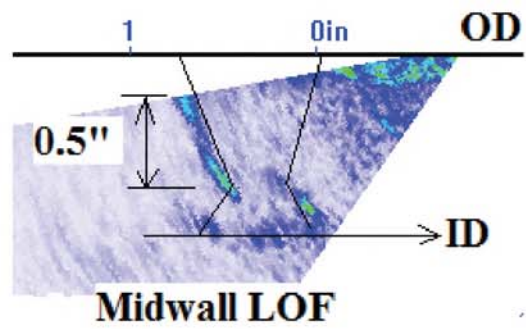
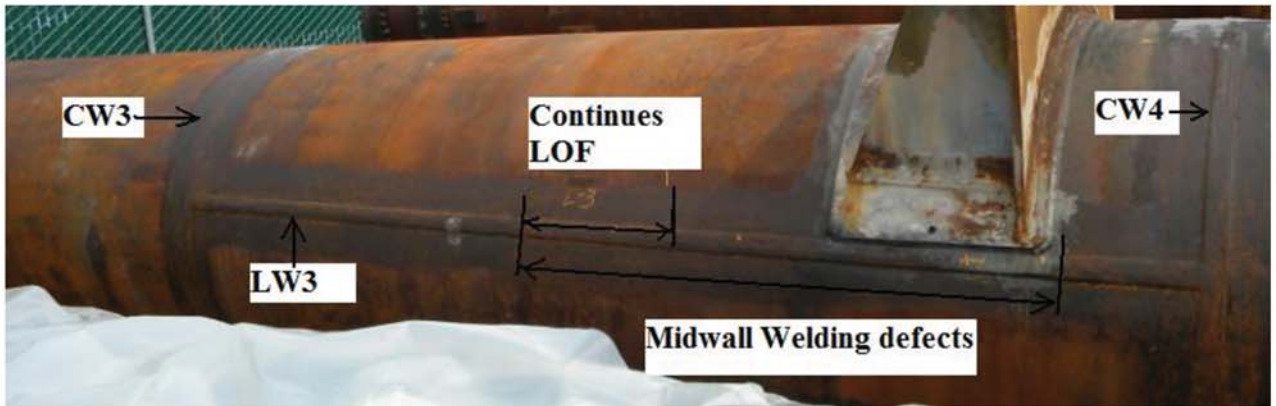
2. Phased Array inspection found 30" long intermittent mid wall lack of fusion (LOF) in longitudinal weld LW3 (include 10" continuous LOF). Internal visual and WFMT does not find indication on ID surface.

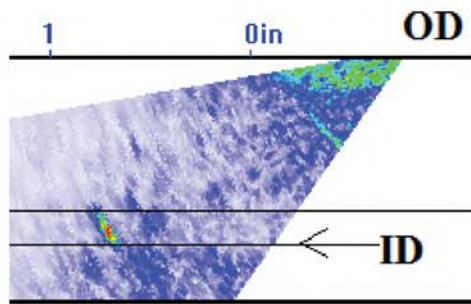
3. Localized ID connected Lack of fusion found in circumferential weld CW5. It was measured at 4' long and 0.17" deep from ID surface. WFMT confirmed the indication on ID surface.

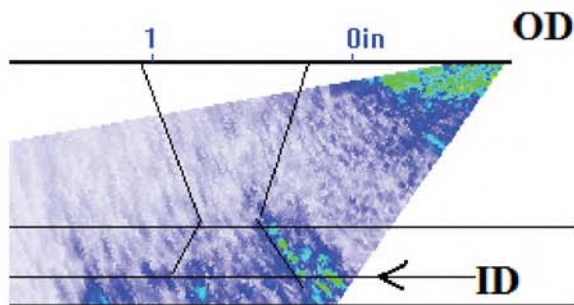
4. Localized ID connected Lack of fusion found in longitudinal weld LW-5

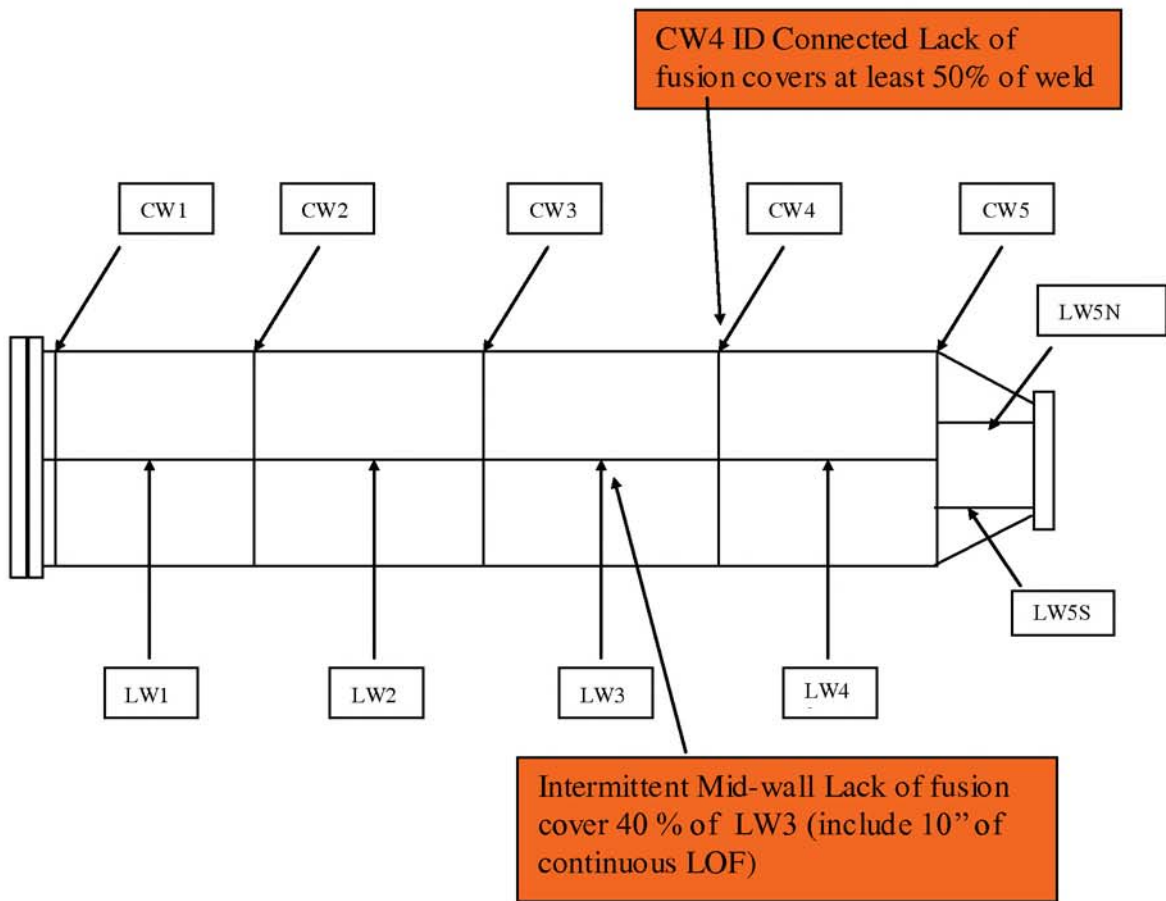
Exchanger E6600B Indication locations

5. Above indications found in Circumferential weld CW4 (ID connected Lack of fusion or crack) and Longitudinal weld LW3 (Mid wall lack of fusion) are same location as exchanger E6600-E fracture area.
6. Rest of welds (CW1, CW2, CW3, LW1, LW2 and LW4) in good condition.
7. No Hydrogen attack fissure indication found in exchanger shell based metal.
8. No Hydrogen attack fissure indication found in weld and HAZ.
9. Material identification confirmed exchanger E6600B is made of carbon steel. Please see detail composition in page 12.
10. Hardness test found average hardness number in welds are 130 BHN to 159 BHN. HAZ are 120 BHN to 157 BHN. Based metal are 114 BHN to 146 BHN. Please see detail hardness number in page 11.

E6600B defect location same as E6600E fracture area

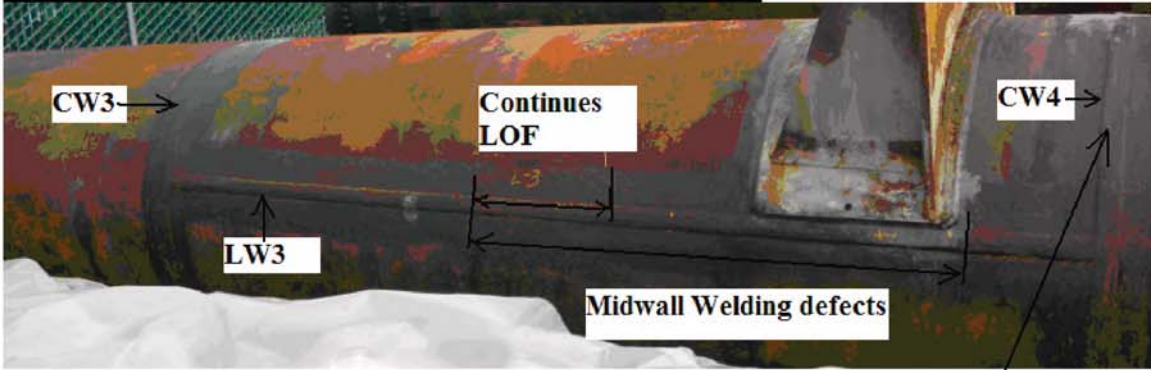
Exchanger E6600B Indication locations CW4 and LW3

**ID Connected
Lack of fusion**

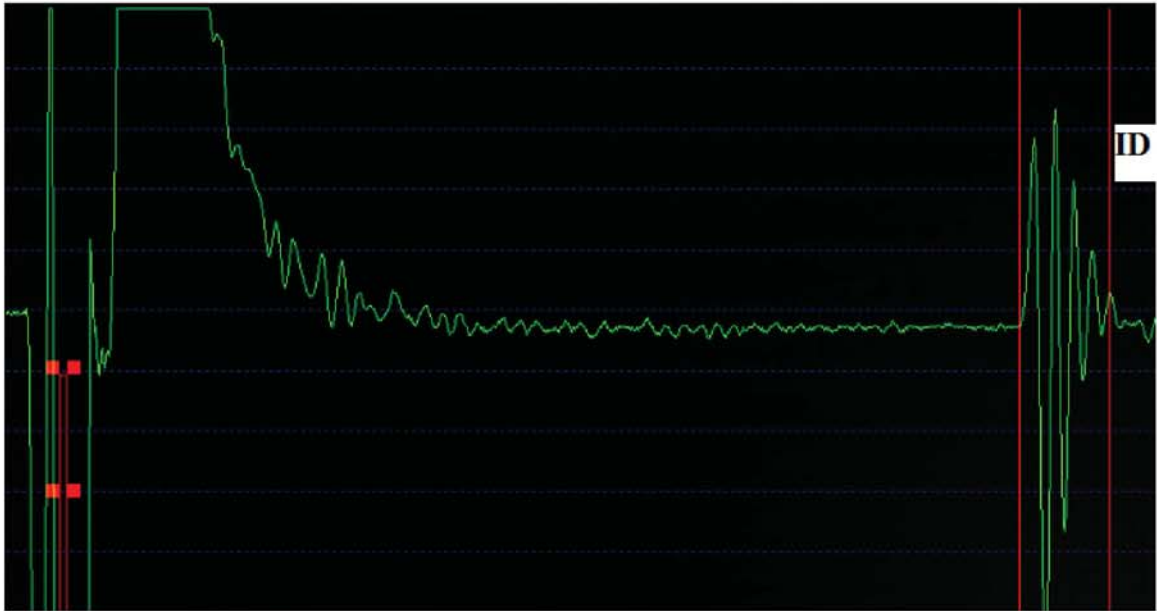
AUBT in Based Metal did not find Hydrogen Attack fissures.

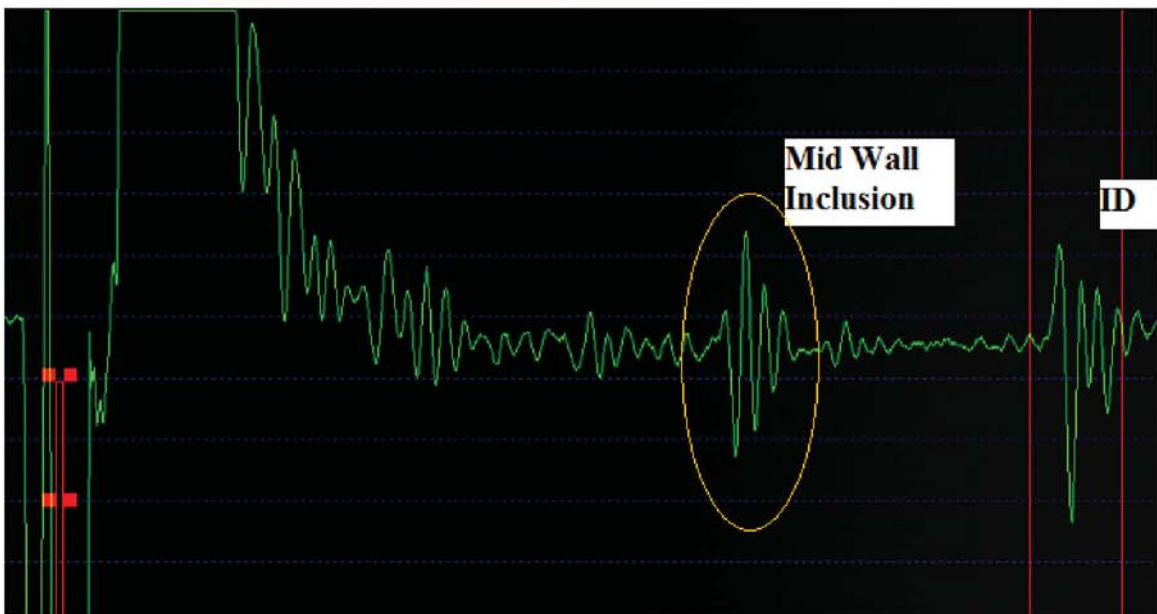
AUBT did not find hydrogen attack fissures in weld and HAZ.

All indications are confirmed that small Hydrogen attack fissures were not found by frequency Spectrum Analysis. (Red curve is reference back wall frequency spectrum and blue curve is frequency spectrum of indication found in the weld). These large indications are welding defects or large macro-cracking but not small fissures along grain boundary.

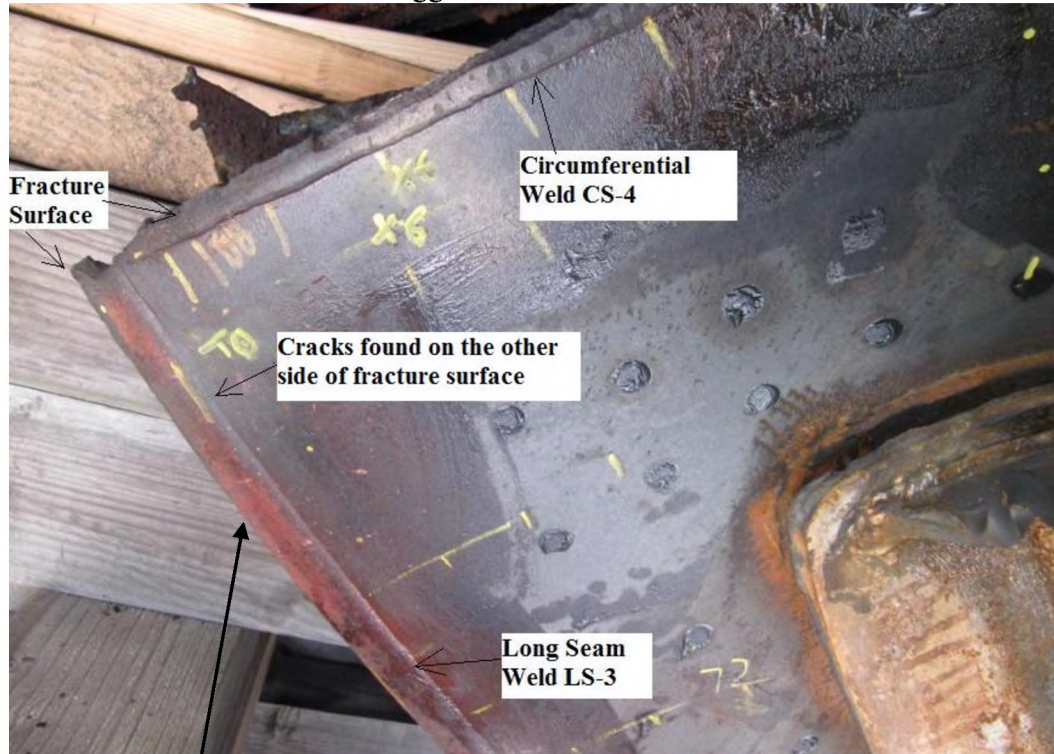
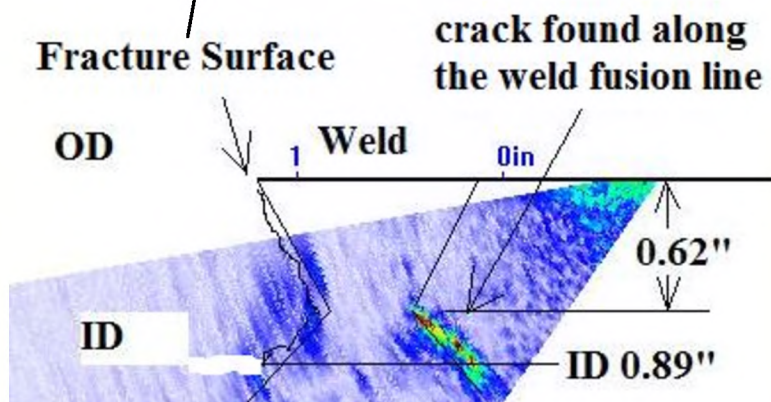
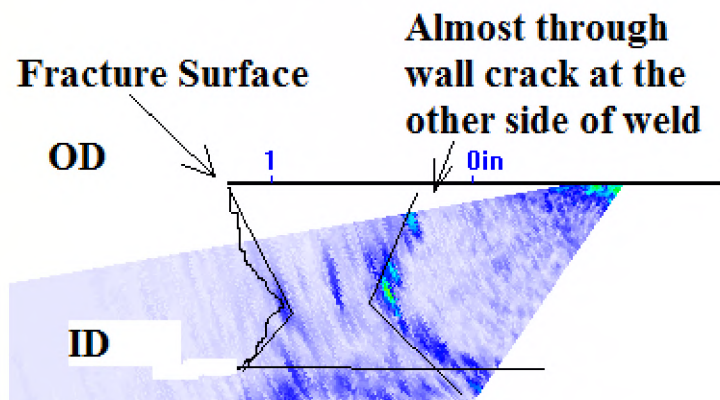
1. Phased Array found cracks in both side of weld in Long Seam L-3 (cracks at fracture surface and the other side of weld fusion line). Letter Stamp T0 marked on vessel external surface. This area is suggested to have lab microstructure exam.

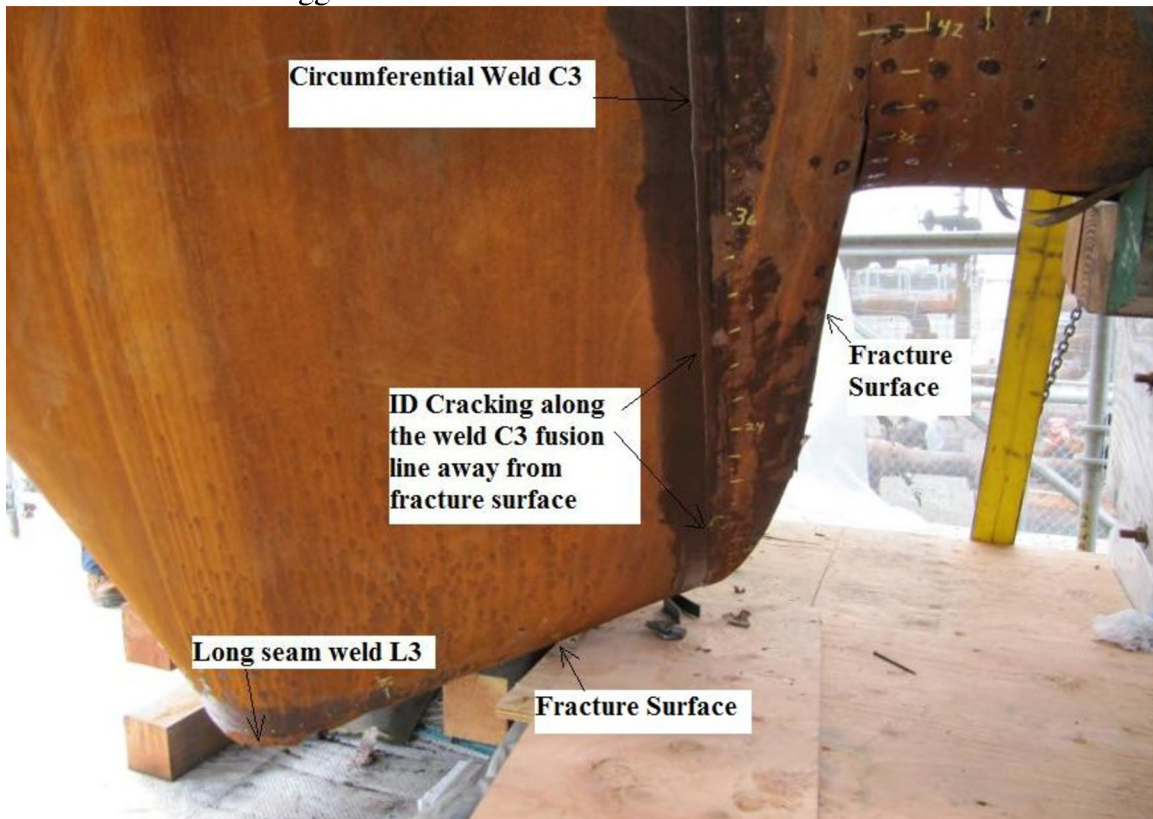
2. Phased Array found ID cracking in Circumferential weld C-3 away from fracture surface (crack is 0.13" deep from ID surface). Letter Stamp T1 Marked on vessel external surface. This area is suggested to have lab microstructure exam.

**Crack in C3 weld fusion line
2" from fracture surface**

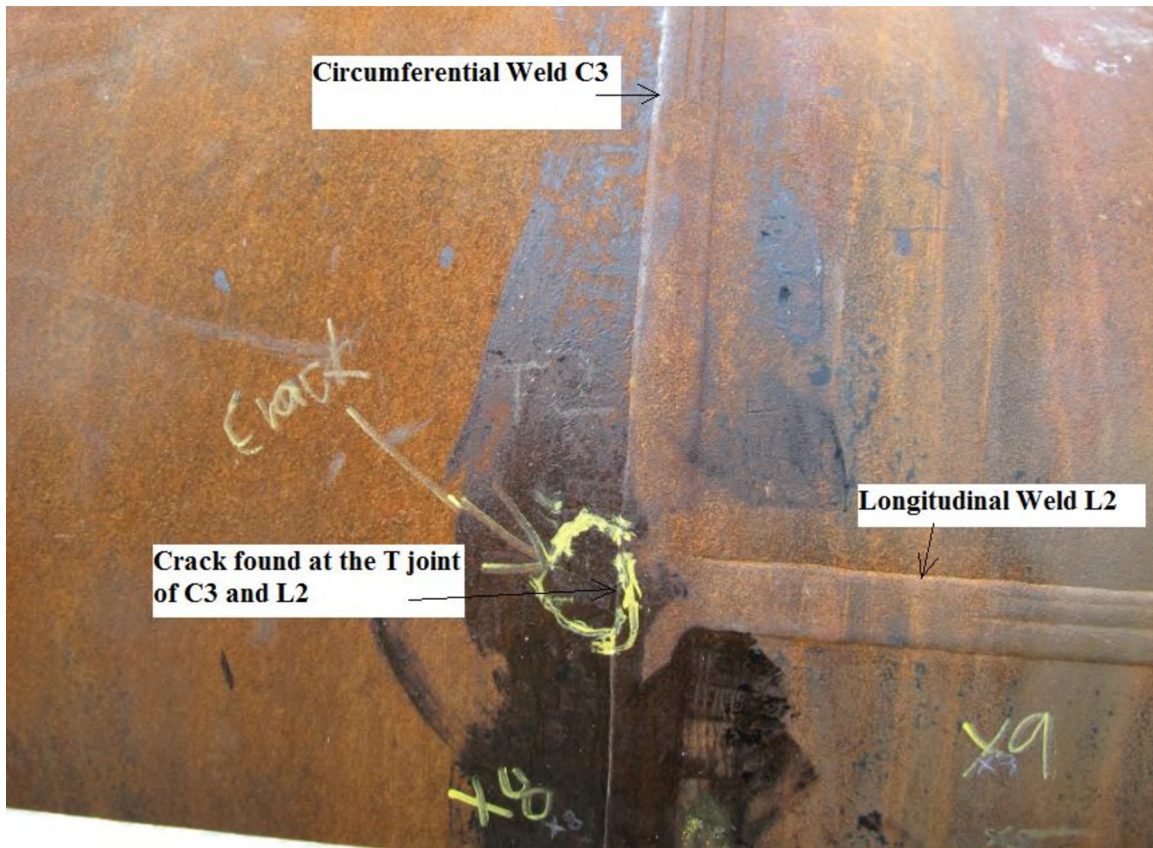
T joint of Circumferential weld C3 and Longitudinal L2

3. Phased Array found crack in T joint of C3 and L2. Letter stamp T2 marked on vessel external surface. It is suggested to have lab microstructure exam at this location.

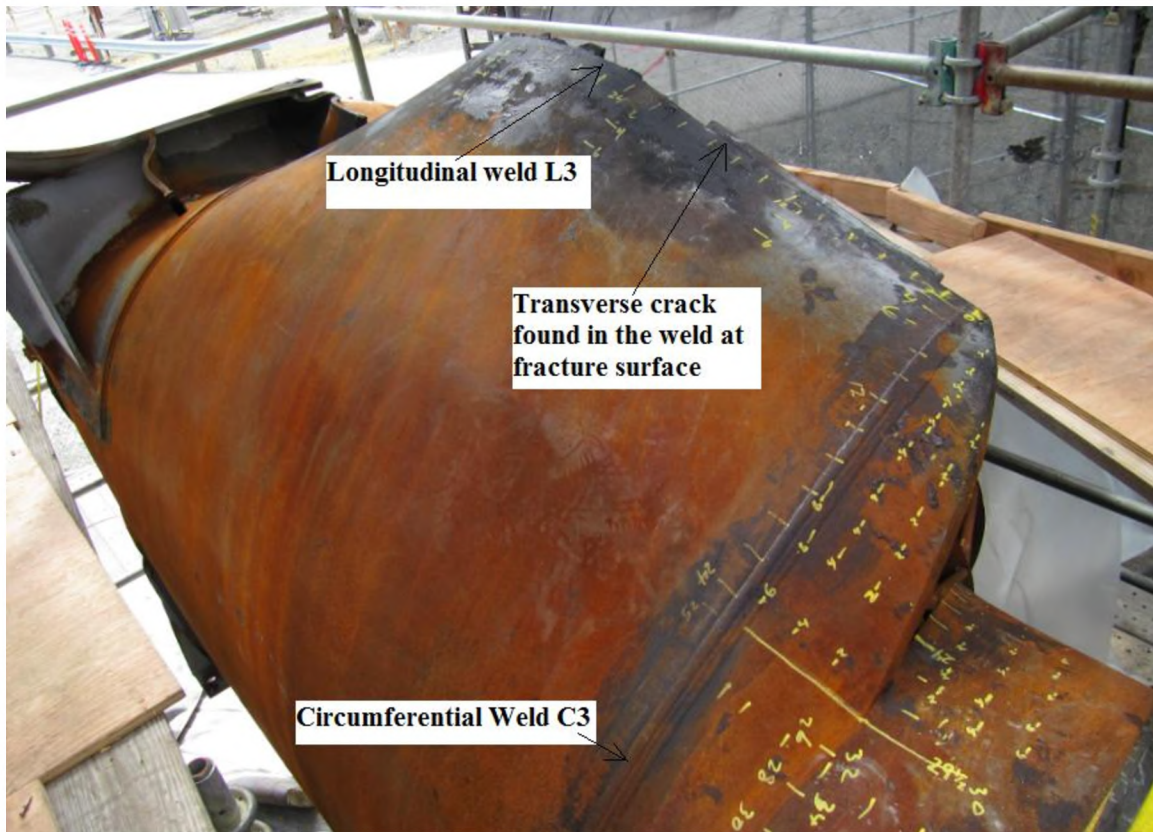
3. Transverse crack found on top of long seam weld LS-3. Letter stamp T3 marked on vessel external surface. This area is suggested to have lab microstructure exam.

**Fracture surface follow
with weld fusion line**

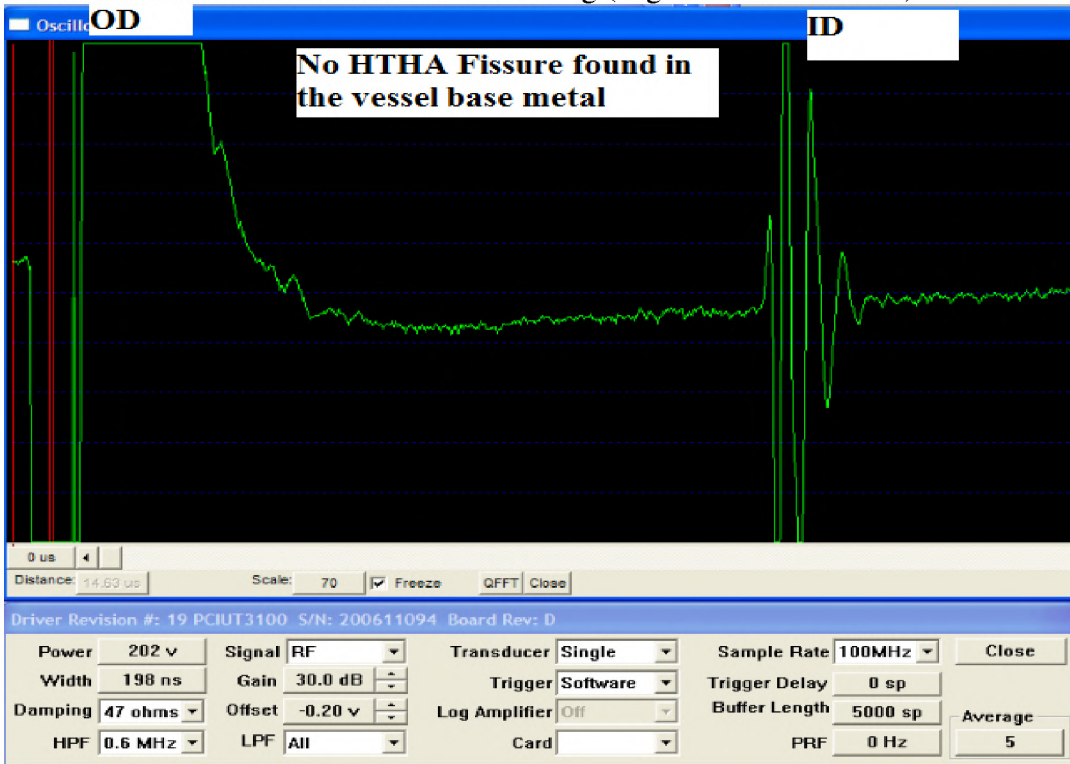
Shell base metal with Stainless Steel Cladding (Right side of Weld C4)

4. No HTHA fissures found in Shell base metal.

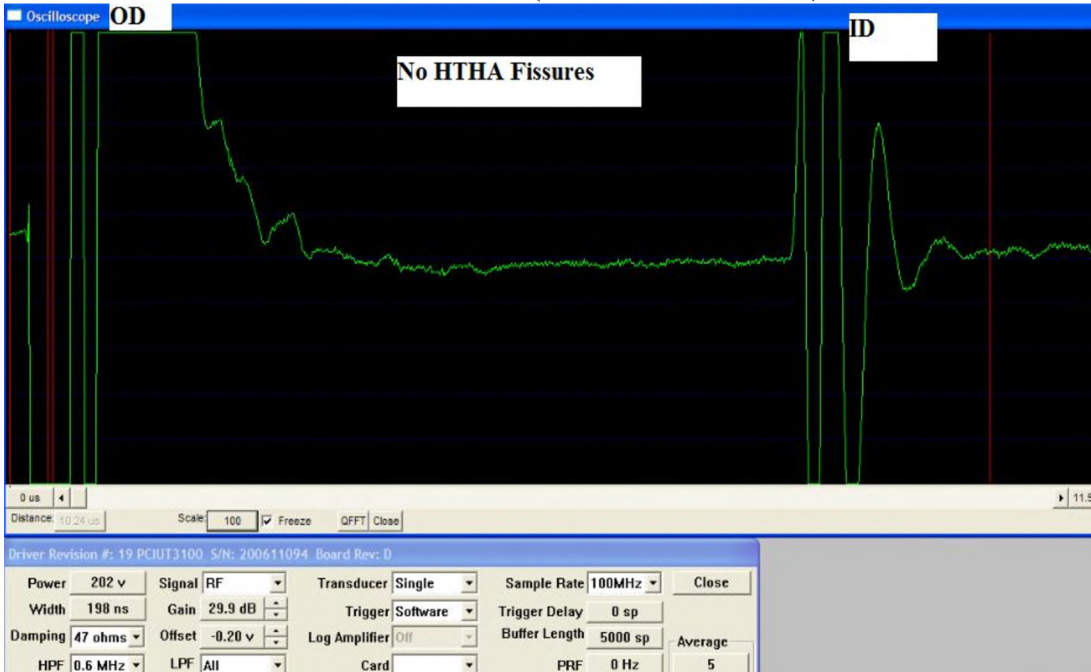
Shell Base Metal without Stainless Steel (Left side of Weld C4)

5. Velocity Ratio (Longitudinal wave Vs Shear wave) found 0.549 that indicates less chance of Hydrogen Attack in base metal.

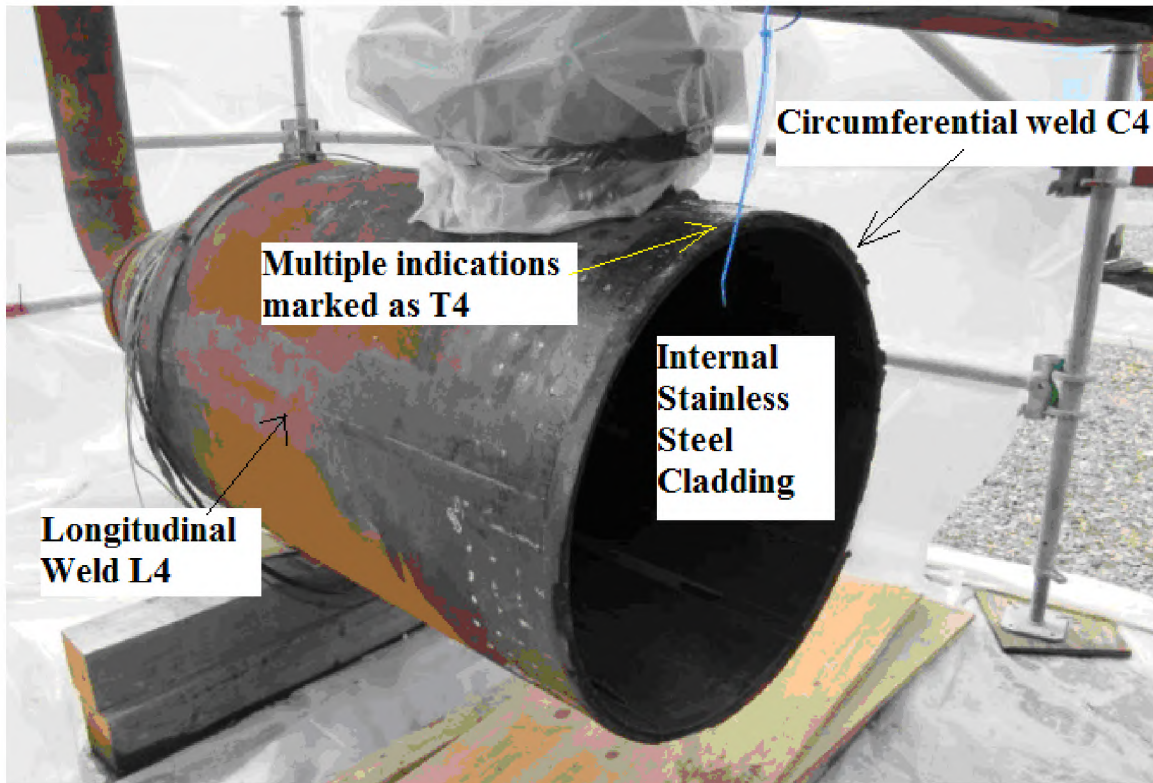
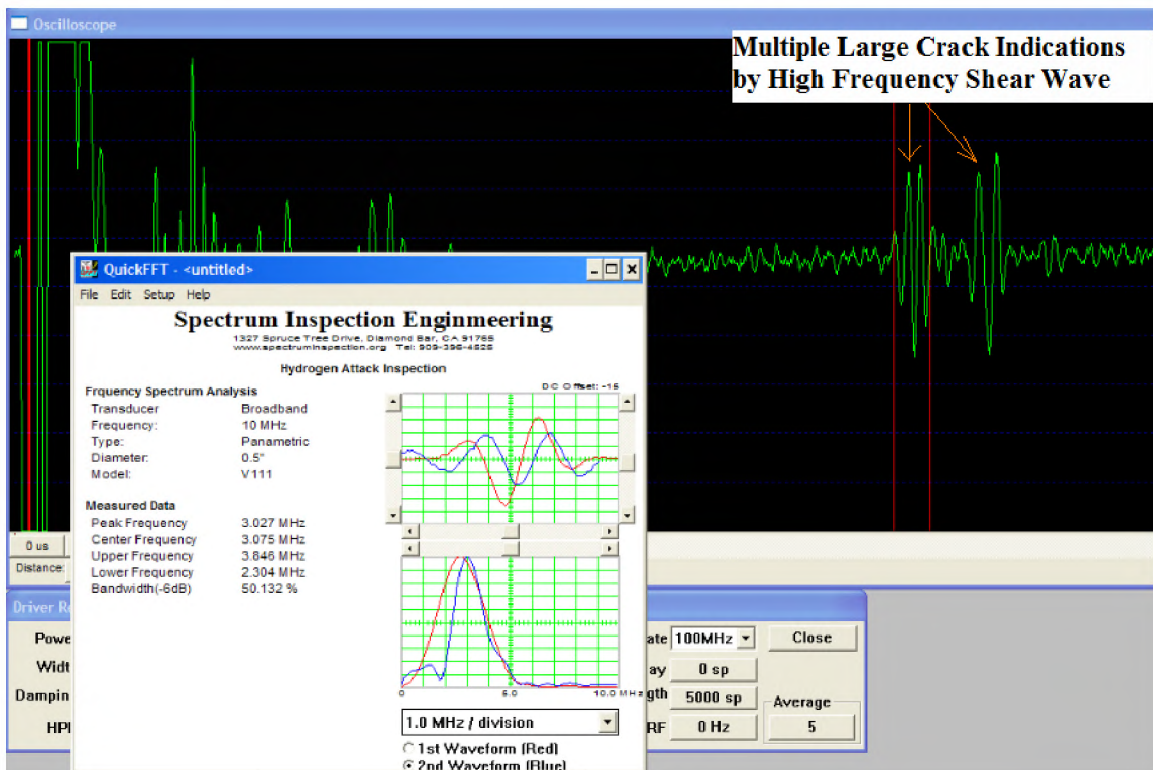
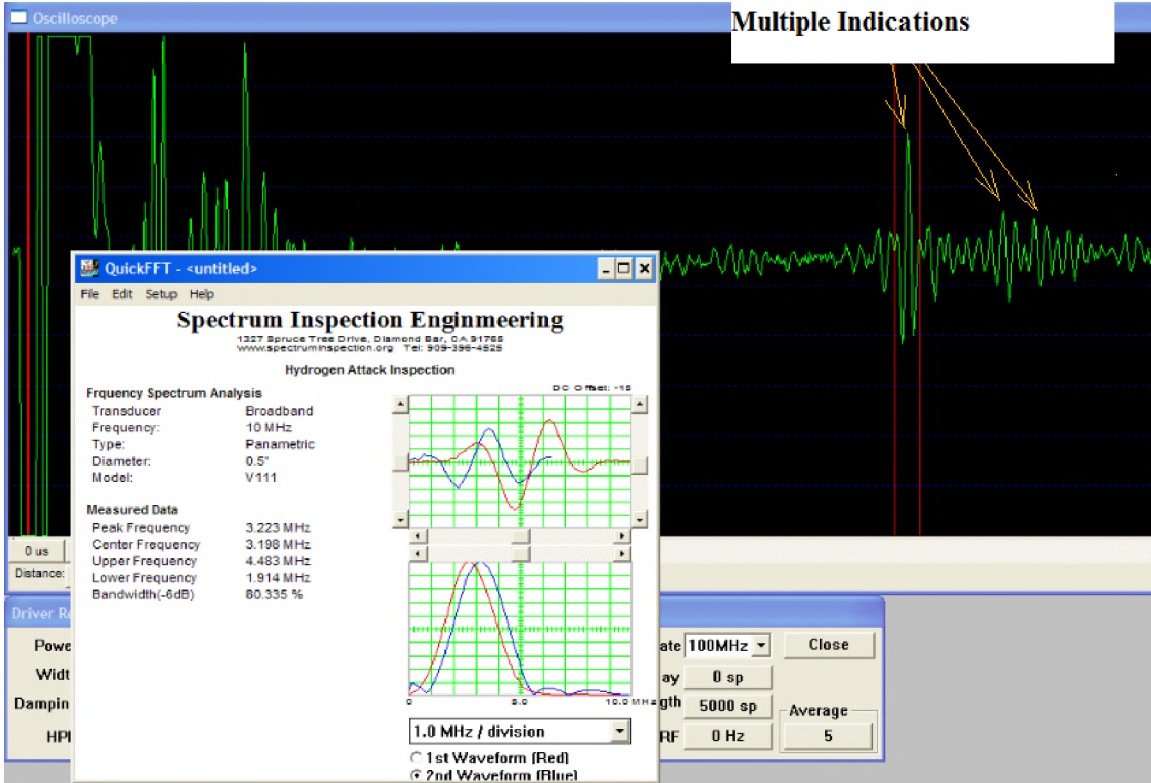
6. High frequency shear wave AUBT found multiple large crack indications in the fracture surface weld/HAZ. These large cracks are not hydrogen attack fissures. However, due to the size of the cracks they may mask small hydrogen attack fissures near the HAZ. Letter Stamp T4 is suggested to have lab microstructure examination.

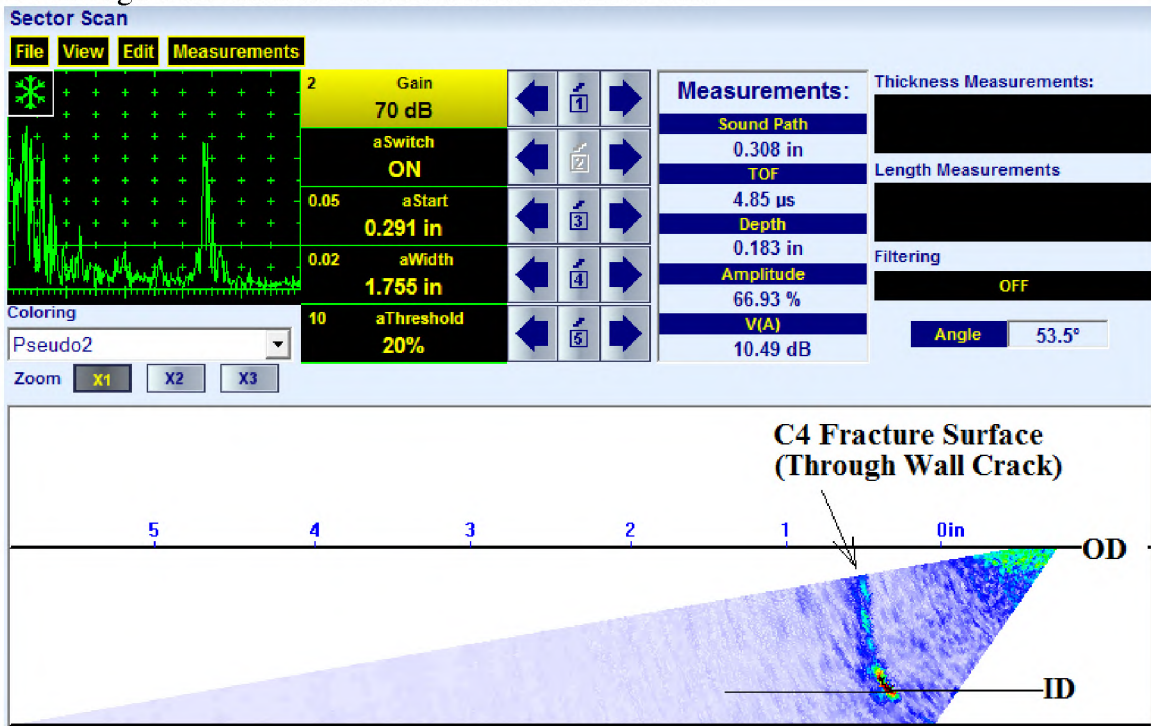
C4 through wall crack at Fracture Surface without weld

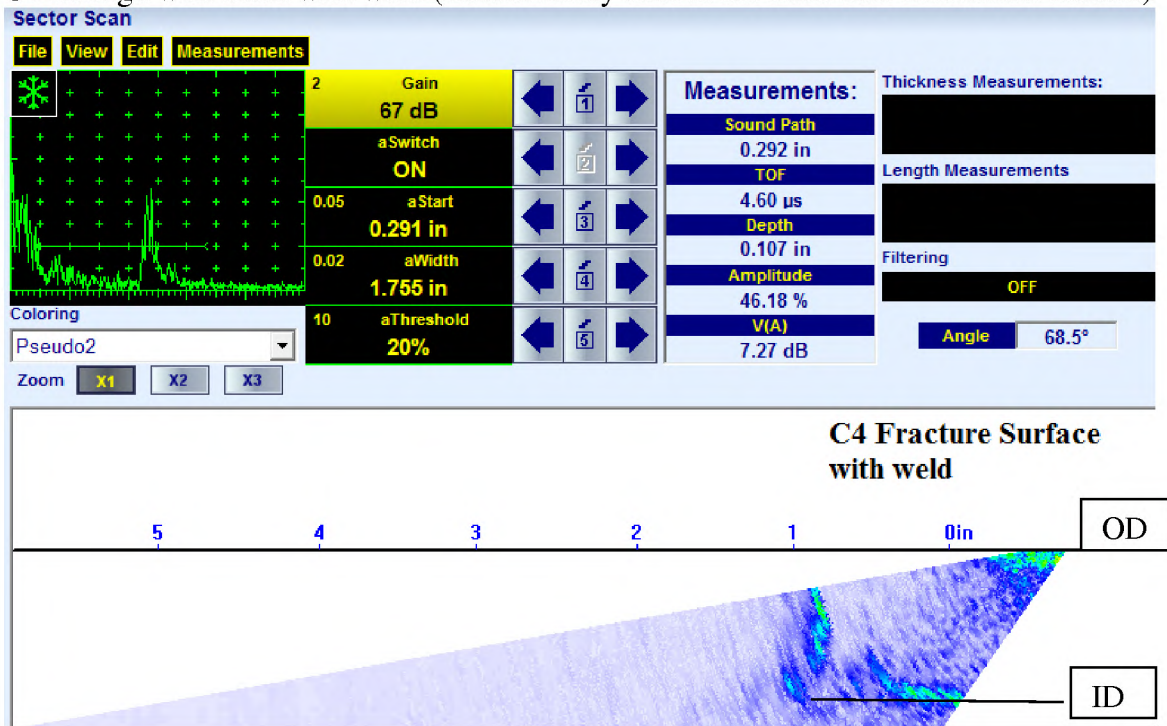
C4 through wall crack with weld (Phased Array scan at the other side of Fracture surface)

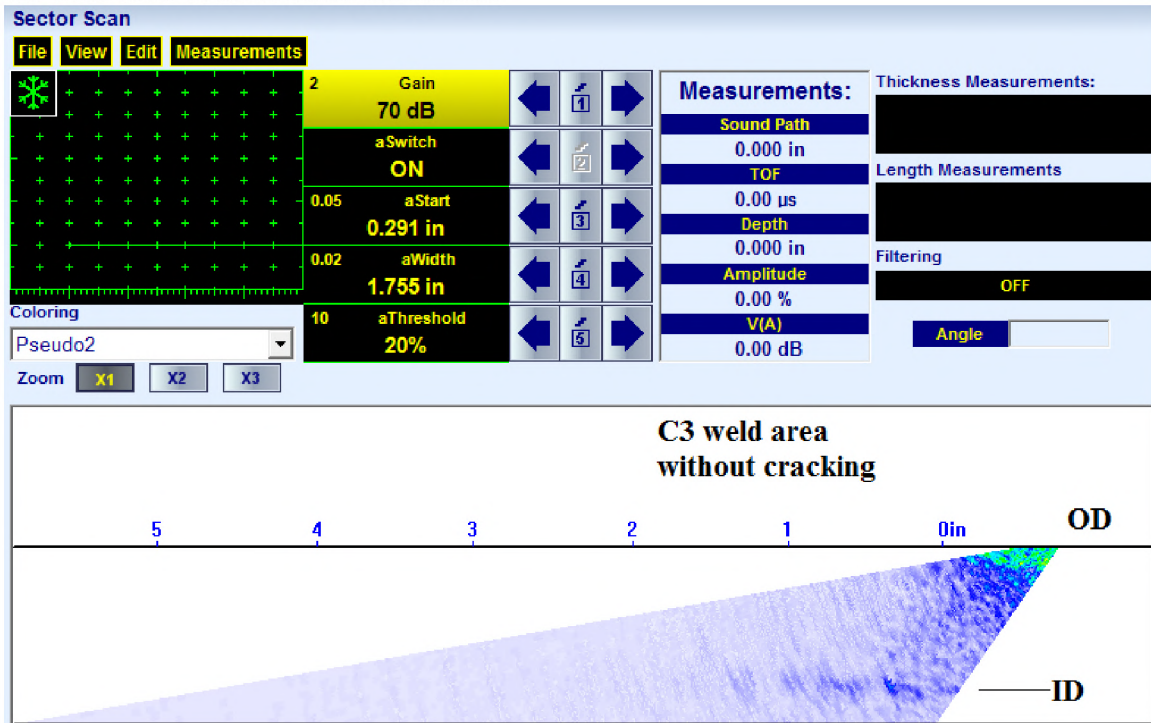
C3 weld area without crack indication.

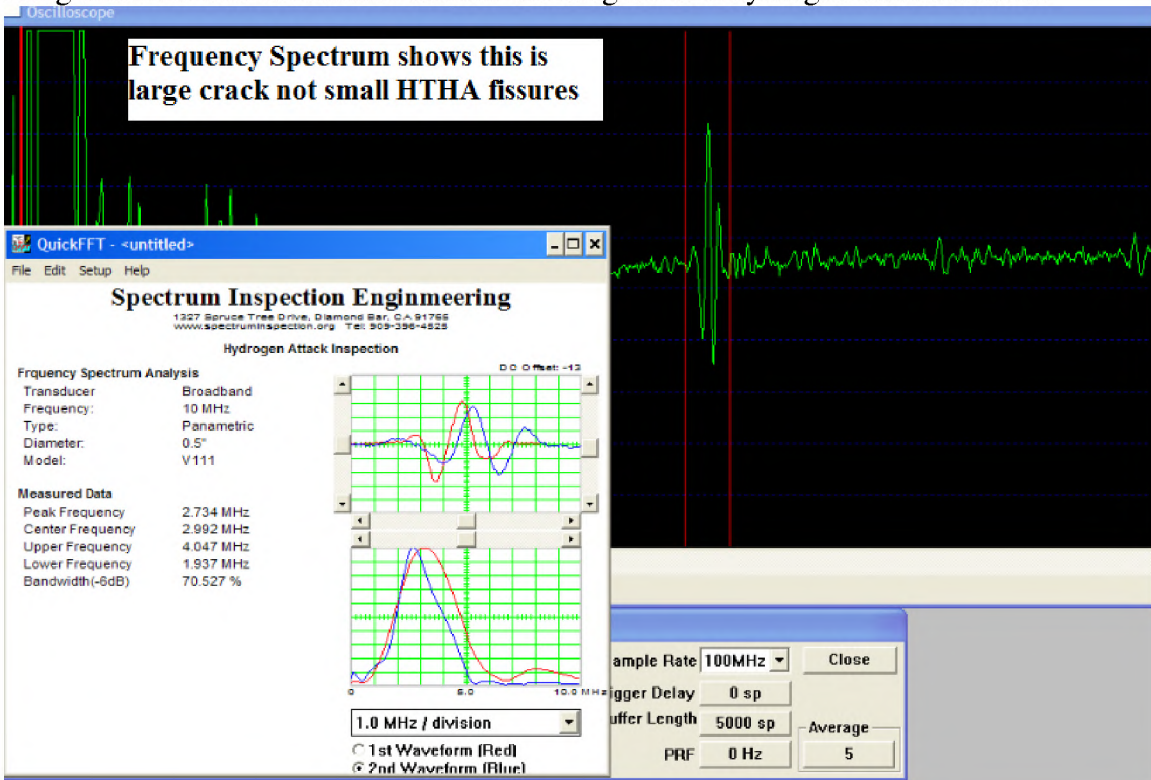
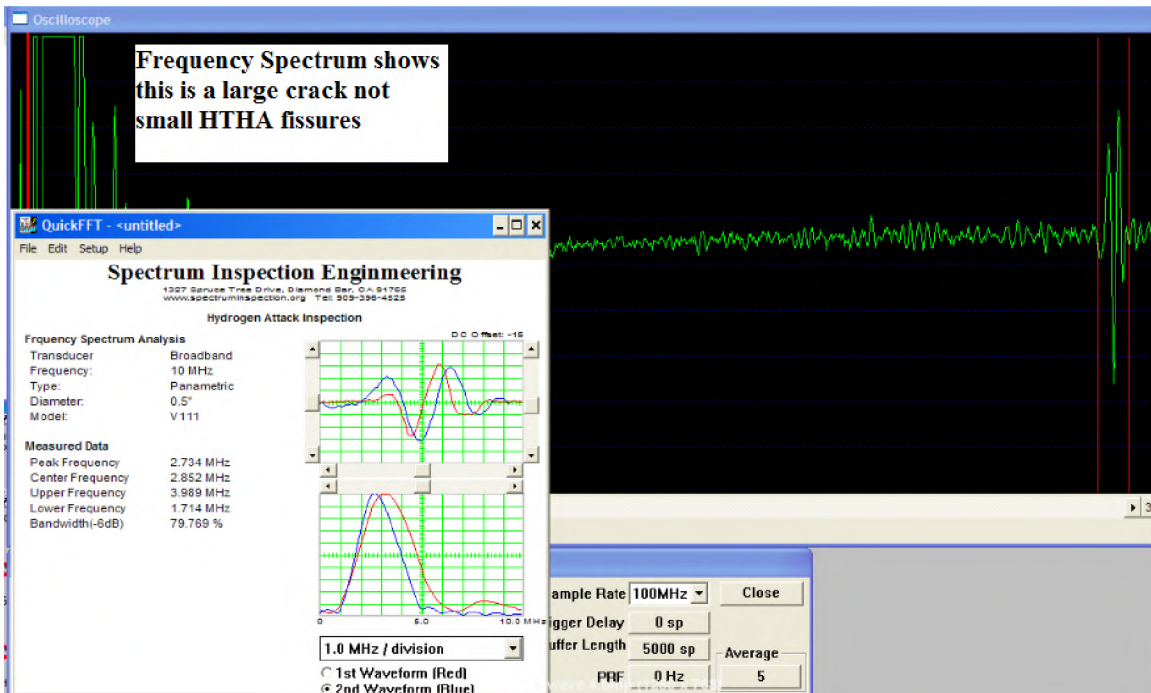
Long Seam L3 bottom fracture surface cracking are not Hydrogen attack fissures.
