DATE: JANUARY 14, 2025

INCIDENT REPORTS

EVENTS REPORTED TO THE CSB UNDER THE ACCIDENTAL RELEASE REPORTING RULE

U.S. Chemical Safety and
Hazard Investigation Board

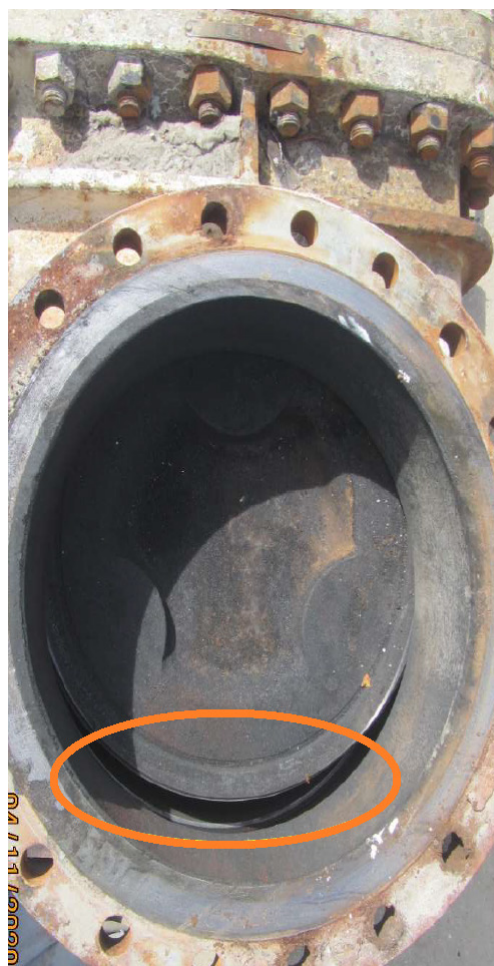
The hazard of closing the outlet valve instead of closing one of the inlet valves was not recognized. Although the two 6-inch inlet valves were designed for high-pressure conditions—2,470 pounds per square inch (psi), the 20-inch outlet valve to the flare system was rated for just 275 psi. Closing the 20-inch outlet valve would subject this valve to about 2,100 psi of pressure from the flammable vapor flowing from the cold separator, much greater than the valve's 275 psi pressure rating.

When the operations team had the outlet valve about 90 percent closed (**Figure 2**), the valve failed—releasing a high-pressure mixture of hydrogen and hydrocarbon vapor into the surrounding air. The flammable gas formed a vapor cloud, which ignited resulting in the explosion and fire.

Based on Valero's investigation, the CSB determined that the probable cause of the accidental release, explosion, and fire was the closure of the 20-inch manual isolation outlet valve (located downstream of the emergency pressure-relief valve) instead of one of the two inlet (upstream) 6-inch isolation valves that were rated for the high-pressure condition.

Figure 2. Nearly closed outlet valve. (Credit: Valero Meraux Refinery, modified by CSB)

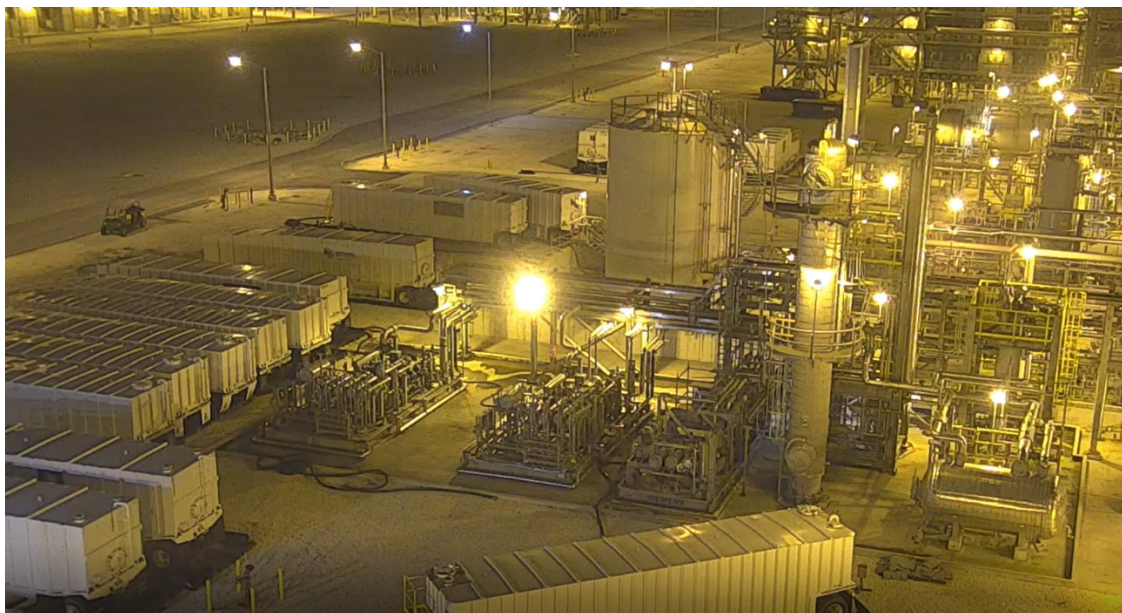
Figure 1. Spent Caustic Storage and Handling Equipment at the LACC Facility. (Credit: LACC)

When the operator opened the valve at the frac tank, pressurized fluid in the chemical hose flowed into the tank, erupting spent caustic from the unsecured top hatch (manway) and splashing the corrosive liquid onto the operator. The operator's personal protective equipment (PPE) did not protect from caustic liquid exposure. It took the operator about two minutes to reach the closest plant safety shower to rinse off the corrosive liquid because there was no safety shower near the frac tank, despite the site requirement for a safety shower within 25 feet of the tank. The operator then went to the control room and reported the incident. Emergency responders transported the operator to a hospital, where she was admitted for treatment of chemical burns.

Based on LACC's investigation, the CSB determined that the probable cause of the spent caustic release was pressurized fluid flowing from a chemical hose into a nearly full frac tank of spent caustic with an unsecured top hatch (manway). Contributing to the incident was the company's use of these frac tanks to address a short-term reliability issue with LACC's oxidizing reactor. Reliability problems with the oxidizing reactor resulted in the continual use of these frac tanks.

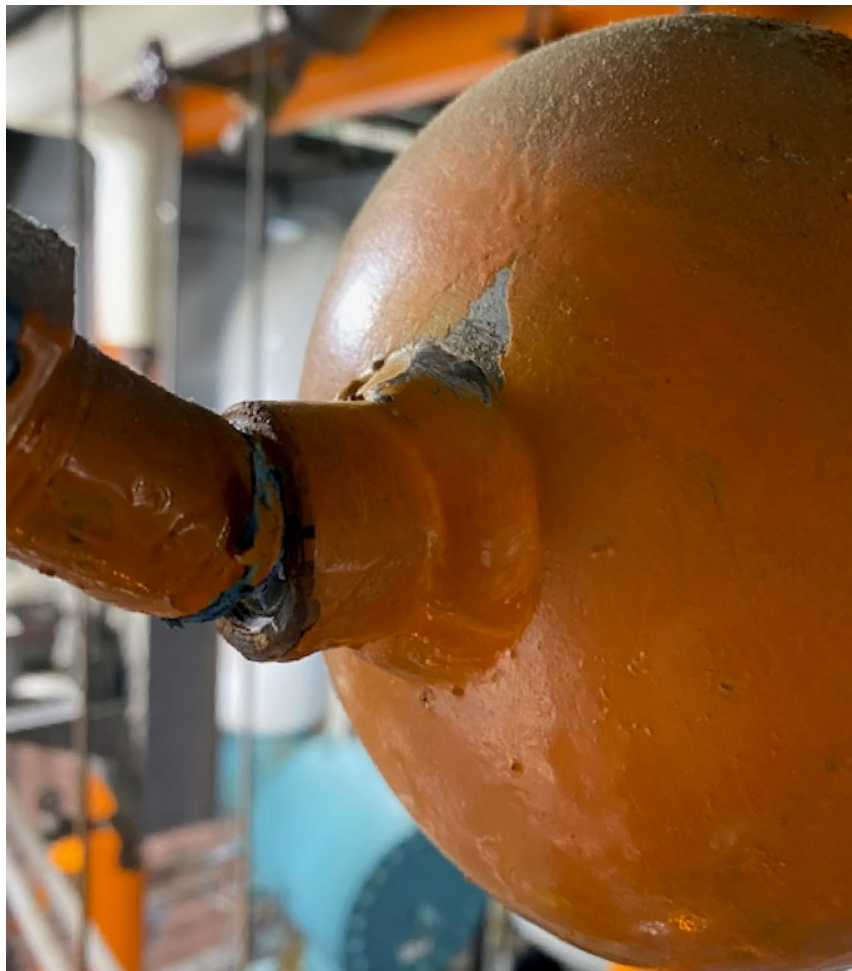
Figure 1. Damaged Ammonia Piping. (Credit: HMF)

After the scissor lift impacted the piping, a leak formed at the partially severed ½-inch threaded piping connection to the larger ammonia system piping. The anhydrous ammonia was released as a vapor and engulfed the workers. Contractor 1, who was directly in front of the damaged piping, was unable to escape and was fatally injured by the release. Contractor 2, who was further away from the point of release, jumped over the lift's guardrail to escape from the area.

Based on HMF's investigation, the CSB determined that the probable cause of the anhydrous ammonia release was piping damage caused by the force applied by the scissor lift.

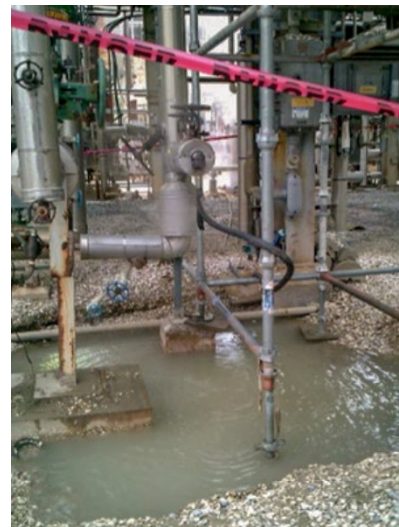
At 10:46 p.m., the control board operator observed a low boiler feedwater pressure alarm and requested an outside operator to investigate. Personnel identified that the boiler feedwater piping was the source of the low-pressure alarm and, realizing there was a leak, closed an upstream valve to stop the leak. Dow reported that 670 gallons of hot water were released. At about 11:45 p.m., an outside operator attempted to close the two open bleed valves and inadvertently stepped into a pool of the hot boiler feedwater that had accumulated in a depression (**Figure 1**). The high-pressure boiler feedwater release may have created or enlarged this hole. The operator was seriously injured when his lower leg was submerged in the hot water above the top of his rubber boot, and the hot water contacted his lower leg and foot.

Figure 1. Pool of Hot Water.
(Credit: Dow)

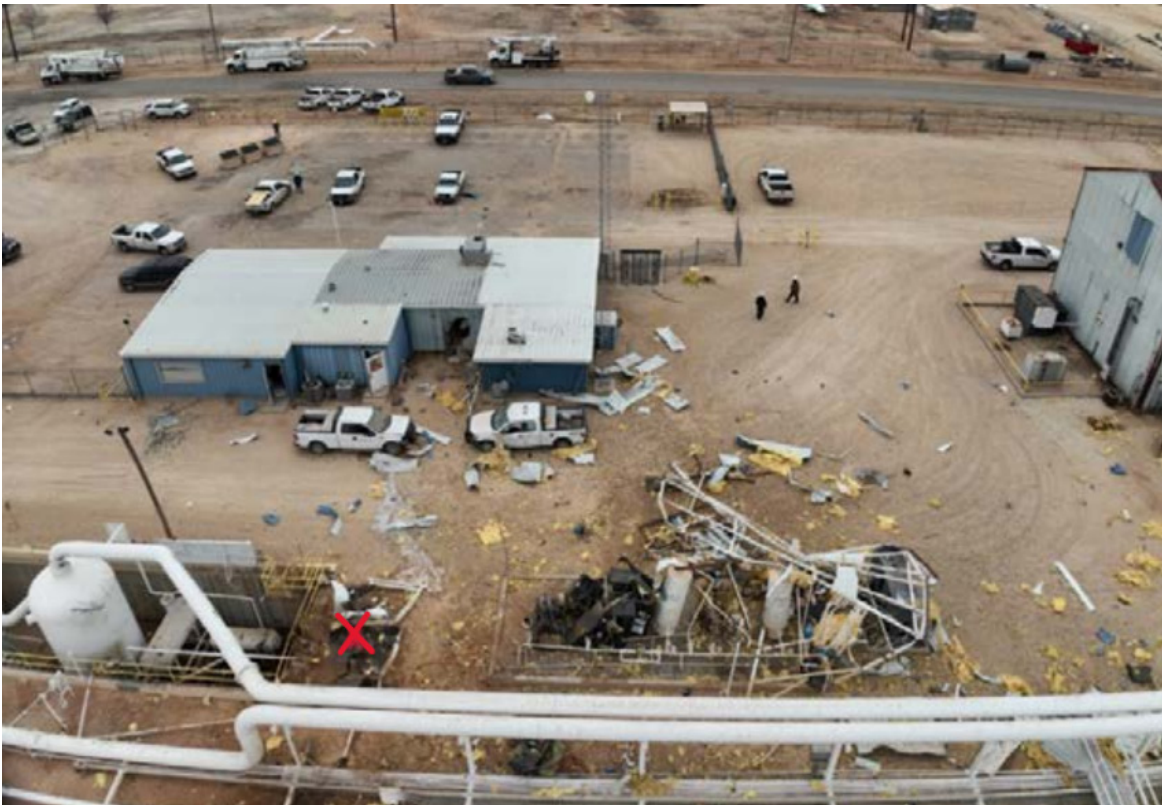
On January 31, 2023, at 6:40 a.m., an accidental release of high-pressure carbon dioxide (CO₂) occurred when a vessel overpressured and catastrophically ruptured at a Kinder Morgan CO₂ gas plant in Snyder, Texas. Vessel fragments propelled up to 1,200 feet away and heavily damaged a control room (**Figure 1**). Kinder Morgan estimated the property damage to be over \$14 million.

Figure 1. Aftermath of vessel overpressure, vessel location marked with red 'X.' (Credit: Kinder Morgan, annotated by CSB)

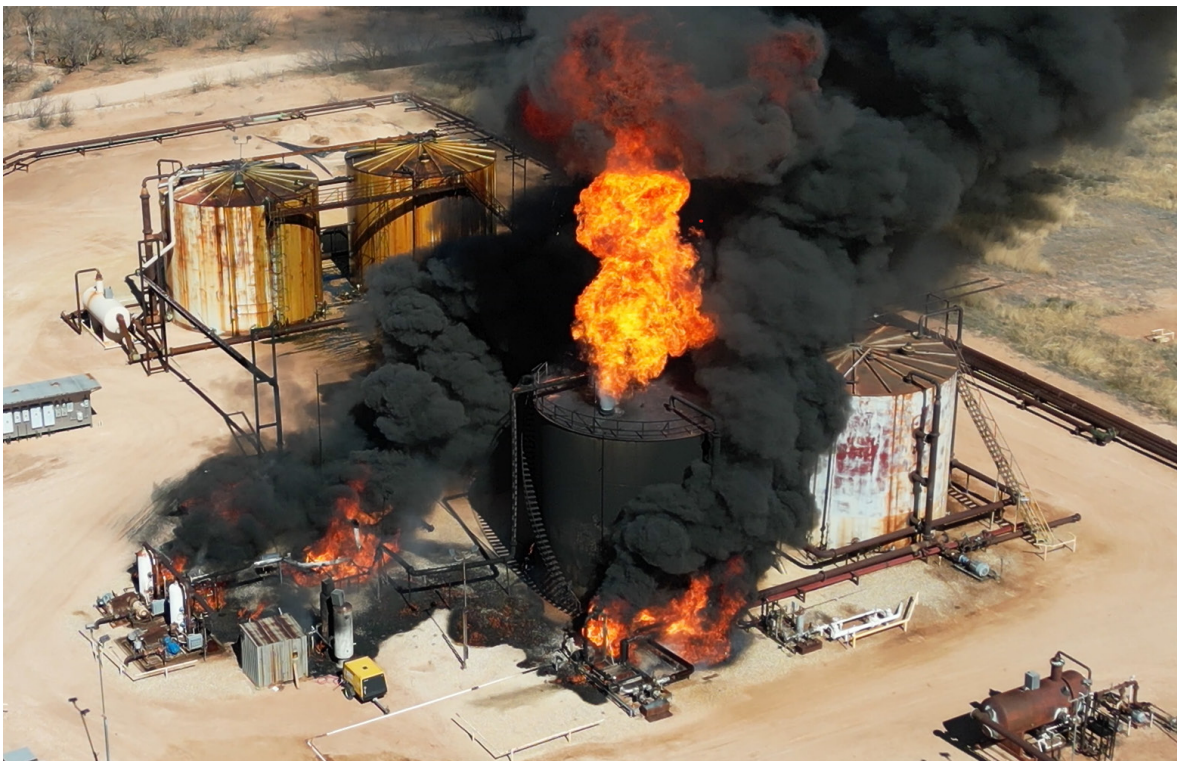
Figure 1. Aerial view of the fire and equipment involved in the incident. (Credit: Kinder Morgan)

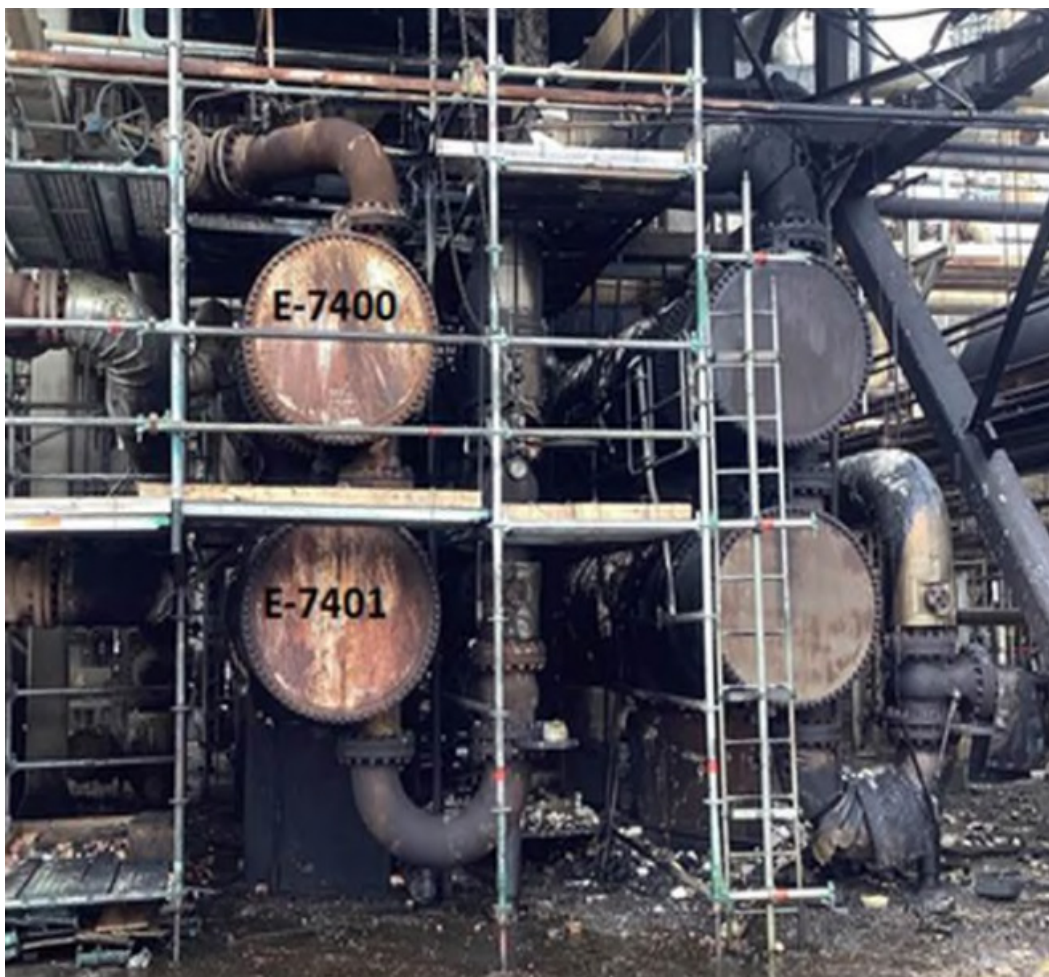
Figure 1. Heat exchangers after the incident. (Credit: Pemex)

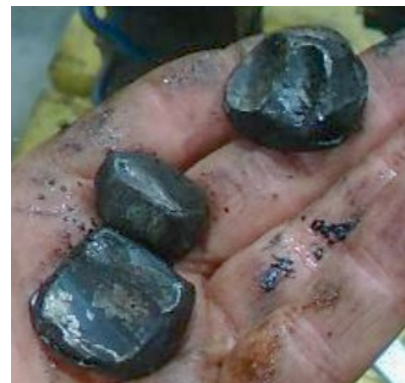
During the unit startup approximately five days before the incident, the pump (a centrifugal pump) had operated with low suction (inlet) pressure for nearly two hours due to a low liquid level in the upstream equipment. The low suction pressure caused the pump to cavitate, which vibrated the pump and damaged the pump’s bearings (**Figure 1**). Five days later, on March 14, the damaged bearings and the resulting stress on the pump’s mechanical seal caused the seal to fail. The hot hydrocarbons within the pump were released into the atmosphere and ignited, causing a fire. The material was released at 590 degrees Fahrenheit (°F) and had an autoignition temperature of 484 °F.

Figure 1. Damaged Pump Bearings. (Credit: Pemex)

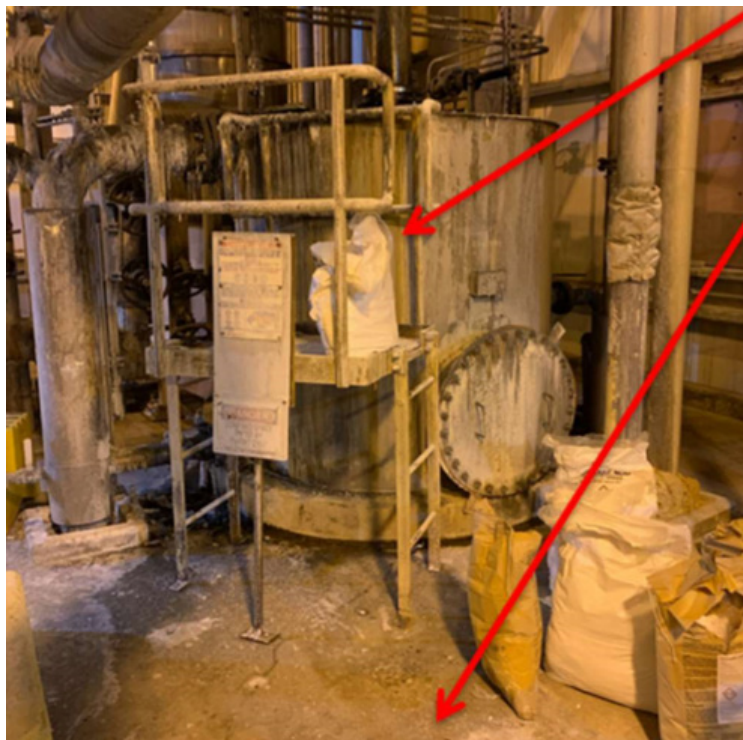
Operator 1, who was standing directly over the tank opening (**Figure 1**), lost consciousness from exposure to the hydrogen sulfide gas that evolved from the tank. Operator 3 was able to call for help over the plant radio system but lost consciousness soon after. Operator 2 was seriously injured after losing consciousness (while trying to help Operator 1), falling to the floor, rolling through a guardrail system, and falling about 11 feet to a lower area of the structure.

Figure 1. The Tank. The red arrows show the approximate locations of two of the operators. (Credit: Domtar)

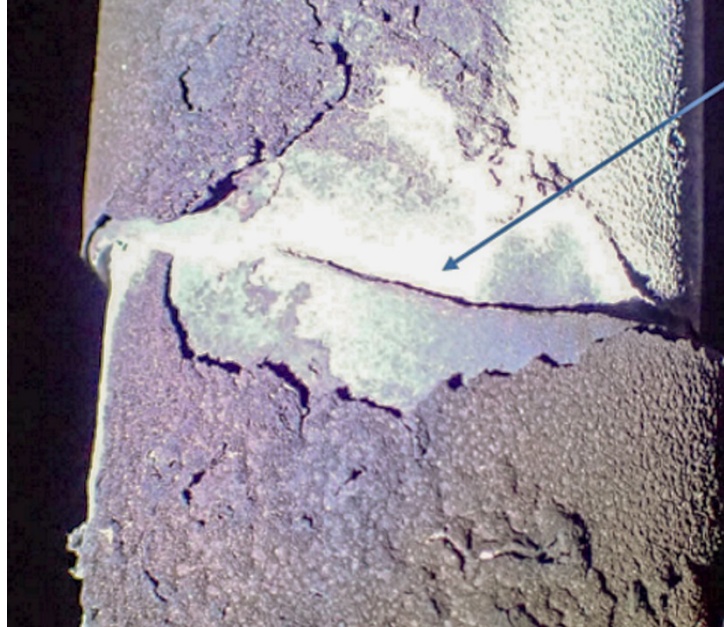
FHR determined that the accidental release resulted from a ruptured tube within the waste heat boiler of the sulfur recovery reaction furnace (Figure 2). The tube rupture was caused by a damage mechanism known as sulfidation corrosion (also known as high-temperature sulfidic corrosion). Under certain temperature conditions, sulfidation corrosion causes thinning in iron-containing materials over time due to a reaction between sulfur compounds and iron.

Figure 2: Ruptured Tube. (Credit: FHR)

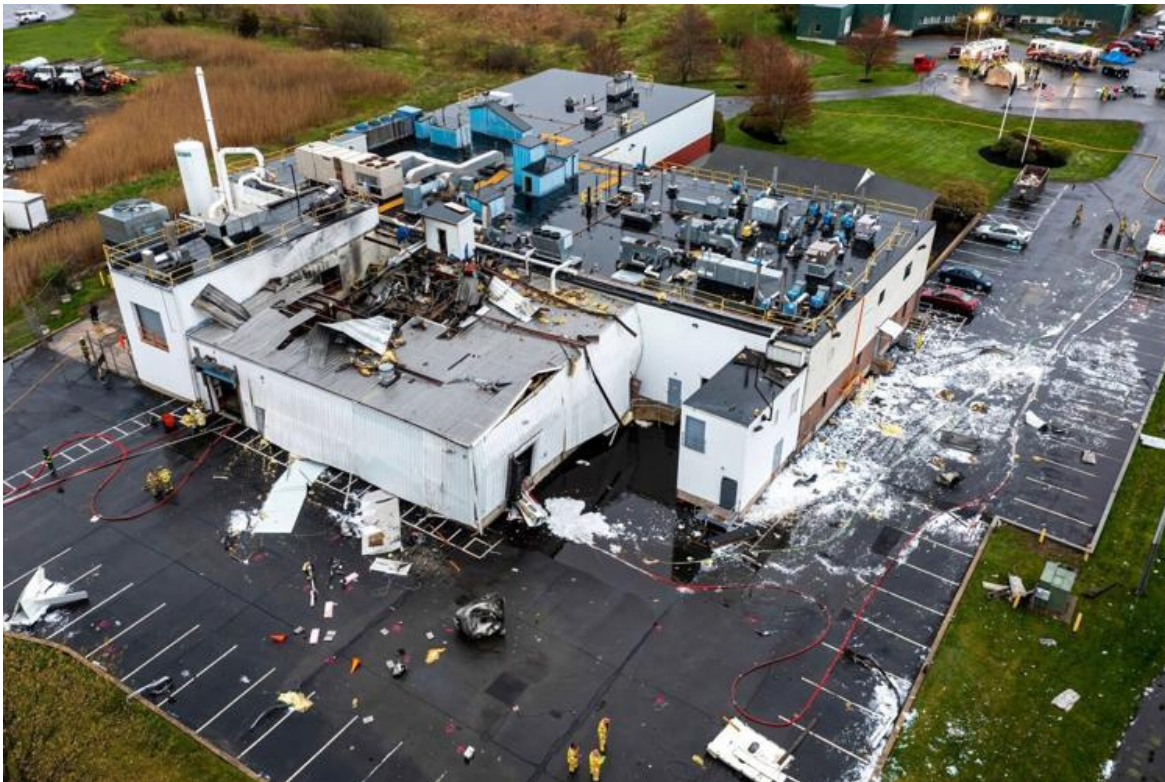
On May 4, 2023, at about 12:40 a.m., a pressure Nutsche filter vessel (“vessel”) exploded at the Polycarbon Industries, Inc. (“PCI”) facility in Newburyport, Massachusetts. The explosion and fire fatally injured one PCI operator and caused approximately \$48 million in loss from property damage, which led to the permanent closure of the facility (**Figure 1**).

Figure 1. Damages After Explosion at PCI. (Credit: The Salem News)

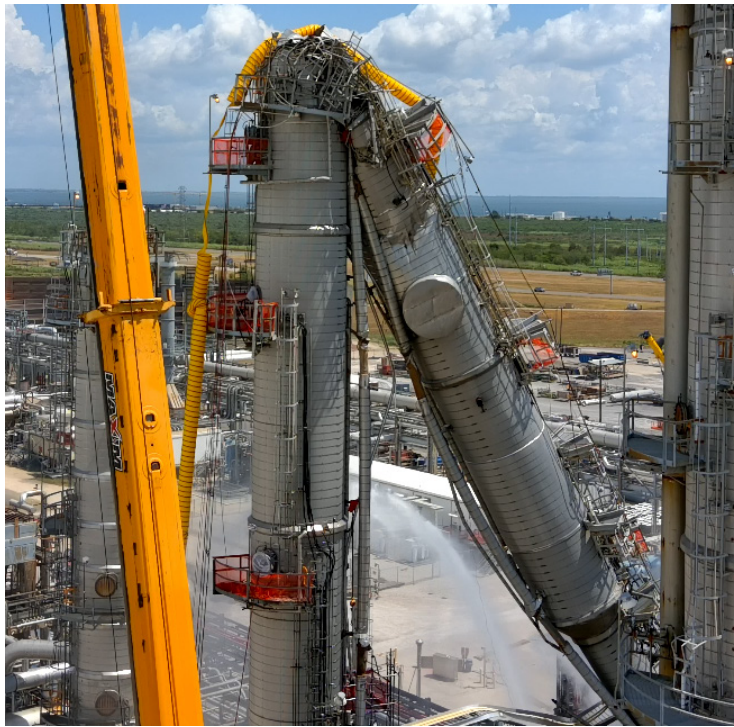
On September 5, 2023, at 11:50 a.m., a distillation tower (“Tower”) collapsed (**Figure 1**) at the BASF TOTALEnergies Petrochemical, LLC (“BTP”) facility in Port Arthur, Texas. The collapse was the result of a fire inside the distillation tower. The incident resulted in approximately \$194 million in property damage.

Figure 1. Collapsed Distillation Tower at BTP. (Credit: BTP)
