VOLUME: 2

DATE: MARCH 12, 2025

# INCIDENT REPORTS

EVENTS REPORTED TO THE CSB UNDER THE ACCIDENTAL RELEASE REPORTING RULE

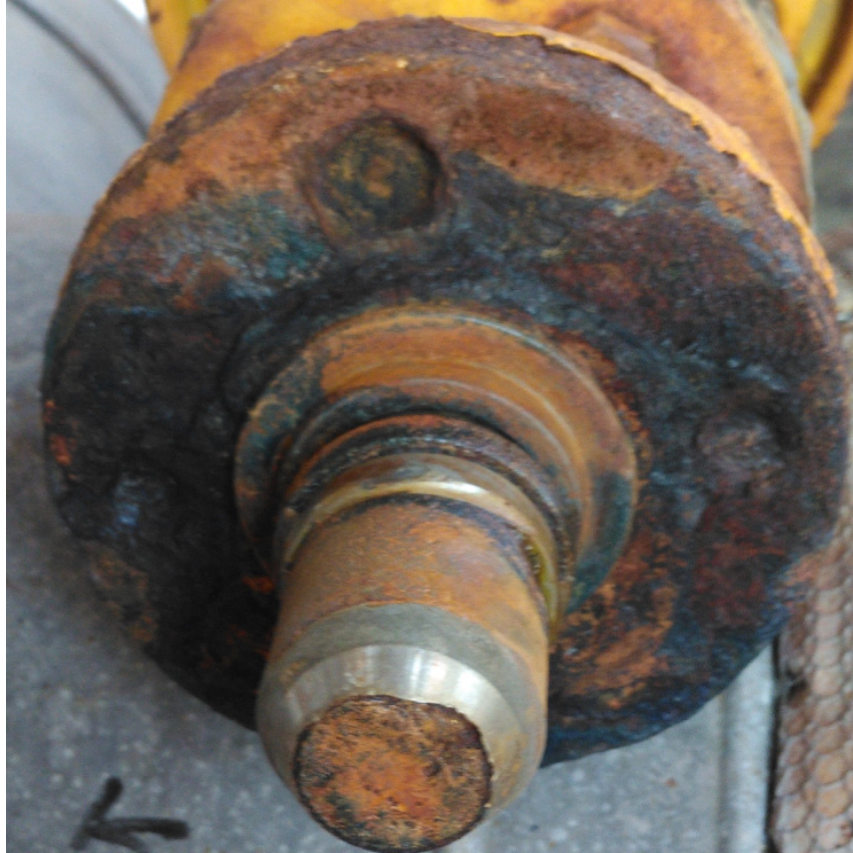
BASF's investigation found that the drain valve was severely corroded. Over time, chlorine being released from the drain valve had reacted with condensed water that had accumulated in the piping system's insulation blanket, creating hydrochloric acid that had corroded the valve and deteriorated the bolts in the valve's bonnet (**Figure 1**). After the incident, BASF discovered that three other valves were similarly corroded.

**Figure 1.** Corroded drain valve's bonnet and bolts. (Credit: BASF)

Based on BASF's investigation, the CSB determined that the probable cause of the incident was the catastrophic failure of corroded bolts in the drain valve's bonnet. The corrosion was caused by prolonged exposure to hydrochloric acid, created by the reaction between chlorine and condensed water.

Contributing to the incident was BASF's mechanical integrity program. Had BASF inspected the valve before authorizing this job, the extent of the corrosion could have been identified, and a shutdown could have been initiated to replace the drain valve instead of attempts to repair it. Contributing to the severity of the incident was BASF's respiratory protection program, which did not ensure its workers could effectively transition to the escape bottle during an emergency. Had BASF effectively trained its workers to switch to their escape bottles during an emergency, the employee should have not been exposed to the chlorine.

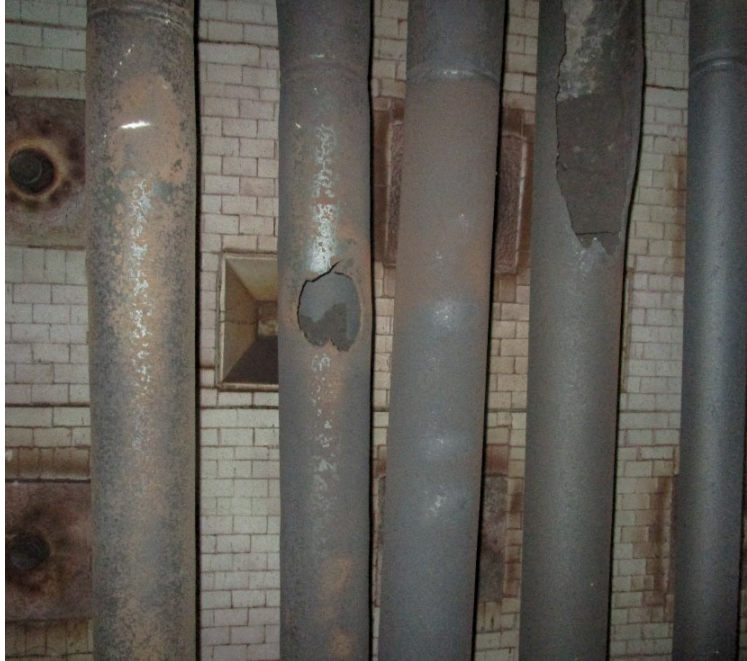
Chevron Phillips’ investigation determined that freeze-related operational issues due to extreme cold weather from Winter Storm Uri caused the facility’s boiler units to shut down. This shutdown decreased the supply of steam and water to an ethylene unit at the facility. A safety system automatically shut the fired heater down due to insufficient steam and water flow. Although the automatic valves closed to prevent feed from entering the tubes, the fired heater’s fuel gas isolation valve failed to close as intended. This failure allowed the burners to continue operating. Without any flow through the tubes to remove heat from their walls, the tubes in the fired heater reached excessively high temperatures. Some tubes ruptured, likely due to short-term overheating, but a metallurgical analysis was not performed to confirm the cause of the tube failures (**Figure 2**). When the tubes ruptured, hydrocarbons downstream from the fired heater were released through the broken tubes and ignited by the burner flames inside the firebox, causing a fire.

**Figure 3.** Failed fired heater tubes. (Credit: Chevron-Phillips)

During post-incident testing by Chevron Phillips in temperatures above freezing, the fuel gas isolation valve successfully closed as designed. Chevron Phillips' investigation concluded that the fuel gas isolation valve did not close because water in the instrument air supply had frozen or ice formed on the external actuator components (related to inadequate winterization), preventing the isolation valve from closing.

Based on Chevron Phillips's investigation, the CSB determined that the probable cause of the incident was the rupture of fired heater tubes from short-term overheating. When the tubes were broken, a hydrogen and hydrocarbon gas mixture flowed from downstream equipment into the firebox. Flames from the burners ignited the flammable materials, resulting in the fire. Inadequate winterization of flow control equipment contributed to the incident.

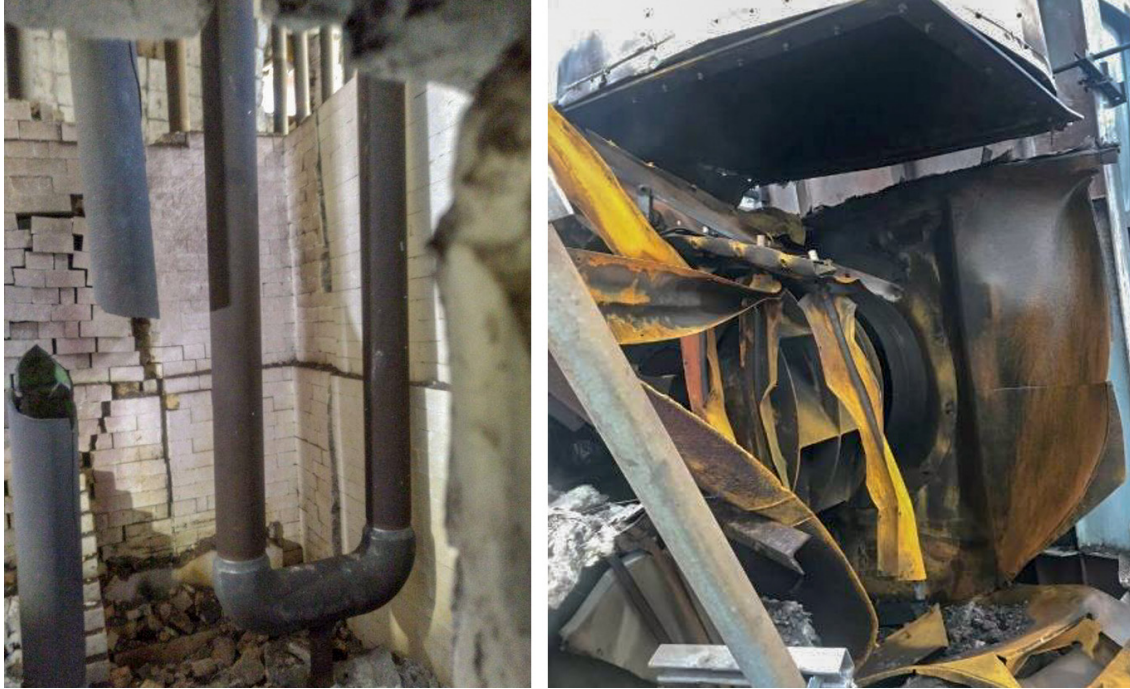
Chevron Phillips’ investigation revealed that further utility upsets caused the facility to stop all fuel gas supply and fully shut down the remaining fired heaters. During the shutdown, a valve between one of the ethylene unit’s fired heaters and downstream equipment remained open. The open valve allowed downstream flammable hydrogen and hydrocarbon gas to flow backward into the fired heater tubes. Approximately 30 minutes after this happened, a tube within the fired heater ruptured, allowing the flammable gas to enter the firebox. The gas accumulated, ignited, and exploded, causing extensive damage to the fired heater (**Figure 2**).

**Figure 5.** Fired heater explosion damage. The left image shows the broken tube and walls, and the right image shows a fan. (Credit: Chevron Phillips)

Chevron Phillips' investigation determined that the tube failure likely occurred because the fired heater tubes were shut down without decoking. Coke fouling can insulate the tube surface, resulting in local hotspots and increasing the risk of thermal shock and tube failure in fired heaters. These conditions stressed the tube's walls when the metal cooled faster than the internal coke, breaking the tube. Chevron Phillips' investigation concluded that hot insulation inside the firebox likely ignited the gas (autoignition).

Based on Chevron Phillips's investigation, the CSB determined that the probable cause of the incident was a fired heater tube failure from thermal stress due to the rapid shutdown. When the tube broke, a hydrogen and hydrocarbon gas mixture from downstream equipment flowed into the firebox. Hot insulation within the firebox likely ignited the flammable gas, resulting in an explosion. Inadequate winterization of multiple valves, instruments, and control systems contributed to the incident.

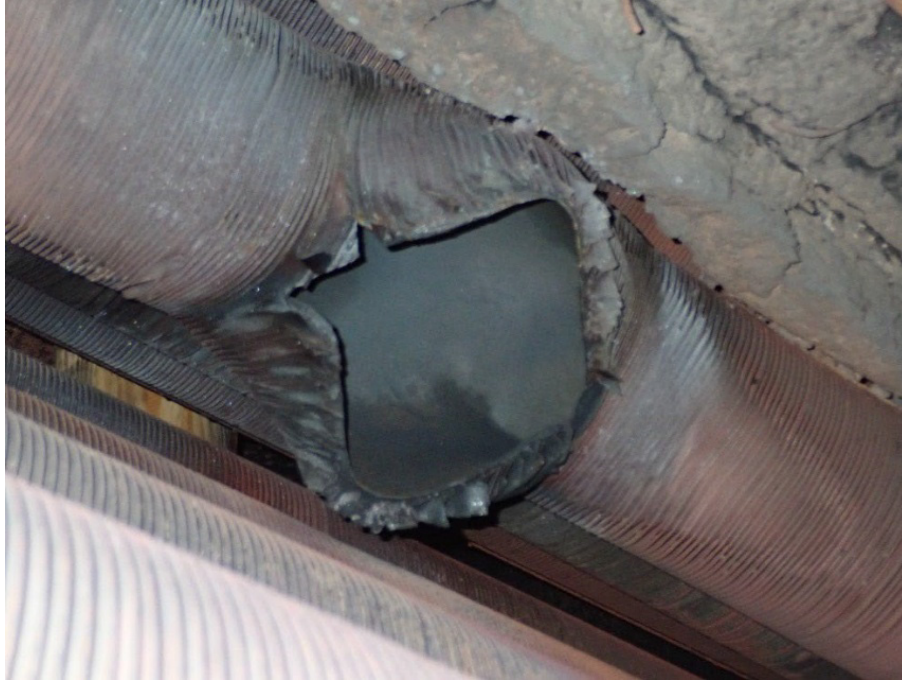
Valero's investigation of the incident found that without the fluid flowing through the fourth pass to remove heat, the tube's metal wall temperature reached 1,500 degrees Fahrenheit (°F), which exceeded the design temperature limit. After the operations supervisor noticed the high temperature, field operators were sent to inspect the heater tubes. The field operators reported that some tubes were "glowing red hot," and consequently they manually turned off two of the fired heater's eight burners. The field operators then reduced the flow through the first three passes to help drive feed material into the fourth pass. Although operators reported hearing material flowing in the fourth pass, the meter indicated no flow. The Valero operations team concluded that the flow meter was malfunctioning.

Less than an hour later, a convection section tube in the fourth pass ruptured due to short-term overheating (**Figure 2**), releasing a flammable mixture of hydrogen and hydrocarbons into the firebox. Flames from the gas-fired burners ignited the mixture, resulting in a large fire.

**Figure 7.** Ruptured fired heater tubing. (Credit: Valero)

Based on Valero’s investigation, the CSB determined that the probable cause of the incident was a ruptured fired heater tube from short-term overheating. Flames from the fired heater’s gas-fired burners ignited these flammable chemicals, resulting in the fire. The lack of automated safeguards that did not prevent the burners from being ignited before the minimum flow was established through each of the four tube passes contributed to the incident. Had Valero had such automated safeguards in place, this incident likely could have been prevented.

Additionally, Valero found that the fired heater lacked engineered safeguards to prevent the burners from being lit before establishing flow in each of the four passes. In response to the incident, Valero modified its automated burner controls to help ensure that the flow rate through every pass exceeds a predetermined minimum flow rate before operators can ignite a burner.

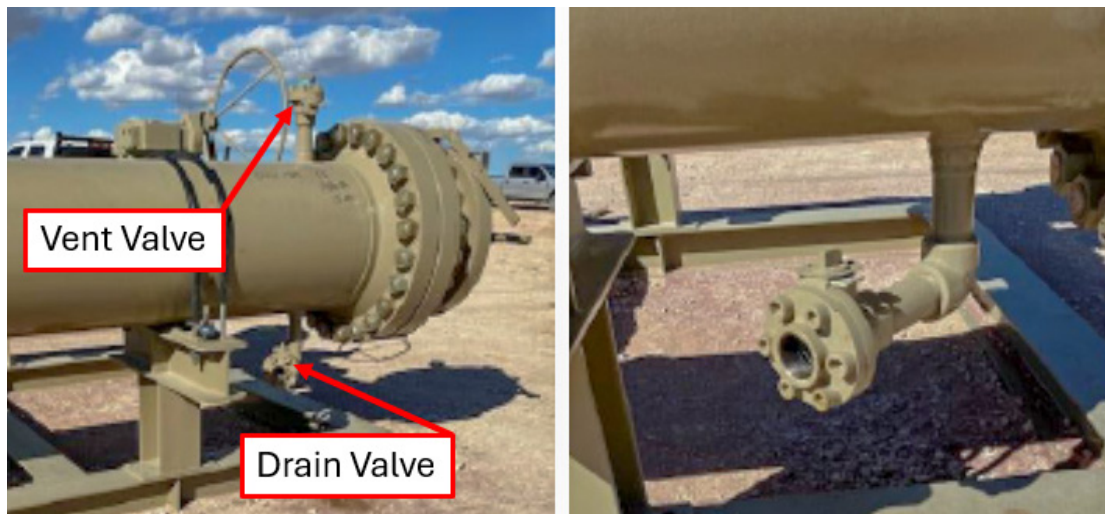
When the two workers went to remove the pig from the receiver, the pressure in the receiver was above 1,150 pounds per square inch (“psi”). To safely remove the pig, the pressure needed to be reduced by relieving it through a vent valve located at the top of the receiver. The contractor initially tried to remove the plug from the vent valve to relieve the pressure but found that the plug could not be removed with hand tools. This indicated that there could be pressure between the valve and the plug, forcing the threads tightly against each other. The contractor concluded that the vent valve might be leaking and decided to relieve the pressure inside the receiver using the drain valve instead, which was located at the bottom of the receiver (**Figure 1**).

**Figure 1.** Orientation of the vent valve and drain valve (left) and post-incident position of the drain piping after opening the valve (right). (Credit: XTO, edited by the CSB)

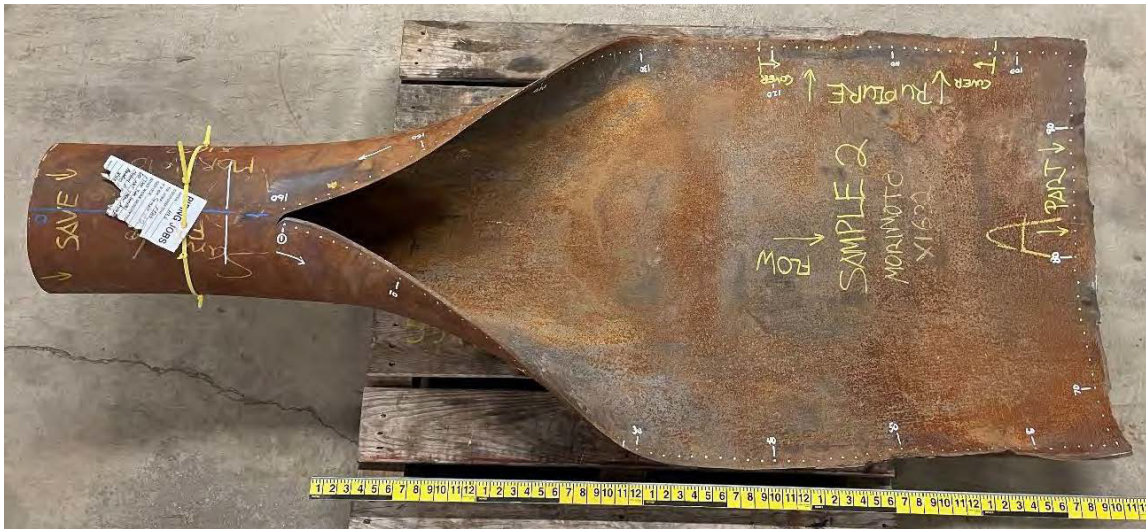
the tube failure was likely the result of a combination of localized creep damage (which results from prolonged exposure to stress at elevated temperatures) and short-term overheating.

Figure 11. Ruptured tube. (Credit: PBF Energy)

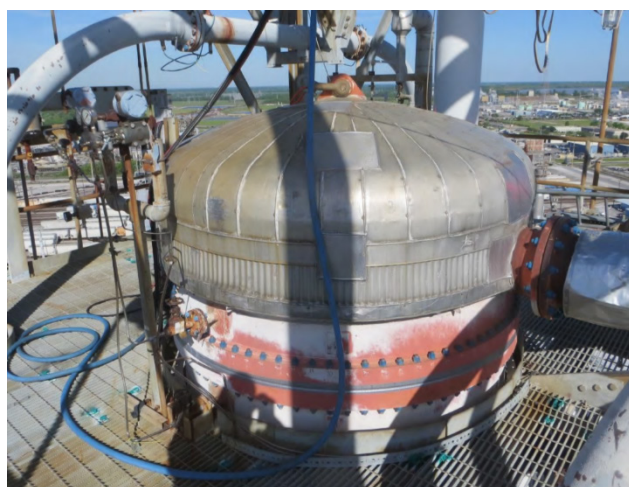
The vessel is connected to a flare system to vent unreacted gases. At the time of the incident, a series of valves were available to isolate the vessel from the flare system, but only one valve

**Figure 2.** Top head of incident vessel. (Credit: Dow)

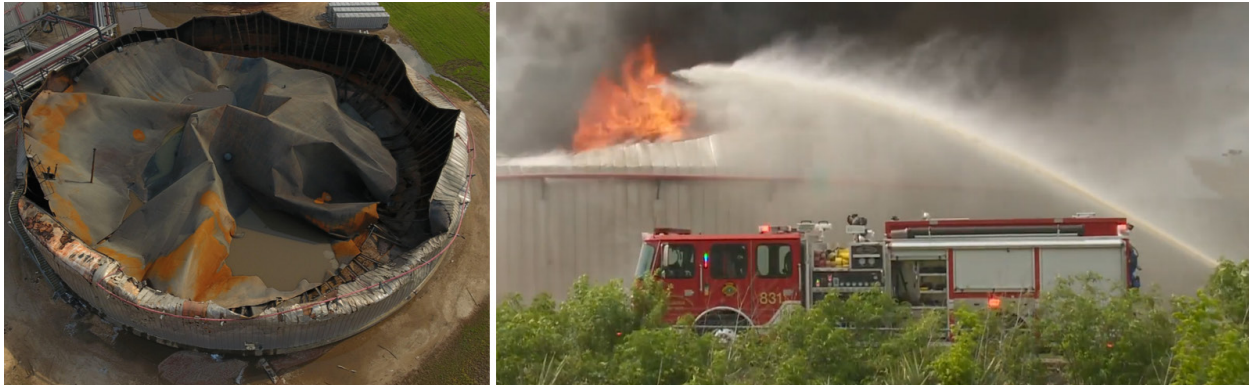
(Figure 2). Flammable hydrocarbon liquid burned in the tank for about nine hours before emergency responders extinguished the fire.

**Figure 13.** Post-incident photo of the damaged tank (left, Credit: IMTT) and the emergency response to the tank fire (right, Credit: WWL-TV).

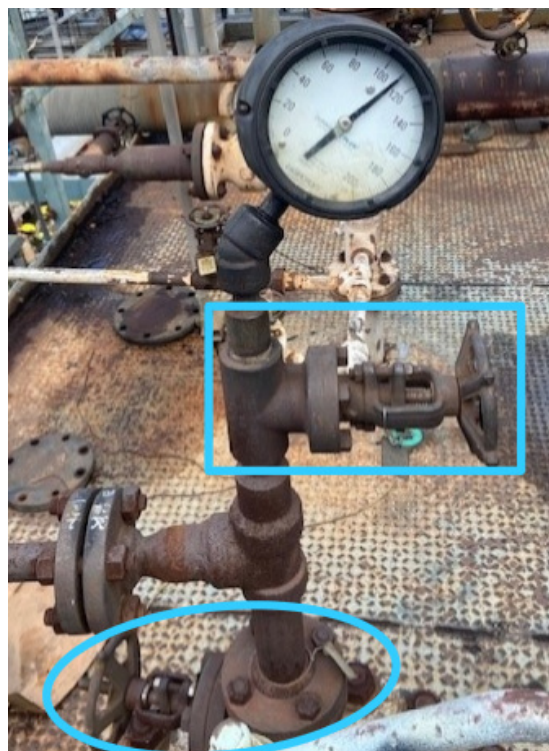
With the valve isolating the pressure gauge appearing to be closed, one of the operators began unscrewing the pressure gauge to relieve any residual pressure. The operator did not identify a potential leak as there was no indication of residual pressure while unscrewing the last threads of the pressure gauge. After the gauge was removed, however, the process pressure likely dislodged debris in the piping, causing the process stream to discharge into the atmosphere. This released flammable hydrocarbons containing hydrogen sulfide, exposing all four operators to the toxic hydrogen sulfide. Post-incident, Marathon found that the pressure gauge was plugged (**Figure 2**).

**Figure 1.** Photo of the pressure gauge and valves involved in the incident. (Credit: Marathon, annotations by CSB)

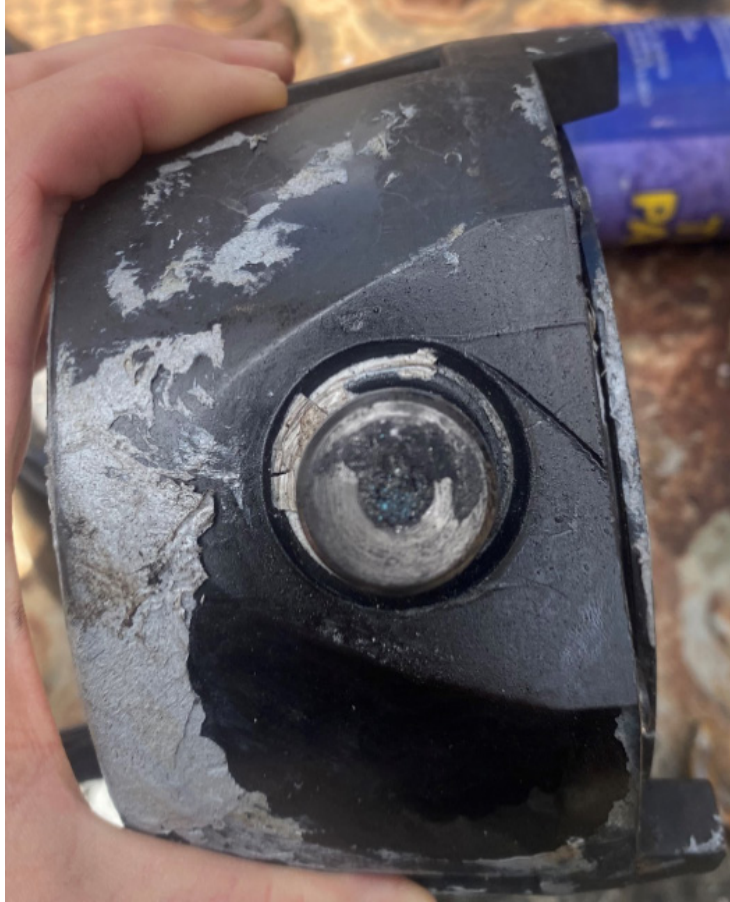
**Figure 2.** Pressure gauge involved in the incident.  
(Credit: Marathon)

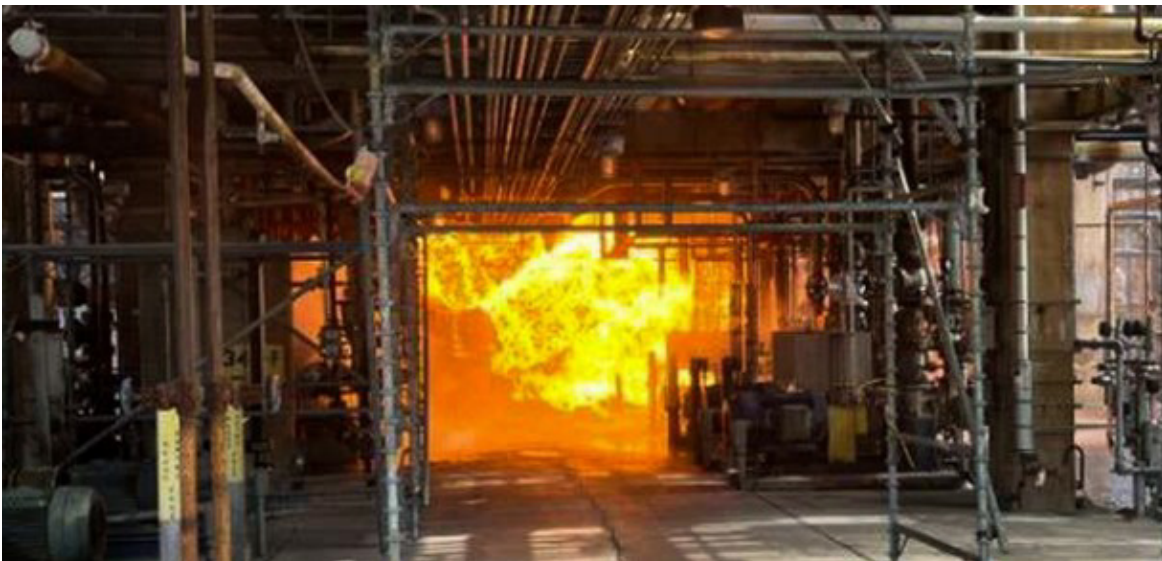
On the morning of the incident, two Marathon employees were completing an equipment oil change on an elevated platform above a pump that was supplying naphtha to downstream equipment. The pump’s coupling failed, reducing outlet flow and creating high vibration that broke a small bore ( $\frac{3}{4}$ -inch) piping section, releasing flammable naphtha. Employee 1 was on the platform cleaning up the work area while Employee 2 was carrying a bucket of oil down the stairs from the platform. Employee 2 smelled the released hydrocarbon and saw what looked like a steam cloud. Within minutes of the release, the flammable vapor ignited (**Figure 1**).

**Figure 14.** Fire from breached piping. (Credit: Marathon)

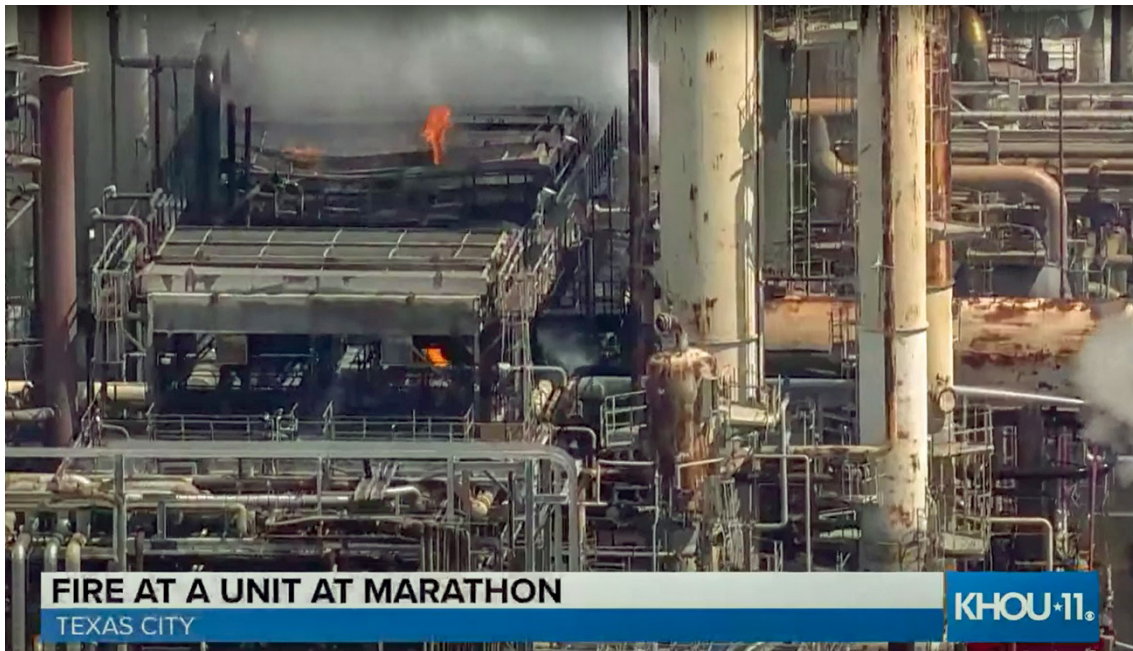
The heat from the fire ruptured piping and damaged other equipment (**Figure 2**). Employee 2 was able to exit the unit before the flammable naphtha ignited. Employee 1 did not escape from the elevated platform and was fatally injured by the fire.

Figure 15. Fire impacting elevated platforms. (Credit: KHOU 11 News)

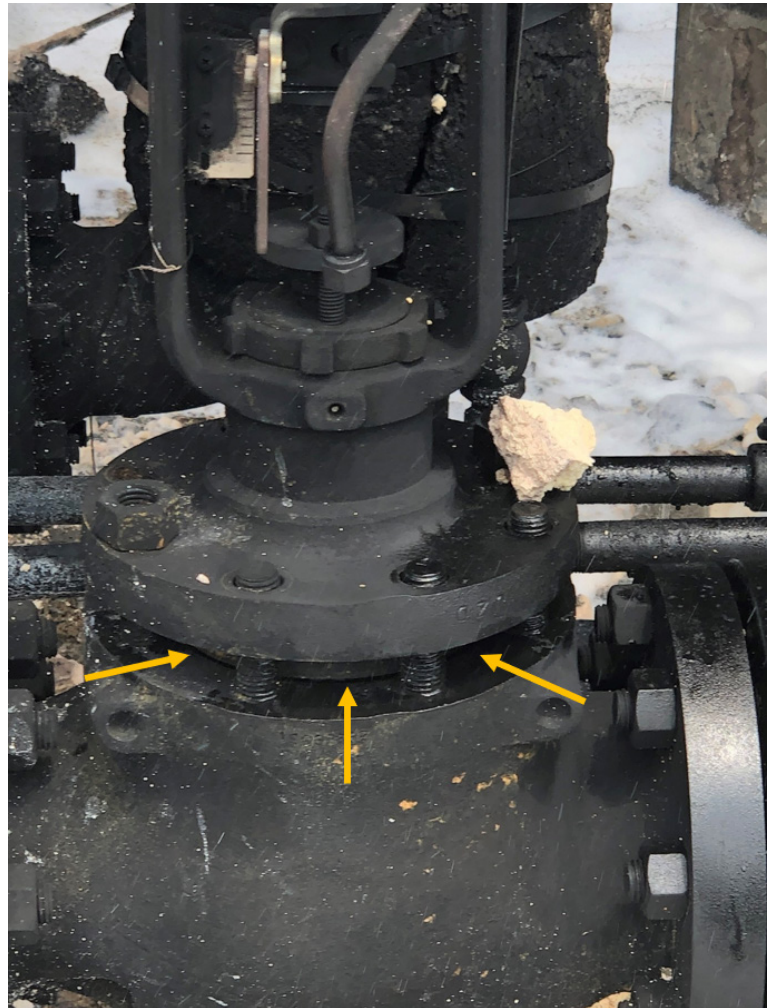
The investigation revealed that six of the eight nuts had been removed from the control valve's bonnet flange, which was the typical practice at the refinery when preparing to access the internal components. The control valve's bonnet flange had been partially disassembled while its downstream isolation valve was open, and it contained naphtha at 250 pounds per square inch gauge pressure and 425 degrees Fahrenheit. It is unknown whether the maintenance employees thought the system was safe to disassemble the control valve or did not recognize the hazard of disassembling the pressure-retaining components.

**Figure 2.** Naphtha release point (gold arrows). (Credit: CVR Energy with annotations by CSB)

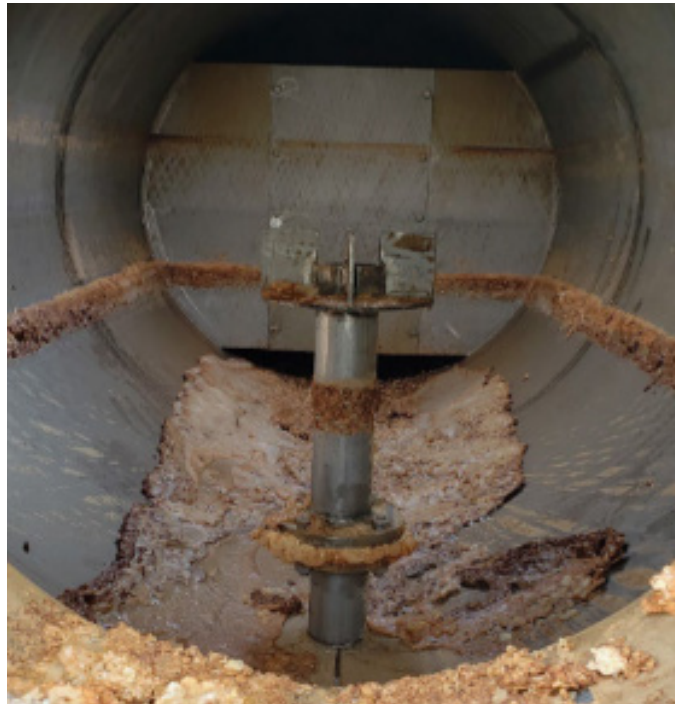
The incident occurred in SABIC’s latex production area during a maintenance shutdown. Employees were tasked with removing an internal part (a “baffle”) at the back of the horizontal tank (which was approximately five feet in diameter and nine feet in length). SABIC’s procedure stated that the tank should be cleaned using high-pressure water to remove any accumulated solids before entry. However, this procedure was not followed, and residual solids remained in the tank and potentially contained some butadiene (**Figure 1**). The work inside the tank disturbed these solids, which likely released about two pounds of butadiene vapor, creating a flammable atmosphere within a portion of the tank. In addition, while continual monitoring of the confined space was taking place during the entry, the end of the air monitor hose was not near the bottom of the tank where the solids were located, and this likely prevented the 5-gas detector from identifying the presence of flammable butadiene vapor.

**Figure 1.** Tank Containing Solids at SABIC. (Credit: SABIC)

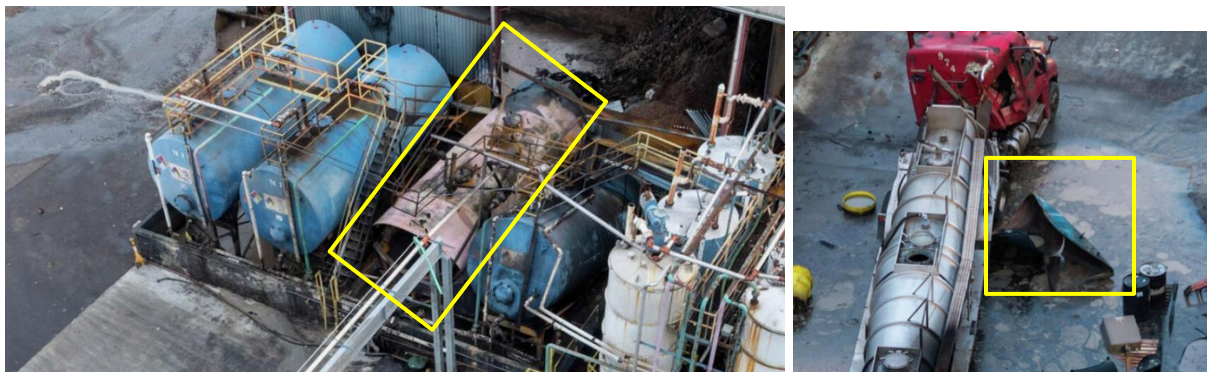
**Figure 1.** The tank that exploded (left). A portion of the tank after the explosion (right) (Credit: Tradebe, annotated by the CSB).

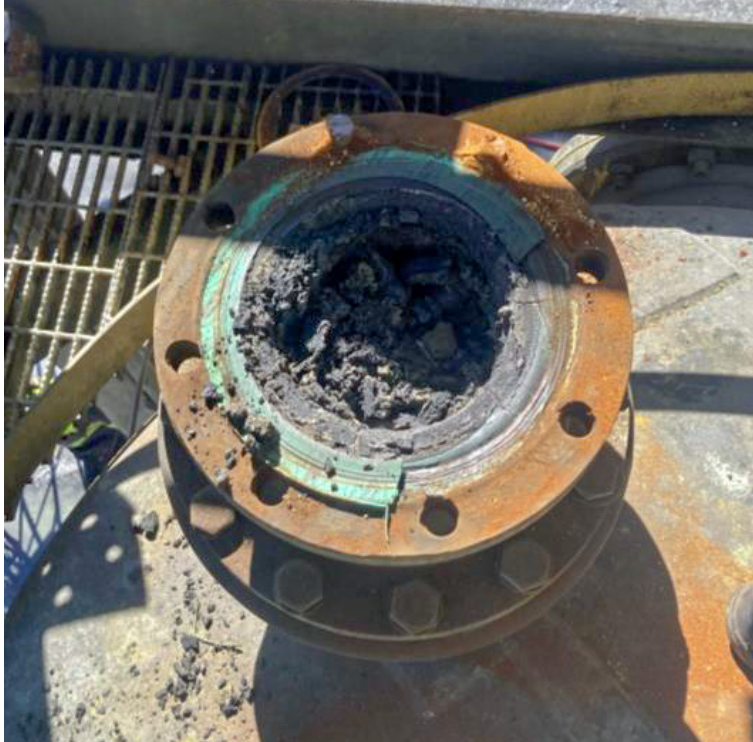
Tronox’s investigation determined that the high-pressure condition inside the water tank was created by a violent chemical reaction between titanium tetrachloride and water that generated hydrogen chloride vapor and heat. Liquid titanium tetrachloride had accumulated within the plugged piping from an upstream spray injection system. When the workers cleared the solids from the piping into the water tank, the liquid titanium chloride also entered the water tank, triggering the chemical reaction. Although the water tank was equipped with a rupture disc to protect the equipment from high-pressure conditions, the rupture disc did not activate during the incident because its inlet piping was blocked with solids (**Figure 2**). The investigation also found that although previous high-pressure events had occurred, Tronox’s employees were not required to wear respiratory protection for the pipe-clearing activity.

**Figure 2.** Solids in the rupture disc inlet piping. (Credit: Tronox)

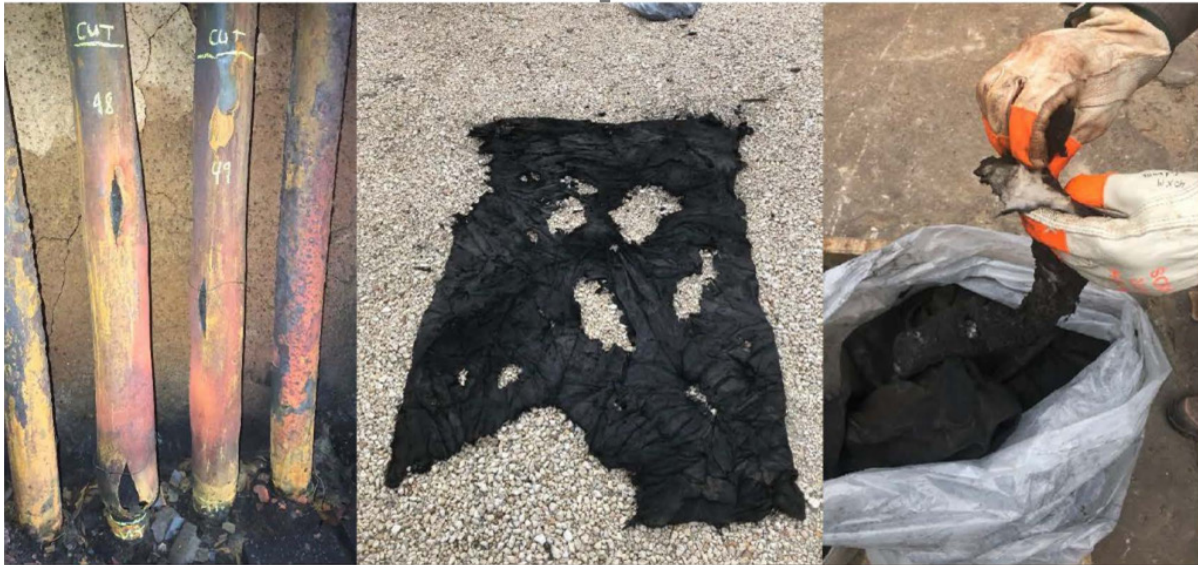
**Figure 17.** Failed fired heater tubes (left) and debris removed post-incident (center and right).  
(Credit: ExxonMobil)

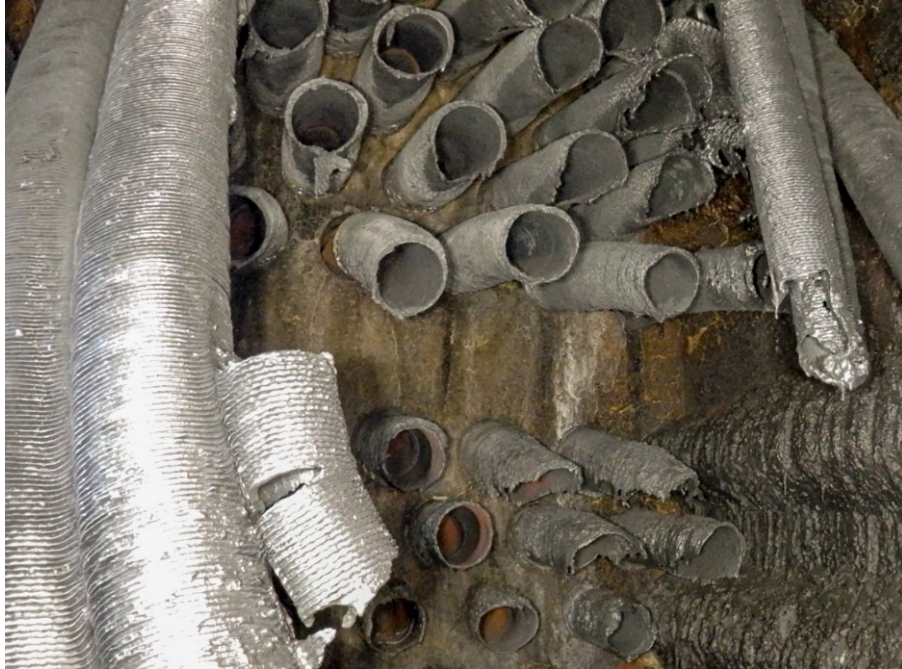
**Figure 19.** Broken fired heater tubes. (Credit: LyondellBasell)

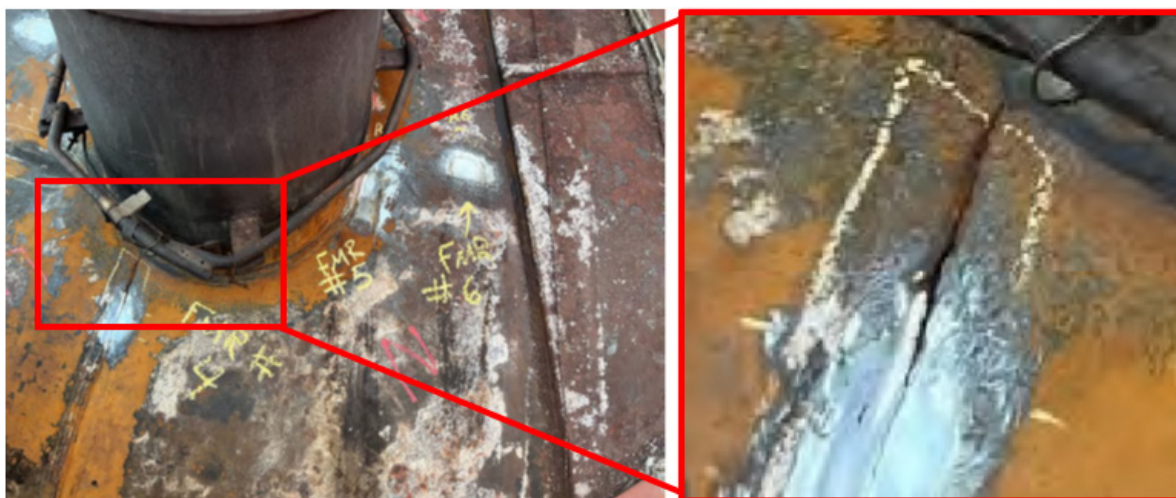
**Figure 2.** One of the cracks in the reactor’s head. (Credit: LyondellBasell, edited by the CSB)
