Safety Bulletin

U.S. Chemical Safety and Hazard Investigation Board

MANAGEMENT OF CHANGE

No. 2001-04-SB | August 2001

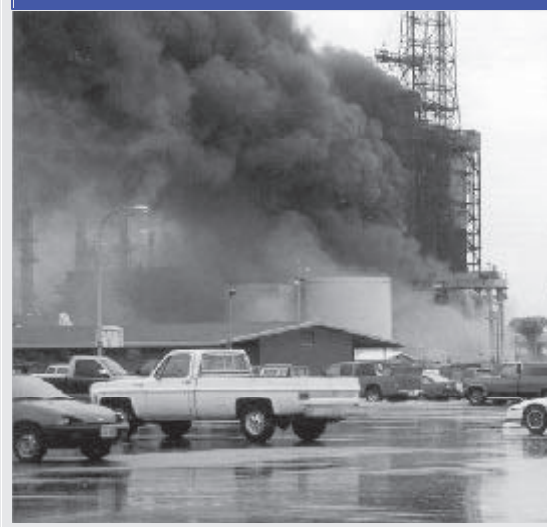
On November 25, 1998, a fire at the Equilon Enterprises oil refinery delayed coking unit in Anacortes, Washington, caused six fatalities (Figure 1). A loss of electric power and steam supply approximately 37 hours prior to the fire had resulted in abnormal process conditions.

● Figure 1. Equilon Enterprises oil refinery fire.

The top head was unbolted and lifted from the drum. The bottom head was also unbolted and held in place by a hydraulic dolly. The operator then activated a release mechanism to lower the dolly. Witnesses reported hearing a whooshing sound and seeing a white cloud of vapor emanate from the bottom of the drum. The hot petroleum vapor burst into flames. The process supervisor, an operator, and the four contract personnel assisting were caught in the fire and did not survive (Figure 2).

Followup Analysis—The supervisor and operators analyzed the situation and devised process changes to empty the drum. The relative coolness of the bottom flange erroneously suggested to them that the temperature inside the drum was also cool – when, in

the low temperature readings were not representative of the hot core.

It was assumed that the entire drum contents had cooled to safe levels during the 2 days since the power failure. However, heat transfer calculations would have indicated that weeks would be required for the

Unknown to the coker unit personnel present, the core of the mass remained insulated from heat loss. Within the core, residual heat continued to break down the petroleum, creating a pocket of hot pressurized volatile oil. Had the limitations of temperature-sensing devices been better understood, personnel may have realized that

After the incident, Equilon relocated the controls for the hydraulic dolly to allow workers to position themselves farther from a drum when opening it.

The Equilon incident could have been avoided if the “change” was managed by a team experienced in hands-on operations, safety procedures, and engineering calculations. Written procedures for cooling and emptying partially filled drums, as recommended by an Equilon investigation team in 1996, might also have reduced the likelihood of this incident.

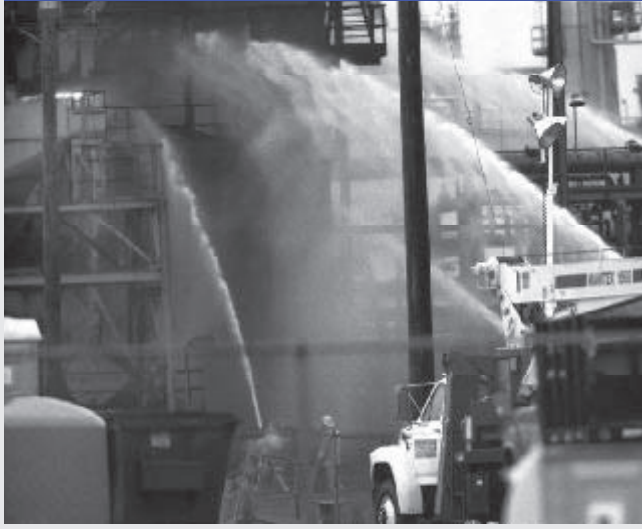
● Figure 2. Fire control efforts at Equilon refinery.

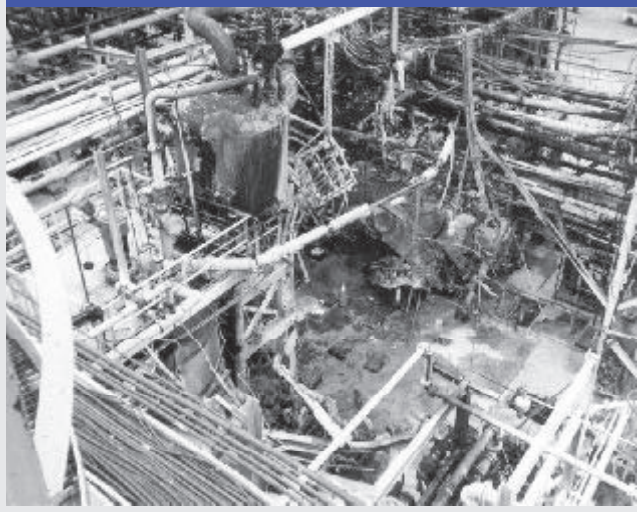
On October 13, 1998, a reaction vessel explosion and fire at the CONDEA Vista Company detergent alkylate plant in Baltimore, Maryland, injured four people (Figure 3).

When the process was shut down for maintenance, the operators were unable to empty the liquid that remained in the reactor. Sludge had settled in the vessel, plugging the bottom outlet nozzle.

● Figure 3. Site of ruptured reactor, CONDEA Vista Company detergent alkylate plant.

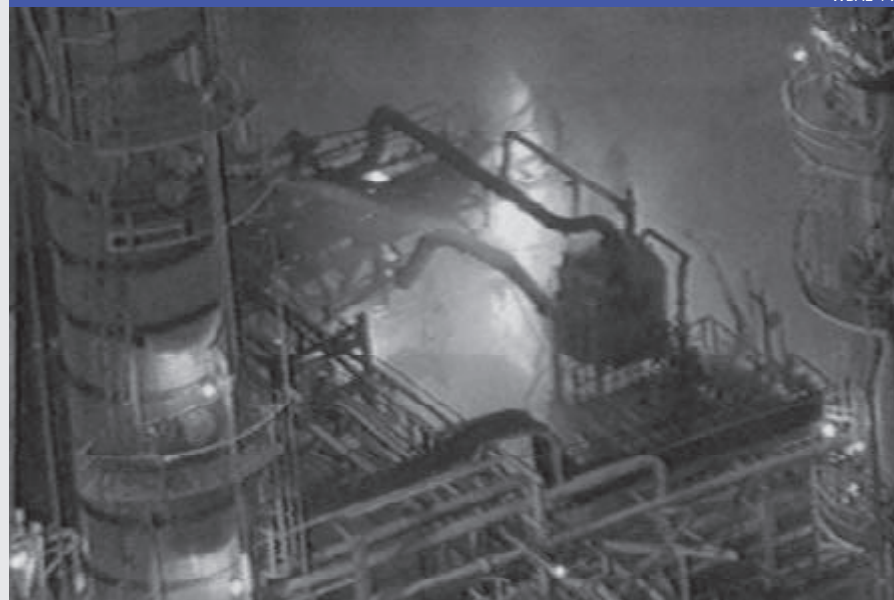
The night shift supervisor instructed an operator to add steam to the reactor. Minutes after the operator started to continuously inject the steam, it reacted with the metallic aluminum and the aluminum chloride residue in the sludge. The reactor vessel exploded (Figure 4).

From both a project and an operational standpoint, the incident at CONDEA Vista emphasizes the importance of systematically managing changes. Post-incident investigations noted that the density of the new catalyst (powdered aluminum) was higher than that of aluminum chloride. The higher density material—combined with problems related to initial overfeeding of the aluminum—overtaxed the mixing capability of the agitator and allowed aluminum to settle in the bottom of the reactor, where it plugged the lower nozzle and accumulated as sludge.

● Figure 4. CONDEA Vista plant fire.

- The temperature-sensing device did not accurately indicate the process temperature because it was located in a stagnant pipeline between the reactor and another vessel. The chemist and the engineer relied on misleading temperature indications when they noted the stabilization of the reactor temperature before leaving for the day.

variances in operating conditions and practices. In this case, the absence of written instructions increased the likelihood of miscommunication between the two shift supervisors, which led to the unsafe application of steam in the reactor vessel.

A hazard analysis of the proposed procedure could have assisted in the identification of potential safety issues. Ideally, the extent of analysis undertaken should be tailored to the degree of risk.

Another lesson learned is the value of having an authorization or approval step as part of an MOC system for abnormal situations. If such a procedure had been in place, a technical manager would have reviewed the proposed procedure and may have detected its deficiencies.
