## Investigation Report

Published: March 2025

On November 19, 2023, at 12:21 a.m., a metal tube ruptured within a fired heater during the initial startup of a renewable diesel hydroprocessing unit at the Marathon Martinez Renewables (“Marathon Martinez”) facility in Martinez, California.<sup>a</sup> The ruptured tube released renewable diesel and hydrogen, resulting in a fire that seriously injured one Marathon Martinez employee. The incident occurred while the unit was starting up for the first time as a renewable diesel hydroprocessing unit.

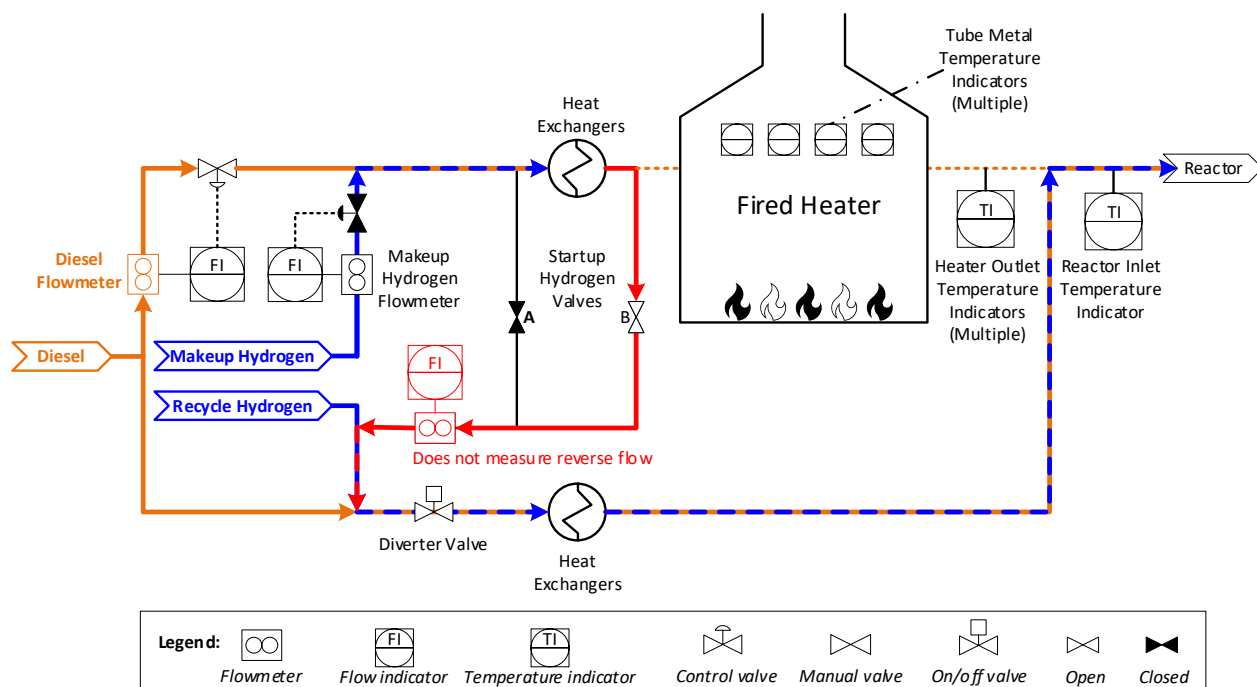
**Figure 8.** A portion of the diesel-hydrogen mixture diverted around the heater on November 11. (Credit: CSB)

With reduced process flow through the fired heater tubes, tube metal temperatures began to rise. Some of the convection section tube metal temperature indicators triggered high-temperature alarms at 790 °F within the first half hour of the routing change and eventually reached approximately 900 °F.<sup>a</sup>

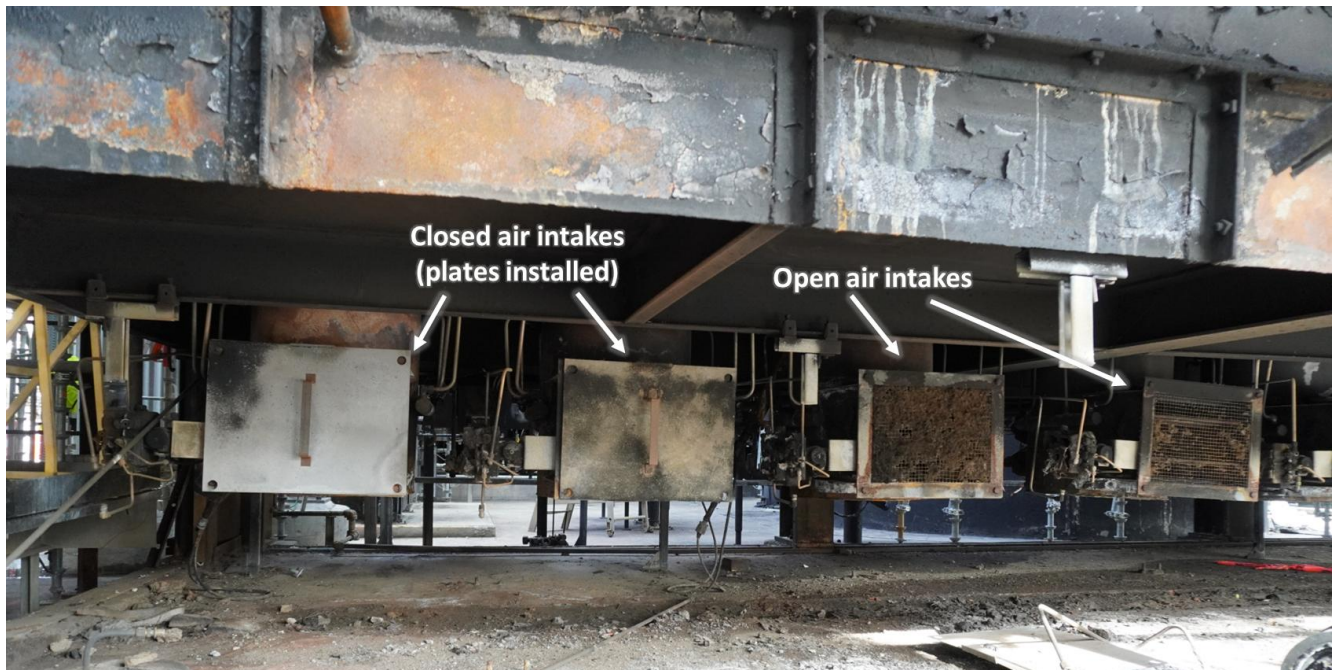
Figure 9. Post-incident as-found condition of the air side of four of the burners. (Credit: CSB)

The blocked air intakes likely prevented the required combustion air flow through these burners and affected the air-fuel mixing at the burners. Without proper air-fuel mixing at the burners, some unburnt fuel likely moved upward in the fired heater where it subsequently came into contact with available air at or near the convection section and ignited there, a condition known as afterburning (see *Section 3.3*). Only one of the four burners that were lit (burner 1) was equipped with a flame detector, which indicated that the burner remained lit until the incident.<sup>a</sup> The flame status of the other three burners that were lit, however, was unknown. The heater began to operate with higher temperatures in the convection section than in the radiant section (**Figure 12**), indicative of afterburning.

- Updated operating procedures with steps to remove air register cover plates prior to lighting burners and caution statements to warn operators of the hazards of blocked air registers.<sup>a</sup>

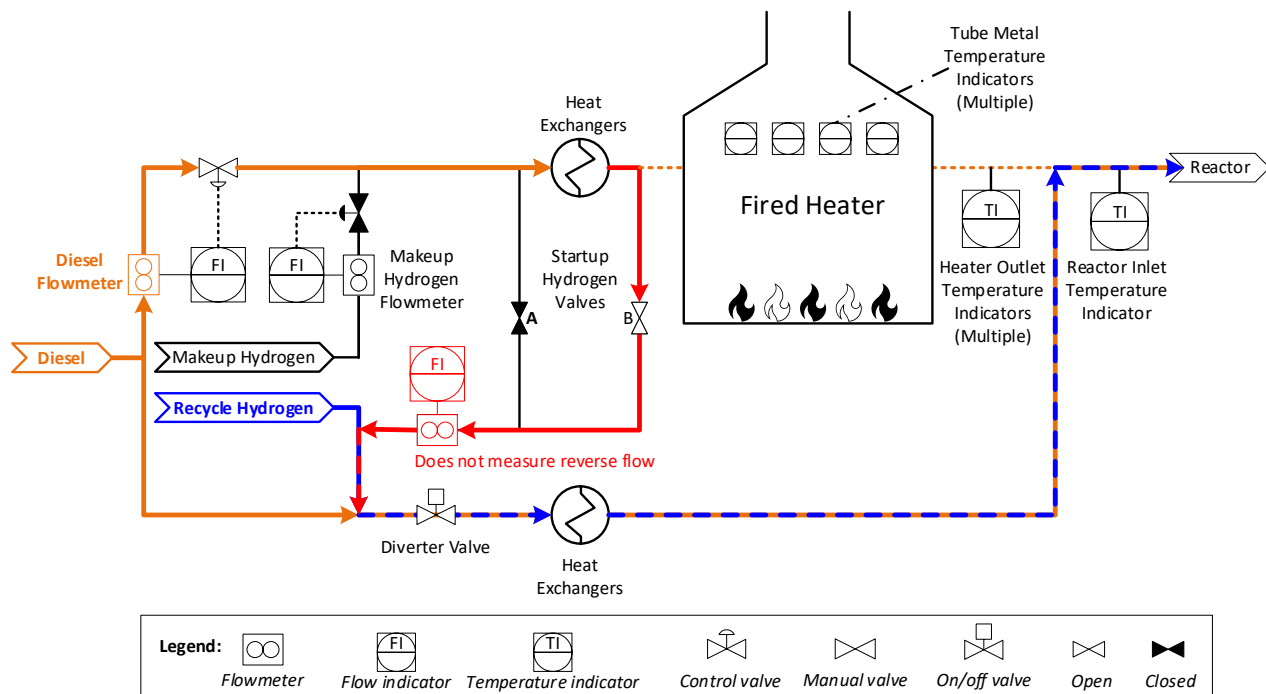
**Figure 10.** Flow diversion from the heater. Reverse flow indicated in red. (Credit: CSB)<sup>a</sup>

Unbeknownst to the operators, most of the renewable diesel again reverse-flowed through the startup piping on which the open Valve B was installed (**Figure 10**). Again, the board operator did not see this flow diversion on his display because the startup piping flow meter was not configured to detect flow in the reverse direction.<sup>b</sup>

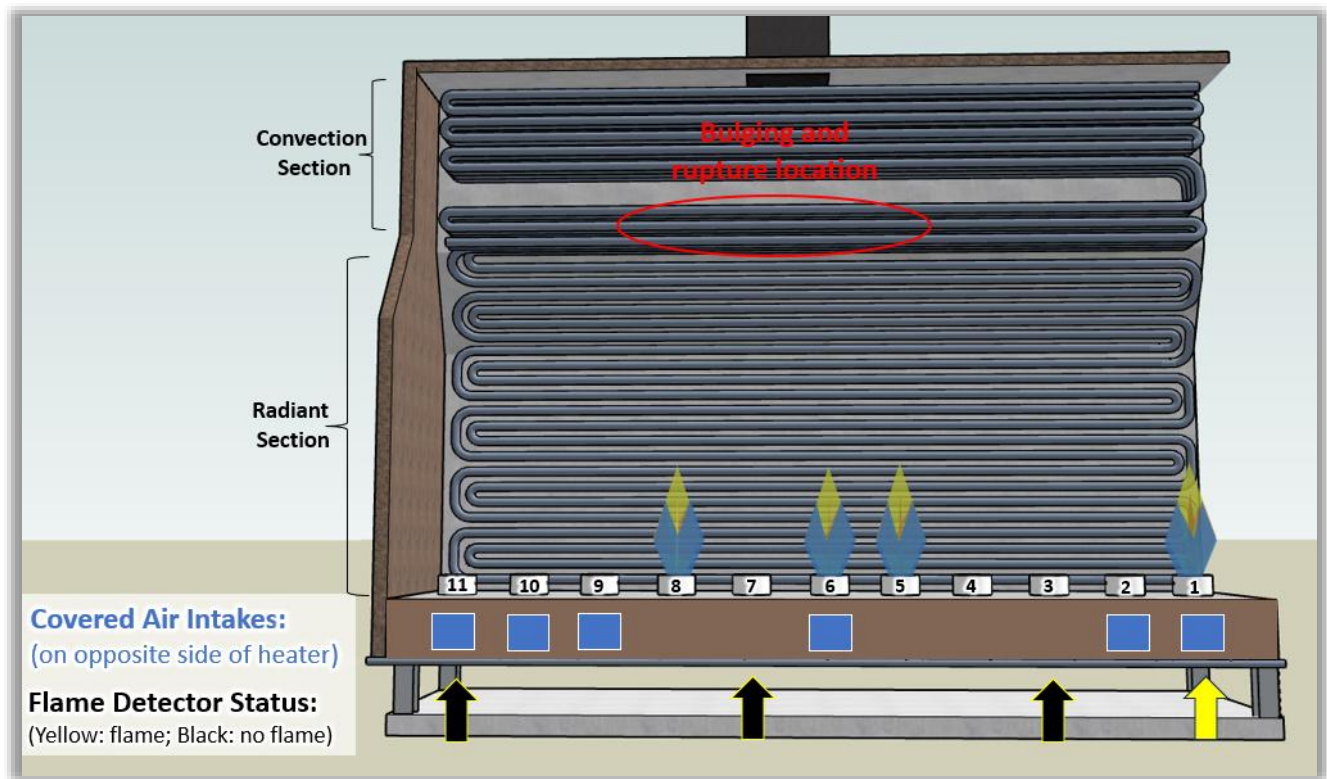
**Figure 11.** Burner configuration when heater was restarted approximately one hour before the incident. (Credit: CSB)

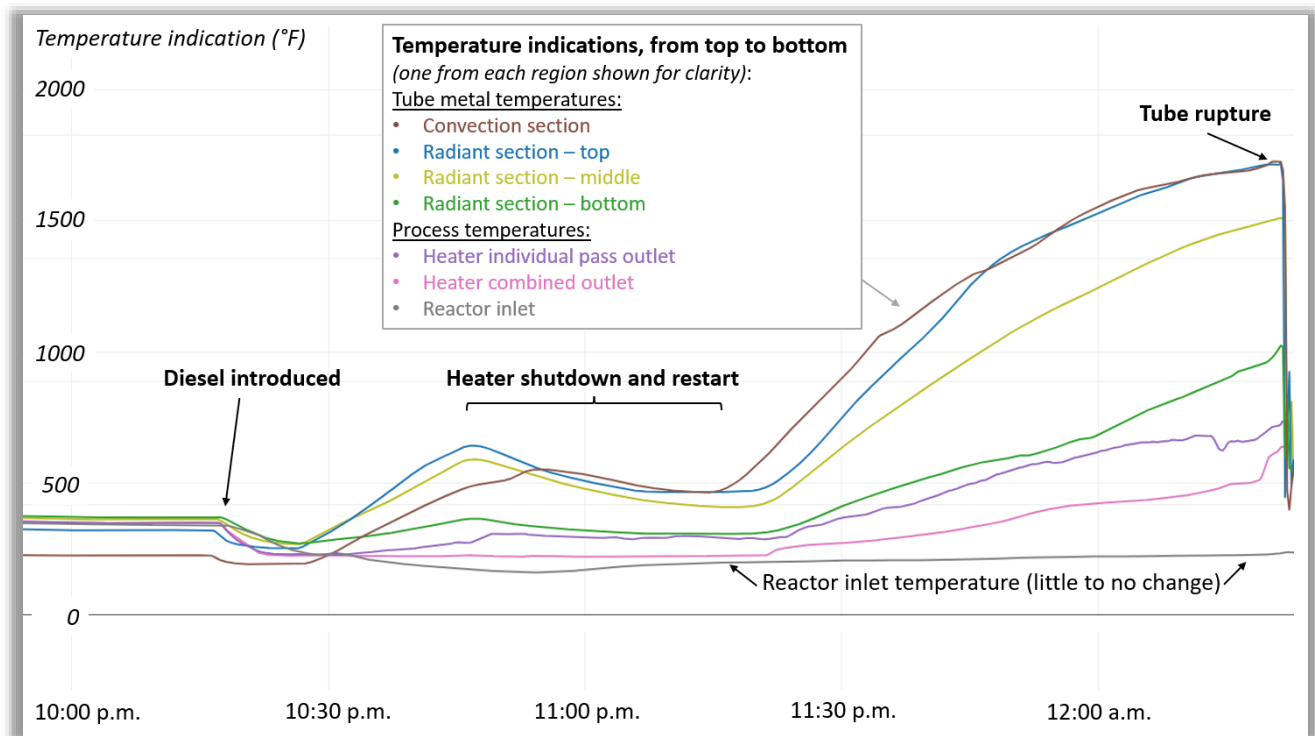
**Figure 12.** Process and tube metal temperatures in the two hours leading up to the tube rupture. (Credit: CSB)

The board operators increased diesel flow to the heater, expecting that additional flow would remove heat from the tube walls and cause the tube metal temperatures to decrease. They also made heater draft adjustments to draw in more combustion air in an attempt to cool the tubes, and they lowered the fired heater feed temperature. Unknown to Marathon Martinez personnel, the added diesel flow continued to bypass the fired heater through the open Valve B, and tube metal temperatures continued to increase. At 11:45 p.m., tube metal temperatures in the radiant section exceeded 1,100 °F and activated additional high-temperature alarms (**Figure 12**, blue trend). By this time, some of the convection tube metal temperatures had already exceeded 1,100 °F (**Figure 12**, brown trend).

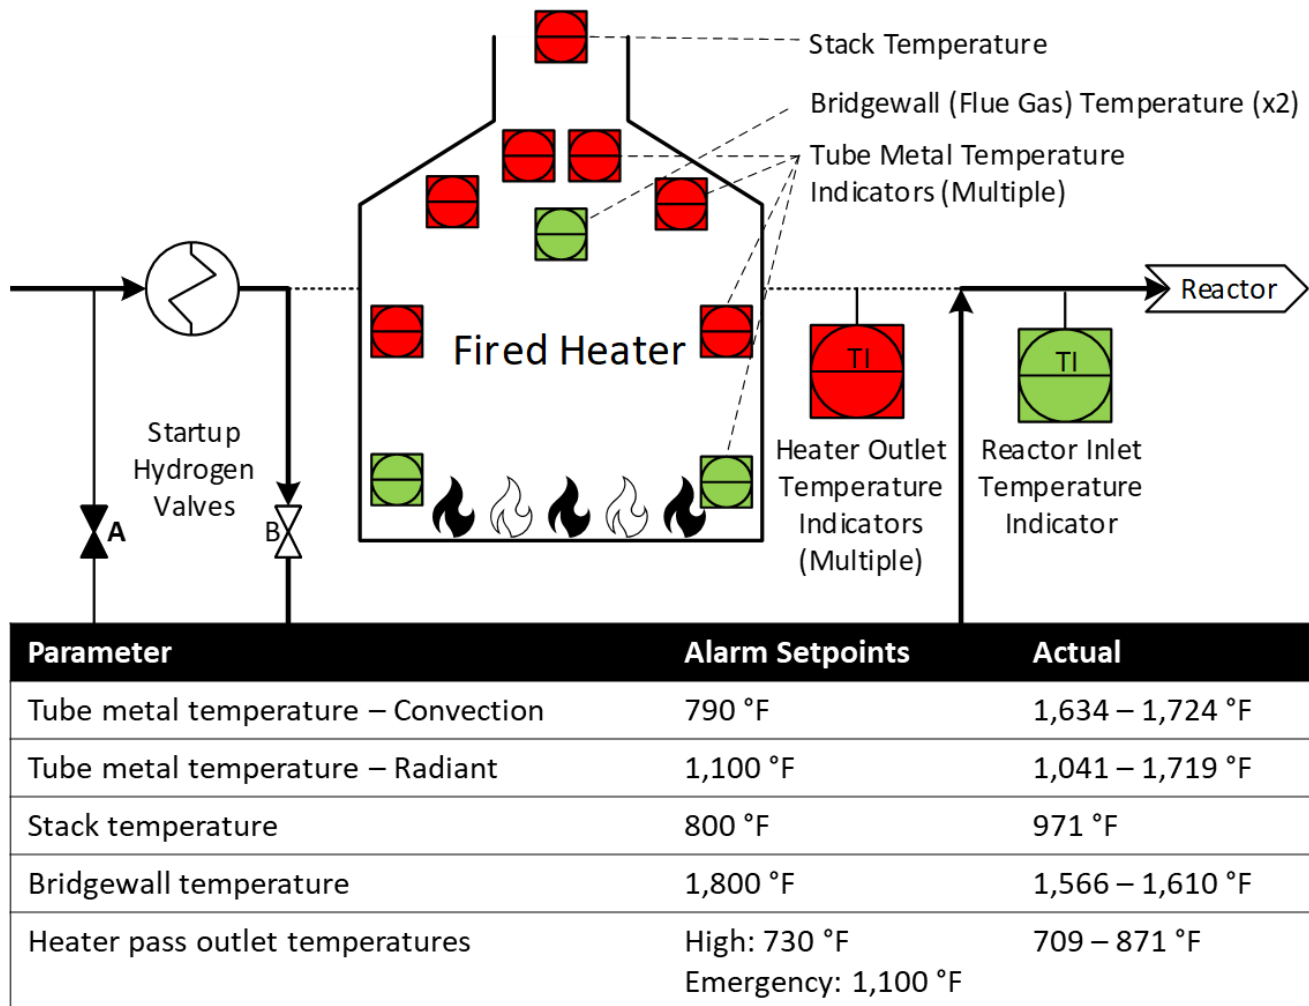
<sup>a</sup> The two bridgewall temperatures (configured to alarm at 1,800 °F) and the two radiant tube metal temperatures nearest to the floor of the heater were not in alarm.

**Figure 13.** Temperatures in alarm approximately one minute before the tube rupture. Red indicates in alarm state, green indicates not in alarm state. (Credit: CSB)

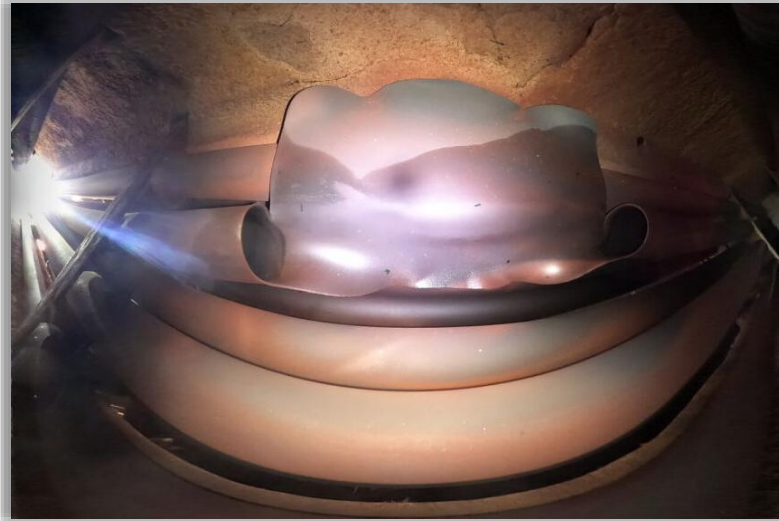
At 12:21 a.m., just after the field operator had shut down the second burner, one of the fired heater's convection section tubes ruptured (**Figure 15**). The tube had become dangerously hot and suddenly failed from short-term overheating of the tube metal (see *Section 3.1*). The ruptured tube, which had been operating with an internal pressure of approximately 620 psig, released renewable diesel and hydrogen into the firebox (the fired heater enclosure). The released flammable material suddenly ignited, and a fire erupted (**Figure 16**). The release and ignition increased the pressure inside the firebox, forcing the flame and unburnt fuel out of openings in the fired heater. Some of the flammable material was likely released out of the burner view ports, which were located directly above the fuel gas valves and were equipped with free-swinging doors that opened outward (**Figure 17**). The field operator, who was standing next to the heater to access the manual fuel gas valves, became engulfed in flames. Marathon Martinez operations personnel initiated an emergency shutdown within less than one minute of the tube rupture, depressurized the unit, and responded to the fire.<sup>a</sup> The fire was mostly extinguished after about 15 to 20 minutes.

**Figure 15.** Post-incident image showing the failed heater tube from above. (Credit: Marathon)

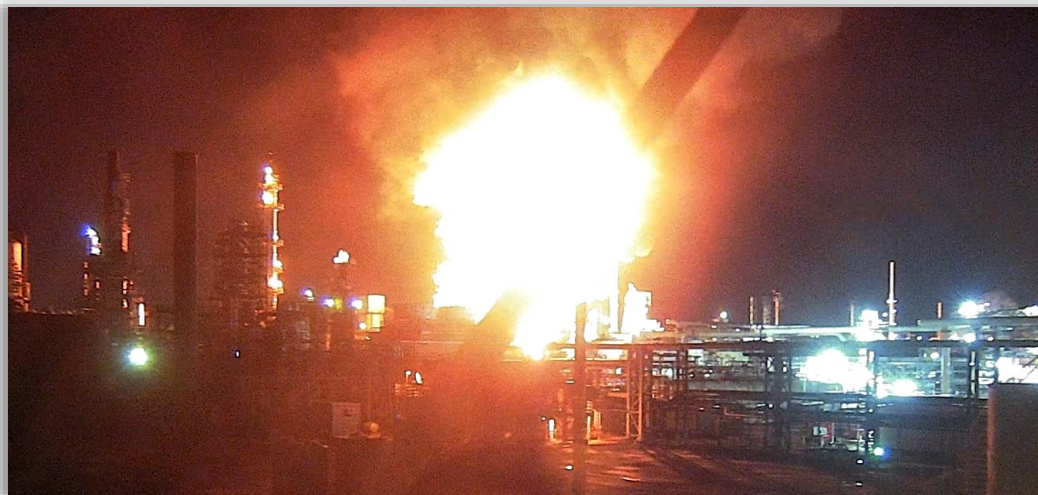
**Figure 16.** Surveillance footage of heater fire. (Credit: Marathon)

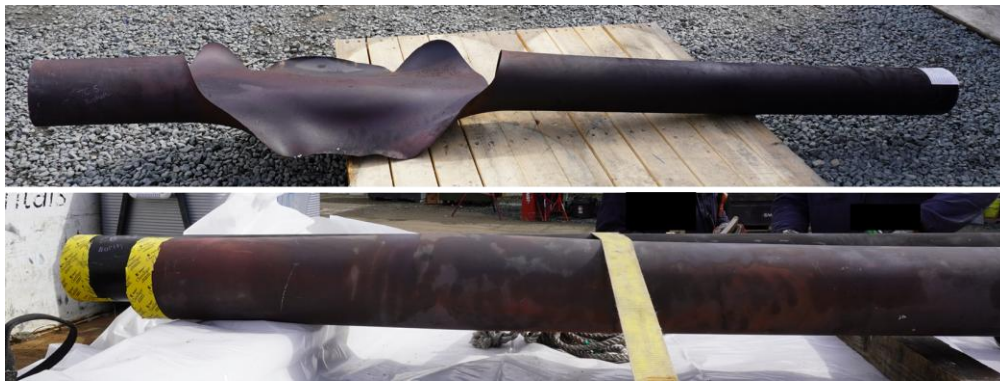
Short-term overheating damage is typically characterized by localized bulging exceeding 3 percent of the tube’s original diameter [28, p. 281]. Post-incident, the CSB and Marathon identified tube bulging immediately around the ruptured area, as well as bulging in nearby tubes that had not ruptured (**Figure 18**). The bulging was indicative of tube metal temperatures being highest in the convection section (**Figure 19**).<sup>b</sup>

**Figure 18.** Convection section tubes showing more than 3% outer diameter growth. (Credit: CSB)

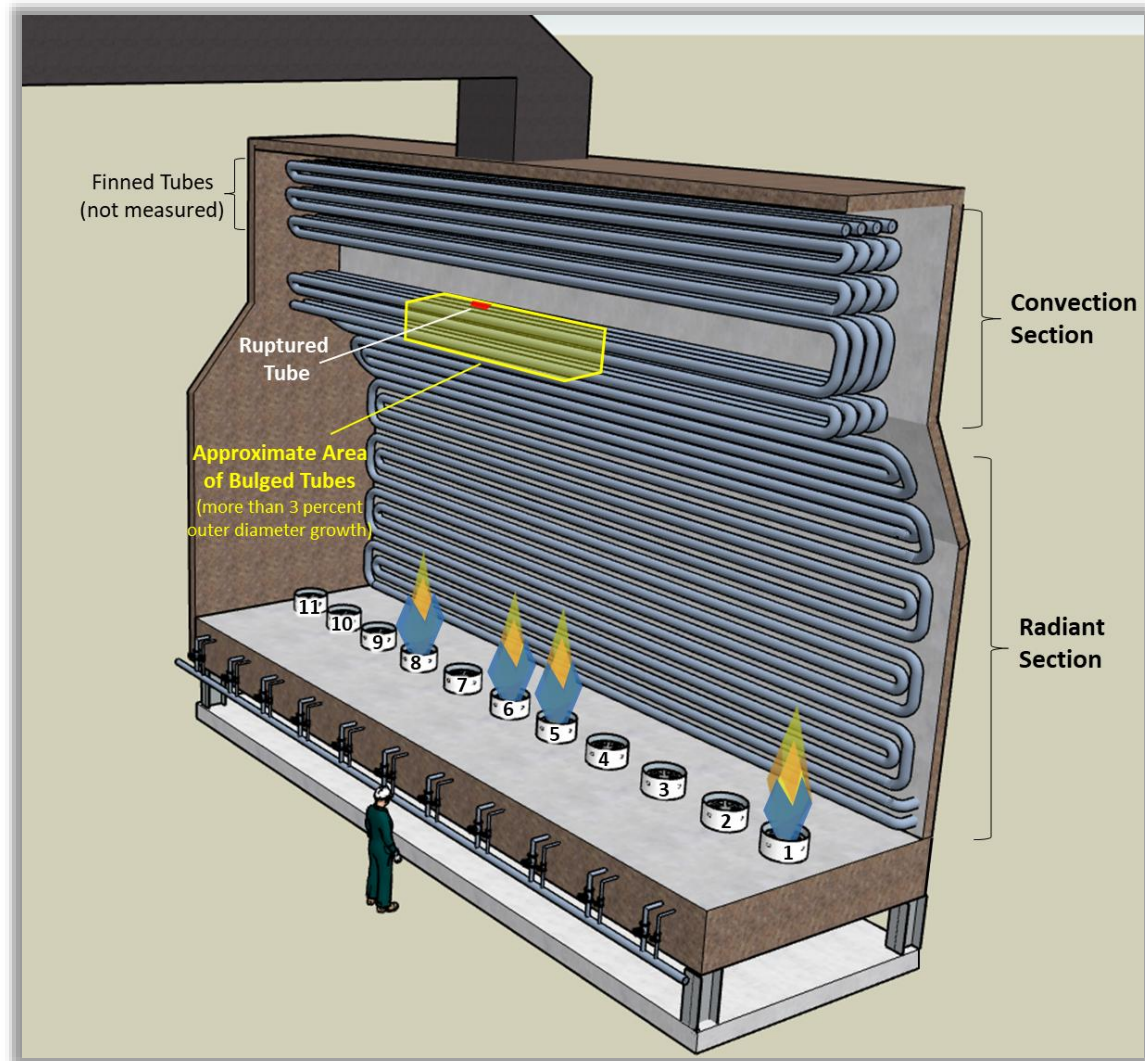
<sup>b</sup> Marathon collected outer diameter measurements of all heater tubes in the radiant section and the convection section up to the ruptured tube. No damage was noted on the tubes in the middle and lower radiant section. The finned tubes in the upper convection section were not measured.

**Figure 19.** Heater illustration depicting tube damage found upon internal inspection post-incident. Note: The lit burners do not necessarily depict their actual state at the time of the incident. (Credit: CSB)

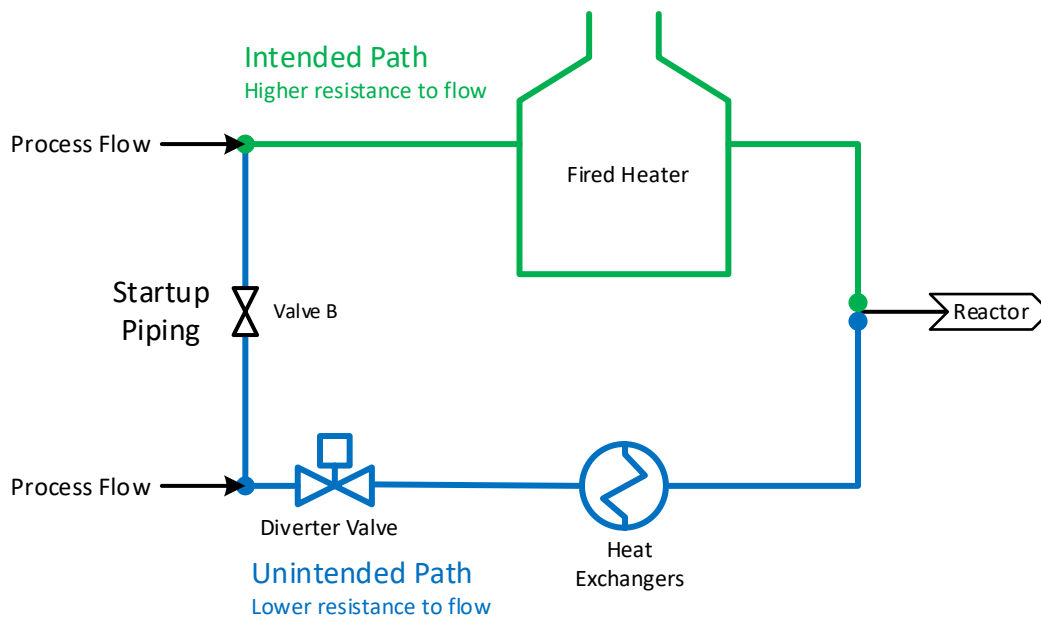
After the incident, Valve B was found in the open position when it should have been in the closed position. A post-incident hydraulic analysis found that with Valve B and the Diverter Valve in the open position, the flow path of least resistance was through the path shown in blue in **Figure 20**.<sup>a</sup> Process data also indicates that tube metal temperatures rapidly increased each time that the Diverter Valve was open, indicating that the flow path shown in **Figure 20** was available even when operators had closed Valve A (not shown in this figure).<sup>b</sup> The CSB concludes that leading up to the incident, process fluid diverted around the fired heater through a misaligned valve (open when it should have been closed), causing low flow through the fired heater tubes.

**Figure 20.** Simplified diagram of the two potential flow paths introduced by the open Valve B. (Credit: CSB)

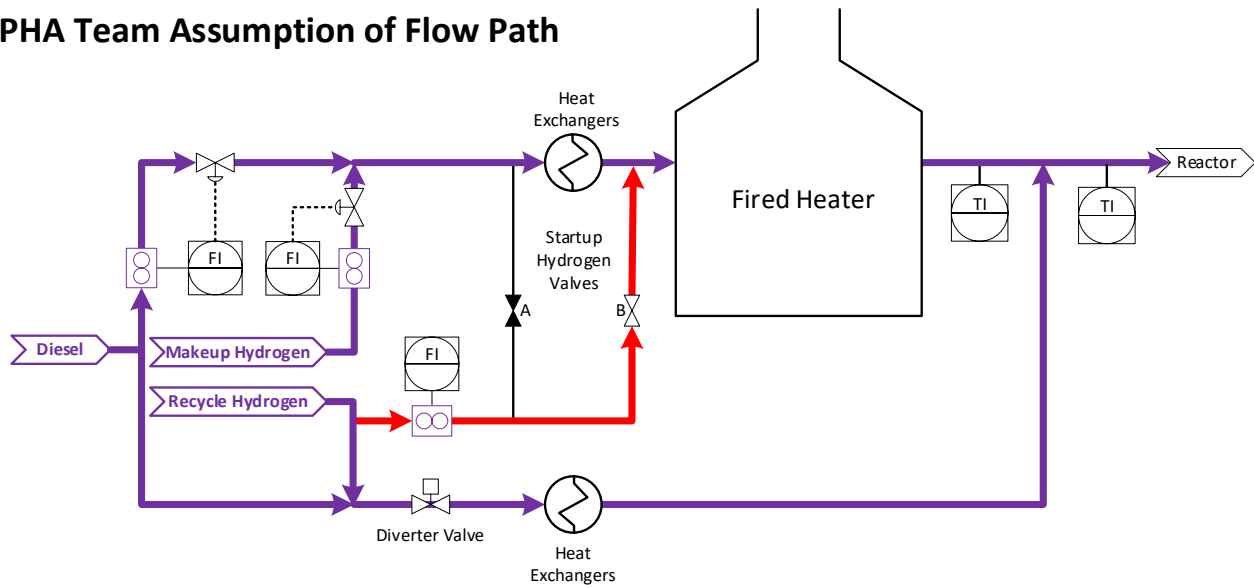
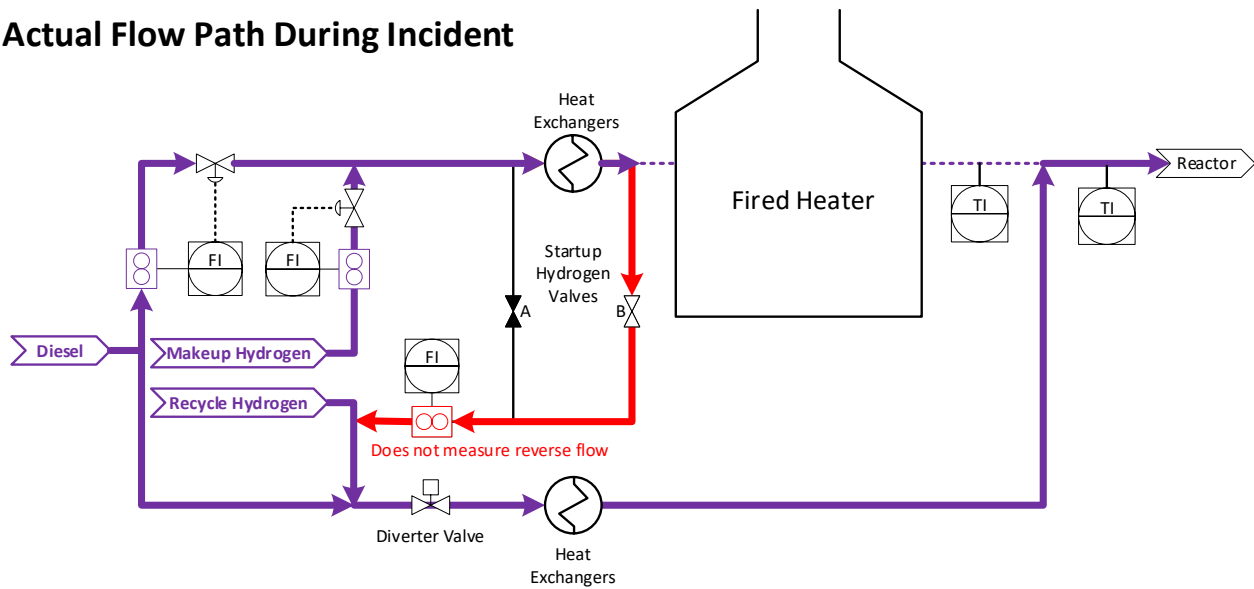
**Figure 21.** Flow path assumed by the PHA team compared with the actual flow path during the incident. (Credit: CSB)

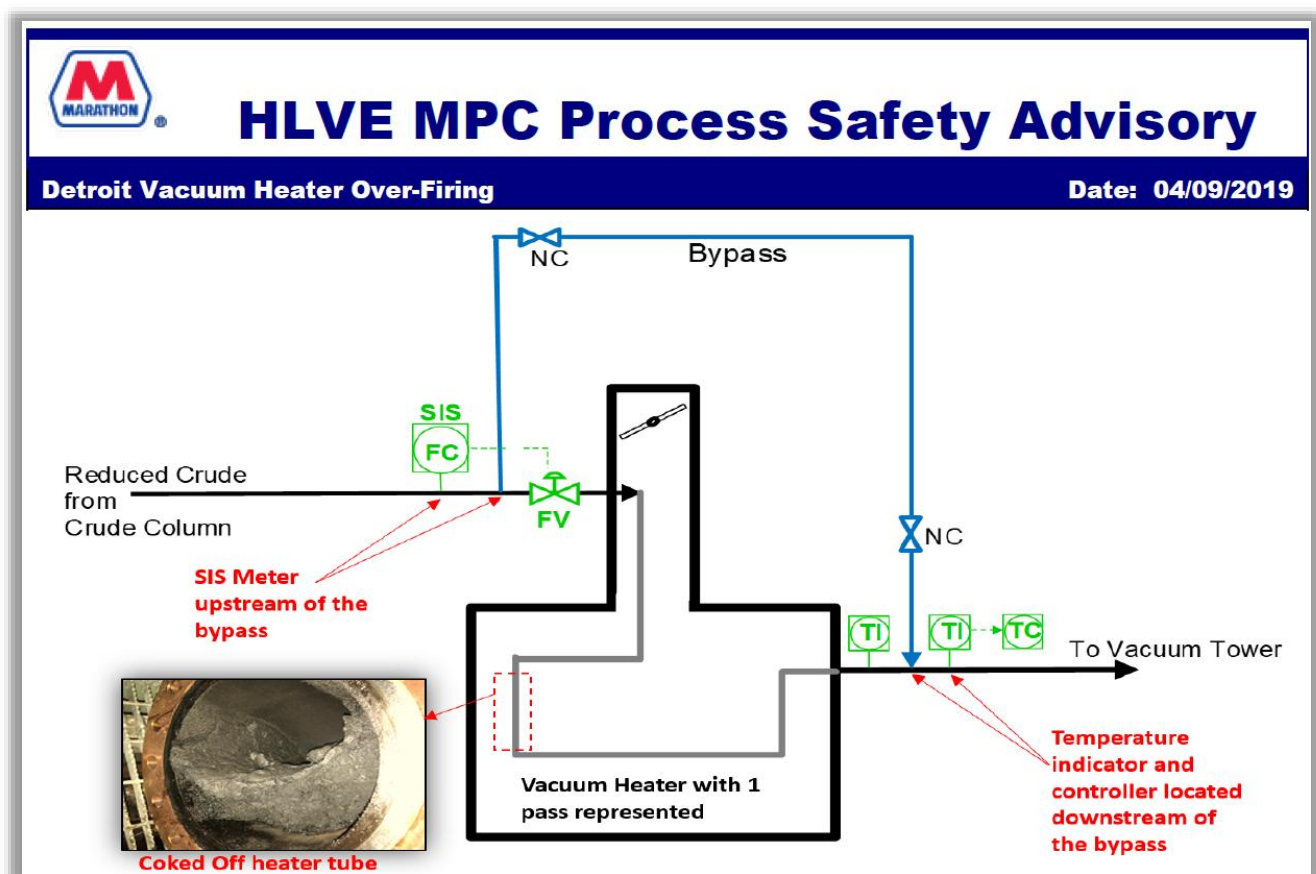
In a process safety advisory sent to all Marathon refineries in 2019, Marathon discussed a 2018 incident at its Detroit refinery where a fired heater was damaged due to low process flow through its tubes.<sup>a</sup> Two valves, labeled in **Figure 22** as being normally closed (NC), were open during the 2018 incident, diverting flow away from the heater during the startup through the bypass piping. The advisory stated: “the low-flow condition was not detected because the bypass line was installed downstream of the SIS flow meter [...], essentially defeating the safety system.” [Appendix C](#) provides further details on this incident.

**Figure 22.** 2019 Marathon process safety advisory showing the defeated SIS flow meter. (Credit: Marathon)

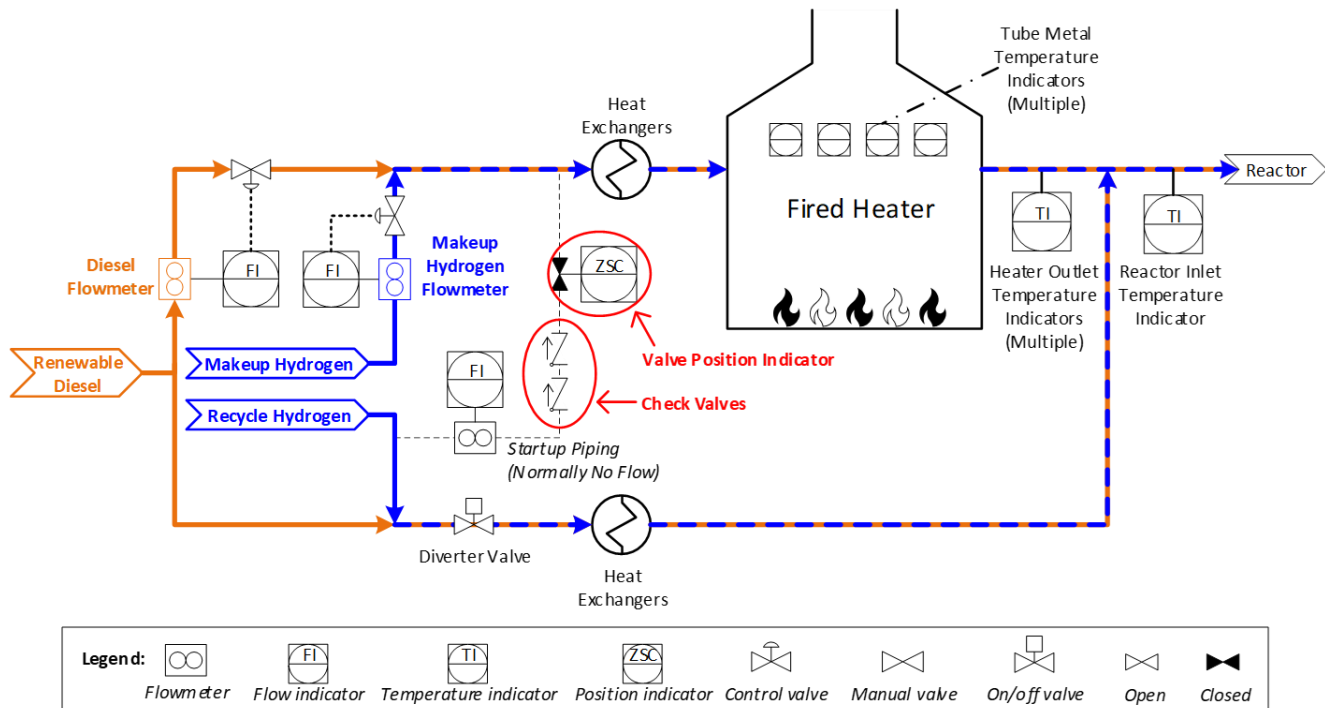
Figure 23. Marathon’s post-incident modifications to the startup piping. (Credit: CSB)

Post-incident, the Marathon Martinez facility made physical changes to the startup piping to prevent a recurrence of this incident after revising its PHA to properly reflect the potential for flow diversion through the startup piping. Changes include the removal of the startup hydrogen Valve B, the addition of a valve position indicator on Valve A viewable from the control room,<sup>a</sup> installing dual diverse check valves in the startup hydrogen piping (Figure 23, circled in red), and updating operating procedures and operator training on the use of the startup piping [34, pp. 5-6].<sup>b</sup>

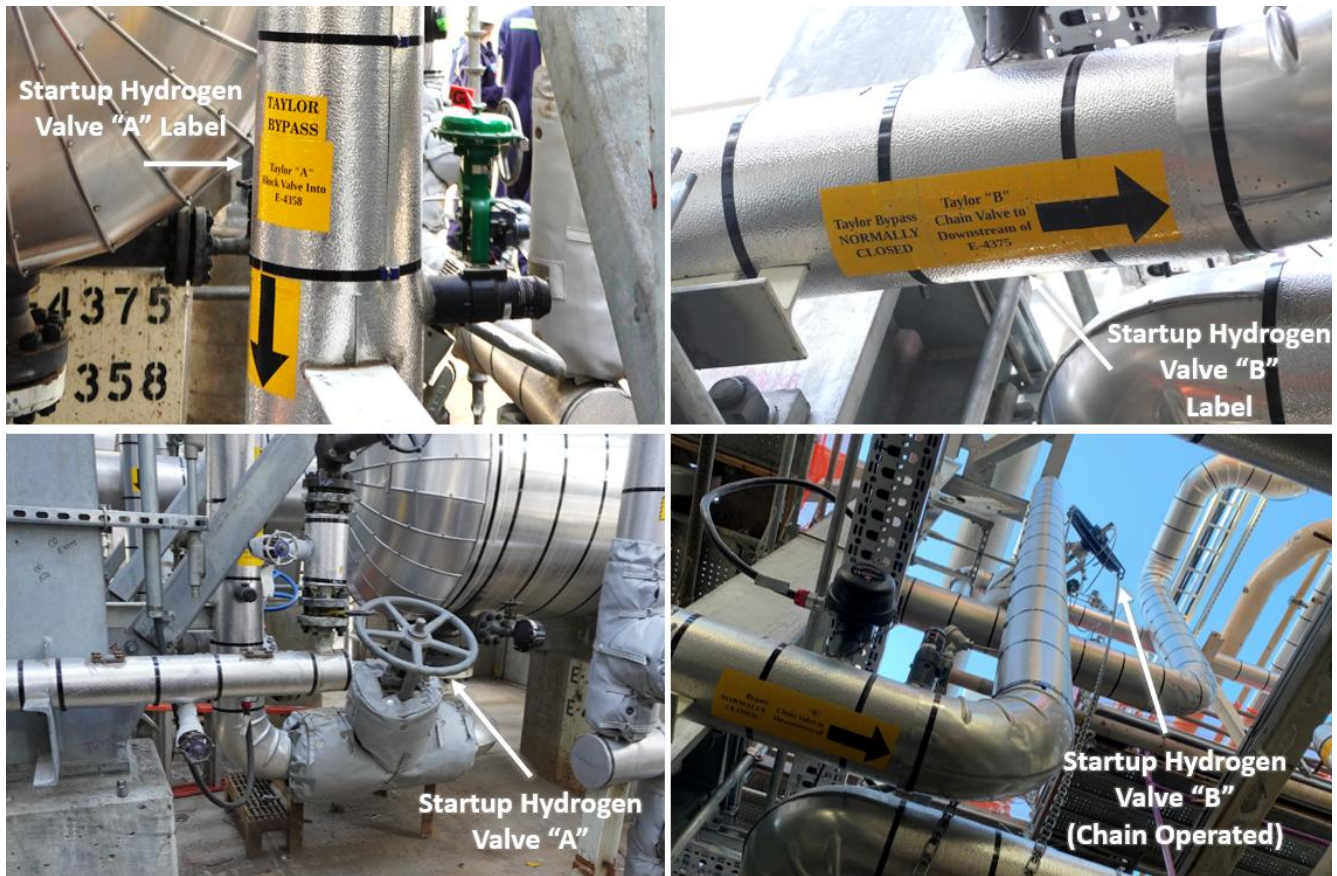
The startup piping that the Marathon Martinez unit’s startup procedure referenced was colloquially referred to by both personnel and the procedure as the “Taylor Bypass.” Valves A and B were identically sized manual valves labeled with this “Taylor Bypass” name (**Figure 26**). Valve A was located at grade, and Valve B was at an elevated platform, operated by a chain valve.

**Figure 26.** Location and labeling of startup Valves A (left) and B (right), photos taken post-incident. (Credit: CSB)
