Investigation Report

Published: October 11, 2022

U.S. Chemical Safety and Hazard Investigation Board

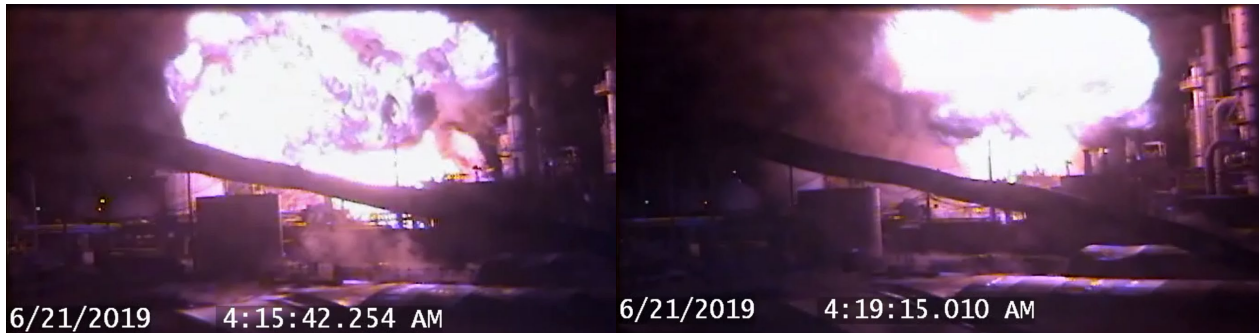
Figure 11. Surveillance video stills of explosions in the unit. (Credit: PES)

At 4:15 a.m. an explosion occurred in the unit (**Figure 11**). Based on the fact that the unit was operating normally before the elbow rupture and that there was fire in the unit at the time of this explosion, it appears to have been a secondary event caused by the fire. Another explosion occurred at 4:19 a.m., which also appears to have been an additional secondary event caused by the fire.

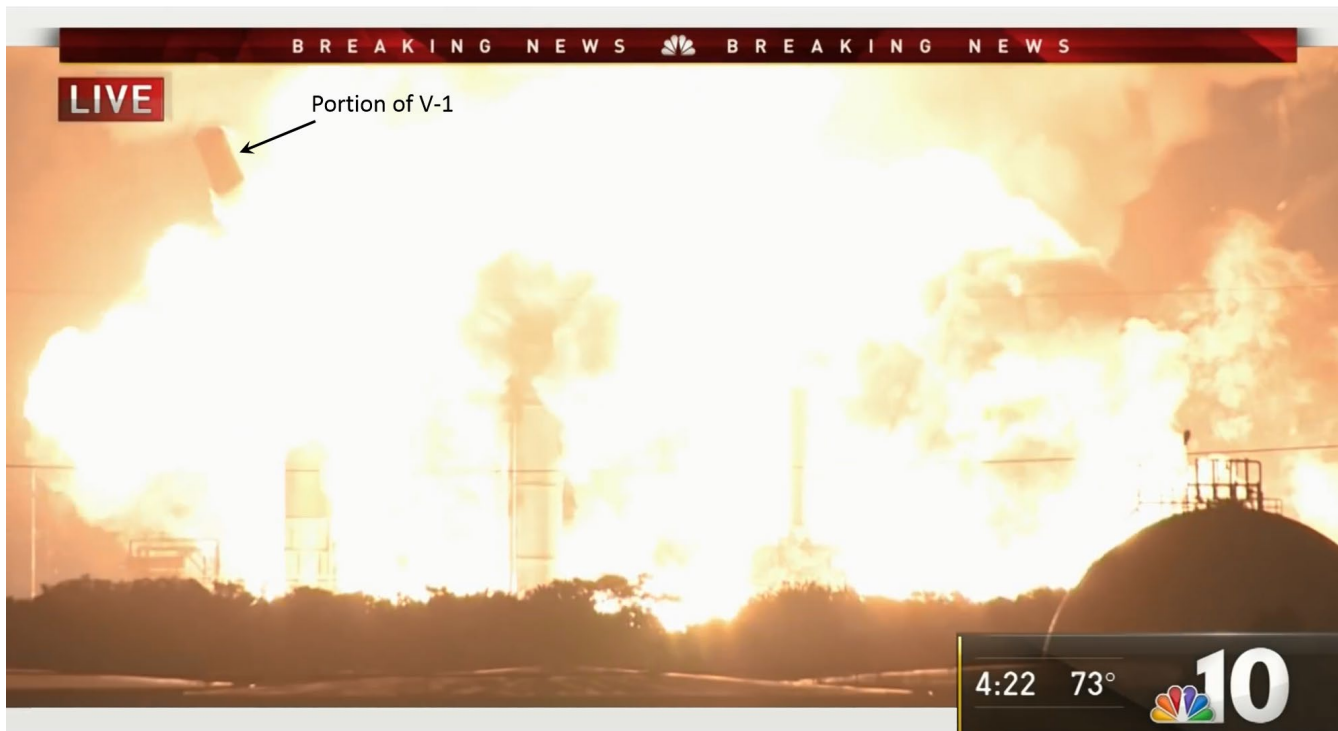
Figure 12. Video still of the V-1 explosion. (Credit: NBC10 Philadelphia [16] with annotations by CSB)

At 4:22 a.m., a third, and the largest, explosion occurred when the V-1 treater feed surge drum, containing primarily butylene, isobutane, and butane, violently ruptured (**Figure 12** and **Figure 13**). A fragment of the vessel weighing approximately 38,000 pounds flew across the Schuylkill River, and two other fragments, one weighing about 23,000 pounds and the other 15,500 pounds, landed in the PES refinery (**Figure 14**). This was also a secondary event caused by the fire. In **Figure 14**, the fragment 1 photo was taken after the fragment was recovered from the bank of the river and relocated to the PES refinery. The deformation of fragment 1 appears to be consistent with the deformation expected from its impact with the riverbank.

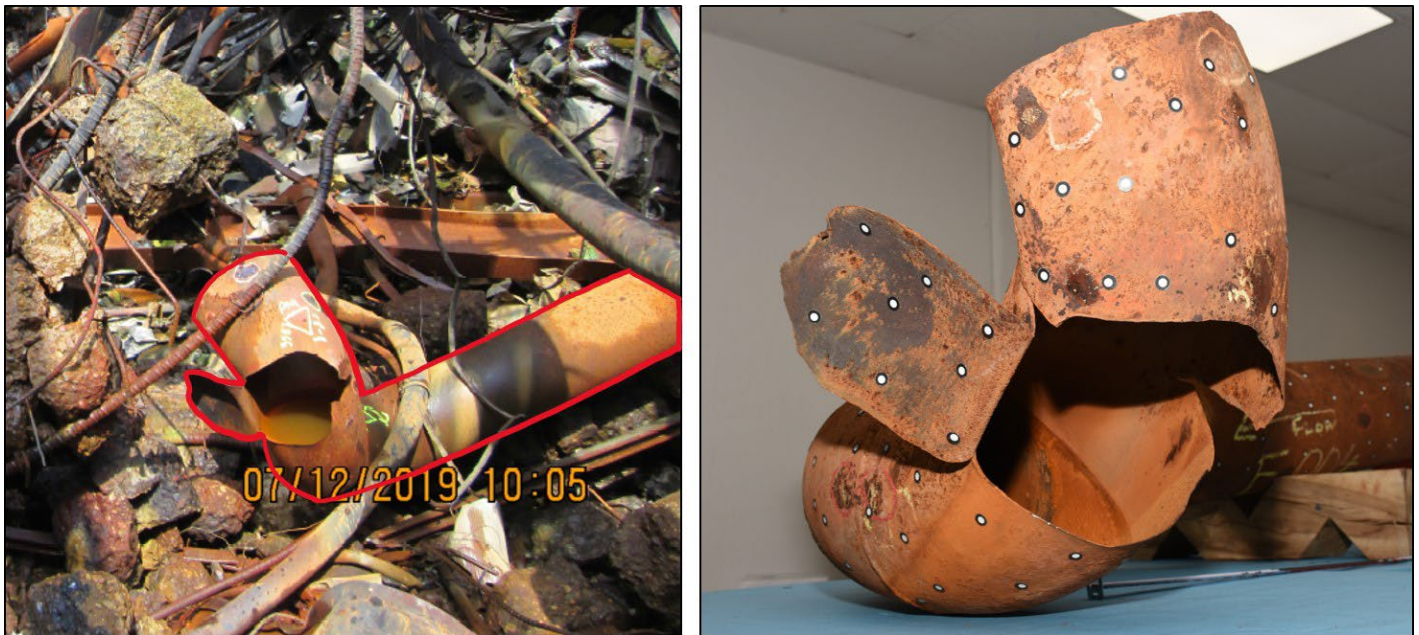
Figure 15. The ruptured elbow as found in the PES alkylation unit after the incident (left, outlined in red) and the same rupture during metallurgical testing (right).

The failed pipe elbow was found in the PES HF alkylation unit after the incident. The CSB performed metallurgical testing of the elbow. The testing found that the failed steel elbow had a high nickel and copper content.

The original thickness of the elbow and adjacent piping was 0.322 inch when it was installed in 1973. Thickness measurements of the ruptured elbow show that the piping had a minimum wall thickness of 0.011 inch,^a which is less than 7% of the PES default retirement thickness of 0.180 inch—the thickness at which PES removes and replaces piping. The ruptured elbow operated in a portion of the alkylation unit containing “trace acid” as defined by API Recommended Practice (RP) 751 *Safe Operation of Hydrofluoric Acid Alkylation Units* [17, p. 47], at temperatures of around 100°F and HF acid concentrations of around 2.5 weight percent.

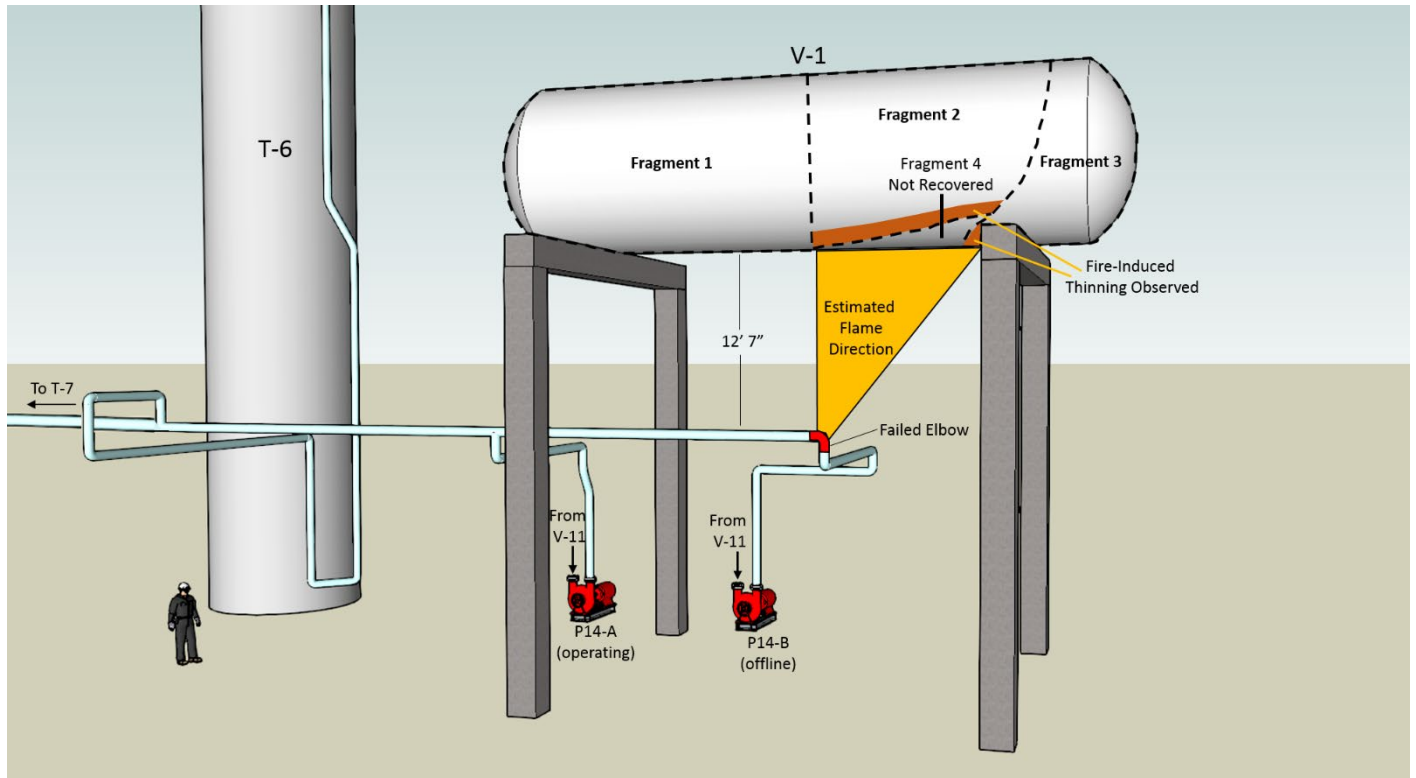
Figure 19. Locations of observed V-1 thinning, and depiction of the estimated flame size originating from the failed elbow, which impinged on the bottom of V-1. (Credit: CSB)

- **Remotely Operated Emergency Isolation Valves.** Based on the thinning of the V-1 vessel steel, the CSB concluded that a jet flame from the ruptured elbow impinged upon the bottom of the V-1 vessel, causing the steel to stretch and thin until the vessel ruptured. The large hydrocarbon sources downstream of the failed elbow could not be remotely or automatically isolated, and therefore PES was unable to stop the jet flame in a timely manner to prevent the V-1 vessel rupture. ([Section 2.3](#))

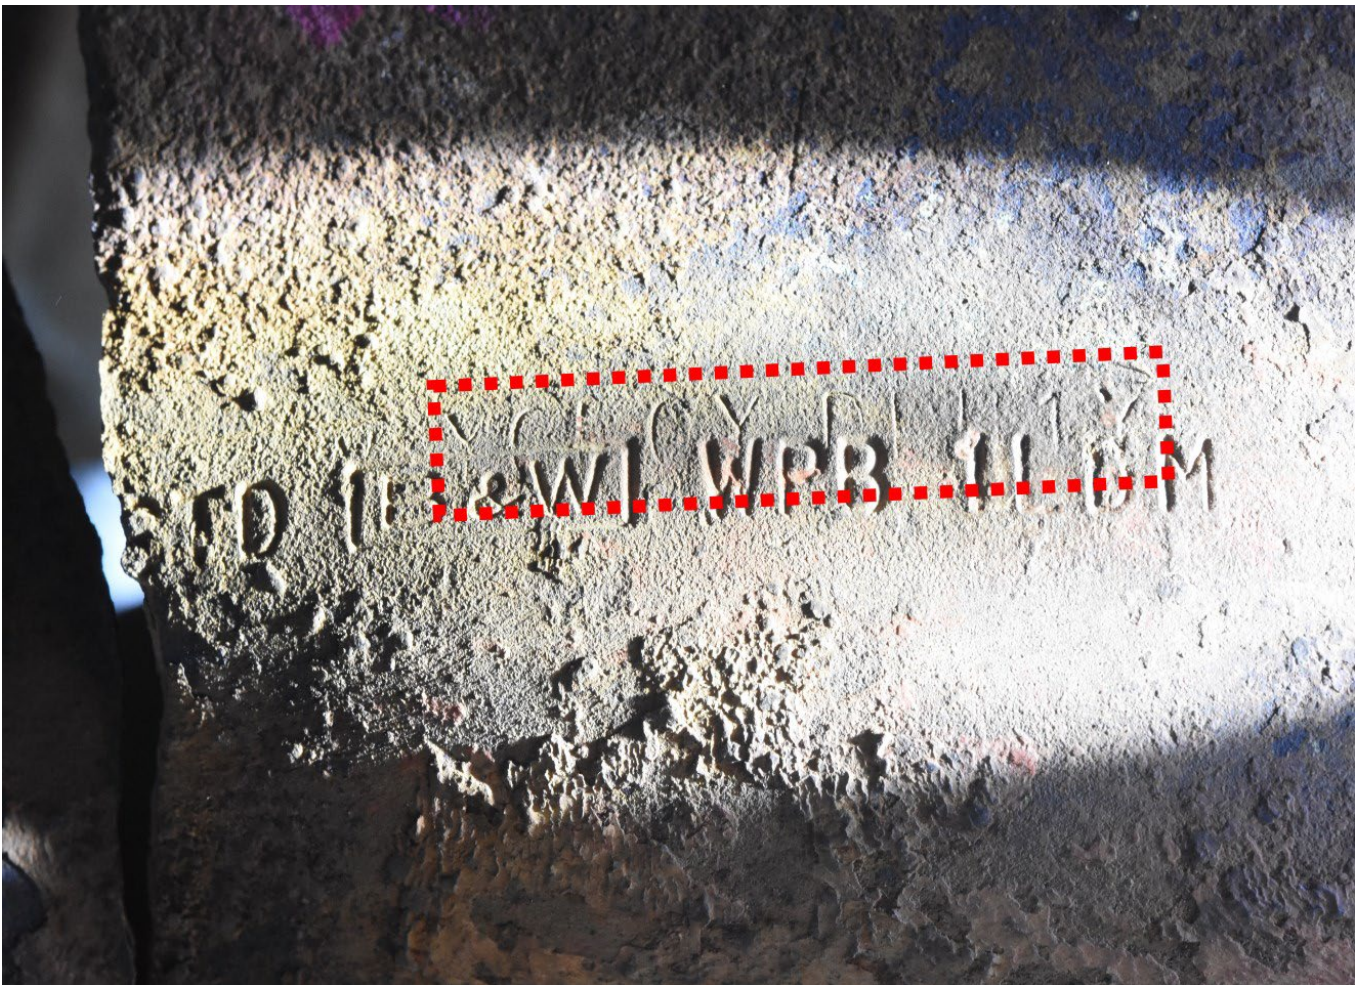
Figure 24. Photo of specification stamps on the failed elbow. “YOLOY,” highlighted with red, is faintly visible behind the “WPB” stamp.

- After the elbow’s installation around 1973, language changes to ASTM A234 were made in 1980 and 1996 that make it clear that YOLOY steel cannot be labeled or restamped as ASTM A234 WPB steel. These language changes should prevent future instances of this improper material substitution.
