# Safety Bulletin

No. 2005-04-B | October 12, 2006

*BP TEXAS CITY, TX REFINERY FIRE*

## POSITIVE MATERIAL VERIFICATION: PREVENT ERRORS DURING ALLOY STEEL SYSTEMS MAINTENANCE

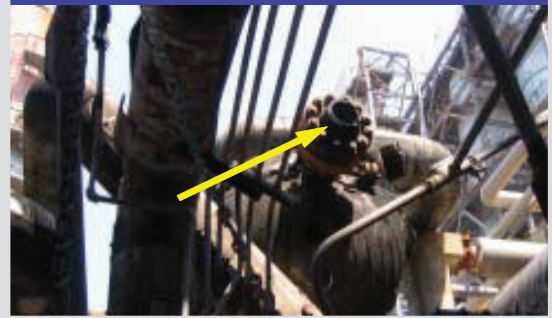
The RHU incident investigation determined that an 8-inch diameter carbon steel elbow inadvertently installed in a high-pressure, high-temperature hydrogen line ruptured after operating for only 3 months. The escaping hydrogen gas from the ruptured elbow quickly ignited.

This incident occurred after a maintenance contractor accidentally switched a carbon steel elbow with an alloy steel elbow during a scheduled heat exchanger overhaul in February 2005. The alloy steel elbow was resistant to high temperature hydrogen attack (HTHA) but the carbon steel elbow was not. Metallurgical analyses of the failed elbow concluded that HTHA severely weakened the carbon steel elbow.

Figure 1. Carbon steel RHU heat exchanger outlet pipe (arrow) ruptured after operating only 3 months in high-temperature hydrogen service.

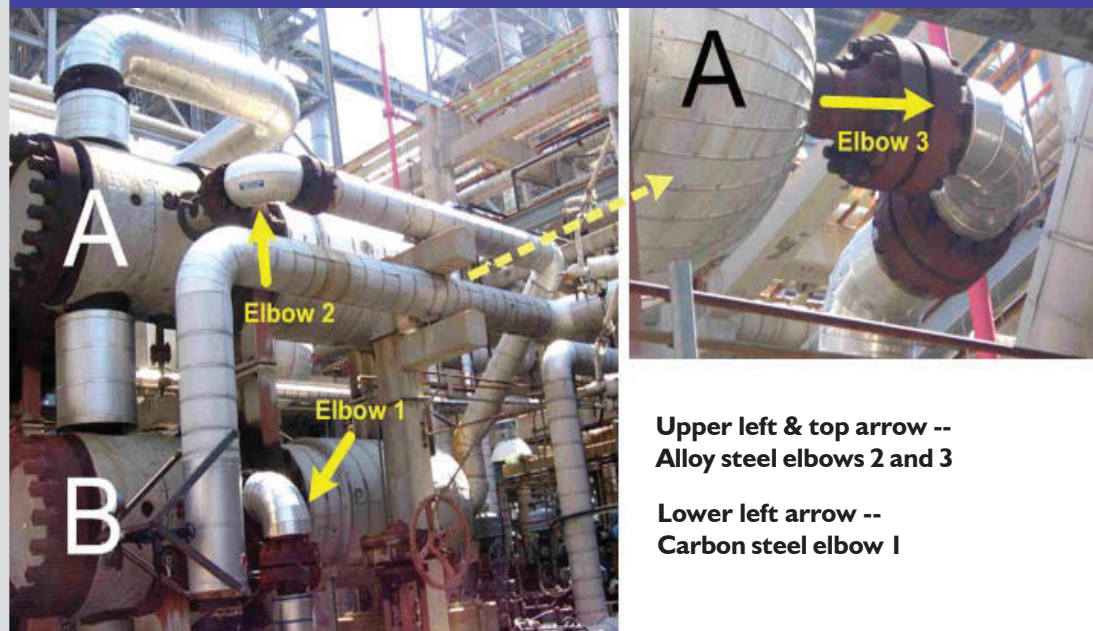
Figure 2. Dimensionally identical piping elbows on RHU heat exchangers A and B.

Construction costs may have been saved by making elbows 1, 2, and 3 on each heat exchanger assembly dimensionally identical, as doing so requires fewer pipe assembly fabrication drawings and weld joints in each assembly. Because the elbows are dimensionally identical, the piping contractor had to ensure that the low alloy steel elbows 2 and 3 were installed in the correct locations when the RHU was built. Had the elbow 1 design

dimensions been different, elbow 1 would not have been interchangeable with elbow 2 or 3 (see Figure 2).

Because of this component interchangeability, any heat exchanger piping disassembly/reassembly for maintenance or repair requires the maintenance crew to be careful to install each elbow in the correct location. Because carbon steel and low alloy steel are visually indistinguishable, special test equipment<sup>6</sup> is needed to distinguish the two low alloy steel elbows from the carbon steel elbow. Otherwise, to prevent switching elbow 2 or 3 with incompatible carbon steel elbow 1, the crew must clearly label or mark each elbow before removing them, then confirm that each has been reinstalled in the correct location.

- Piping systems can be designed such that incompatible components cannot be interchanged. All three elbows could have been made from the same low alloy steel material, even though this would have meant additional material expense. Alternatively, elbow 1 could have been dimensionally different from elbow 2 and 3, although this would have meant additional construction costs.

Designers should consider the entire process system life cycle, including planned maintenance, to avoid piping configurations that allow critical alloy piping components to be interchanged with non-compatible piping components.

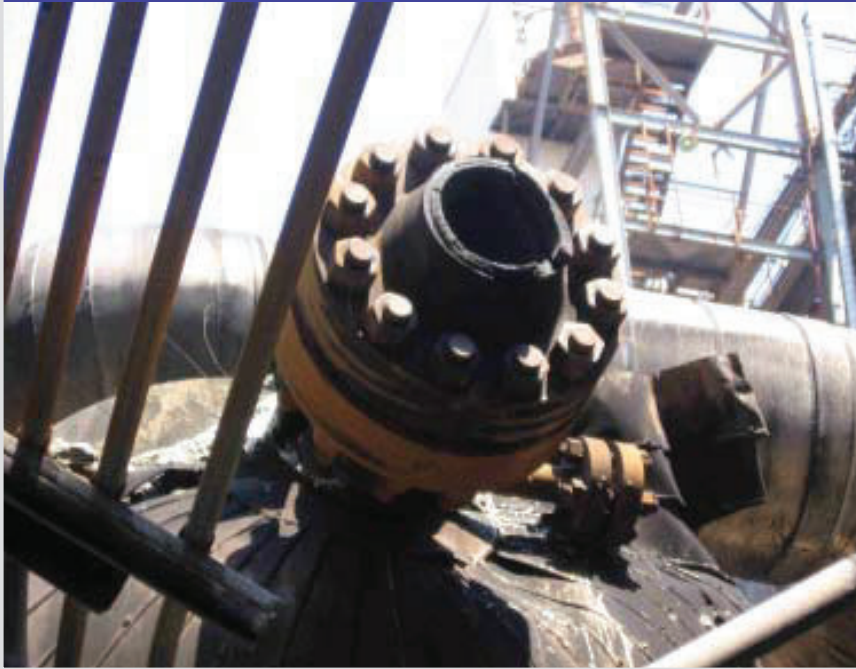
BP personnel examined the extensively damaged unit and determined that an 8-inch diameter pipe elbow on an RHU heat exchanger hydrogen gas outlet pipe ruptured (Figure 3). The BP investigation team recovered the elbow segments that remained attached to the pipe and three pieces found in the debris (Figure 4).

Figure 3. Ruptured 8-inch pipe elbow on heat exchanger A outlet.

The elbow segments recovered from the damaged unit were examined to identify the steel and the failure mechanism. Chemical analysis and microscopic examination determined that the elbow was made from carbon steel. Microscopic examination also revealed that the segments were severely decarburized and had deep fissures on the inside surface (see Figure 4). The decarburized steel and severe fissuring confirmed that HTHA caused the catastrophic elbow failure.

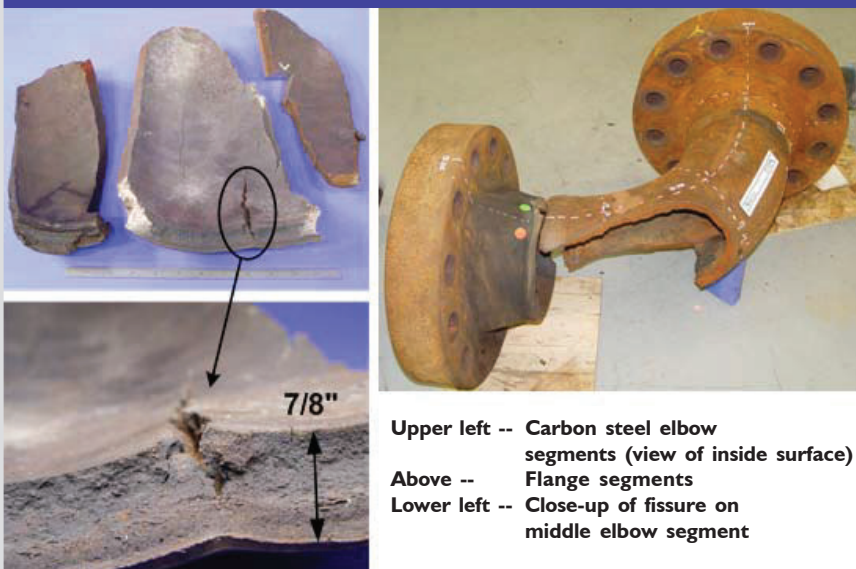
Figure 4. Ruptured 8-inch carbon steel pipe elbow pieces recovered after the fire

Detailed metallurgical examinations and micro-hardness testing quantified the extent of hydrogen damage to estimate the total time the elbow could have been in the high-temperature, high-pressure hydrogen service before it failed. The results, compared to existing experimental data and empirical service life predictions, concluded that the elbow failed after being in service for fewer than 3000 hours.<sup>4</sup>

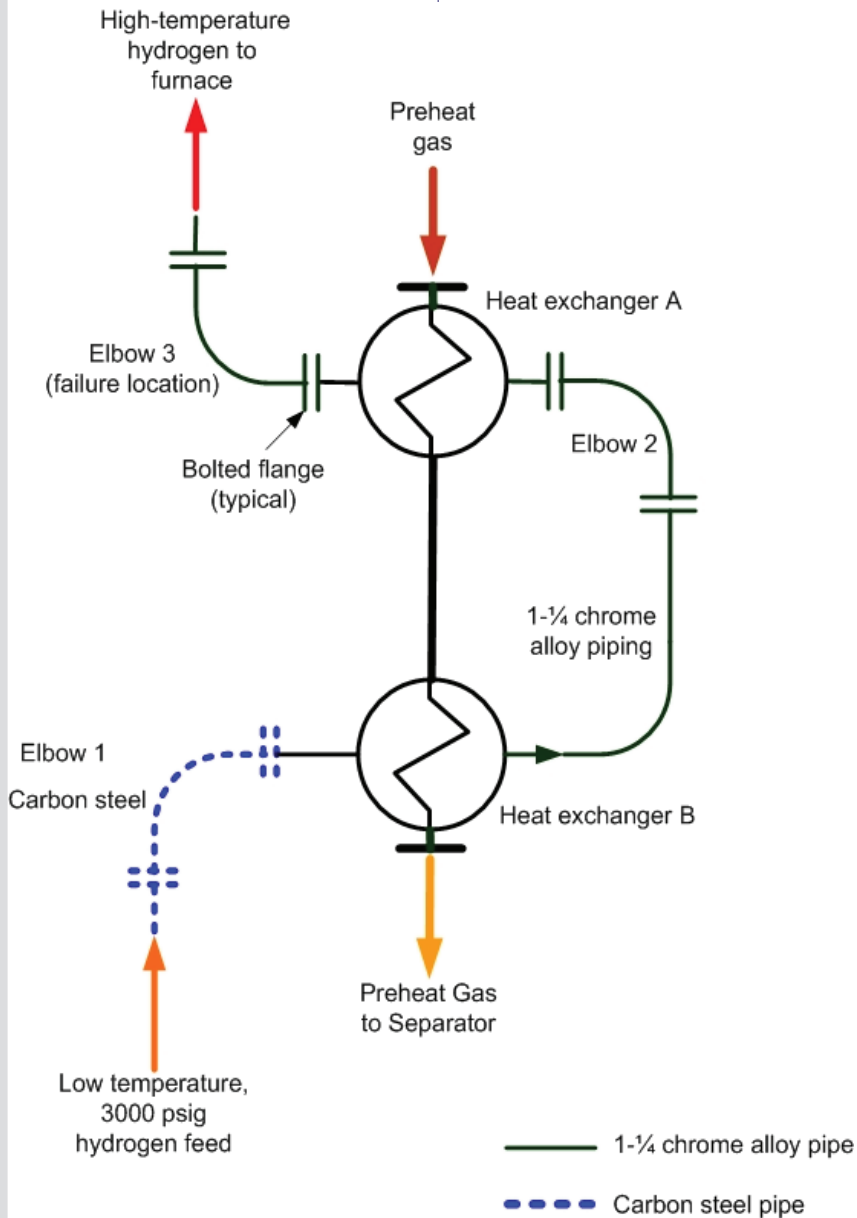
Designed in the early 1980s, the RHU has three parallel operating systems. Each system contains a heat exchanger assembly that consists of two series-connected heat exchangers to preheat the hydrogen. For high-temperature hydrogen gas service piping to resist HTHA, the piping design specification requires 1.25% chrome “low alloy” steel, but for piping in hydrogen service at low temperatures, or those below 450°F, non-HTHA resistant carbon steel is specified, as using this material minimizes material cost.<sup>5</sup> Because heat exchanger B inlet piping and components operate at temperatures below 450°F, they are carbon steel; heat exchanger B outlet and all downstream piping and components (Figure 5) are required to be low alloy steel because they operate at temperatures above 500°F.

Figure 5. RHU hydrogen heat exchanger piping material requirements.

Metallurgical analyses after the incident concluded that the carbon steel elbow could withstand the high-temperature, high-pressure service for only a few thousand hours. X-ray fluorescence testing confirmed that an alloy steel elbow was installed in the carbon steel elbow position on the heat exchanger B inlet. Therefore, the CSB concluded that carbon steel elbow

1 was inadvertently switched with alloy steel elbow 3 when the maintenance contractor reassembled the piping during the winter 2005 heat exchanger overhaul.

- BP did not alert the maintenance contractor that two of the three elbows were alloy steel piping components and must not be interchanged with the carbon steel elbow.
- The maintenance contractor, JV Industrial Companies, did not adequately control the disassembly, storage, and reassembly of the piping components to ensure that all the piping components were returned to their original installed locations.
- The maintenance contractor inadvertently switched carbon steel elbow 1 (Figures 2 and 5) with the alloy steel elbow 3 during the January 2005 RHU heat exchanger overhaul.

At a minimum, piping components and their respective locations should be tagged or marked before removal, and the correct installed location is verified after reinstallation.

Revise the maintenance quality control program to require positive material identification testing or another suitable material verification process for all critical service alloy steel piping components removed and reinstalled during maintenance, and inform work crews of special material handling precautions.

Develop/update the written piping component installation quality control procedure to require positive material identification testing or other suitable verification or tracking process for all alloy steel piping components removed during maintenance.
