# Molten Sodium Hydroxide Eruption at TS USA Liquid Nitriding Facility

Chattanooga, Tennessee | Incident Date: May 30, 2024 | No. 2024-01-I-TN

## **Investigation Update**

September 2024

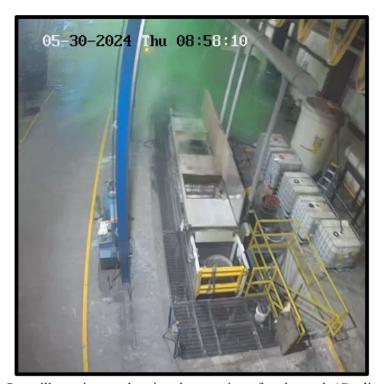
- Approximately 5 minutes later, at 8:46 a.m., the plant manager discussed the plan to rework the rollers with the line operator based on guidance from the process engineer. The operator was instructed to reintroduce the rollers back into the oxidizing bath without preheating.
- At 8:51 a.m., the operator lowered the rollers into the oxidizing bath. The rollers were submerged by 8:54 a.m.
- At 8:58 a.m., chemicals<sup>a</sup> erupted from the oxidizing bath (**Figure 2**), releasing molten salt into the processing area.

Figure 2. Surveillance image showing the eruption of molten salt (Credit: TS USA)

• The released molten salt engulfed and fatally injured one employee. b The ejected molten salt contacted various combustible materials, triggering multiple fires inside the building due to the molten salt exceeding the autoignition temperature of the ignited materials.

<sup>&</sup>lt;sup>a</sup> While sodium nitrate and sodium hydroxide are crystalline, white solids at room temperature, the molten mixture is bright green.
