DATE: JANUARY 14, 2025

INCIDENT REPORTS

EVENTS REPORTED TO THE CSB UNDER THE ACCIDENTAL RELEASE REPORTING RULE

U.S. Chemical Safety and
Hazard Investigation Board

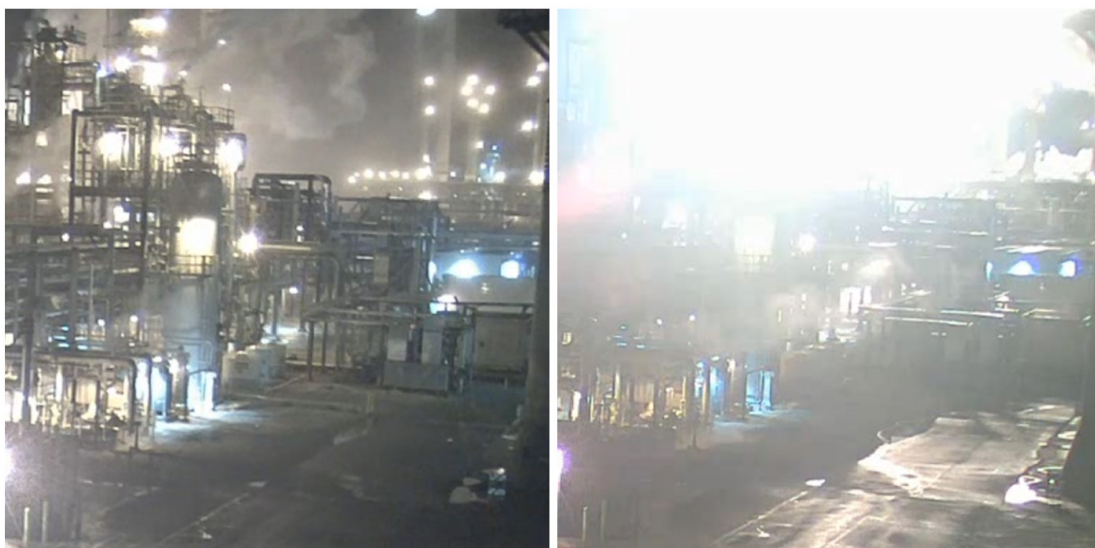
On April 10, 2020, at 12:46 a.m., a mixture of hydrogen and hydrocarbon gas was accidentally released within the Hydrocracker unit of the Valero Meraux Refinery (“Valero”) in Meraux, Louisiana. The flammable gas formed a vapor cloud that ignited, resulting in an explosion and fire (**Figure 1**) that seriously injured one Valero operator and caused approximately \$5.15 million in property damage.

Figure 1. Surveillance camera images before (left) and during (right) the fire at Valero Meraux Refinery. (Credit: Valero Meraux Refinery)

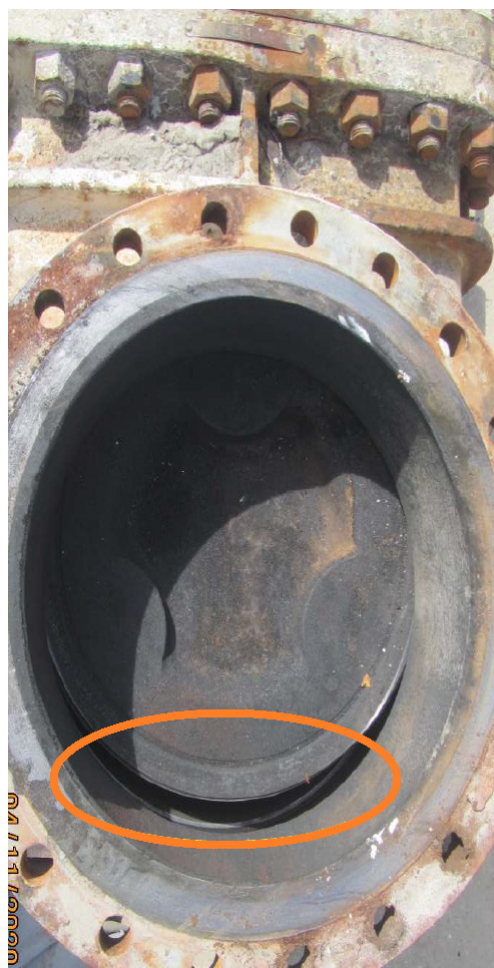
The hazard of closing the outlet valve instead of closing one of the inlet valves was not recognized. Although the two 6-inch inlet valves were designed for high-pressure conditions—2,470 pounds per square inch (psi), the 20-inch outlet valve to the flare system was rated for just 275 psi. Closing the 20-inch outlet valve would subject this valve to about 2,100 psi of pressure from the flammable vapor flowing from the cold separator, much greater than the valve's 275 psi pressure rating.

When the operations team had the outlet valve about 90 percent closed (Figure 2), the valve failed—releasing a high-pressure mixture of hydrogen and hydrocarbon vapor into the surrounding air. The flammable gas formed a vapor cloud, which ignited resulting in the explosion and fire.

Based on Valero's investigation, the CSB determined that the probable cause of the accidental release, explosion, and fire was the closure of the 20-inch manual isolation outlet valve (located downstream of the emergency pressure-relief valve) instead of one of the two inlet (upstream) 6-inch isolation valves that were rated for the high-pressure condition.

Figure 2. Nearly closed outlet valve. (Credit: Valero Meraux Refinery, modified by CSB)

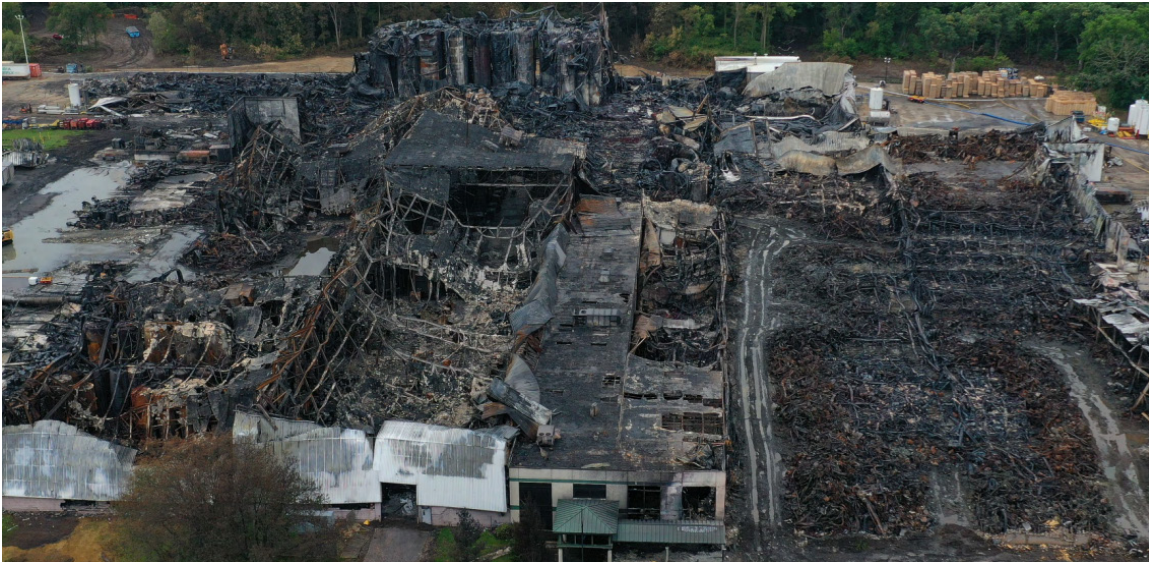
On June 14, 2021, at approximately 6:50 a.m., an accidental release of mineral oil occurred at Lubrizol's Chemtool facility in Rockton, Illinois. The mineral oil ignited and caused a fire. The event resulted in \$380 million in property damage and the permanent closure of the Chemtool facility (**Figure 1**). Before the incident, Chemtool employed approximately 200 people.

Figure 1. Damages After the Fire at Chemtool. (Credit: Chemtool)

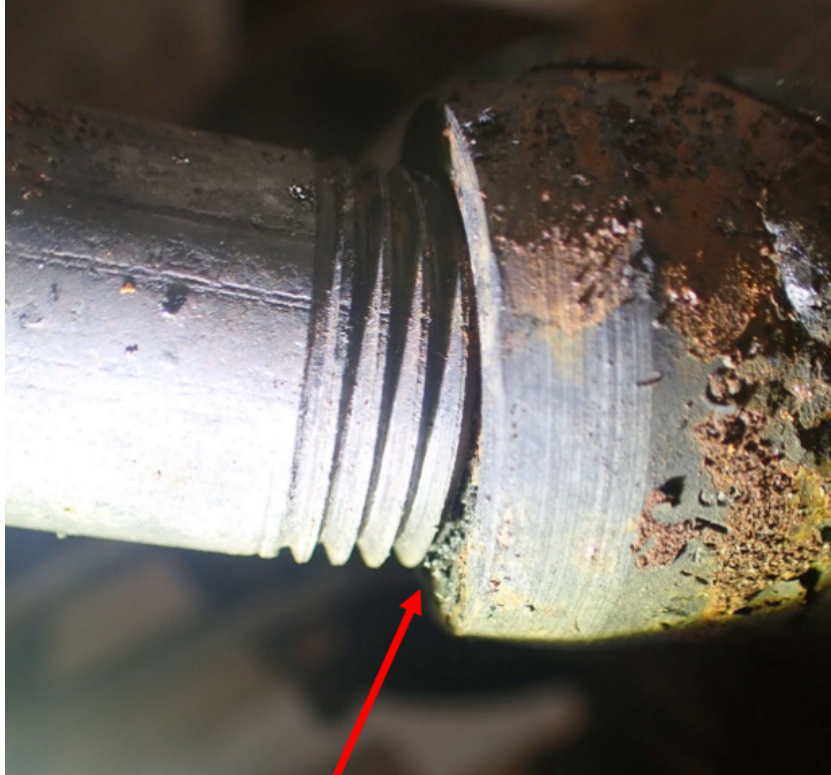
After the guardrail impacted the piping, a leak formed at the ½-inch threaded connection to the four-inch piping (**Figure 2**). The hot mineral oil, which was over 500 degrees Fahrenheit, was released as an aerosol. The mineral oil formed a white cloud and created the electrostatic conditions that most likely ignited the mineral oil.

Figure 2. Damaged Mineral Oil Piping. (Credit: Chemtool)

Based on Chemtool's investigation, the CSB determined that the probable cause of the mineral oil release was piping damage that resulted from force applied by the scissor lift. The flammable mineral oil was most likely ignited by static electricity. The hot oil system did not allow for the remote isolation of the damaged piping. Had Chemtool been able to stop the flow of mineral oil through remote isolation from a safe location, the incident could have been less severe.

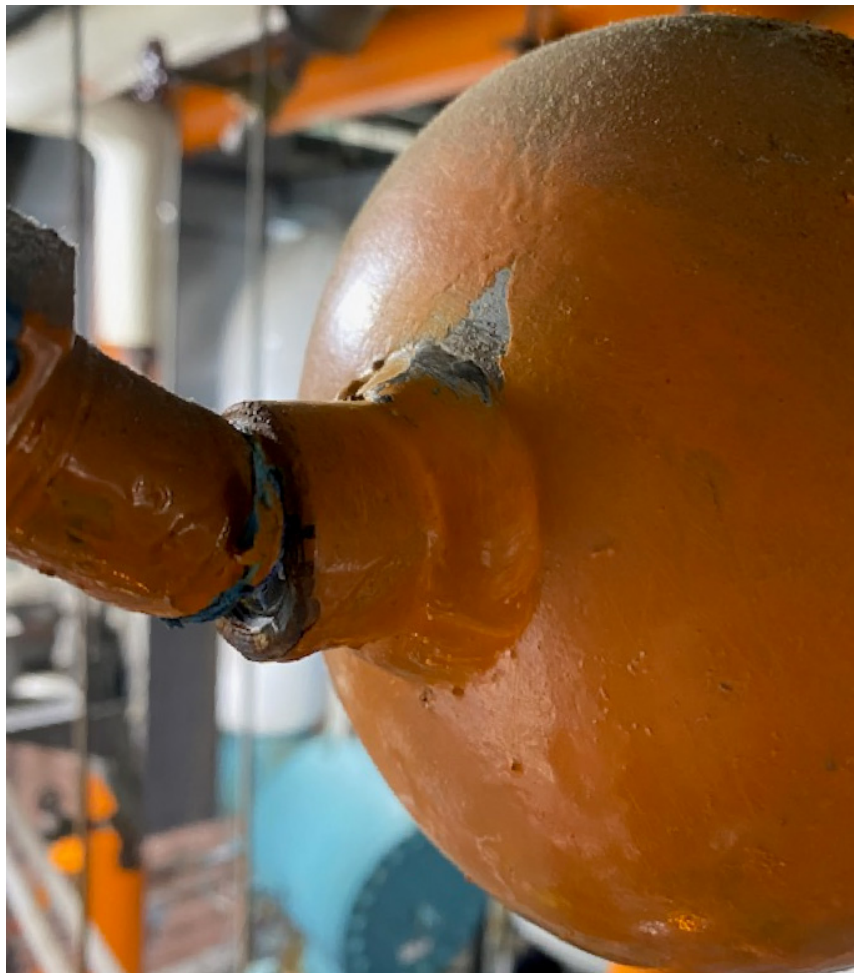
HMF had hired a contractor to install an electrical (ceiling-mounted) heater to replace an existing leaking steam heater that provided comfort heating inside the facility’s ammonia refrigeration room. The work plan included using a scissor lift to access the installation area. At the time of the incident, two contract workers were on the scissor lift to install the electric heater. While the scissor lift was in an elevated position, the lift was moved forward and then upward, impacting an ammonia refrigeration system valve (Figure 1).

Figure 1. Damaged Ammonia Piping. (Credit: HMF)

After the scissor lift impacted the piping, a leak formed at the partially severed ½-inch threaded piping connection to the larger ammonia system piping. The anhydrous ammonia was released as a vapor and engulfed the workers. Contractor 1, who was directly in front of the damaged piping, was unable to escape and was fatally injured by the release. Contractor 2, who was further away from the point of release, jumped over the lift's guardrail to escape from the area.

Based on HMF's investigation, the CSB determined that the probable cause of the anhydrous ammonia release was piping damage caused by the force applied by the scissor lift.

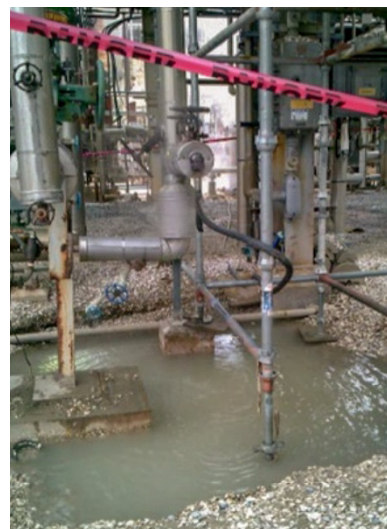
At 10:46 p.m., the control board operator observed a low boiler feedwater pressure alarm and requested an outside operator to investigate. Personnel identified that the boiler feedwater piping was the source of the low-pressure alarm and, realizing there was a leak, closed an upstream valve to stop the leak. Dow reported that 670 gallons of hot water were released. At about 11:45 p.m., an outside operator attempted to close the two open bleed valves and inadvertently stepped into a pool of the hot boiler feedwater that had accumulated in a depression (**Figure 1**). The high-pressure boiler feedwater release may have created or enlarged this hole. The operator was seriously injured when his lower leg was submerged in the hot water above the top of his rubber boot, and the hot water contacted his lower leg and foot.

Figure 1. Pool of Hot Water.
(Credit: Dow)

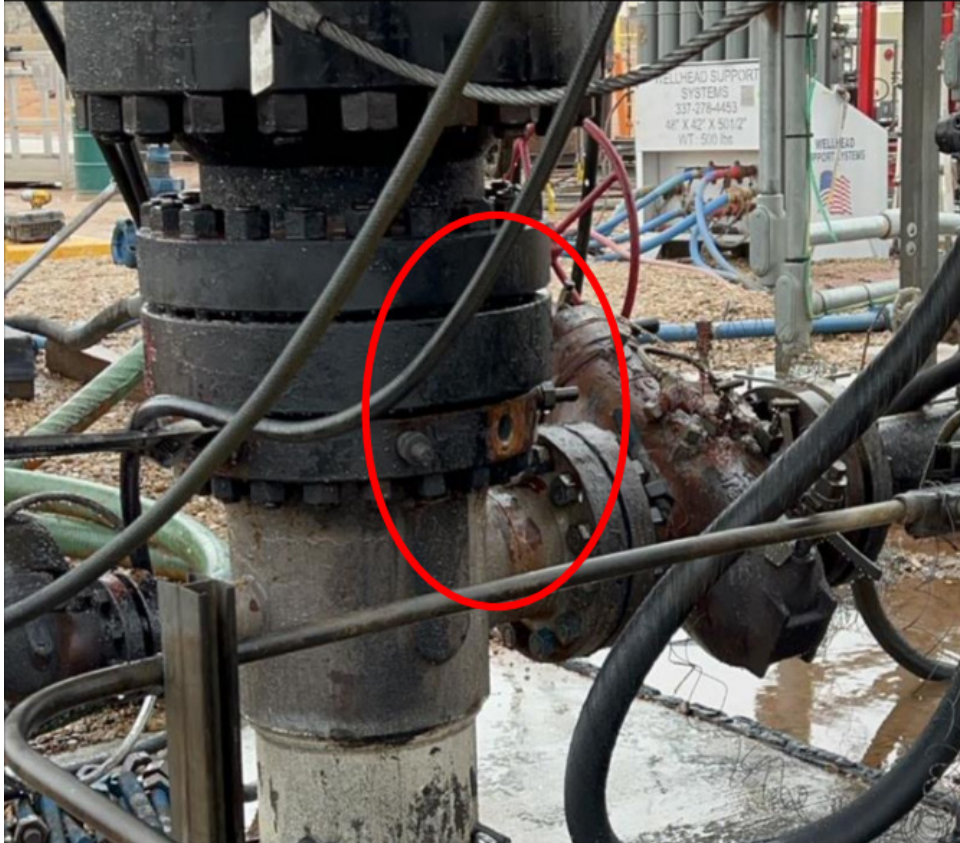
Figure 2. Assembly where lockdown screw was removed. (Credit: Phillips 66)

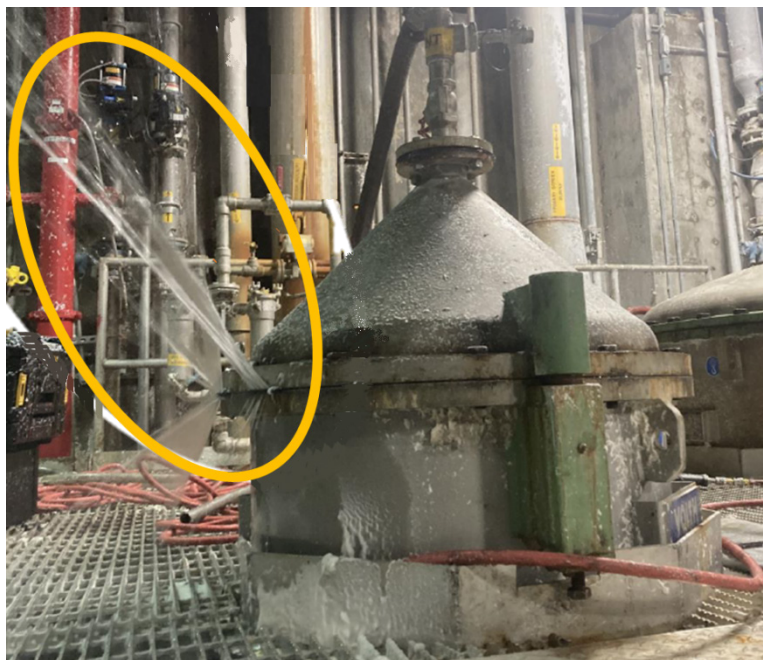
Figure 1. Hot water and pulp sprayed out of the pulp screen.
(Credit: Georgia-Pacific)

After the incident, Georgia-Pacific added safety interlocks to shut down this equipment automatically during certain abnormal conditions.

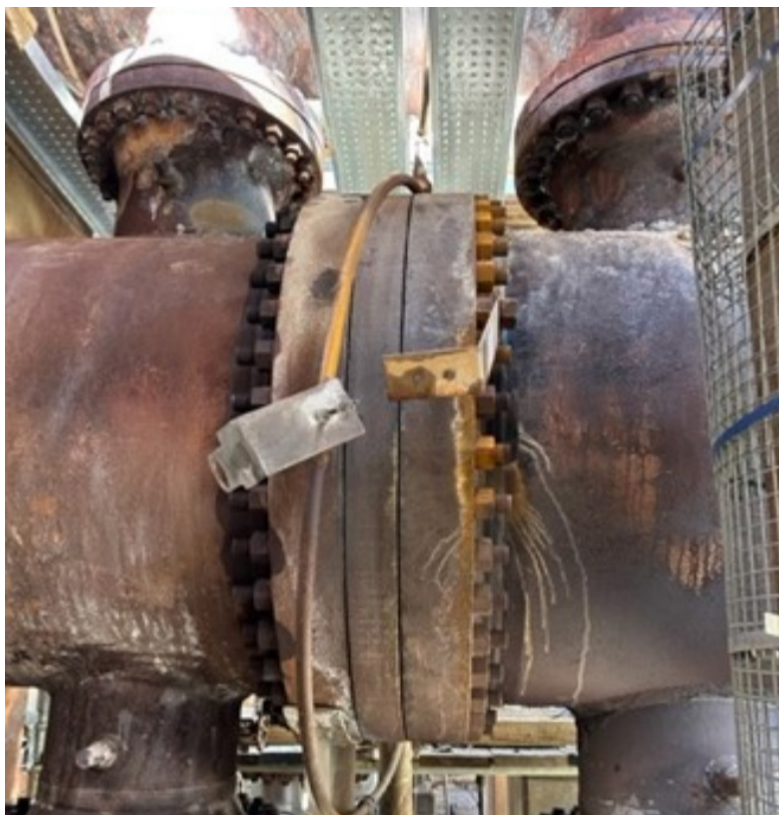
The hydrogen release originated from the flange between the heat exchanger channel and shell and occurred during unit startup (**Figure 1**). The heat exchanger was assembled in 2013 and had undergone 43 thermal cycles. During that time, the bolts had relaxed (a normal event) but had relaxed to the point that the flange could no longer contain the hydrogen within the heat exchanger. CITGO’s investigation found that the bolt torque value used to assemble the heat exchanger in 2013 was too low and should have been much higher to prevent leakage.

Figure 1. The Flange Where the Leak Occurred. (Credit: CITGO)

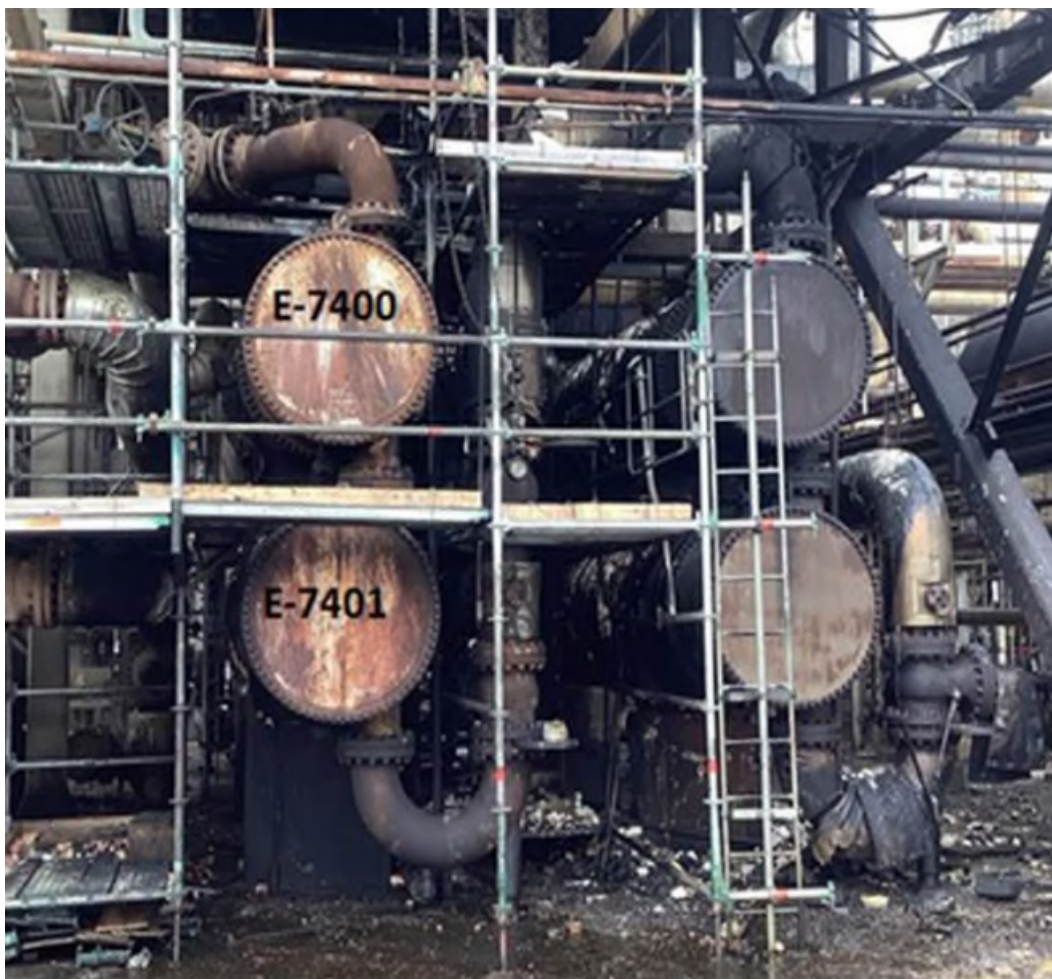
On February 23, 2023, at 8:15 p.m., an accidental release of approximately 164 pounds of hydrocarbons (pentane and heavier hydrocarbons) occurred at the PEMEX Deer Park Refinery (“Pemex”) in Deer Park, Texas. Deer Park Refining Limited Partnership operates this Pemex refinery. The hydrocarbons were released from an open bleed valve on a crude unit heat exchanger (E-7400) during startup (**Figure 1**). The hot hydrocarbons ignited (autoignition), causing a fire that damaged nearby equipment. Pemex estimated the property damage from the incident to be \$2.3 million.

Figure 1. Heat exchangers after the incident. (Credit: Pemex)

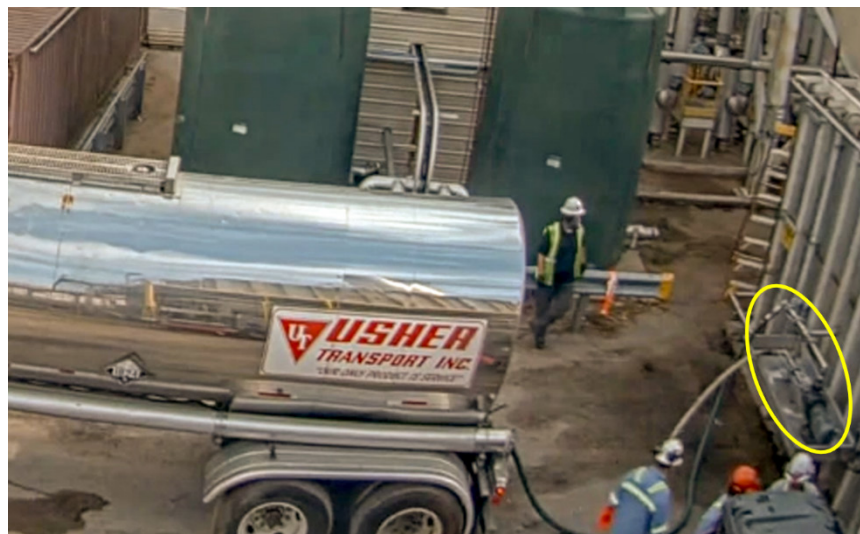
Before disassembling the pump, it was decided to flush it out with water from a fire hose (**Figure 1**). This action was taken to prevent employees from getting the caustic solution on their hands when the pump was disassembled. An employee connected a fire hose to the pump and partially opened the valve. The pump could not handle the pressure supplied by the firewater, and the plastic pump casing cracked. Caustic solution and water sprayed out of the pump, seriously injuring one employee.

Figure 1. Caustic Unloading Pump (yellow oval). (Credit: Georgia-Pacific)

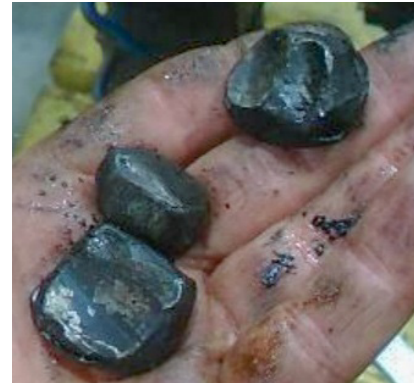
During the unit startup approximately five days before the incident, the pump (a centrifugal pump) had operated with low suction (inlet) pressure for nearly two hours due to a low liquid level in the upstream equipment. The low suction pressure caused the pump to cavitate, which vibrated the pump and damaged the pump’s bearings (**Figure 1**). Five days later, on March 14, the damaged bearings and the resulting stress on the pump’s mechanical seal caused the seal to fail. The hot hydrocarbons within the pump were released into the atmosphere and ignited, causing a fire. The material was released at 590 degrees Fahrenheit (°F) and had an autoignition temperature of 484 °F.

Figure 1. Damaged Pump Bearings. (Credit: Pemex)

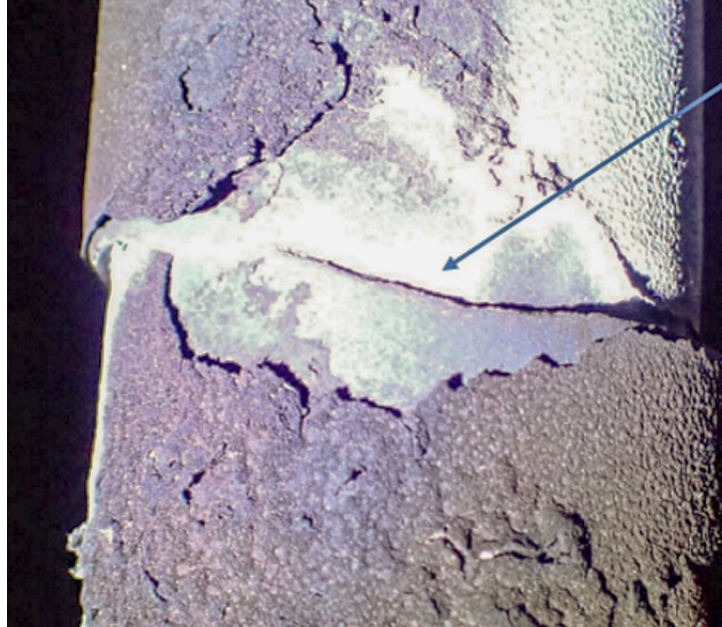
FHR determined that the accidental release resulted from a ruptured tube within the waste heat boiler of the sulfur recovery reaction furnace (Figure 2). The tube rupture was caused by a damage mechanism known as sulfidation corrosion (also known as high-temperature sulfidic corrosion). Under certain temperature conditions, sulfidation corrosion causes thinning in iron-containing materials over time due to a reaction between sulfur compounds and iron.

Figure 2: Ruptured Tube. (Credit: FHR)

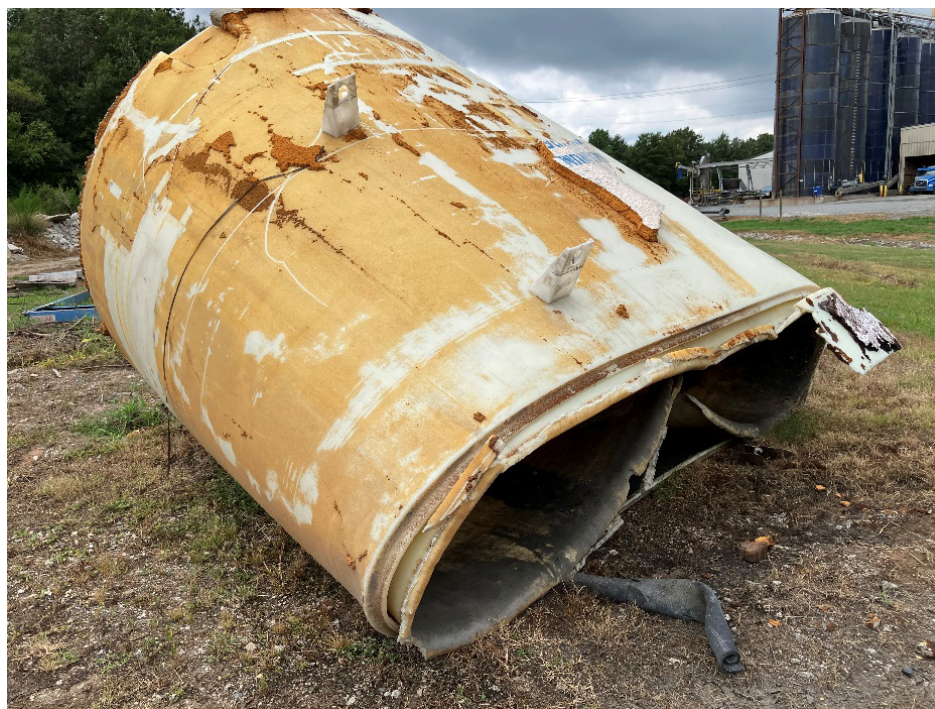
Darling’s investigation appeared to focus on the incorrect reaction rather than a reaction scenario consistent with the available evidence. Darling’s research materials pointed to the reaction between sulfuric acid and aluminum metal that generated hydrogen gas. The company concluded that the hydrogen gas was released at its autoignition temperature (over 1,000 degrees Fahrenheit (°F)) and ignited, triggering an explosion. Post-incident photographs of the damaged tank do not appear to support a scenario where the internal tank temperature reached 1,000 °F, however (**Figure 1**). The melting temperature of the polyethylene is approximately 260 °F. Therefore, the company’s reaction scenario appears inconsistent with the available evidence.

Figure 1. Ruptured Polyethylene Tank at Darling. (Credit: Darling)
