## Investigation Update

February 2025

This document provides an update on the CSB’s investigation of the November 12, 2024, incident at the Givaudan Sense Colour (“Givaudan”) facility in Louisville, Kentucky.

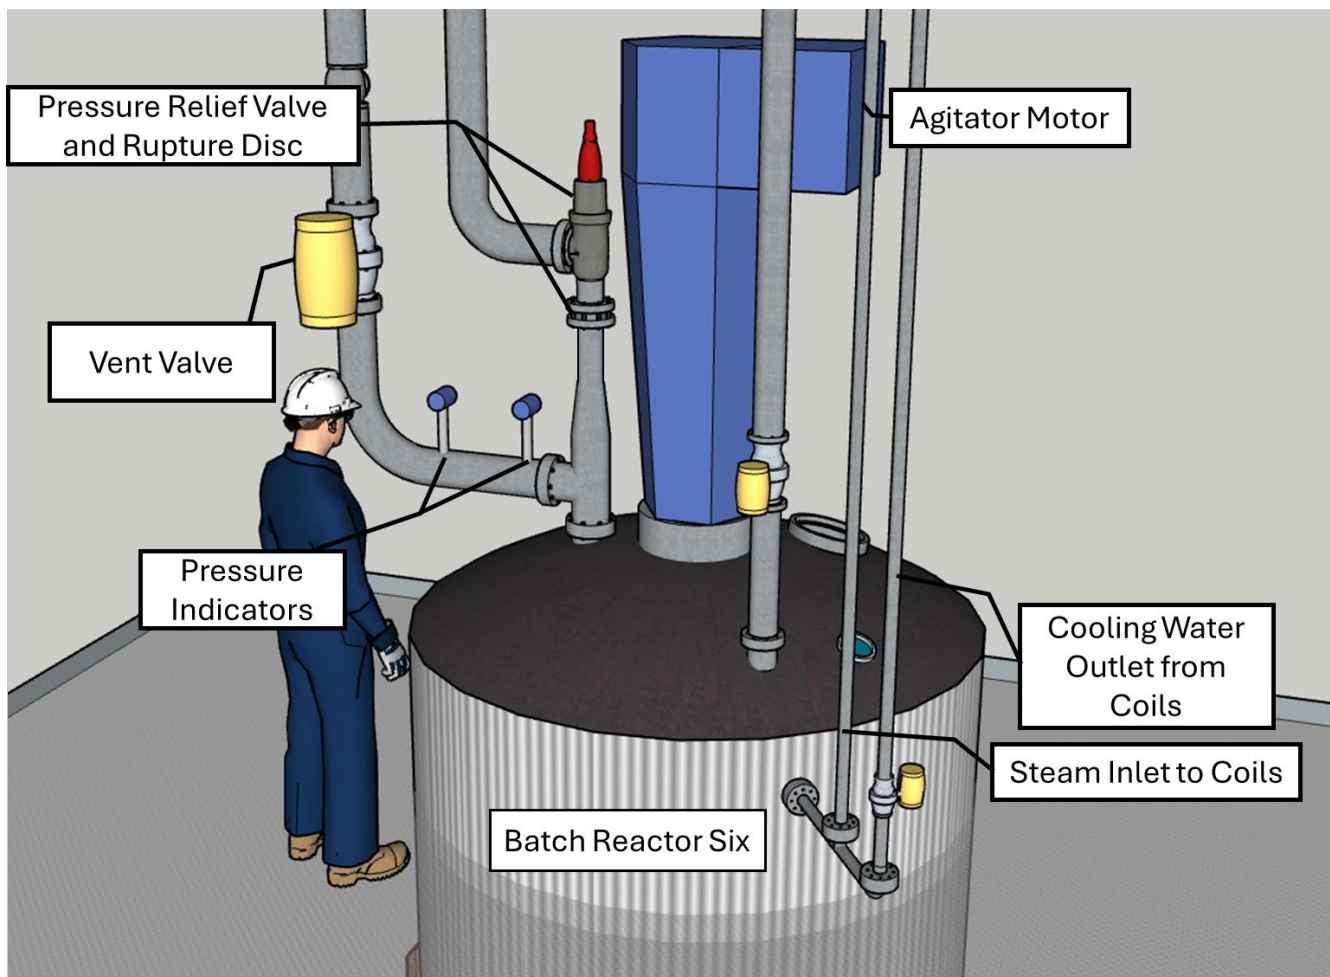
- The Givaudan facility operated six different batch reactors inside its manufacturing building to produce caramel coloring. On November 12, 2024, Givaudan was producing caramel coloring in Batch Reactor Six. A simplified schematic of the top portion of Batch Reactor Six is shown in **Figure 2**. Batch Reactor Six was equipped with a vent valve that could automatically open and close to control the batch reactor pressure. The batch reactor temperature was controlled by either steam or cooling water flowing through coils mounted to the inside wall of the reactor. The contents of the batch reactor could be mixed by an agitator. The batch reactor was also equipped with a rupture disc with a burst pressure of 75 pounds per square inch gauge (psig) and a pressure relief valve with a 75 psig set pressure. Design documents indicate that Batch Reactor Six was a 2,500-gallon vessel constructed of 316 stainless steel with a maximum allowable working pressure of 75 psig and a maximum allowable working temperature of 355 degrees Fahrenheit (°F).

Figure 2. Depiction of the top portion of Batch Reactor Six. (Credit: CSB)

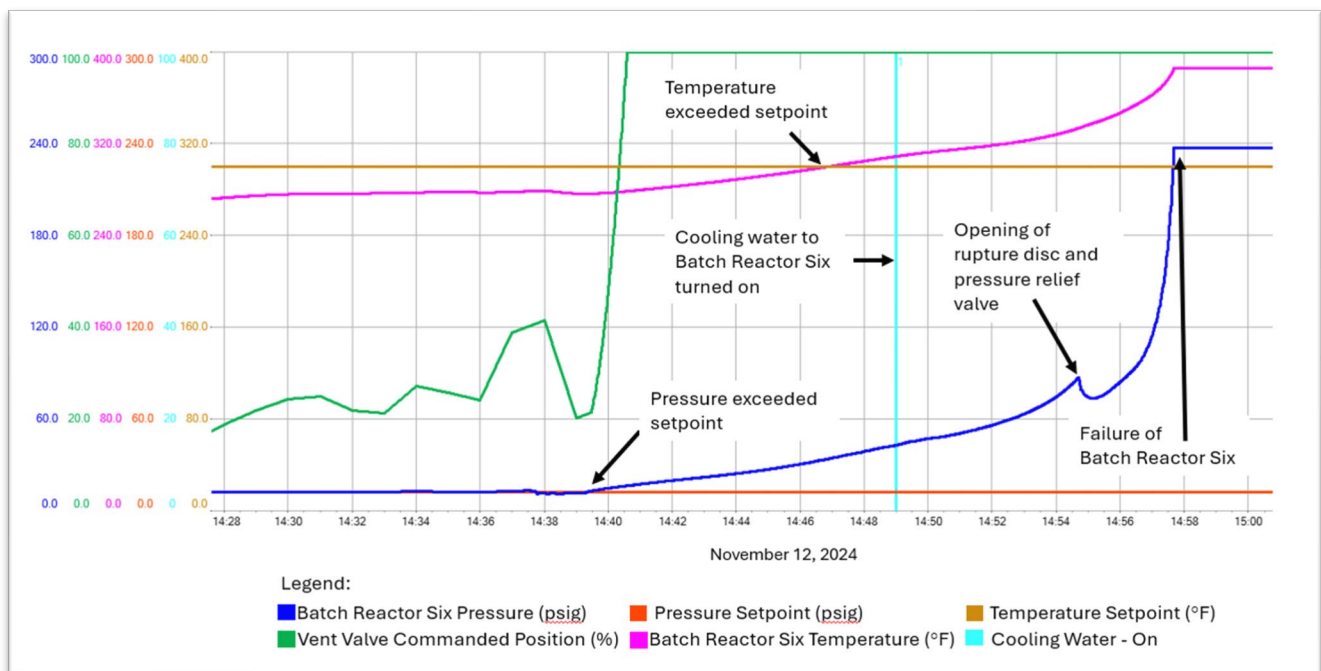
- At 2:39 p.m., the batch reactor pressure began to exceed the 12 psig setpoint (**Figure 3**). The process data indicates that the vent valve was commanded to fully open at 2:40 p.m. The purpose of this action was to reduce the batch reactor pressure, but the pressure continued to rise even after the valve was commanded to fully open, as the valve might not have physically opened (see Additional Information below). At 2:47 p.m., the batch reactor temperature exceeded the 300°F setpoint. Operators observed the abnormal pressure and temperature increases, and cooling water was introduced to the coils at 2:49 p.m. The temperature and pressure continued to rise even after the cooling water system was activated.

- Process data indicates the pressure relief valve opened at 2:54 p.m., and the pressure temporarily reduced before it again began to rise (**Figure 3**). Both the temperature and pressure continued to rise until Batch Reactor Six catastrophically ruptured at 2:57 p.m. The maximum temperature observed before rupture was 385°F, thirty degrees above the maximum allowable working temperature of 355°F. The maximum pressure observed before rupture was 237 psig, more than three times the maximum allowable working pressure of 75 psig.

**Figure 3.** Process data from Batch Reactor Six leading up to the explosion. (Credit: CSB)

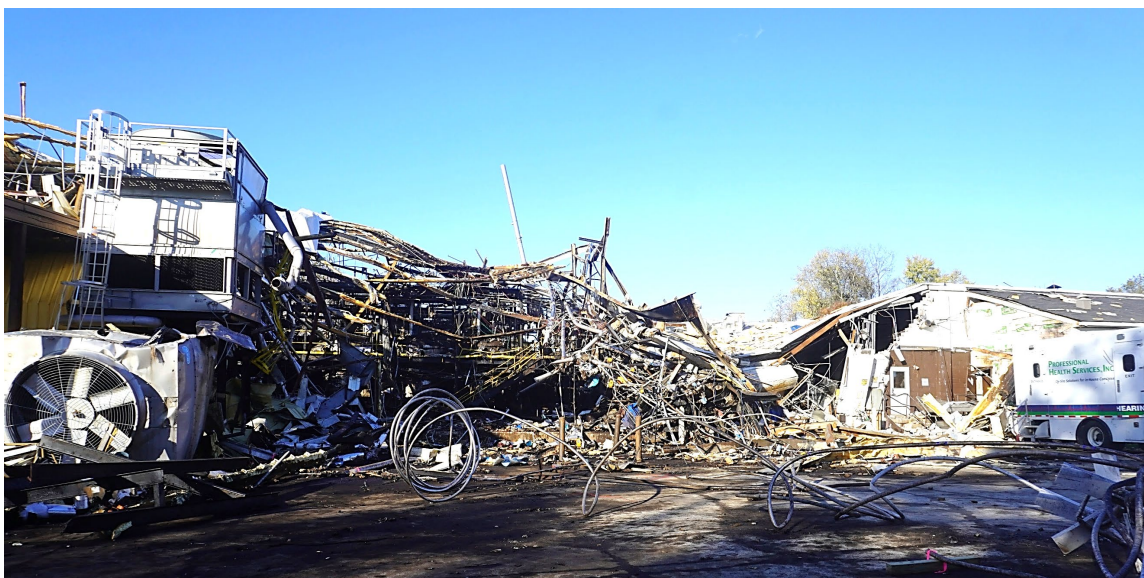
- The facility was severely damaged by the explosion (**Figure 5**). Debris from the explosion of Batch Reactor Six was ejected outside the fence line and into the nearby neighborhood. Debris that was found in the neighborhood included large pieces of Batch Reactor Six (**Figure 6**), pipe fragments, instrumentation, valves, and other building materials. Fragments of the exploded vessel flew as far as about 400 feet from the facility.

**Figure 5.** Property damage at the Givaudan facility in Louisville, Kentucky. (Credit: CSB)

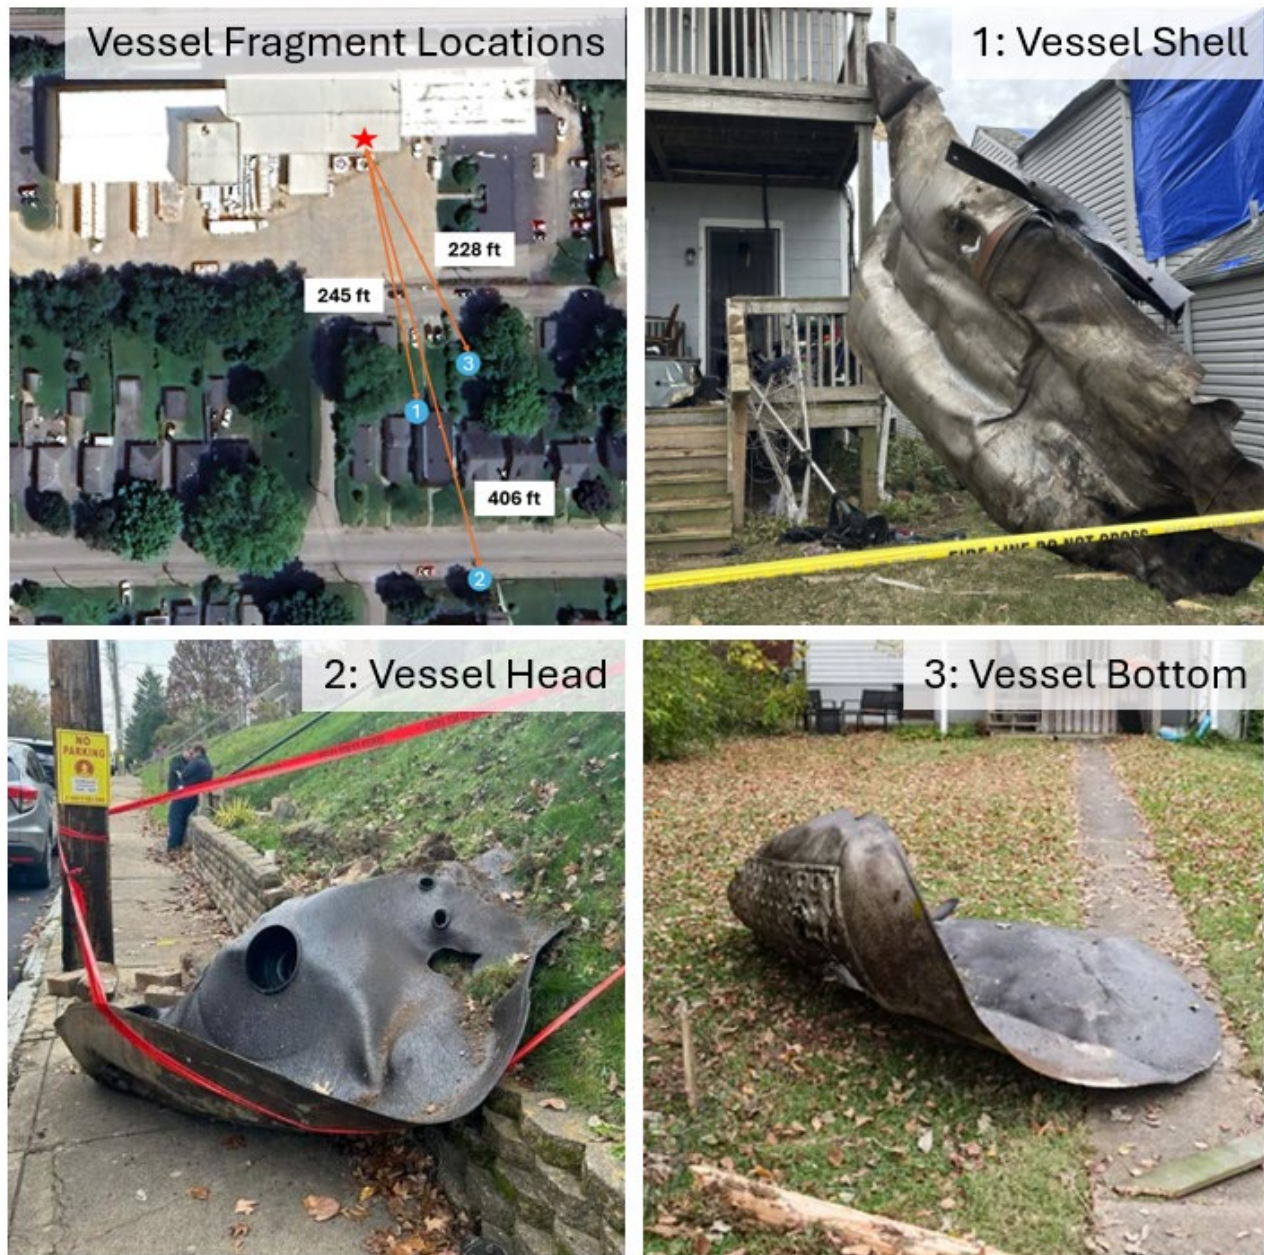
**Figure 6.** Locations of Batch Reactor Six debris scattered throughout the surrounding neighborhood. (Credit: Map: Google Earth with annotations by CSB; Photo 1: Dylan Lovan, Associated Press via Louisville Public Media [10]; Photo 2: WDRB News [11]; Photo 3: Louisville Courier Journal [12])

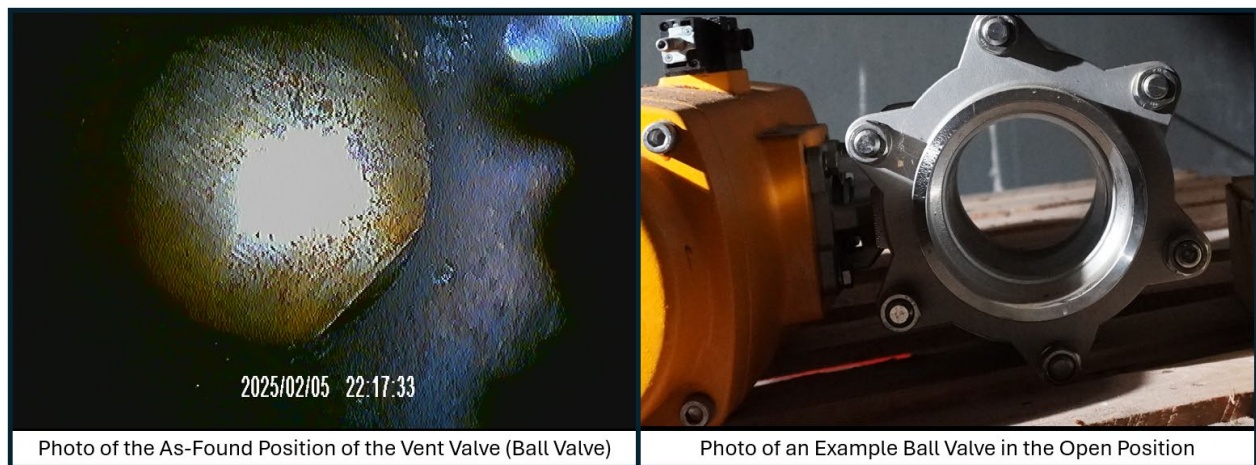
- After the incident, at the direction of the CSB, Givaudan inserted a borescope into piping connected to the recovered vent valve to identify the valve's position. Borescope photos show that, at the time of inspection, the vent valve is almost fully closed (**Figure 7**). The vent valve is a ball valve. When the ball opening is aligned with the attached piping, process fluid can flow through the valve. When the ball opening is perpendicular to the attached piping, process fluid cannot flow through the valve. Givaudan had specified that the vent valve actuator was to be configured to "fail open,"<sup>a</sup> meaning that the valve should automatically open in the event the instrument air pressure to the actuator was lost [14] [15]. The CSB will inspect the recovered vent valve actuator as part of the ongoing investigation.

**Figure 7.** Photo of the as-found position of the vent valve (left), and photo of an example ball valve in the open position (right). (Credit left photo: Givaudan; Credit right photo: CSB)
