INVESTIGATION REPORT

REFINERY FIRE INCIDENT

TOSCO AVON REFINERY

REPORT No. 99-014-I-CA
ISSUE DATE: MARCH 2001

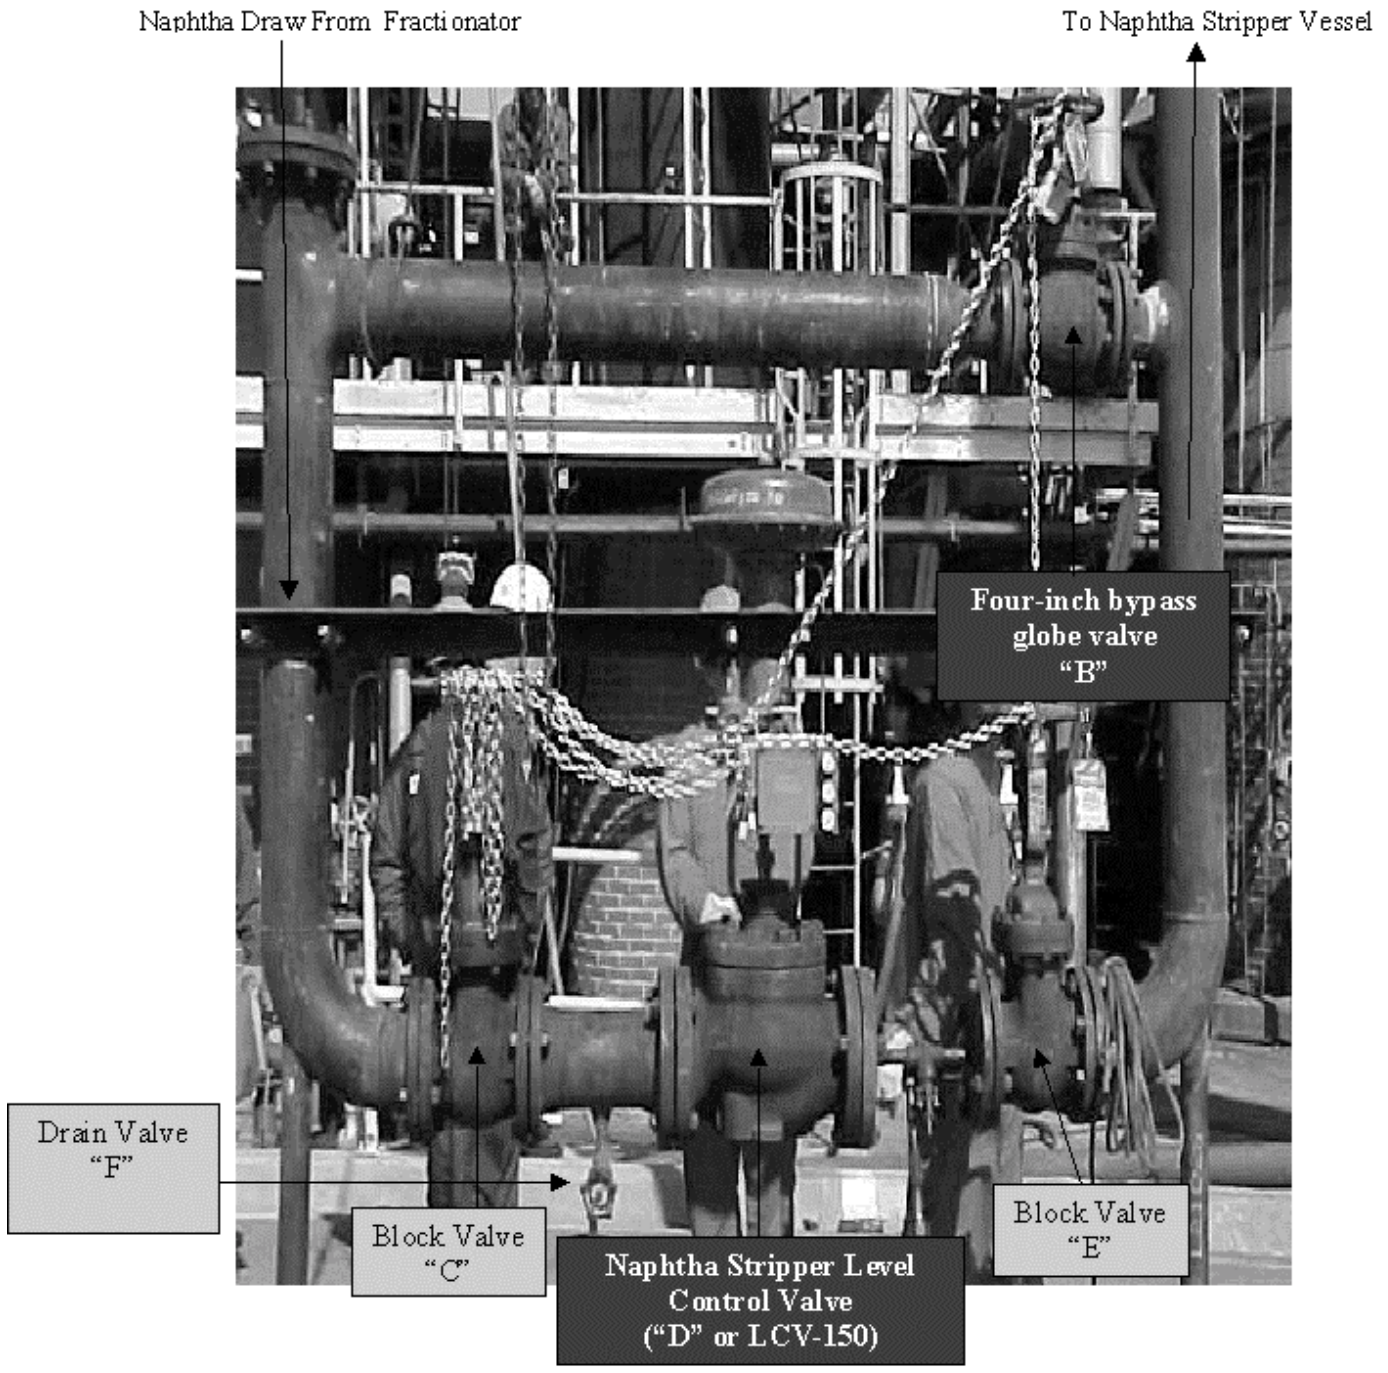
Figure 1. Naphtha stripper level control valve manifold removed to ground level. The valve at the top right of manifold is the 4-inch bypass valve.

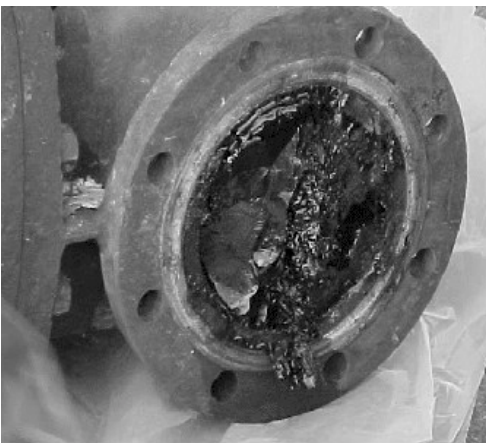
On February 18, pipefitters again attempted to clear the drain lines (valves F and G) at the naphtha stripper level control valve by using a reaming device. However, the device broke due to the hardness of the material in the line.

Figure 3. Closeup of material blockage of block valve (C), upstream of LCV-150.

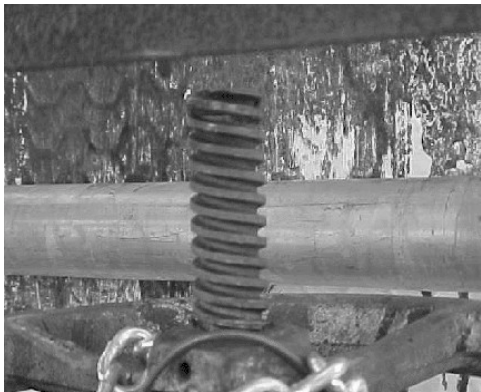
Figure 5. Closeup of stem of block valve (C), upstream of LCV-150, with the valve wheel fully tightened.

The protruding stem shows the valve to be jammed partway open, indicating possible material blockage in the line.

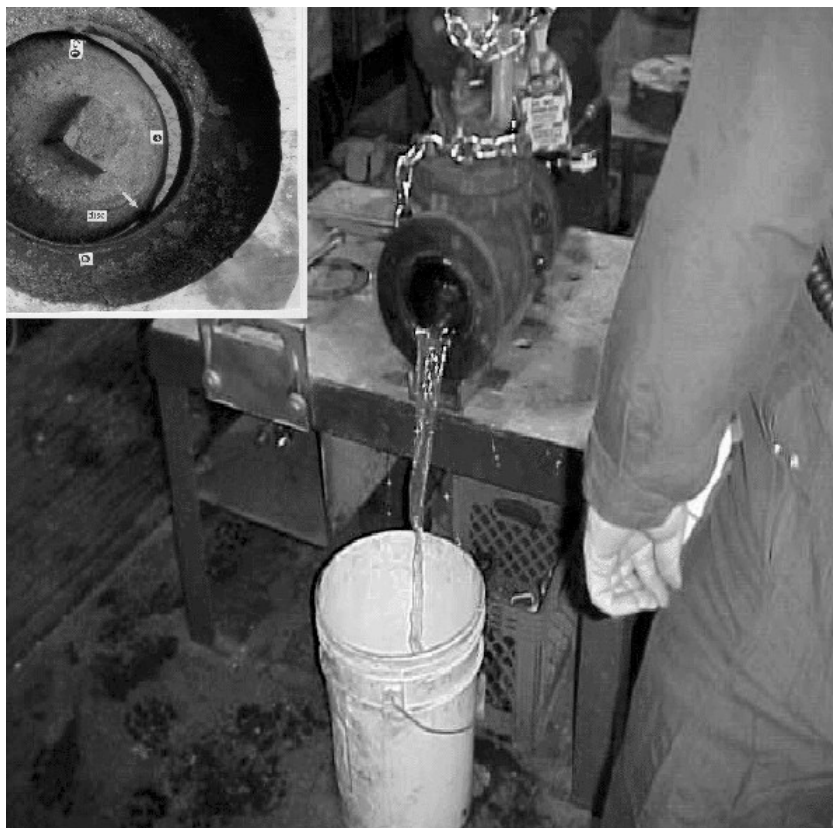
Following the incident, Cal/OSHA commissioned a metallurgical analysis of the failed piping and components. It was determined that the bypass valve was eroded to such an extent that—when closed—it leaked (Figure 7) at a rate equivalent to a 1.5-inch-diameter hole (FTI Anamet, 1999; p. i).

Figure 7. Leak test of the naphtha stripper level control bypass valve (B) in the closed position, showing significant water flow.

The inset photo highlights the gap between the seat and disc of the bypass valve in the closed position. This gap was equivalent to a 1.5-inch-diameter hole.
