INVESTIGATION REPORT

COMBUSTIBLE DUST FIRE AND EXPLOSIONS

CTA ACOUSTICS, INC.

REPORT NO. 2003-09-I-KY

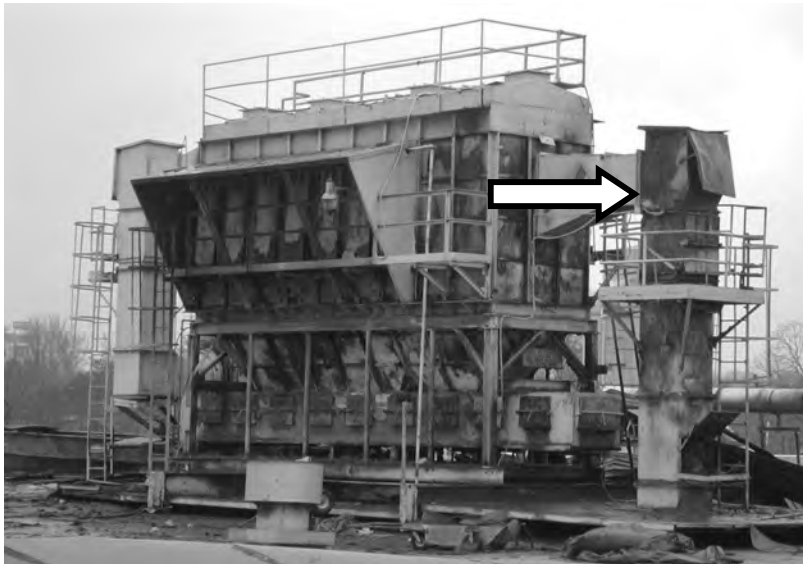
Figure 4. Fire damage to inlet duct of line 405 baghouse.

Two operators on the roof stated that moments after the baghouse was turned back on at 7:30 am, flames shot up through the inlet ducts, into and out of the baghouse (Figure 4). Both operators were burned—one received minor facial burns; the other received second-degree burns to his hands and face, which required a lengthy hospital stay. Inside the plant, personnel located about 80 feet northwest of line 405 observed smoke coming from the line prior to the initial explosion. Once the explosion occurred, personnel both heard it, and saw a fireball emerge from the south end of the oven.

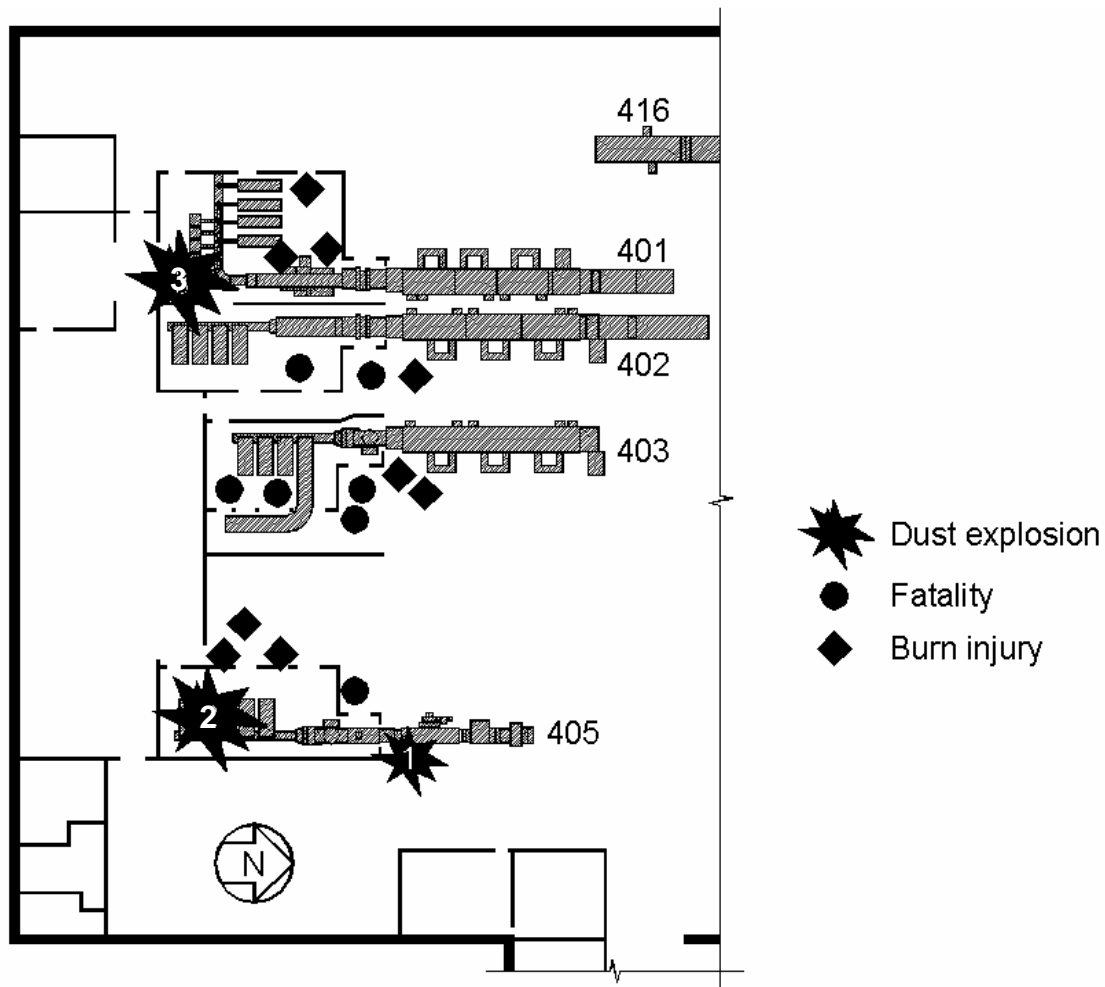
Figure 5. Sequence of dust explosions and likely locations of those killed and burned in the production area (Note: All employee injuries not shown in figure).

Figure 5 depicts the sequence of explosions and shows the likely locations of those who were burned in the production area. See Section 5.4 for a description of the extent of injuries to employees.

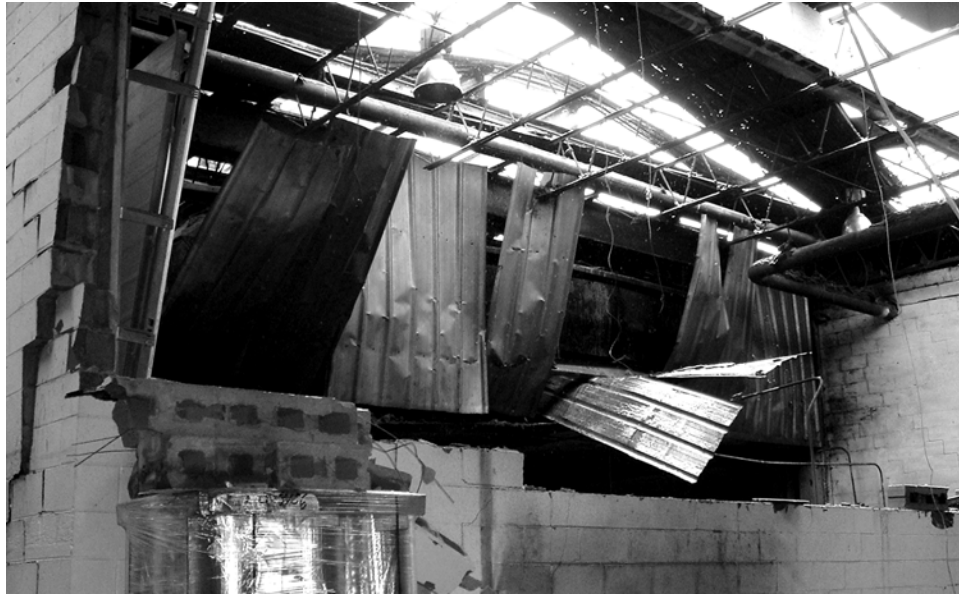
Figure 6. Collapsed firewall and metal panels at south end of line 405 blend room.

The fireball generated by the initial explosion near the line 405 oven ignited dispersed combustible dust, which caused a secondary explosion in the relatively confined area above the line 405 blend room. The force of this explosion damaged the firewalls to the east and south and pushed metal wall panels above the blend room roof on the south side out to the south (Figure 6). The explosion also pushed ceiling

panels and lights down inside the blend room. The pressure wave vented out of the building, damaging metal wall panels on both the south and east outer walls.

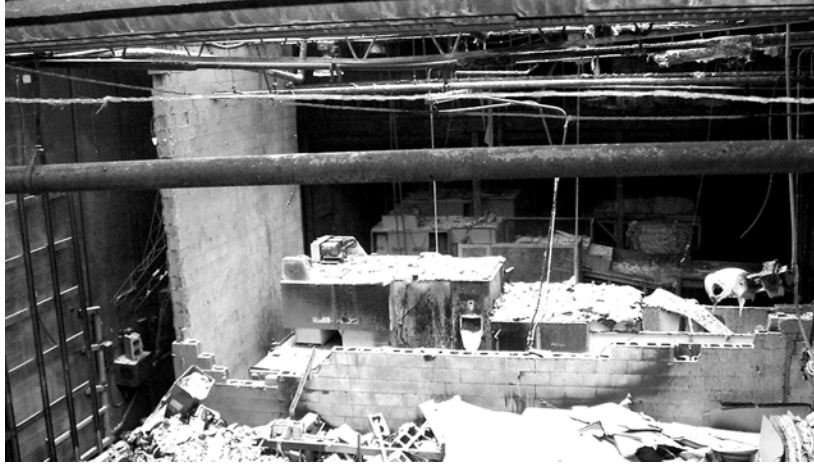
Figure 7. Collapsed firewall between lines 403 and 405.

- A collapsed firewall between lines 403 and 405 (Figure 7).
- Metal wall panels above the line 403 blend room on the east side that were blown to the west.
- Burnt residue on the building's roof trusses.

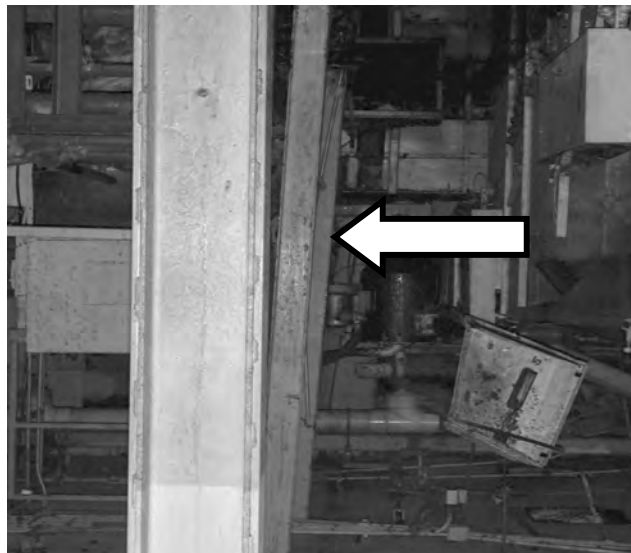
Figure 8. Bent support column in line 401 blend room.

The fireball continued to move west over the top of the line 402 blend room and into line 401. CSB investigators noted extensive explosion damage at line 401, nearly 300 feet from the initial explosion's point of origin at line 405. Physical evidence revealed that an additional secondary dust explosion

occurred in the southeast corner of the line 401 blend room, another confined area. The firewall south of line 401 was partially collapsed, and concrete blocks dislodged from this wall fell to the south. The force of the dust explosion pressure wave likely bent a steel column on the west side of the blend room (Figure 8). Metal panels of the north and west walls were deformed outward. A large hole was blown in the building roof above the southeast corner of the blend room.

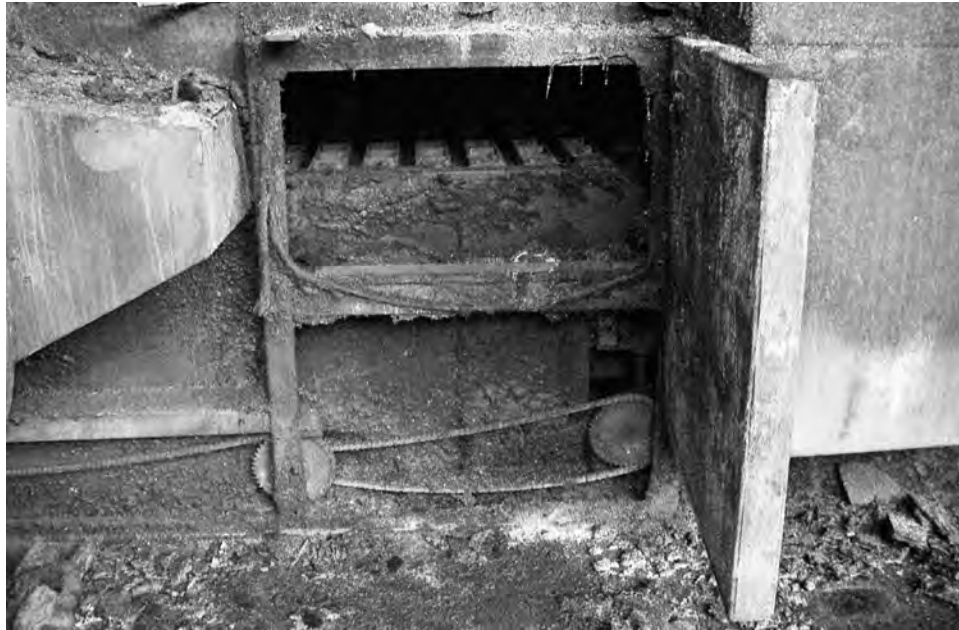
Figure 13. Interior of line 405 oven.

CSB also examined the interior of the oven; virtually all the combustible material that likely had been inside was burned away (Figure 13). In contrast, the interior of the ovens on lines 401, 402, and 403 contained accumulations of resin powder/fiberglass debris. The chain-driven oven flights for 405 were

burned clean but otherwise intact and undamaged. Metal discoloration was noted on the interior of the line 405 oven; however, CSB found no evidence of explosion damage inside the oven.

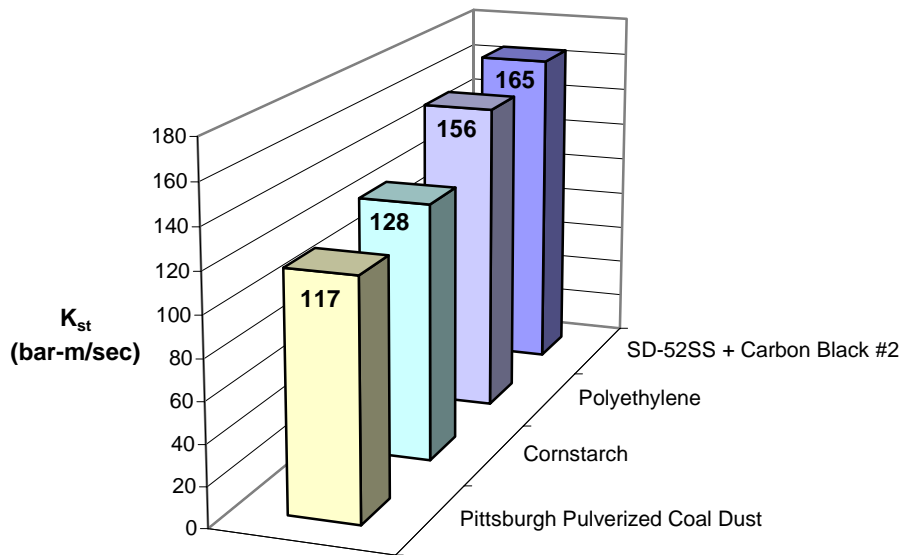
Figure 14. Explosion severity of Durite SD-52SS compared with other common combustible dusts.

Test data from the resin samples were also compared to the explosion characteristics of other common combustible dusts—namely, Pittsburgh coal dust, polyethylene dust, and cornstarch. Figure 14 shows that the Borden Chemical black phenolic resin used at CTA has a higher K_{st} value than the other dusts.

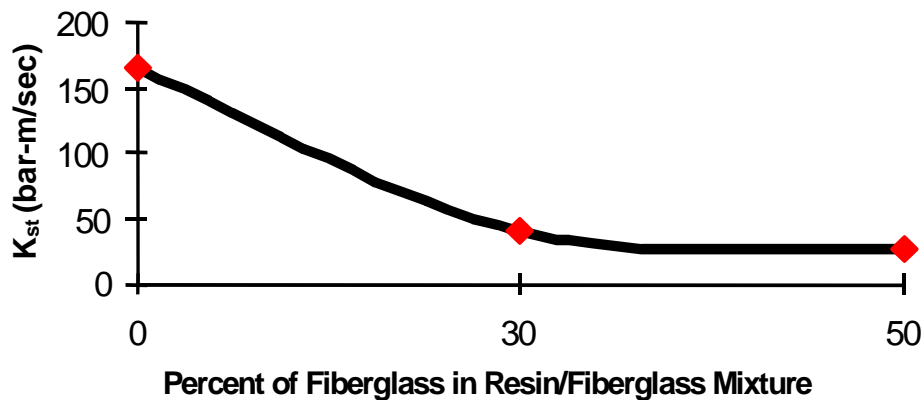
Figure 15. Explosivity testing results for resin/fiberglass mixtures.

Dust that settled in the CTA production area was typically a mixture of phenolic resin and small fiberglass fibers. Samples of ground fiberglass and phenolic resin were mixed in varying percentages in the CSB contractor's laboratory and tested. The test results show that as the fiberglass content increased, the mixtures remain explosible, but explosion severity decreased (Figure 15).

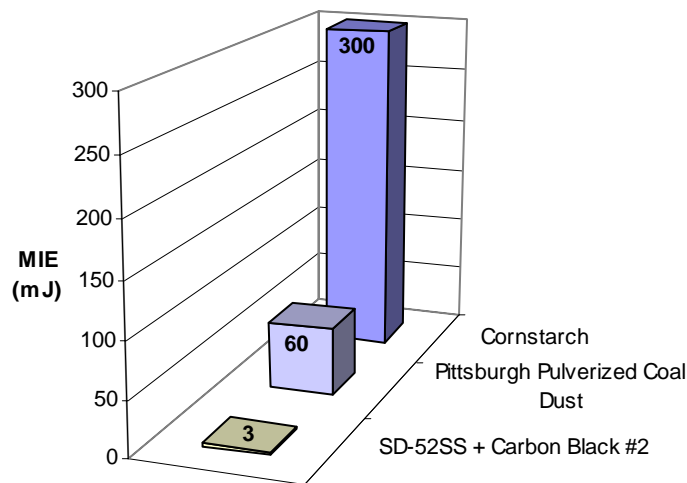
Figure B-4. Minimum ignition energy of Durite SD-52SS compared with other common combustible dusts.

Figure B-4 shows MIE test results for a Durite SD-52SS dust cloud in air. Results indicate that the phenolic resin is very easy to ignite, requiring only 3 millijoules (mJ) of energy to initiate an explosion.

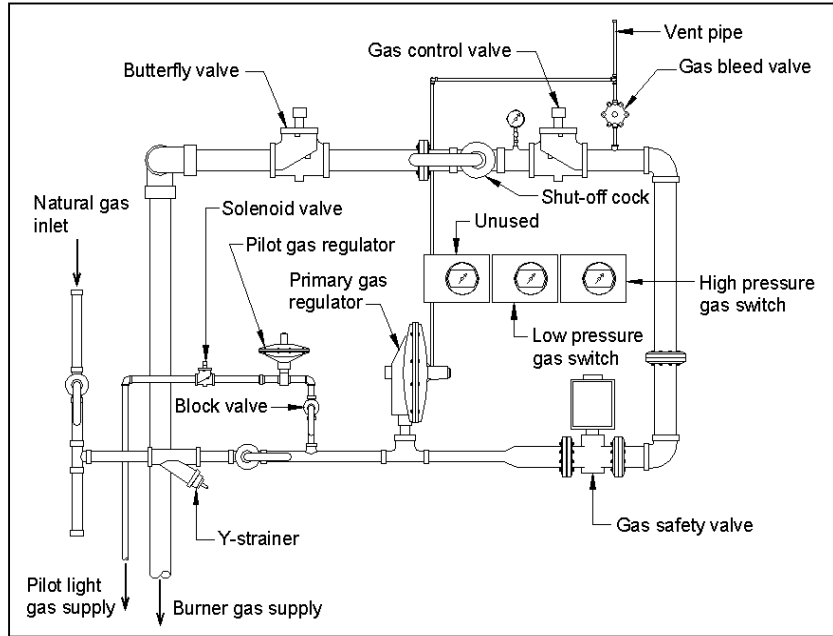
Figure C-1. Oven natural gas piping manifold.

No significant external gas leaks into the building were found. All internal gas leaks (i.e., gas control valve, gas bleed valve) would have been directed to the externally piped gas vent line.

CSB reviewed these findings and conclusions and determined that equipment testing results identified no single component failure as the cause of the incident.
