**U.S. CHEMICAL SAFETY AND HAZARD INVESTIGATION BOARD**

# **INVESTIGATION REPORT**

## **CATASTROPHIC VESSEL OVERPRESSURIZATION (4 DEATHS)**

Sonat Exploration Company  
Temple 22-1 Common Point Separation Facility  
Pitkin, Louisiana  
March 4, 1998

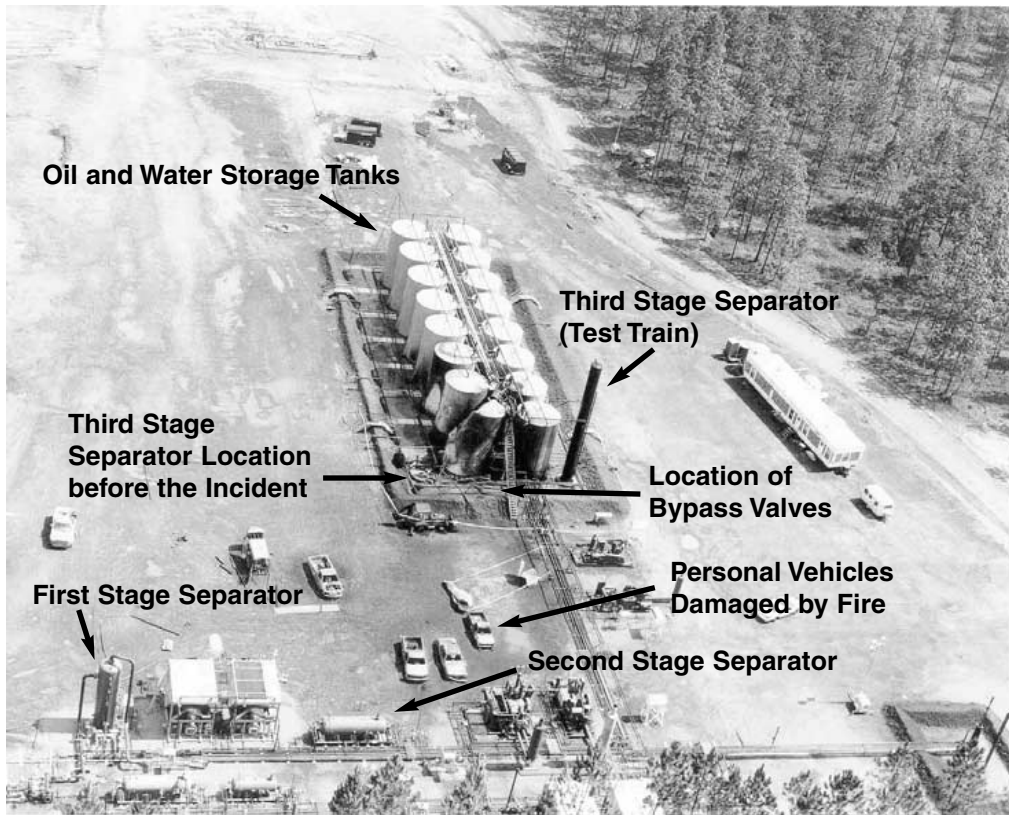
**Figure 1. Aerial View of the Temple 22-1 Common Point Separation Facility after the Incident**

In addition to the fatalities, the incident resulted in about \$200,000 worth of damage, including the destruction of the third-stage separator, four private vehicles, and a backhoe and damage to the facility storage tanks. Figures 1, 7, and 8 document the condition of the facility after the incident.

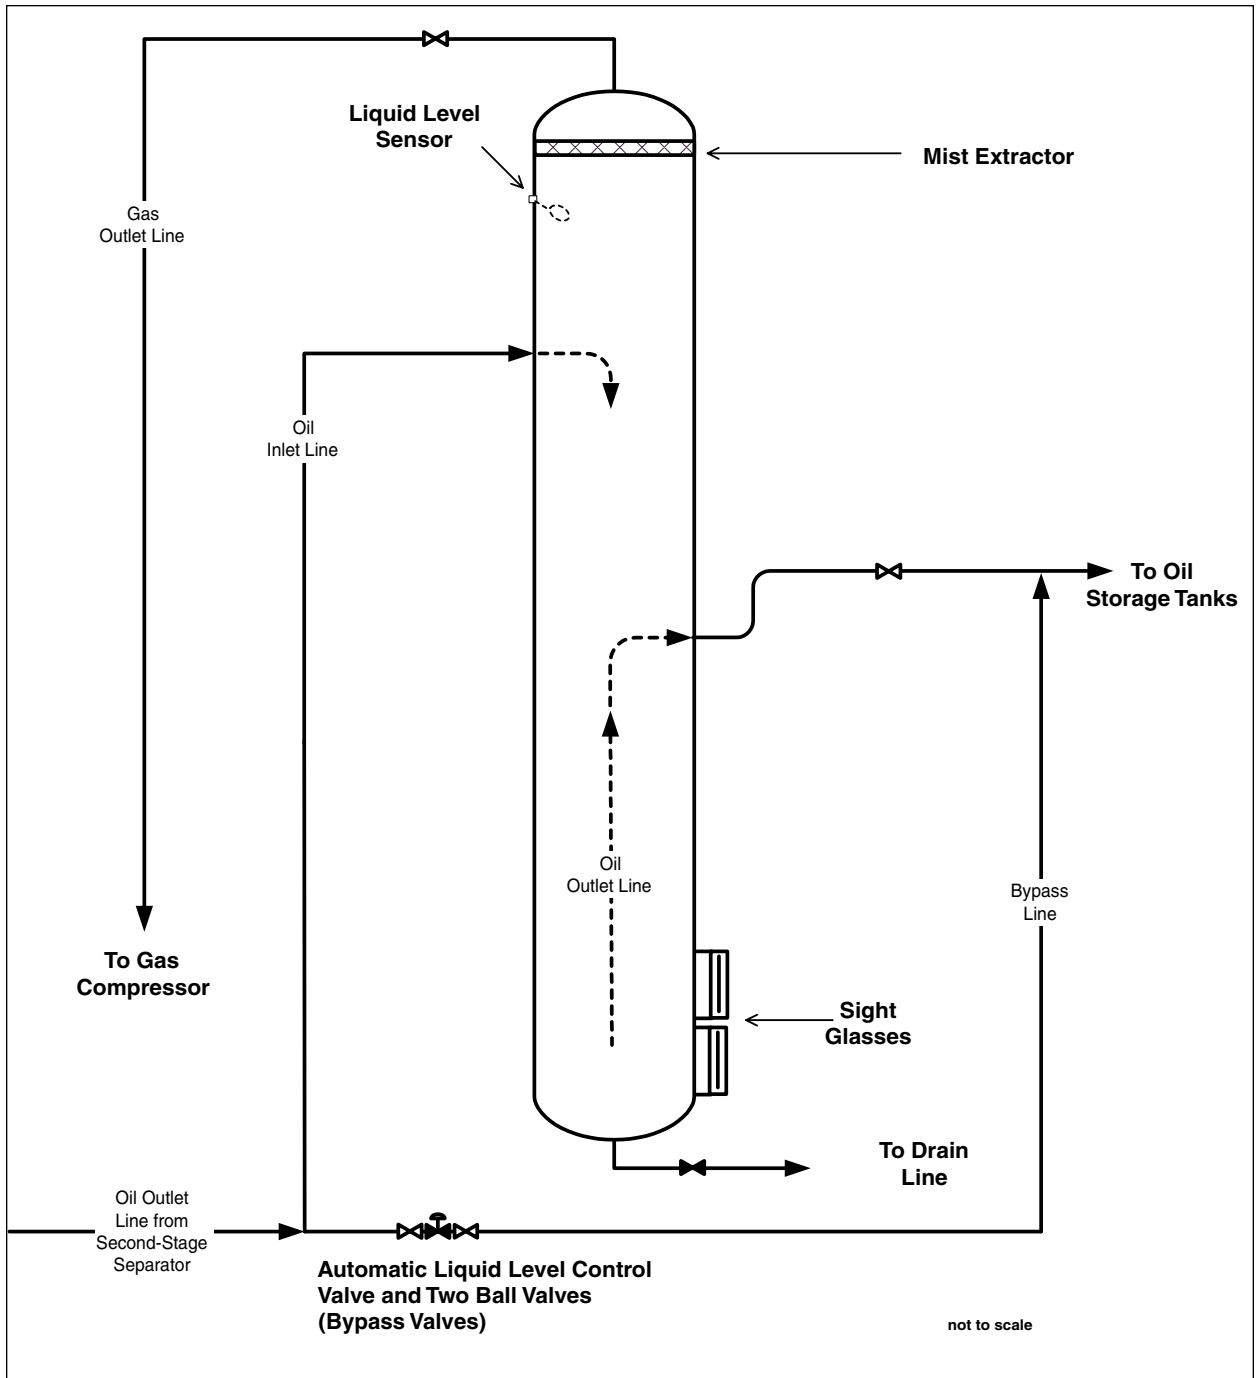
**Figure 4. Third-Stage Separator Schematic**

Each third-stage separator (Bulk and Test) was a 45-foot-tall vessel with a diameter of four feet (see Figure 4 for details). In operation, the vessel would be approximately 80% full with fluid. Well fluid was introduced into the separator at a height of approximately 35 feet, and separated

The third-stage separator was only rated for atmospheric pressure service (14.7 psia). Vessel failure was the result of overpressurization by purge gases and was both sudden and catastrophic. Four personnel were within 40 feet of the third-stage separator at the time it ruptured.<sup>27</sup>

Another design deficiency was the absence of an inlet block valve upstream from the third-stage separator. Such a valve could have been used to isolate the separator from the high-pressure purge gases that caused the vessel failure. An inlet block valve would be an adjunct, not a substitute, for a pressure-relief system on the separator. Similarly, the inclusion of a block valve (valve **15**) on the oil outlet line of the third-stage separator allowed the separator to be isolated from the storage tanks, whose roof hatches offered a potential means of venting. At the time of the incident, valve **15** was closed. The third-stage separator also had an outlet line to a gas compressor; excess flow into the compressor would be vented via the gas flare. However, the gas

Prior to operating the Bulk Train, the third-stage separator should thus have been equipped with a pressure-relief system, as recommended by API consensus guidance.<sup>33</sup>

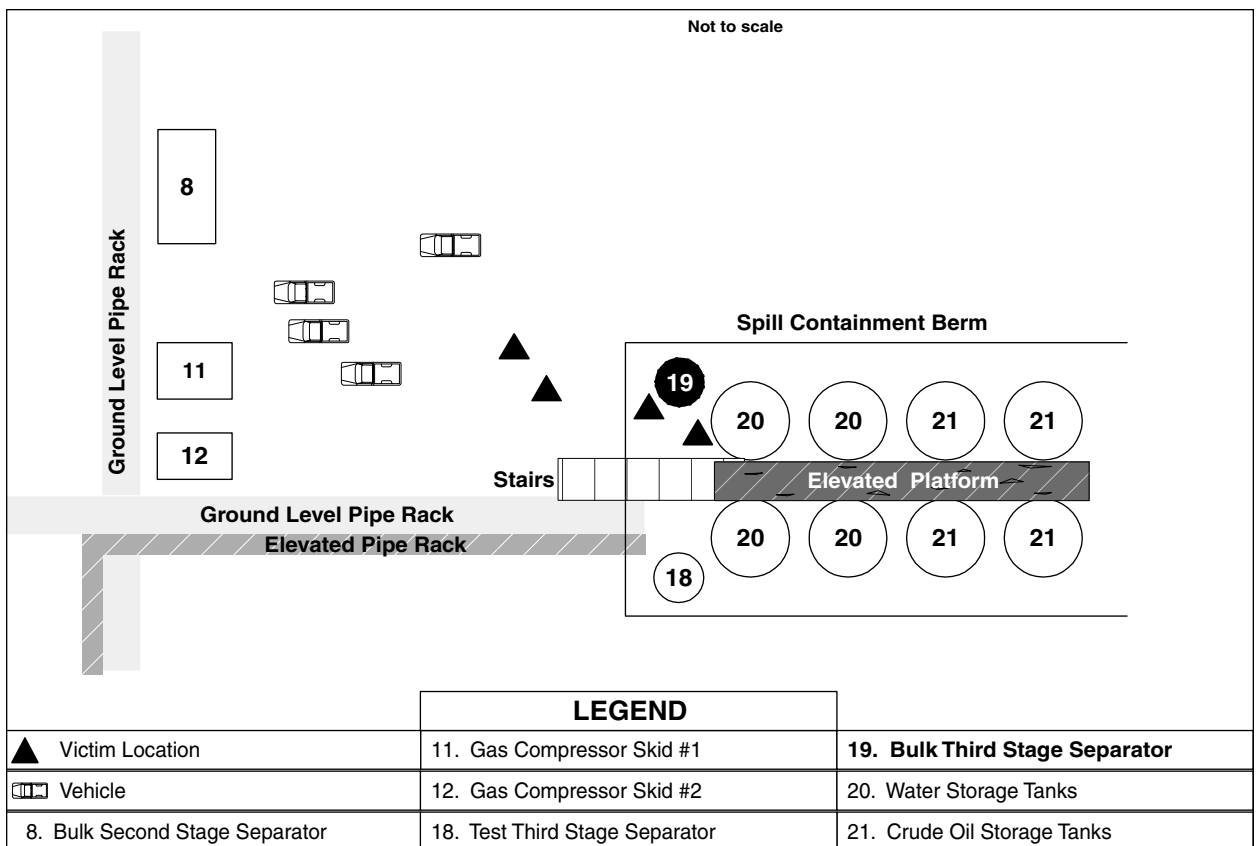
**Figure 6. Locations of the Four Victims Found after the Incident**

All four operators who were near the separator at the time of the failure were killed at once; in each case the cause of death was severe blast injuries. Figure 6 shows the approximate locations of the four victims, as found after the incident. The operator stationed near the header, about 190 feet from the separator, was thrown about five feet by the blast, and the construction supervisor was severely jolted as he exited his truck over 300 feet away at the pipeline valve. Both survived without serious injury.

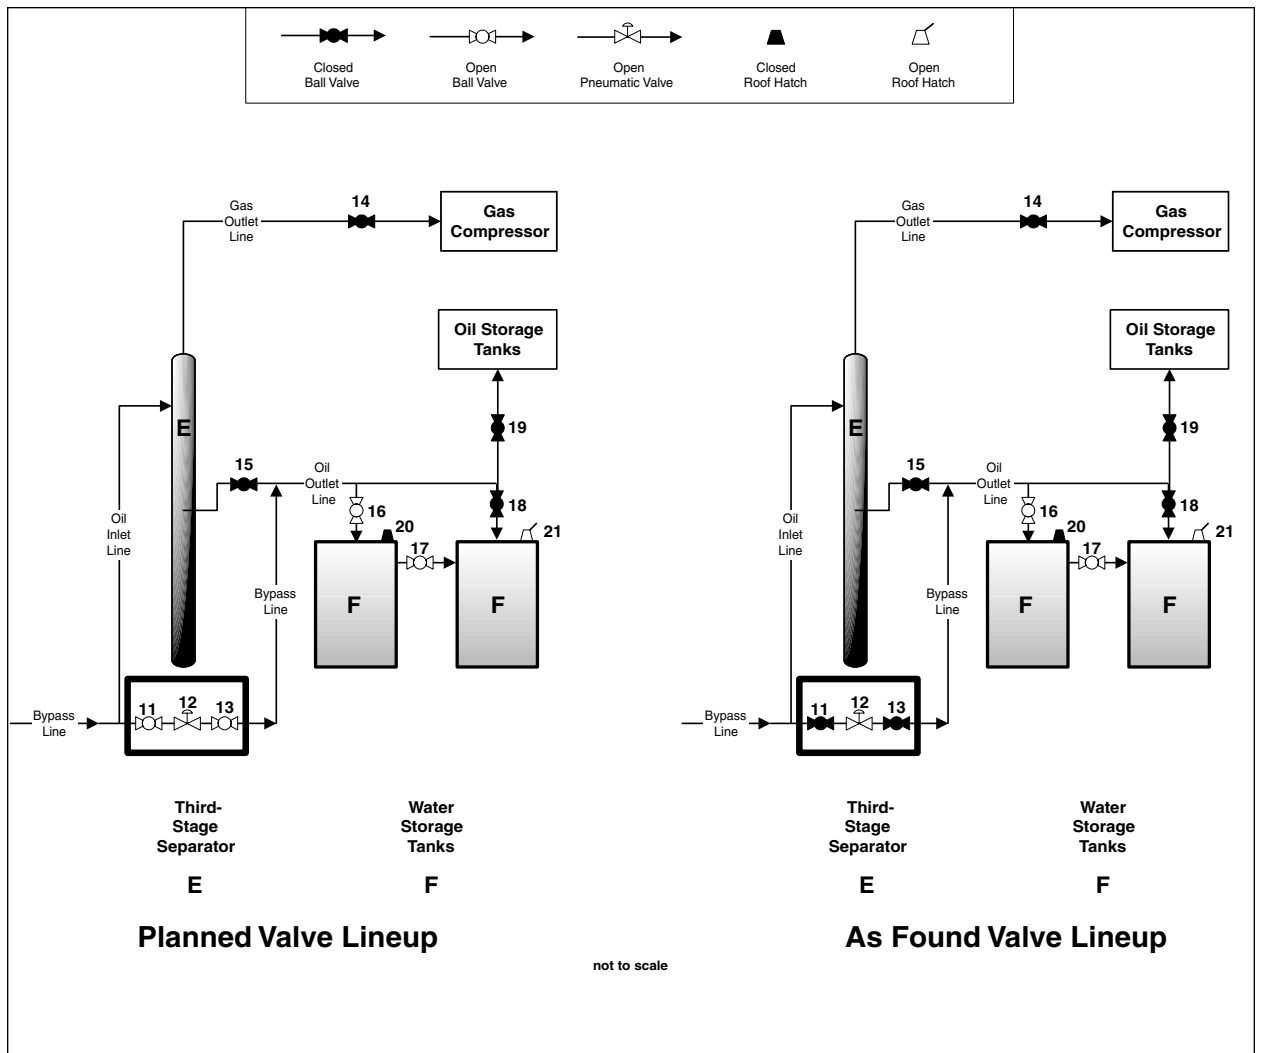
Figure 9. Comparison of Valve Alignments as Planned and as Found after the Incident

Soon after the fires stemming from the incident had been brought under control, Louisiana State Police inspected the area around the failed separator. They were accompanied by the Sonat production and construction supervisors. It was then discovered that, in contrast to the planned valve alignment, valves **11** and **13** were actually in the closed position.

Similarly, the timing of the closure of valves **11** and **13**, which triggered the vessel failure, could not be absolutely determined.<sup>28</sup> These two valves were opened in the morning but then closed early in the afternoon prior to the purging of the Bulk Train separators. The valves were not continuously monitored during most of the day. It is possible that the valves were not reopened as intended prior to the final purging process, and remained closed until vessel failure finally occurred. Alternatively, the valves may have been correctly opened during the final valve alignment, only to be manually closed later. However, no surviving personnel reported seeing the valves closed during any part of the final purging process, and there was no operational reason to close the valves once the purging was under way. The surviving supervisors did not report giving any such instruction, nor were any Bulk Train valve realignments whatsoever planned during the final purging process. Valves **11** and **13** were not intended to be closed once the Bulk Train entered routine production.<sup>29</sup>
