U.S. CHEMICAL SAFETY AND HAZARD INVESTIGATION BOARD

INVESTIGATION REPORT

CATASTROPHIC VESSEL OVERPRESSURIZATION (4 DEATHS)

Sonat Exploration Company
Temple 22-1 Common Point Separation Facility
Pitkin, Louisiana
March 4, 1998

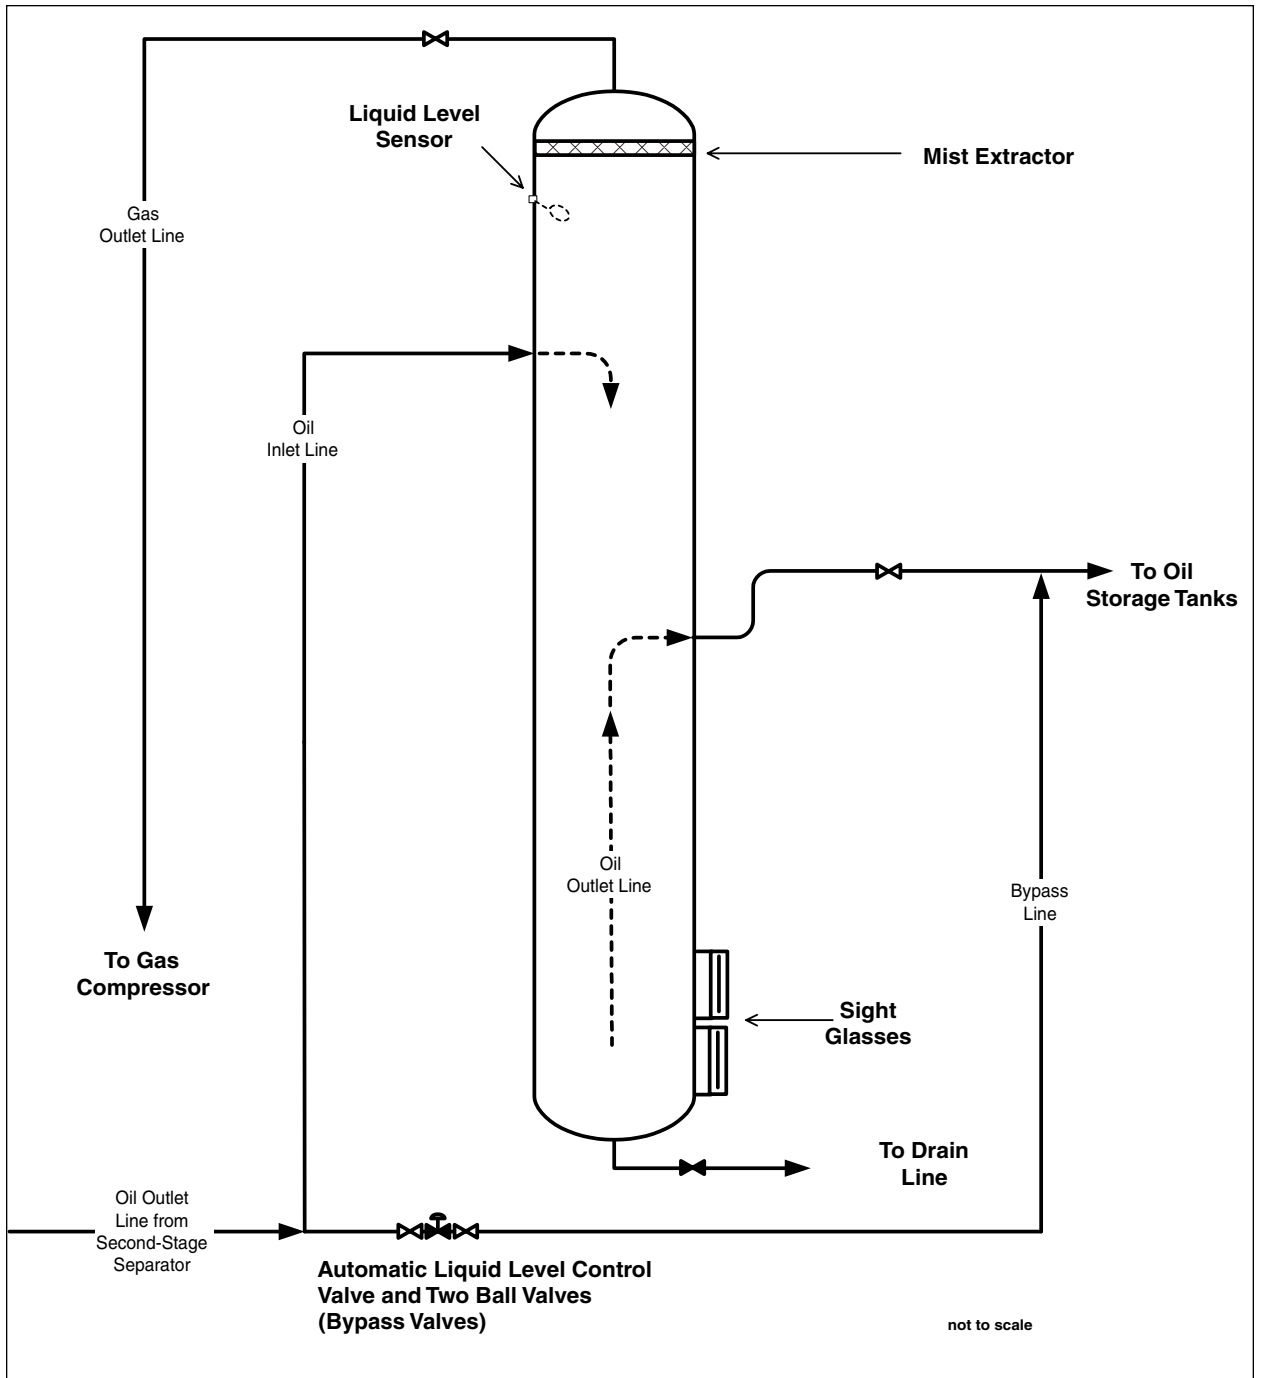
Figure 4. Third-Stage Separator Schematic

Each third-stage separator (Bulk and Test) was a 45-foot-tall vessel with a diameter of four feet (see Figure 4 for details). In operation, the vessel would be approximately 80% full with fluid. Well fluid was introduced into the separator at a height of approximately 35 feet, and separated

The third-stage separator was only rated for atmospheric pressure service (14.7 psia). Vessel failure was the result of overpressurization by purge gases and was both sudden and catastrophic. Four personnel were within 40 feet of the third-stage separator at the time it ruptured.²⁷

Prior to operating the Bulk Train, the third-stage separator should thus have been equipped with a pressure-relief system, as recommended by API consensus guidance.³³

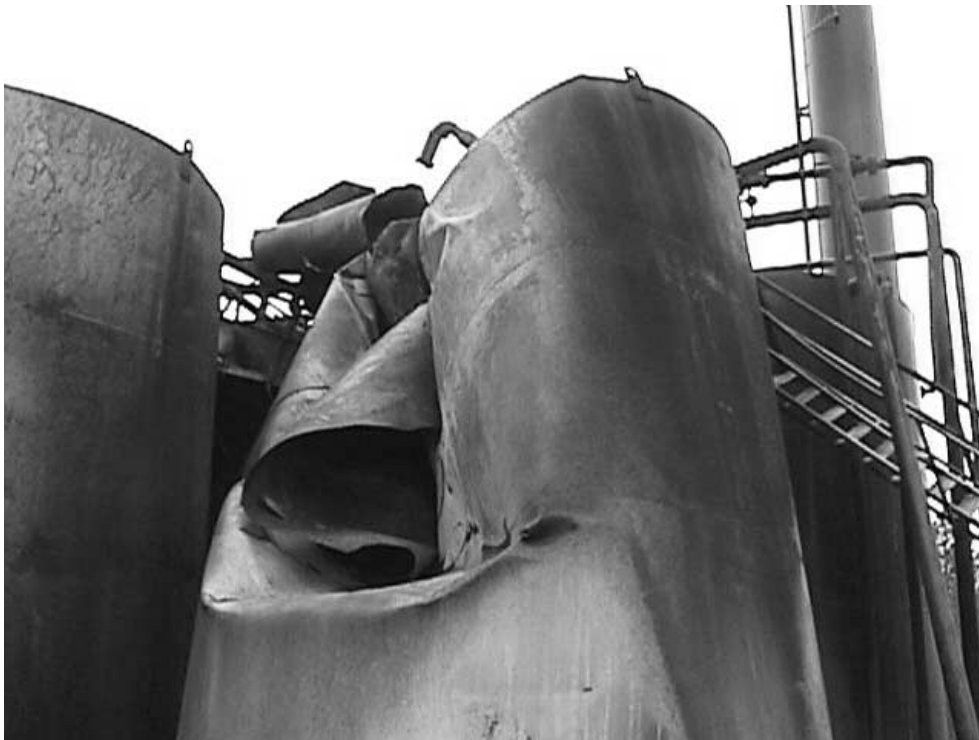
Figure 8. Damaged Water Storage Tank with Fragment of Third-Stage Separator

At approximately 6:15 p.m., the Bulk Train third-stage separator experienced a catastrophic failure. Gas from the ruptured separator immediately ignited, producing a large fireball centered over the location of the separator. Additional fires were ignited, fueled by natural gas leaking from the damaged storage tanks and piping.

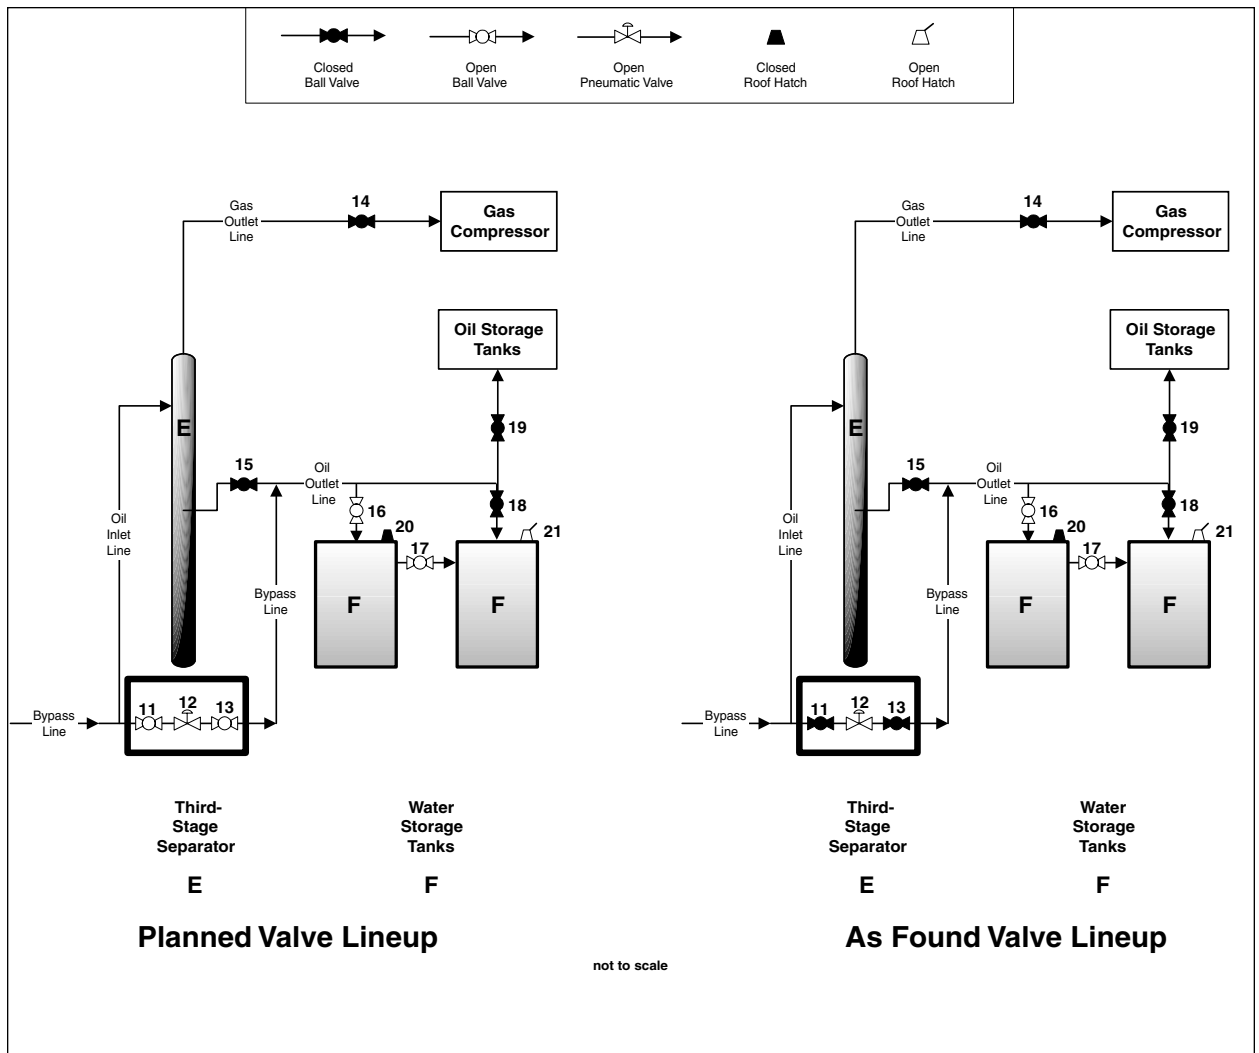
Figure 9. Comparison of Valve Alignments as Planned and as Found after the Incident

Soon after the fires stemming from the incident had been brought under control, Louisiana State Police inspected the area around the failed separator. They were accompanied by the Sonat production and construction supervisors. It was then discovered that, in contrast to the planned valve alignment, valves **11** and **13** were actually in the closed position.

Similarly, the timing of the closure of valves **11** and **13**, which triggered the vessel failure, could not be absolutely determined.²⁸ These two valves were opened in the morning but then closed early in the afternoon prior to the purging of the Bulk Train separators. The valves were not continuously monitored during most of the day. It is possible that the valves were not reopened as intended prior to the final purging process, and remained closed until vessel failure finally occurred. Alternatively, the valves may have been correctly opened during the final valve alignment, only to be manually closed later. However, no surviving personnel reported seeing the valves closed during any part of the final purging process, and there was no operational reason to close the valves once the purging was under way. The surviving supervisors did not report giving any such instruction, nor were any Bulk Train valve realignments whatsoever planned during the final purging process. Valves **11** and **13** were not intended to be closed once the Bulk Train entered routine production.²⁹
