U.S. CHEMICAL SAFETY AND HAZARD INVESTIGATION BOARD

INVESTIGATION REPORT

CHLORINE RELEASE

DPC ENTERPRISES, L.P.

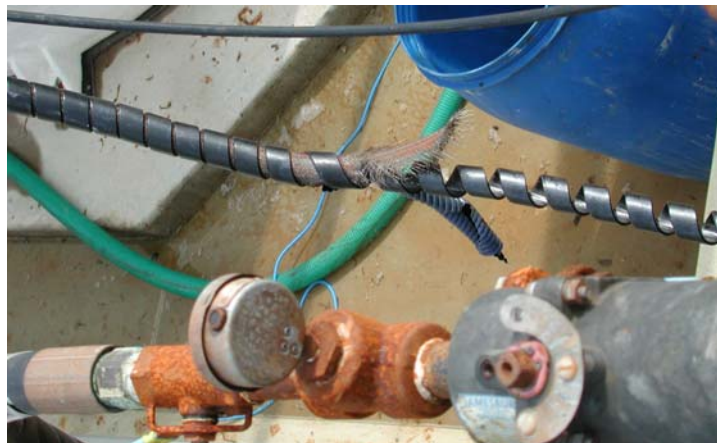
Figure 2. Failed stainless-steel transfer hose.

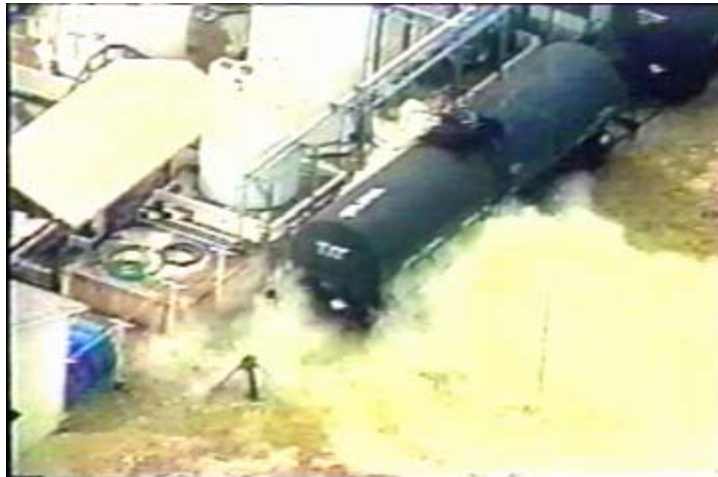
remained in the breakroom. At approximately 9:20 am, the three men outside heard a loud pop and observed a continuous release of chlorine at tank car station #3 (Figure 14). They immediately evacuated the area.

Figure 14. Chlorine release at tank car station #3.

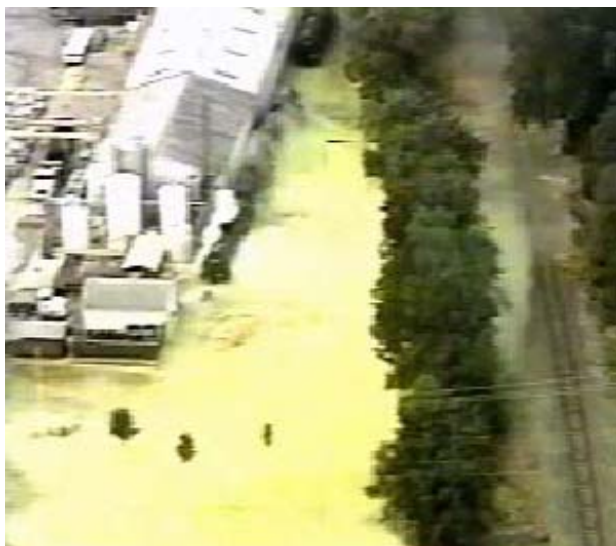
Wind speed was generally 3 to 5 miles per hour (mph) on the morning of August 14. The chlorine plume (Figure 16) moved primarily east-to-southeast in the direction of Goodwin Brothers Construction and Intermodal Tire, though it is likely that it migrated into the adjacent Blue Fountain mobile home park

when there was no wind. As indicated by dispersion modeling,⁹ chlorine concentrations of 3 ppm could have extended to approximately 3.7 miles from the point of release (Trinity Consultants, 2003).

Figure 16. Movement of chlorine plume offsite.

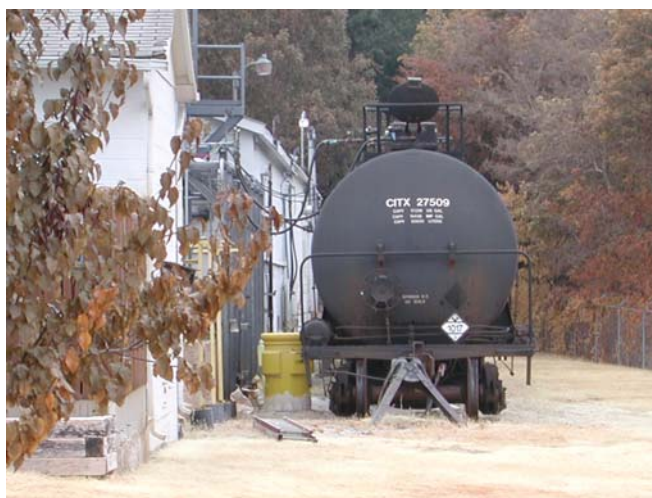
DPC began cleanup activities immediately after the R-7 fire department released the scene. Figure 18 shows the area of cleanup. Alarms were turned off, the chlorine piping system was evacuated and depressurized, and all fill stations were isolated.

Figure 18. Cleanup area around tank car station #3.

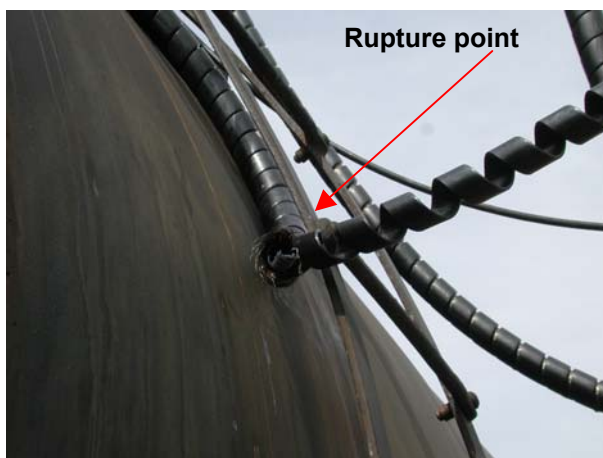
The catastrophic rupture of a 1-inch transfer hose attached at tank car station #3 initiated the chlorine release (Figure 19). Reconstructive analysis determined why the chlorine transfer hose ruptured and why the ESD valves failed to close. The excess flow valves were dismantled and inspected to determine if they should have closed.

Figure 19. Ruptured chlorine transfer hose at tank car station #3.

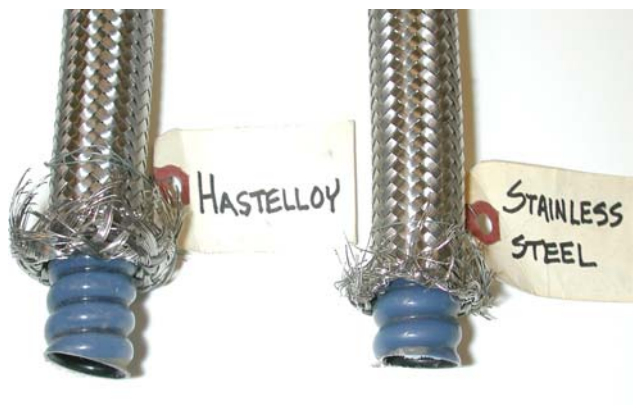
structural integrity, The Chlorine Institute (1998) recommends that hoses with such inner lining “have a structural layer braid of polyvinylidene fluoride (PVDF) monofilament material or a structural braid of Hastelloy C-276”¹³ (Figure 20).

Figure 20. Structural braid layer pulled back to expose Teflon inner liner.

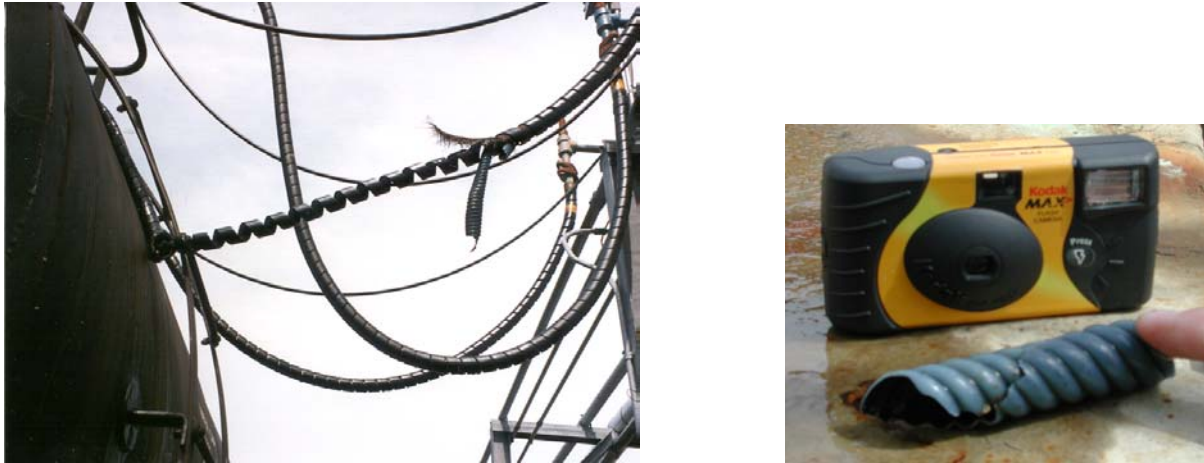
The rupture occurred in the chlorine transfer hose attached to tank car valve A, about 3.5 feet from its connection to the tank car (Figure 21). CSB investigators found a 2.5-inch-long segment of the hose inner liner and several pieces of the structural braiding scattered throughout the immediate area. The external spiral guard kept the ruptured hose attached to both the tank car and the plant piping.

Figure 21. Ruptured hose and piece of Teflon inner liner.

The HDPE spiral guards around each of the three hoses were cut off, and each hose was visually inspected. The structural braid layer of the intact hoses showed no signs of deterioration or discoloration; however, the structural braiding of the ruptured hose was significantly corroded, as evidenced by brown discoloration and granular flakes. The inner liner of the ruptured hose showed no sign of deterioration.

Materials testing of the structural braiding of both the ruptured hose and one of the intact hoses revealed that the ruptured hose braid layer was constructed of 316L stainless steel and the braid layer of the intact hose was constructed of Hastelloy C-276. As discussed in Section 4.1, nonmetallic inner liners (e.g., Teflon) must be reinforced with chlorine-resistant outer layers.

Once the hose was put into service at tank car station # 3, atmospheric moisture in combination with permeating chlorine molecules from the Teflon inner liner caused the 316L stainless-steel braid layer to corrode. Thus, CSB concludes that the hose ruptured because its stainless-steel structural braiding was inappropriate for chlorine transfer.

During chlorine unloading operations, the transfer hose is subjected to maximum operating pressures of about 175 pounds per square inch gage (psig). The hose also encounters bending forces during each connection/disconnection to the tank car. CSB concludes that corrosion of the 316L braid layer weakened the structural integrity of the hose. Normal operating pressure, in combination with repetitive bending forces, caused the hose to rupture and release chlorine. (See fault tree analysis of hose rupture in Appendix E.)

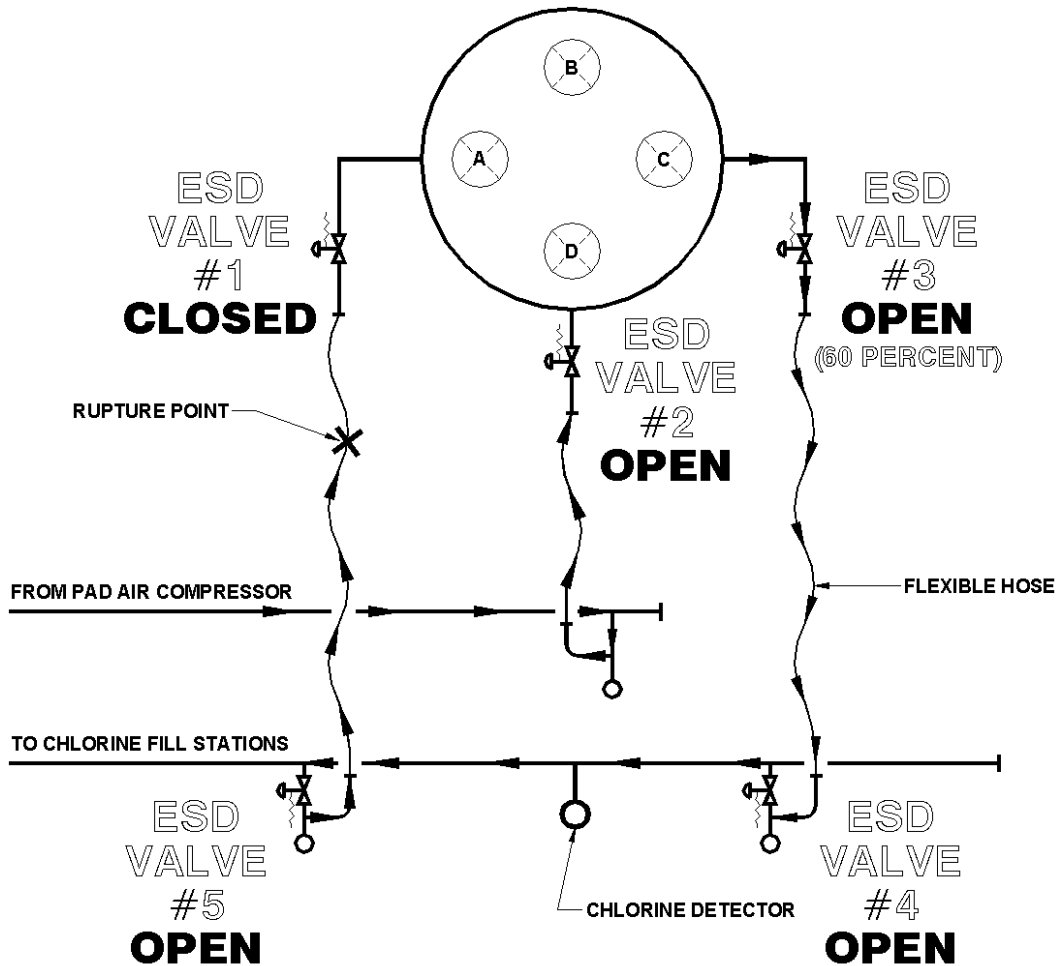
Section 2.4 describes the DPC Festus ESD system. CSB investigators checked the indicators on all five ESD valves at tank car station #3 after the incident.¹⁴ Although both the automatic and manual ESD mechanisms were employed, four of the five valves failed to completely close and isolate the release (see Figure 22):

The one valve that did close was ESD valve #1, connected to the ruptured chlorine transfer hose.

Determining the actual positioning of the five ESD valves at tank car station #3 led CSB investigators to conclude that the chlorine flowed through the partially opened ESD valve #3, to the attached intact liquid CTH line, into the plant side piping, and back through the ruptured hose (see Figure 22). Closing tank car

valve A did not stop the release because valve C continued to supply chlorine through the intact liquid CTH line.

Figure 22. Positioning of ESD valves at time of release.

The failure of ESD valve #2 to close and isolate the pad airflow supplied pressure to push chlorine out of the tank car during the release. DPC Festus had no other automatic mechanism to shut down the pad air system in an emergency. Such a mechanism may have slightly reduced the flow of chlorine from the tank

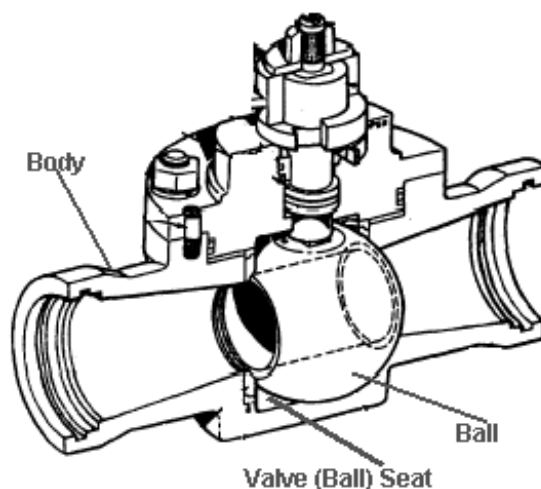
Testing of ESD valves # 3 and 4 revealed that the torque necessary to close the valves—in excess of 40 foot-pounds—far exceeded the 5 foot-pounds available from the actuators. Visual inspection of both valves revealed corrosion product buildup around the valve balls (Figure 23); these deposits were found to be ferric chloride. CSB investigators recognized that some corrosion within the repackaging system, including the unloading piping assemblies, occurred after the release. Therefore, a second set of piping assemblies—not in use at the time of the incident—was inspected and tested; these assemblies were also found to have corrosion, and they did not close properly when activated. It was concluded that corrosion products impeded motion of the ESD valves.

The valve balls were constructed of Monel, which is resistant to moisture-induced corrosion in chlorine service. The corrosion products were determined to have migrated to the valves from the pad air supply and tank car assemblies, as well as from parts of the plant liquid and pad air carbon steel piping.

Figure 23. Schematic of ESD valve.

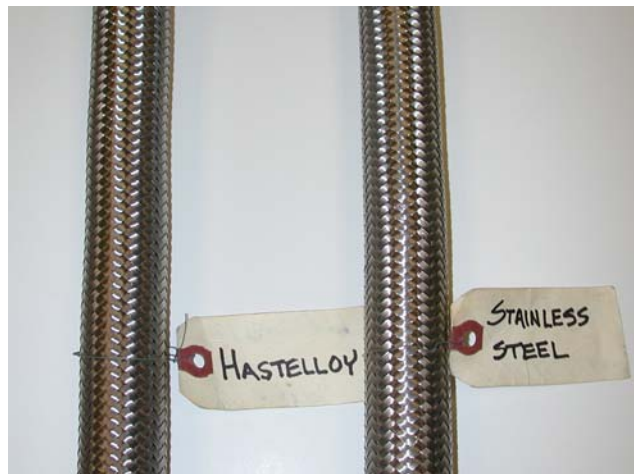
Hastelloy C-276 and 316L stainless-steel structural braiding appear to be identical (see Figure 24). CSB investigators believe that the inability to visually distinguish these two structural braid layer alloys facilitated installation of the incorrect hose at DPC Festus. In fact, throughout the hose supply chain, there was no adequate mechanism (e.g., color-coding, stenciling, or stamping) to help identify similar looking hoses.

Figure 24. Identical appearance of HastelloyC-276 and 316L stainless-steel structural braiding.

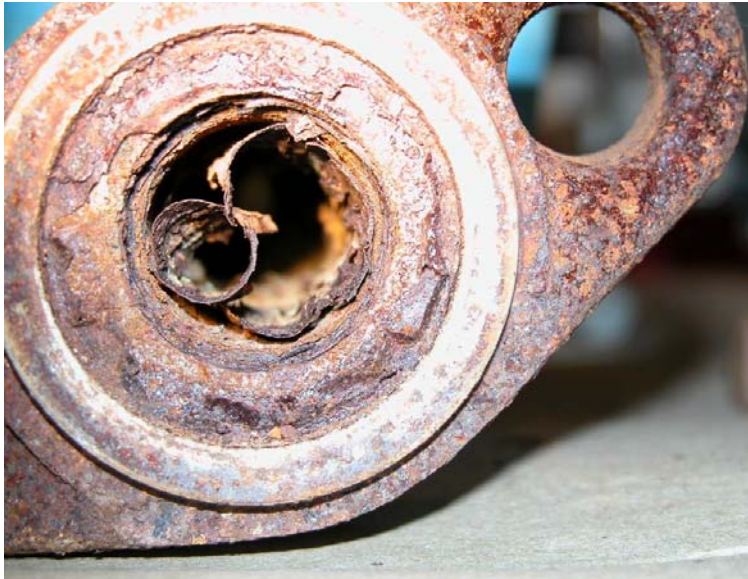
²⁰ The unloading assembly in use at tank car station #3 at the time of the incident and a second set of assemblies not in use were inspected; both exhibited corrosion.

Figure 25. Corrosion buildup in chlorine repackaging piping system.

The DPC Festus MI program was not successful in preventing corrosion within the chlorine repackaging system because it did not adequately address related supervision, procedures, and inspection.
