U.S. CHEMICAL SAFETY AND HAZARD INVESTIGATION BOARD

EXPLOSION AT BIOCHEMICAL FACILITY: LIQUID NITRIC OXIDE RELEASE

No. 2003-15-C-OH
August 2004

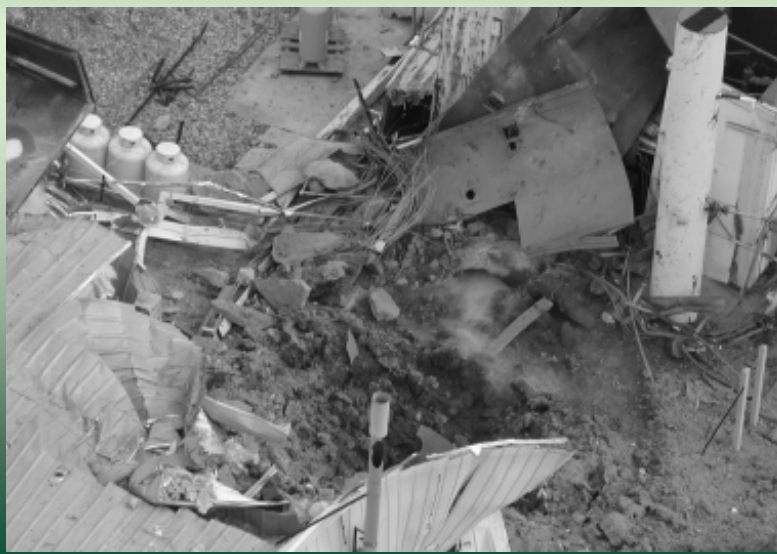
Figure 1

At 10:15 am—with no warning—a violent explosion destroyed the distillation column, the blast containment structure, and nearby buildings (Figure 1). Windows were blown out of the main office building, about 140 feet from the explosion; and glass shards lacerated the hand of an Isotec employee. No other injuries were reported.

20-foot-diameter, 8-foot-deep crater and structural damage caused by NO process unit explosion

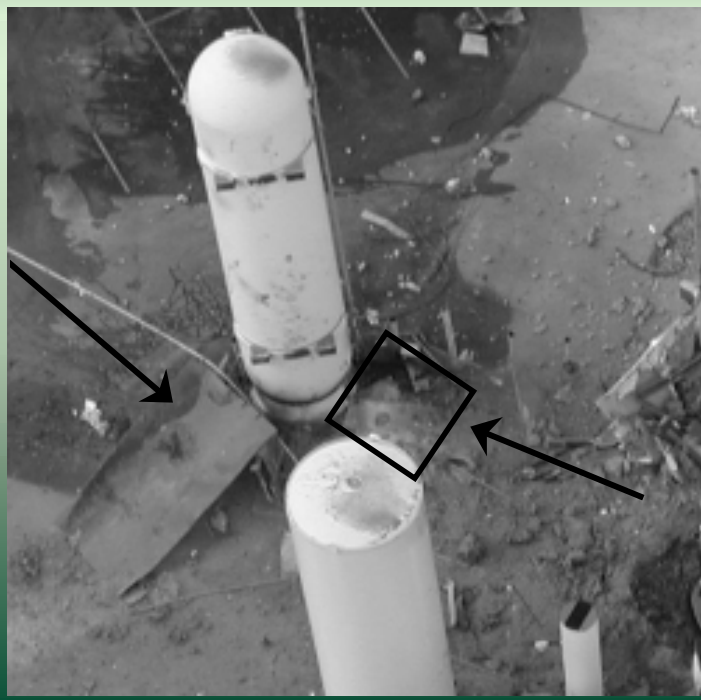
Figure 2

A large steel panel from the blast containment structure struck and dislodged a 52,000-pound gaseous carbon monoxide (CO) storage vessel, pushing it about 10 feet off its foundation (Figure 2). A second steel panel severely damaged adjacent equipment (Figure 3). A ruptured fill line vented CO gas, which then ignited and burned for about 1 hour, until the vessel was empty (Figure 4).

52,000-pound, 42-foot-tall CO vessel pushed 10 feet off foundation (right arrow) by blast panel (left arrow)

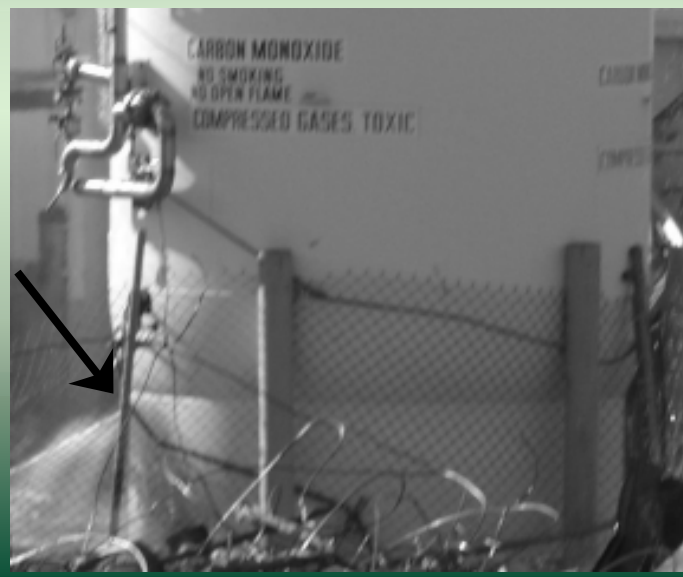
Figure 4

CO gas venting from ruptured fill line (arrow) on displaced vessel

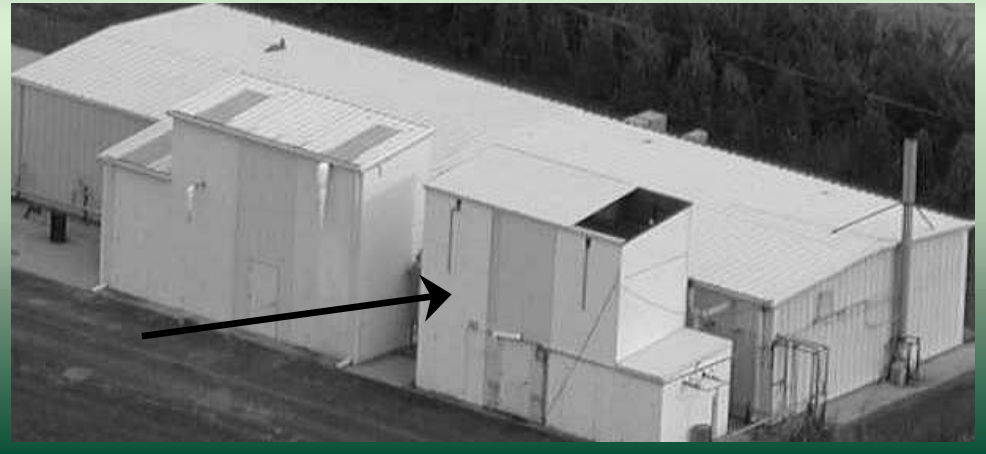
Figure 8

The exterior blast containment structure was an open-top, four-wall rectangular carbon steel plate configuration. Each wall was fabricated using two unreinforced 0.5-inch-thick plates spaced about 4 inches apart. The gap between the plates was filled with sand; the wall panels were welded at the corner joints using structural steel angle shapes.

Although Isotec management reported that the shield was based on an LANL design, the Isotec structure omitted two key safety features:

Blast shield around N6 distillation column, similar to N3 blast shield

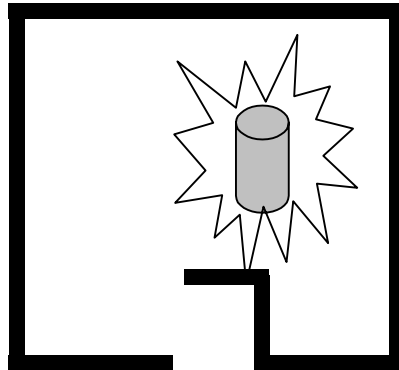
- ◆ A heavy steel wire mesh top to capture debris.
- ◆ A wide top-to-bottom labyrinth opening in one wall to prevent pressure buildup, as depicted in Figure 9 and discussed in Section 5.2.3.

Labyrinth opening to release pressure and block projectiles

A more effective blast shield structure would have included a labyrinth opening (Figure 9) and a steel wire mesh top similar to the LANL blast structure. This configuration would be much less likely to catastrophically fail.

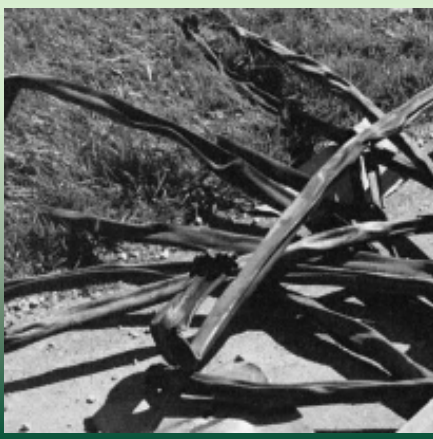
Figure 10

Distillation column components ejected from near the top of the well casing provided strong evidence that the column piping experienced high temperature and extreme crushing pressure, most likely from a high-energy explosion in the vacuum jacket (Figure 10). The debris from the vacuum jacket consisted of small metal shards (Figure 11), indicating high-order explosive failure.¹¹

2-inch-diameter stainless-steel piping oxidized and crushed

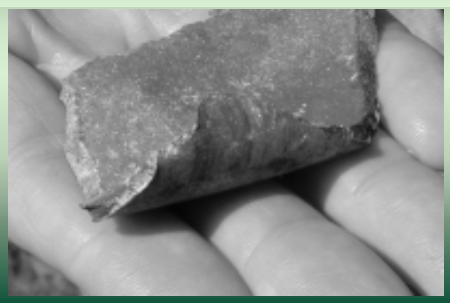
Figure 11

¹¹ NFPA 921 characterizes a high-order explosion as shattering of the structure, producing small, pulverized debris. Rapid rates of pressure rise splinter or shatter walls, roofs, and structural members; and the building is completely demolished.

Stainless-steel shard,
likely from vacuum jacket
