CASE STUDY

Fire at Formosa Plastics Corporation: Evaluating Process Hazards

2006-01-I-TX

Point Comfort, Texas
October 6, 2005

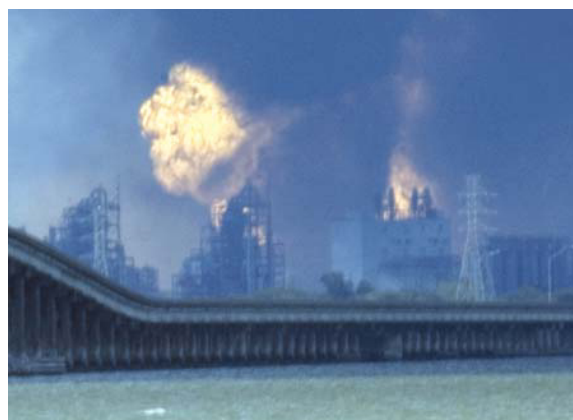
Figure 1. Point Comfort fire.

At about 3:07 PM, the vapor ignited, creating an explosion.² The explosion knocked down several and burned two (one seriously) operators exiting the unit. Flames from the fire reached more than 500 feet in the air (Figure 1).

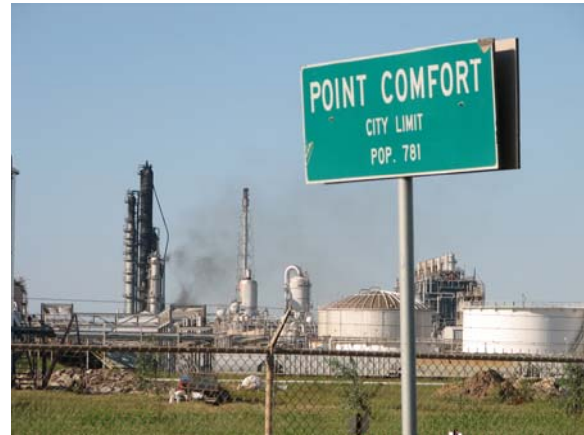
Figure 2. View of the Damaged Plant from Highway 35.

Within minutes of the initial explosion, local officials ordered a shelter-in-place for the Point Comfort community and closed Highway 35 that runs adjacent to the Formosa complex and through Point Comfort (Figure 2). Students and staff at the Point Comfort Elementary School evacuated to Port Lavaca, about five miles away. Local officials rescinded these measures by 9:00 PM that night.

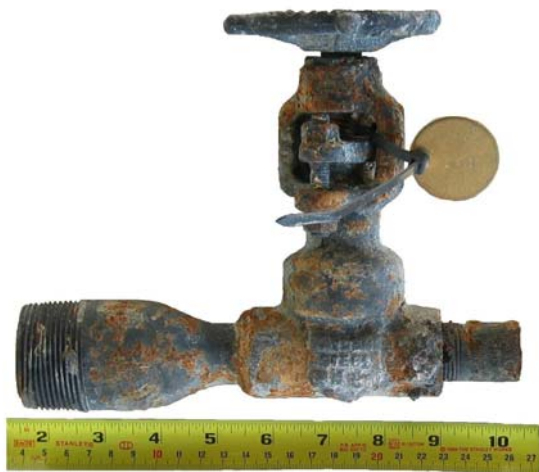
Figure 4. Valve and pipe.

- A worker driving a fork truck towing a trailer under a pipe rack backed into an opening between two columns to turn around.
- When the worker drove forward, the trailer caught on a valve protruding from a strainer in a propylene piping system.
- The trailer pulled the valve and associated pipe (Figure 4) out of the strainer, leaving a 1.9-inch diameter opening.⁶

⁶ The valve was attached to a pipe that was threaded into the strainer cover.

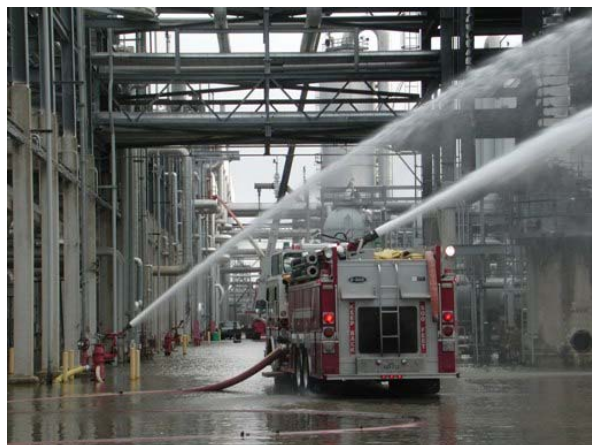
Figure 5. Formosa ERT equipment.

- The Formosa ERT arrived and took command of the incident response (Figure 5).

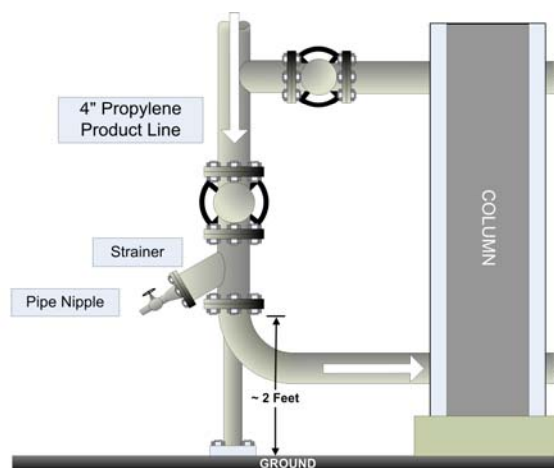
Figure 6. Pipe and valve arrangement.

The propylene piping involved in this incident protruded into an open space, yet had no impact protection (Figure 6).

Formosa has administrative safeguards for vehicle operation in the unit, including a plant-wide speed limit, a vehicle permitting process, and a crane use procedure. However, these safeguards do not specifically address where vehicles may operate within the unit.

The plant design drawings designate specific access ways for vehicles; these are not physically marked in the unit. The area where the impact occurred was not a designated access way but was large enough for a vehicle to easily pass.

The ASME B31.3 “Process Piping Code” states, “Impact forces caused by external or internal conditions shall be taken into account in the design of piping.”

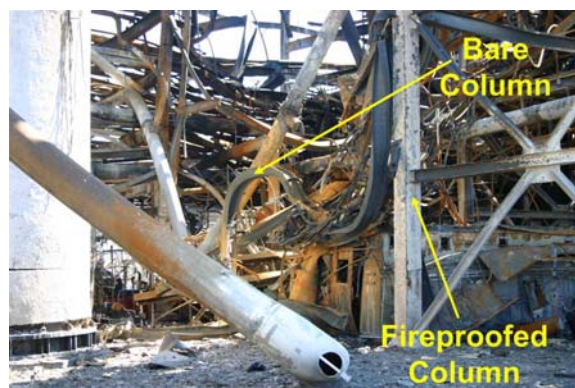
Figure 7. Fireproofed and bare steel support columns.

During the fire, part of a structure supporting the relief valves and emergency piping to the flare header collapsed. The collapse caused several pipes to crimp, likely preventing flow through the pipes and leading to the rupture of major equipment and piping that added fuel to the fire.

Passive fire protection (fireproofing⁹) was installed on only three of four support column rows and the columns that supported the pressure relief valves and emergency vent piping had no fireproofing (Figure 7). The bare steel columns bent over, while the fireproofed columns remained straight.

Had the steel been fireproofed as API recommends, the consequences of this incident would likely have been less severe.

Evaluate the applicability and use of current consensus safety standards when designing and constructing a chemical or petrochemical process plant. This should include reviewing and updating earlier designs used for new facilities.

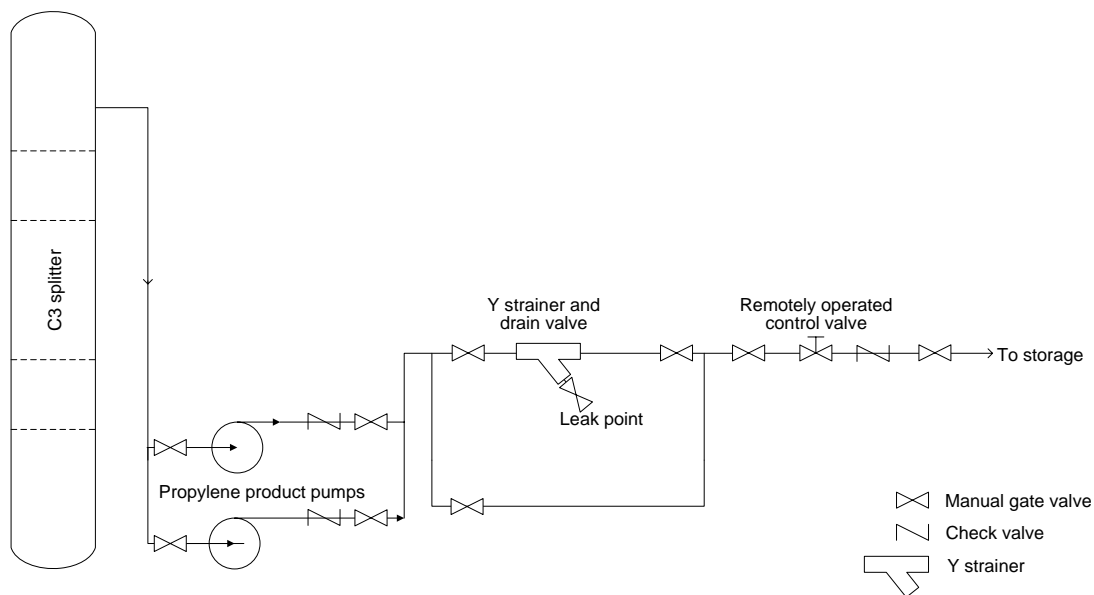
Figure 8. Propylene product flow.

Figure 8 shows the general arrangement of the piping and valves around the leak point. The leak occurred between manual block valves and a remotely operated control valve. While a check valve and remotely operated isolation valve downstream of the leak prevented the backflow of propylene from product storage, operators were unable to reach the manual valves capable of stopping the flow from the distillation column. The operators were also unable to reach the local control station to turn off the pumps supplying propylene, although they eventually turned off the pumps at the motor control center located in the control room building, slowing the rate of propylene feeding the fire.

Had a remotely actuated valve been installed upstream of the pumps, this incident would likely have ended quickly, possibly even before ignition occurred. Additionally, had

remote control of the pumps been possible from the control room, the propylene flow could have been quickly reduced, potentially reducing the severity of the incident.

Had Formosa been able to isolate the major hazard inventories in the unit as recommended in industry guidance, the consequences of this incident would likely have been lessened.

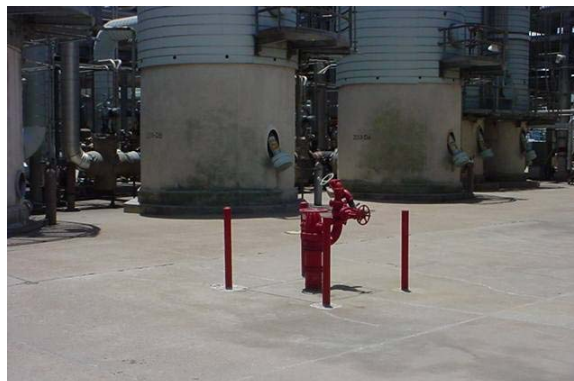
Figure 9. Protection of fire fighting equipment.

The contrast between the physical protection for firefighting equipment and the administrative provisions for process piping and other equipment is striking. Figure 9 shows the protection afforded firefighting equipment, while Figure 10 shows the lack of protection where the impact and release occurred.

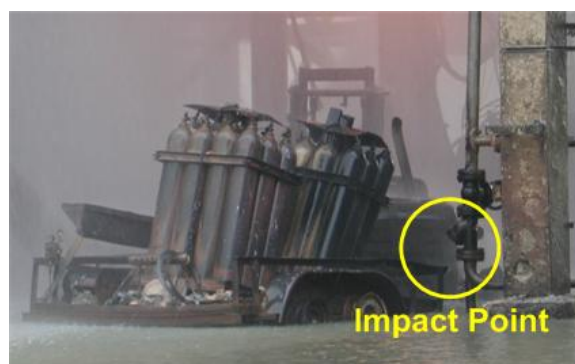
Figure 10. Vehicle impact point.

During the facility siting analysis, the hazard analysis team discussed what might occur if a vehicle (e.g., fork truck, crane, man lift) impacted process piping. While the consequences of a truck impact were judged as “severe,” the frequency of occurrence was judged very low (i.e., not occurring within 20 years), resulting in a low overall risk rank.¹¹ Because of the low risk ranking, the team considered existing administrative safeguards adequate and did not recommend additional traffic protection.

Revise policies and procedures for process hazard analysis and pre-startup safety review to more fully evaluate vehicle impact hazards, passive fire protection, and catastrophic releases.
