U.S. CHEMICAL SAFETY AND HAZARD INVESTIGATION BOARD

INVESTIGATION REPORT

T2 LABORATORIES, INC.

RUNAWAY REACTION

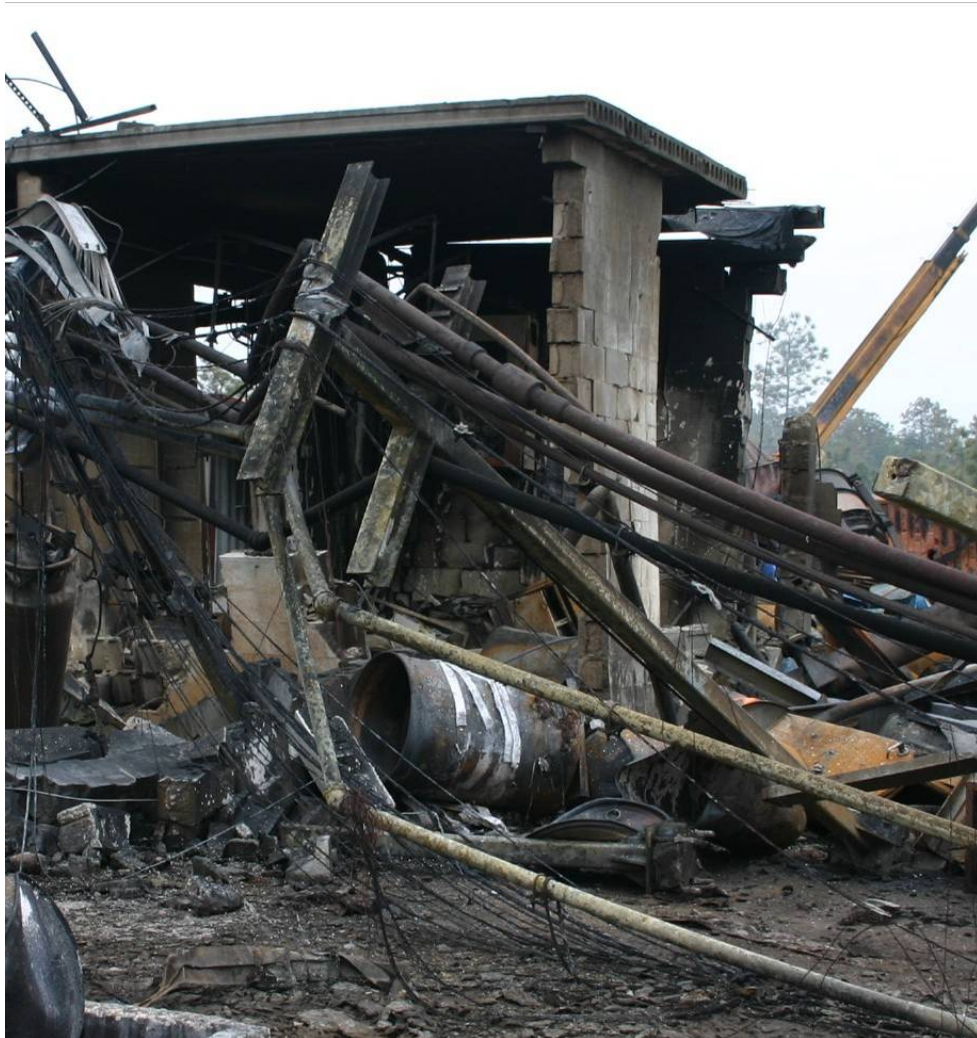
Figure 2. Control room.

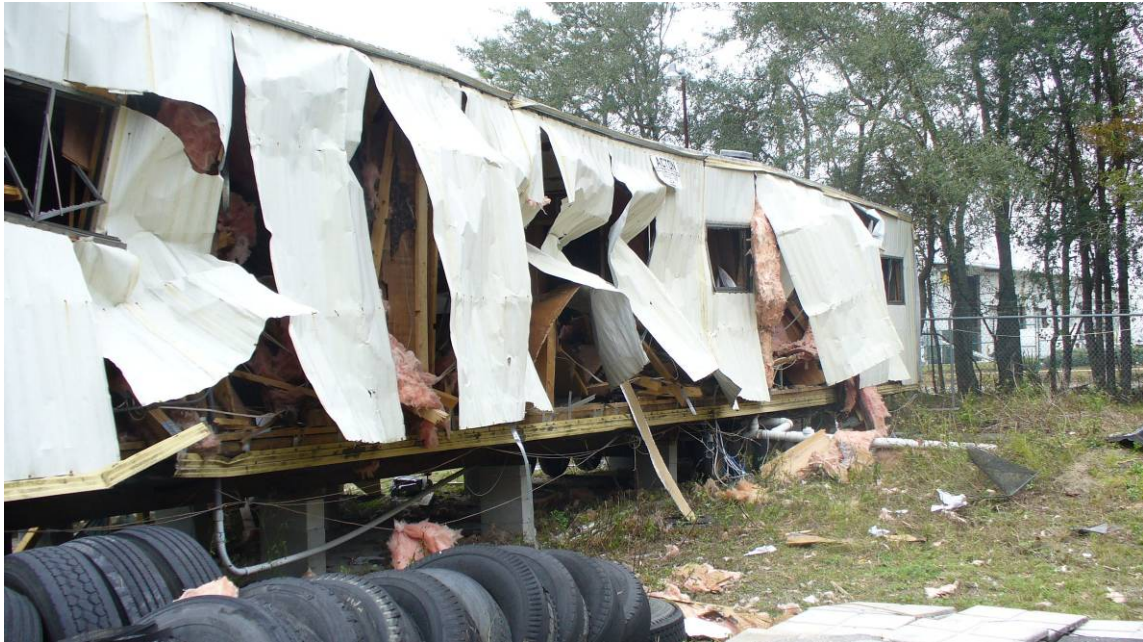
Businesses near T2 sustained heavy damage. Structures sustained window damage from the overpressure up to 1,700 feet away from T2. The explosion destroyed a trucking company office trailer located 250 feet from the reactor (Figure 7). If trucking company employees had been in the trailer at the time of the incident, it is likely that they would have been seriously injured or killed.¹¹ Two warehouses located about 400 to 500 feet from the reactor both sustained heavy damage; nine of the 25 employees at these two businesses were injured.

Figure 7. Trucking company trailer adjacent to T2.

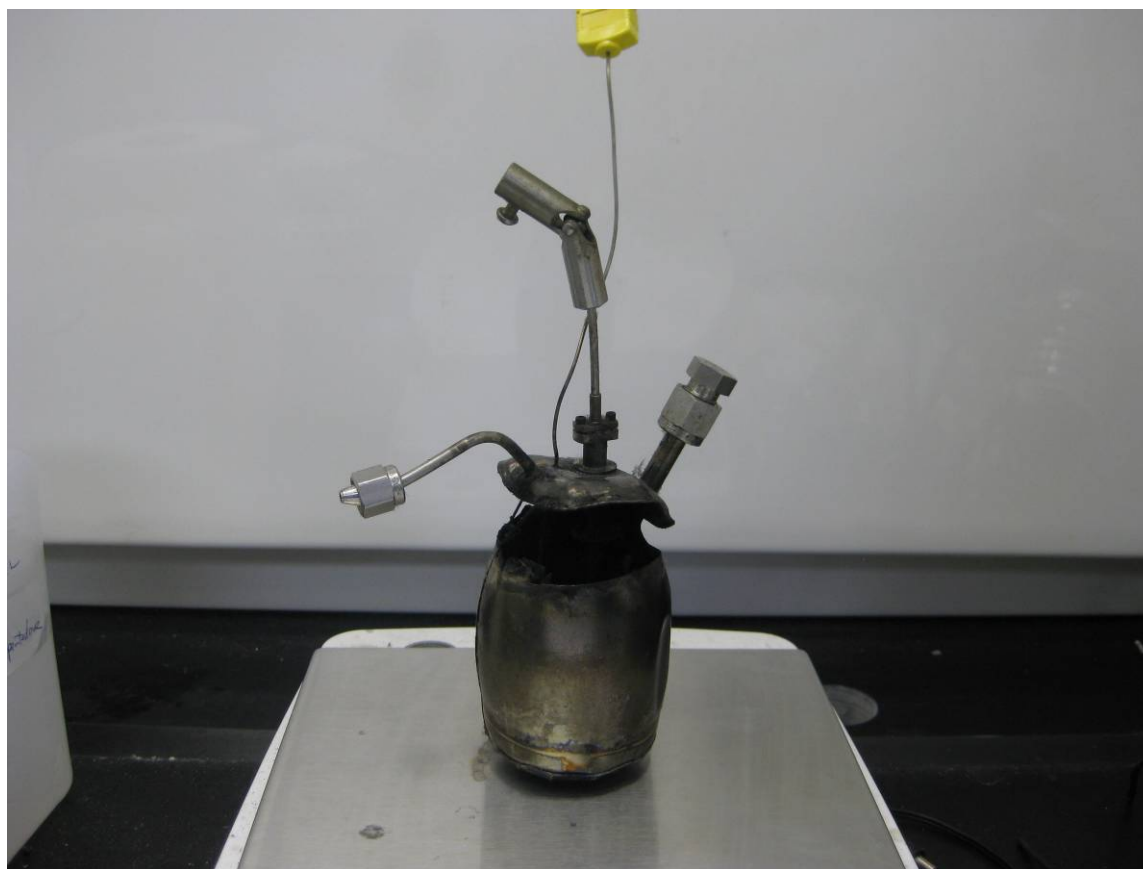
For the first two VSP2 tests, the test cell was open to the containment vessel and results similar to the ARRST tests were obtained. The CSB conducted the remaining four VSP2 tests in a closed (sealed) test cell. A second and more energetic exothermic reaction was observed when the temperature exceeded 390°F (198.9°C) in two test that used the T2 recipe. The pressure and temperature rise during the second exothermic reaction was about 32,000 psig per minute (2,206 bar per minute) and 2340°F per minute (1300°C per minute) respectively and burst the test cells (Figure 16). The other two tests performed using only sodium and diglyme solvent, suggest that this second more energetic exothermic reaction is a reaction between the sodium and diglyme solvent.

Figure 16. Burst VSP2 Test Cell.

The results of this testing show that the standard T2 chemical recipe is capable of producing the reactor failure observed on December 19, 2007. Using the data obtain from these tests, the CSB determined by calculation failure of the reactor from this second exothermic reaction could not have been prevented by an overpressure relief device. Failure could only be prevented by relieving pressure before the second exothermic reaction and allowing the MCPD and Diglyme solvent to boil and vent. Allowing the MCPD and diglyme to boil and vent removes heat from the mixture and reactants from the reactor. For T2 this would have required a rupture disk set at 75 psig in lieu of the 400 psig disk that was used.

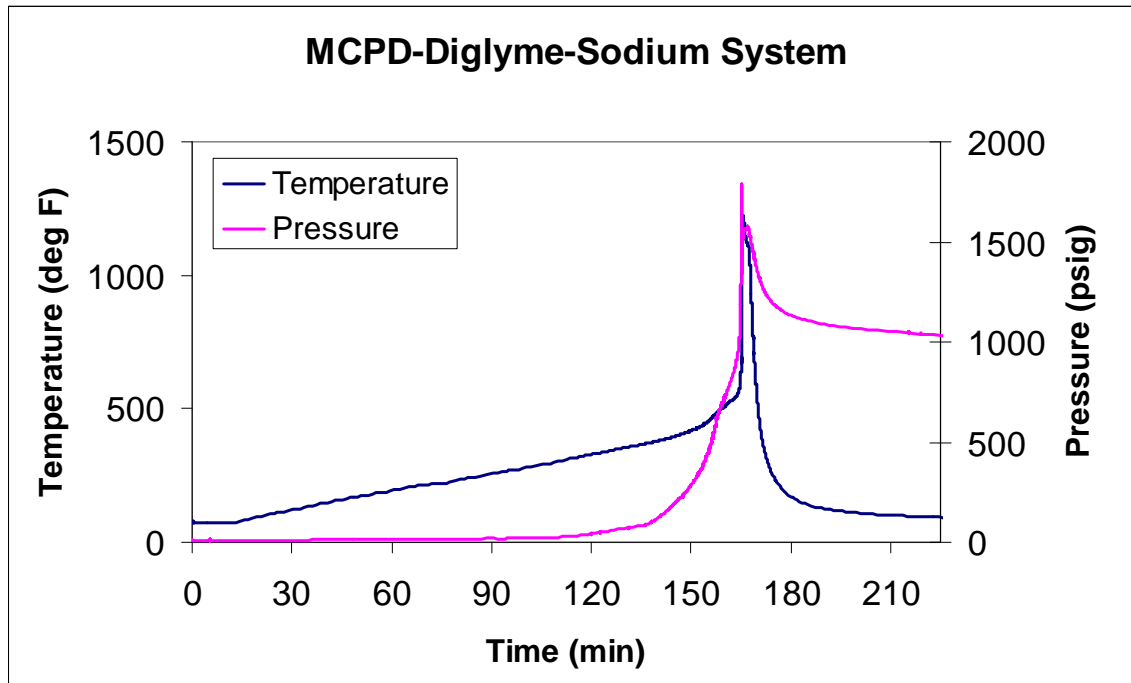
Figure 18. MCPD Diglyme Sodium Test Results.

The peak rate of temperature rise for the final test is 2340°F/minute (1300°C/minute) and the peak rate of pressure rise is 32,000 psi/minute (2206 bar/minute). In the closed system, a strong exothermic reaction occurs using the normal T2 chemical recipe.
