U.S. CHEMICAL SAFETY AND HAZARD INVESTIGATION BOARD

INVESTIGATION REPORT

LPG FIRE AT VALERO – MCKEE REFINERY

REPORT NO. 2007-05-I-TX

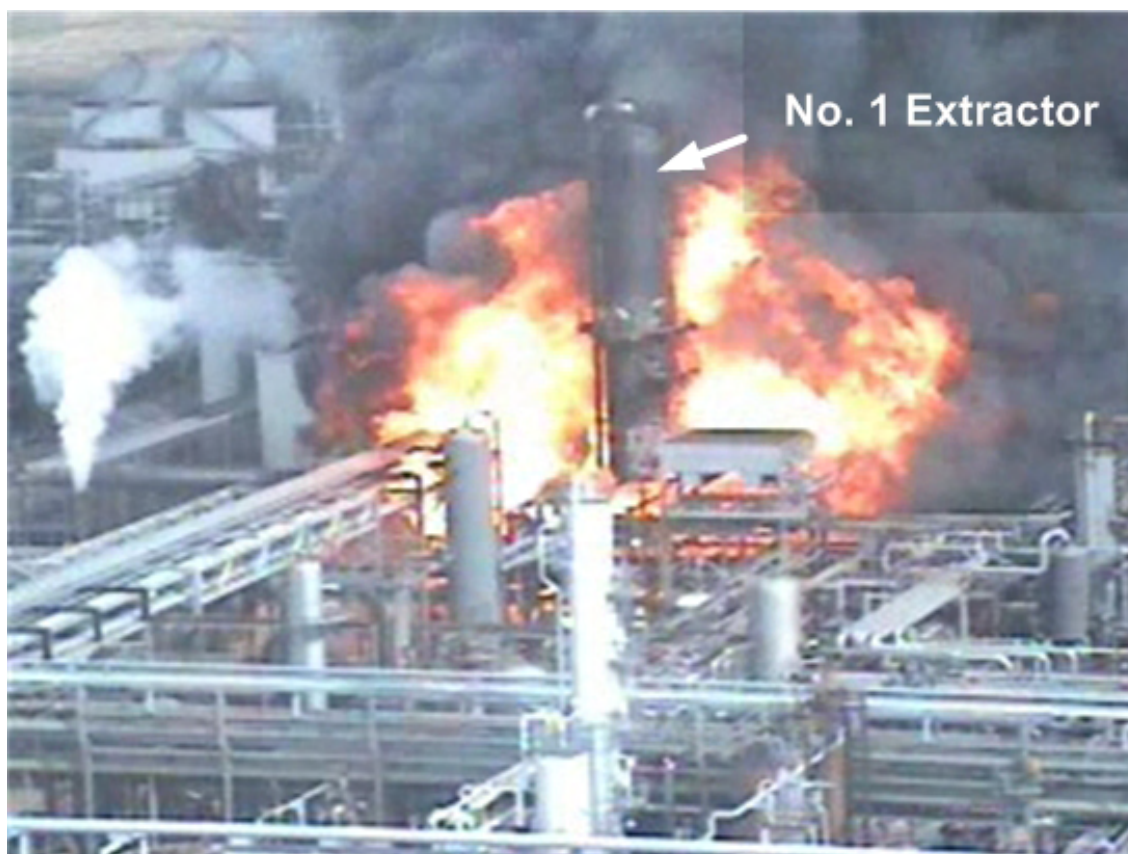
Figure 3. Approximately 90 seconds after ignition (from surveillance video)

A steel support column on the east/west (E-W) pipe rack was impacted by a high-pressure propane jet fire. The column, which was not protected by fireproofing insulation, buckled, collapsing the rack and causing multiple pipe failures. Liquid petroleum products discharged from the damaged pipes, contributing to the rapid spread of the fire and the damage caused to surrounding equipment, such as the No. 2 Cooling Tower and No. 4 Naphtha Column.

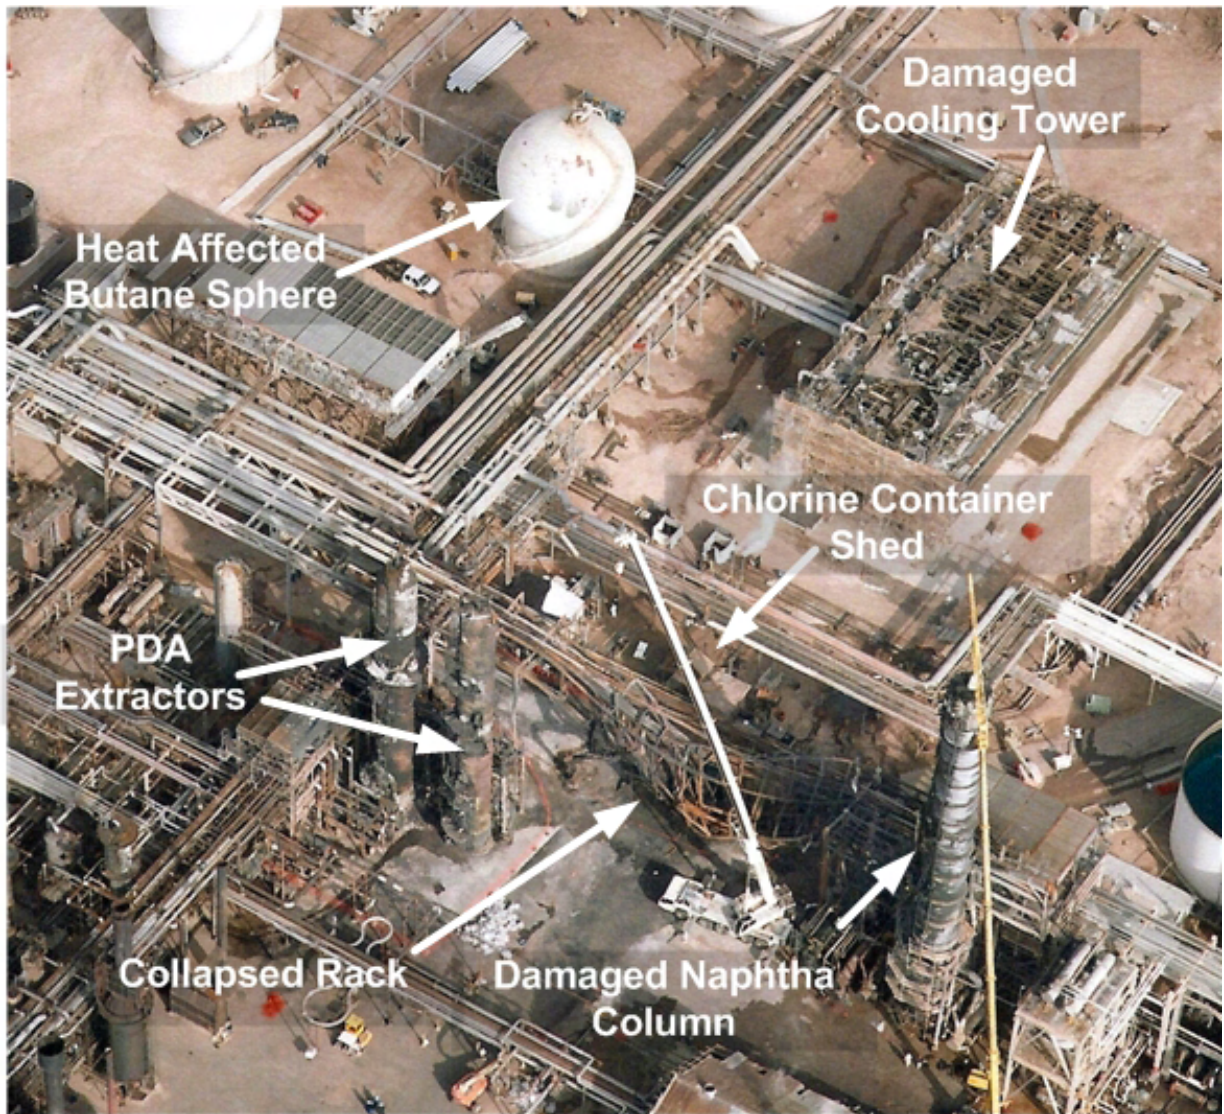
Figure 4. Aerial photograph of damage from the PDA unit fire

The PDA unit was heavily damaged (Figure 4). Much of the piping, control wiring, and heat exchange equipment in the area of the extractors was destroyed and major equipment items, including the extractor towers, required extensive evaluation to determine if they were safe for continued use. Valero restarted the rebuilt PDA unit in January 2008, nearly one year after the fire, restoring the refinery to full production capacity.

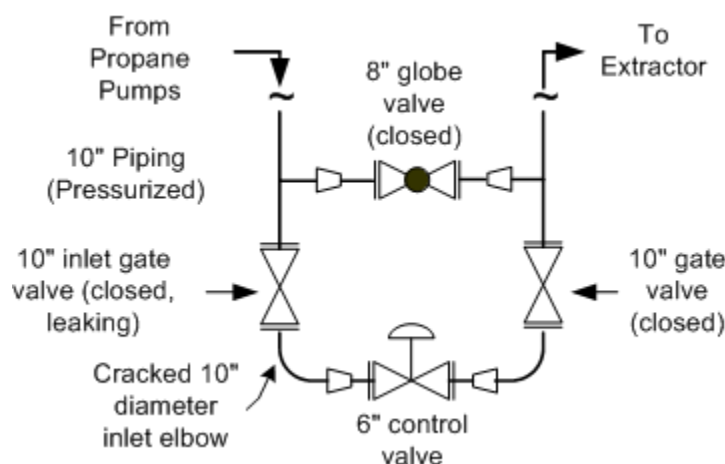
Figure 5. Propane mix control station schematic (not to scale)

In this incident, water settling out of a propane stream likely leaked through a 10" NPS²⁰ (250 DN) inlet block valve and accumulated in the low point formed by a control station (Figure 5). The control station was connected to the process, but had not been used for approximately 15 years. A period of cold weather likely froze the water, fracturing the pipe elbow upstream of the control valve. Warmer weather then melted the ice, resulting in a release of highly pressurized liquid propane through the fractured elbow. Appendix B contains a detailed time line of the incident.

The station's configuration made it a dead-leg: a section of piping connected to the process with no flow through it. Water in the propane likely sank into the dead-leg, leaked by the inlet block valve, and accumulated in the control station piping.²⁴

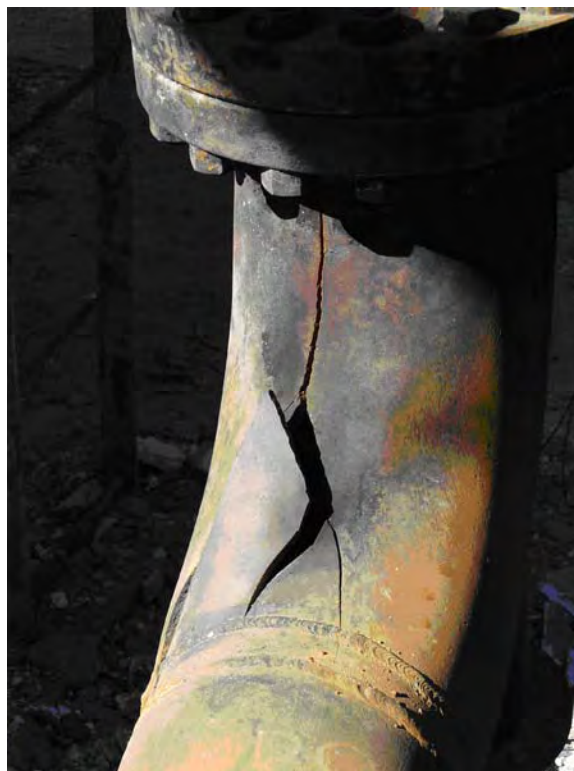
Figure 6. Crack in the 10" diameter propane mix control station inlet elbow

The extended period of cold weather and the lack of freeze protection on the control station allowed the water to freeze and expand, cracking the elbow upstream of the control valve. The crack propagated along the inner radius of the elbow, the line of highest stress (Timoshenko, 1958), opening wider as it developed (Figure 6). Appendix C contains a more detailed discussion of the CSB's analysis of crack formation and propagation. The damage to the inlet elbow and the post-incident leak rate determined for the inlet block valve are consistent with the estimated initial propane release rate during the incident.

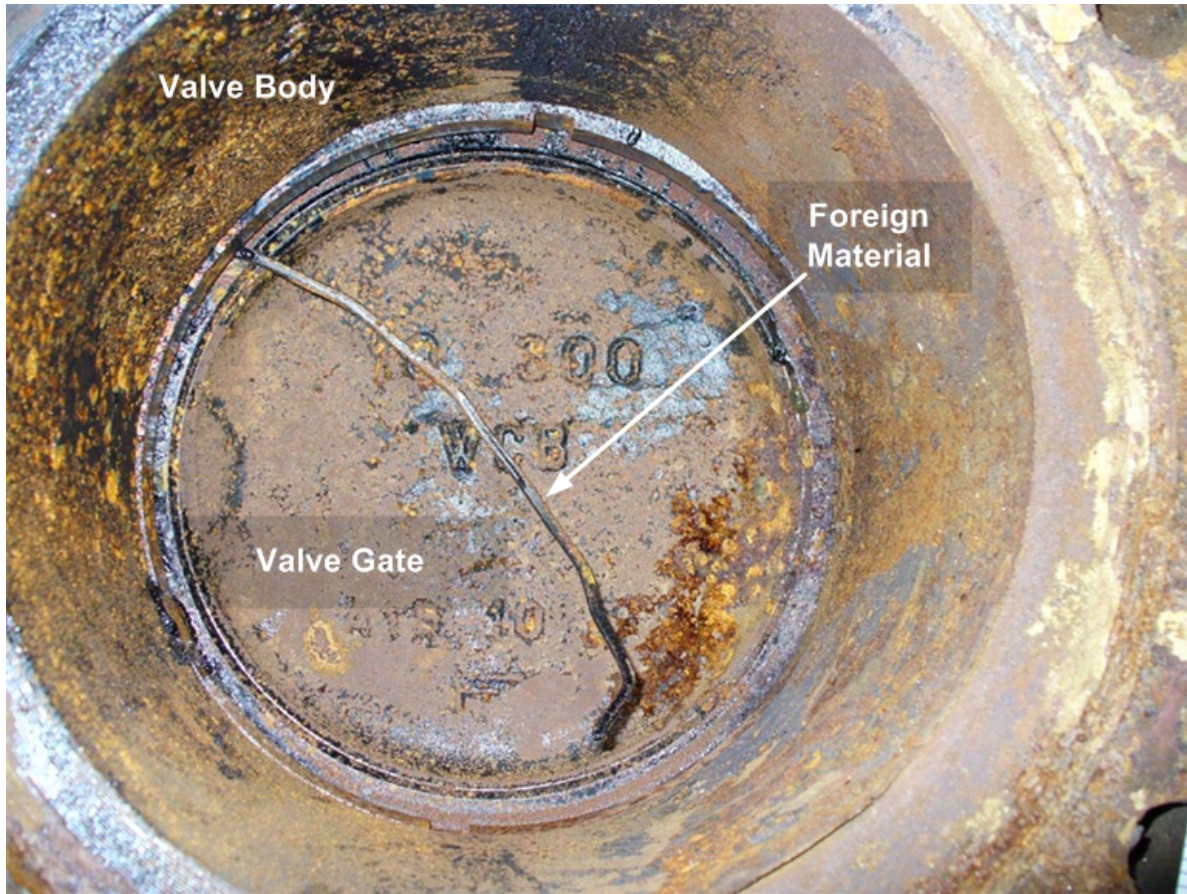
Figure 7. Downstream view of propane mix control station inlet block valve

On February 16, 2007, shortly after 9:00 a.m., ambient temperatures rose above freezing and the ice inside the elbow began to thaw. Post-incident examination of the control station inlet block valve (Figure 7) revealed that a foreign object was jamming the valve,²⁵ creating a leak path. When tested in a laboratory after the incident, this valve allowed over 1,025 gpm (233 m³/hour) of water to leak through at process pressure. At approximately 2:09 p.m., melting ice opened the leak path, releasing liquid propane at 500 psig (3,447 kPa) pressure through the cracked elbow. A flammable vapor cloud rapidly formed. Based on recorded data from the PDA unit's computerized control system, the CSB estimated an initial propane leak rate of 4,500 pounds (2,040 kg) per minute (Appendix D describes the propane mass balance calculations used to develop this figure).

²⁵ In gate valves, a circular gate slides against metallic seat rings, providing a leak-tight seal when the valve is closed. The foreign object in the inlet gate valve prevented a tight fit between the gate and the seat rings.

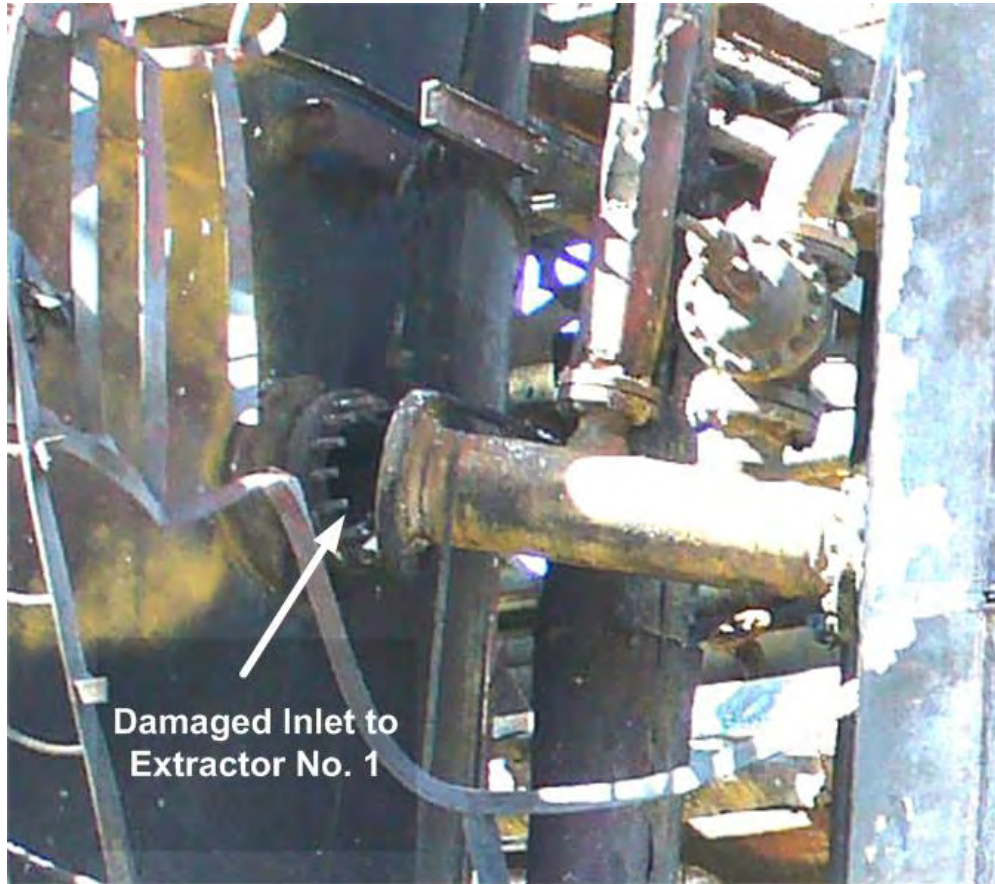
Figure 8. Damaged 10" propane inlet on Extractor No. 1

The wind blew the propane cloud toward the boiler house, where it likely ignited.²⁶ The flames flashed back to the release point. The size and intensity of the resulting fire blocked access to manual shut-off valves and pump on-off switches that might otherwise have been used to control the propane discharge. Within minutes, the fire damaged piping and pipe rack supports, spreading the fire (Figures 4, 8, 9).

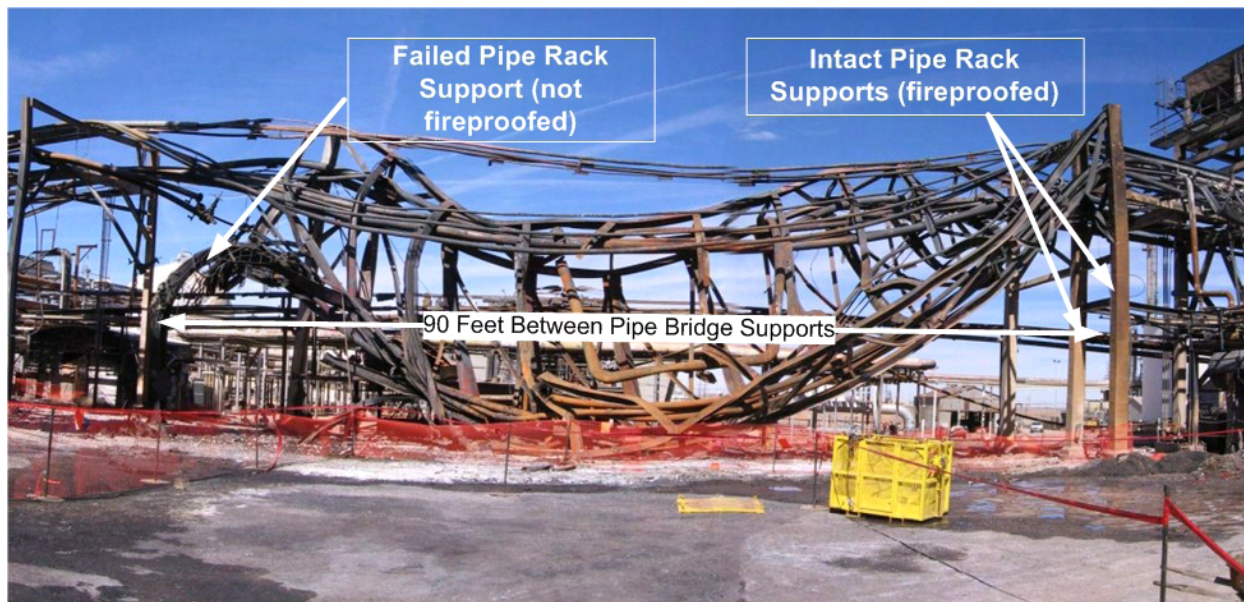
Figure 9. Pipe bridge support fireproofing

A non-fireproofed structural support for a pipe bridge³³ spanning a 90-foot wide open area north and east of the PDA unit (Figure 9) collapsed early in the incident, greatly increasing the magnitude of the fire. The support was located on a major E-W pipe rack north of the unit, outside the fireproofing distances recommended by API guidance and Valero internal standards. The collapse opened multiple lines carrying flammable and combustible materials from other areas of the refinery, contributing significantly to the damage experienced by adjacent units, and extending the time that the refinery was down for repairs. Fireproofed pipe rack support steel columns inside the PDA unit and at the No. 4 Naphtha Column all survived the fire without collapsing (Figure 10).

Valero Energy Corporation's SP-00-04, *Fire Proofing Specifications*, calls for fireproofing pipe racks within 30 feet of equipment with the potential to cause a serious fire, but makes no special provisions for processes handling LPG. A loss-prevention report produced for the McKee Refinery listed fireproofing of pipe rack support steel, including the E-W pipe rack north of the PDA unit, as a top priority for the site fireproofing program, but the rack had not been fireproofed at the time of the incident.

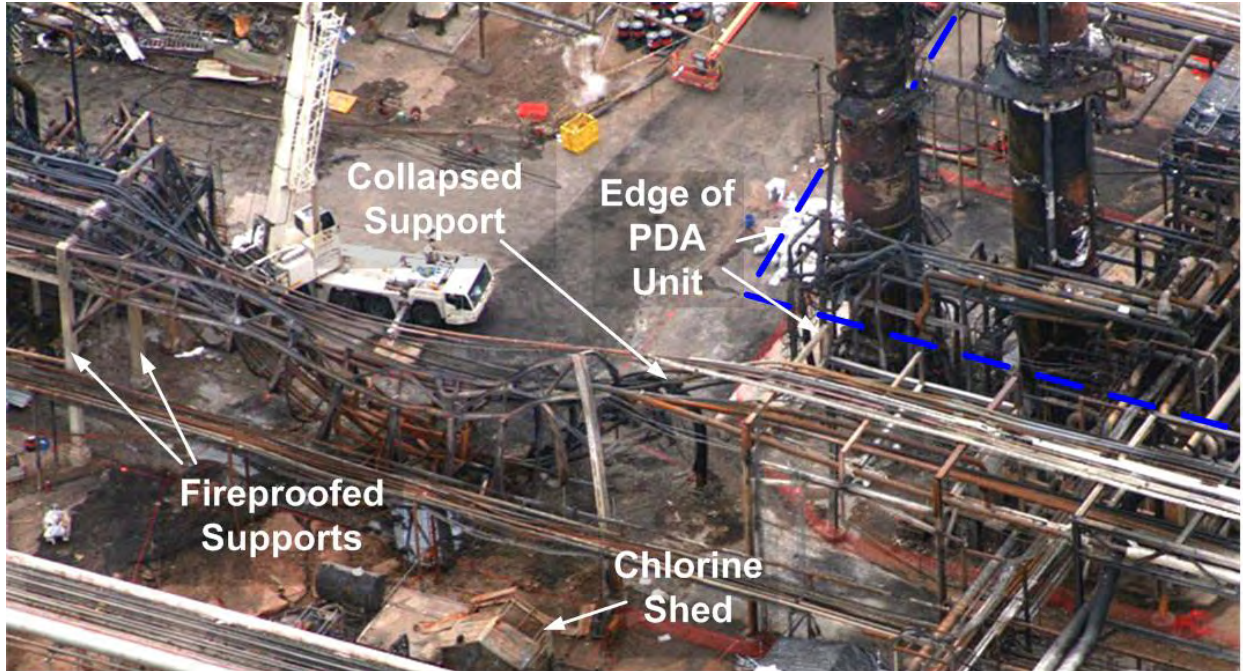
Figure 10. Extractor towers (upper right) and collapsed pipe rack

A failed inlet flange to the No.1 Extractor, located 77 feet away from the buckled pipe bridge support, was the most likely source of the jet fire that collapsed the pipe bridge (Figure 11). The closest major process vessel (the No. 2 Extractor) was 51 feet away from the support. These distances exceed both API's and Valero's recommended fireproofing distances.

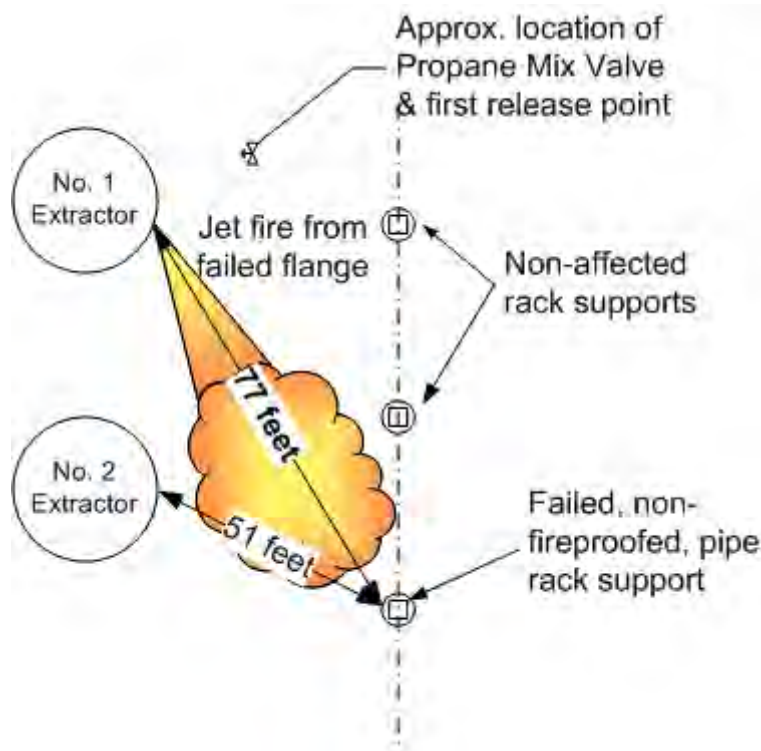
Figure 11. Distances between the E-W pipe rack supports and the extractors

API 2218 references the API 2210/2210A LPG fireproofing distance of 50 feet, developed for pool fires in LPG storage units. Neither standard addresses fireproofing for LPG processes or jet fire scenarios, even though process unit conditions, including pressure, can be more extreme than those found in storage facilities. In this incident, the high operating pressure of the extractors (500 psig, 3,447 kPa) likely produced a jet fire with a range and intensity beyond that anticipated in the API standards for LPG storage releases.

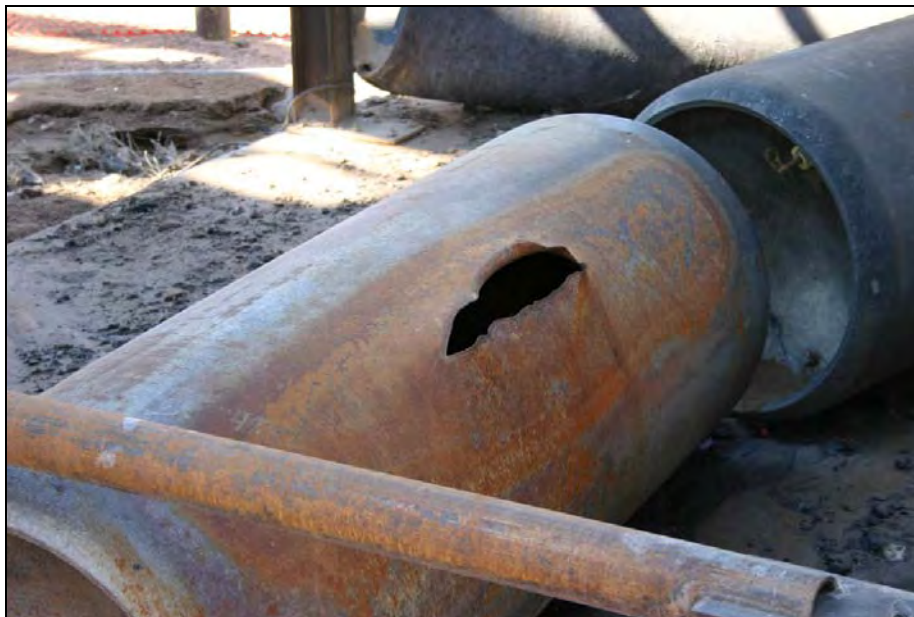
Figure 13. Ruptured one-ton chlorine container

Post-incident examination revealed that three one-ton chlorine containers in a cooling tower water treatment shed were subjected to radiant heating due to their proximity to the PDA unit (100 feet to No. 2 Extractor) and pipe rack (20 feet). All three containers vented when their fusible plugs, installed to prevent container rupture, melted as designed. One container ruptured despite the operation of its fusible plugs, and another vented completely. The third developed a leak through a partially melted plug that was repaired by emergency responders using self-contained breathing equipment for protection against the toxic vapor. More than 2.5 tons of chlorine, an extremely toxic material, were released.¹⁸

Safer materials for controlling biological growth in cooling towers are available, and Valero has identified replacing chlorine in cooling water treatment at all its refineries as a safety goal in its 2008-2012 Strategic Plan. The plan noted that 10 of its 18 refineries (as of May 2007) used ton container quantities of gaseous chlorine as a cooling water biocide. The McKee Refinery substituted sodium hypochlorite (bleach) for chlorine in its No. 2 Cooling Tower during PDA unit reconstruction. Bleach essentially stores chlorine in a form that presents a much lower inhalation hazard, an example of the inherently safer principal of attenuation (Kletz, 1998).^{49, 50}

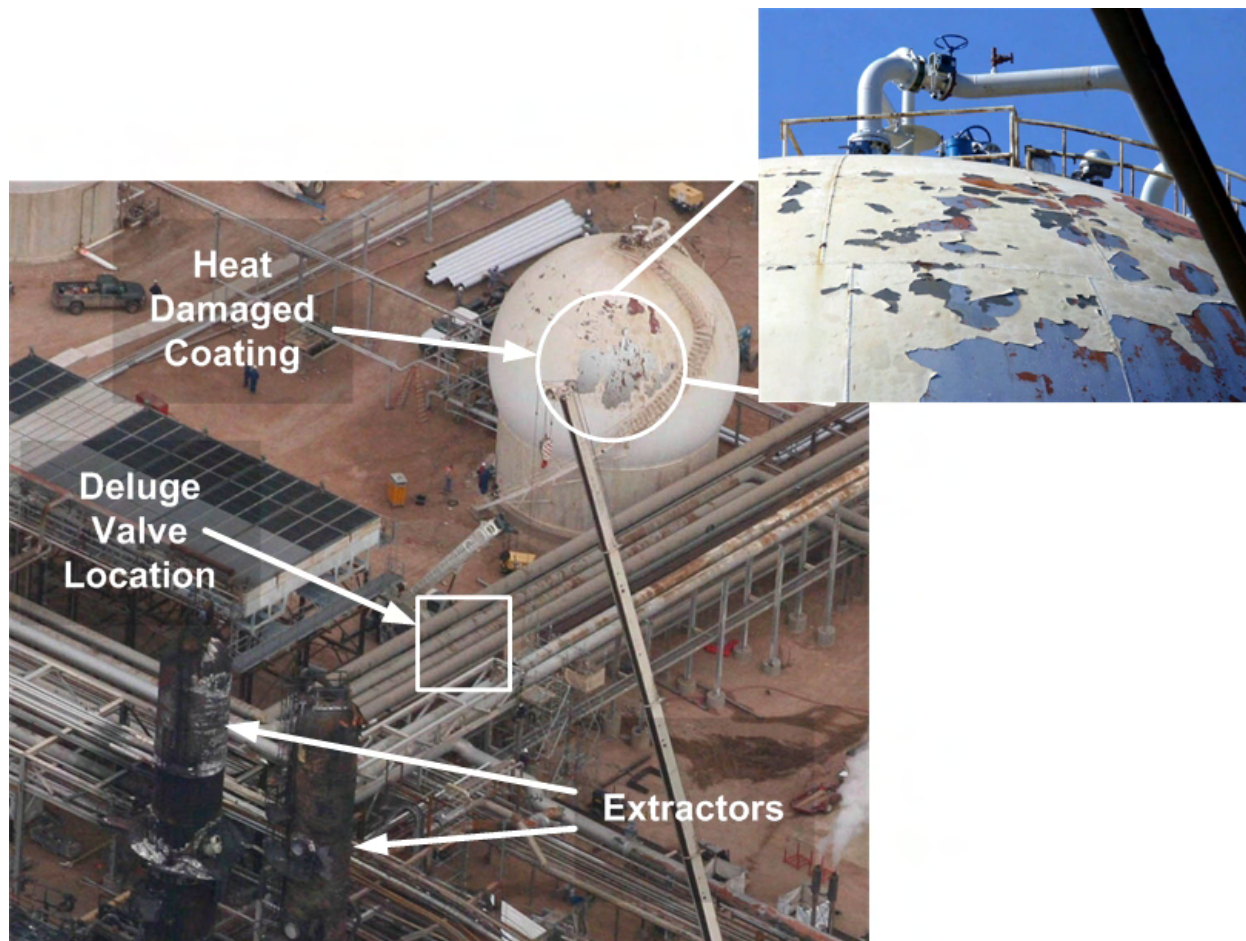
Figure 14. Heat-damaged coating on sphere and location of sphere deluge valves

approximately 3,600 barrels (151,000 gallons, 572 m³) of liquid butane under pressure, and was exposed to radiant heat from the fire. Figure 14 shows heat damage to the white protective coating on the tank's exterior.

Analysis of the overall effects of the fire revealed significant vessel damage as far as several hundred feet away from the PDA unit, generally downwind from the initial release, and including the insulated No. 4 Naphtha Column. Although the wind shifted several times during the fire, it never blew strongly from the southeast, which would have directed the flames toward the uninsulated butane sphere. Exposure to direct flame impingement or to significant heating over a prolonged period might have resulted in a vessel failure with potentially catastrophic consequences.

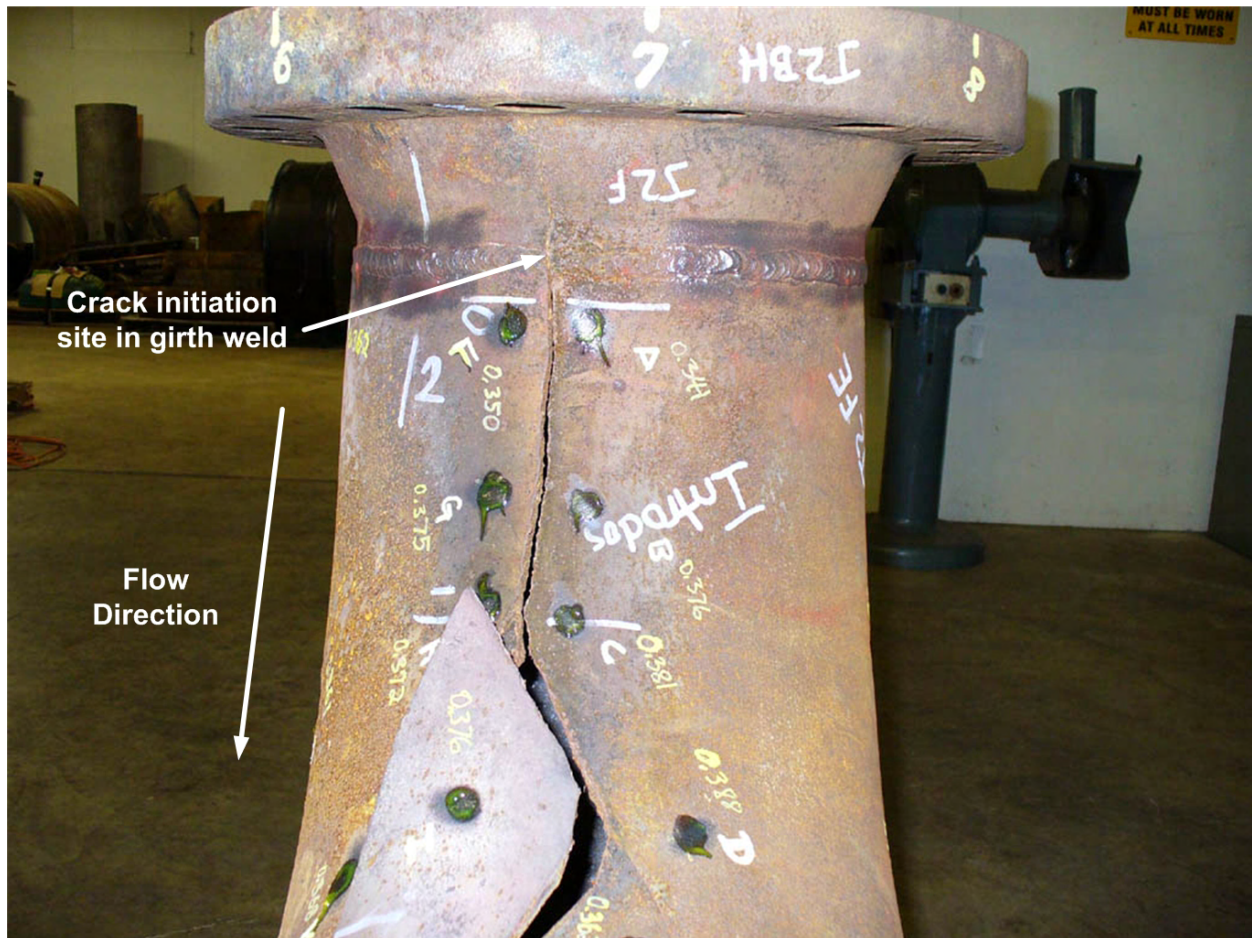
Figure C- 1. Fractured inlet elbow

The fracture in the inlet elbow of the No. 1 Extractor propane mix control station initiated in the exterior surface (cap) welding pass of the girth weld that joined the 10" NPS inlet flange to the 10" elbow, on the intrados (the inner radius) of the elbow (Figure C- 1). No flaw was observed at the initiating site, and the elbow and flange materials were within specification for tensile properties and chemical composition.¹

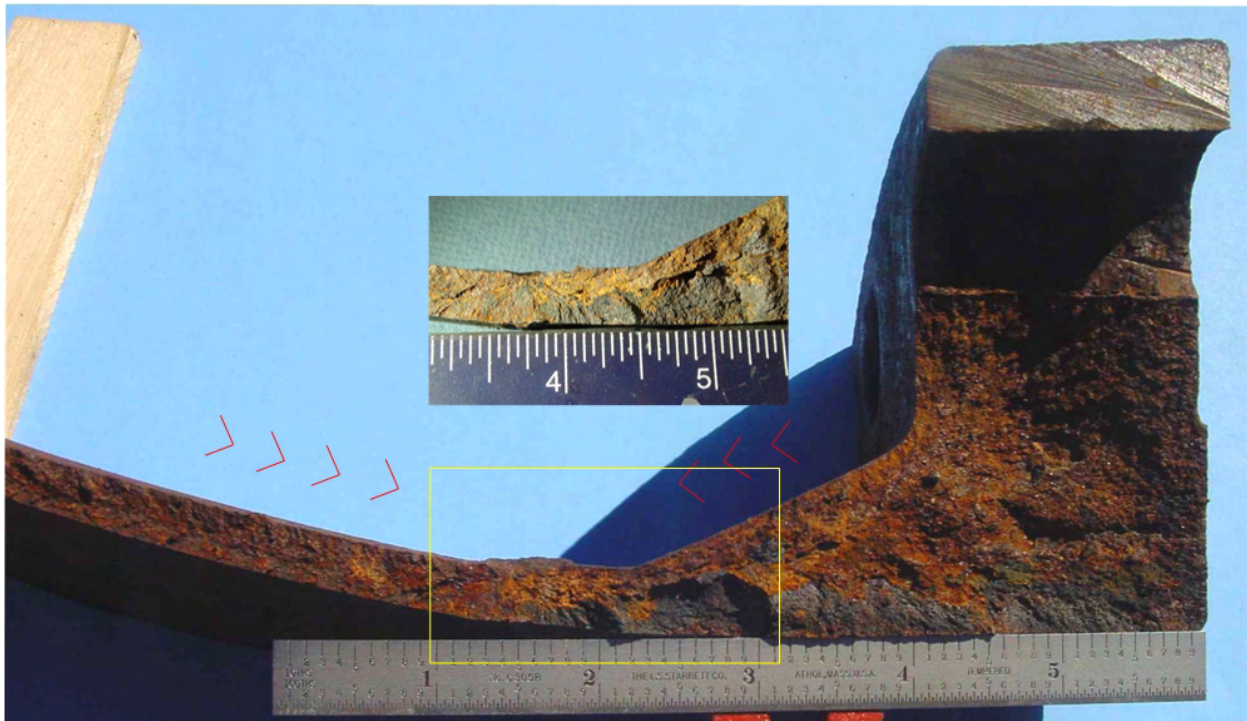
Figure C- 2. Origin and brittle propagation markers

The fracture propagated parallel to the pipe axis in both directions, with the surface exhibiting brittle fracture propagation features (Figure C-2).

Charpy V-notch (CVN) toughness tests were performed on the elbow and flange materials. Based on a 50 percent shear-area appearance, ductile to brittle transition temperatures were determined to be 95°F and 70°F (35°C and 21°C), respectively. Given that this piping was exposed to temperatures as low as 6°F (-14°C), brittle propagation behavior could be expected in these components.
