# INVESTIGATION REPORT

## XCEL ENERGY HYDROELECTRIC PLANT

### PENSTOCK FIRE

REPORT No. 2008-01-I-CO

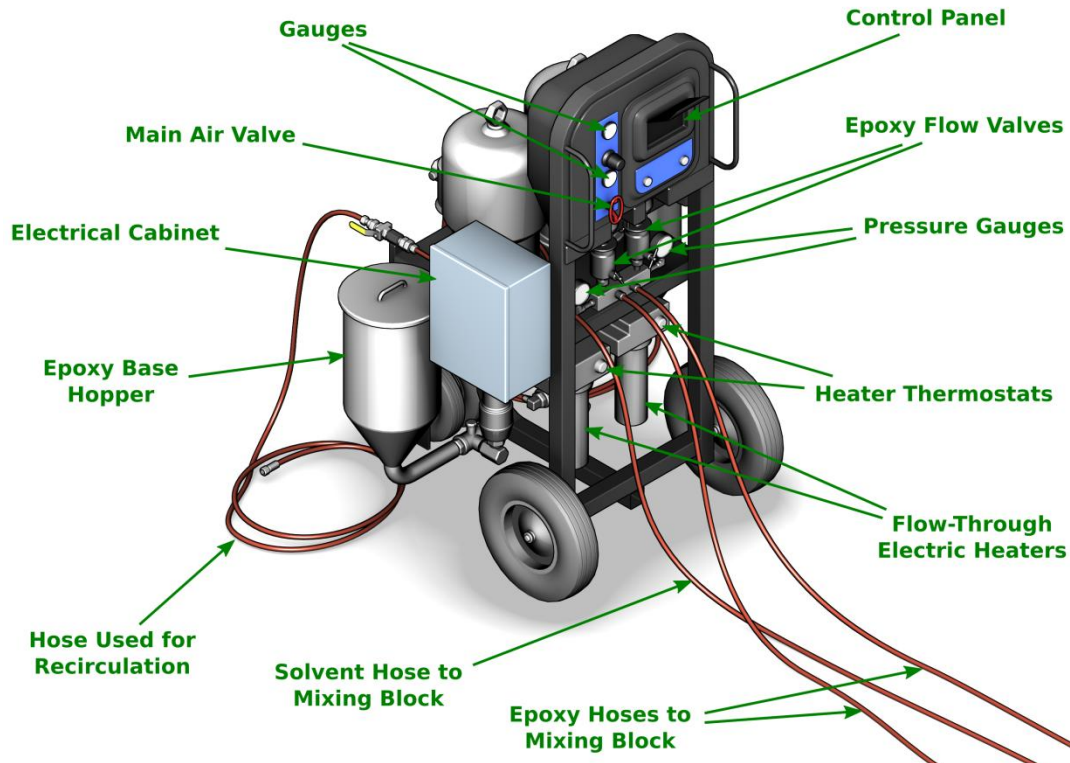
Figure 5. The epoxy sprayer system used within the penstock

At approximately 1:55 p.m., on Tuesday, October 2, 2007, a flash fire ignited at the sprayer in the immediate vicinity of the base hopper while the contractors were flushing the system with MEK. An RPI contractor was circulating the MEK from the base hopper through the pump, discharging the solvent back into the hopper through a nylon hose. At the time of the ignition, the contractor was holding the end of the hose equipped with a metal fitting inside the base hopper; he reported witnessing the initial flash arising from the interior of the hopper. The burning solvent forcefully erupted from the hopper and sprayed onto the contractor and the surrounding area. The flash fire caught the contractor's sleeve on fire and quickly engulfed the buckets of MEK. Another contractor, who left the work area to retrieve portable fans to help dissipate the strong MEK odor, was about 40-50 feet (12-15 meters) from the sprayer when the fire ignited. Two others, on their way out of the penstock to retrieve more MEK, heard a loud rumble; they turned in the direction of the noise and saw a flash of fire that seemed to roll toward them. These eyewitnesses reported that the fire appeared to come from the base hopper.

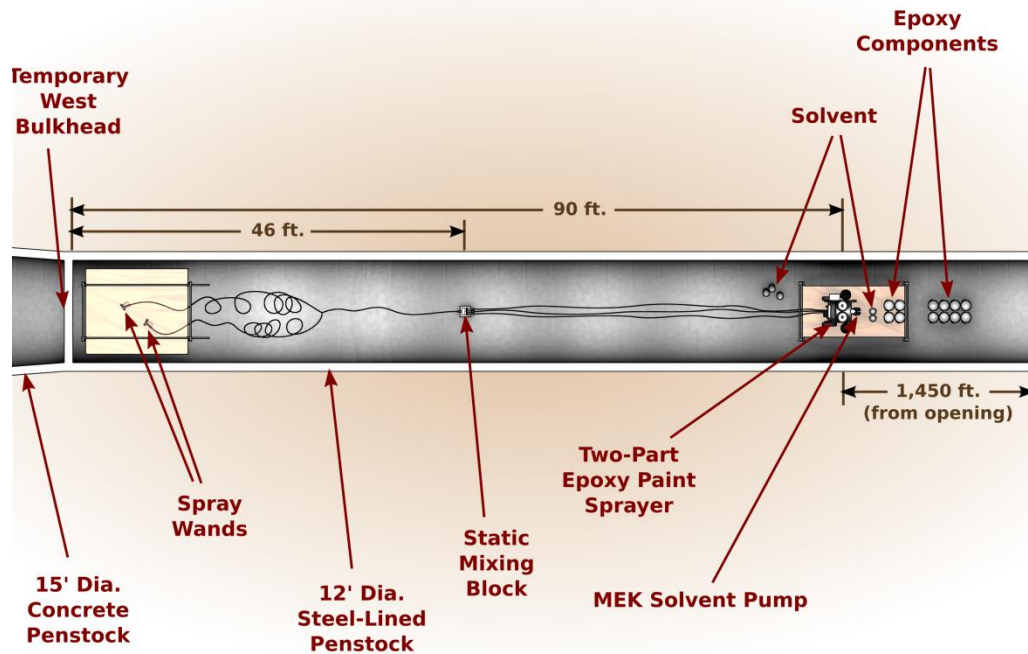
Figure 7. Aerial view of equipment arrangement in work area of the penstock

The sprayer was positioned in the penstock on wheeled scaffolding, which the RPI crew called the “stage,” about 1,450 feet (442 meters) from the access door and approximately 90 feet from the west bulkhead (Figure 7). The controls for the sprayer faced the west bulkhead, so that when a contractor was in position to manipulate the controls, he was looking in the direction of the access door, with the sprayer between him and that single point of egress.

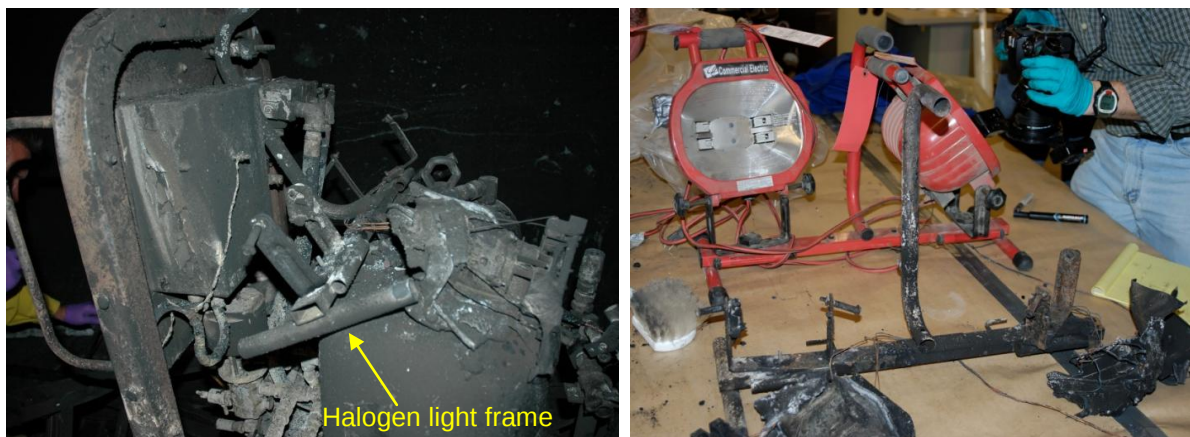
Figure 10. Remains of the halogen light sitting atop the sprayer inside the penstock (left); the same remains being compared to an exemplar halogen light (right).

Unsafe lighting was also used within the penstock when flammables were present. RPI's "Spraying Equipment and Operations" policy within its IIPP states: "Explosion proof [sic] portable lamps must be used to illuminate the spray areas." However, the penstock spray area, including where the sprayer system was setup, was illuminated with a variety of lighting, not all of which was explosion-proof. Specifically, several halogen lamps were placed around the sprayer, with one resting on top of the sprayer pumps at the time of the incident (Figure 10).

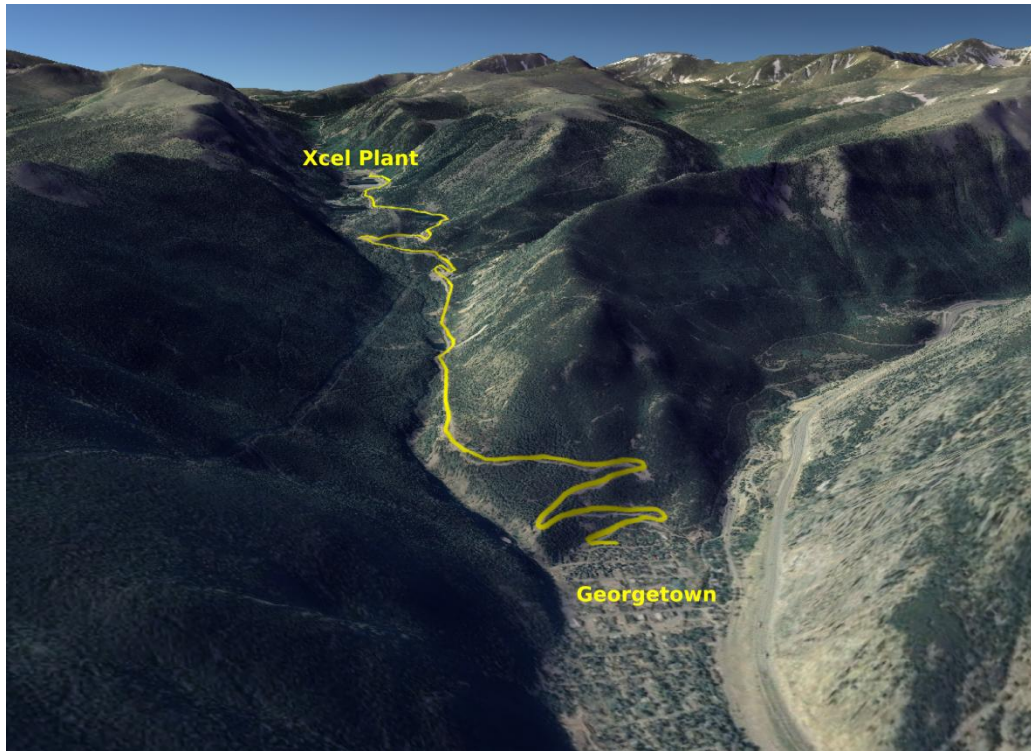
Figure 11. The winding, steep and narrow road from Georgetown to the Xcel hydroelectric plant

<sup>65</sup> CCFA personnel told the CSB investigators that the turns were so tight that one of their fire support vehicles had to completely stop and back up several times to navigate through the turns.

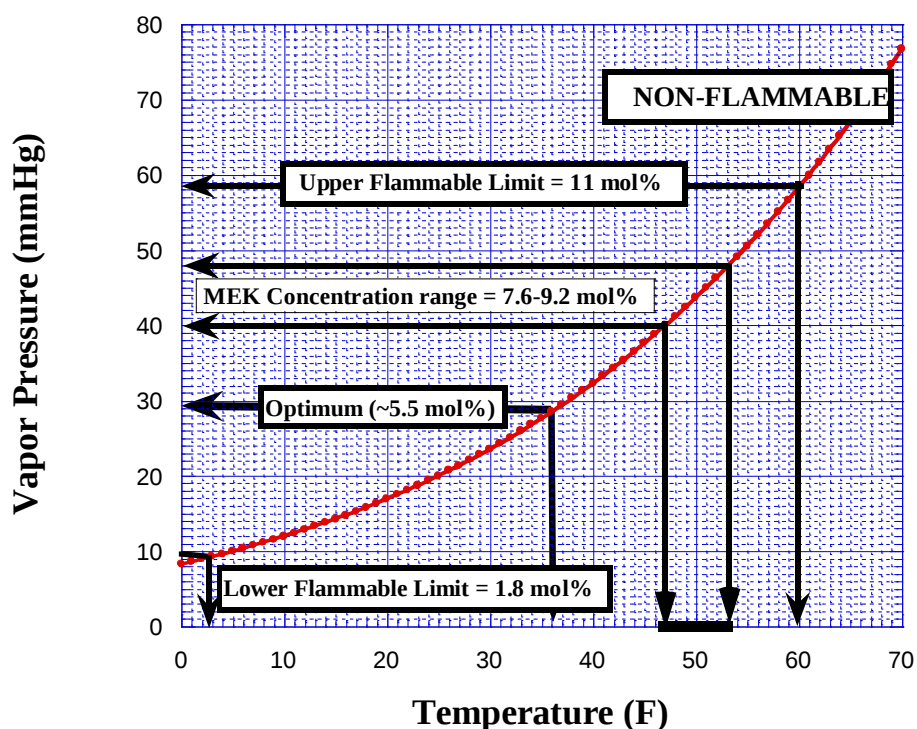
Figure E- 1. Equilibrium vapor pressure of MEK near liquid surface in base hopper

At 523 mmHg, the vapor-liquid equilibrium curve (Figure E-1) shows that the lower and upper flammable limits of MEK in air (1.8-11 volume percent) are attained at respective equilibrium temperatures of 3 to 60 °F (-16 to 15 °C). Between these temperatures, MEK vapor in equilibrium with liquid, such as deep inside the liquid hoppers on the sprayer, is ignitable. MEK vapor becomes most easily ignitable at an “optimum” concentration of about 5.5 volume percent, attained at an equilibrium temperature of about 36 °F (2.4 °C).

Although the low atmospheric pressure in the penstock (523 mmHg) has negligible effect on the flammable limits, it significantly increases the mole fraction of vapor in air at any given temperature; consequently the flash point is decreased (Figure E-2). The calculated lower theoretical flash point, temperature limit of flammability (TLF), is -16 °C (3.4 °F). For ignition in the base hopper, this TLF should be more accurate than a measured flash point because of the ambient pressure and upwards flame

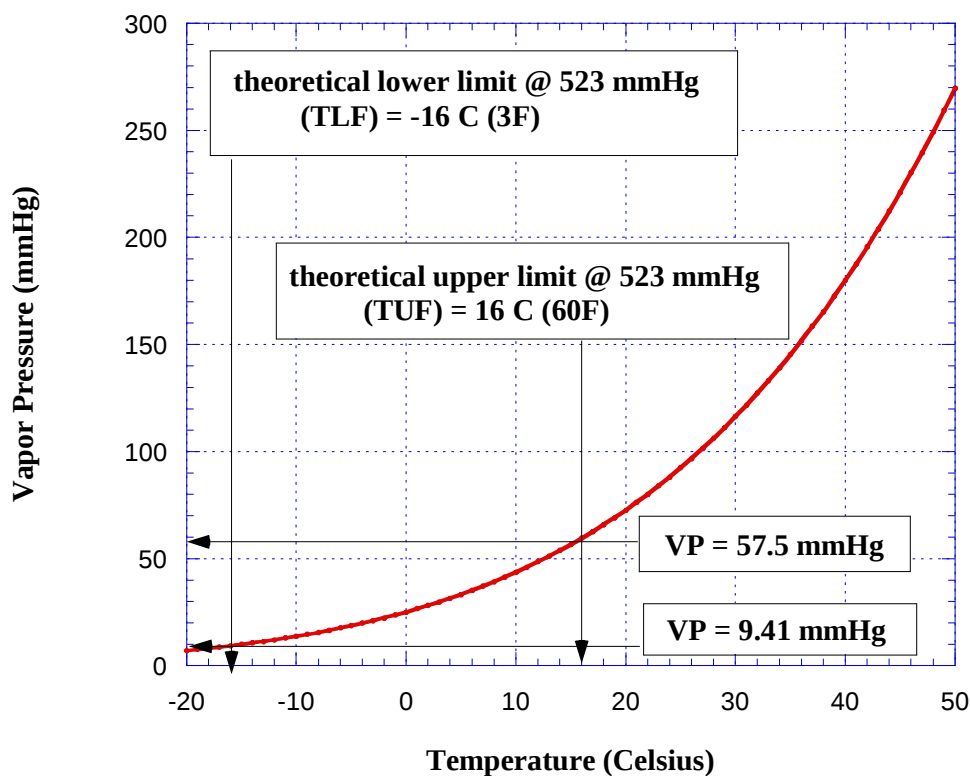
Figure E- 2. Theoretical MEK flammability limits at penstock conditions

Similarly, the “upper temperature limit of flammability” (UFL) can be calculated. The UFL is generally not sensitive to pressure in the range being considered, so the corresponding MEK vapor pressure is 57.5 mmHg to achieve 11 mole percent MEK in the vapor and the theoretical upper flammability limit (TUF) is found to be 15 °C (60 °F). This result shows that MEK in the penstock could be within the flammable range (ignitable) at all times inside a pail or hopper.

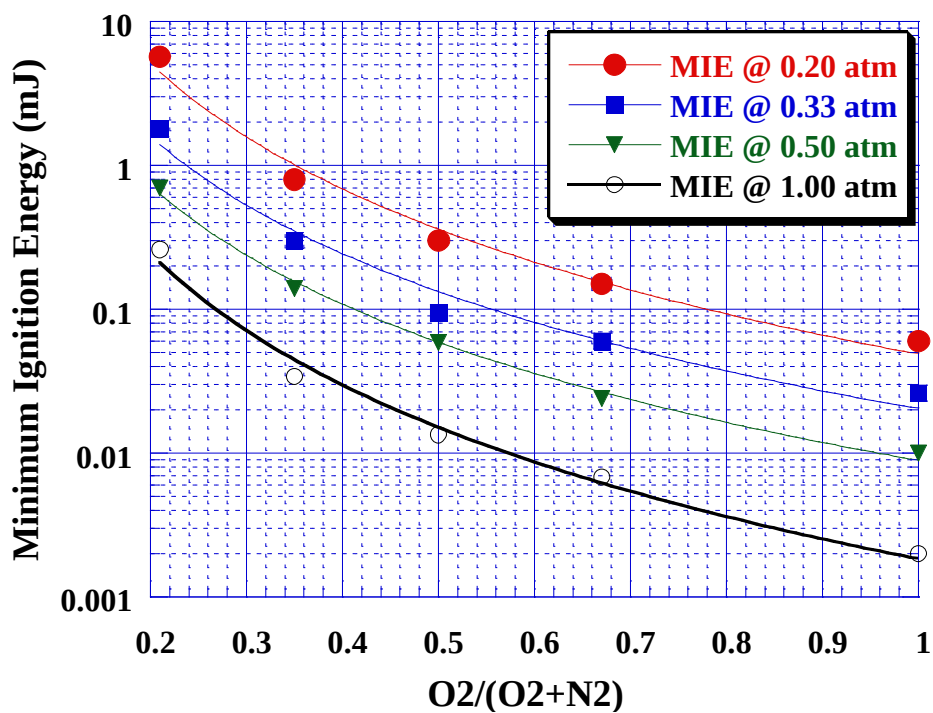
Figure F-1. Effect of pressure on MIE of propane in various oxygen-nitrogen mixtures

However, the LMIE generally increases as pressure decreases. In the penstock, the ambient pressure was about 523 mmHg (0.69 atmospheres). By analogy with data for propane (Figure F-1), the LMIE of MEK at 0.69 atmospheres (523 mmHg) should be approximately 0.5 mJ. (Britton, 1999):

Hence, the lowest MIE for MEK is approximately 0.5 mJ (5.50 mole percent MEK in dry air at 298 K, 0.69 atm).
