# FINAL INVESTIGATION REPORT

## CARIBBEAN PETROLEUM TANK TERMINAL EXPLOSION AND MULTIPLE TANK FIRES

### **CARIBBEAN PETROLEUM CORPORATION (CAPECO)**

REPORT NO. 2010.02.I.PR  
U.S. CHEMICAL SAFETY AND HAZARD INVESTIGATION BOARD

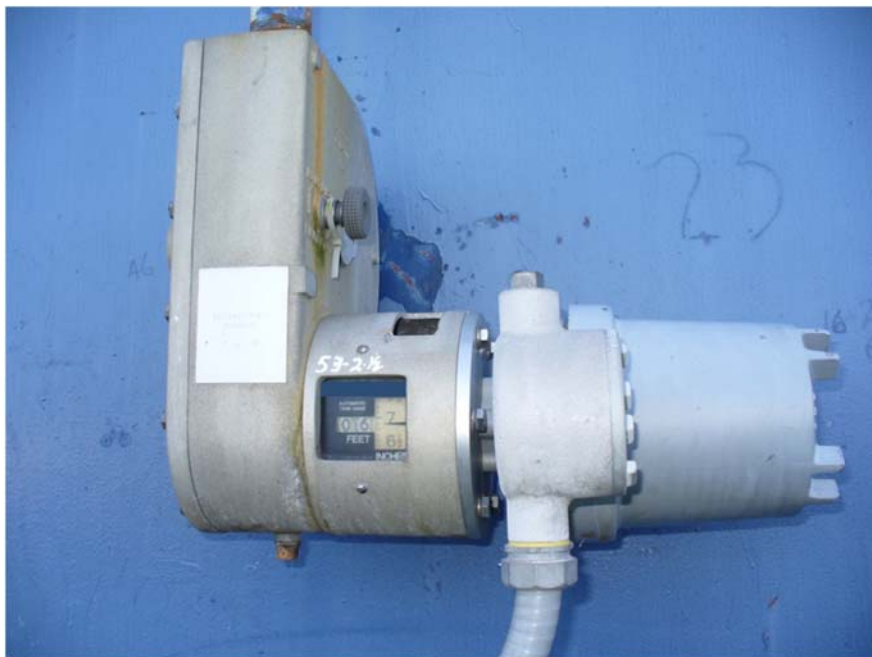
Figure 4: Side gauge: mounted on the side on a tank and displaying the amount of liquid in the tank

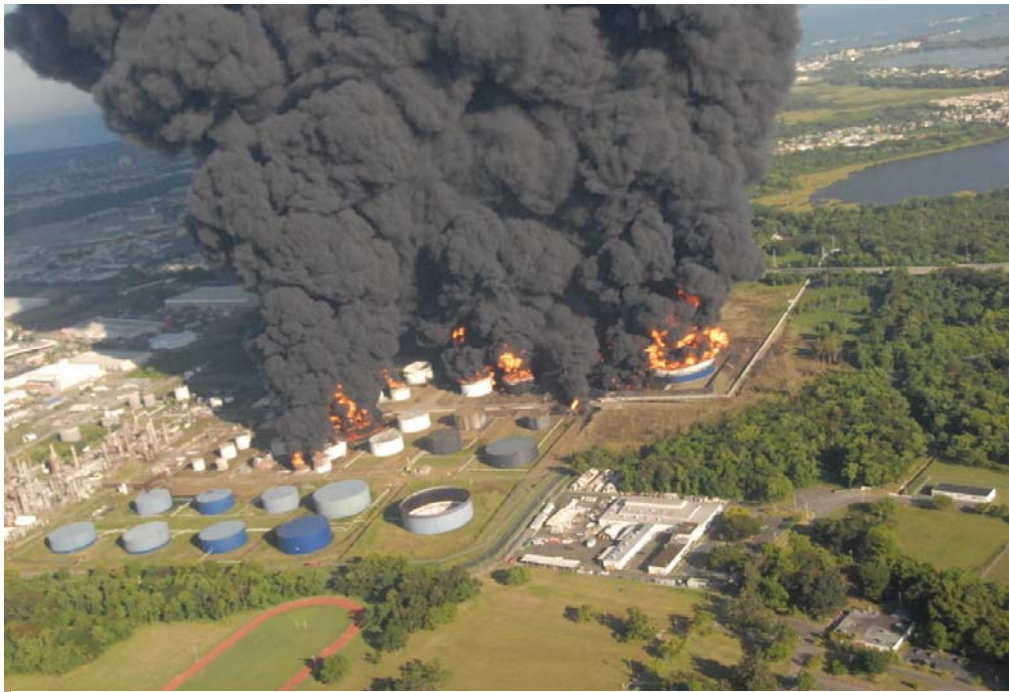
Figure 5: CAPECO multiple tank farm fire, October 23, 2009.

After the explosion, fuel in the damaged tanks burned for over two days while emergency responders fought to control the fire and prevent other tanks from igniting. The large fire demanded emergency personnel and resources from across the Commonwealth of Puerto Rico and the US mainland. Local fire departments with assistance from an industrial firefighting company took 66 hours to extinguish the fire after the explosion. As a result, 17 of the 48 tanks burned. (See Figures 5 and 6.)

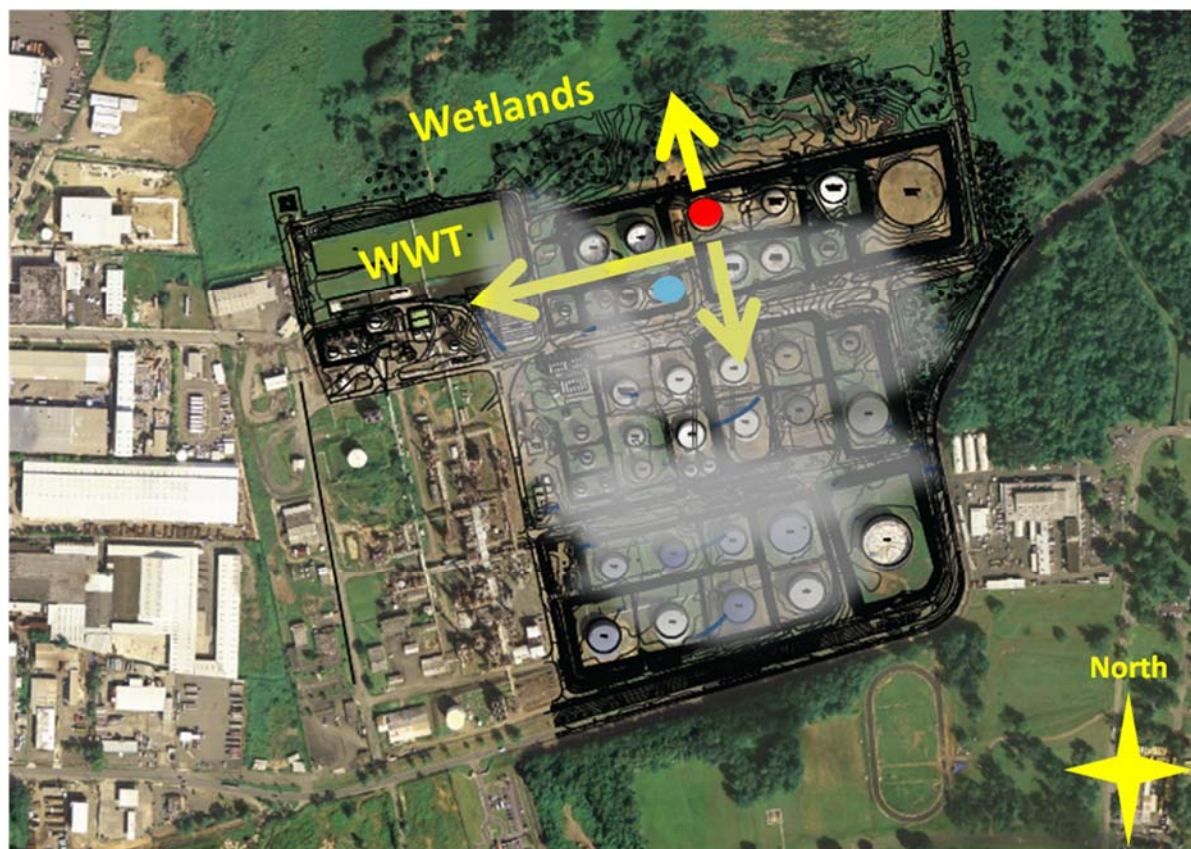
Figure 7. Topographic Survey of CAPECO Tank Farm showing the gasoline vapor cloud migration from higher elevation (Tank 409-Red and Tank 411-Blue) toward low-lying areas by the WWT plant, the south eastern end of the refinery and wetlands to the north. The cloud indicates the approximate area where the vapor cloud migrated based on surveillance footage.

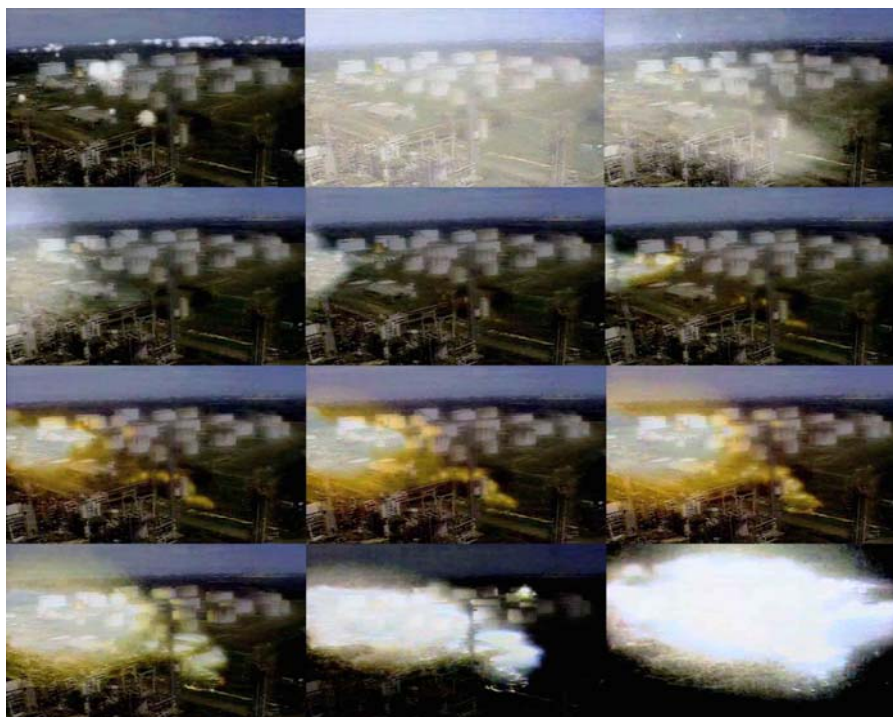
Figure 8: CAPECO surveillance footage of flame propagation during October 23, 2009 CAPECO explosion

The developing vapor cloud expanded from east to west toward the WWT area, north toward the wetlands area and the highway, south toward an east-west CAPECO site road, and east toward the neighboring Fort Buchanan (Figure 7). Onsite security video captured the ignition and initial flash fire in the WWT area occurring seconds before the explosion (Figure 8). The open secondary containment valves allowed the gasoline pool to extend to the storm water retention pond in the WWT area, which is not electrically classified.<sup>28</sup> The CSB did not determine the exact source of the ignition, but the areas where the vapor cloud traveled contained multiple potential ignition sources.

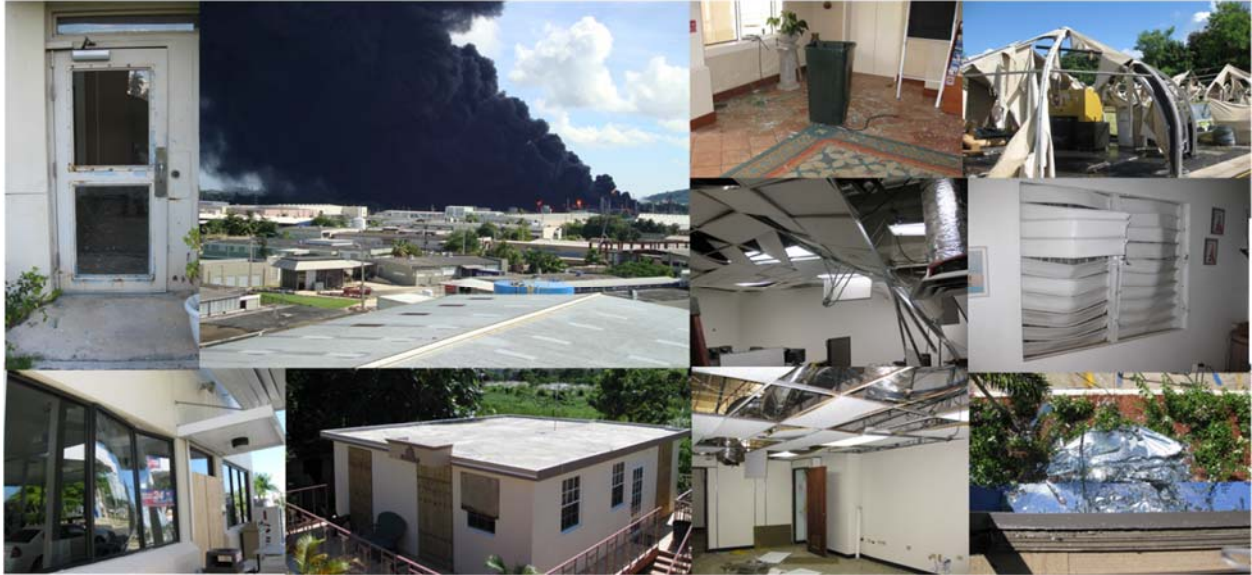
Figure 10: Community damage surrounding the CAPECO facility

Fort Buchanan experienced the most severe damage—suffering an estimated \$5 million in repair costs. Community impact assessments<sup>39</sup> found most of the structural damage occurred in the Puente Blanco neighborhood where PREMA and the Department of Housing (DOH) found damage to 232 of the 266 homes assessed; 139 were repaired and six were demolished by November 2009.<sup>40</sup> The Puente Blanco community also experienced environmental contamination to several surface water bodies, including federally protected wetlands and streams surrounding the CAPECO site. After assessing 289 homes damaged by the explosion in the Cataño community, the Small Business Administration (SBA)<sup>41</sup> designated 25 single-family homes as destroyed or severely damaged at or beyond 40% of their fair market value. (See Figure 10.)

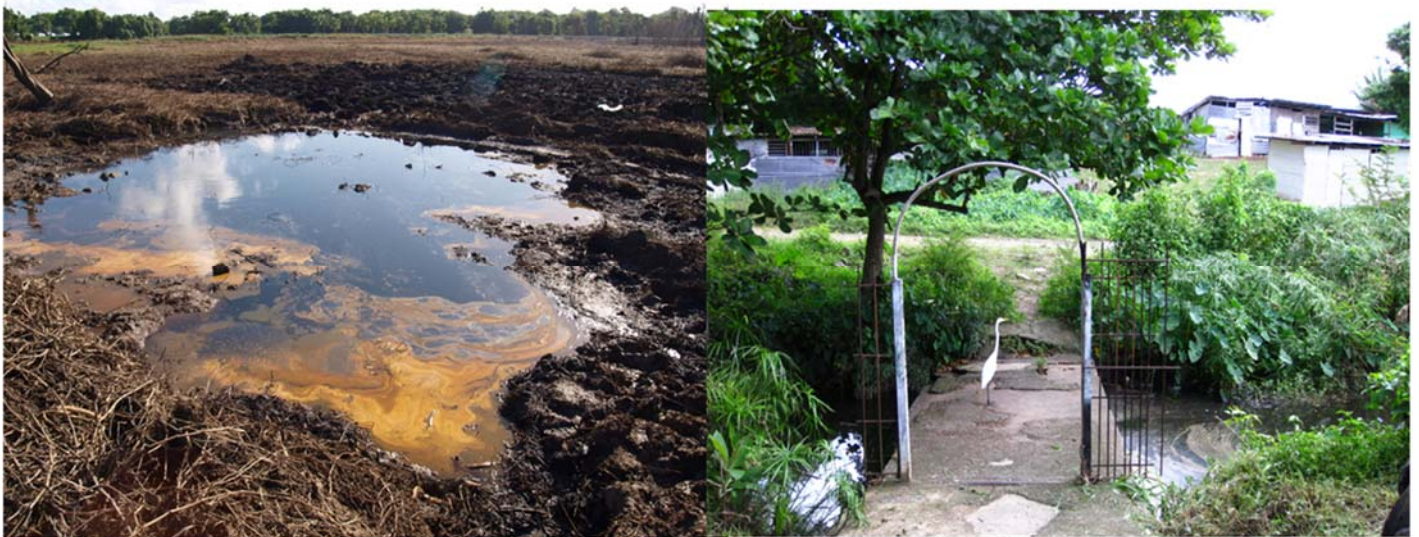
Figure 11: Oil Spill into nearby wetlands (photo from NOAA.gov) and in a local community drain after CAPECO explosion and tank fires

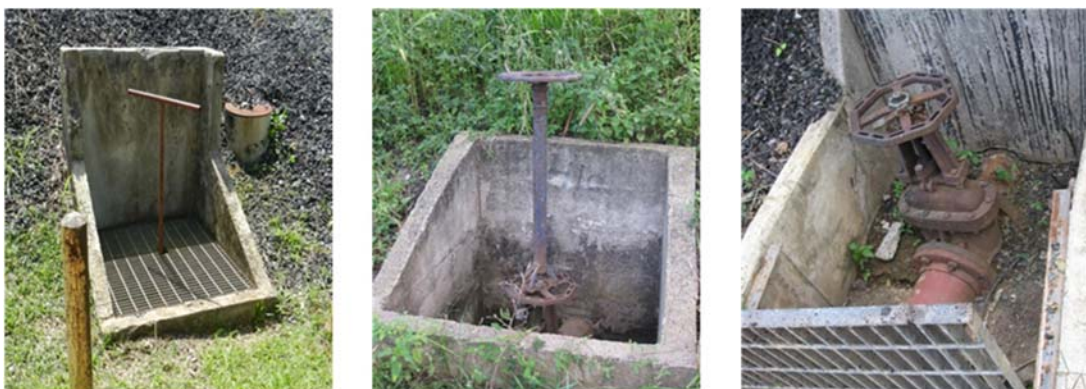
CAPECO's normal practices required operators to open and close valves during the day shifts. Operators customarily inspected whether the dike drain valves were open or closed from their vehicles as they drove by. The tank farm used both rising stem and fixed stem valves on the dike drains leading to the storm water retention pond in the WWT area. Rising stem valves allowed operators to easily observe the open or closed position while fixed stem valves do not provide a visual indication of the position. The fixed stem valve on the dike drain for Tank 409 made it difficult for tank farm operators to observe its position without physically turning it. (See Figure 15.) In some cases, the valve position could not be determined with a visual inspection because the rising stem valve position was hidden in the sump. (See Figure 15, center photo.) Furthermore, none of the dike valves shown in Figure 15 were consistent with RAGAGEP. Regulatory coverage under the EPA Risk Management Plan (RMP) or OSHA's Process Safety Management (PSM) Standard requires that CAPECO use the best available engineering practices to assess valve open/close status.

Figure 15: Various dike drain valves at CAPECO. Tank 409 fixed stem dike drain valve (left): position of the valve is undeterminable without physically turning the valve. Rising stem valves (center, right). In some cases, the valve position is hidden in the sump (center).
