Investigation Report

Published: December 2019

KEY ISSUES:

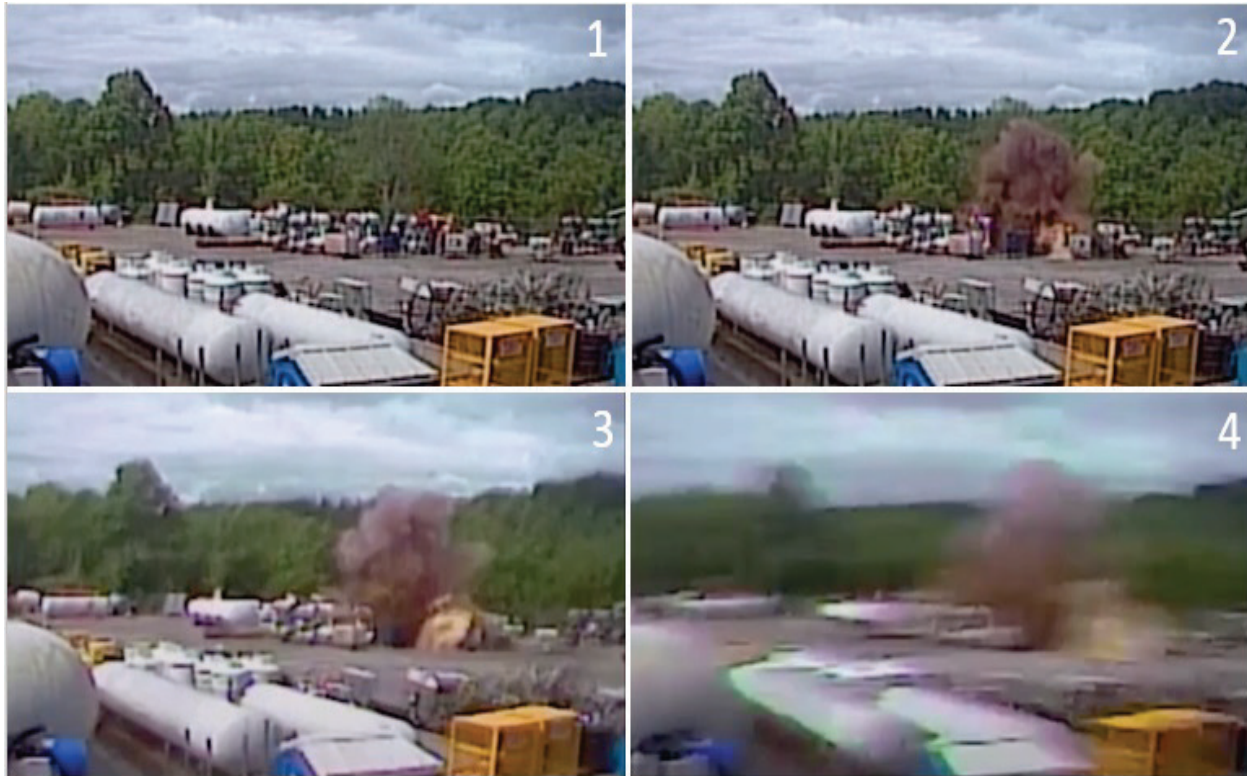
Figure 9. Surveillance Video Capturing May 24, 2017, Explosion. These still frames from an MRR surveillance camera capture the May 24, 2017, explosion. (Credit: MRR).

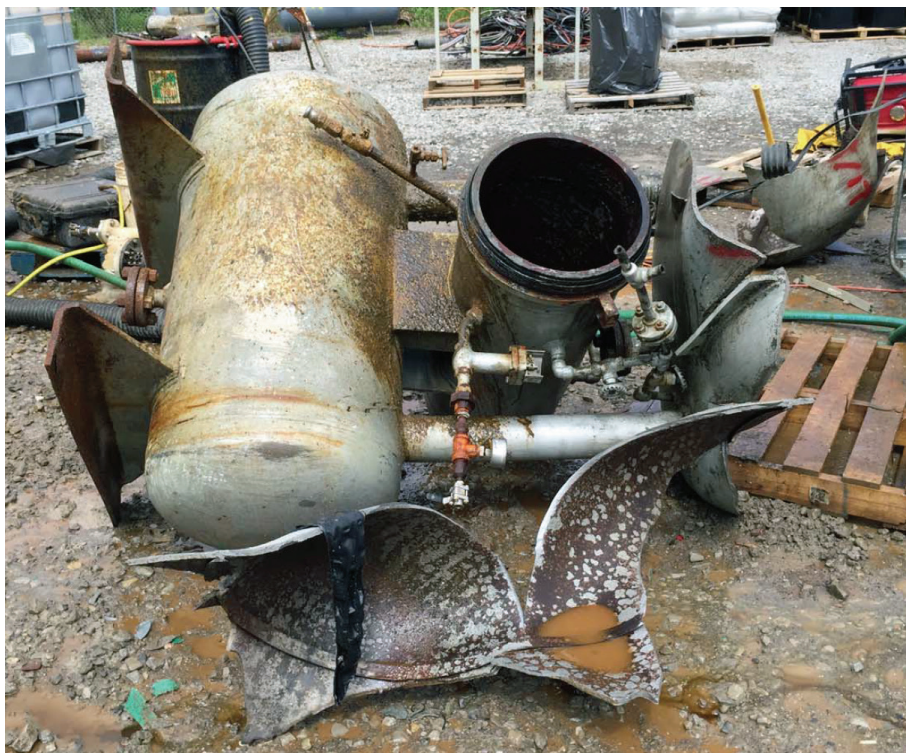
The CSB could not determine the exact actions of the three personnel leading up to the explosion because there were no immediate witnesses, and surveillance footage could not be used to determine their actions definitively. Figure 9 shows still frames of the explosion from the surveillance footage. Figure 10 and Figure 11 show the MP odorizer after the incident. Figure 12 shows the variation in appearance of process water within MRR’s chemical treatment process. Figure 13 shows aluminum components that were likely inside the middle chamber of the MP odorizer. MRR

Figure 10. MP Odorizer That Exploded on May 24, 2017. This photo shows the failed MP odorizer from the May 24, 2017, explosion. (Credit: MRR).

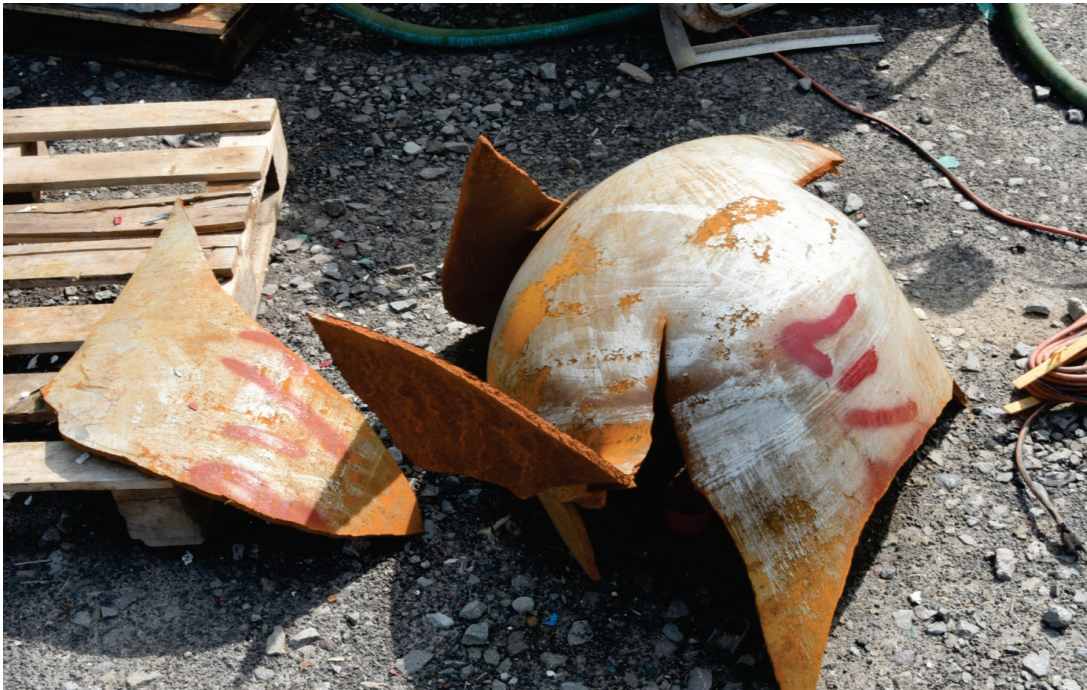
Figure 11. MP Odorizer Fragment from May 24, 2017, Explosion. This photo shows a portion of the top chamber of the MP odorizer after the May 24, 2017, explosion. (Credit: CSB).

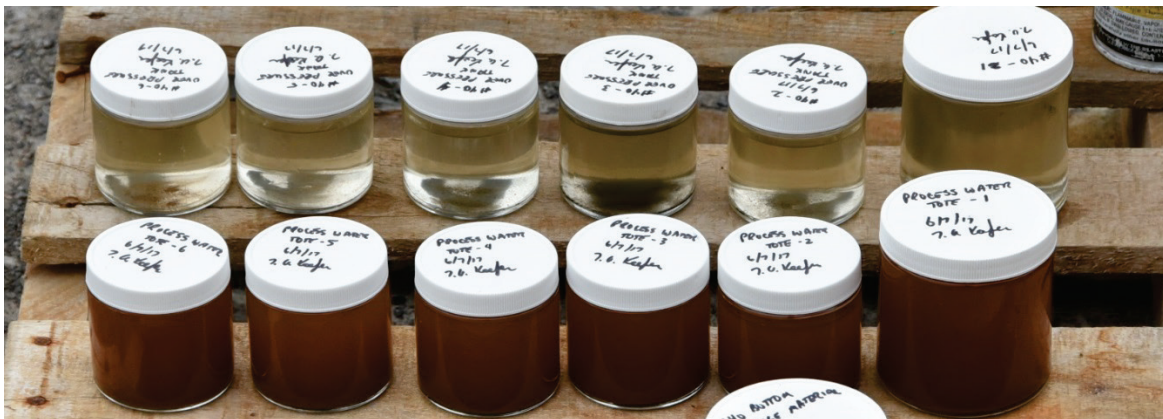
Figure 12. Process Water. The light-yellow samples (top row) were taken from the bottom chamber of the MP odorizer that exploded on May 24, 2017. The brown samples (bottom row) were taken from a “process water” tote not involved in the May 24, 2017, incident. Note the color differences showing the drastic color variation of the process water, indicating that different vessels likely had different types and quantities of materials in them before chemical treatment. (Credit: CSB).

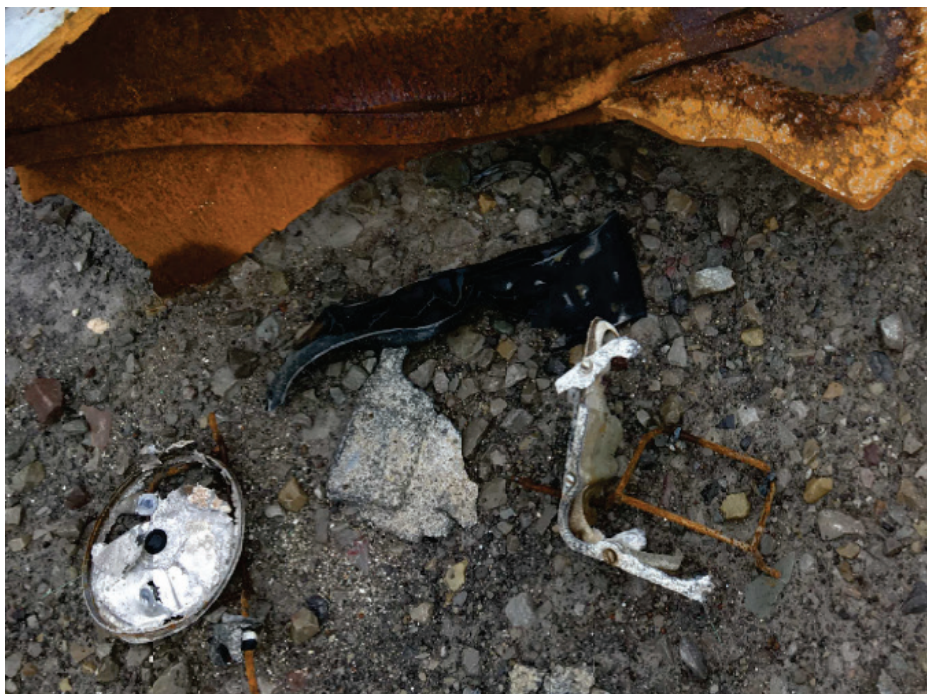
provided the CSB documents from 1964, showing that Peerless used aluminum components in the middle chamber as part of the gas metering and odorant delivery system.

Figure 13. Aluminum Parts. This photo shows aluminum internal components that were likely in the middle chamber of the MP odorizer, found after the May 24, 2017, incident. The explosion destroyed the aluminum pan and components that were inside the middle chamber of the MP odorizer. (Credit: SPSI).

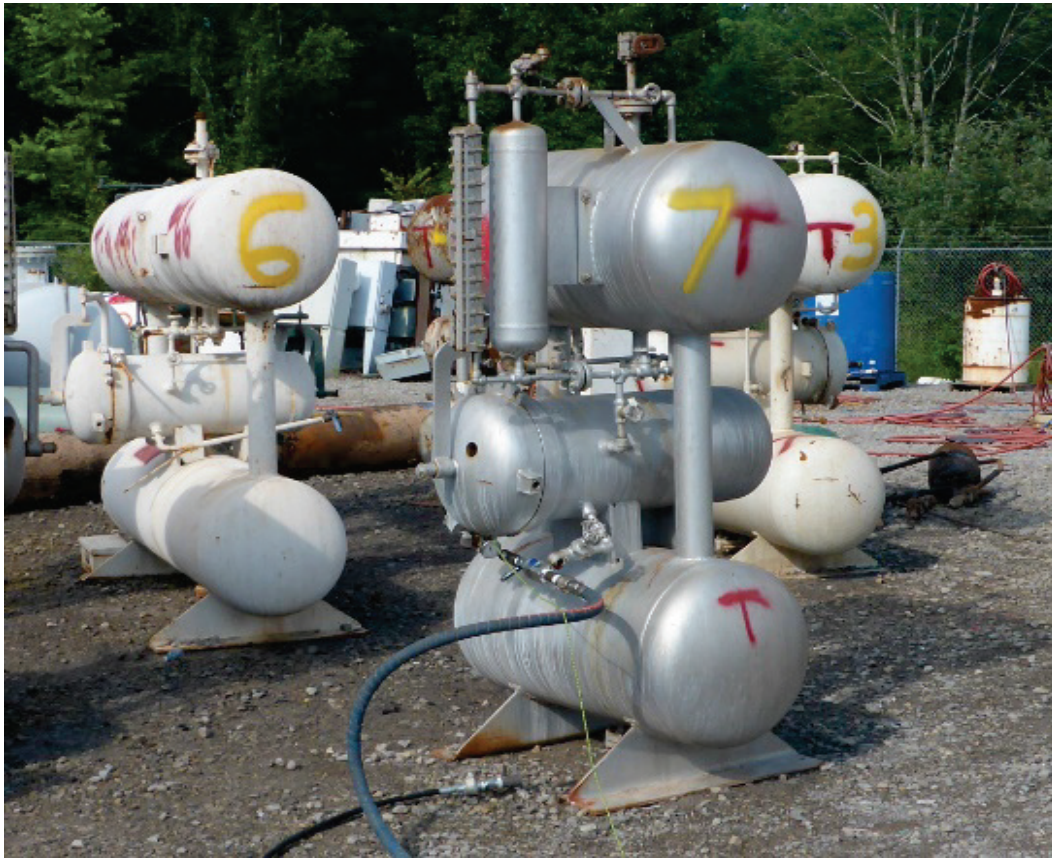
SPSI had installed an additional (new) valve and pressure gauge into the piping coming off the middle chamber (Figure 14—piping to the left of sight glass). SPSI had also put a rope on the existing valve on the pipe, for use in opening the valve (Figure 14). To start the draining operation, SPSI's field supervisor opened the valve using the rope. The pressure gauge indicated zero pressure in the MP odorizer. SPSI's procedure called for halting the operation if the pressure gauge showed more than 30 psig. Because the pressure gauge showed no pressure, the operation continued.

Figure 14. MP Odorizer Before June 20, 2017 Explosion. This pre-incident photo shows the MP odorizer and equipment connections that SPSI workers were using to drain liquid when the June 20, 2017 explosion occurred.^a (Credit: CSB).

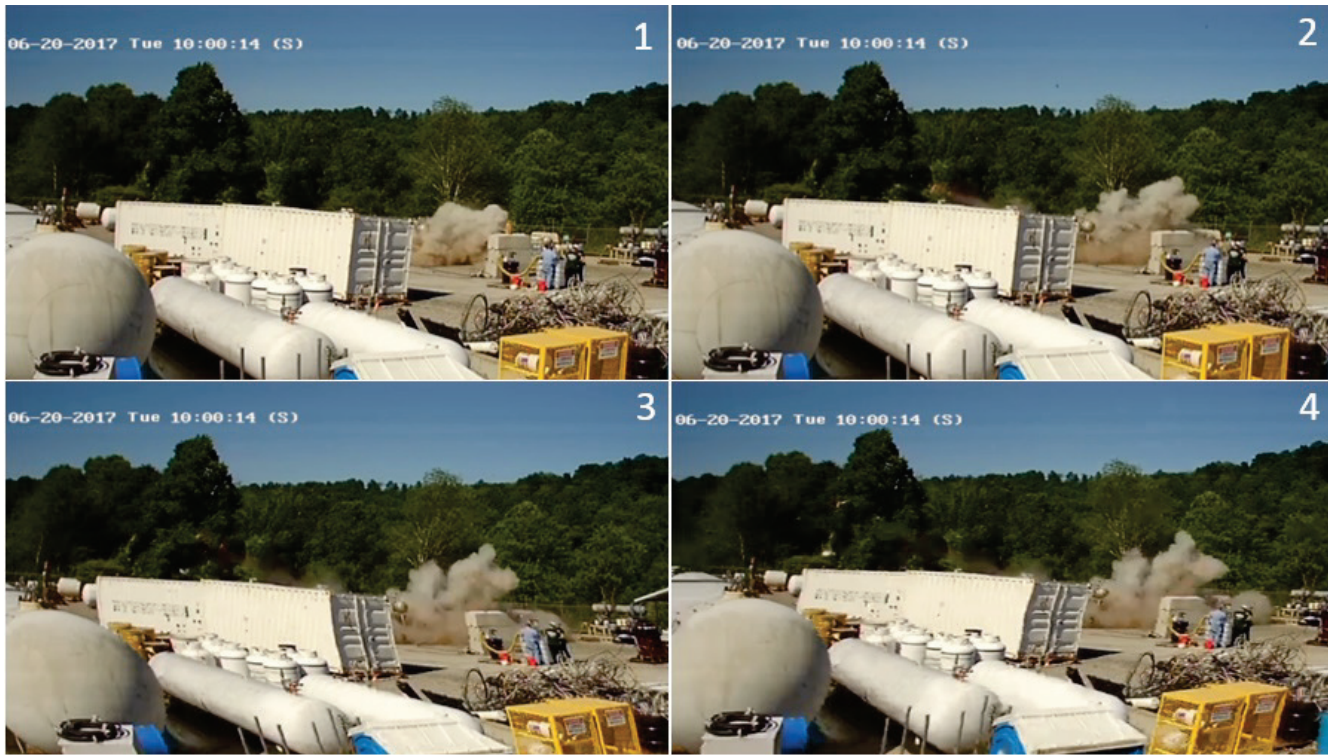
Based on surveillance video, the MP odorizer exploded less than five minutes after the draining operation had begun (Figure 15 and Figure 16). A portion of the MP chamber struck and fatally injured the field supervisor. Figure 15 shows still frames of the explosion from a security video.

Figure 15. Surveillance Video Capturing June 20, 2017, Explosion. These still frames from an MRR surveillance camera capture the June 20, 2017, explosion. The MP odorizer involved in the explosion is partially obstructed from view, behind the white shipping container. No flames were visible in the surveillance footage. (Credit: MRR).

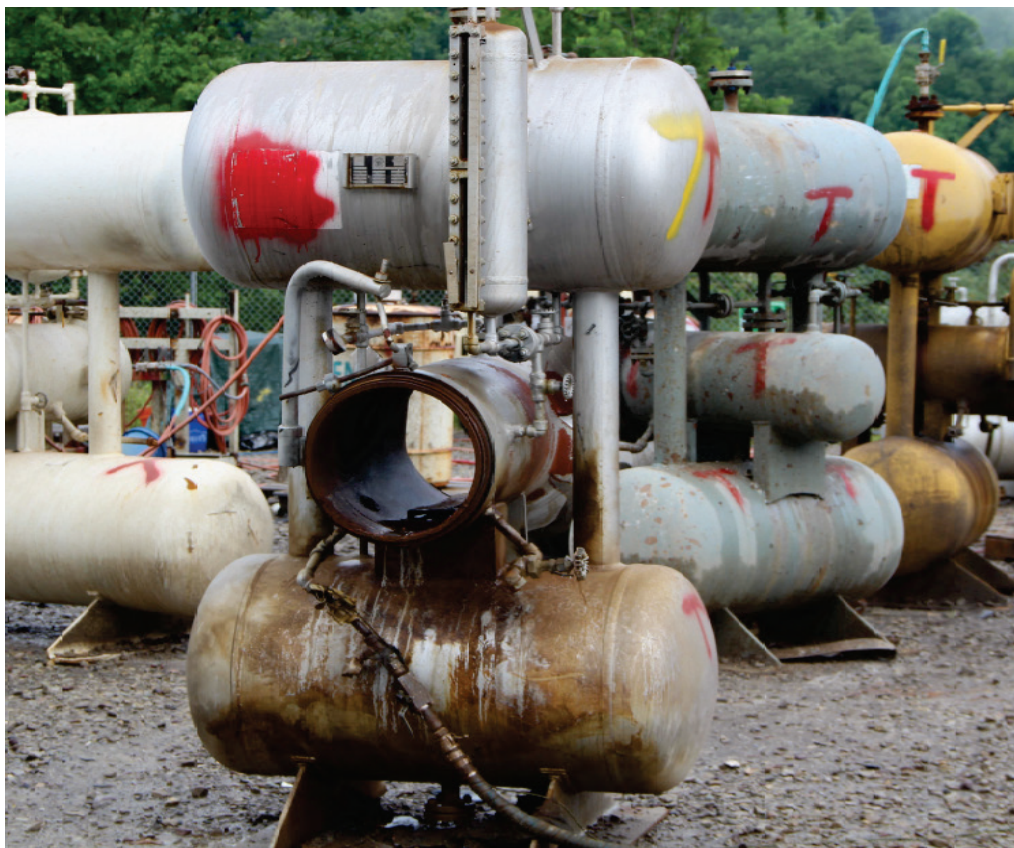
Figure 16. MP Odorizer Vessel That Exploded. This photo shows the MP odorizer that exploded on June 20, 2017. The back portion of middle chamber ruptured (see also Figure 17) and the front threaded section blew off. The aluminum tray and mechanical parts that were inside the middle chamber were expelled from the MP during the event. (Credit: SPSI).

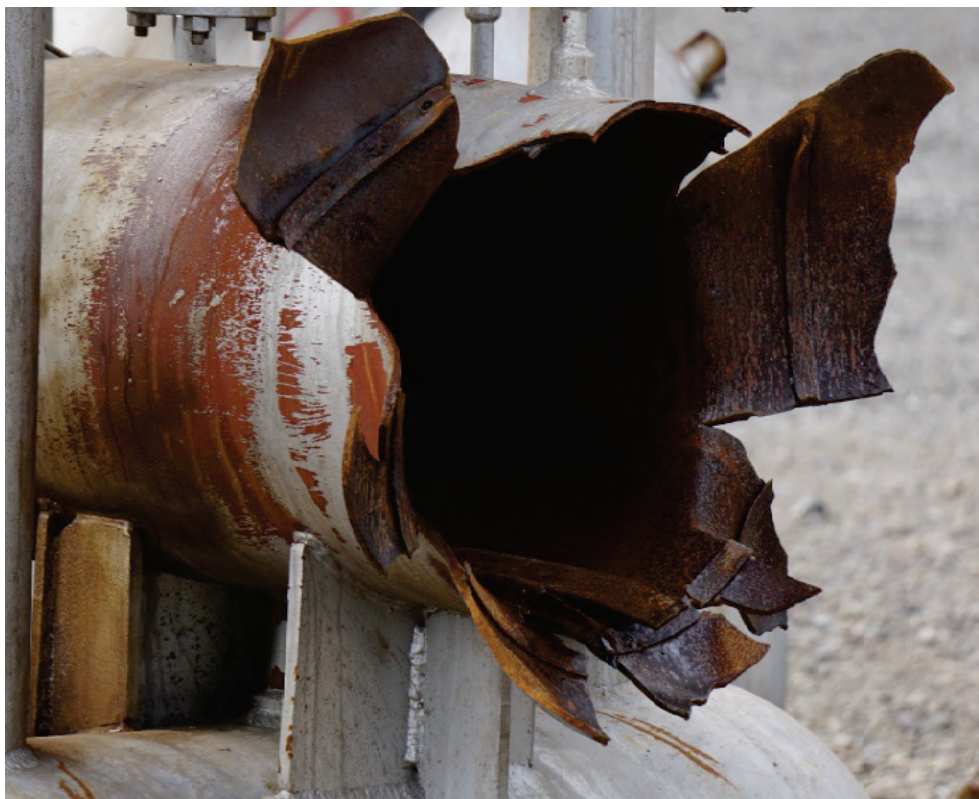
Figure 17. Ruptured MP Odorizer Middle Chamber from June 20, 2017, Incident. This photo shows the post-incident condition of the rounded end of the middle chamber that ruptured in the June 20, 2017, explosion. (Credit: SPSI).

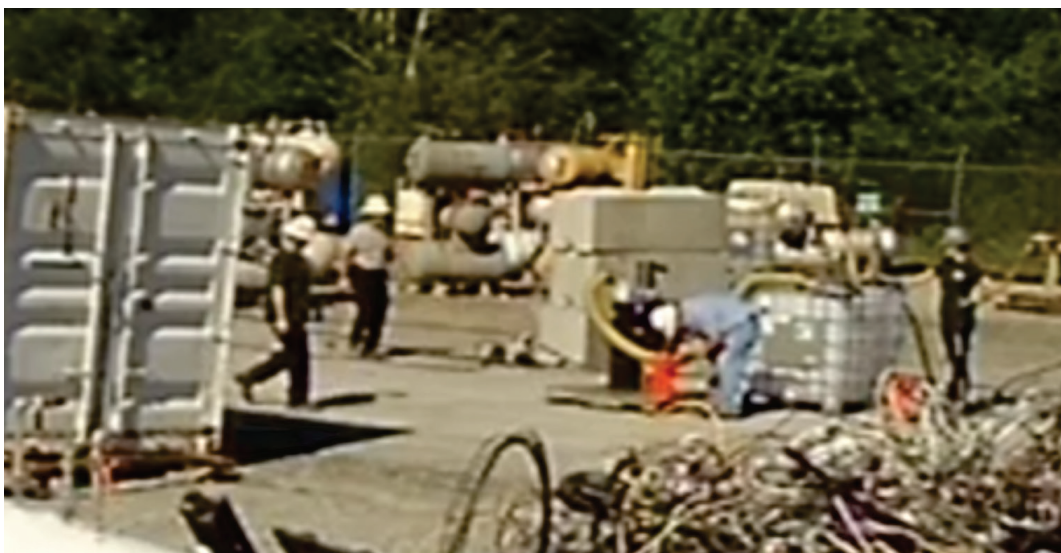
The SPSI manager’s statement about the concrete barriers is consistent with the protocol SPSI developed to drain the process water from the MP odorizers. The protocol does not mention the concrete barriers, establish any type of exclusion zone near the MP odorizer, or suggest that SPSI workers would use the concrete barriers as a safeguard while performing the work. The SPSI manager’s statement is also consistent with the worker actions that took place on June 20, 2017. During the nearly five minutes from when SPSI started their activities to drain the process water from the MP odorizer up to the time of the explosion, only one of the four SPSI employees consistently remained behind the concrete barrier wall (Figure 18).

Figure 18. Concrete Barriers. This surveillance video image from June 20, 2017 at 9:56 a.m., shows only one of four SPSI workers positioned behind the concrete barrier. Two other concrete barriers were placed, but they are outside the view of this surveillance camera (Credit: MRR).

Based on SPSI worker actions captured by the surveillance video leading up to the explosion, MRR and SPSI needed to provide more barriers and strengthen their work plan for these concrete barriers to properly serve as a worker protection safeguard. Had MRR and SPSI established a more robust barrier system, such barriers may have helped to protect the SPSI field supervisor from being struck and fatally injured by the projectile when the MP chamber

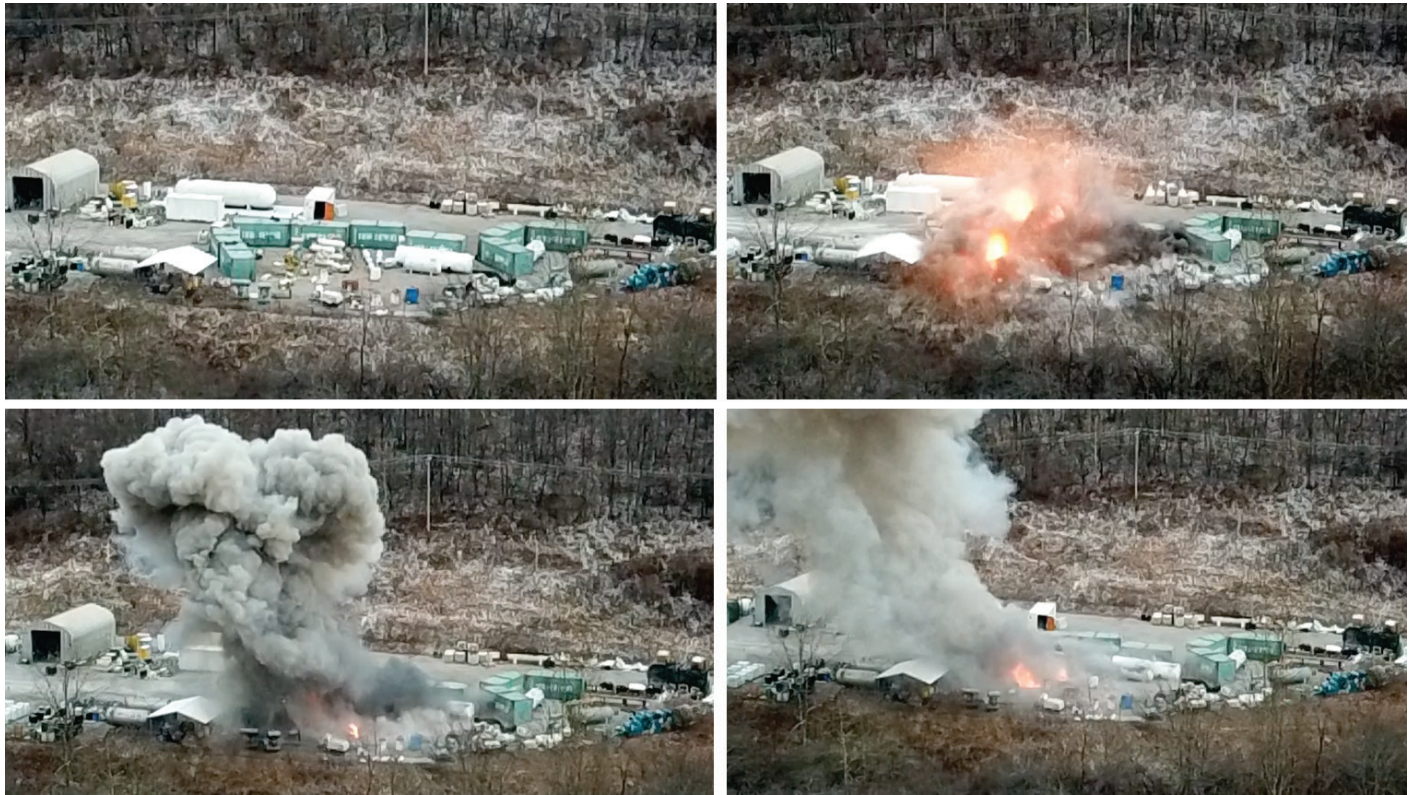
Figure 19. Explosive Venting. These drone video images show the explosive venting used to cut holes in a group of MP vessels to drain the vessels while minimizing risk to people. The bottom right image shows a fire that erupted from flammable liquids that drained from some of the MP vessels. (Credit: MRR).

The use of explosive venting of the vessels at MRR provides the safest means to reduce the risk of another incident. Both incidents have resulted after manual manipulation, of some kind, of valves or fittings on the vessels. The use of explosive venting of large and small compressed gas vessels, is and has been used for at least 35 years and is the industry standard for reducing risk of catastrophic pressure vessel failure [Figure 19].

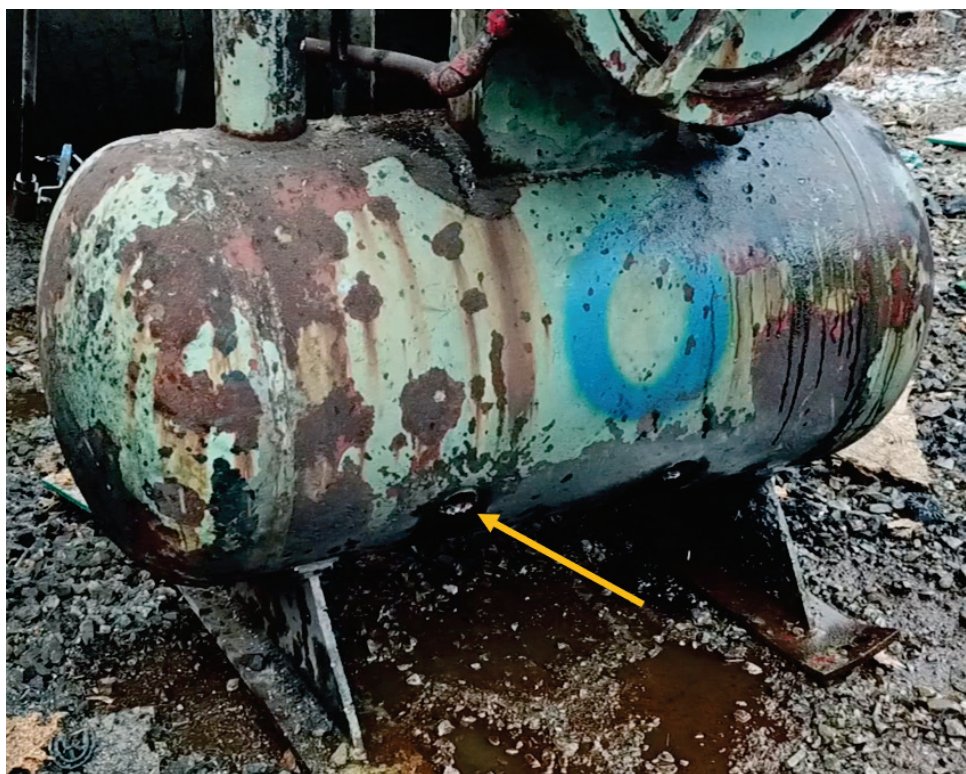
Figure 20. Drain Hole. This drone image shows one of the holes cut by the explosion venting process used to drain the bottom chamber of an MP vessel. (Credit: MRR).

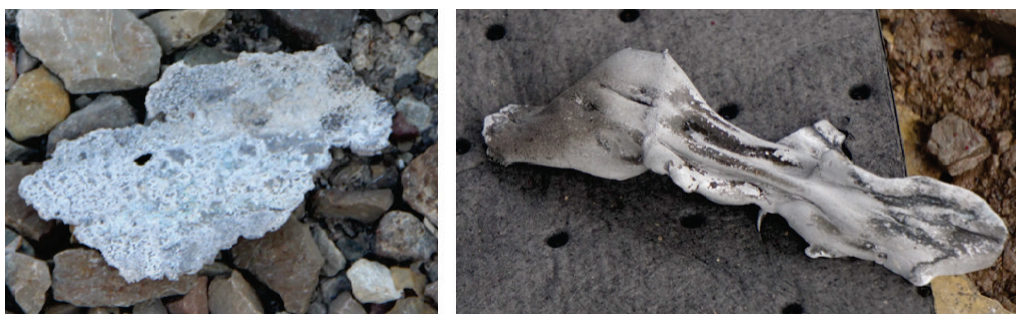
Physical evidence from the May 24, 2017, and June 20, 2017, incidents show differences in the aluminum MP odorizer components. For example, aluminum components from the May 24, 2017, incident have a general corrosion appearance while aluminum parts from the June 20, 2017, incident show signs of melting from heat (Figure 21). These differences could be related to how much exposure the aluminum parts had with the sodium hypochlorite and whether or not liquid was present in chamber two, affecting how much these parts were heated by the explosion. It is also possible that the physical difference in the aluminum parts may indicate that the reactive chemical mechanism involved was not the same.

Figure 21. Aluminum Parts. The picture on the left shows an aluminum part from the MP odorizer involved in the May 24, 2017, incident that appears to have general corrosion. The photo on the right shows an aluminum part from the MP odorizer involved in the June 20, 2017, incident that appears to show signs of melting from heat. (Credit: MRR (left), SPSI (right)).
