U.S. Chemical Safety and
Hazard Investigation Board

Fatal Release of Acetic Acid and Methyl Iodide Mixture at LyondellBasell La Porte Complex

La Porte, Texas | Incident Date: July 27, 2021 | No. 2021-05-I-TX

Investigation Report

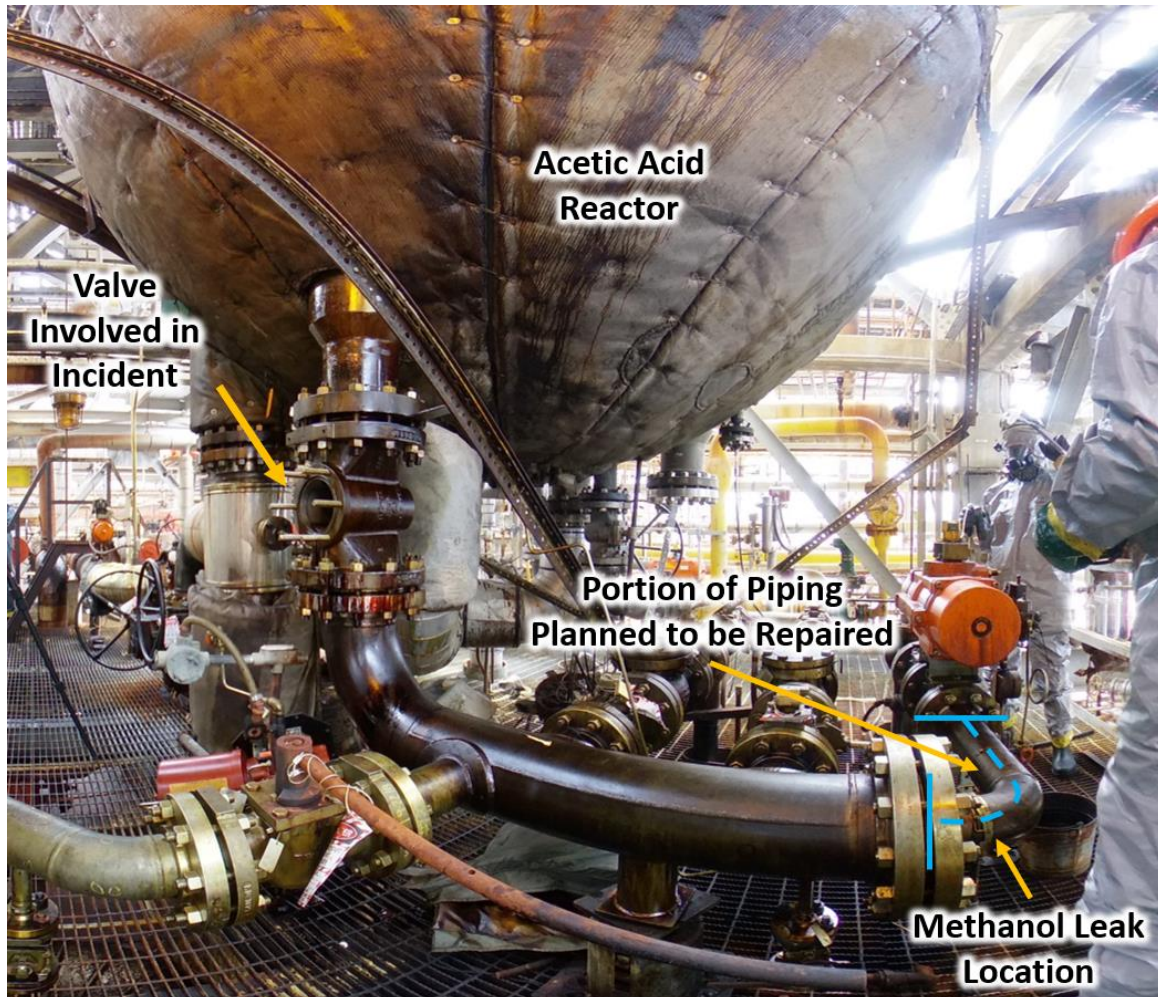
On Saturday, July 24, 2021, an operations technician for the LyondellBasell acetic acid unit discovered a small leak on methanol piping upstream of the unit's acetic acid reactor. A subsequent inspection identified that the leak originated in a weld within the methanol piping. Shortly after the leak was discovered, the shutdown of an adjacent process unit required the acetic acid unit to also shut down acetic acid production. LyondellBasell personnel decided to use the shutdown opportunity to remove and repair the leaking portion of the methanol piping (**Figure 3**).

Figure 3. Post-incident photograph of the methanol leak location, the portion of the piping that LyondellBasell planned to repair, and the location of the plug valve involved in the incident. (Credit: CSB)

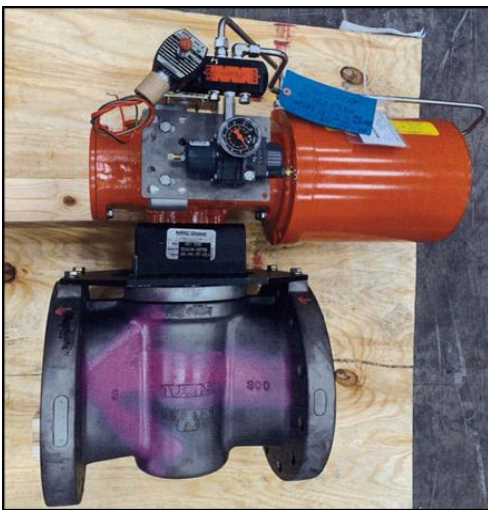
Figure 4. Plug valve involved in incident. (Credit: MRC Global)

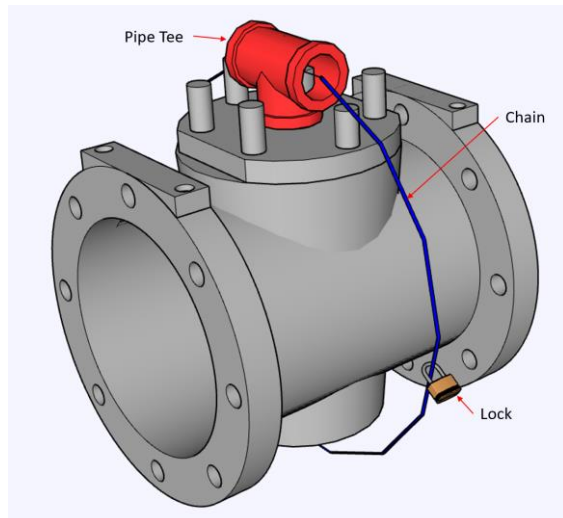
To isolate the piping, which contained methanol and acetic acid, LyondellBasell personnel chose to use the valve located between the leaking piping and the nearby acetic acid reactor—a pneumatically actuated eight-inch plug valve—as an isolation device (**Figure 4**). LyondellBasell's Energy Isolation Procedure specified that

Figure 5. Schematic showing LyondellBasell's lockout plan for the plug valve. (Credit: CSB)

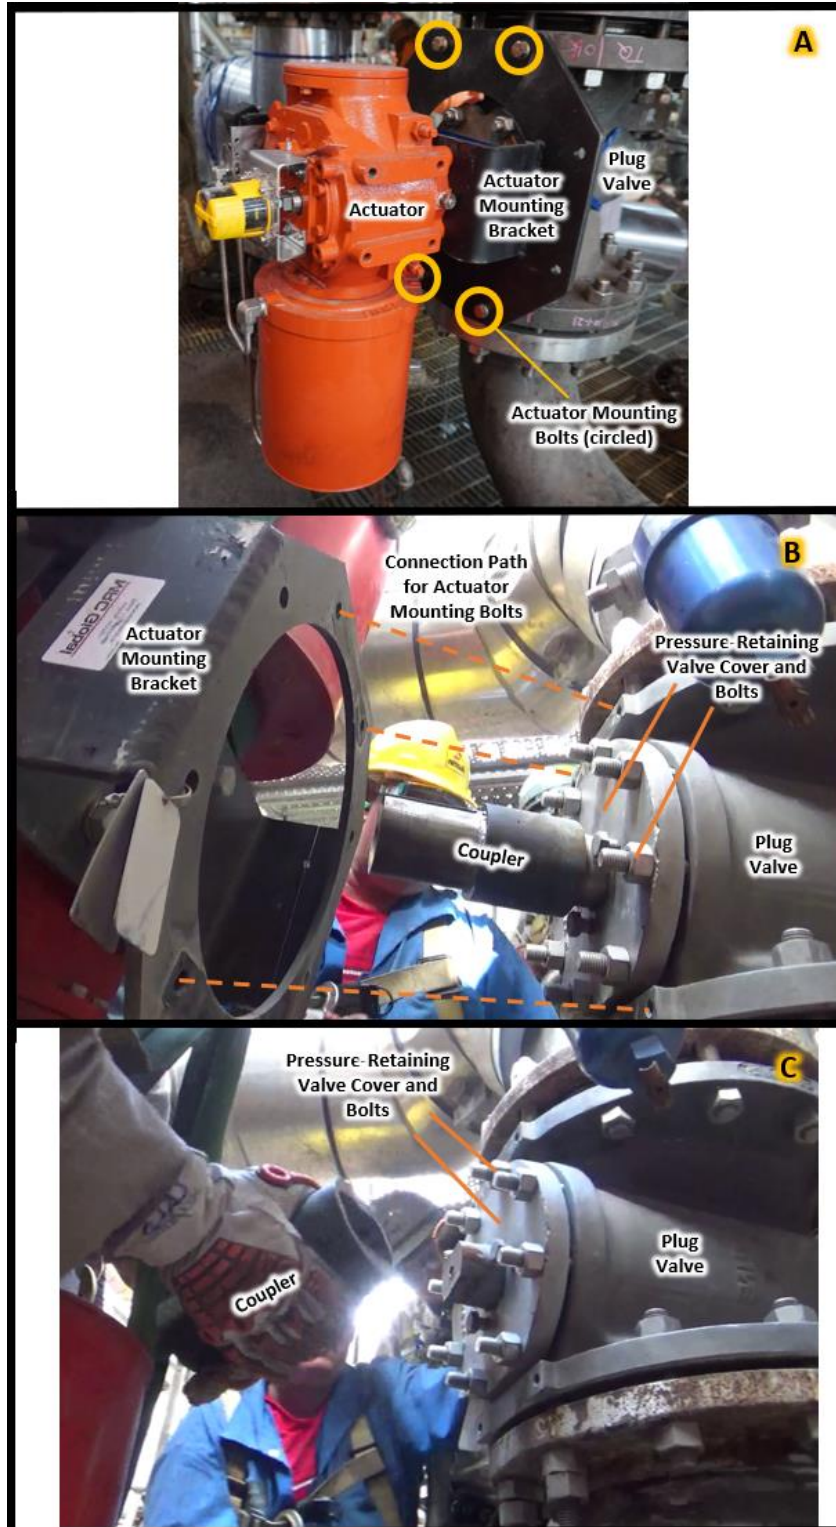
After removing all of the bracket mounting bolts and inadvertently removing the pressure-retaining valve cover nuts from the plug valve, the Turn2 work crew removed the actuator and the affixed actuator mounting bracket from the plug valve and placed it on the deck grating (**Figure 7**). Once the actuator was removed, the Turn2 work crew noticed that the coupler was still seated in its designated slot on the top of the valve stem (**Figure 6B and 6C**). The Turn2 workers attempted to slide the coupler off of the valve stem, but because it was too tight to remove by hand, the Turn2 work crew decided to use a pry bar to try and remove it. While using the pry bar on the coupler, the combination of forces from the pry bar and the process fluid pressure inside the plug valve caused the unfastened valve cover and plug to eject from the plug valve body, and acetic acid rapidly released from the open plug valve.

^a One of the workers explained his reasoning for removing the pressure-retaining nuts shown in Figure 6B. He told the CSB they had to remove the interior fasteners because "...it's all connected. As [the actuator] sits up there, it's all connected to one another." This worker did not seem to understand that the interior fasteners were pressure-retaining and should not have been removed.

Figure 6. (A) Photo of the incident valve with the four actuator mounting bolts highlighted; (B) Photo of exemplar valve pressure-retaining nuts, and (C) Photo of exemplar valve with coupler removed. (Credit: CSB)

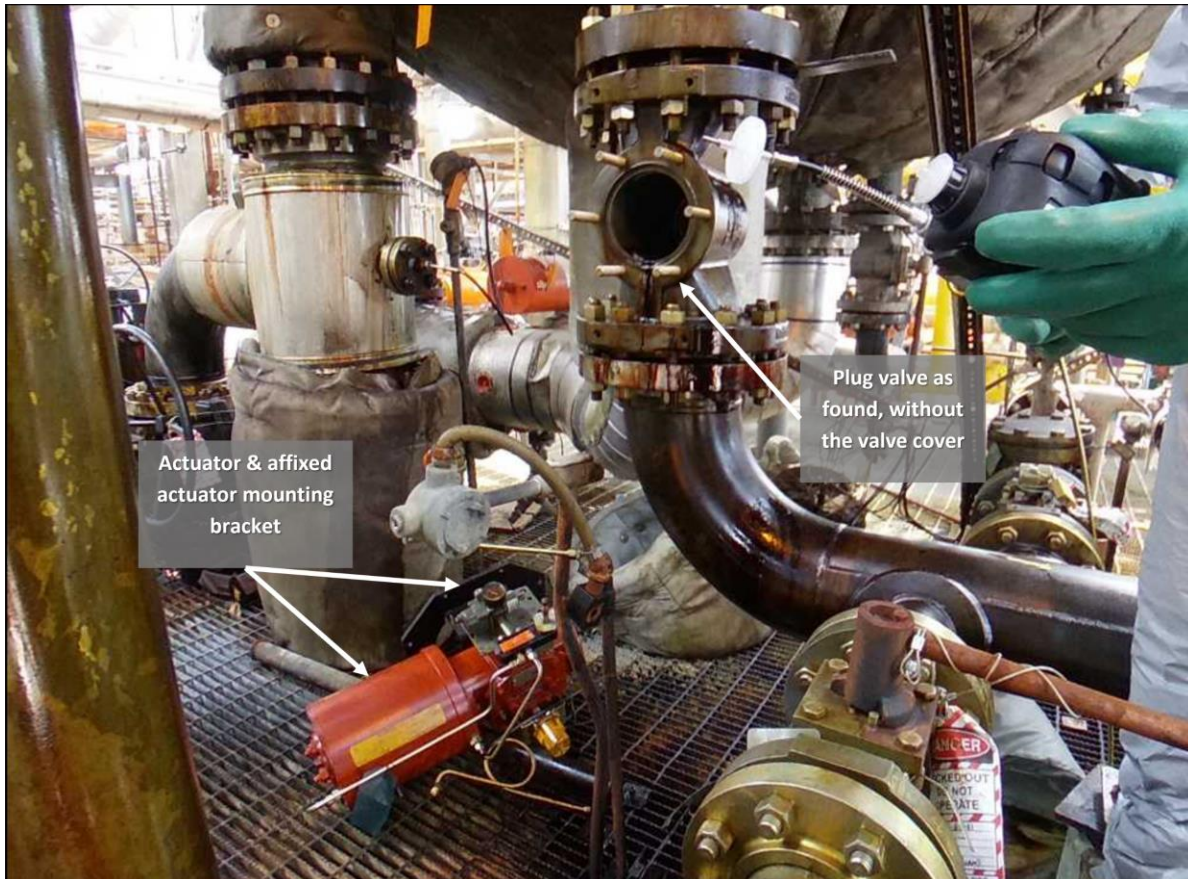
Figure 7. Post-incident photo showing the actuator and the affixed mounting bracket positioned on deck grating. (Credit: CSB)

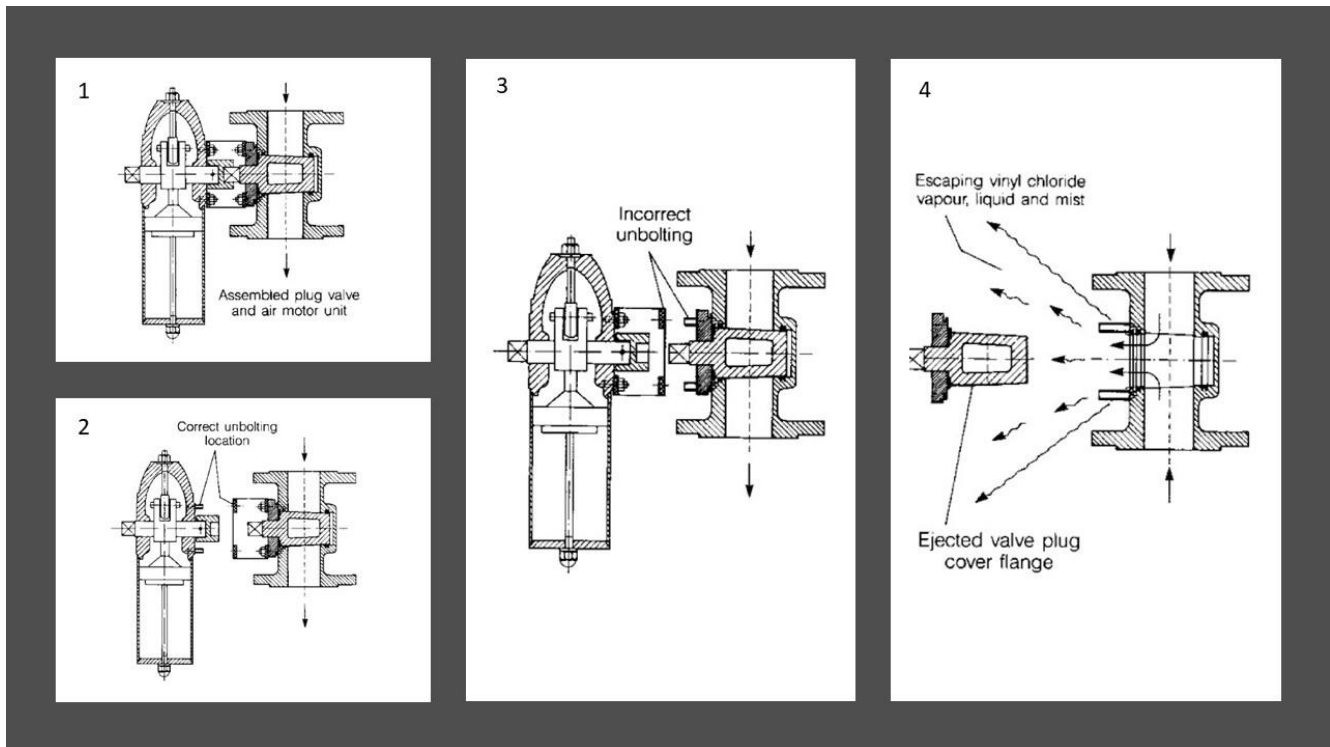
On June 19, 1977, in Puebla, Mexico, a maintenance worker incorrectly removed an actuator from a plug valve that was situated on a liquid discharge line beneath a vinyl chloride storage tank. The worker mistakenly removed pressure-retaining bolts instead of the bolts that connected the actuator to the adaptor (**Figure 8**). The plug, sleeve, and valve cover then blew out under the system pressure and caused a massive release of vinyl chloride. The vinyl chloride formed a vapor cloud that eventually ignited, and led to additional subsequent explosions, causing severe damage to the site. The incident fatally injured one person and severely injured four other people. Nearly 90 additional people suffered burns from the intense thermal radiation from one of the explosions [5].

Figure 8. Series of schematics showing the inadvertently dismantled valve in the Puebla, Mexico, incident: (1) Assembled plug valve and actuator; (2) Correct unbolting locations; (3) Actual unbolting location; (4) Plug ejected from valve. (Credit: Loss Prevention Bulletin 100 [5])

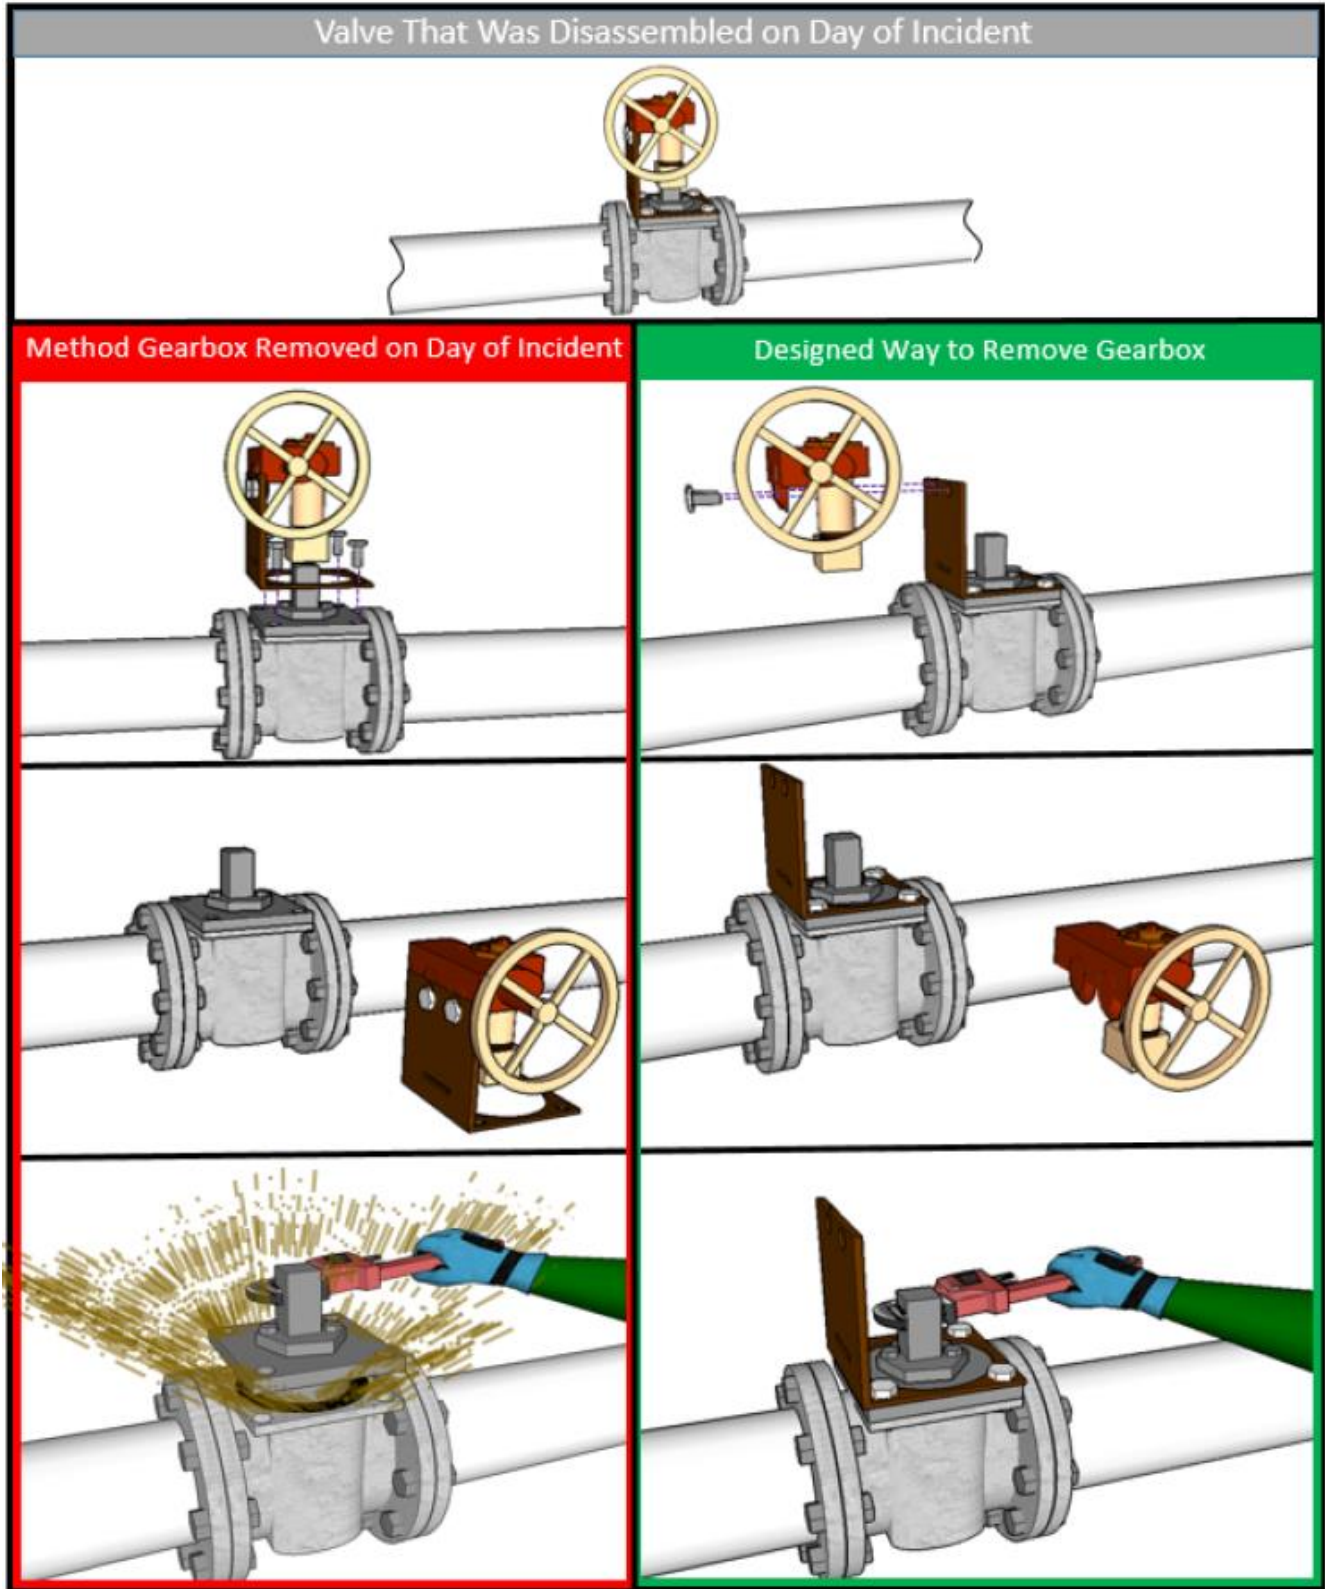
On November 22, 2016, during the removal of an inoperable gearbox on a plug valve, the operator performing the activity removed critical pressure-retaining bolts securing the pressure-retaining top-cap of the valve instead of bolts that secured only the gearbox (**Figure 9**). When the operator then attempted to open the plug valve with a pipe wrench, the valve came apart and released isobutane into the unit, forming a flammable vapor cloud. The vapor cloud ignited and severely burned four workers. The CSB investigated this incident and published a Safety Bulletin titled *Key Lessons from the ExxonMobil Baton Rouge Refinery Isobutane Release and Fire* [8].^a

Figure 9. Depiction of the gearbox removal on the day of the ExxonMobil Baton Rouge 2016 incident (left), and depiction of how the gearbox should have been removed (right). (Credit: CSB [8])

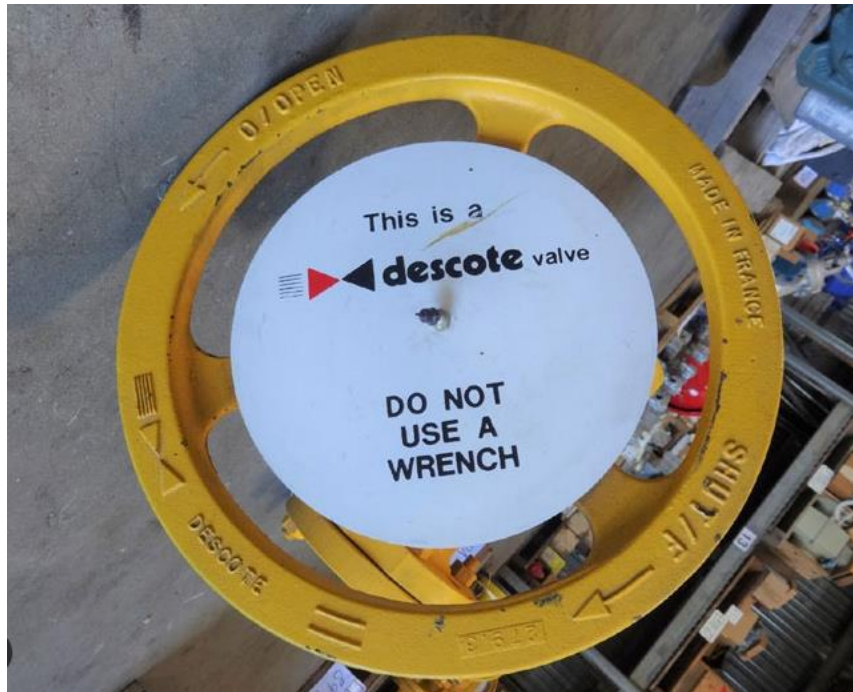
Figure 10. Photograph of a Descote valve’s warning sign to not use a wrench on the valve. (Credit: Steven Levy Enterprises [14])

To prevent future incidents in which workers inadvertently remove pressure-retaining components from plug valves while attempting to remove actuating equipment, facilities should clearly mark or identify pressure-retaining bolts on existing plug valves, for example through color coding techniques and/or warning labels or signs.

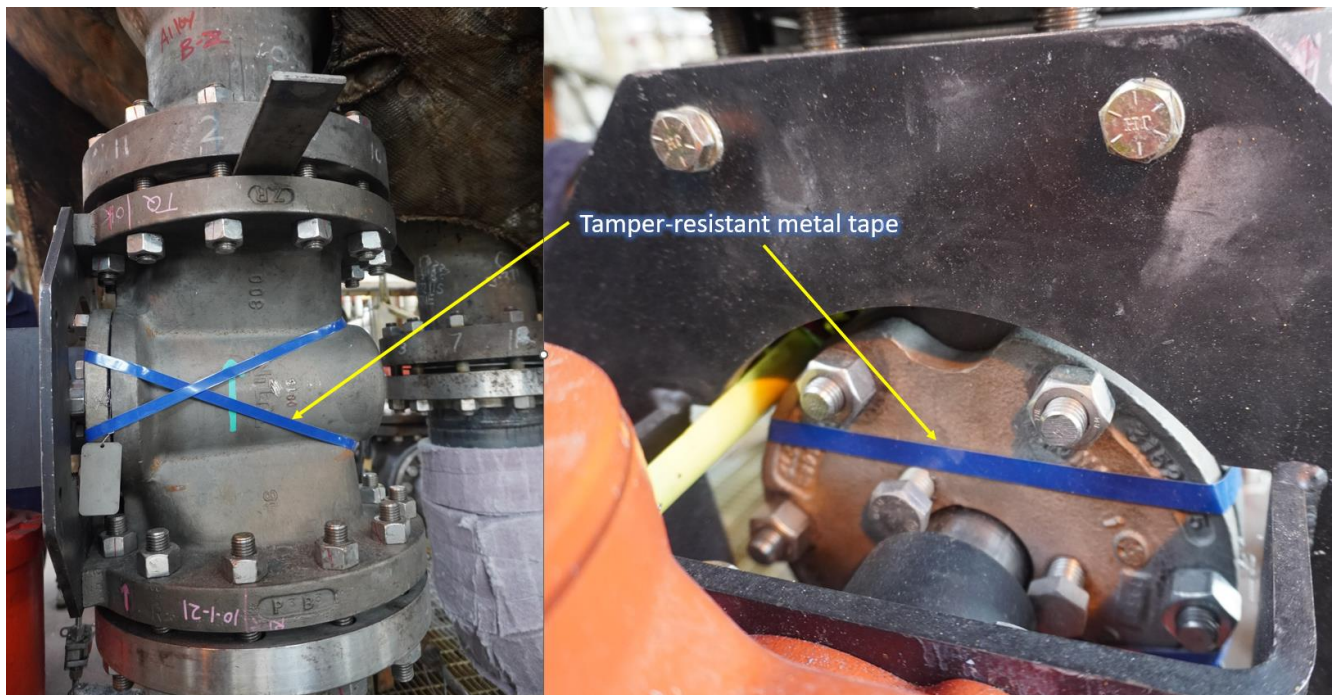
Figure 11. Example of tamper-resistant mechanism incorporated by LyondellBasell. (Credit: CSB)

The CSB concludes that had the LyondellBasell plug valve pressure-retaining bolts been clearly identified (such as through paint markings or a warning label or sign), the work crew might have removed only the bolts securing the actuator to the plug valve, which would have prevented the incident. The CSB also concludes that to prevent future incidents in which workers inadvertently remove pressure-retaining components from plug valves while attempting to remove actuators and gearboxes, prevailing valve standards should be revised to require that pressure-retaining components on existing valves are clearly marked, and that new plug valves be designed to prevent the inadvertent removal of pressure-retaining components while attempting to remove the actuating equipment. The CSB notes that after the incident, LyondellBasell installed tamper-resistant mechanisms and tags on the valve cover fasteners of actuated plug valves within the unit to help prevent the inadvertent removal of pressure-retaining components while the valves are in service (**Figure 11**).
