U.S. Chemical Safety and  
Hazard Investigation Board

# Equipment Fracture and Fatal Hydrogen Chloride Release at Wacker Polysilicon North America

Charleston, TN | Incident Date: November 13, 2020 | No. 2021-01-I-TN

## Investigation Report

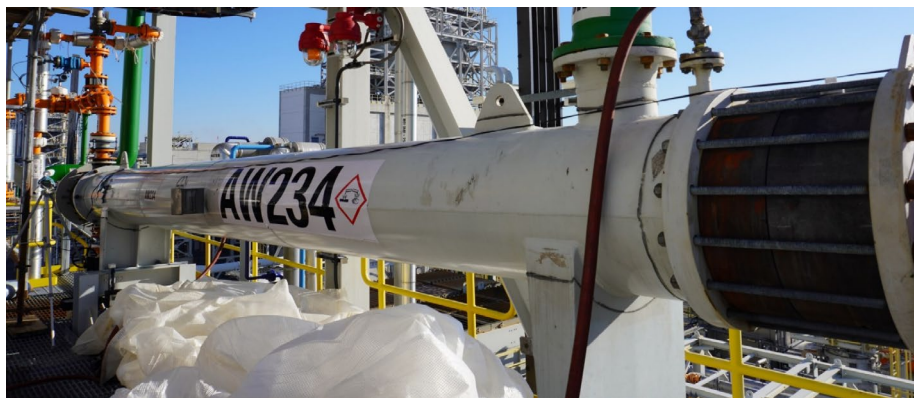
The incident occurred when gaseous HCl released from a crack that formed in the vapor outlet nozzle of a heat exchanger in HCl service (referred to by Wacker as heat exchanger AW234) after a contractor pipefitter inadvertently over-tightened (torqued) flange bolts installed on the heat exchanger. The heat exchanger consisted of a carbon steel shell (which contained cooling water) and a graphite tube bundle (which contained HCl). A photograph of the heat exchanger is shown in Figure 1.

Figure 1. Heat exchanger AW234. (Credit: CSB)

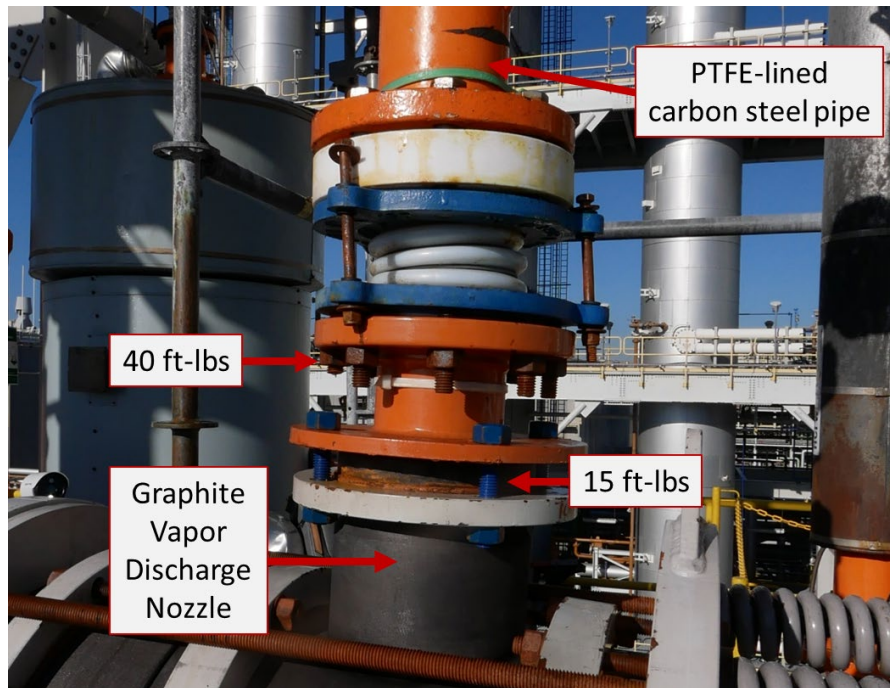
The bolts that were used to connect the nozzle equipment to the PTFE-lined carbon steel pipe required various tightening (torque) requirements, based on the materials of construction of the equipment being connected and the properties of the bolts. The heat exchanger manufacturer indicates that the recommended bolt torque for bolts connecting equipment to the graphite heat exchanger (the blue bolts in **Figure 2**) is 15-foot pounds (ft-lbs). By contrast, the torque requirement for connecting PTFE-lined carbon steel piping components (shown in **Figure 2**) is significantly higher, at 40 to 67 ft-lbs.

Figure 2. AW234 vapor discharge piping configuration. (Credit: CSB)

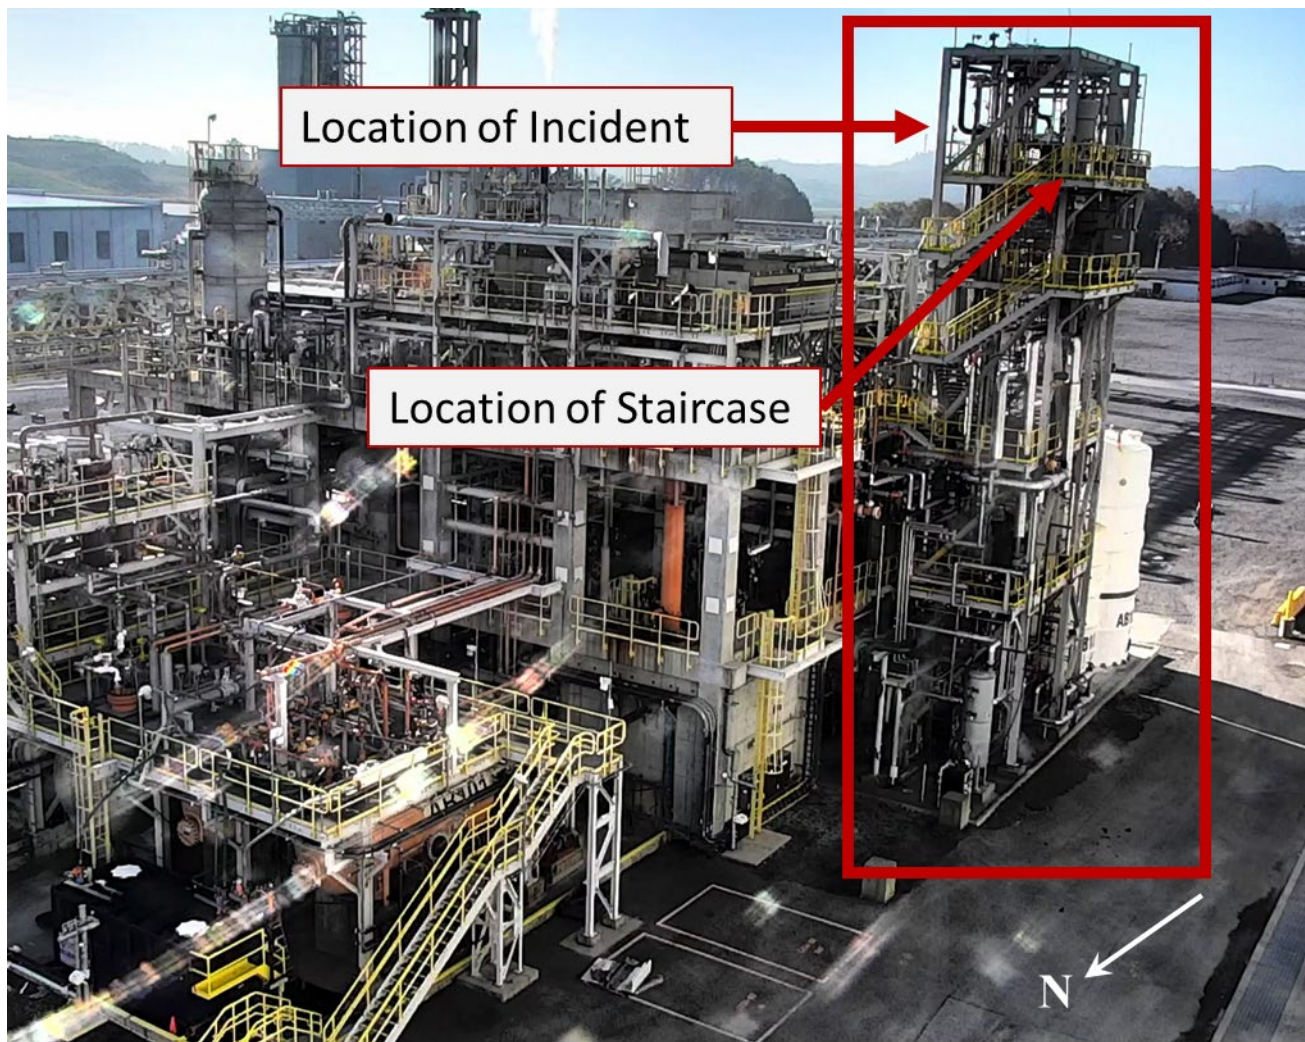
The AW234 heat exchanger was located on a fifth-floor platform, shown in **Figure 3**. The fifth-floor platform was equipped with a single staircase, visible in **Figure 3**, for access and egress. The platform was approximately 70 feet above the ground.

**Figure 3.** Equipment access structure where incident occurred. Directional arrow is approximate. (Credit: Wacker, annotations by CSB)

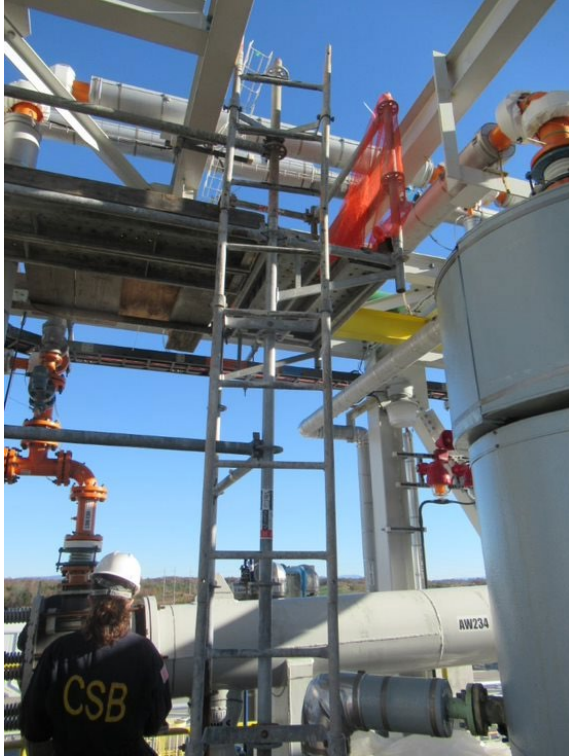
**Figure 4.** Scaffolding located near the release obstructing movement on the platform. (Credit: CSB)

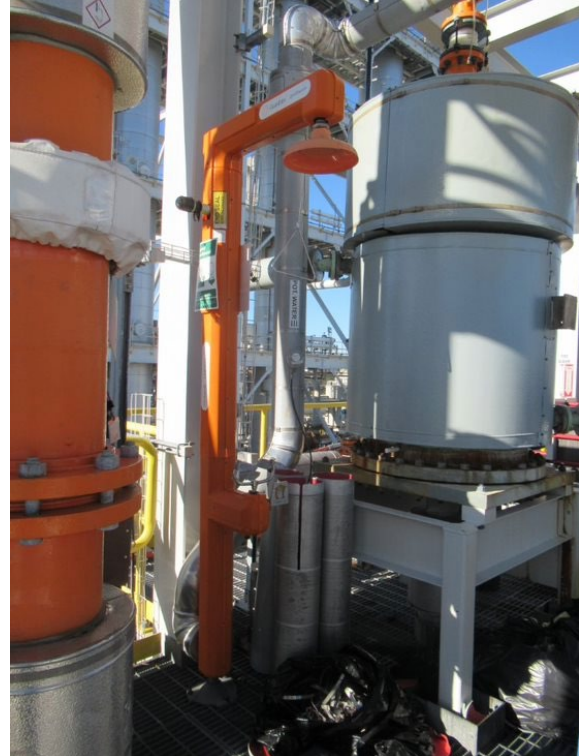
**Figure 5.** Fifth-floor safety shower. (Credit: CSB)

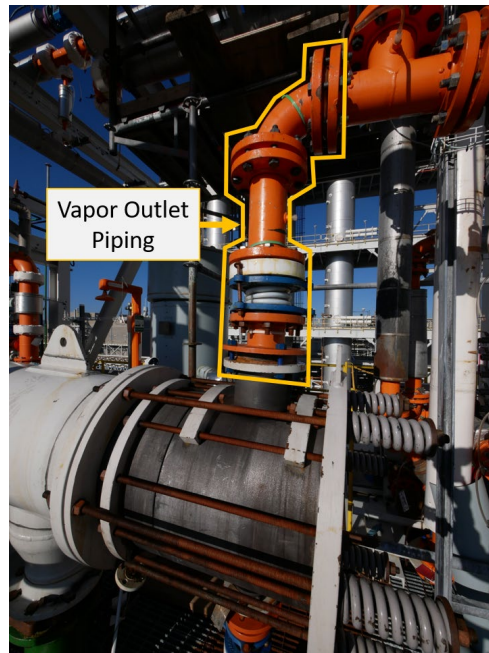
**Figure 7.** HCl vapor outlet piping on the AW234 heat exchanger vapor outlet nozzle. (Credit: CSB)

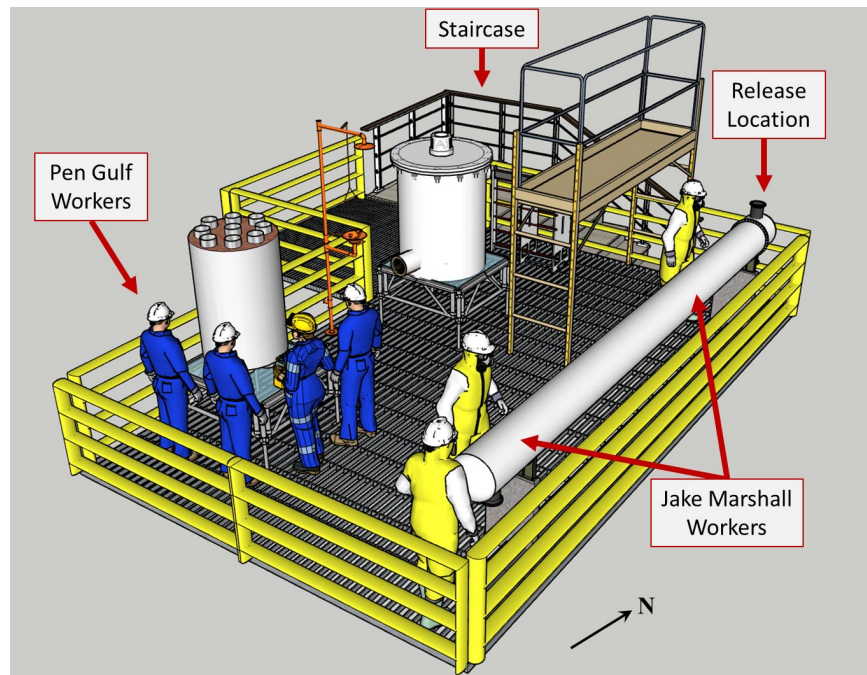
**Figure 8.** Pen Gulf and Jake Marshall work locations. Figure is not to scale and is intended to provide a general spatial representation of workers and equipment. (Credit: CSB via SketchUp)

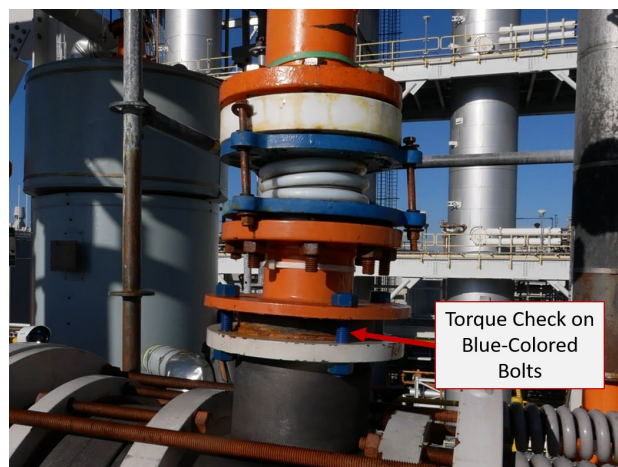
Just after 10:00 a.m., the Jake Marshall apprentice pipefitter used the torque wrench set at 40 ft-lbs to check the torque on the blue-colored bolts (shown in **Figure 9**), which have a manufacturer-recommended torque value of 15 ft-lbs. At 10:04 a.m., the excess torque applied to the blue-colored bolts caused the graphite heat exchanger AW234 to crack, releasing gaseous HCl (**Figure 10**).

**Figure 9.** Torque check location. A Jake Marshall employee was checking the bolts connecting the graphite flange when the release occurred. (Credit: CSB)

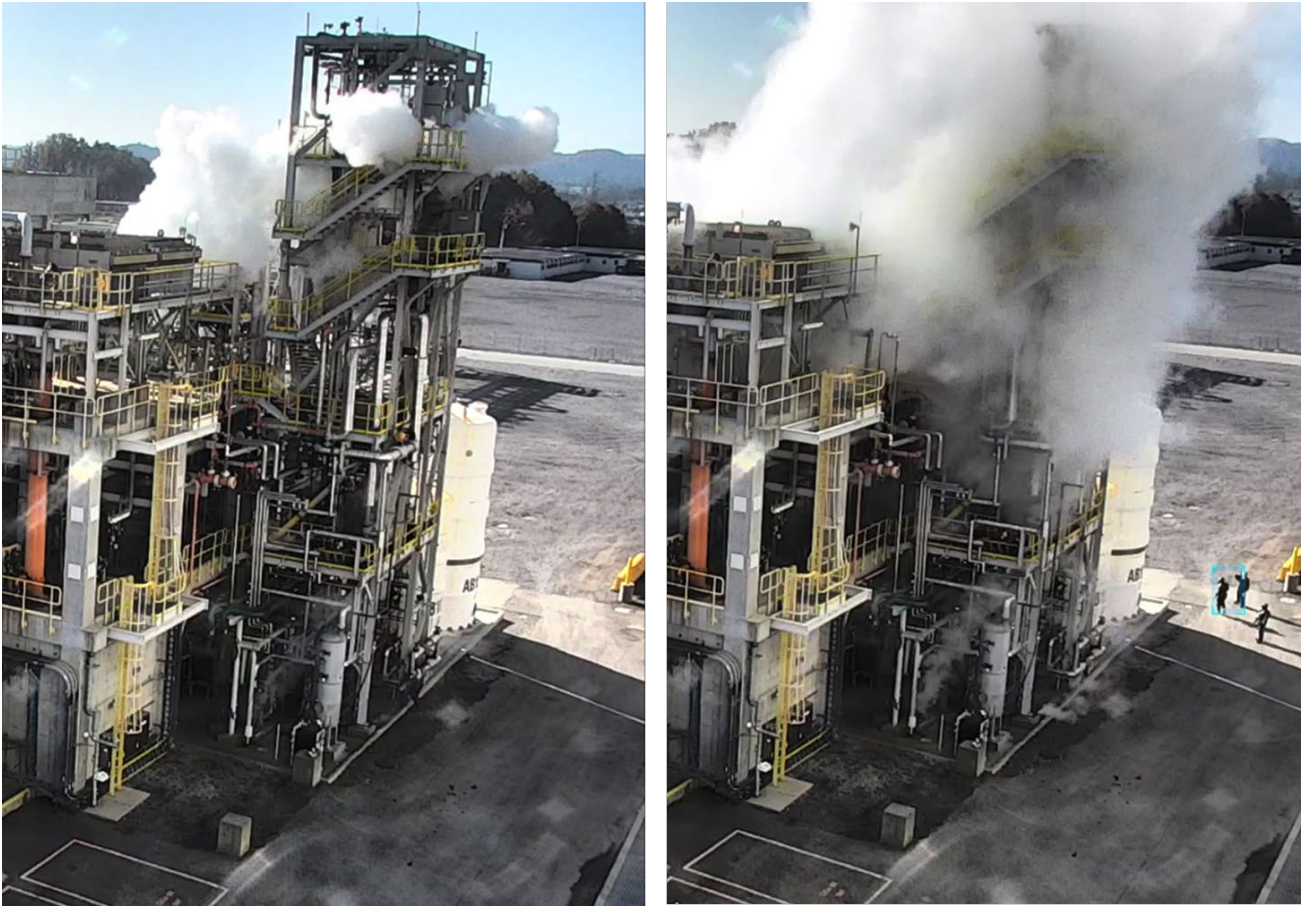
**Figure 10.** Image of HCl release at the time of release (left) and 15 seconds after release (right).  
(Credit: Wacker)

A white gaseous HCl cloud filled the area within 15 seconds (**Figure 10**), preventing the workers on the platform from being able to see their surroundings. When the Jake Marshall apprentice pipefitter attempted to move away from the release, his chemical suit was snagged and tore open, allowing HCl to enter the suit and cause chemical burns to his skin. While engulfed in the white HCl cloud, he also bumped into equipment on the platform, which knocked off his respirator. Due to the breach of his PPE and location of the release, the apprentice pipefitter was unable to escape to the single staircase to exit the platform. He moved to the opposite side of the platform where the other Jake Marshall and Pen Gulf employees had been working (**Figure 11**). Jake Marshall workers placed the injured worker in the adjacent safety shower to protect him from the release (**Figure 5**).

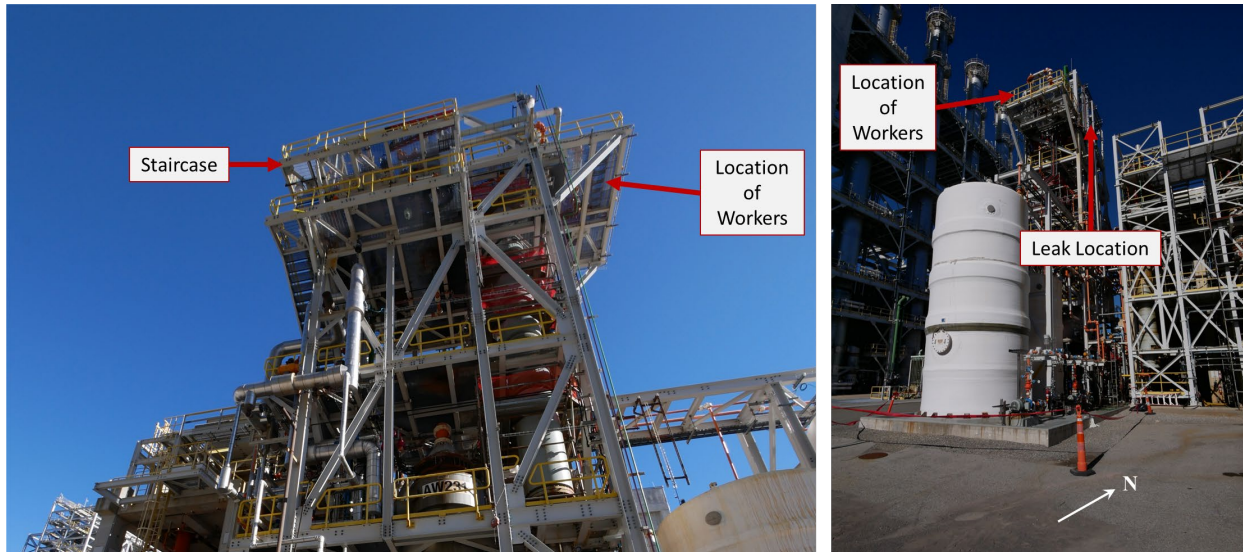
**Figure 11.** Location of trapped workers. When the release occurred, two Jake Marshall employees and four Pen Gulf employees were working on the south end of the platform. Directional arrow is approximate. (Credit: CSB)

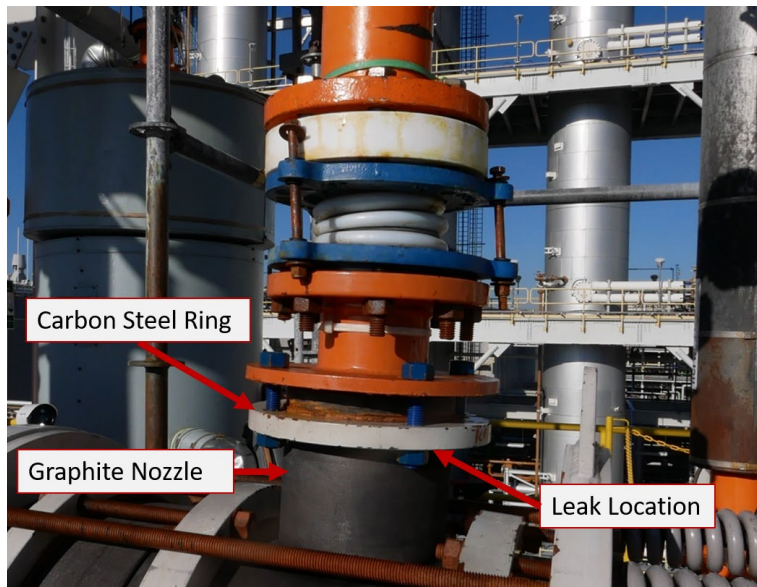
A leak test was conducted on the heat exchanger involved in the incident to determine the approximate location of the failure. The test identified a leak on the heat exchanger vapor outlet nozzle. The leak was under the carbon steel ring that was connected to the blue bolts that the Jake Marshall employee was torque checking (**Figure 12**).

**Figure 12.** Location of leak. Leak tests on the heat exchanger revealed a leak from the graphite nozzle underneath a carbon steel ring used to attach the nozzle to carbon steel piping. (Credit: CSB)

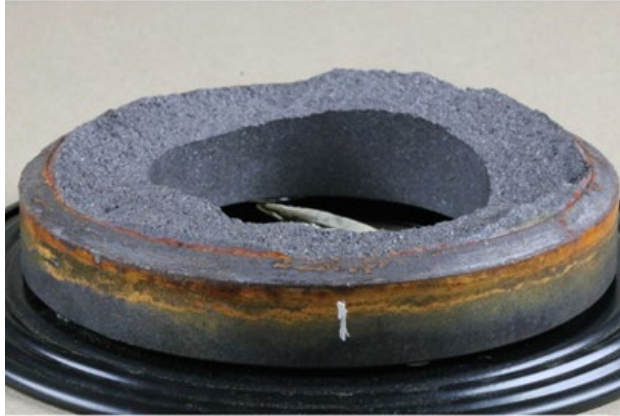
Following the incident, Wacker commissioned testing and failure analysis of the AW234 graphite nozzle, which included laboratory analysis; non-destructive testing (NDT); fractography; scanning electron microscopy (SEM); and tensile, flexural, and thermal expansion testing. The graphite AW234 heat exchanger nozzle was found to have failed from a full circumferential fracture on the top flange, as shown in **Figure 13**. Destructive testing indicated that the nozzle fracture was consistent with brittle overload. The U.S. Chemical Safety and Hazard Investigation Board (CSB) concludes that the failure of the graphite heat exchanger nozzle was due to over-torquing the bolts connecting the graphite nozzle to PTFE-lined equipment.

**Figure 13.** AW234 graphite nozzle fracture. (Credit: Wacker)

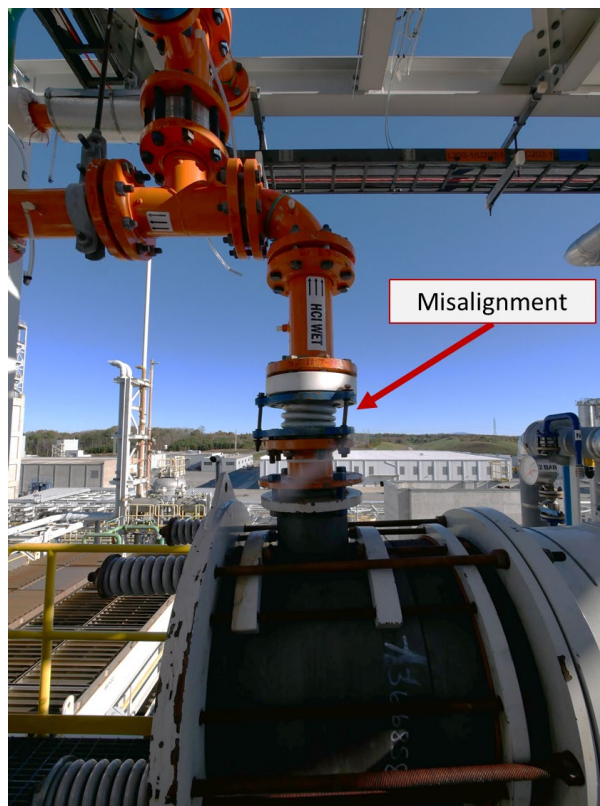
Further analysis identified potential radial misalignment between the AW234 nozzle and the outlet piping (as shown in **Figure 14**). Misalignment could have imposed external loading that resulted in stresses within the graphite nozzle. While misalignment stresses may typically be mitigated by the present expansion joint, it is possible that if sufficient torque had been applied to the flanged connection to initiate cracks, the misalignment stresses could have provided the driving force to complete the nozzle fracture.<sup>a</sup>

**Figure 14.** Possible radial misalignment on AW234 outlet piping. (Credit: CSB)

<sup>a</sup> While the misalignment may have exacerbated the fracture, the CSB did not consider misalignment of the vapor outlet piping causal to the nozzle failure, and therefore, piping misalignment is not detailed in this report.

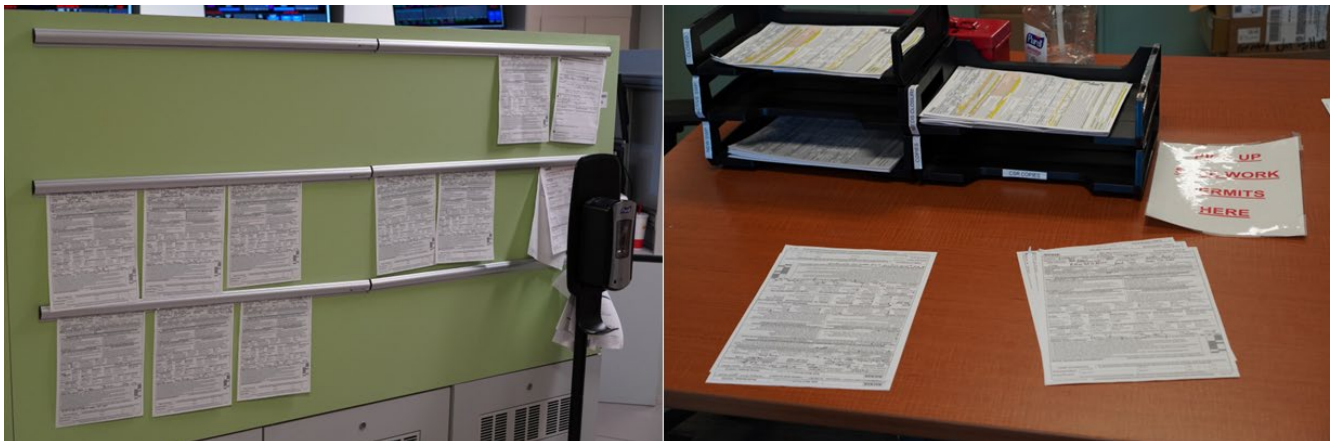
This incident, however, occurred during the COVID-19 pandemic, and Wacker had implemented practices to reduce personnel in areas of crowding. To limit foot traffic in the control room, Wacker began permitting some tasks in the area manager's office, and copies of those permits were placed on the area manager's desk. Under this practice, some permits were posted in the control room, and some permits were placed on the area manager's desk (**Figure 17**), and there was no organized tracking system for Wacker employees to find which permits were in what location. While the CSB could not determine where the Pen Gulf and Jake Marshall safe work permits were displayed before the incident, this new, somewhat disorganized permit posting method in response to the COVID-19 pandemic may have contributed to the permit authorizers not realizing that two separate crews were scheduled to work on the fifth-floor platform on the day of the incident.

**Figure 17.** Active work permits posted on a board in the control room (left). Work permits on a table in the area manager's office (right). (Credit: CSB)
