Perspectives on Containment Wall Failure at ITC Deer Park, Texas
Fire at First & Second 80's Tank Farm at
Intercontinental Terminals Company
Event of March 17, 2019 at Deer Park, Texas

Issued Date

April 24, 2023

U.S. Chemical Safety and Hazard Investigation Board
1750 Pennsylvania Avenue, NW Suite 910
Washington, DC 20006

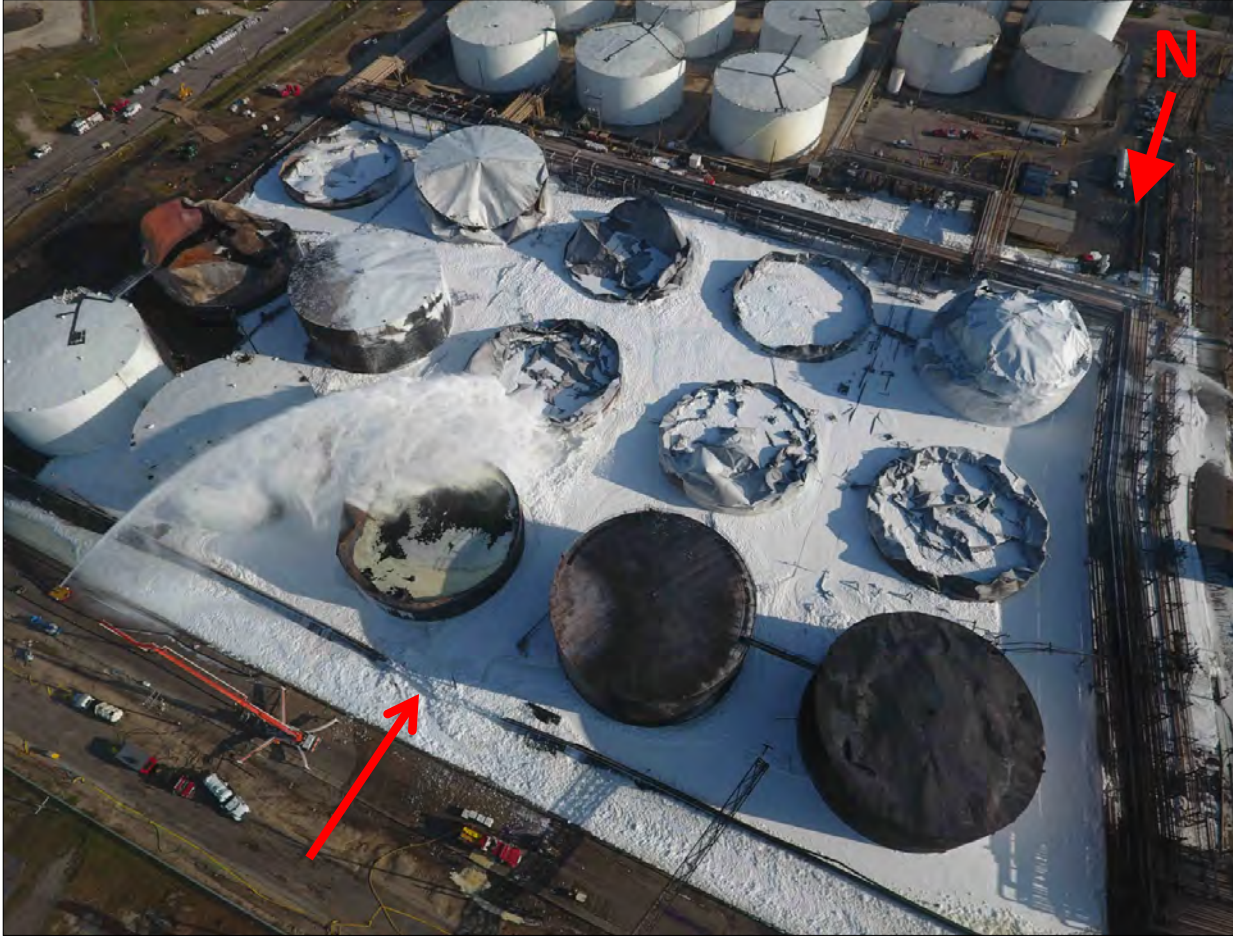
On March 22, the fire had been successfully suppressed and the firefighters were periodically re-applying additional firefighting foam to maintain a continuous blanket of foam across the site. UAS overflights were being conducted periodically to observe the status of the tank farm. Operations planned for that day included removal of product from vessel 80-7 by utilizing a concrete pump truck to reach damaged vessels from outside the containment wall. Drains and pumps throughout the site were also being used to lower the liquid level inside the containment area. But at approximately 12:00pm on March 22, a section of the containment wall on the north side of the tank farm, between tanks 80-4 and 80-7, failed, allowing the liquid mixture inside the tank farm to flow into the drainage ditch between the tank farm and Tidal Road (photo 4).

Photo 4: Containment wall failure (red arrow) during fire suppression efforts¹²

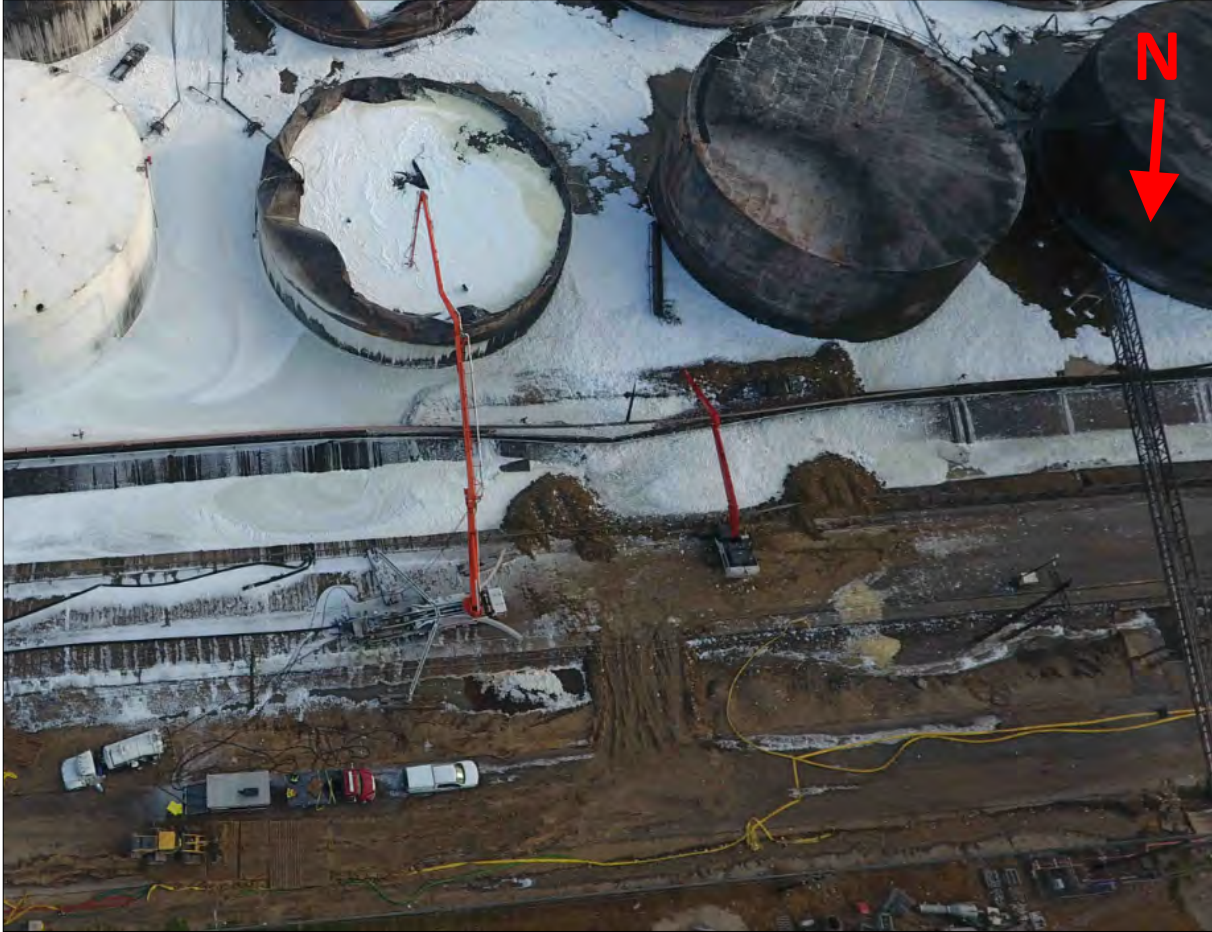
The response team had to retreat from immediately impacted areas. Flare-ups of fire in the drainage ditch and tank farm required re-application of firefighting foam. The team deployed additional booms in the waterways to contain product, and took measures to mitigate the leak from the tank farm. Initially, the incident response team utilized T-rail Jersey Barriers and sandbags inside the tank farm in an attempt to build a new containment structure to stop the breach and reestablish containment. This was augmented on March 23 by bringing in off-site soils to reinforce the immediate measures and construct a dike wall inside the breach (photo 5).

Photo 5: Responders constructing soil dike wall inside containment area to mitigate breach¹³

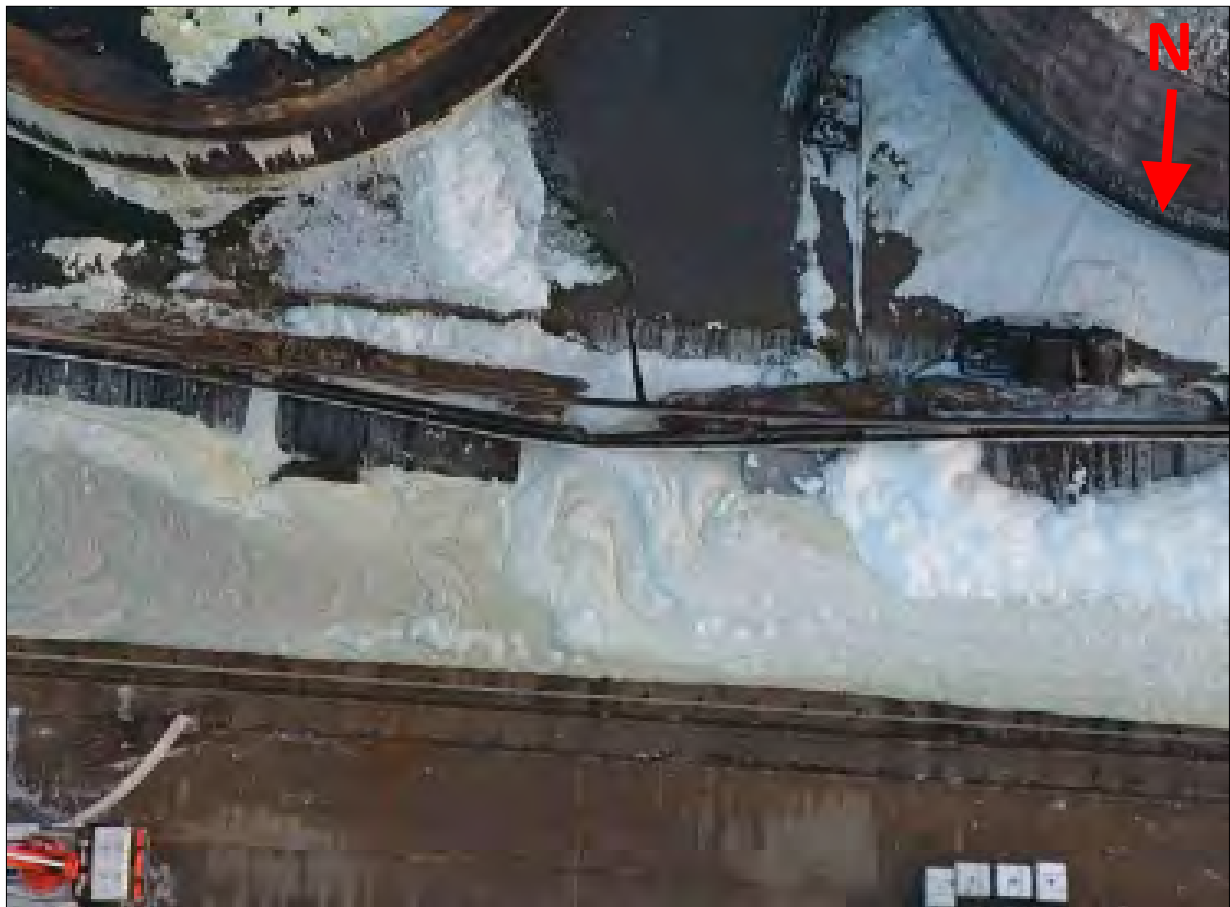
UAS overflight video footage was made available to Atlas by the CSB to aid in determining the condition of the wall during the event. Aerial footage showed that a section of the wall had shifted laterally to the north, tearing the waterstop at multiple construction joints and permitting fluid to flow into the drainage ditch north of the tank farm (photo 6). The wall remained straight and continuous between construction joints. A section of the soil immediately south of the containment wall shifted laterally as well, opening a crack in the ground surface that permitted large volumes of fluid to wash down into the soil. A steel pipe that was supported on top of the containment wall was separated from the wall as it displaced, but appears to have remained intact and was suspended above the area of the breach. The two pipes on the exterior of the containment wall, one black and the other white, were displaced by the wall.

Large volumes of firefighting foam flowed out of the containment area during this event, with foam traveling underneath the containment wall at the area of the breach. No foundation was visible in the photo, indicating that the wall may have separated from the foundation slab as it shifted. Much of the drainage ditch is obscured by foam, but there are indications that the sloped slabs lining the ditch, adjacent to the containment wall, have displaced.

Photo 6: Closeup from aerial view of containment wall failure¹⁴

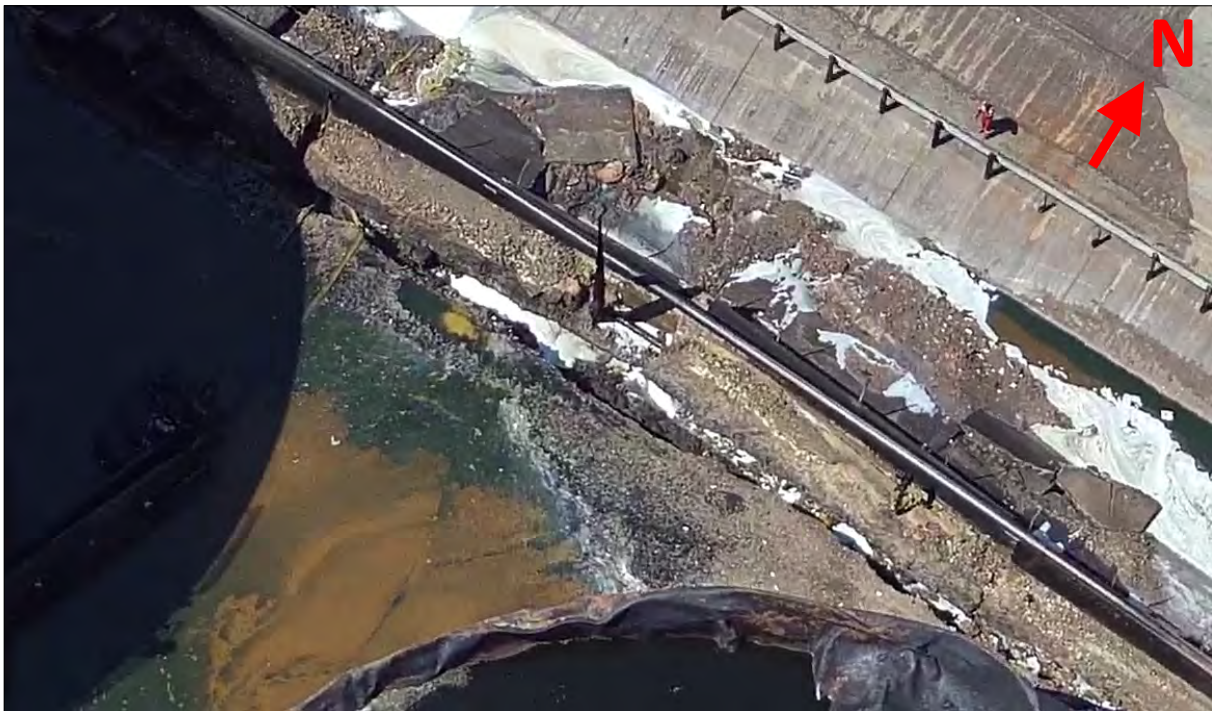
Photo 7 was taken after the bulk of the liquid had ceased to flow from the breach in the containment wall, but before emergency measures to build a temporary berm were taken. In this photo, a large erosion gully has been formed at the location of the primary breach, between 80-4 and 80-7, with smaller erosion gullies formed at adjacent construction joints in the wall where the waterstop was compromised as the wall shifted. The crack in the soil is visible parallel to the containment wall that resulted from the lateral shift of the wall and soil immediately behind the wall. The firefighting water distribution pipe running parallel to the containment wall can be seen exposed where the soil eroded away. It is not possible to determine if the foundation was displaced from its original position from this photo. The remains of a wood light pole that has been burned can be seen standing in this area. The remaining section of the light pole is still vertical. The sloped slabs on the south side of the drainage ditch have been displaced, with many buckling in the middle and some displaced entirely by the flow of liquid into the ditch. Eroded soil can be seen in the drainage ditch.

Photo 7: Aerial photo of containment wall failure after water flow stopped and before temporary dike wall was constructed¹⁵

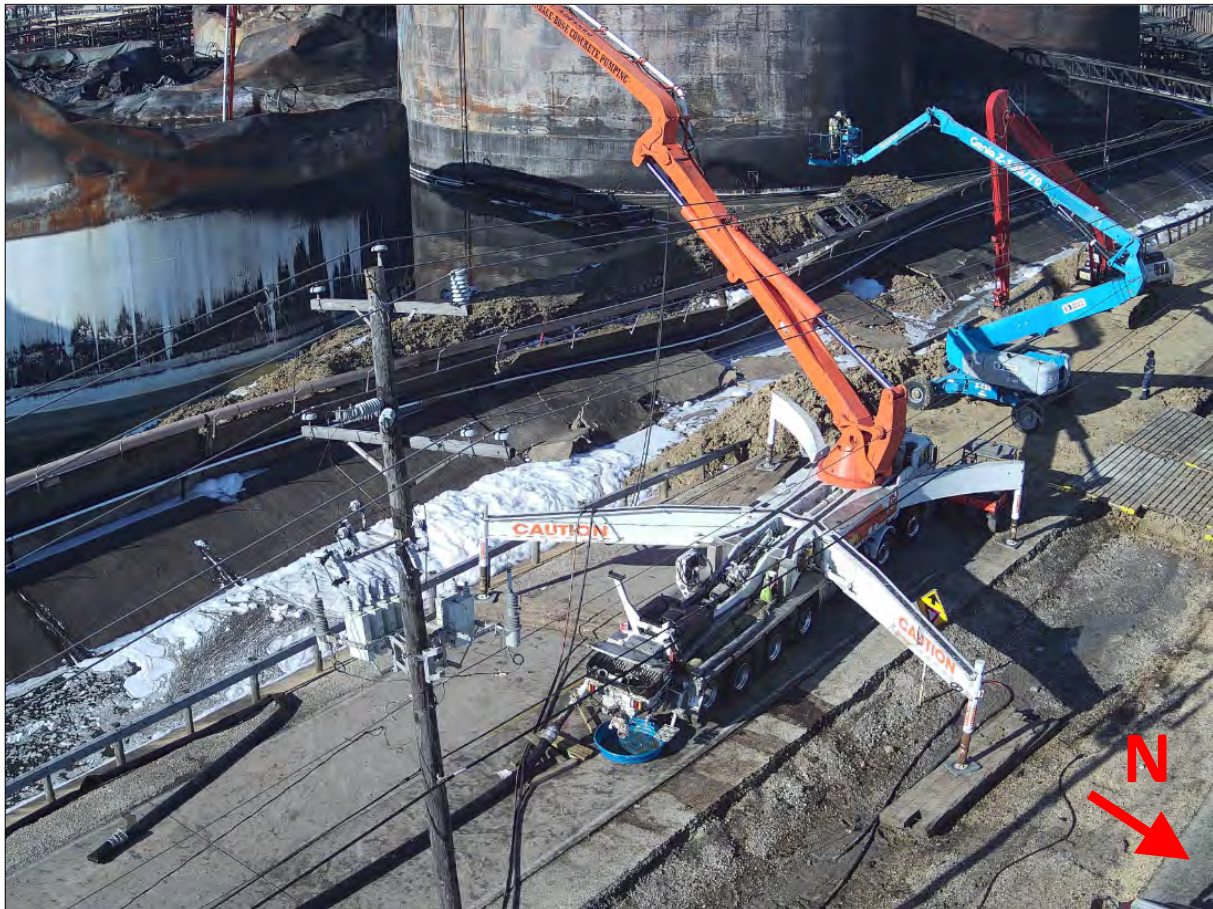
A photo of the breach after the response team had placed soil inside the tank farm to build a temporary berm can be seen in photo 8. The containment wall can be seen to have shifted laterally, with a slight outward rotation in this photo. The wall sections remained intact between construction joints, however the lateral displacement of the wall had resulted in gaps and torn waterstop at several construction joints. The sloped slabs on the south face of the drainage ditch can be seen buckled upward.

Photo 8: View of containment wall failure, after temporary dike wall was constructed¹⁶

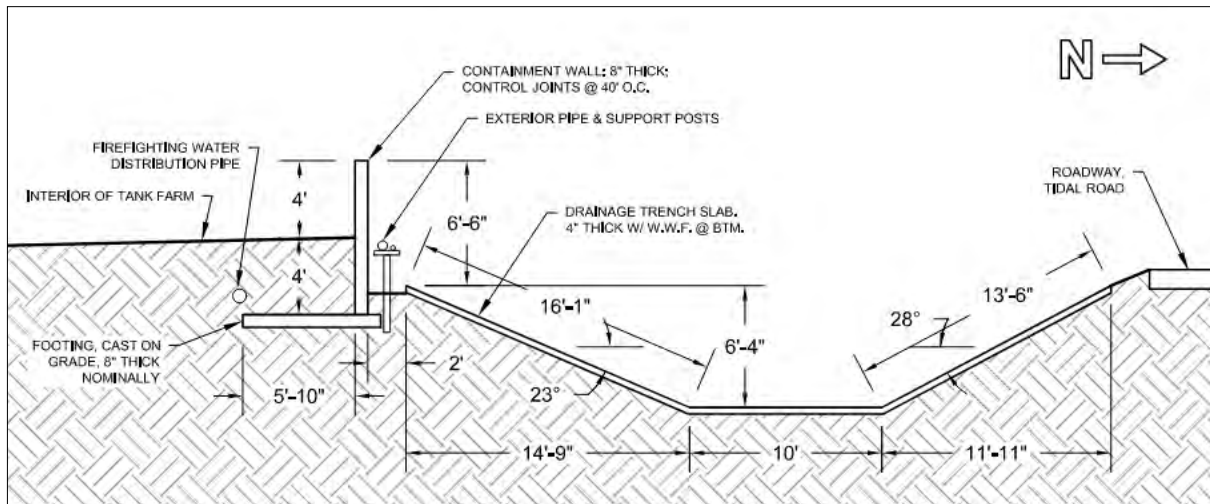
Measurements of the existing wall and drainage ditch were taken to construct a cross section sketch of the area (Figure 3). Measurements of reinforcement in the containment wall were made at locations where the containment wall had been broken by equipment during remediation efforts (Photo 11).

Figure 3: Cross section sketch of the containment wall

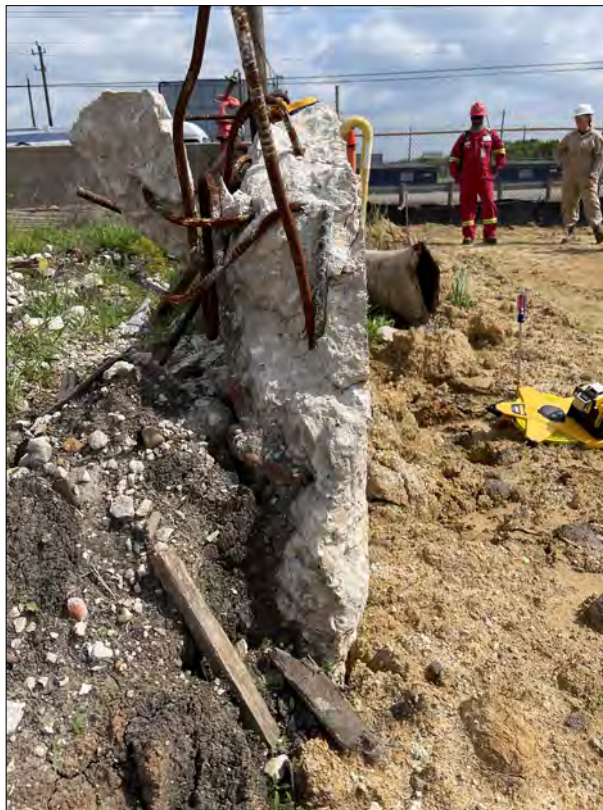
Photo 11: Exposed reinforcement at a section of the east containment wall where the wall was removed during remediation efforts

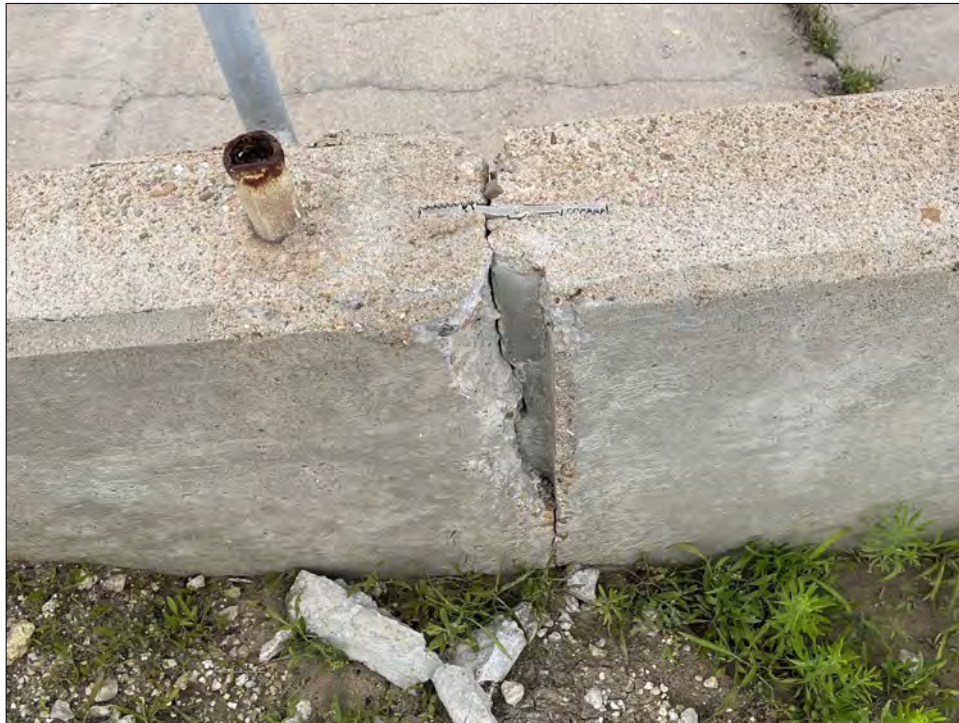
The containment wall was a cast-in-place concrete wall 8-inches thick and extending above the interior grade of the tank farm approximately 4 feet. The depth of the containment wall into the soil was not able to be determined at this visit. The wall had impressions from a panelized formwork system and through-wall break-off form ties, or snap-ties, spaced regularly in the horizontal and vertical direction, indicating it was constructed free-standing with a panelized formwork system on each face (photo 12). The wall was reinforced with two layers of deformed mild-steel reinforcing bars. The wall was cast in sections, with a construction joint every 40 feet. The joints were formed with a shear-key at the joint and a ribbed-wing centerbulb PVC waterstop incorporated into the construction joints to prevent liquids from leaking through the wall at the joints (photo 13 & 14).

Photo 13: Construction joint with cast-in concrete shear key and centerbulb waterstop

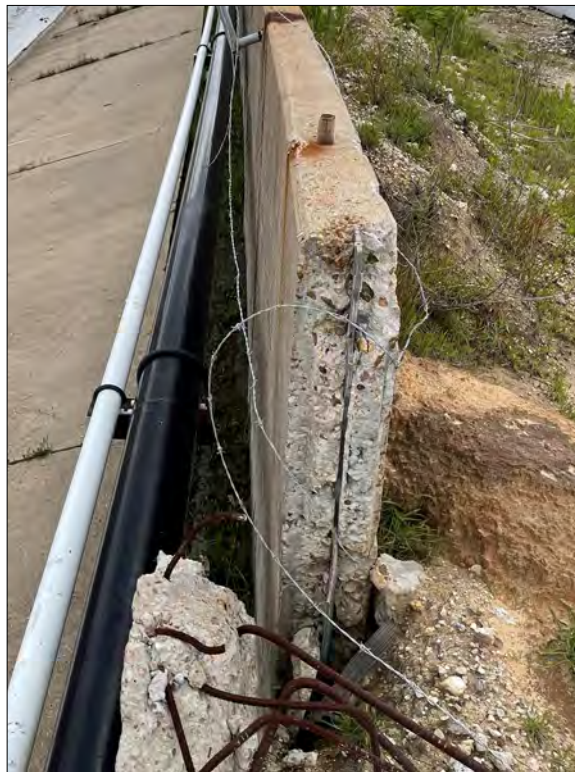
Photo 14: Torn waterstop and displaced wall. Upper section of wall that was displaced has been partially demolished during remediation efforts.

As the wall deflected due to the excessive lateral earth and hydrostatic pressures, the construction joints began to open, tearing the waterstop material and increasing the velocity of the escaping water. As the water velocity increased, the erosion of the soils at the joint and beneath the sloping slab subgrade accelerated and piping increased, increasing the hydrostatic pressure, eventually lifting and damaging the thin drainage ditch slab that lined the slope. In addition, as the wall shifted outward, it further damaged the sloped slab. Eventually, it appears that pieces of the slab were washed out of place by the final torrent of escaping liquid.

5. Incorporate water stop features to develop full continuity of systems. Pay special attention to terminations or transitions between systems, such as where footing-to-wall joints meet wall construction joints.

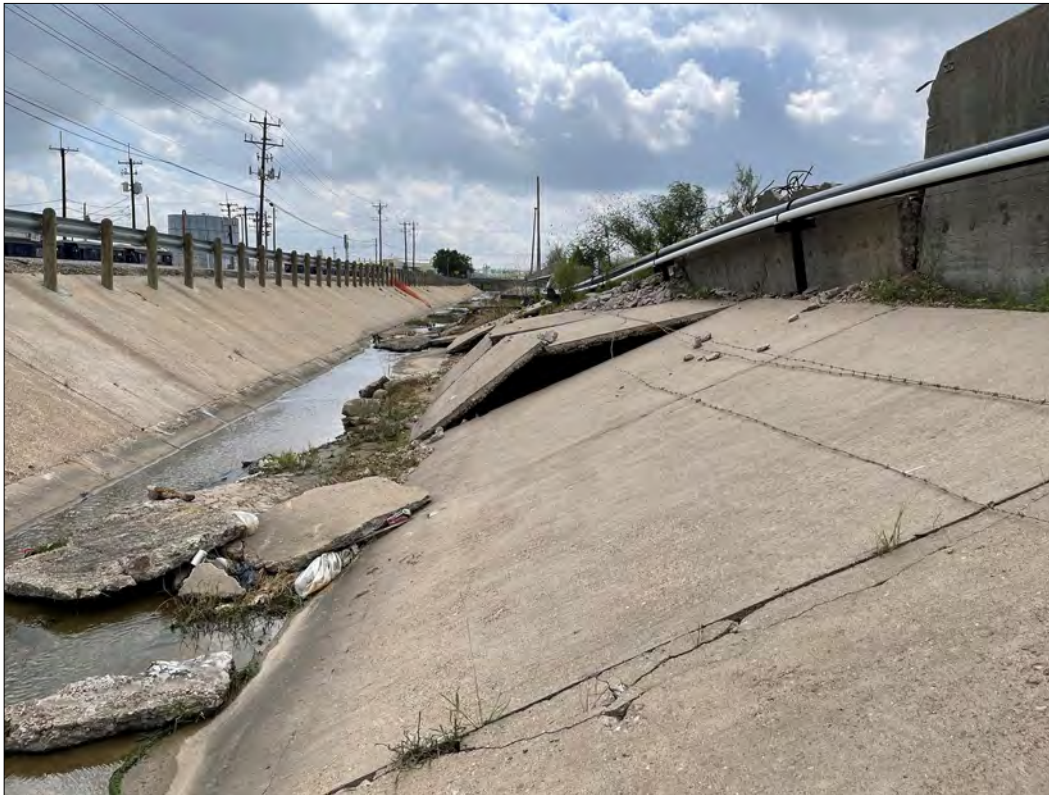
The drainage ditch between the containment wall and Tidal Road was a concrete-lined structure with a flat bottom and sloped side walls (photos 15 & 16). The concrete slab was approximately 4-inches thick, with welded-wire-reinforcement observed at broken sections of the concrete, typically located near the bottom of the slab. The concrete slabs were cast in sections, with construction joints between the slabs (photo 17). The welded-wire reinforcement did not span across the construction joints. Holes through the slab were observed along the bottom edge of the sloped side-wall slabs, appearing to have the purpose of providing drainage of groundwater from behind the side slab into the drainage ditch. In the areas adjacent to the breach that appeared un-disturbed, sections of the sloped sidewall concrete slab had buckled upward in the middle of the slab.

Photo 16: Damaged Section of Drainage Ditch, looking east

During the breach in the containment wall, the sloped slabs of the drainage ditch buckled upward, indicating either a large upward force from soil and hydrostatic water pressures or a large lateral force from lateral sliding of the containment wall. The sloped sidewalls of the ditch were not directly connected to the containment wall, with a gap between the top of the slab and the containment wall of at least 2-feet. Nor were the sloped slabs sized or reinforced in any way that indicates they were intended to brace the containment wall. Their construction appears to be designed to prevent erosion of the soil forming the drainage ditch only.

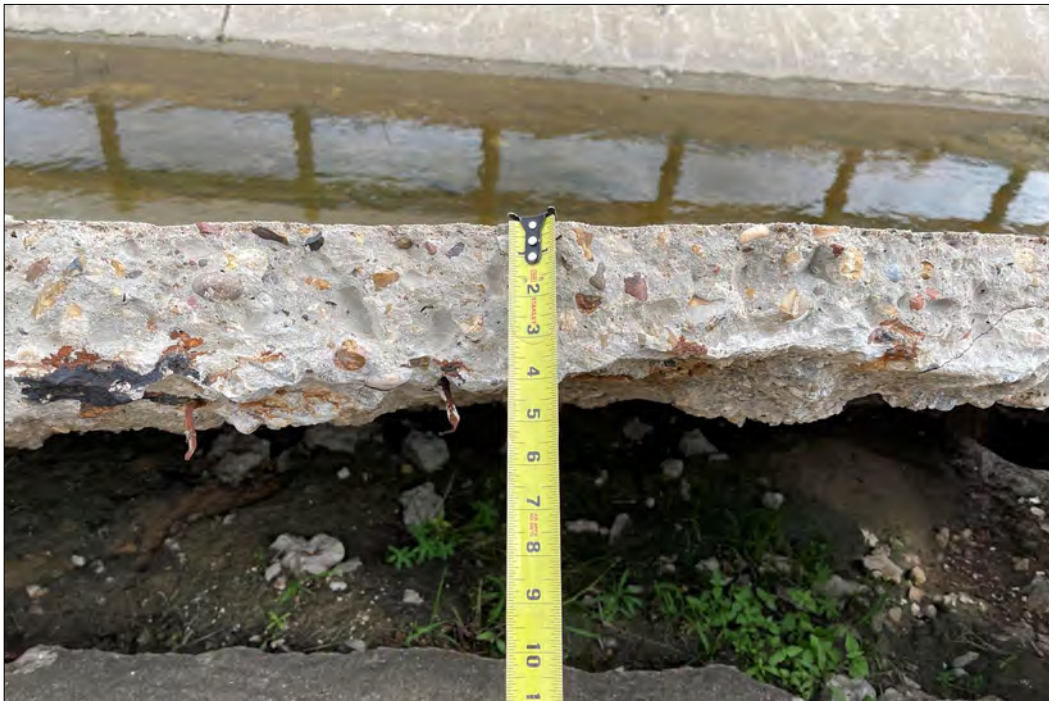
Photo 17: Displaced section of concrete slab that formed sloped sidewall of ditch

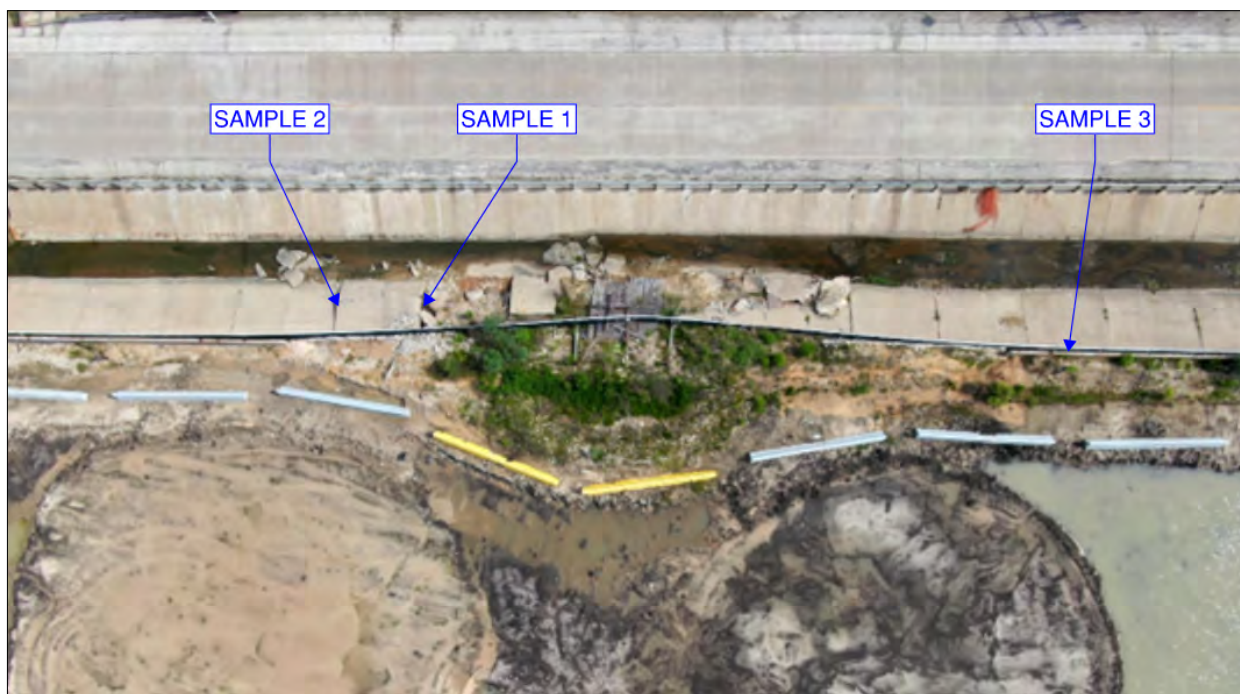
Photo 18: Soil Sample Locations relative to breach in containment wall

Sample 1 appears to be a stiff mottled tan and gray silty deltaic clay. Its classification would be most likely “CH” when classified in accordance with the Unified Classification system. Sample 2 appears to be a dark gray deltaic clay, also likely to be classified as a CH. Sample 3 appears to be a moist soft gray marine clay CH. Both Samples 1 and 2 appear to have been disturbed and are poorly consolidated, whereas Sample 3 is fine grained and well consolidated. Samples 1 and 2 are assumed to be typical of the soils located underneath the sloped side slab of the drainage ditch. Sample 3 is assumed to be similar to the soils inside the containment area at the containment wall. The soil in Samples 1 and 2 appears to be moderately sensitive. Soil sensitivity is a characteristic describing the loss of soil strength when changing from an undisturbed natural condition to a disturbed condition through excavation and re-compaction. Soils with higher sensitivity lose a greater proportion of their strength when disturbed. Sample 3 appears to have a high shrink-swell potential, or a potential to change volume as water content in the soil changes. Soil swelling can increase the pressure on retaining walls considerably higher than normal pressures.

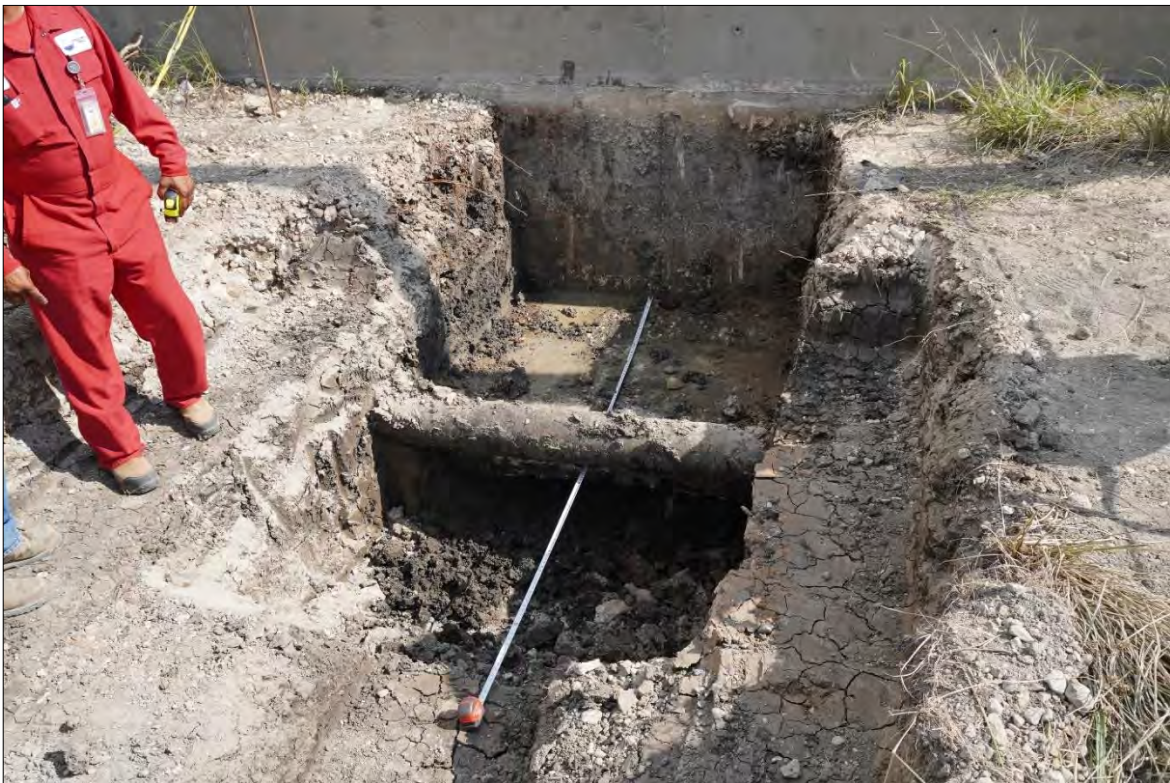
ITC excavated a section of the interior face of the containment wall on June 9, 2022. Atlas Engineering was unable to visit the site during the excavation, however CSB personnel were able to observe the condition of the wall after the excavation and take measurements (Photos 22 & 23). Measurements taken in the excavation area were used to refine the cross-section sketch through the containment wall shown above in Figure 3. The excavation revealed the containment wall extends down 4 feet below the grade level of the interior of the tank farm. There was a horizontal slab extending approximately 5 feet south from the interior face of the containment wall. This slab had a highly irregular edge and bottom surface, indicating it was cast against grade. No standing water was seen in the footing, indicating the natural groundwater level was below the base of the footing. The excavation also revealed the location of an underground firefighting water distribution pipe that supplied the fixed firefighting monitors located along the north wall inside the tank farm.

Photo 22: Containment wall footing excavation, south face of north wall, inside containment area

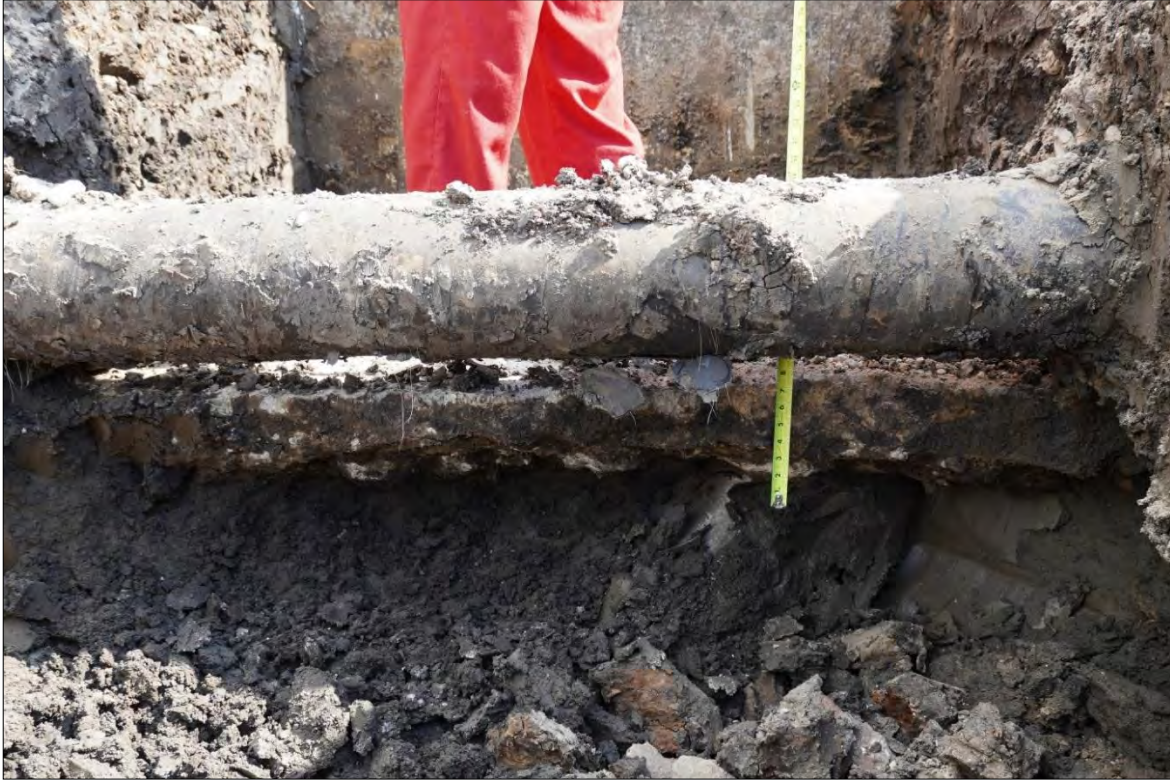
Photo 23: Containment wall footing and underside of footing

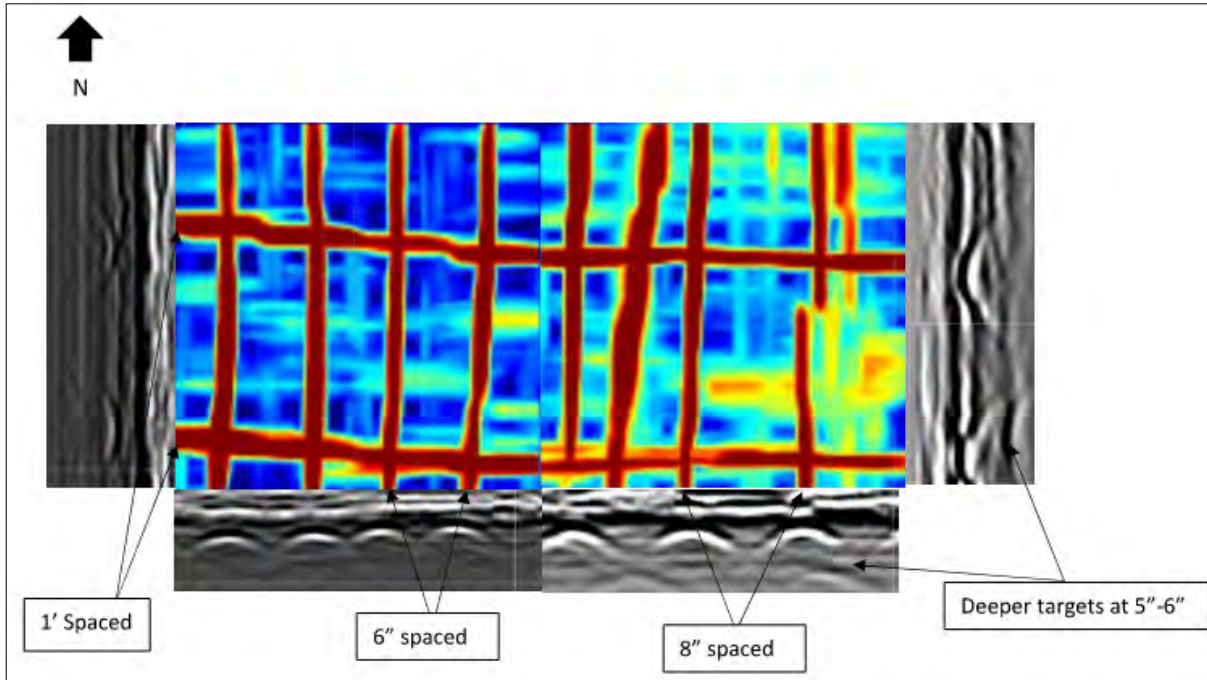
A contractor was utilized to perform a ground penetrating radar (GPR) scan of the foundation in an attempt to determine if reinforcement was present in the foundation and its general configuration. Due to the irregular surface of both the top and bottom of the concrete footing, the GPR instrument was limited in the information it could provide. The depth of the concrete could not be definitively identified due to the irregularities of the bottom surface of the concrete, a result of being cast against grade. GPR did indicate the presence of reinforcement in the concrete foundation, running both longitudinally and across the slab.¹⁸ GPR was not able to identify if any dowels existed between the horizontal concrete slab serving as the footing and the vertical concrete wall forming the containment wall. Longitudinal reinforcement was detected approximately 12-inches on center, while transverse reinforcement was detected with spacings varying from 6 to 8-inches on center (Figure 4). The size of the reinforcement could not be determined from the GPR results. Excavation on the exterior side of the containment wall was not possible due to the presence of active pipelines in the area.

Figure 4: GPR scan results of retaining wall foundation slab from Holes Technology LP Report
