Investigation Report

Published: December 2023

The April 2, 2019, explosion and fire at the KMCO facility in Crosby, Texas, fatally injured James Mangum.

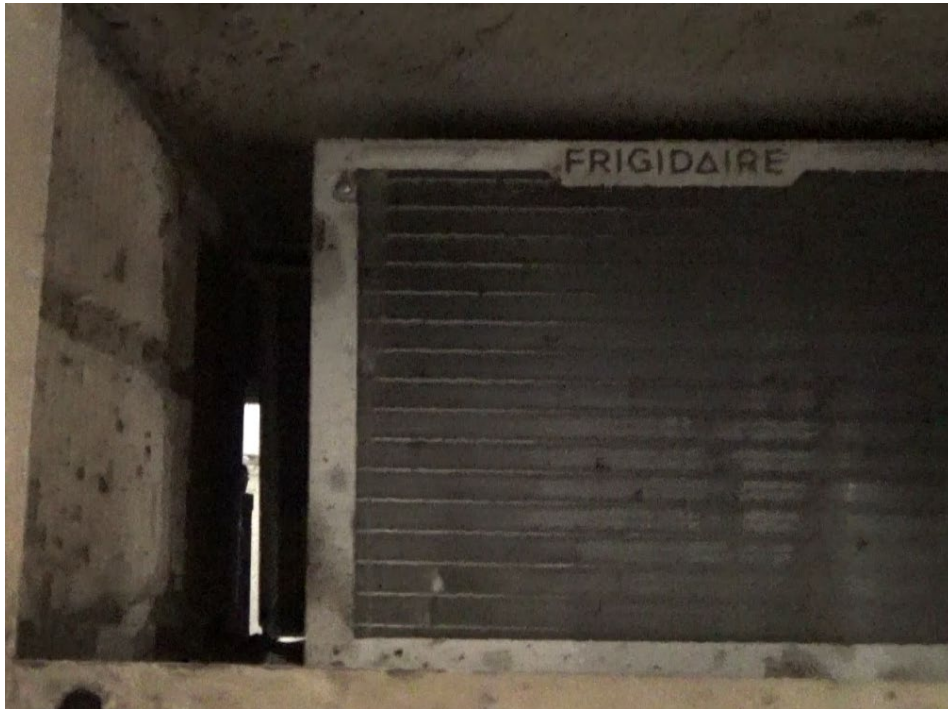
Figure 21. Wall-Mounted Air Conditioner. This photo, taken from outside of the PPE Room, shows an opening to the inside of the PPE Room. (Credit: CSB)

KMCO had identified the area where the R2 Building was located as a Class 1, Division 2 location, one of the hazardous classified locations under the National Fire Protection Association (NFPA) 70, *National Electrical Code*, where the possibility of fire or explosion hazards may exist under abnormal conditions because of the presence of flammable material, such as isobutylene [38, p. 350]. The CSB learned that the R2 Building likely did not meet the NFPA’s requirements because it contained unclassified electrical equipment, such as motor starters, and the building was not pressurized to prevent flammable vapor from entering the building.

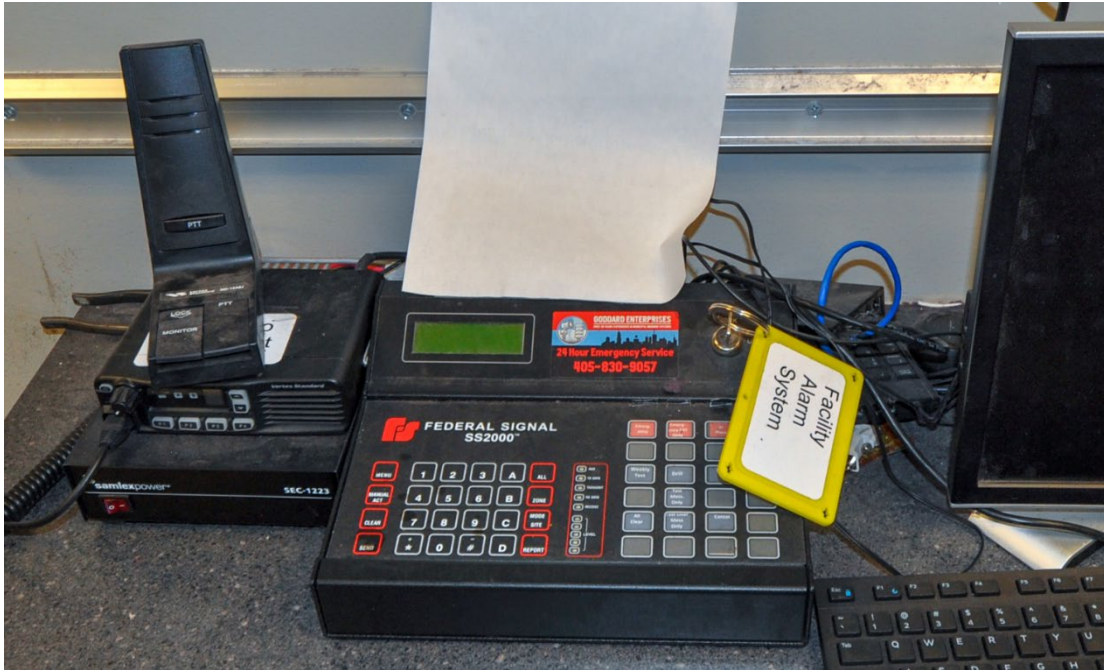
Figure 22. Base Station for Facility Alarm System. (Credit: CSB)

One operations supervisor stated that the old facility alarm system never worked—or at least, not during his 14 years at KMCO—and that he had never heard a facility alarm until the new system was up and running.
