Investigation Report

Published: June 2024

SAFETY ISSUES:

The September 20, 2022, naphtha release and fire at the BP-Husky Toledo Refinery fatally injured two employees, who were brothers:

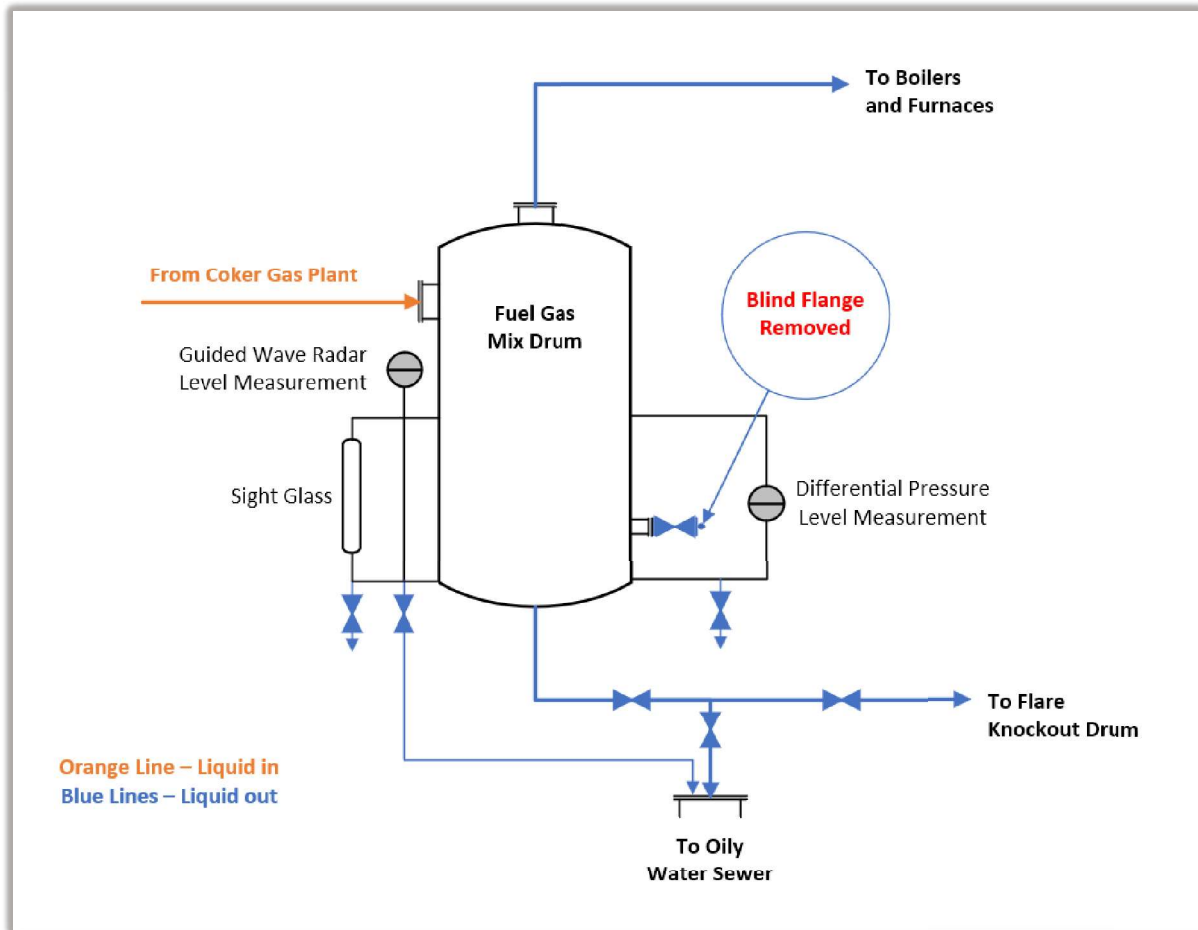
^c This valve on the side of the Fuel Gas Mix Drum was only intended for access by maintenance as part of turnaround or maintenance activities.

Figure 10: Fuel Gas Mix Drum during overfill and attempted emptying. Liquid exit locations are shown in blue. (Credit: CSB)

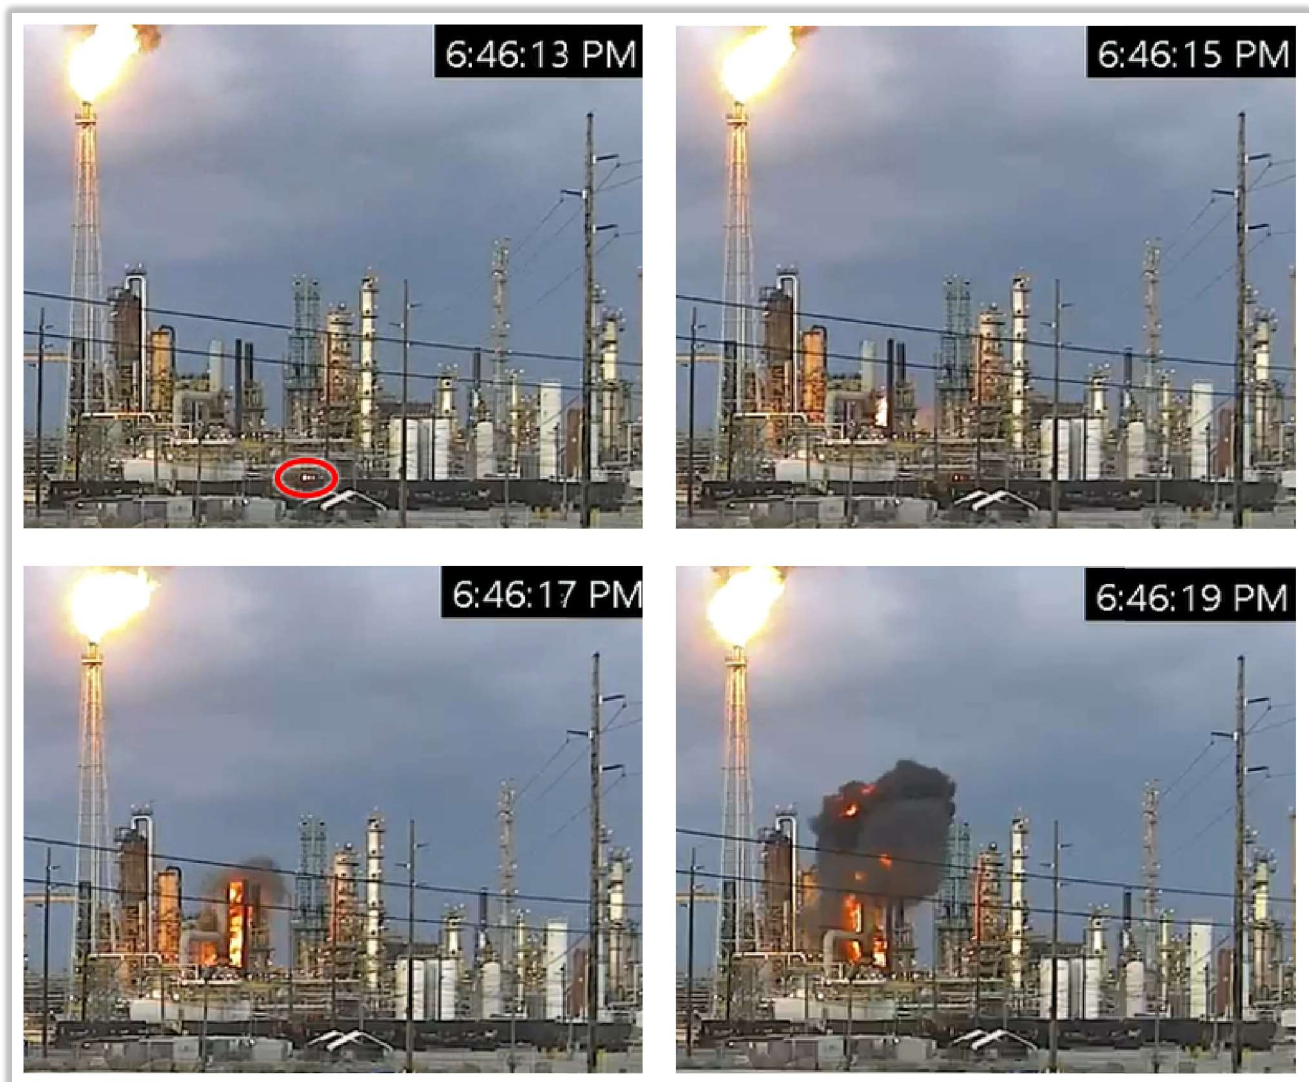
An approaching rainstorm shifted the wind, which likely directed the vapor cloud toward the nearby Crude 1 Furnace, the likely ignition source. The vapor cloud ignited at 6:46 p.m., as shown in **Figure 11**. **Figure 12** shows the Crude 1 Furnace's proximity to the Fuel Gas Mix Drum, the area of the naphtha release, and the eyewitness's location.

Figure 11: Vapor cloud ignition and the ensuing six seconds. Ignition at Crude Furnace (circled in red, upper left photo). (Credit: BP with annotations by CSB)

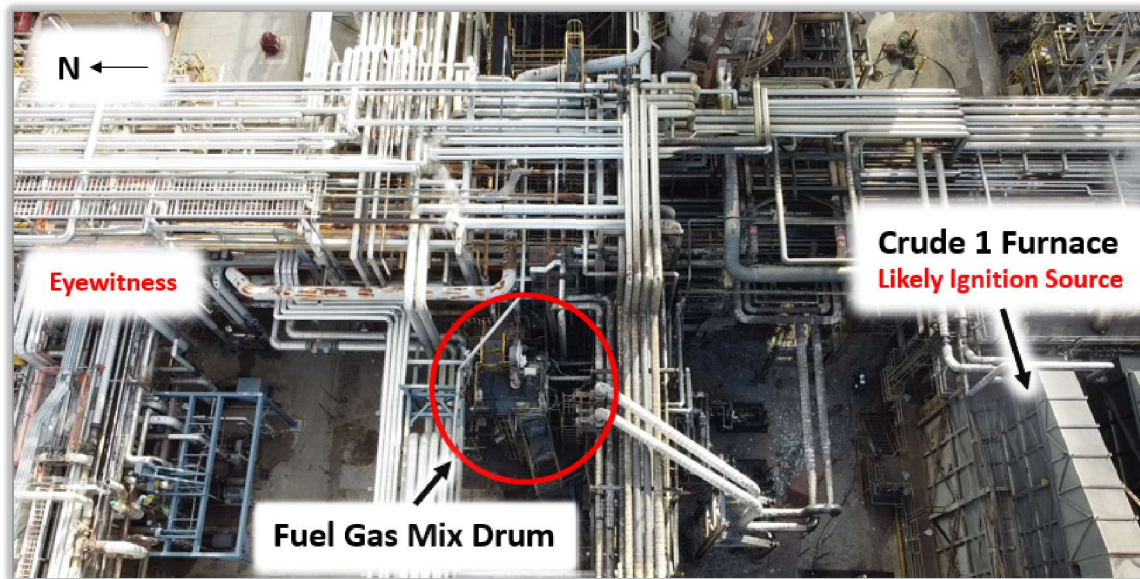
Figure 12: Overhead view of naphtha release, likely ignition source, and eyewitness location. (Credit: BP with annotations by CSB)

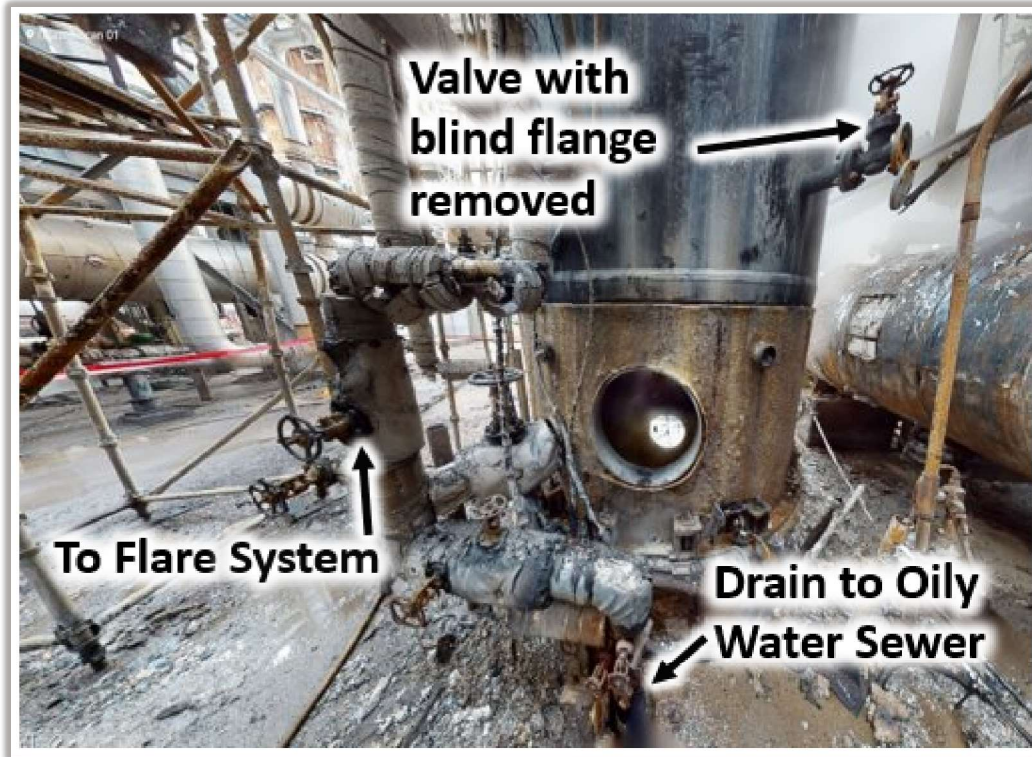
Figure 13: Fuel Gas Mix Drum post-incident. (Credit: BP with annotations by CSB)

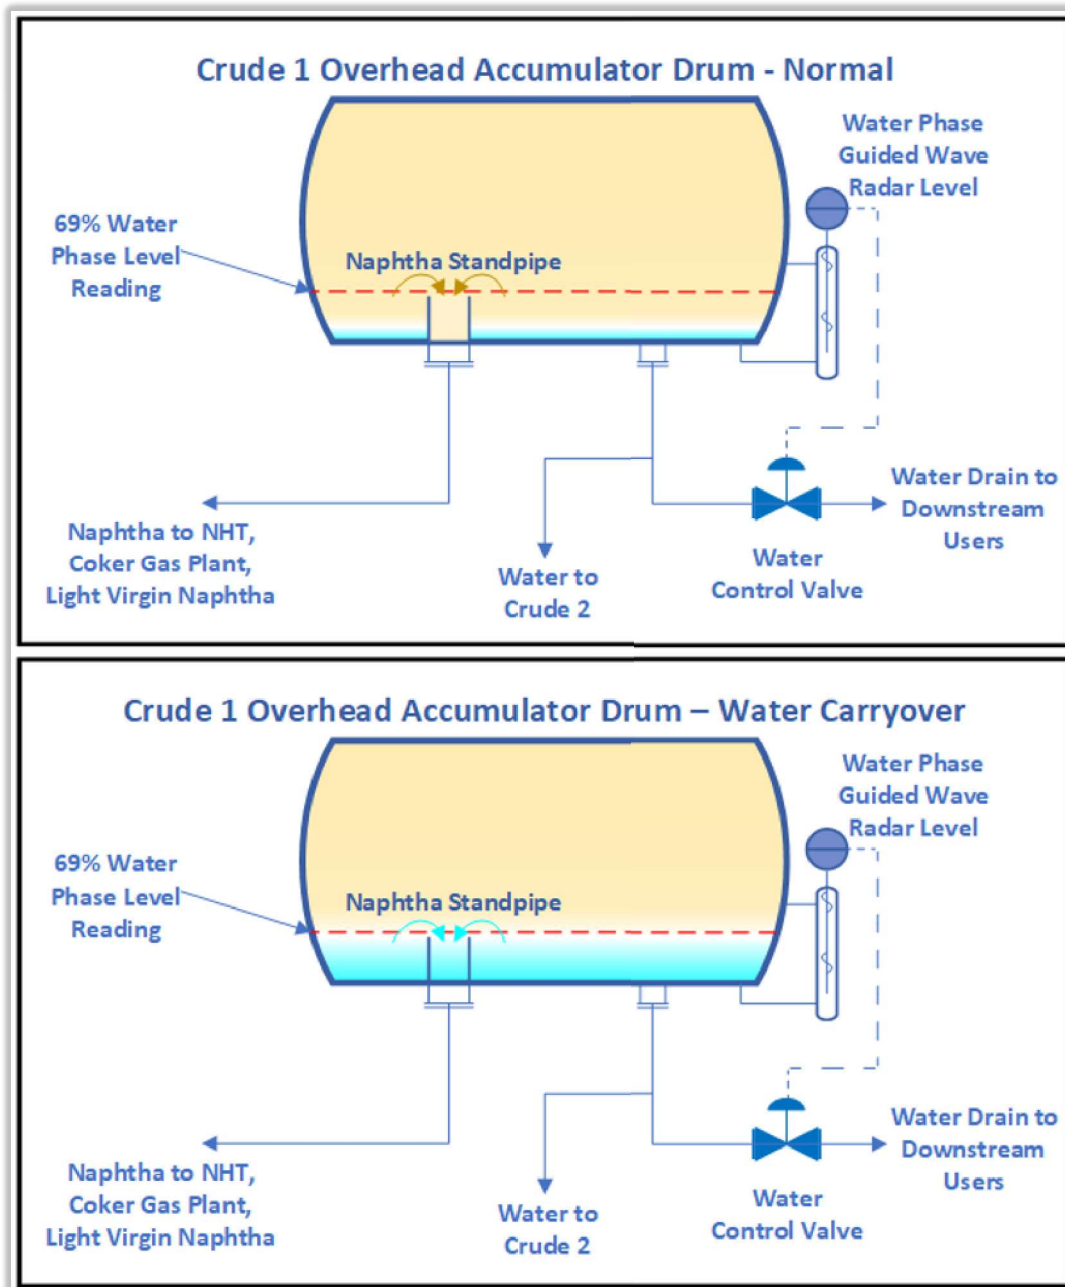
Figure 14: Crude 1 Overhead Accumulator Drum water phase level before water control valve adjustment (top) and during water carryover into naphtha stream (bottom). (Credit: CSB)

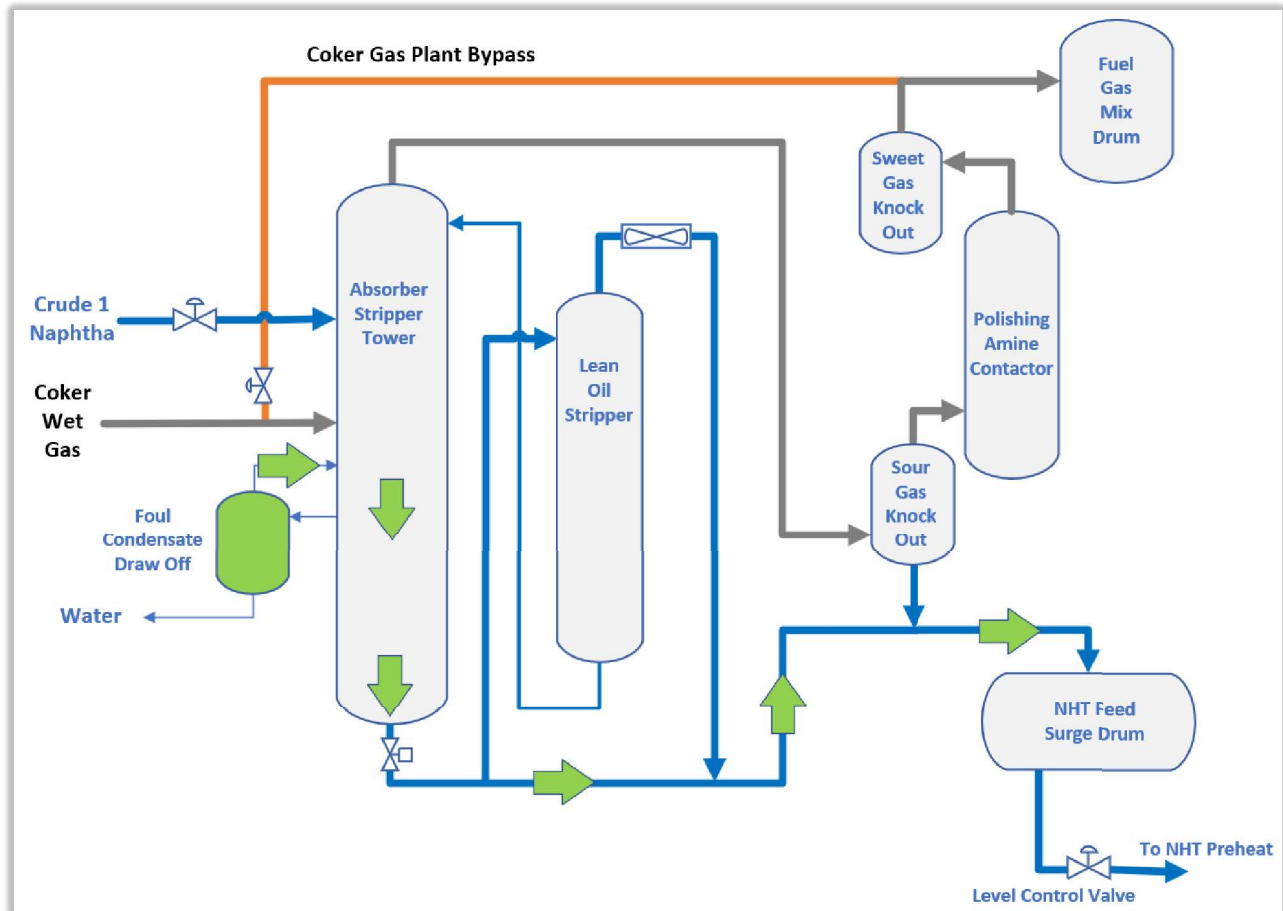
opened to remove the excess level, causing increased liquid level in the NHT Feed Surge Drum. This NHT Feed Surge Drum level increase resulted in higher flow and pressure to NHT Preheat when the NHT Feed Surge Drum level control valve in turn opened further.^a **Figure 15** shows this water overflow and resulting liquid flow increase out of the Absorber Stripper Tower bottoms and into the NHT Feed Surge Drum.

Figure 15: Water overflow in Coker Gas Plant Absorber Stripper Tower and flow increase to NHT Feed Surge Drum (green arrows). (Credit: CSB)

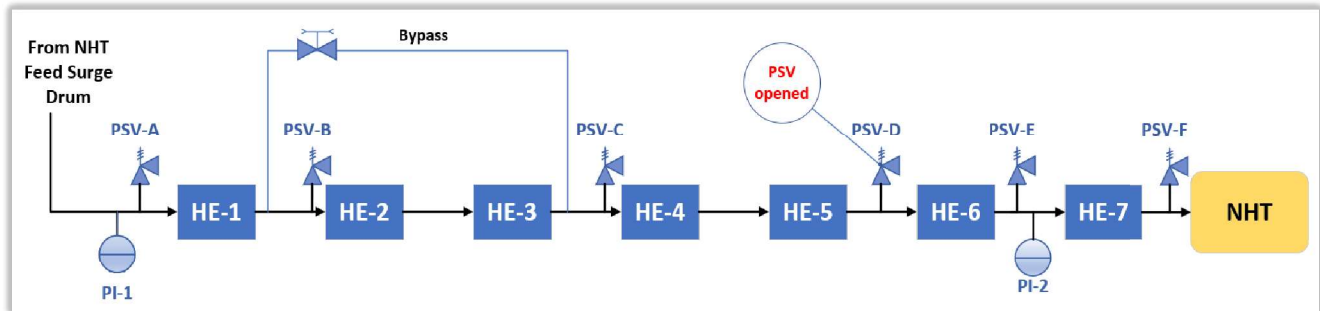
Figure 16: Location of first emergency pressure-relief valve (labeled as PSV-D) opening on NHT Preheat heat exchangers (each labeled as HE).^a (Credit: CSB)

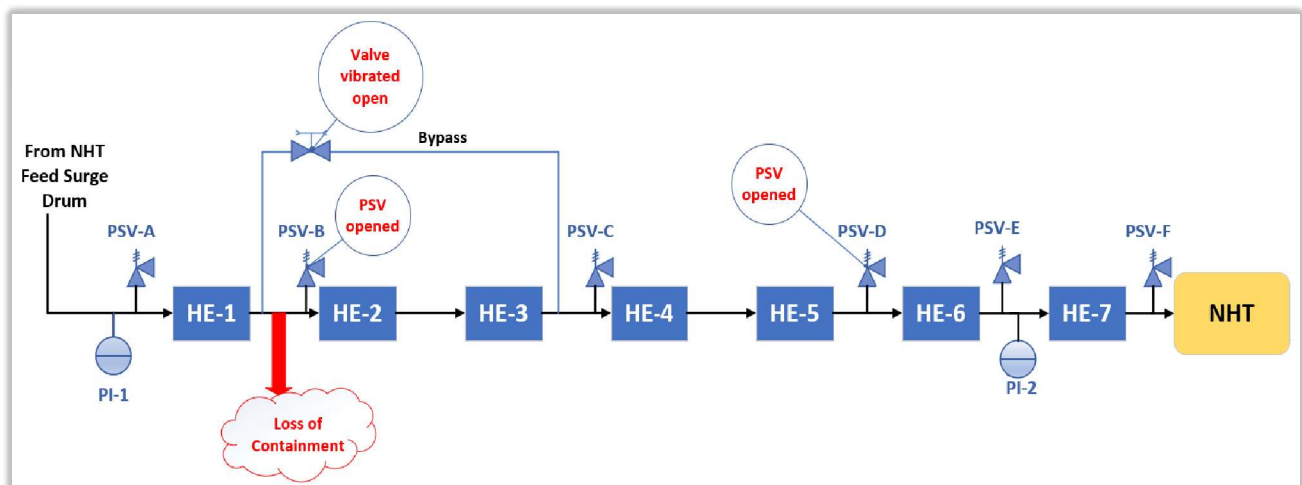
The continuing piping vibration then caused the branch connection to the drain valve to fail completely, and the 3/4-inch bleed broke off at approximately 8:12 a.m., 18 minutes after the first smaller leak began. With this loss of primary containment, the naphtha leak was significantly larger. Operations personnel decided to implement an emergency depressurization and shut down of the NHT unit. **Figure 17** shows the locations of the 3/4-inch bleed failure where the loss of containment occurred, and both emergency pressure-relief valves that opened.

Figure 17: NHT Preheat loss of containment and emergency pressure-relief valve (each labeled as PSV) openings at NHT Preheat heat exchangers (each labeled as HE). (Credit: CSB)

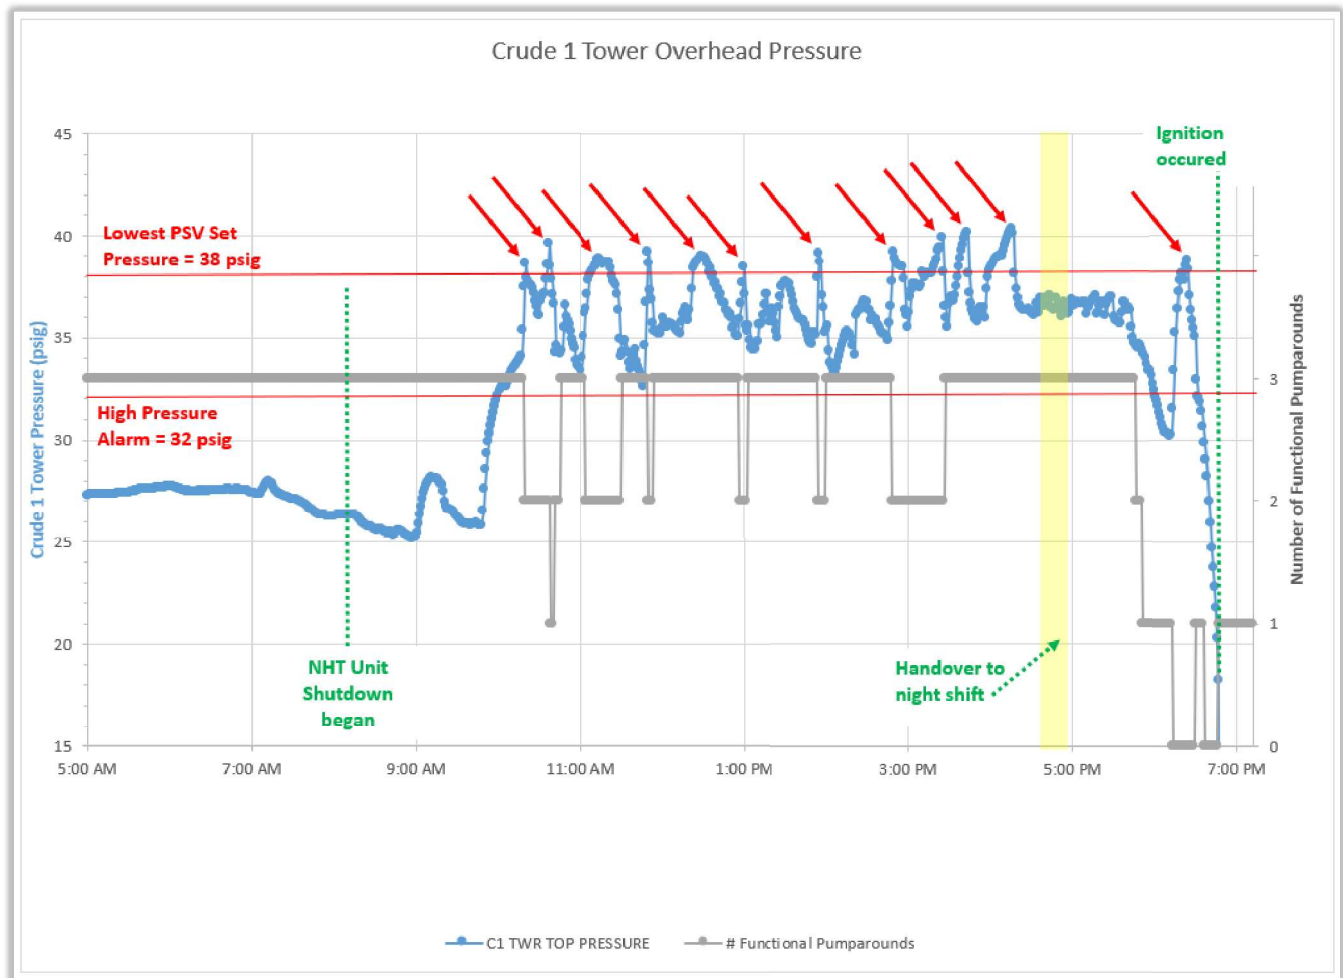
Figure 21: Crude 1 Tower overhead pressure. Red arrows indicate likely emergency pressure-relief valve(s) (PSV) opening. Crude 1 Tower pressure (blue trend) was above the high alarm point (32 psig) for much of the day. (Credit: CSB)

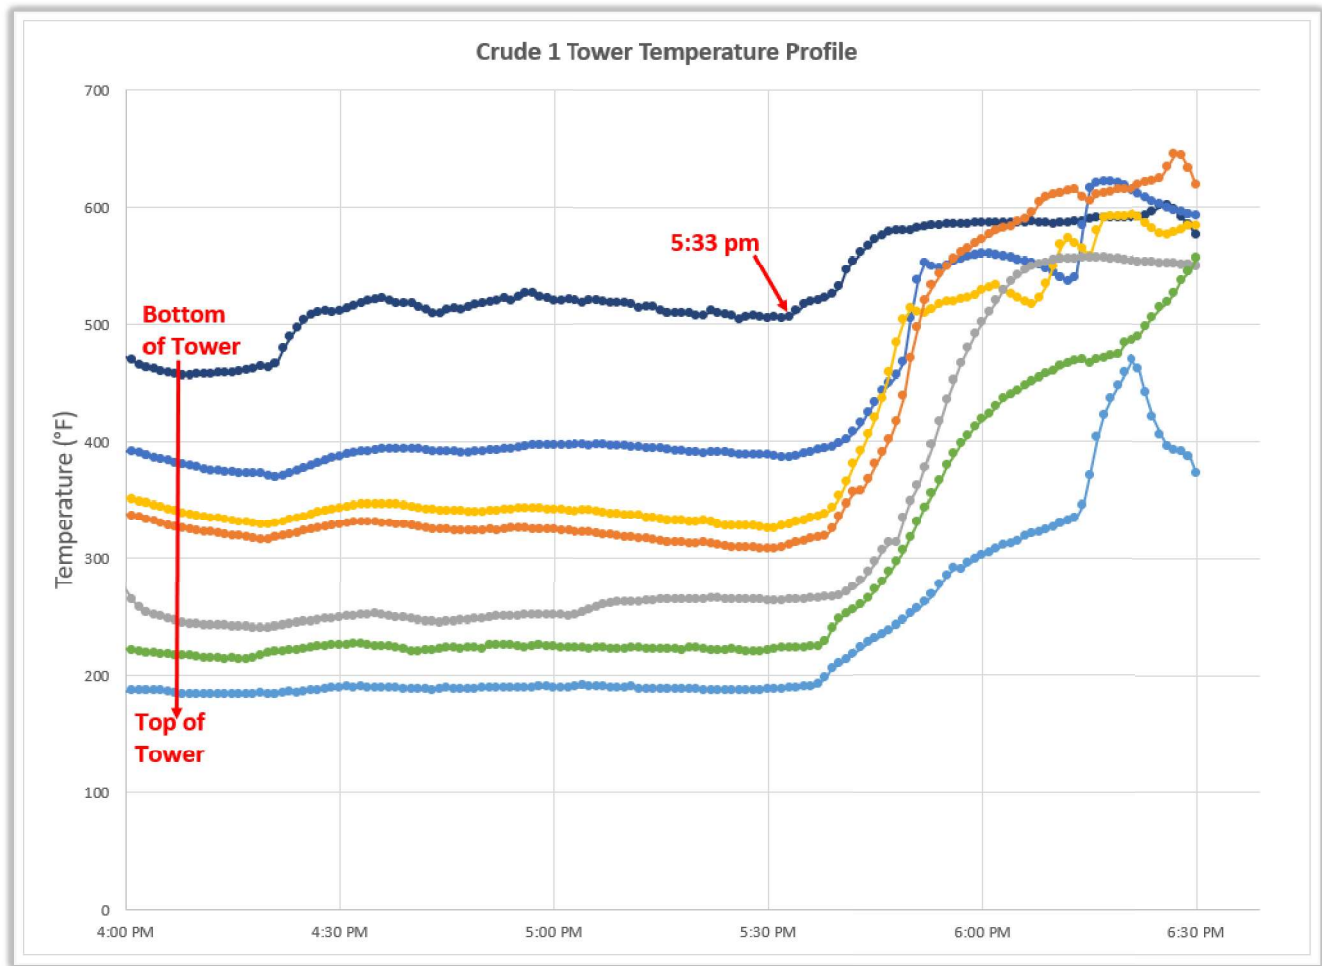
At approximately 5:30 p.m., Crude 1 Tower temperatures began to increase rapidly, initiating the Crude 1 Tower upset, as shown in **Figure 23** below.

Figure 23: Crude 1 Tower temperature profile. Before the upset, temperatures are hottest at the bottom of the tower and decrease going up the tower, normal for any distillation tower. (Credit: CSB)

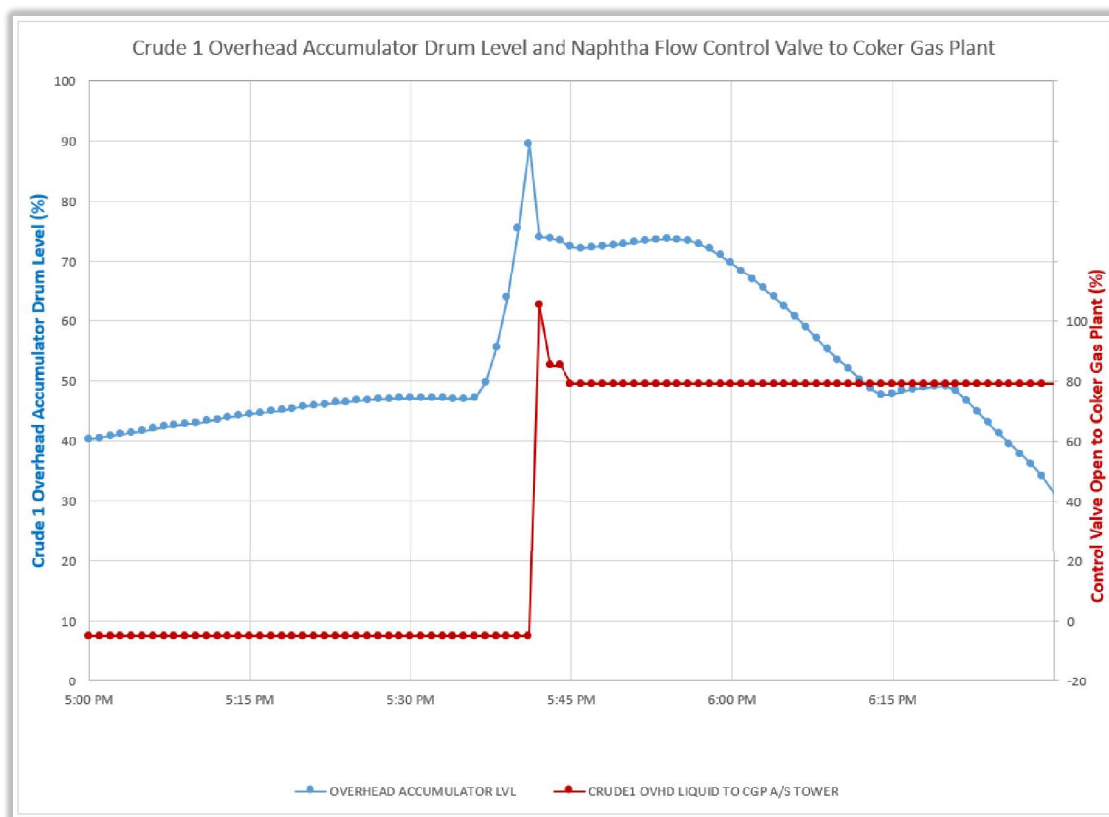
The Crude 1 Tower upset created a tower overhead flow surge a few minutes later, which in turn filled the Crude 1 Overhead Accumulator Drum. Within a five-minute period, the Crude 1 Overhead Accumulator Drum level rose from a steady state of 47 percent to 68 percent (the high level alarm), to 70 percent (the high-high level alarm), and finally to 89 percent level at 5:40 p.m. The Crude 1 Overhead Accumulator Drum level increased so rapidly that the level indication went from 65 percent to 89 percent in less than two minutes. In response to this rapid level increase, the board operators searched for ways to reduce level in the drum quickly. With other liquid naphtha flow paths out of the Crude 1 Overhead Accumulator Drum already either at full capacity or shut down,^a a board operator opened the naphtha flow control valve to the Coker Gas Plant in an effort to reduce the Crude 1 Overhead Accumulator Drum level even though the Coker Gas Plant was intended to be bypassed at the time. **Figure 24** below shows this valve opening (in red) and the Crude 1 Overhead Accumulator Drum's rapid level increase and resulting decrease (in blue) after the naphtha flow control valve to the Coker Gas Plant was opened.

Figure 24: Crude 1 Overhead Accumulator Drum level (blue) and naphtha flow control valve to the Coker Gas Plant opening (red) in response to the high level. (Credit: CSB)

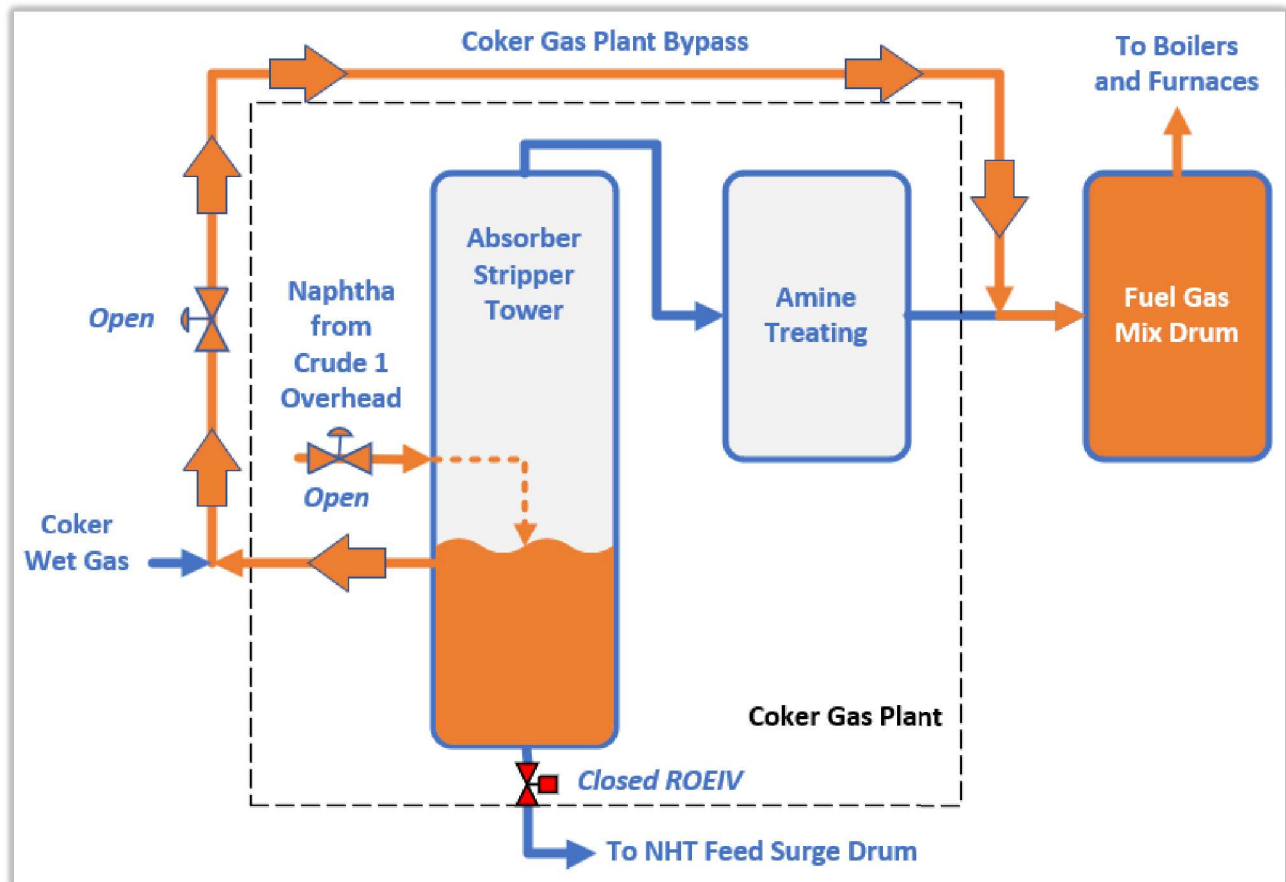
Figure 26: Overflow path from Coker Gas Plant to Fuel Gas Mix Drum (orange arrows).^a (Credit: CSB)

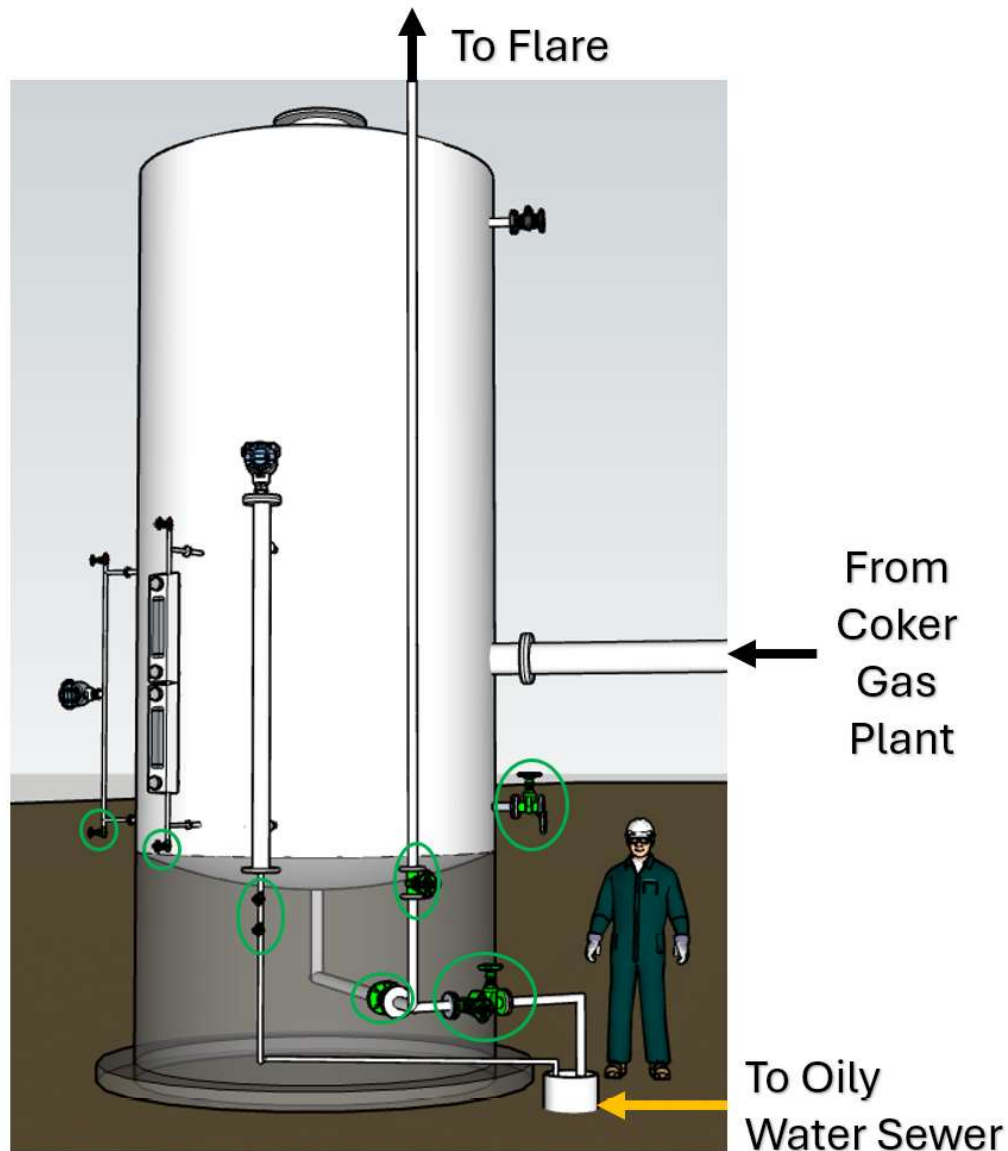
^a This two-inch gate valve with a bolted closed blind flange was to be used for steaming out the vessel for maintenance activities or turnaround.

Figure 28. BP Toledo Refinery Fuel Gas Mix Drum. Valves circled in green were opened to drain and release naphtha. (Credit: CSB)

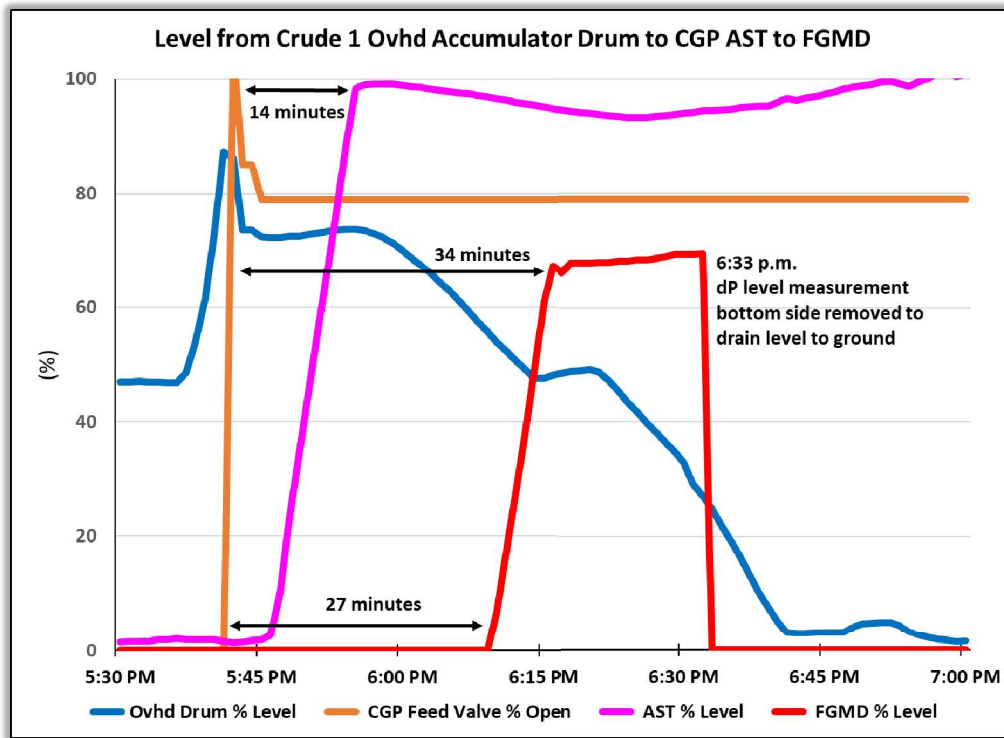
Figure 29. Overflow progression. Decreasing level in the Crude 1 Overhead Accumulator Drum and increasing levels in the Coker Gas Plant Absorber Stripper Tower and Fuel Gas Mix Drum.^a (Credit: CSB)

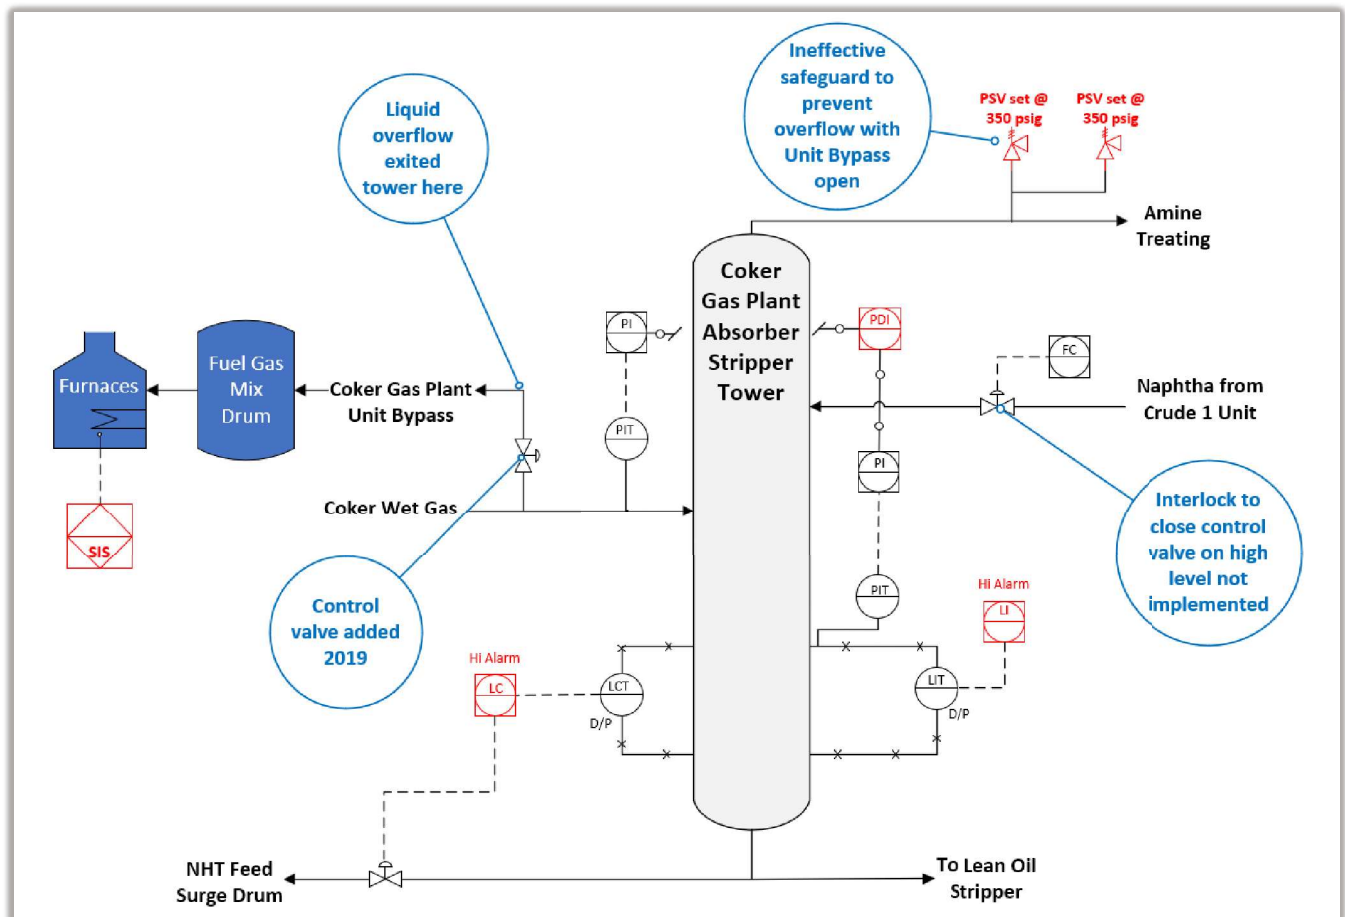
Figure 30: Absorber Stripper Tower safeguards identified in the 2020 Coker Gas Plant PHA, shown in red. (Credit: CSB)

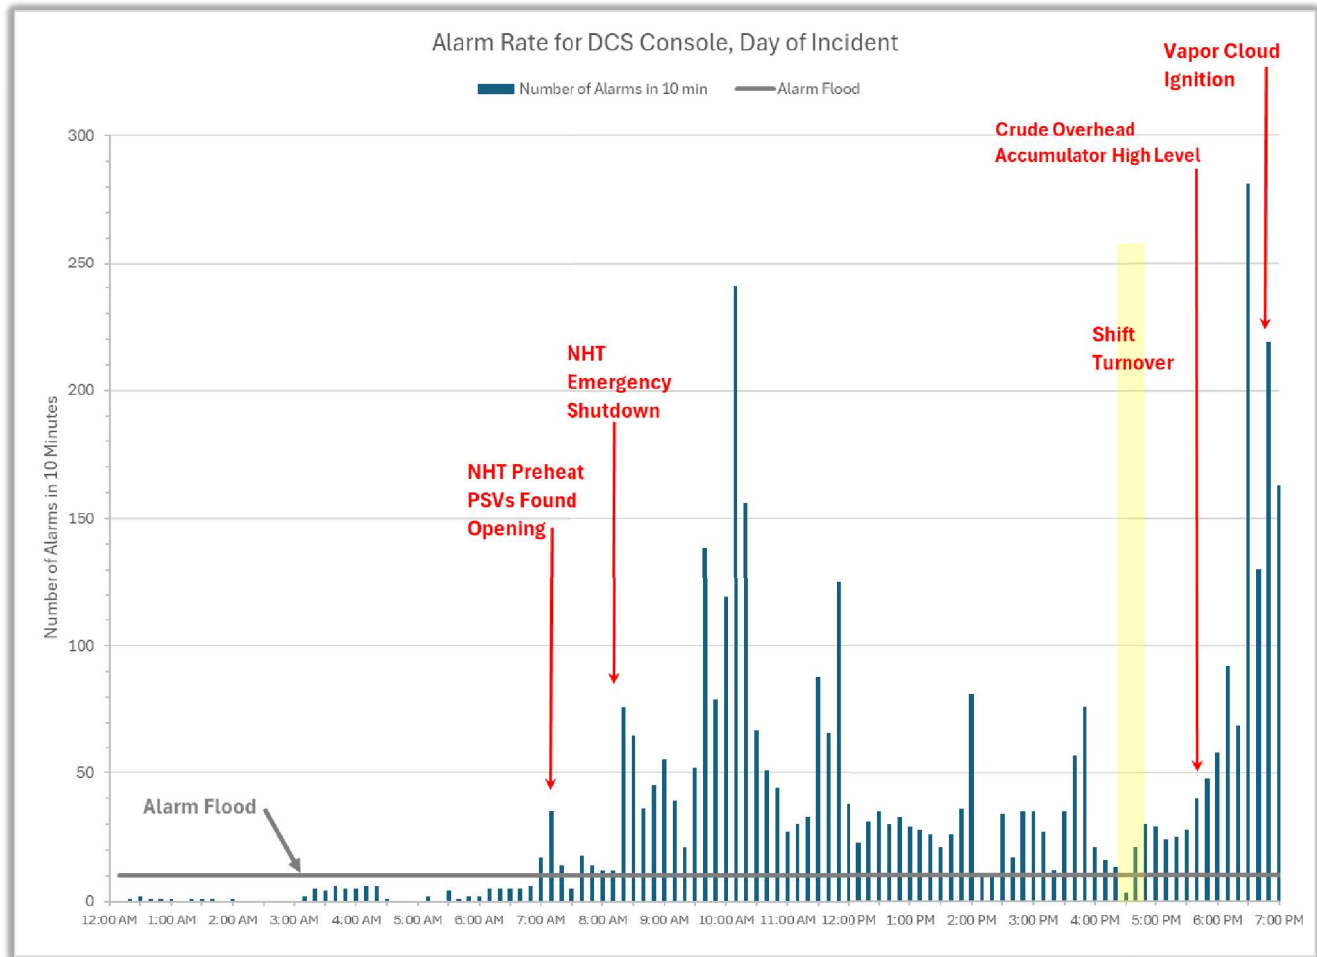
Figure 36: DCS console alarm rate on September 20, 2022, with some process events (in red). The gray line indicates alarm flood rate (10 alarms in 10 minutes). (Credit: CSB)

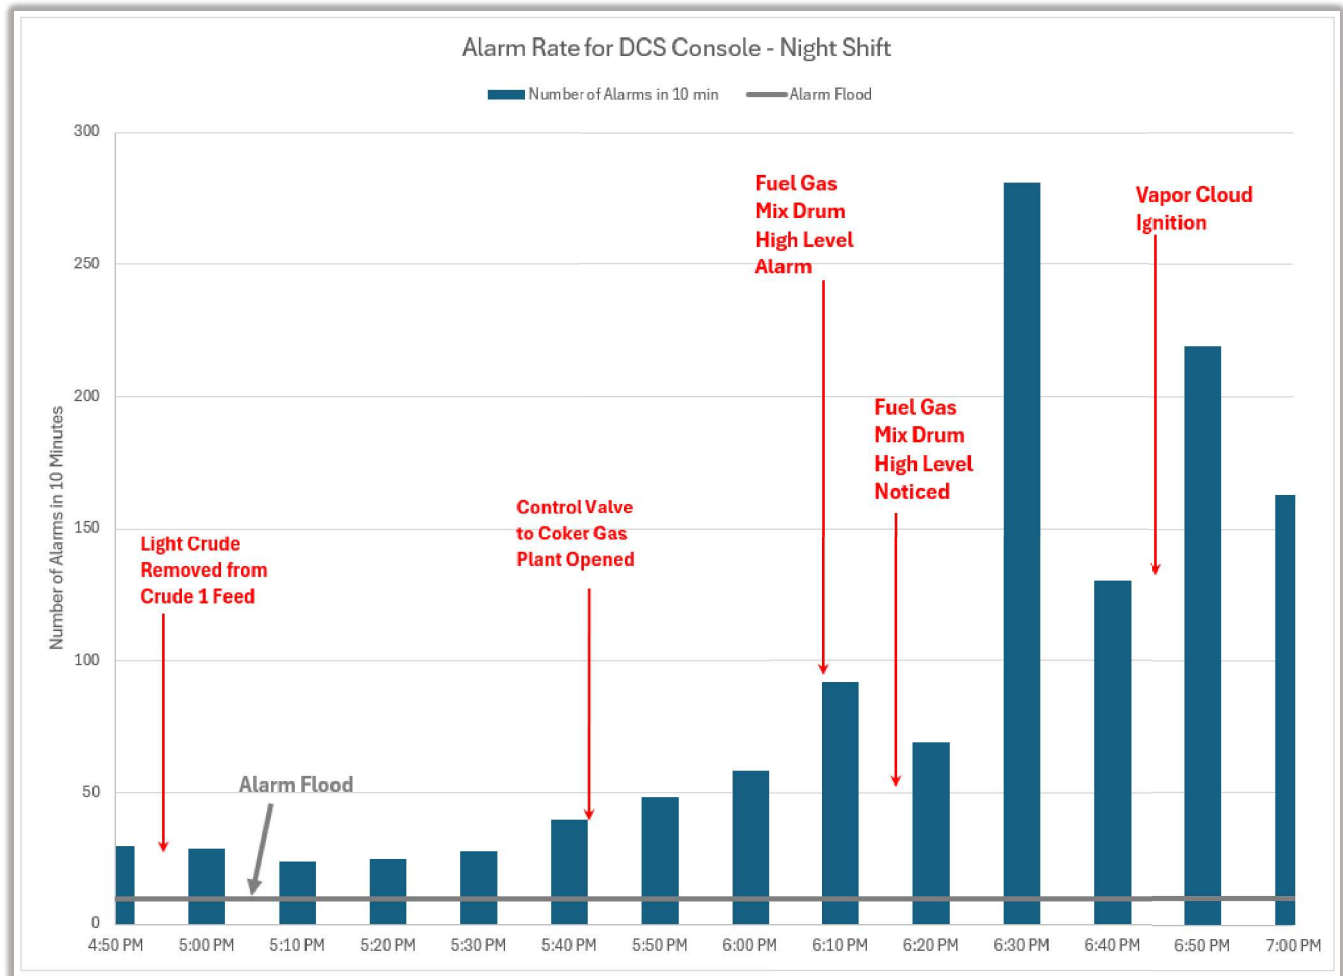
Figure 37: DCS console alarm rate on night shift, with some process events (in red). The gray line indicates alarm flood rate. (Credit: CSB)

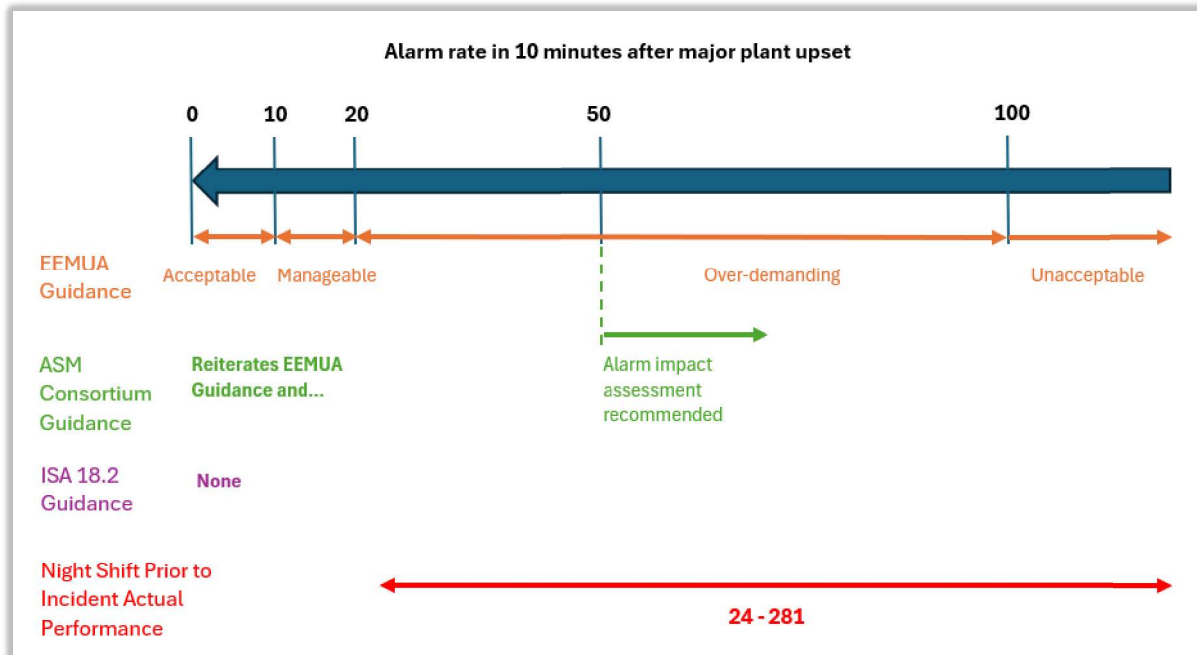
Figure 40: Alarm rate guidance and actual performance following a process upset [35, p. 103]. (Credit: CSB)

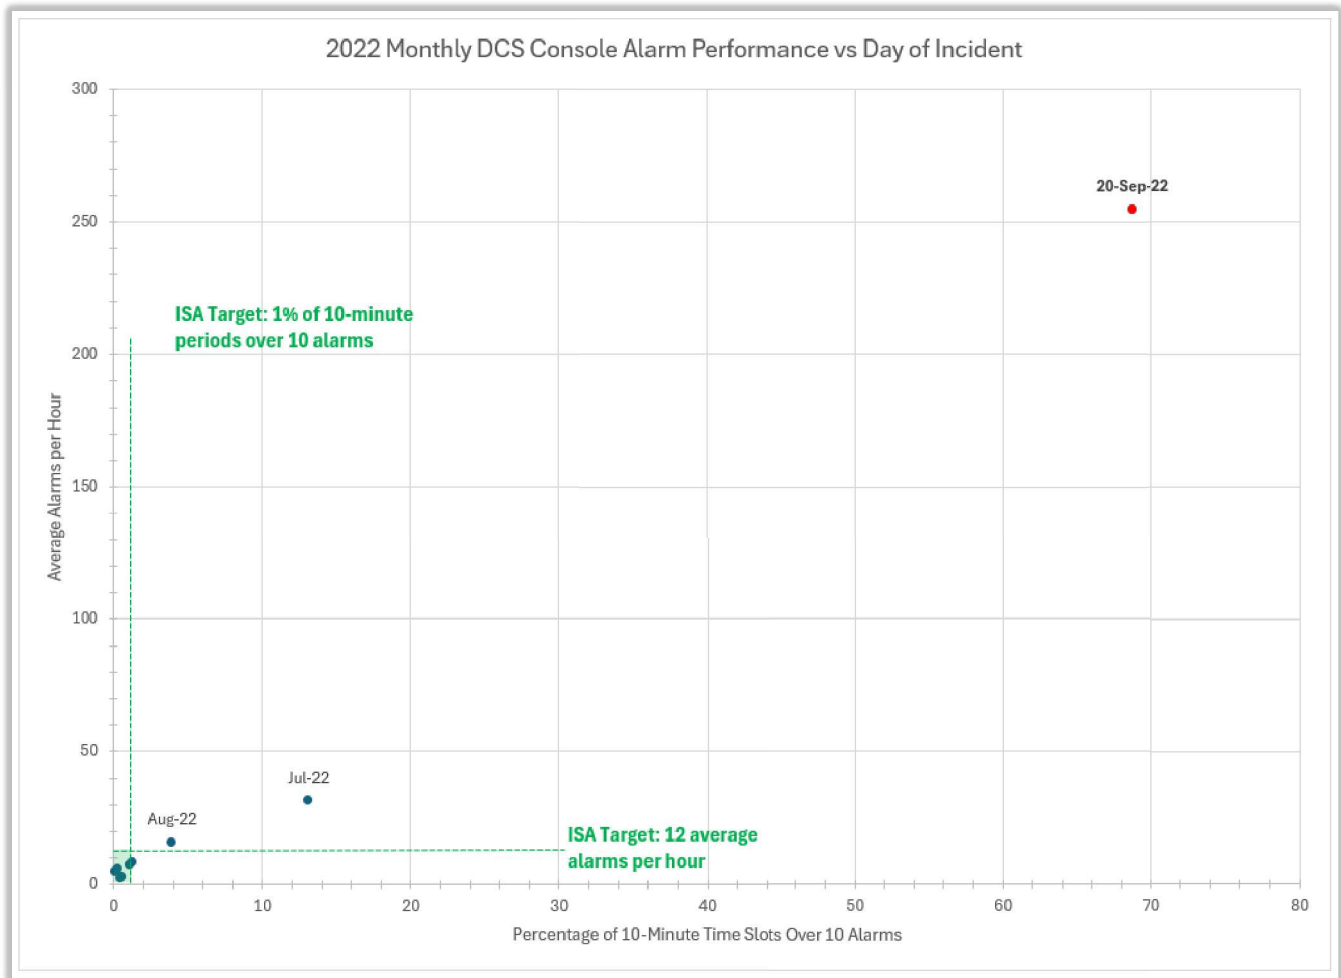
Figure 41: BP Toledo Refinery DCS console alarm performance compared with ISA 18.2 targets (green dotted lines), both monthly (blue dots) and for the day of the incident (red dot) [34, p. 78]. The green shaded area in the lower left corner shows ISA 18.2 target performance. (Credit: CSB)

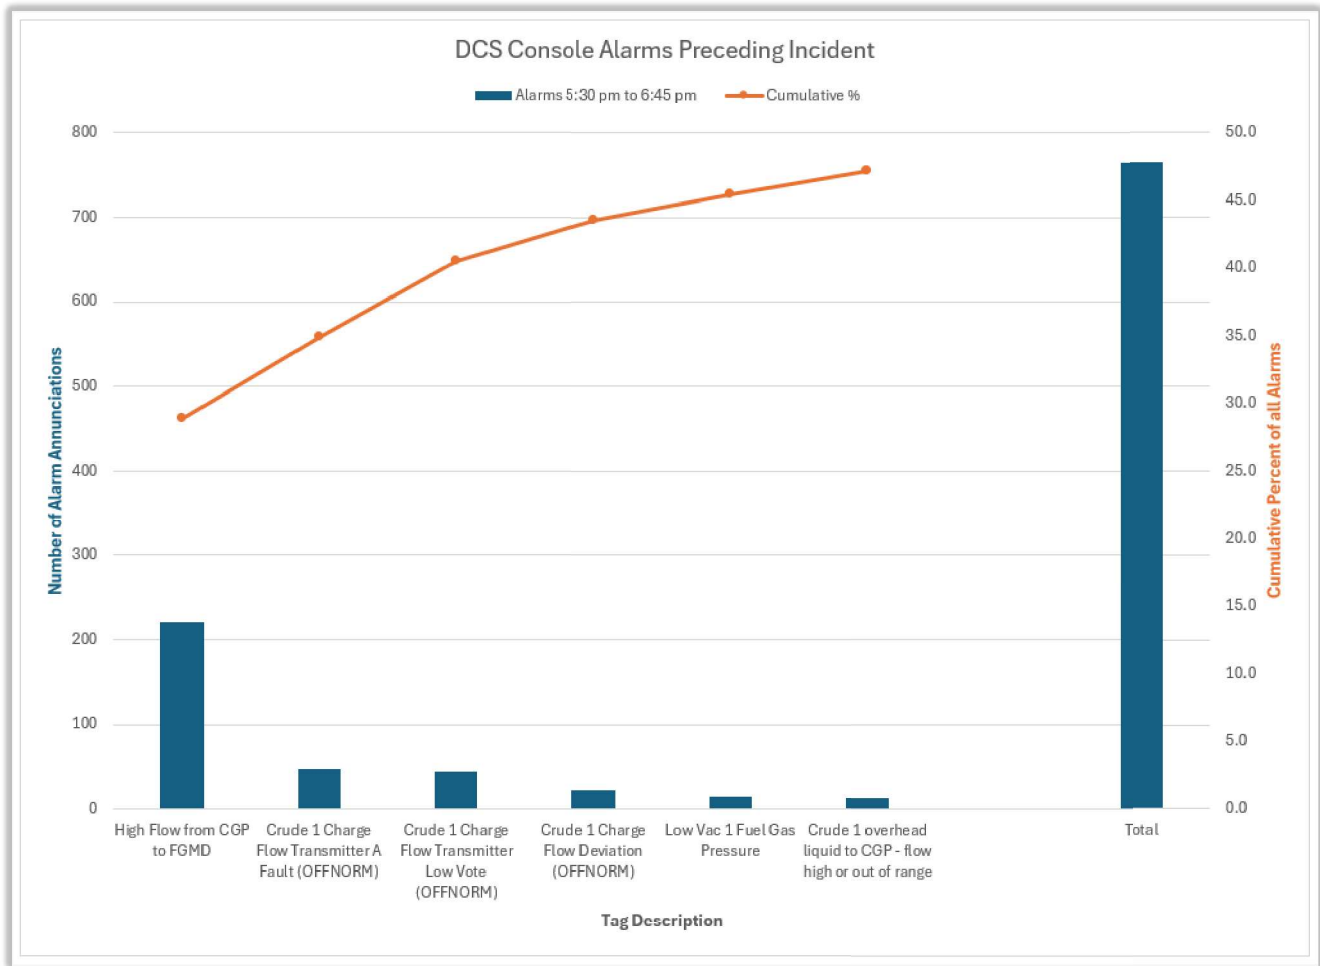
Figure 42: Most frequent alarms annunciated at DCS console between 5:30 p.m. and 6:45 p.m., the hour and 15 minutes preceding the incident. The blue bars show the number of annunciations for each tag, and the orange line shows the cumulative percentage of alarms in that time. (Credit: CSB).
