Investigation Report

Published: June 2024

SAFETY ISSUES:

The September 20, 2022, naphtha release and fire at the BP-Husky Toledo Refinery fatally injured two employees, who were brothers:

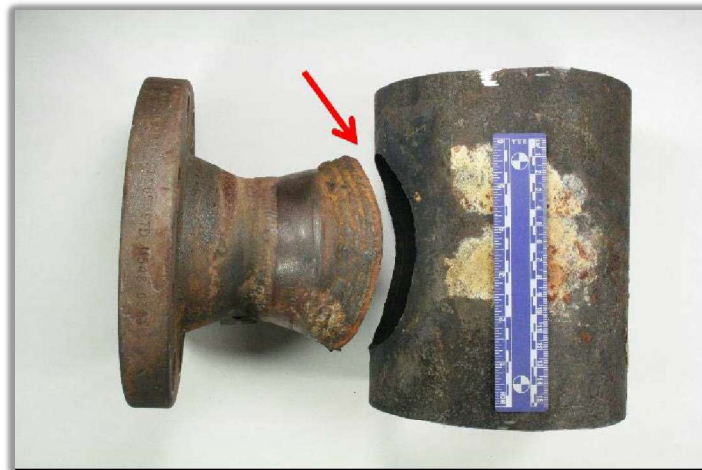
Figure A1-1. Failed branch fitting from the BP Whiting Refinery. (Credit: BP)

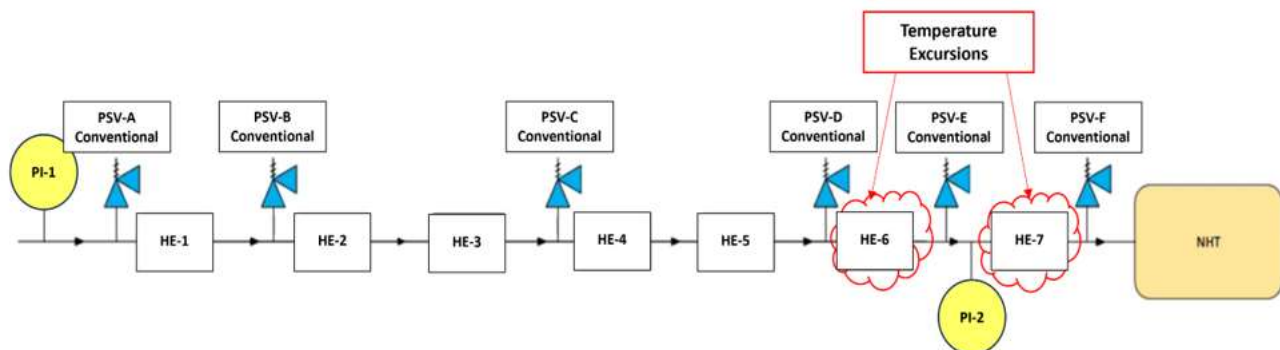
Figure A1-2. Heat exchangers that experienced temperature excursions. (Credit: BP with annotations by CSB)^d

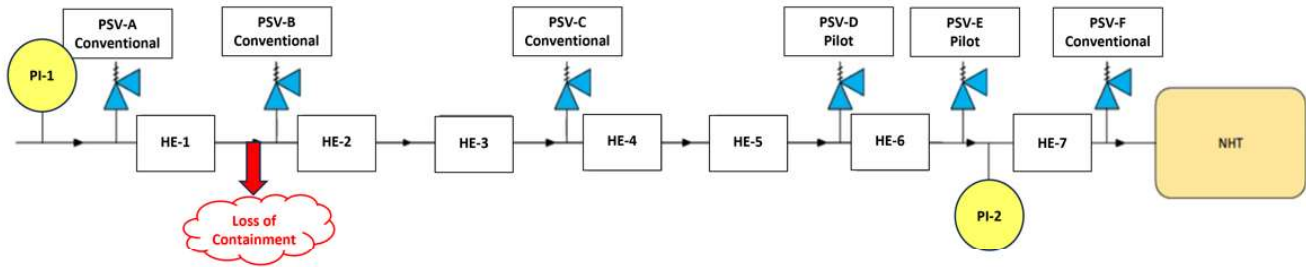
Figure A1-4. Location of loss of containment. (Credit: BP with annotations by CSB)

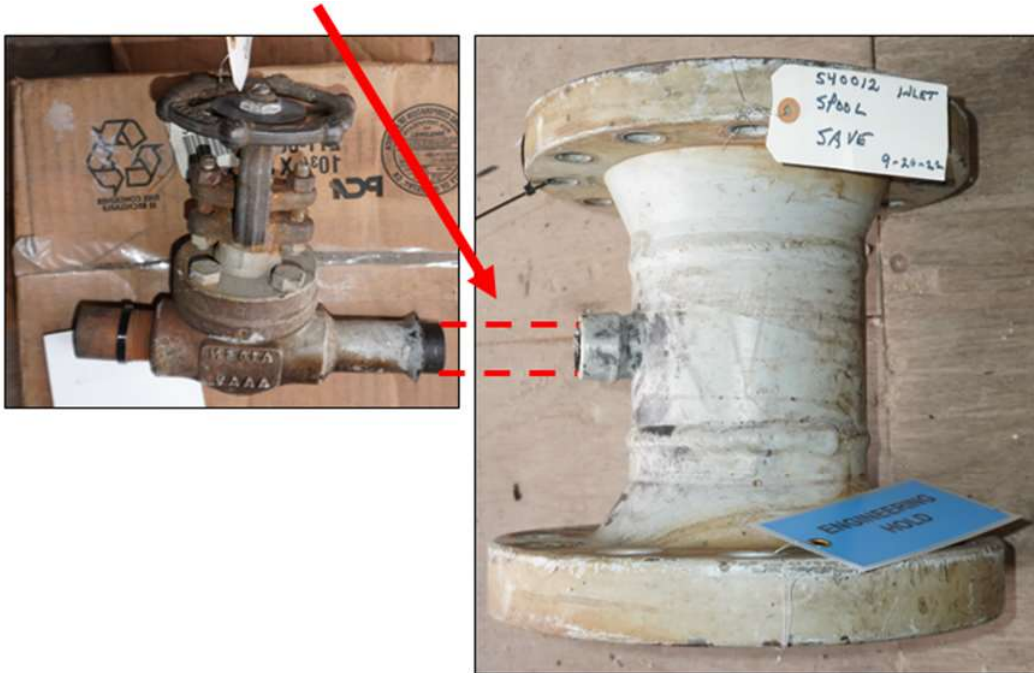
Figure A1-5. Failed ¾-inch branch fitting from the BP Toledo Refinery. (Credit: CSB)
