Case Study

Published: February 13, 2019

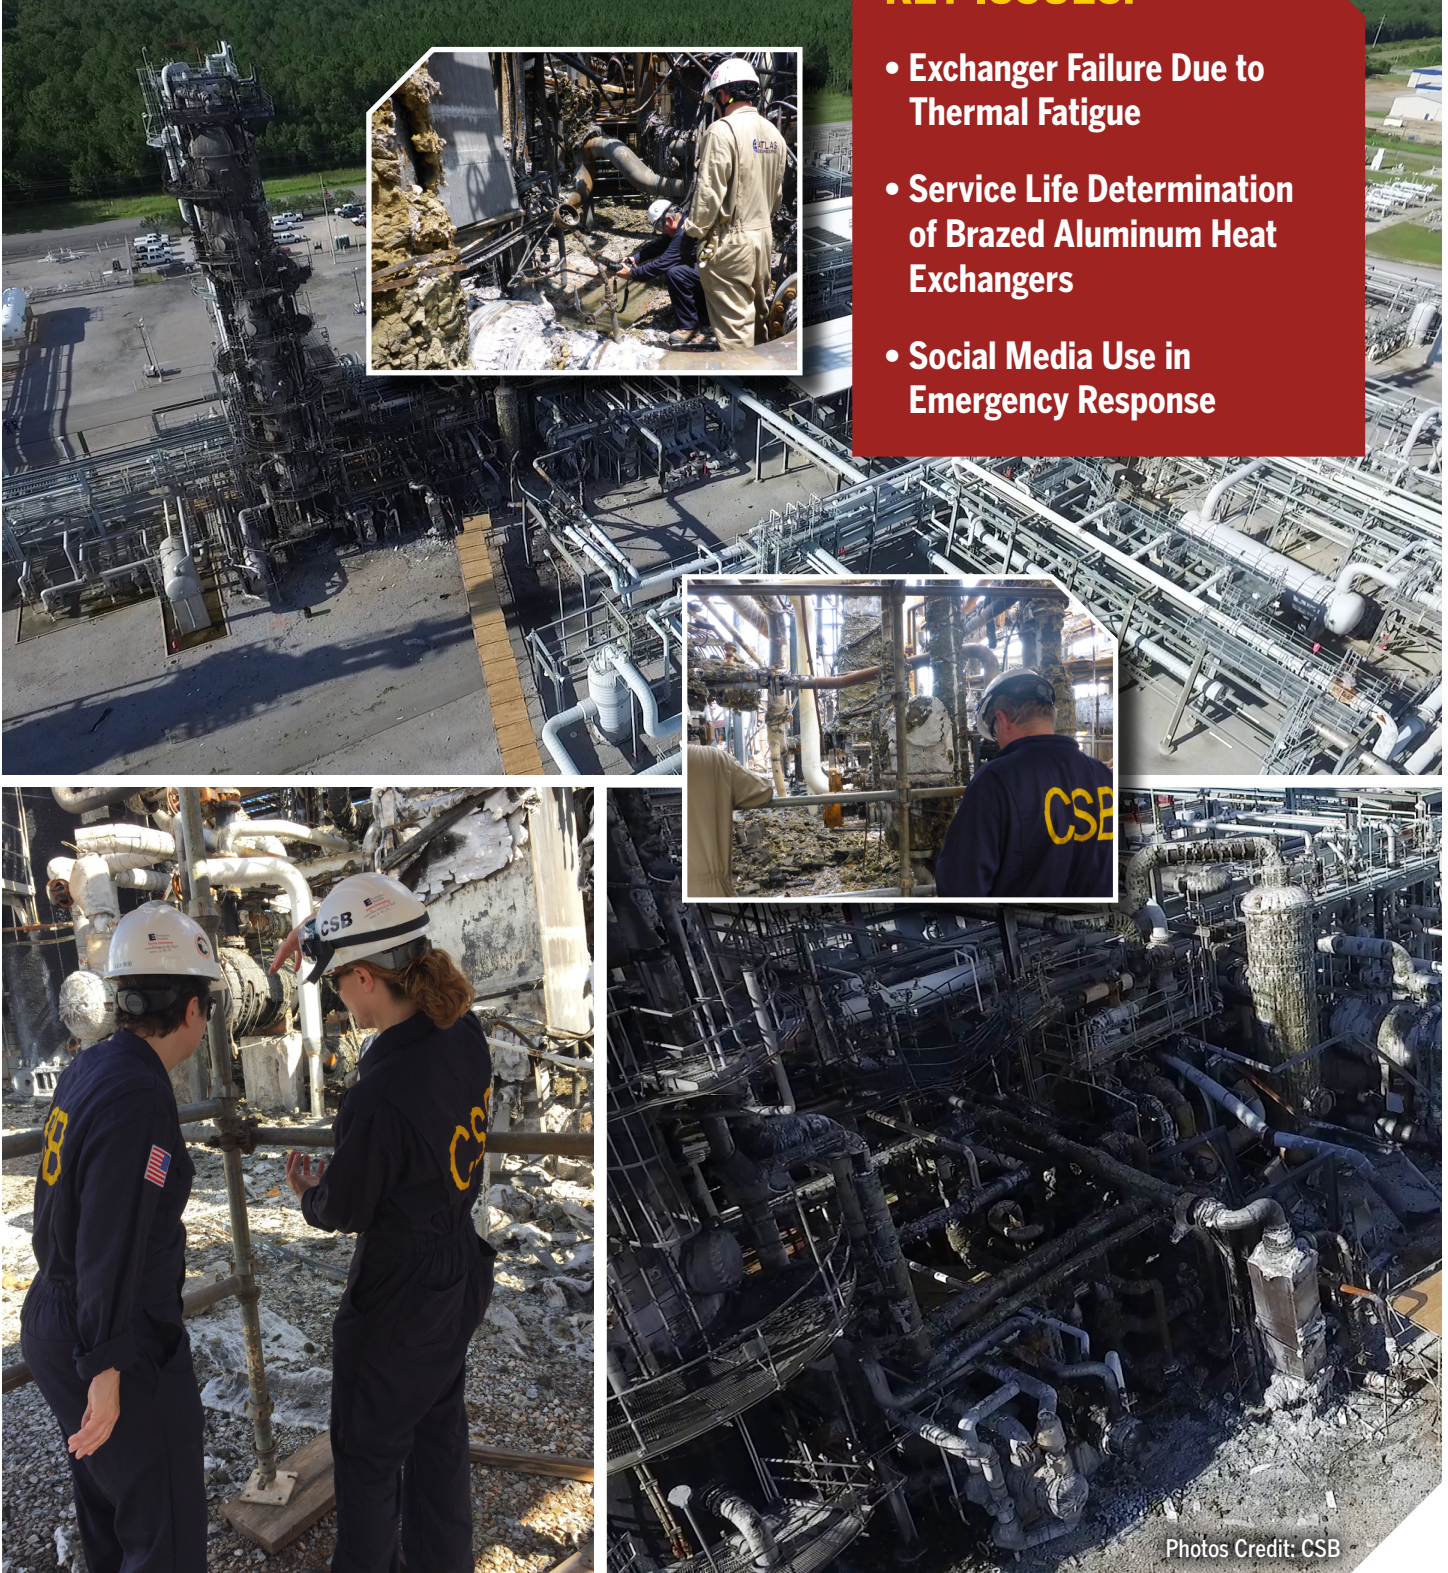
- Exchanger Failure Due to Thermal Fatigue
- Service Life Determination of Brazed Aluminum Heat Exchangers
- Social Media Use in Emergency Response

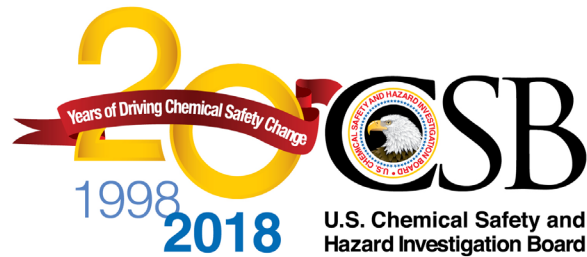
The **U.S. Chemical Safety and Hazard Investigation Board** (CSB) is an independent federal agency whose mission is to ***drive chemical safety change through independent investigations to protect people and the environment.***

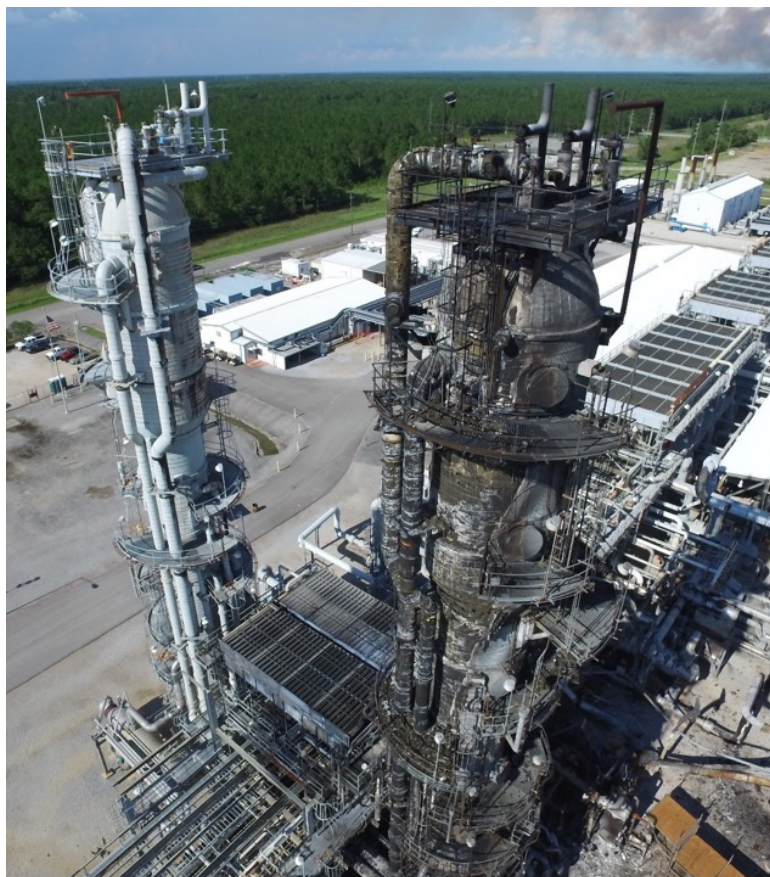
Figure 1. Drone image of the facility depicting fire damage incurred at the plant.

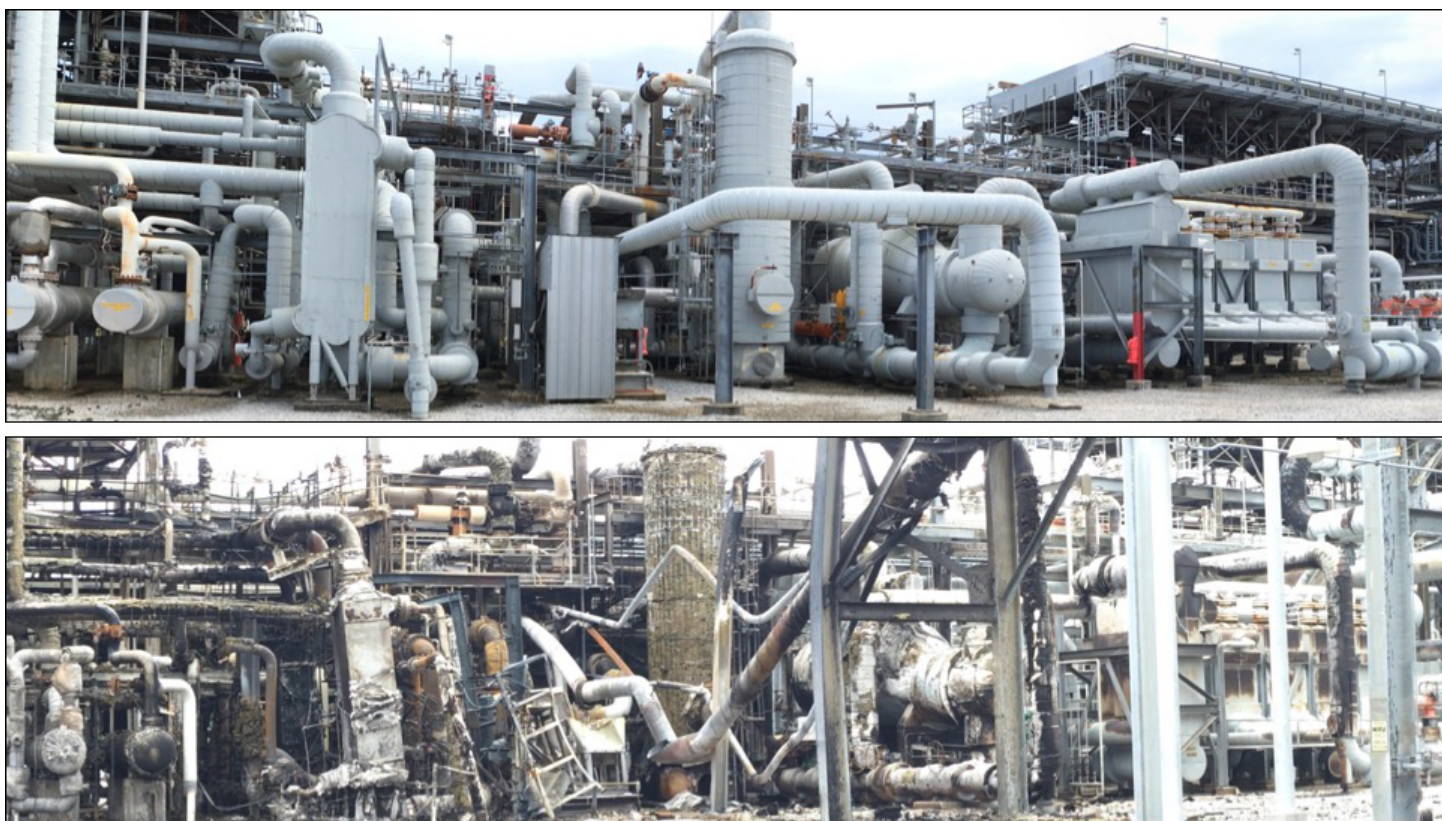
Figure 2. A comparison of the B-Train (top, shown in mirror image to match A-Train) and A-Train (bottom) process areas after the night of the incident.

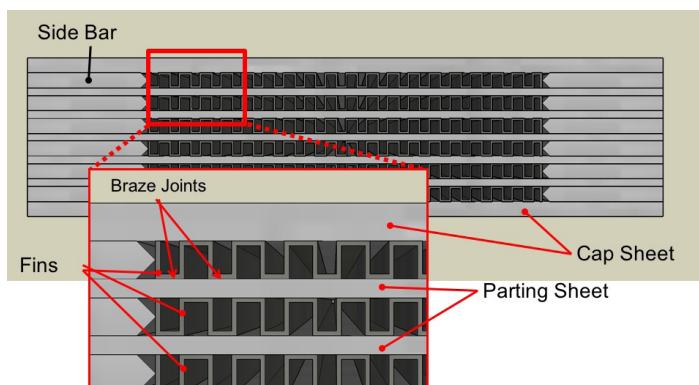
Figure 5. Diagram depicting a view looking down the length of a BAHX core. Pressure from the process fluids applies a force to the fins of the BAHX. The fin arrangement behaves like a bridge truss, distributing the force across the width of the pass.

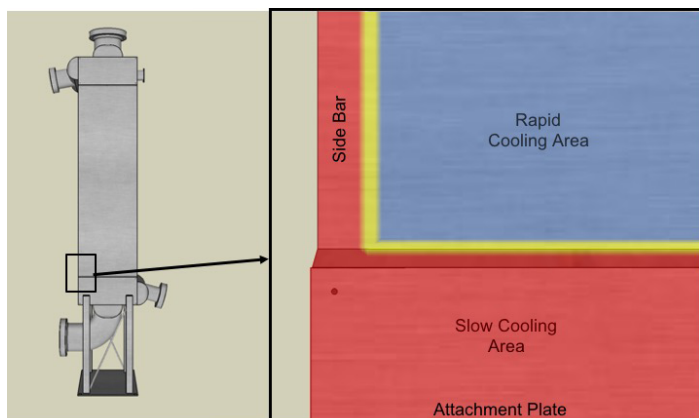
Figure 6. One area of high thermal stress in a BAHX is at the side bar/attachment plate/cap sheet junction. The thicker pieces of aluminum—the side bar and attachment plate (red)—change temperature at a slower rate than the thinner cap sheet (blue). Adding and removing thermal stresses where these pieces join (yellow) can eventually cause thermal fatigue cracks to form.

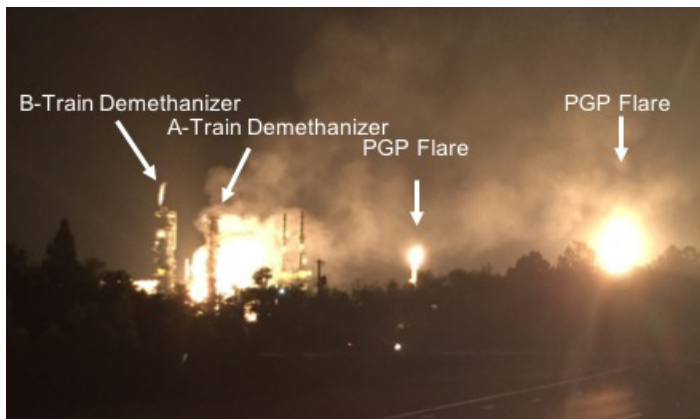
Figure 9. Photograph taken at the intersection of Stennis Boulevard and Old Mobile Avenue, a major thoroughfare running adjacent to the PGP property line. (Credit: Pascagoula Fire Department)

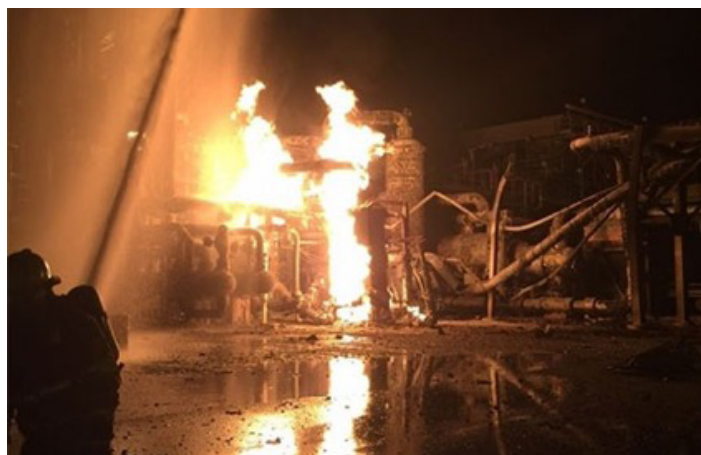
Figure 10. Water monitor being set up by emergency responders to cool equipment. (Credit: Pascagoula Fire Department)

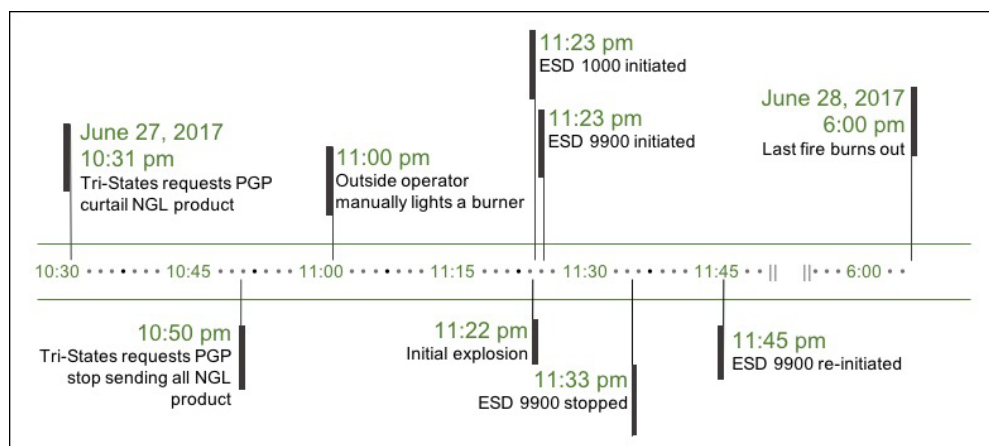
Figure 11. Simplified timeline of events on June 27–28, 2016.

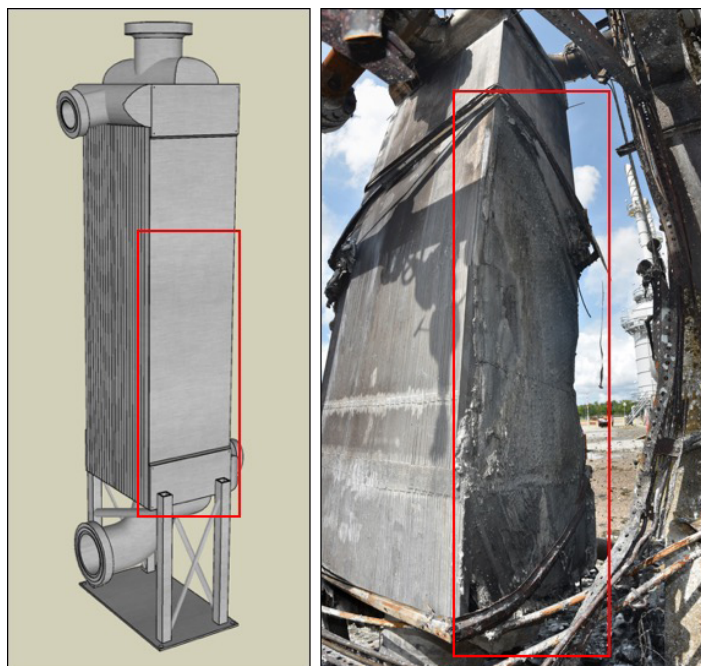
Figure 12. Diagram (left) and post-incident photograph of the ACSR (right). The red box highlights the location of the initial failure, where the partial loss of the north cap sheet along with portions of several layers occurred.

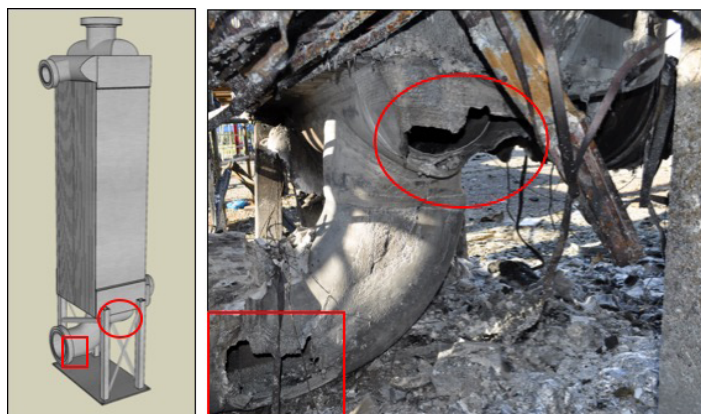
Figure 13. Diagram (left) and post-incident photograph of the ACSR (right) identifying two breaches. The red circle highlights the breach of the header. The red box shows a breach on piping connected to the header. Results of a visual field examination ruled out the latter breach as the initial failure location.

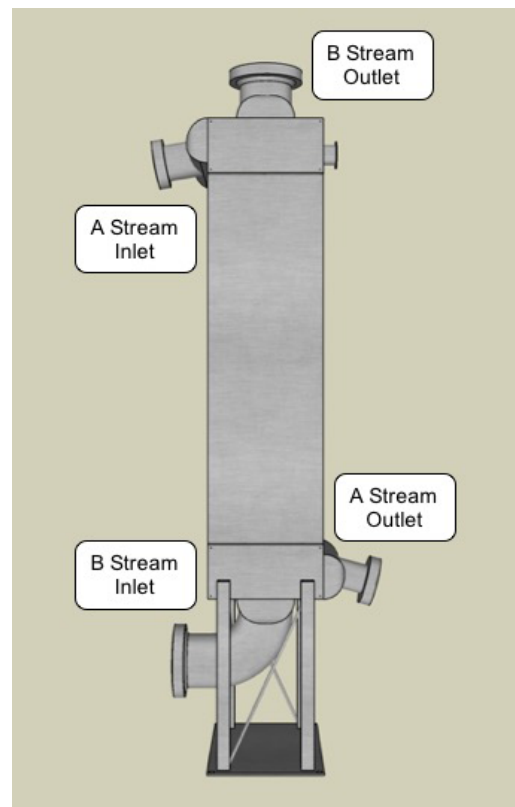
Figure 14. Side view of the ACSR.

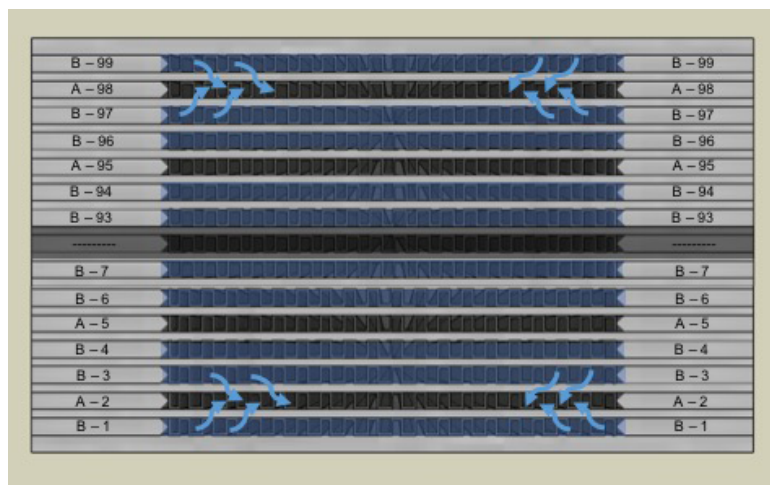
Figure 15. Interpass leaks were detected by pressurizing the B pass layers (blue) of the exchanger and monitoring for leak indicators in the A layers. Leaks into layers 2 and 98 were detected (blue arrows), possibly coming from either layer 1 or layer 3 and either layer 97 or layer 99, respectively.

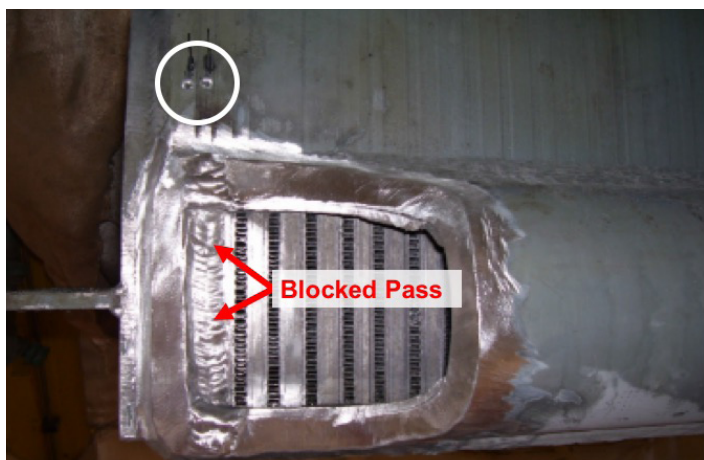
Figure 16. Example of vent holes (white circle) drilled into a BAHX that was in the process of having passes blocked off (red arrow). This image does not depict any exchangers on PGP property. (Credit: Willard, *Field Repair of Brazed Aluminum Plate-Fin Heat Exchangers*, p 7)⁵⁹

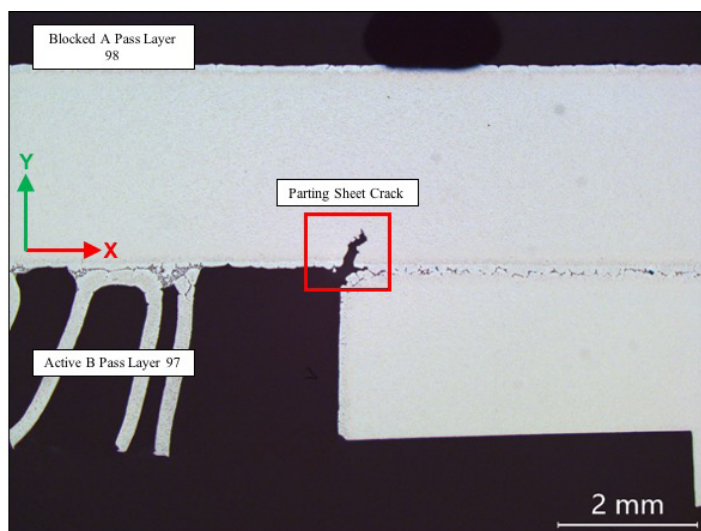
Figure 17. Metallurgical examination revealed a crack in the parting sheet between layer 97 and layer 98. The crack did not extend the full thickness of the parting sheet, but it is an indication that thermal fatigue existed in the parting sheet. Through-wall cracks may have existed in other areas of the parting sheet that were not examined or were destroyed by the ensuing fires.

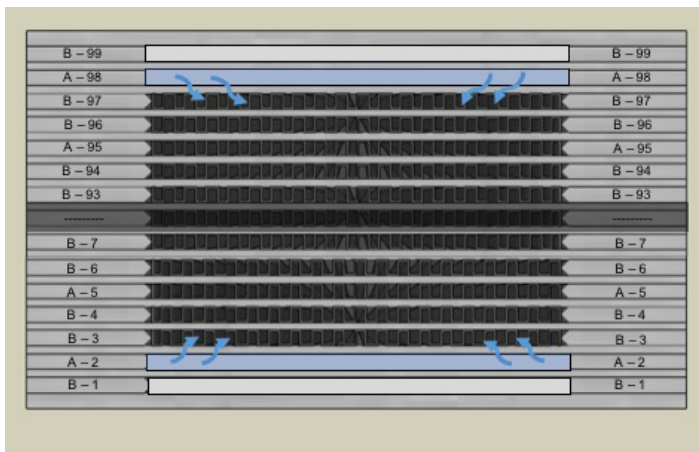
Figure 18. To repair the leaks into layers 2 and 98, workers welded closed layers 99 and 98 as well as layers 1 and 2. Repair documentation states that after welding the four passes closed, workers planned to pressurize the blocked A pass layer 98 (blue) and monitor for leaks into B pass layer 97 (arrows). No records show that workers completed this test to confirm that interpass cracks did not exist between layers 98 and 97.

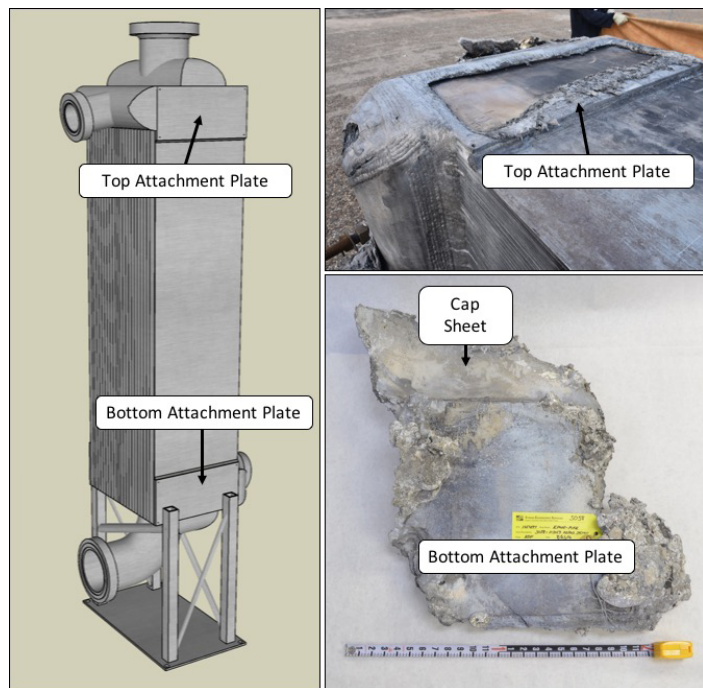
Figure 19. Depiction of the ACSR (left) and two post-incident photos. A portion of the bottom attachment plate and north cap sheet that was found on the ground near the exchanger post-incident (bottom right) shows far less fire damage than the top attachment plate (top right), suggesting that it was not exposed to the effects of the fire as directly as other portions of the exchanger, implying that it fell from the exchanger early during the event.

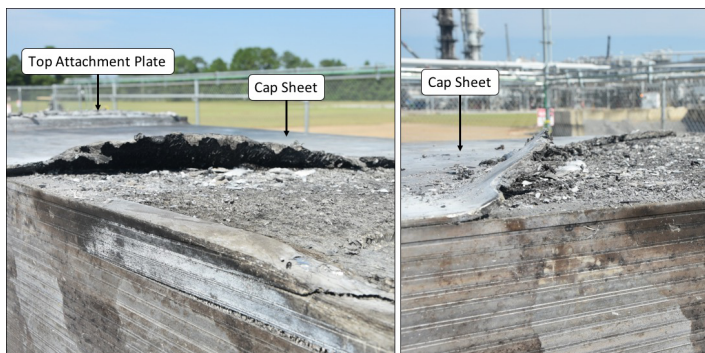
Figure 20. Two post-incident images depicting the remaining north cap sheet attached to the ACSR core. The bottom edge of the cap sheet that remains curls away from the core.

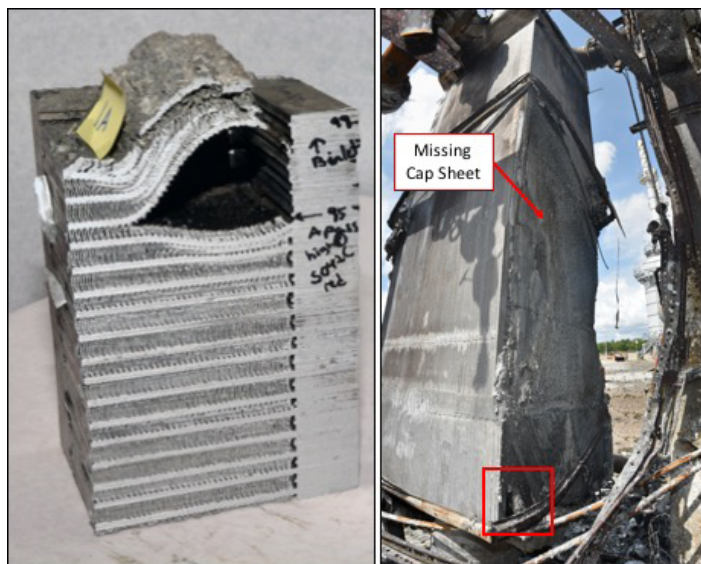
Figure 21. Bulge observed in the ACSR that affected layers 95 through 99 (left). The bulge is on the northeast bottom corner of the exchanger in the area of the missing cap sheet and attachment plate (red box, right). Also shown in the image on the right is the place where the cap sheet is missing from the exchanger.

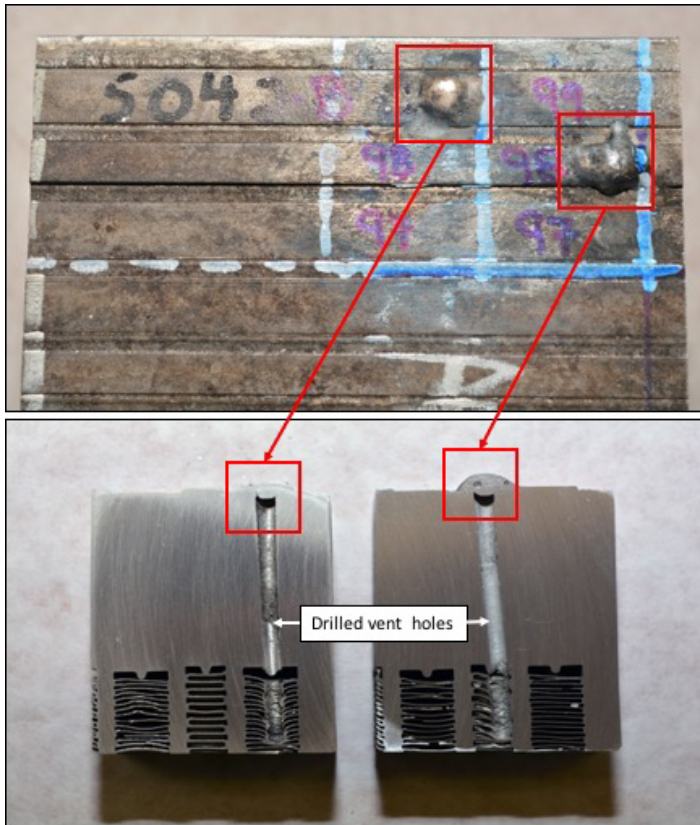
Figure 22. Image of the blocked vent holes. The CSB observed welds on the outside of the exchanger (top). Cross-section of the drilled holes (bottom).

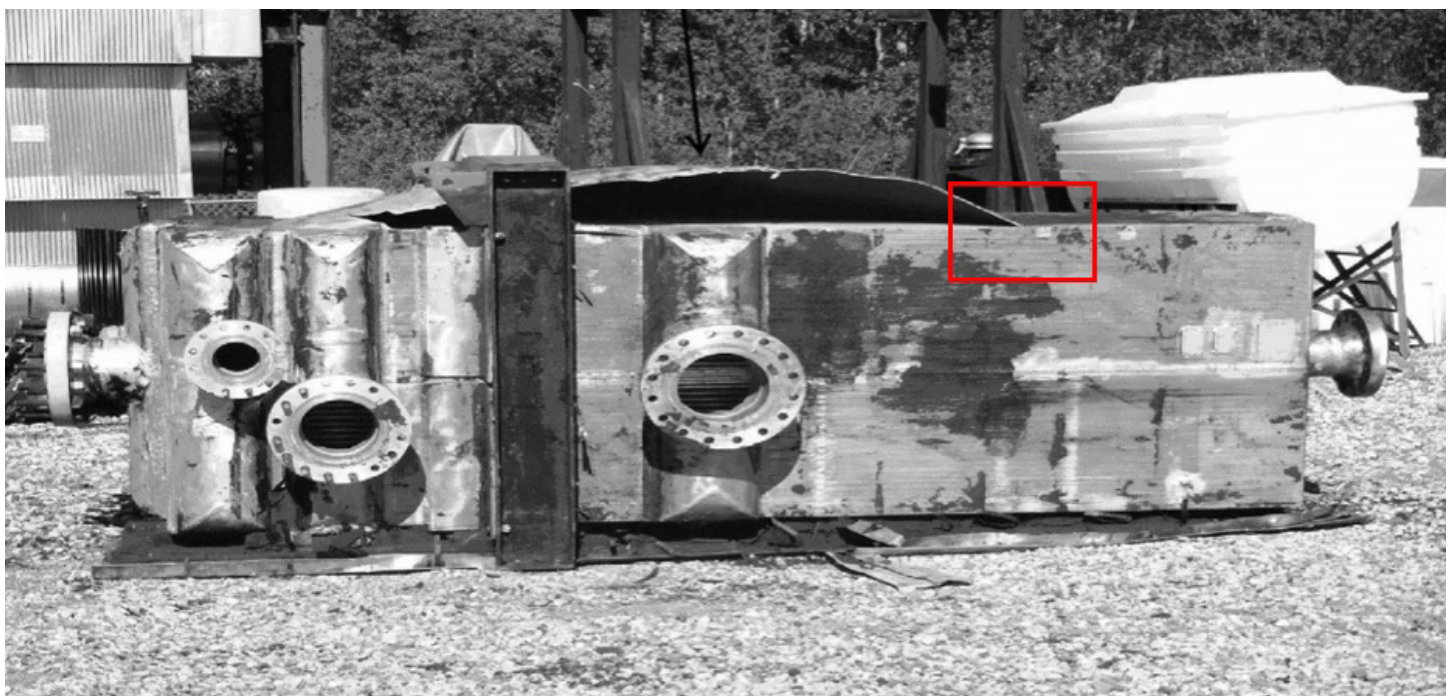
Figure 23. A ruptured BAHX from a ConocoPhillips gas plant in 2015. The red box shows the similarities between the separation of the cap sheet in this incident and the failure scenario described in Section 4.3. (Credit: Chart Industries)

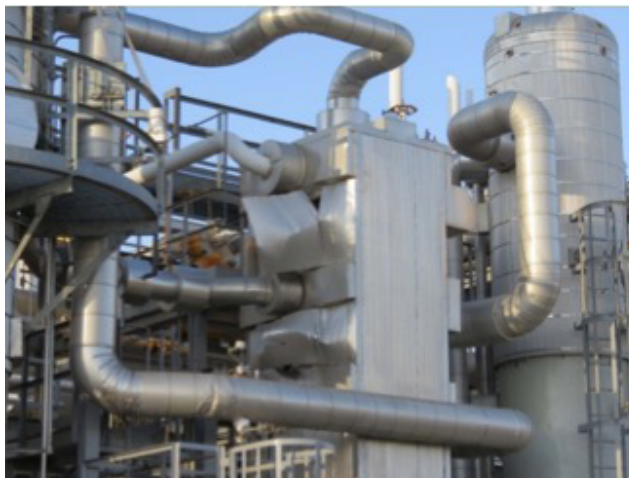
Figure 24. Ruptured cold side reboiler at Enterprise's Chaco gas plant, showing the exchanger still covered in insulation. (Credit: Chart Industries)

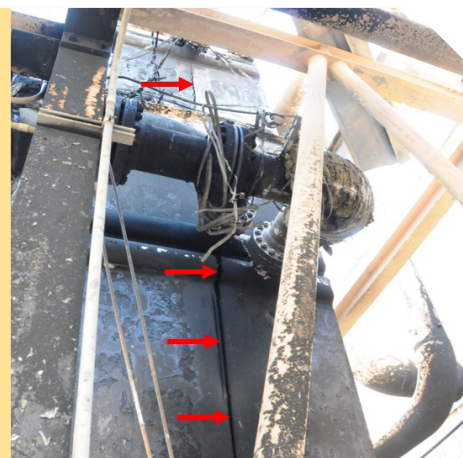
After the exchanger failed, hydrocarbons were released, and a fire ensued. No one was injured, but the process train containing the BAHX was rendered temporarily inoperable. The post-incident metallurgical analysis ruled out several potential failure modes,^b noting that while direct evidence of thermal fatigue was not found, it could not be eliminated as a probable cause.

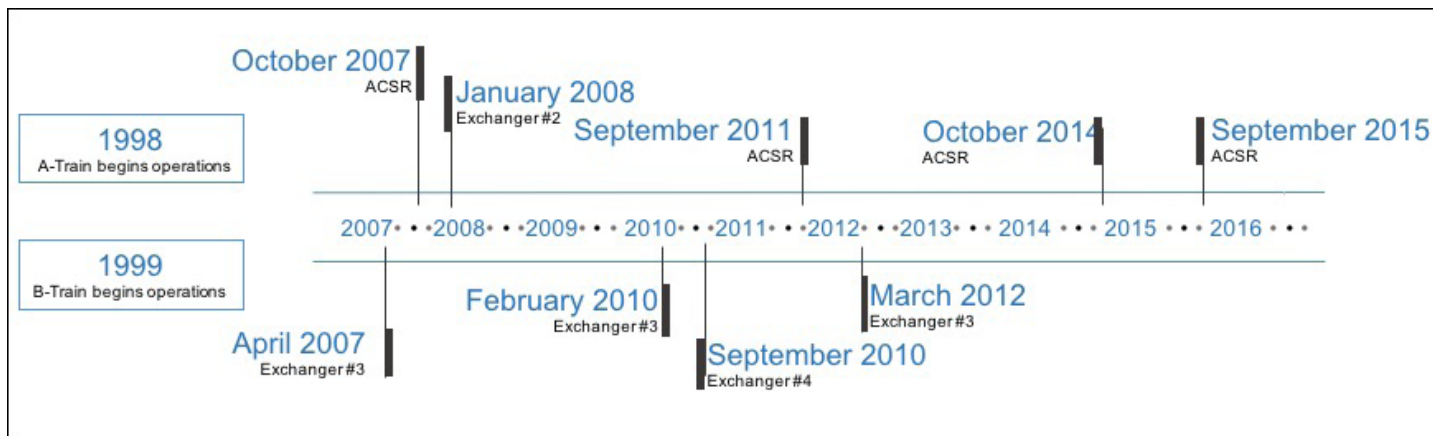
Figure 25. Timeline of hydrocarbon leaks to atmosphere from four BAHXs at PGP.⁷¹

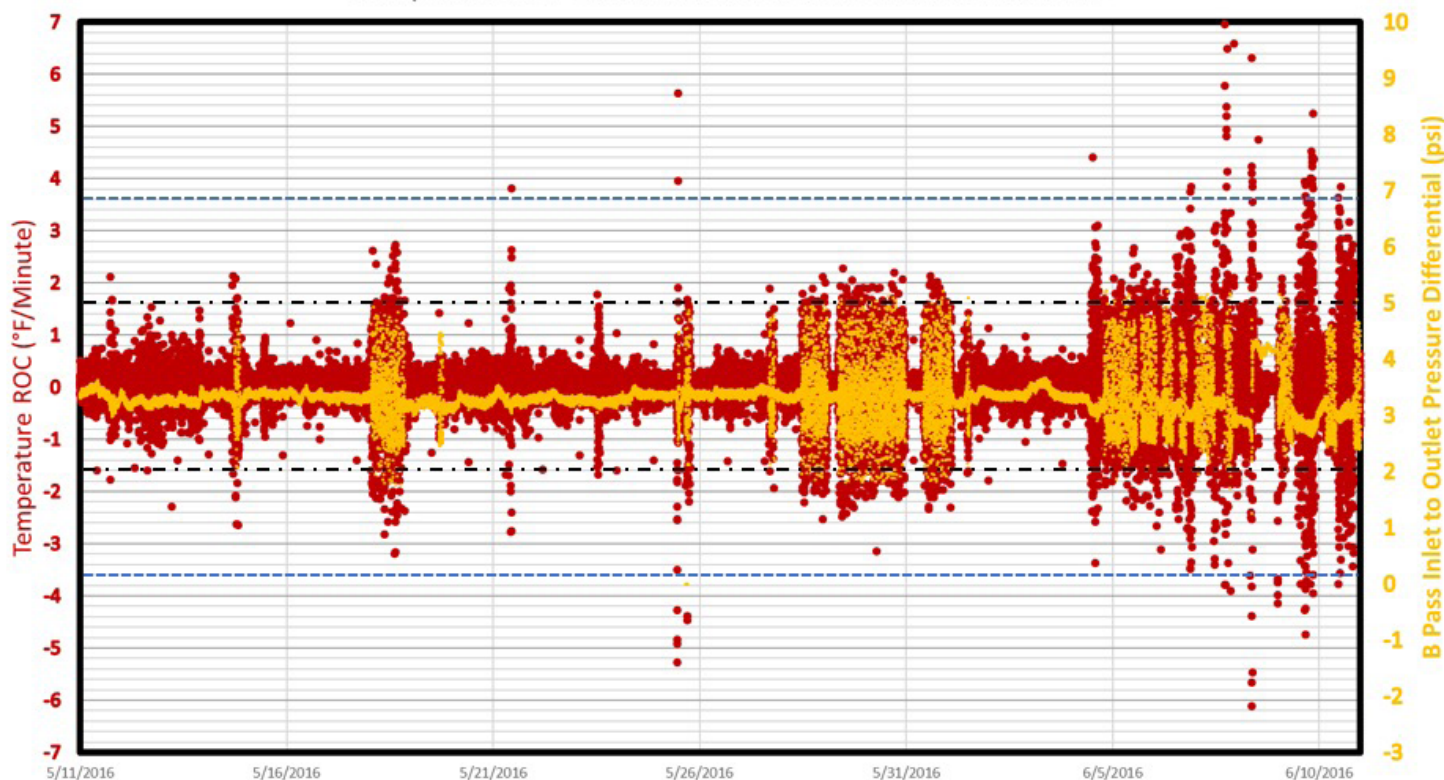
Figure 26. ACSR process stream temperature ROC data for B pass outlet (red) and B pass differential pressure data (yellow). The black dot-dashed lines indicate the maximum temperature ROC for steady-state operations, as recommended by industry guidance of ALPEMA, Chart, and GPA Midstream. The blue dashed lines indicate API guidance for temperature ROC.

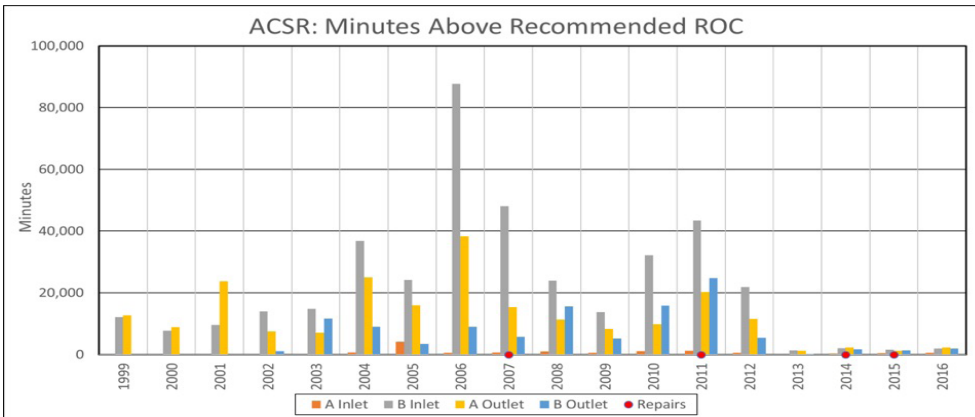
Figure 27. Total minutes per year that the inlet and outlet stream temperatures of the ACSR were greater than the industry-recommended ROC guidelines of 1.8°F/min. Red dots indicate years when cracks that resulted in leaks which were repaired.

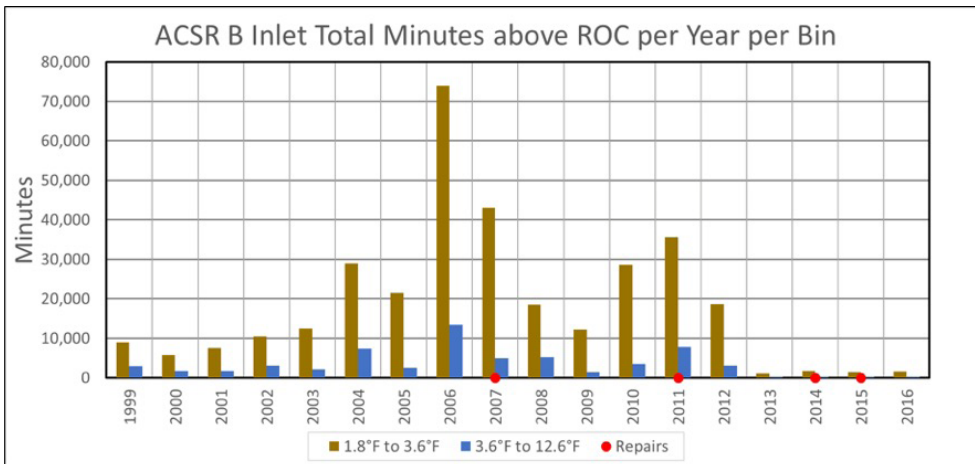
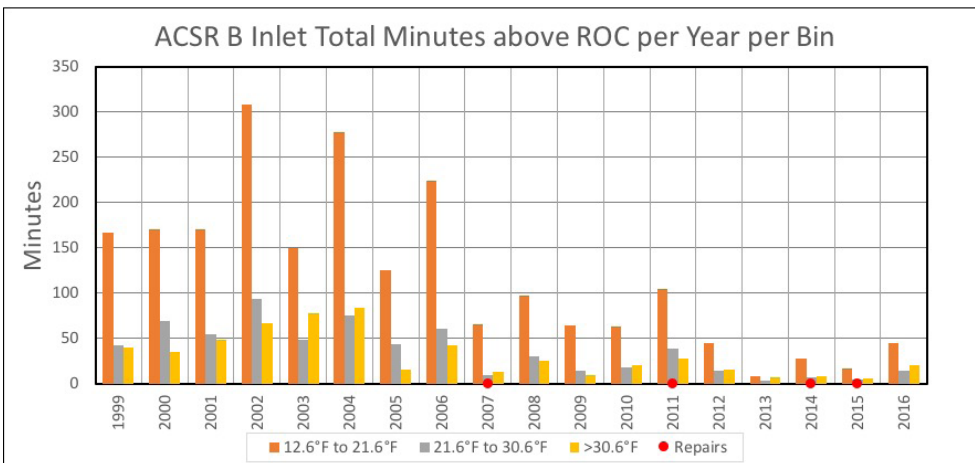
Figure 28. ROC in temperature categorized into five temperature ranges, split between two graphs, to illustrate the magnitude of stream temperature changes for the ACSR over its life-span. The bottom graph shows the bins with an ROC greater than 12.6°F/min. Note that there the scale for the Y axis on each graph is different.

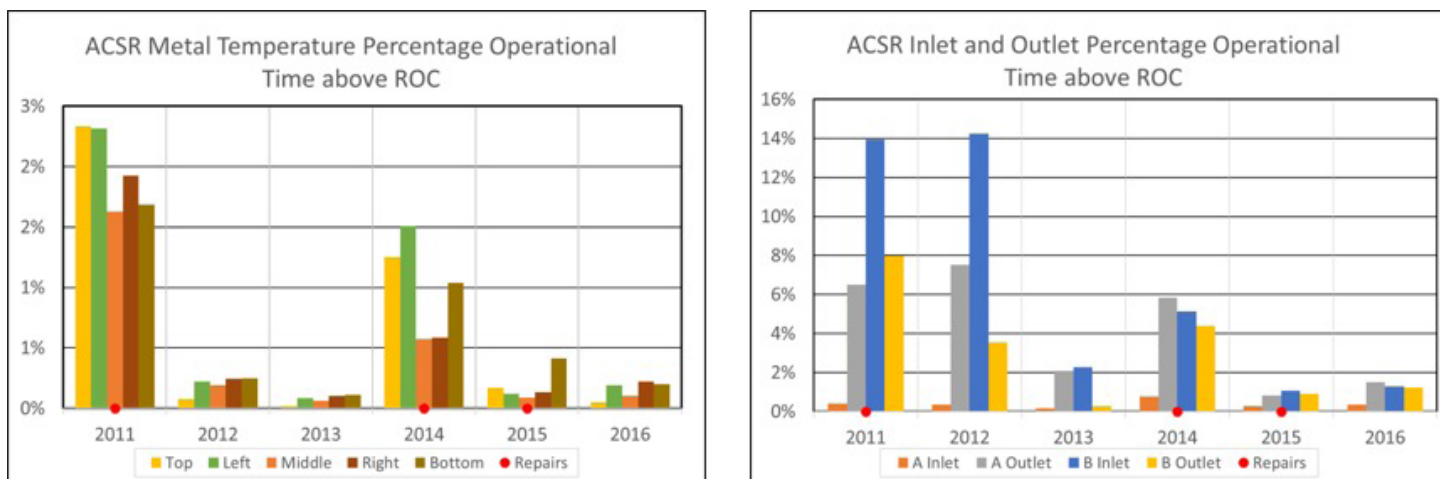
Figure 29. ROC data from January 1, 2011, to June 27, 2016, normalized to the A-Train run time for the inlet, outlet, and metal temperatures of the ACSR. ROCs calculated from the metal temperatures are about 10 times less than those for the stream temperatures.

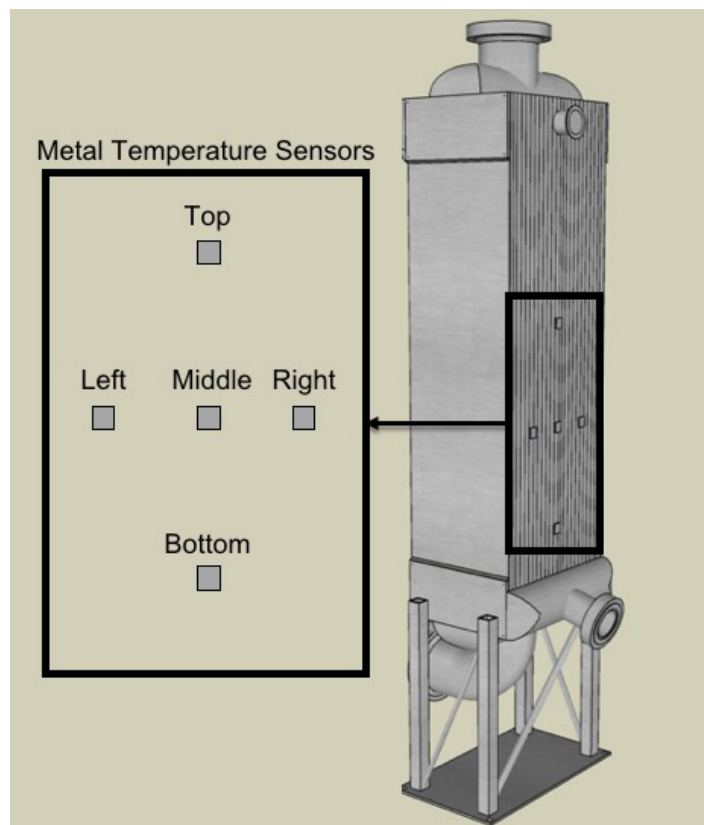
Figure 30. Location of the metal temperature sensors installed on the side bars of the ACSR.

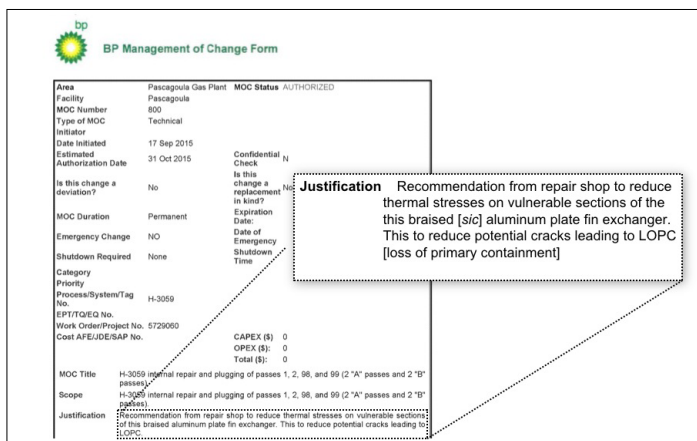
bp Management of Change Form	
Area	Pascagoula Gas Plant
Facility	Pascagoula
MOC Number	800
Type of MOC	Technical
Initiator	17 Sep 2015
Date Initiated	31 Oct 2015
Estimated Authorization Date	Confidential
MOC Duration	Permanent
Emergency Change	NO
Shutdown Required	None
Category	Priority
Process/System/Tag No.	H-3056
EPI/TO/IEQ No.	Work Order/Project No. 5729000
Cost AFE/DESAP No.	CAPEX (\$): 0
	OPEX (\$): 0
	Total (\$): 0
MOC Title	H-3056 internal repair and plugging of passes 1, 2, 98, and 99 (2 "A" passes and 2 "B" passes)
Scope	H-3056 internal repair and plugging of passes 1, 2, 98, and 99 (2 "A" passes and 2 "B" passes)
Justification	Recommendation from repair shop to reduce thermal stresses on vulnerable sections of this braised aluminum plate fin exchanger. This to reduce potential cracks leading to LOPC

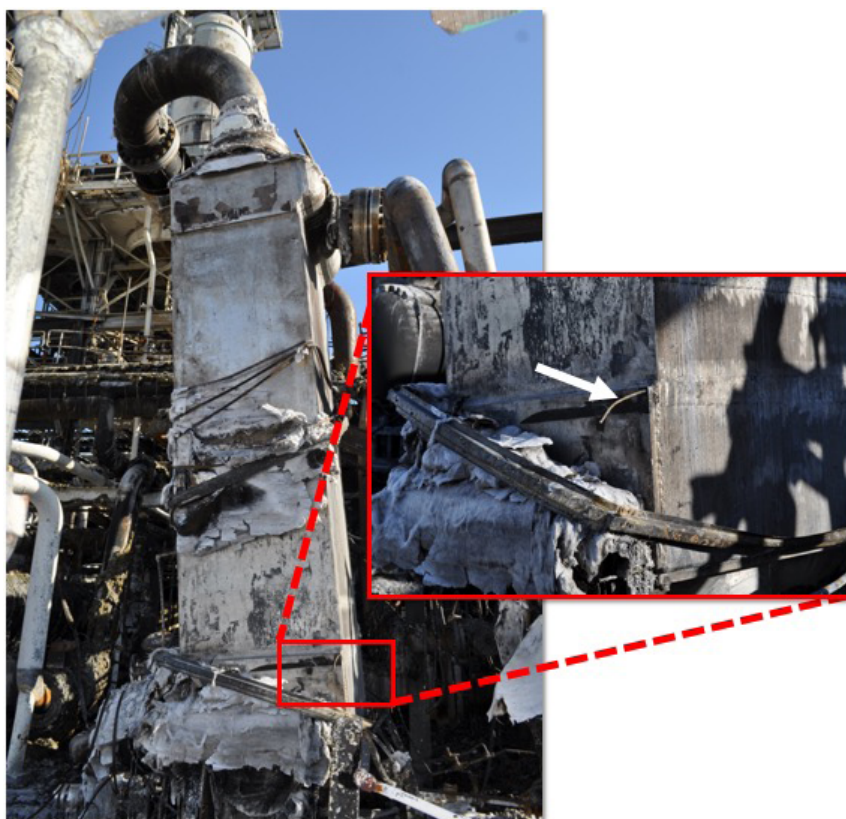
Figure 32. Post-incident image of a tube installed on the ACSR to aid in detecting leaks from the exchanger (white arrow).

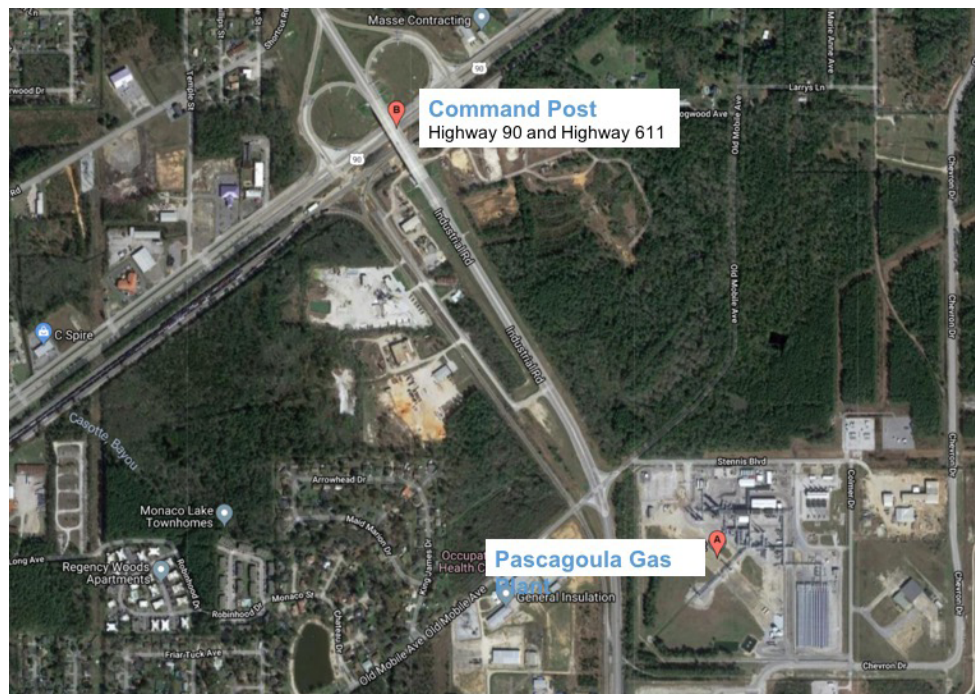
Figure 33. Relative positions of the command post and PGP.

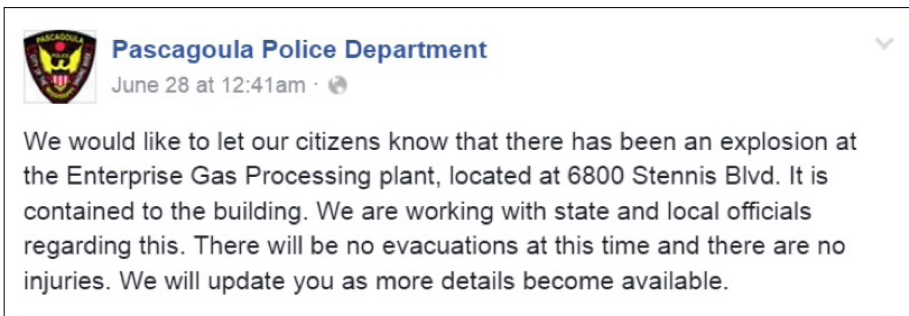
Figure 34. Pascagoula Police Department Facebook post on June 27, 2016, at 11:41 p.m.

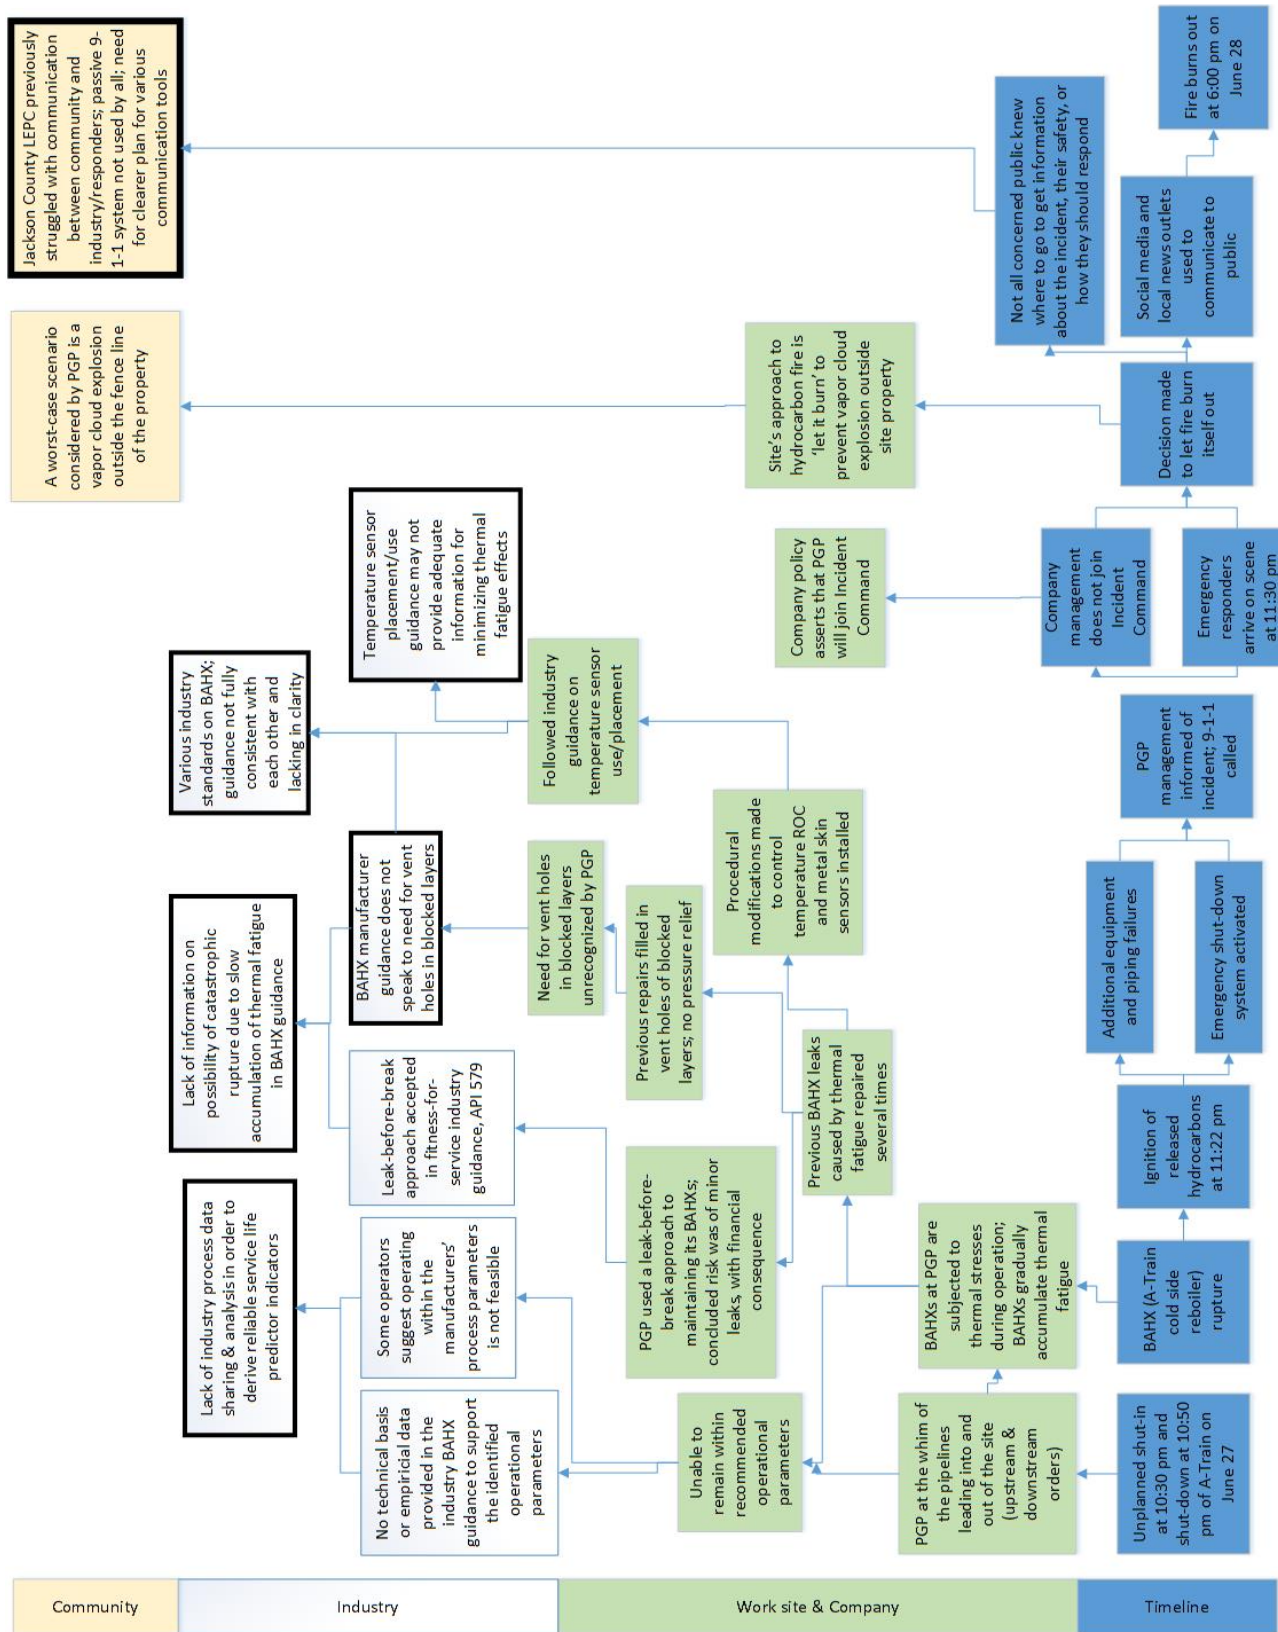
137 The bolded boxes indicate findings and factors that resulted in recommendations.

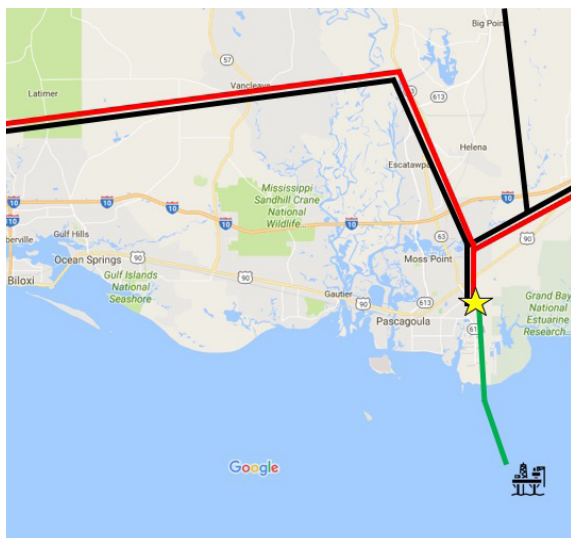
Figure 35. PGP receives raw gas via the offshore Destin (green) pipeline. Natural gas and natural gas liquids leave the plant (star) via the Destin (black) and Tri-States (red) pipelines, respectively. Pipeline locations are approximate.¹³⁸
