Case Study

Published: February 13, 2019

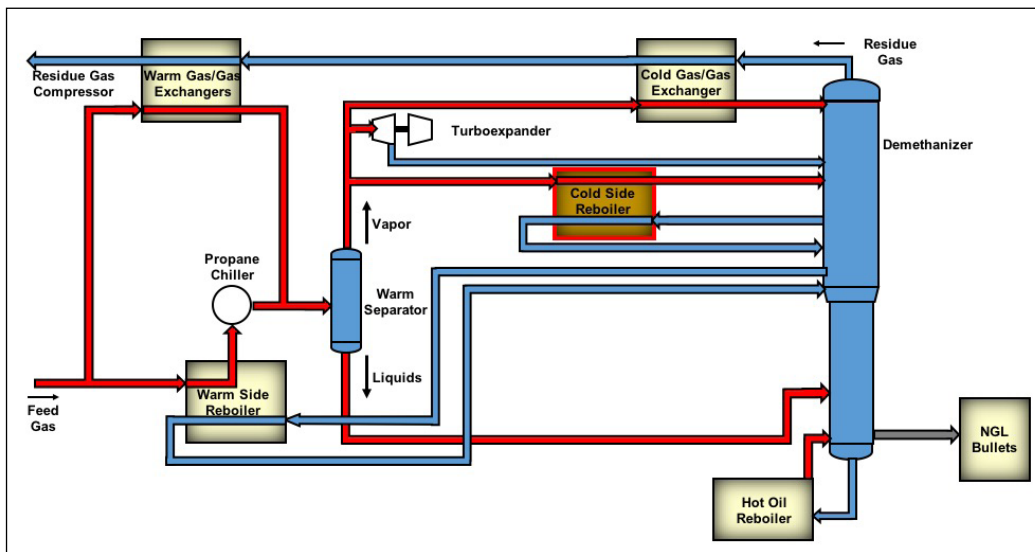
Figure 38. Simplified overview of the cryogenic process. The cold side reboiler (dark orange) is likely the vessel that initially failed. Red arrows indicate the streams that are warmer, blue the cooler streams.

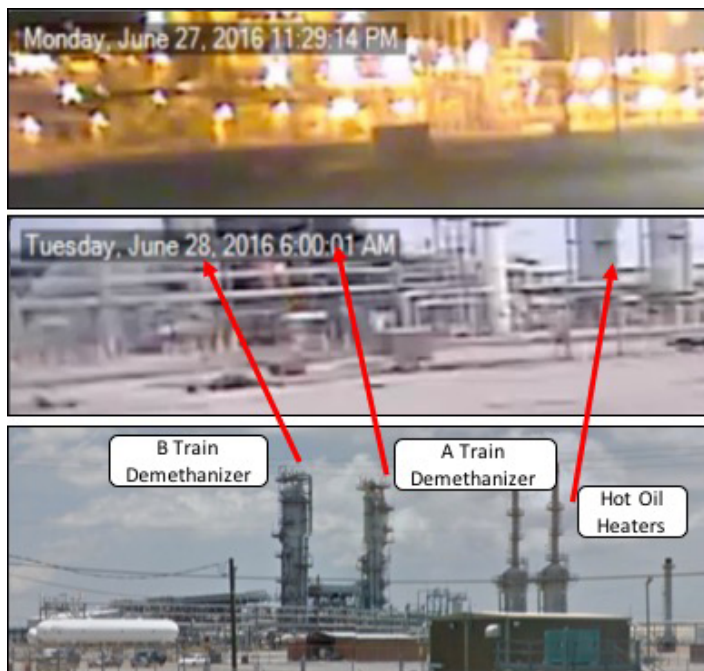
Figure 39. Surveillance camera field of view shown during the night (top) and day (middle). Photo from a nearby roadway showing a wider view of the facility from approximately the same angle as the surveillance footage at PGP on the night of June 27, 2016 (bottom).

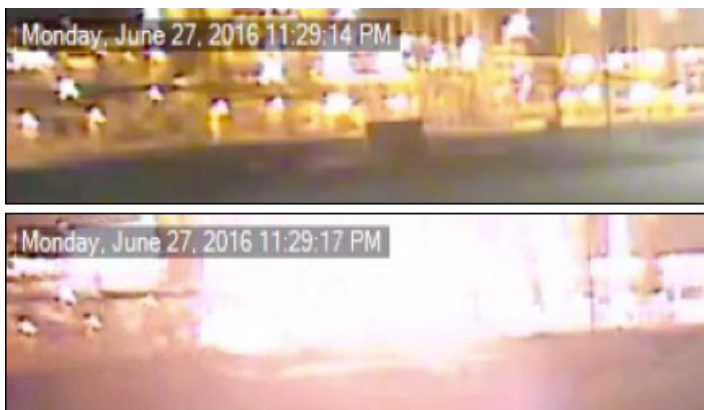
Figure 40. Surveillance camera field of view shown during the night (top) and day (middle). Photo from a nearby roadway showing a wider view of the facility from approximately the same angle as the surveillance footage at PGP on the night of June 27, 2016 (bottom).

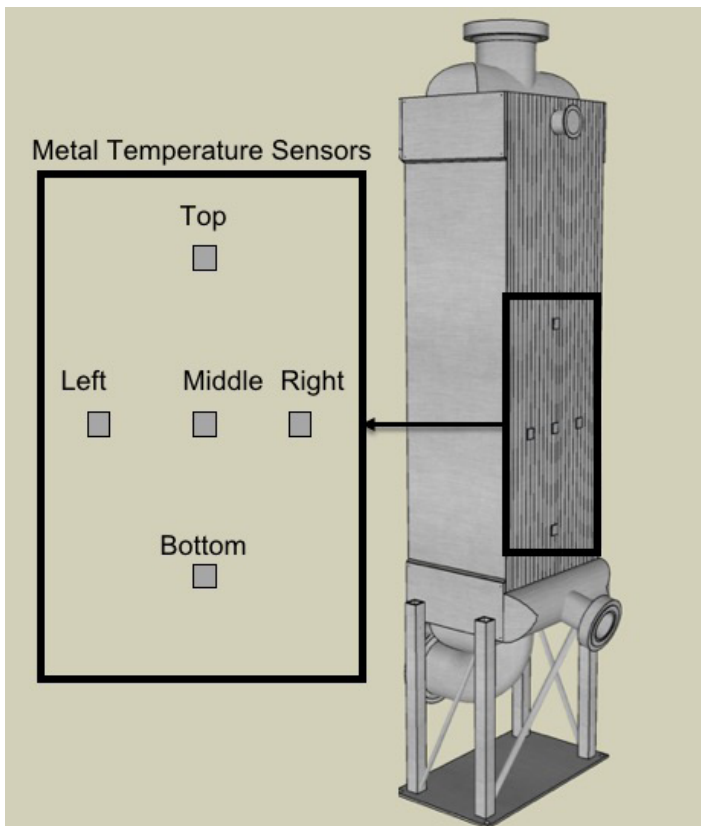
Figure 41. Location of the metal temperature sensors on the cold and warm side reboilers.

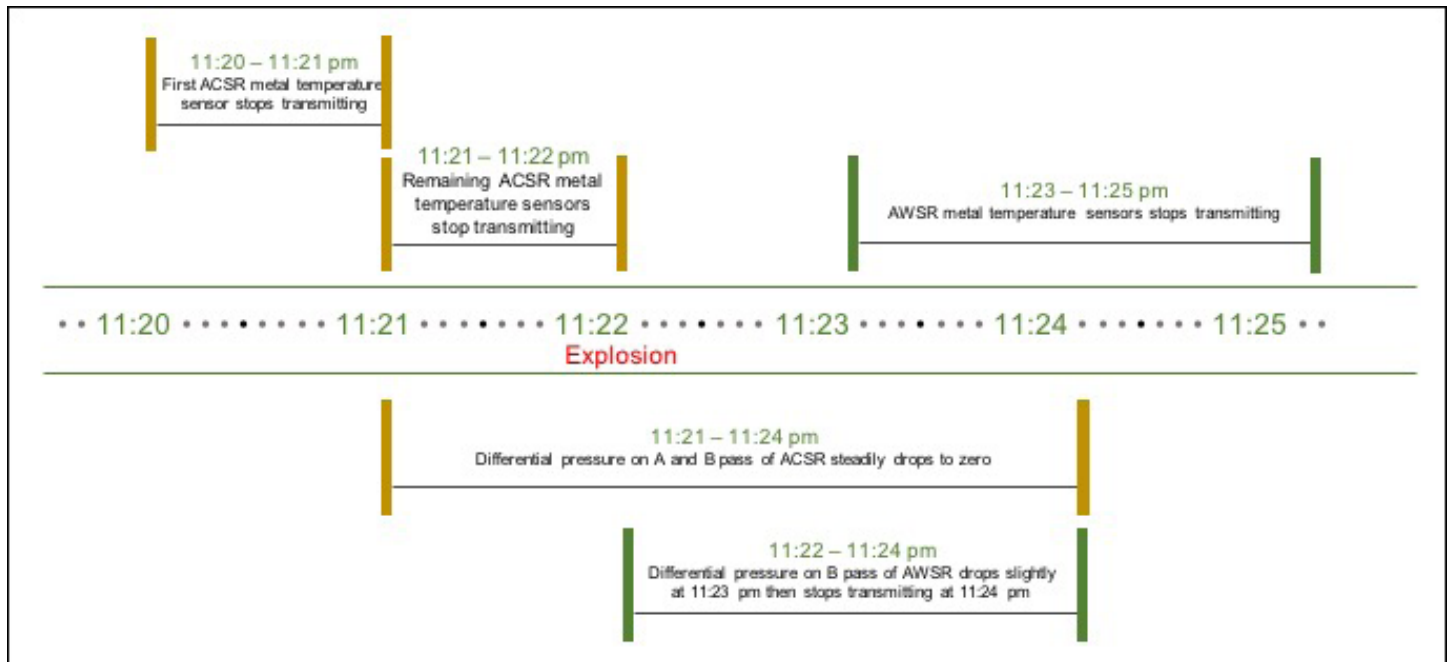
Figure 42. ACSR (gold bars) and A-Train warm side reboiler, or AWSR (green bars) temperature and pressure readings in the minutes before and after the initial incident.

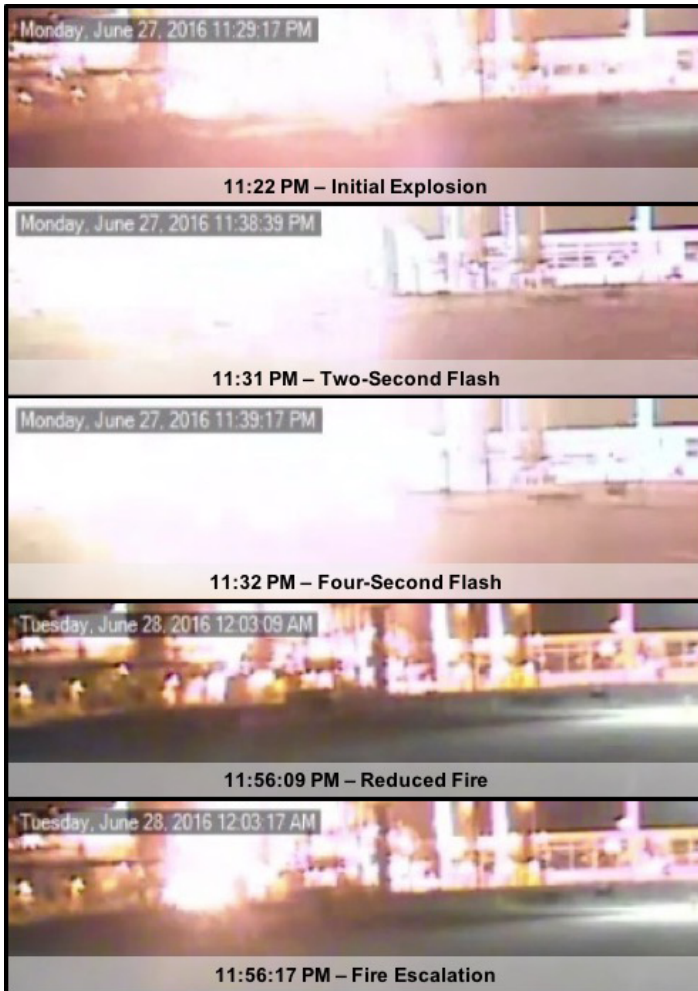
Surveillance video shows that after the initial explosion, the ensuing fire intensified several times over a time frame of about 35 minutes (**Figure 43**).

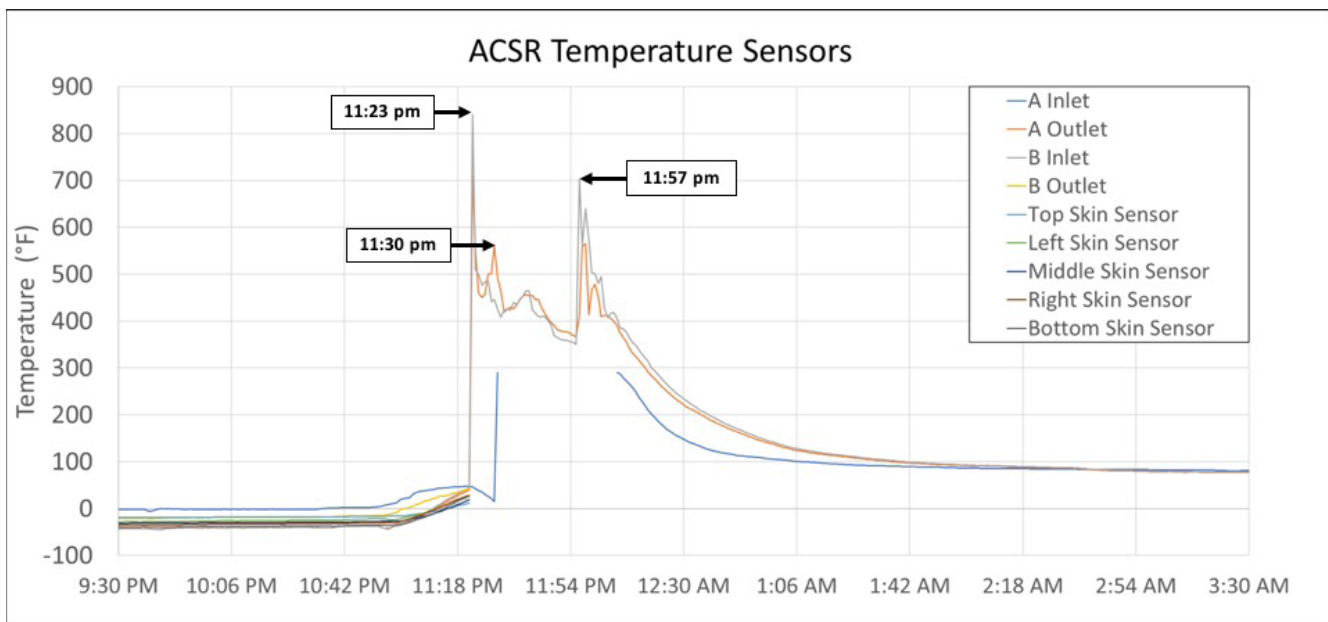
Figure 44. Corresponding temperature data from the ACSR, showing large temperature spikes at the same time as changes in the fire intensity from the security footage.

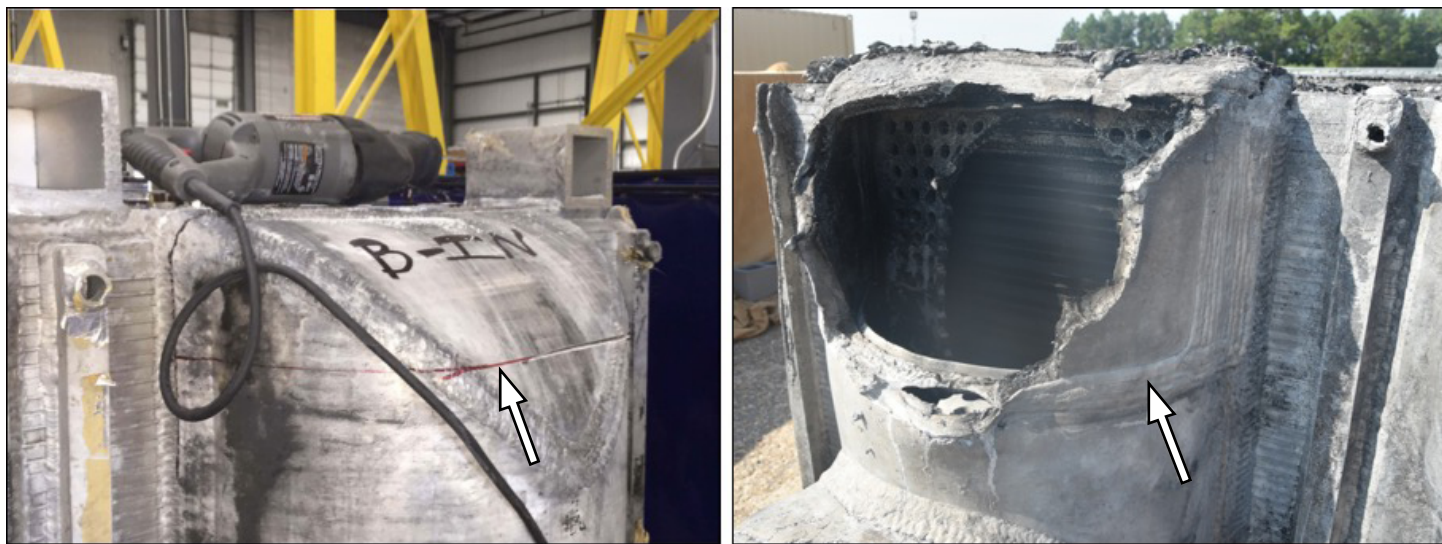
Figure 45. The B-inlet header on the ACSR is marked for cutting during the September 2015 repair (left, white arrow). The breach found in the B-inlet header post-incident partially followed the new weld (right, white arrow).

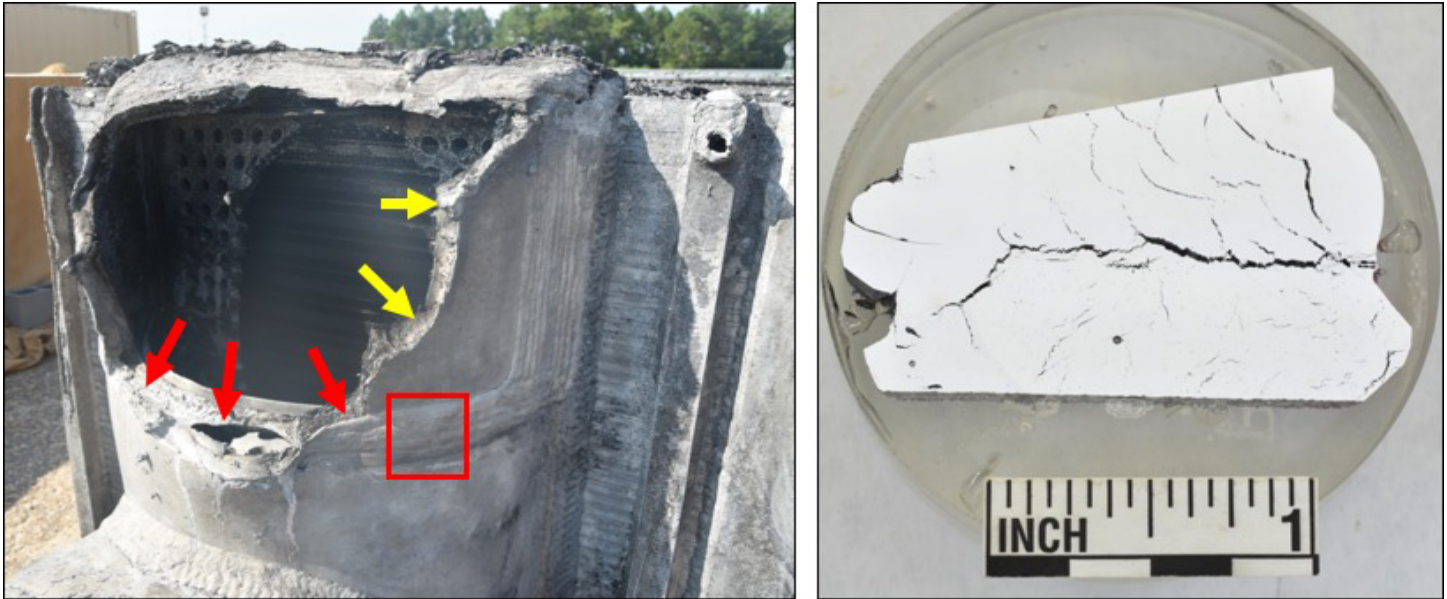
Figure 46. The left image is of the header rupture, showing the fracture surface. The right image is a section of a weld taken from the region identified with the red box in the left image, showing the formation of voids (black lines) due to localized melting of the metal.

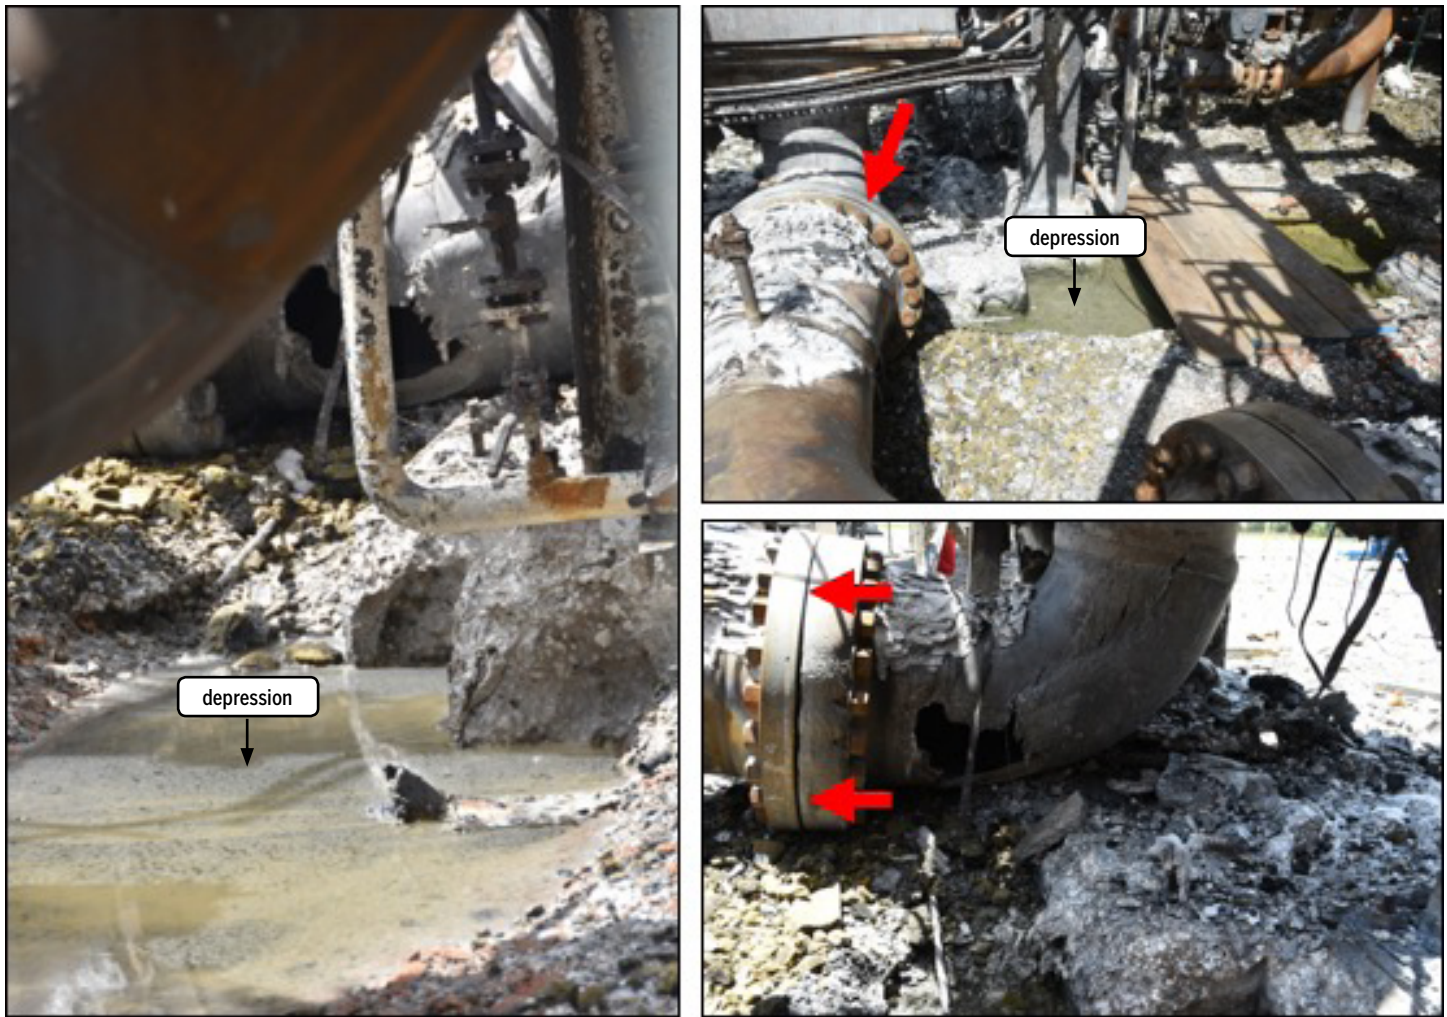
Figure 47. Post-incident examination of the area revealed a large depression in the ground (left and upper right images). The breach visible in the lower right image lines up with the depression in the ground. Red arrows point out the B-inlet flange.

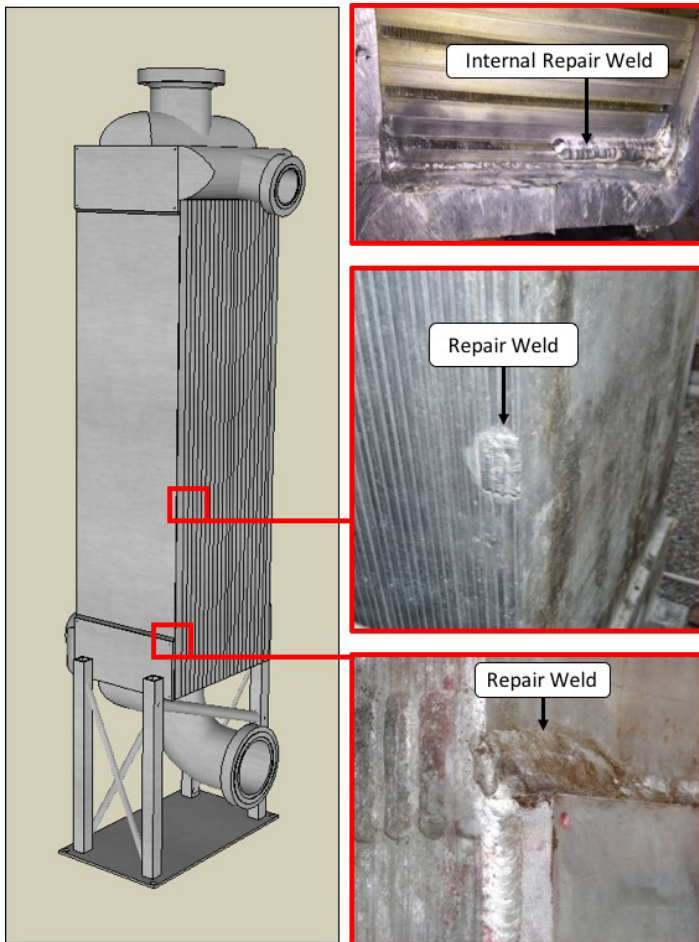
Figure 48. Black arrows point to repair welds: (1) for an internal interpass leak (top left, repair only partially completed in the photograph); (2) side bar repair (bottom left); and (3) cracks on a cap sheet (right).

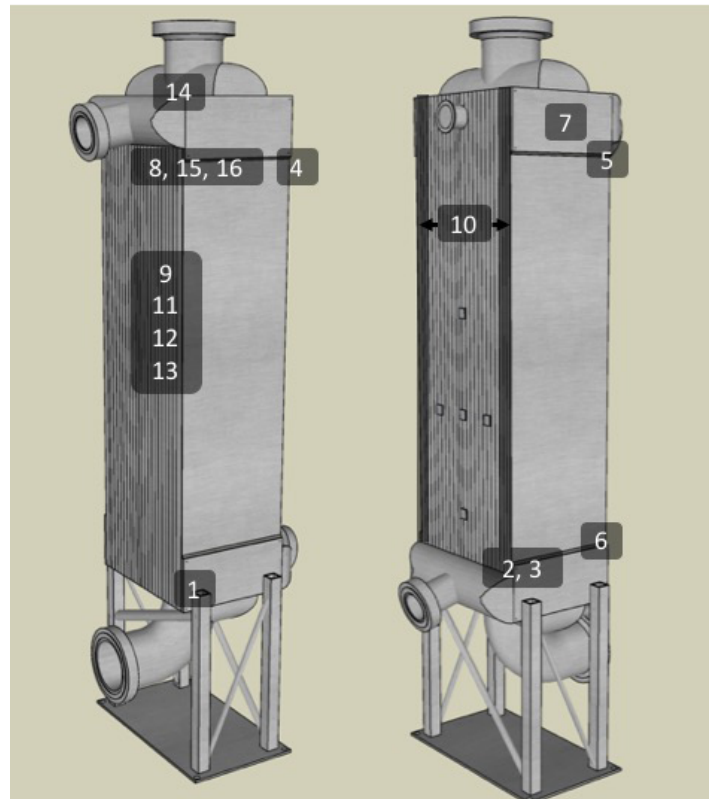
Figure 49. Visual depiction of the repairs on the ACSR. The numbering represents the order in which the leaks or cracks occurred and were repaired.

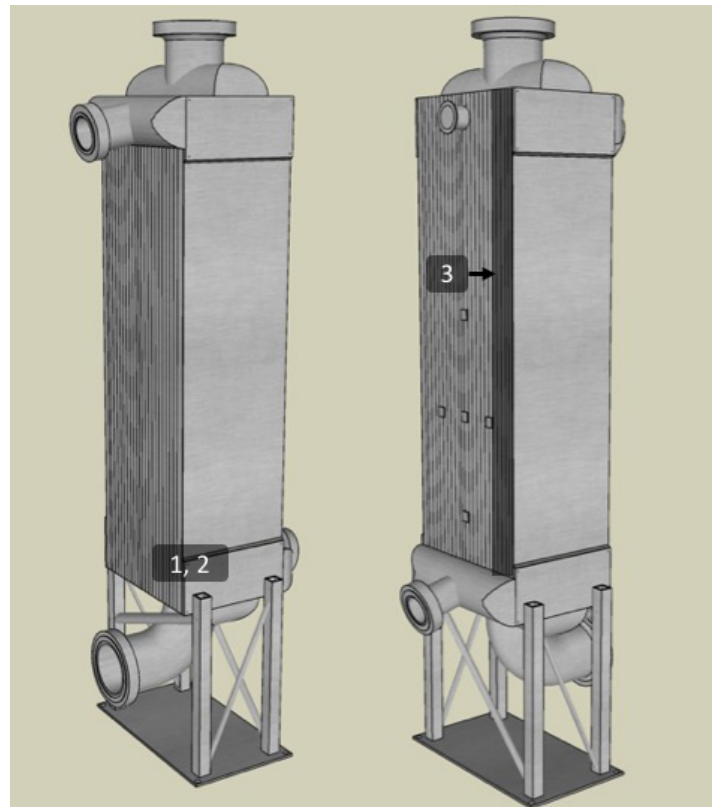
Figure 50. Visual depiction of the repairs on the B-Train cold side reboiler. The numbering also represents the sequential order in which the leaks occurred or were detected.

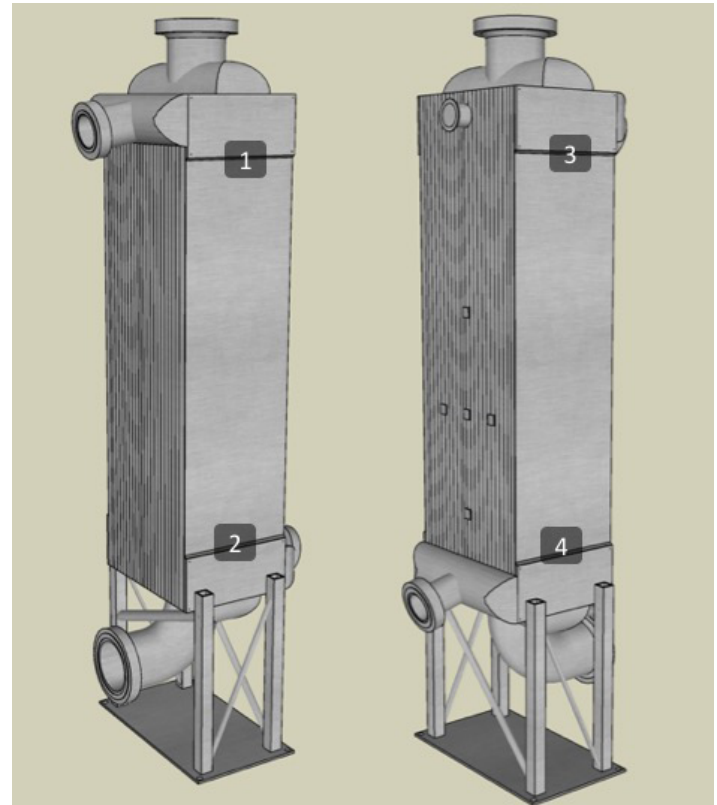
Figure 51. Visual depiction of the repairs on the AWSR. The repair in 2008 covered all four welds where the cap sheet was attached to the attachment plate (1-4).

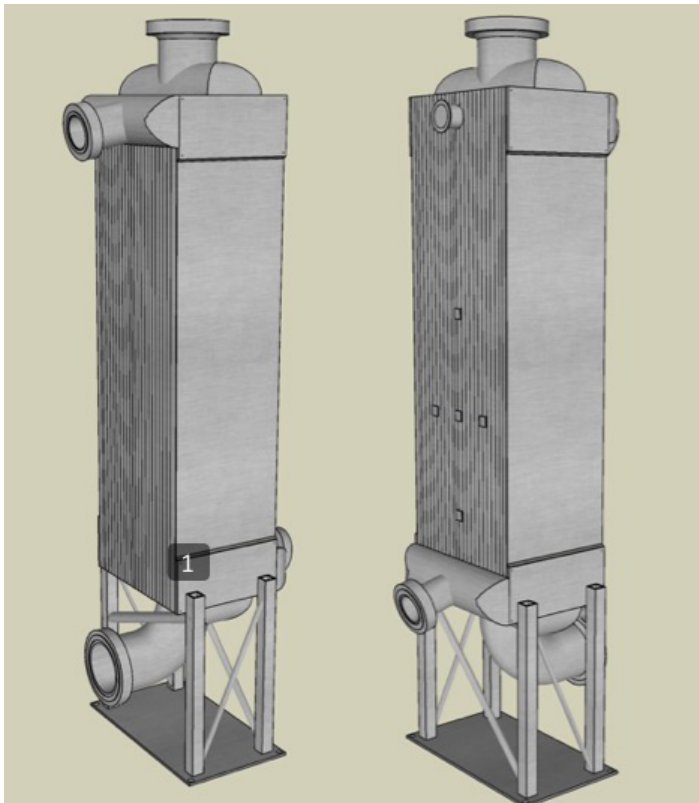
Figure 52. Visual depiction of the repairs on the B-Train warm side reboiler. The crack was repaired in 2010 (1).

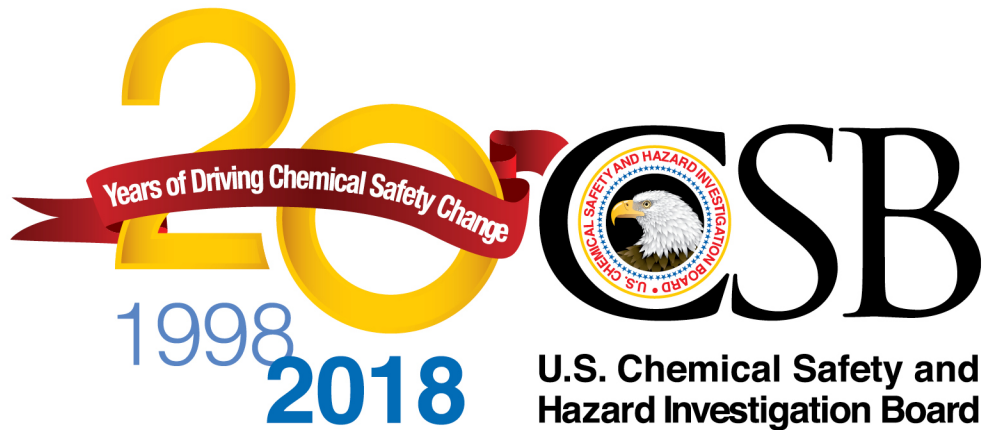
Members of the U.S. Chemical Safety and Hazard Investigation Board
