INVESTIGATION REPORT

CATASTROPHIC RUPTURE OF HEAT EXCHANGER (SEVEN FATALITIES)

TESORO ANACORTES REFINERY

REPORT 2010-08-I-WA

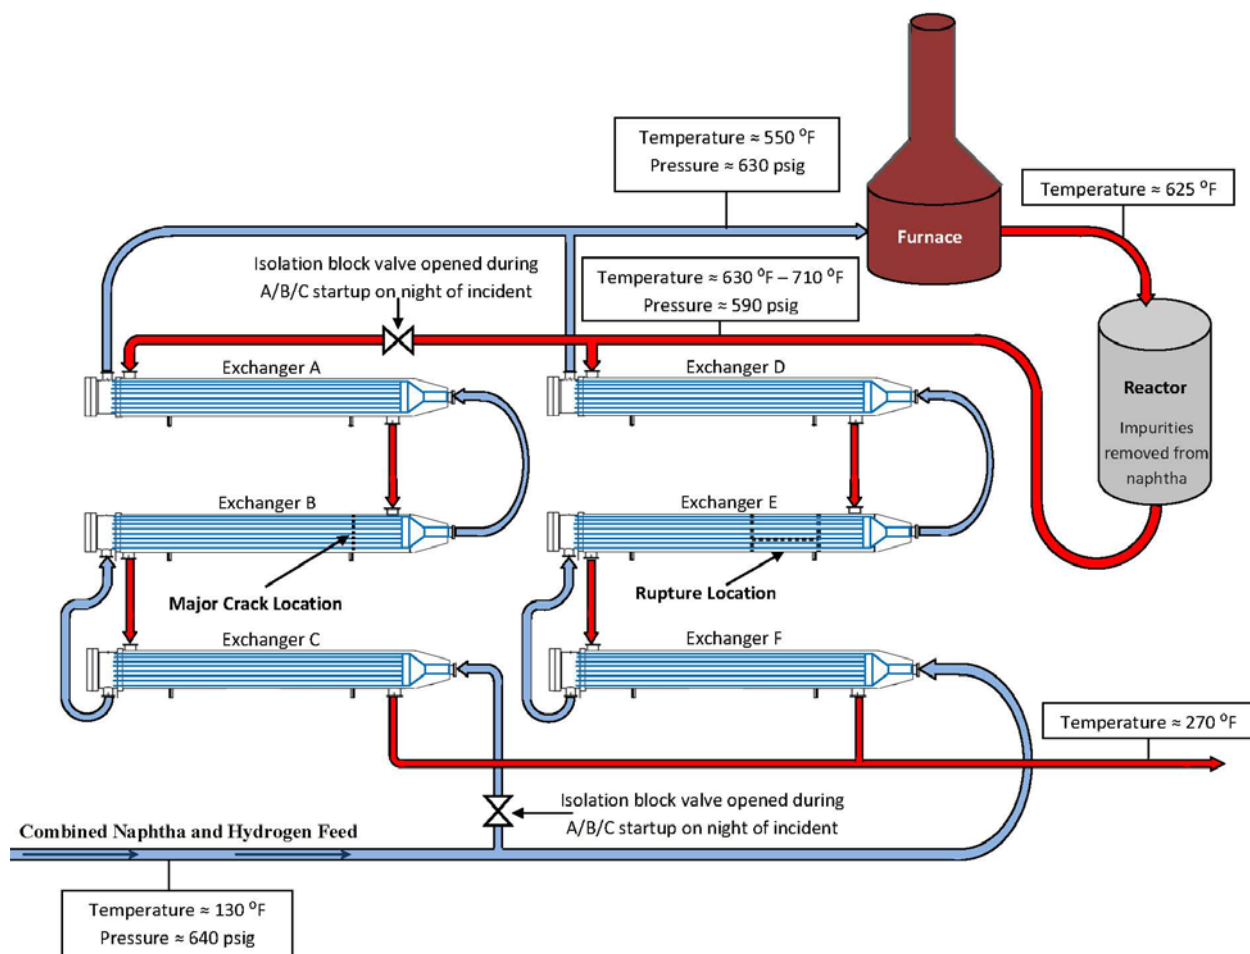
Figure 4. Process Flow of NHT Unit

(effluent) heat exchangers,³⁷ as depicted in Figure 4. (These heat exchangers are referenced throughout this report as the NHT heat exchangers.)

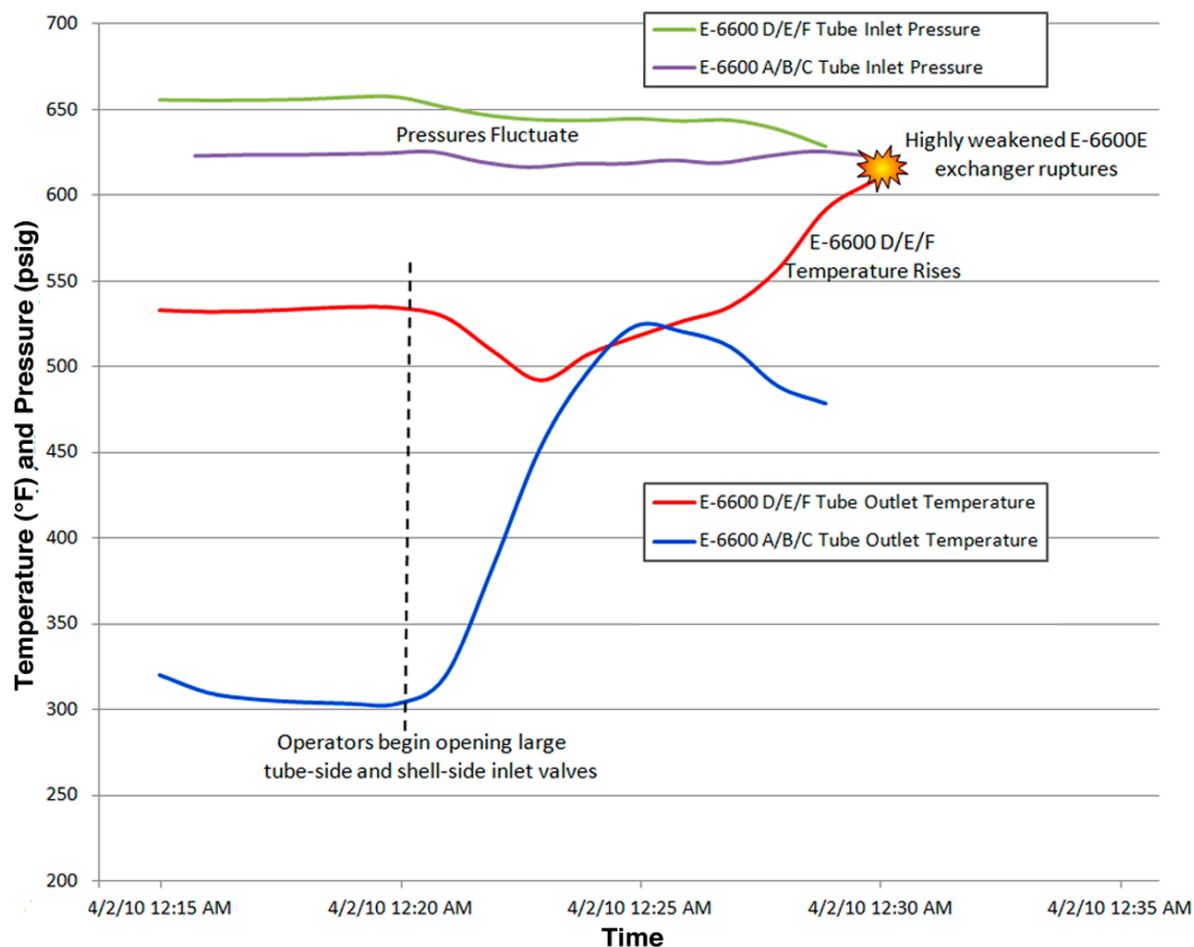
Figure 23. Temperature and Pressure Trends before the Anacortes Incident

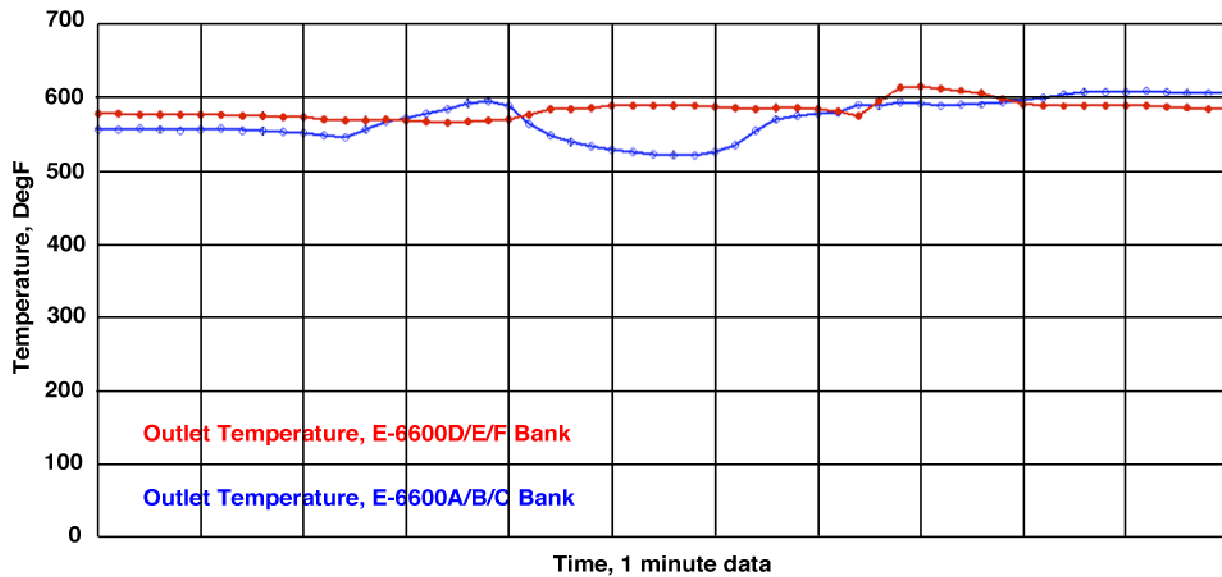
Figure 39. Temperature Data During NHT A/B/C Heat Exchanger Bank Startup on August 29, 2009

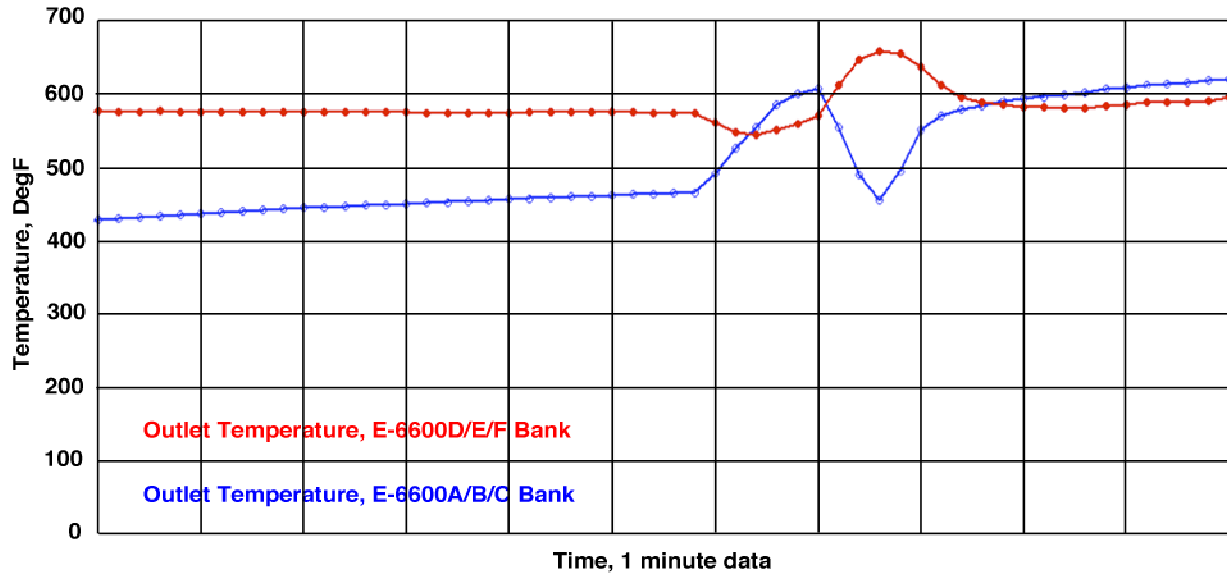
Figure 40. Temperature Data During NHT A/B/C Heat Exchanger Bank Startup on April 2, 2009
