U.S. Chemical Safety and Hazard Investigation Board

Seven Key Lessons to Prevent Worker Deaths During Hot Work In and Around Tanks

Effective Hazard Assessment and Use of Combustible Gas Monitoring Will Save Lives

No. 2009-01-SB

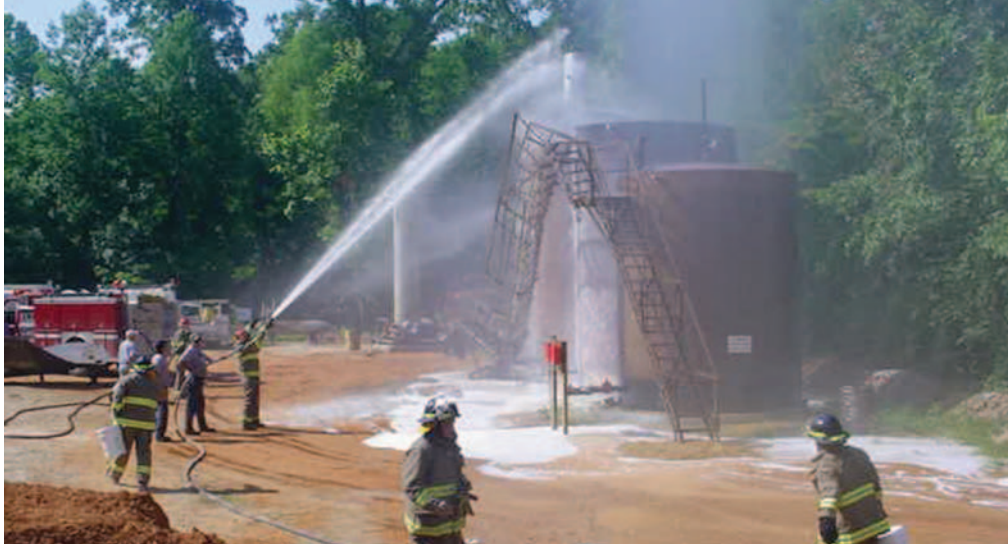
Emergency response efforts following a June 5, 2006, accident at the Partridge Raleigh Oilfield. Courtesy of Smith County Sheriff's Office.

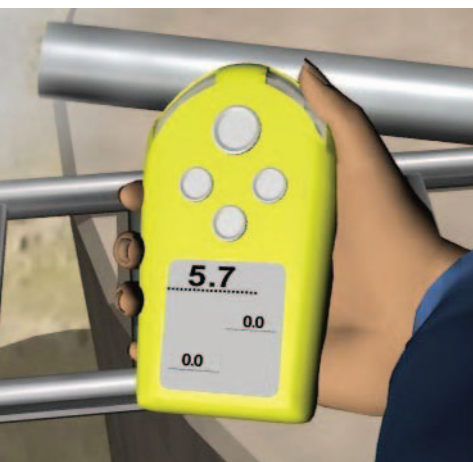
Example of a combustible gas detector used to test for the presence of flammable gas or vapor.

Flammable gas and vapor concentrations are generally determined using a portable combustible gas detector, also called an LEL.³ meter. Combustible gas detectors are relatively inexpensive and widely available. Training in LEL instrument use is a key component to effective gas testing and is a critical aspect of an effective hot work safety program.

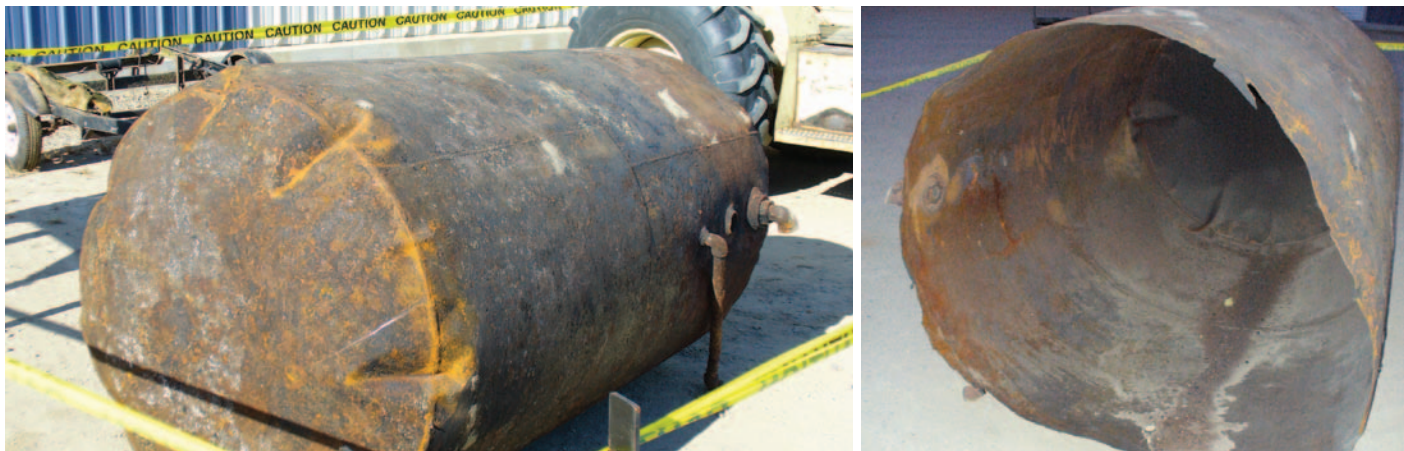
Exterior and interior views of the fuel tank involved in the hot work accident at A.V. Thomas Produce.

Two employees at A.V. Thomas Produce were using an oxygen-acetylene torch to loosen a fitting on an old fuel tank, which the company hoped to refurbish for field storage of diesel fuel. The workers, however, were unaware that the tank contained residual hydrocarbon liquid and vapor from an unknown prior use. The tank was not cleaned or purged before work began. Shortly after applying heat to the tank, an explosion occurred, blowing the end of the vessel off. Both employees were airlifted to a regional burn center, where they were treated for burns covering 30 to 50% of their bodies.

The facility had no formal hot work program, and no permit was issued for the hot work being performed. No combustible gas testing was performed prior to commencement of the hot work; the company did not have a policy that required it. In addition, many workers were mono-lingual Spanish speakers and had not been trained on safe hot work procedures or on the proper use of gas detectors in their native language.

Analyze the Hazards, Monitor the Atmosphere,
Test the Area, Use Written Permits, Train Thoroughly

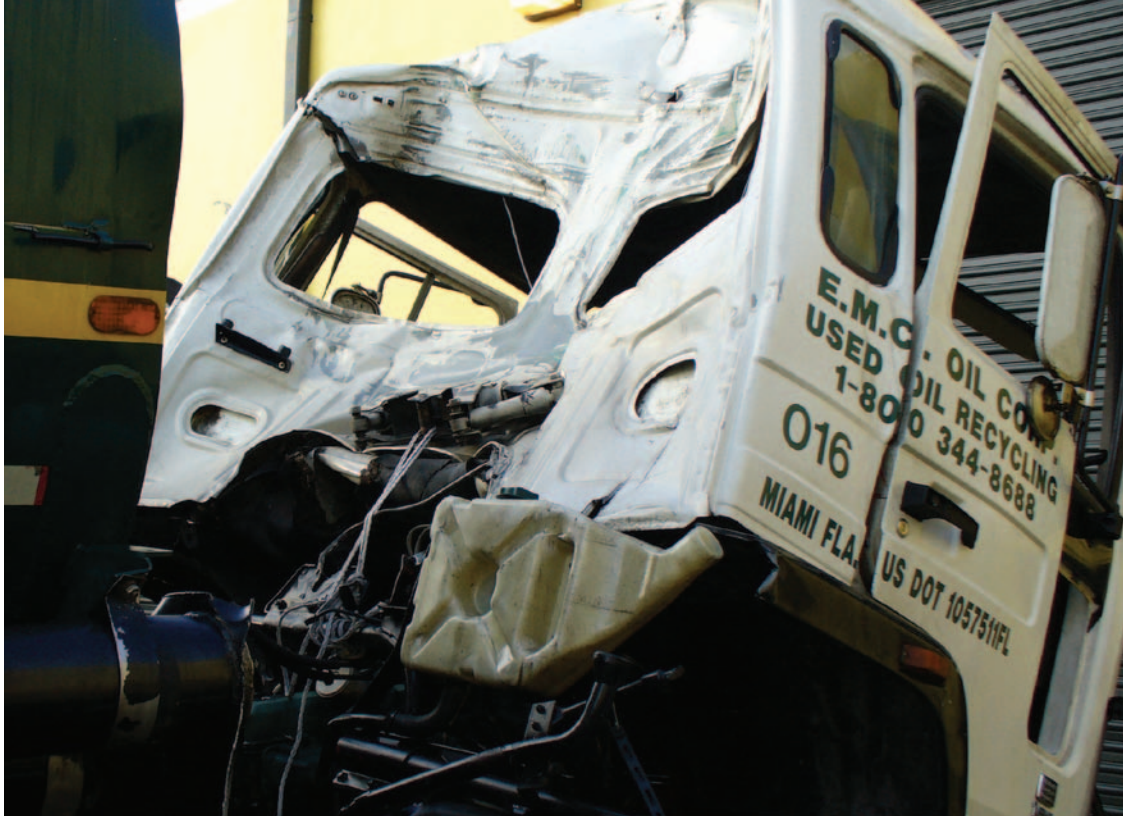
Damage to an oil tanker sustained from the December 2, 2008, explosion at EMC Used Oil Corporation.

An explosion killed a contract welder who was repairing a two-compartment oil tanker and injured another worker at the EMC Used Oil facility. The welder was in the process of welding transfer piping onto the tanker when residual hydrocarbon vapor from the 2,500-gallon rear compartment ignited, causing a powerful explosion.

The surviving worker stated that the contractors did not perform combustible gas monitoring and relied upon the host company to assure that tanks were safe for hot work. However, EMC indicated that it relied on contractors to monitor for gas; although the company owned a multiple gas detector, it was used only for confined space entry. EMC did not have a formal hot work permitting or authorization system.

Use Alternatives, Analyze the Hazards, Monitor the Atmosphere, Test the Area, Use Written Permits, Supervise Contractors

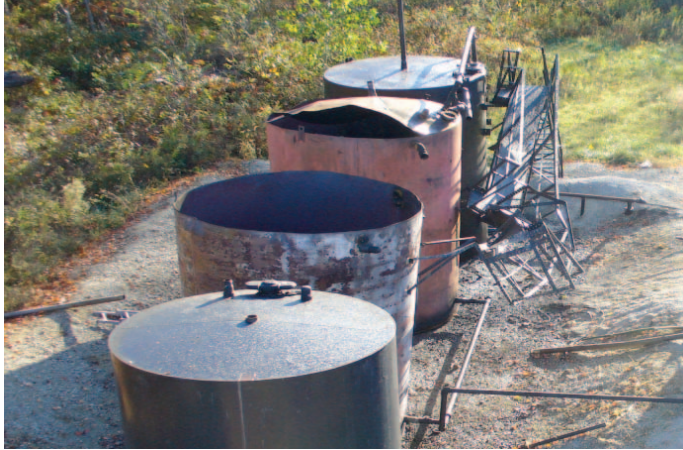
Oil storage tanks involved in fire and explosion at MAR Oil.

An explosion killed two contract workers while they were welding above a series of three interconnected crude oil storage tanks at a MAR Oil site. The explosion occurred when the workers attempted to weld a bracket on top of one of the tanks, near an atmospheric vent. Because the tanks were interconnected, oil flowing into an adjacent tank likely displaced flammable vapor into the tank being welded. The vapor escaped through the vent and was ignited by welding sparks.

The CSB investigators found that combustible gas monitoring was not performed prior to or during the welding. There is conflicting evidence as to whether or not the welding job was authorized by the host company. MAR Oil lacked a formal hot work program that required the hot work be identified in a written permit and be authorized by a person responsible for hot work management. The company had no formal program to select or oversee contractors, and the two contractors lacked documented training on safe hot work practices.

Use Alternatives, Analyze the Hazards, Monitor the Atmosphere, Test the Area, Use Written Permits, Train Thoroughly, Supervise Contractors

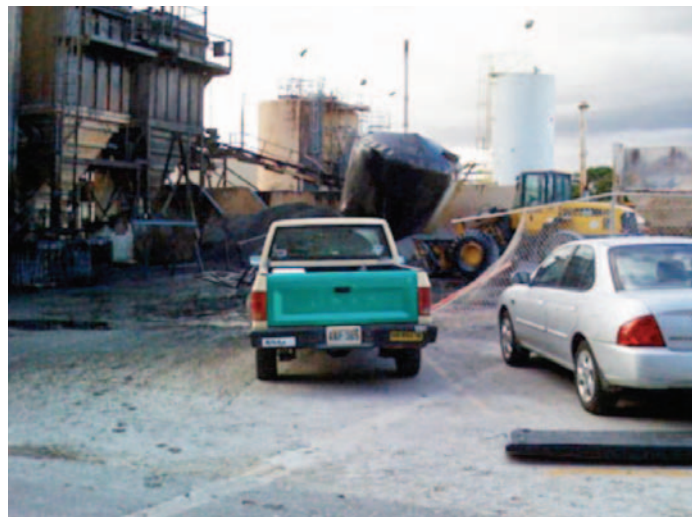
A contract welder was killed while welding on a catwalk located over a 9,300-gallon waste oil storage tank at the Philip Services Corporation (PSC). Following an investigation, the Honolulu Fire Department (HFD) concluded that, during the welding, sparks dropped in and around the vent area of the tank. The contents of the tank ignited, resulting in an explosion and fire. The force of the explosion hurled the contract welder about 120 feet, fatally injuring him. Three others were injured, and the tank was thrown about 30 feet.

According to the HFD investigation, a PSC official asserted that the contractors were not authorized to weld within the dike area surrounding the tank, a hot work permit had not been issued for the welding, and combustible gas monitoring was not conducted. Conversely, the contracting company's personnel asserted that they believed that the work was authorized and that PSC had conducted combustible gas monitoring prior to the welding activity.

View of Philip Services Corporation following a October 7, 2008, waste oil storage tank explosion.

Use Alternatives, Analyze the Hazards, Monitor the Atmosphere, Test the Area, Use Written Permits, Supervise Contractors

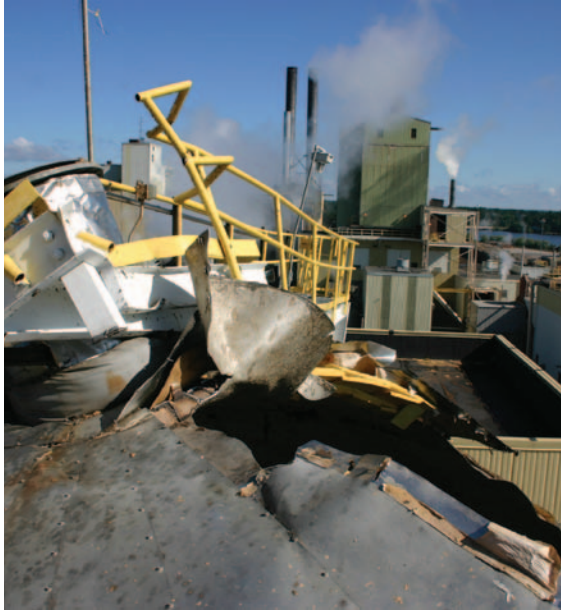
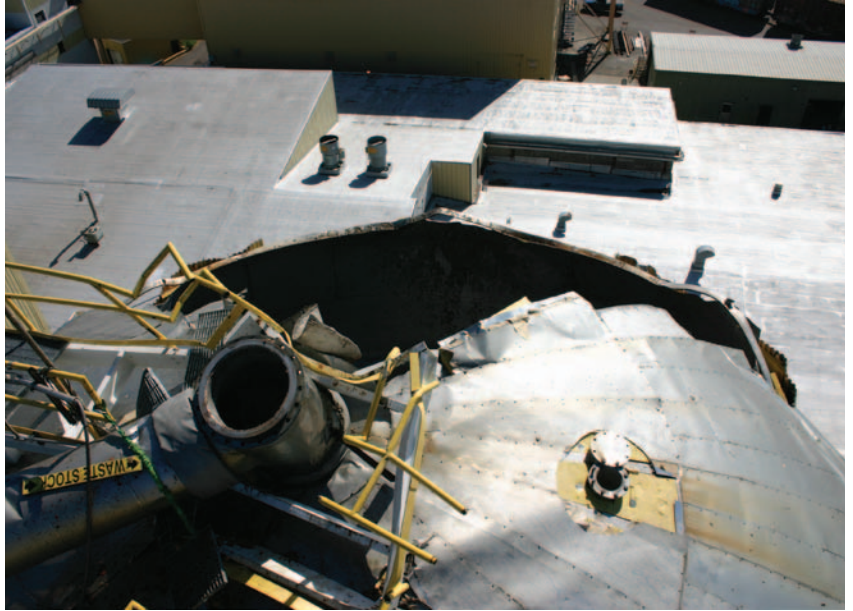
Views of the storage tank involved in the 2008 explosion at Packaging Corporation of America.

Three workers were killed in an explosion at the Packaging Corporation of America (PCA) fiberboard manufacturing facility while they were welding on a temporary metal clamp to stabilize a damaged flange connection. The flange was located on top of an 80-foot tall storage tank that contained recycled water and fiber waste.

Facility personnel were unaware of the potential presence of flammable gas from the decomposition of the organic material in the tank, and combustible gas monitoring was not typically required or performed prior to starting work. At the time of the accident, three workers were on a catwalk above the tank; one began welding the flange into place when sparks from the welding ignited flammable vapors inside the tank. The resulting explosion ripped open the tank lid, knocking two of the workers to the ground 80 feet below. All three workers died of traumatic injuries. A fourth worker, who had been observing the work from a distance, survived with minor injuries.

The CSB analysis of the tank contents determined that anaerobic bacteria had multiplied inside the tank and water recycle system over time, feeding on organic waste material. The bacteria likely produced hydrogen, a highly flammable gas, which ignited during the welding work. The CSB found that at the time of the incident, PCA supervisors and workers were unaware of the risks of flammable gas production from anaerobic bacteria growth. PCA did not perform a hazard analysis or recognize fiber waste tanks as potentially hazardous. Combustible gas monitoring was not required for the work.

Analyze the Hazards, Monitor the Atmosphere,
Test the Area

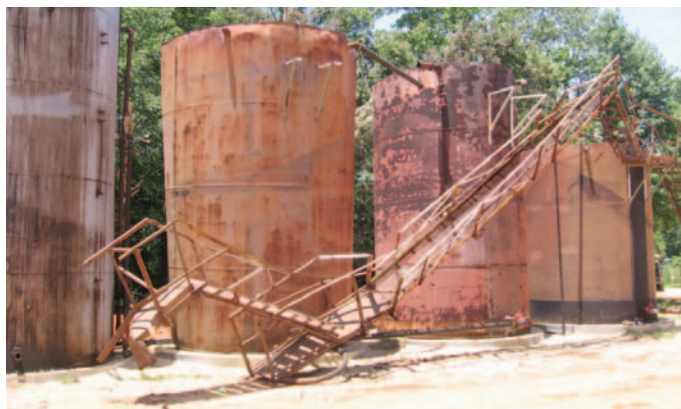
On June 5, 2006, contract workers were installing a new pipe between two oil tanks at a rural oilfield when sparks from a welding torch ignited flammable hydrocarbon vapor venting from one of the tanks. That tank and another nearby tank exploded, killing three workers who were standing above the tanks and seriously injuring a fourth. As in the MAR Oil accident, all of the tanks were interconnected by piping and one of the tanks contained crude oil, the source of the vapor that fueled the explosions.

The workers had not performed combustible gas monitoring prior to or during the hot work, instead relying on the unsafe and unreliable practice of using a lit torch to check one of the tanks for flammable vapor. Workers did not empty or isolate the tank that contained crude oil prior to initiating hot work activities.

Neither the contract company nor Partridge-Raleigh required written hot work permits. The contractor company did not provide hot work safety training to employees. Furthermore, Partridge-Raleigh did not have safety requirements for its oilfield contractors.

Tanks involved in the 2006 accident that killed three workers at the Partridge-Raleigh Oilfield.

Use Alternatives, Analyze the Hazards, Monitor the Atmosphere, Test the Area, Use Written Permits, Train Thoroughly, Supervise Contractors

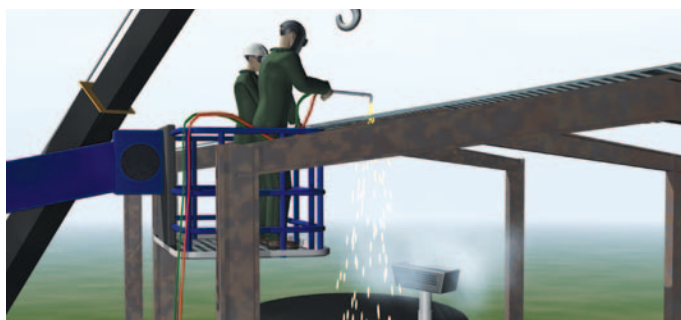
Depiction of hot work from the CSB's 2007 "Public Worker Safety" video illustrating the accident at Bethune Point.

Two workers were killed and another critically injured in an explosion involving a methanol storage tank at a municipal wastewater treatment facility in Daytona Beach, Florida. The explosion occurred while the three workers were cutting a metal roof located directly above the tank vent. Sparks showered from the cutting torch and ignited methanol vapor escaping from the vent, creating a fireball on top of the tank. A corroded and ineffective flame arrester¹⁵ on the vent allowed the fire to propagate through the device, igniting methanol vapors and air inside the tank, resulting in an explosion.

Daytona Beach public employees were not covered by OSHA standards, which is typical for local and state governments in a number of jurisdictions. The city had no formal permitting system for hot work or non-routine maintenance activities, and workers had not received any training on methanol hazards in the previous 10 years. Combustible gas monitoring was not performed or required.

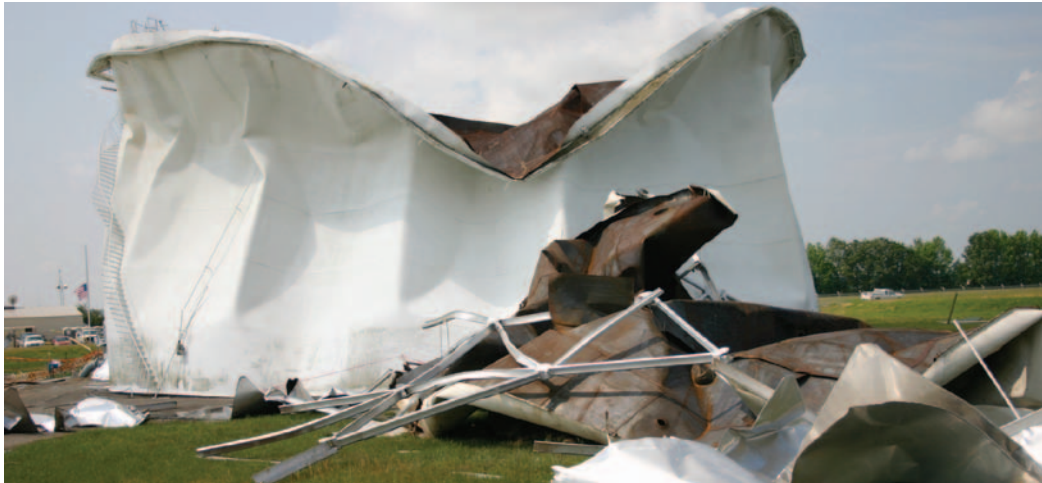
The gasoline storage tank at the TEPPCO McRae Terminal following the 2009 hot work accident that killed three workers.

Three contractors were using a cutting torch on top of the internal floating roof of a 67,000-barrel capacity gasoline storage tank at the TEPPCO Partners McRae Terminal when an internal explosion blew both the top of the floating roof and the secondary dome-shaped lid off the tank. All three were killed. The contractors were preparing to install a gauge pole. The gauge floats within the pole and measures the quantity of product within the tank. Part of the installation process involved cutting an opening into the floating roof for the pole to be inserted. The torch-cutting activity most likely ignited flammable vapor within the tank.

work permit to torch-cut the roof. The hot work permit indicated that gas testing occurred at 7:00 am, the start of the work shift. However, no documentation exists indicating that gas testing was conducted after the workers returned from lunch or when they started the hot work activities just prior to the explosion at approximately 2:30 pm. Work atmospheres can change rapidly; gas monitoring needs to be conducted immediately prior to and during hot work activities to ensure that workers are constantly aware of the potential development of an explosive atmosphere.

Analyze the Hazards, Monitor the Atmosphere,
Test the Area, Supervise Contractors

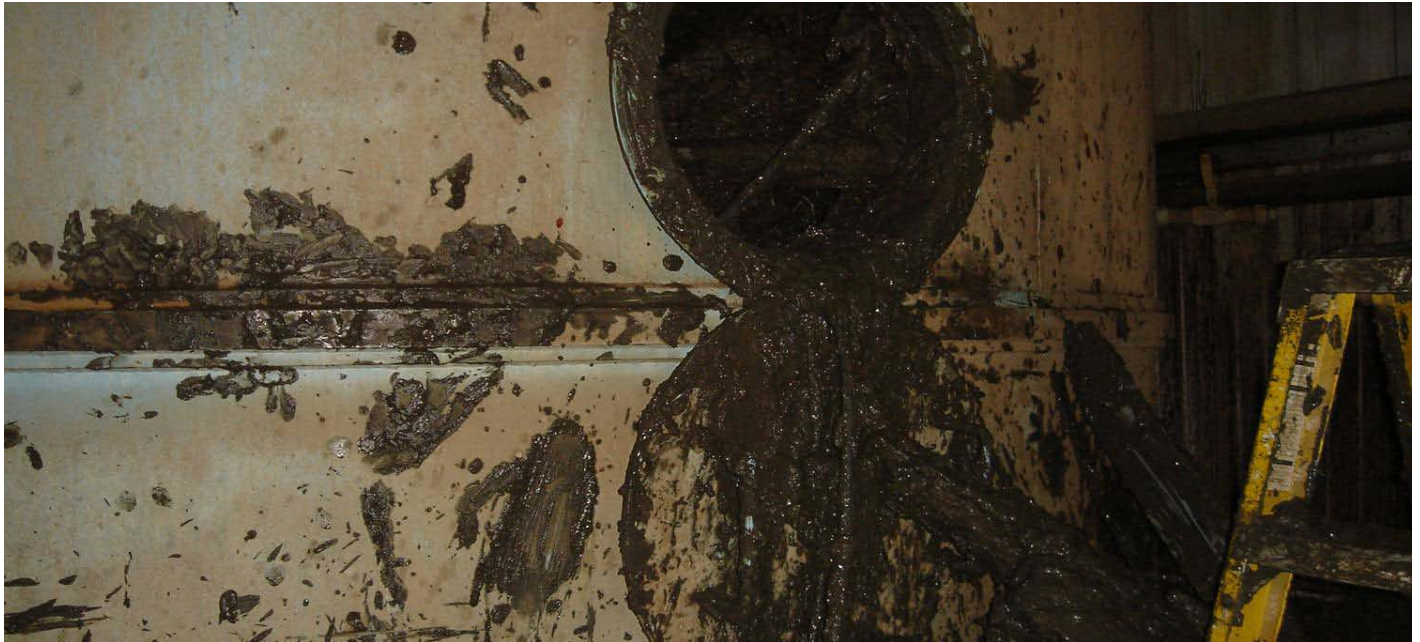
Potato-washing tank involved in the February 2009 accident at ConAgra Foods.

A welding contractor was killed while repairing a 1 ¼ by ½ inch crack on the bottom of a water clarifier tank at a ConAgra Foods facility. The 23-foot-tall tank was used to separate dirt and debris from wastewater in a potato-washing process area. The tank was open at the top and had a metal skirt around its cone-shaped base. While the welder was working inside the tank, an explosion occurred; the internal tank structures collapsed, resulting in his death.

The CSB determined that approximately 14 inches of debris-laden water had leaked through the crack in the tank and accumulated in the hidden space under the tank skirting. Examination of a sample of the liquid indicated that bacterial decomposition of the organic matter likely produced flammable gas, which was then ignited by the welding activity.

In this case, ConAgra personnel had tested for combustible gas inside the tank prior to the hot work, but only from the entrance of the tank and no flammable gas was detected. Monitoring for combustible gases was not conducted in the immediate area of the crack just prior to the initiation of the welding or in the adjacent space where flammable gas was present. Personnel were inadequately trained on the use of the specific combustible gas detector that was used and no hot work permit had been issued prior to commencing the welding.

Analyze the Hazards, Monitor the Atmosphere,
Test the Area, Use Written Permits, Train Thoroughly

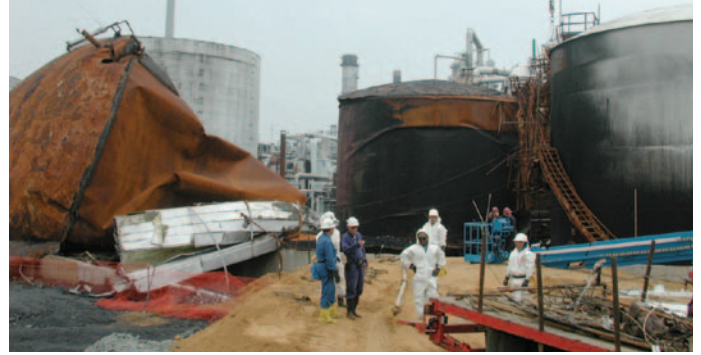
A massive explosion destroyed a large storage tank containing a mixture of sulfuric acid and flammable hydrocarbons at the Motiva Enterprises Delaware City Refinery. One contract worker was killed, eight others were injured, and sulfuric acid from collapsed and damaged tanks polluted the Delaware River. The explosion occurred during welding operations to repair a catwalk above the sulfuric acid tank, when flammable hydrocarbon vapor was ignited by welding sparks. This resulted in a powerful explosion inside the tank, which had holes in its roof and shell and a deficient inerting system.

On the day of the accident, combustible gas testing was performed only at the start of the hot work, but monitoring was not conducted for the duration of the hot work activities. Throughout the five hours between the last gas test and the explosion, the ambient temperature warmed by 14 degrees. This warming increased the evaporation of hydrocarbons inside the tank, and the resulting flammable vapor leaked out the tank's holes into the work area.

Motiva had a hot work program that included written permits, but the program was inadequate. Hot work was allowed near tanks that contained flammables including

A view of the flammable storage tank involved in the accident at the Motiva Refinery.

those that had known holes due to corrosion. Continuous atmospheric monitoring and the control of welding sparks were not required.

Use Alternatives, Analyze the Hazards, Monitor the Atmosphere, Test the Area, Supervise Contractors

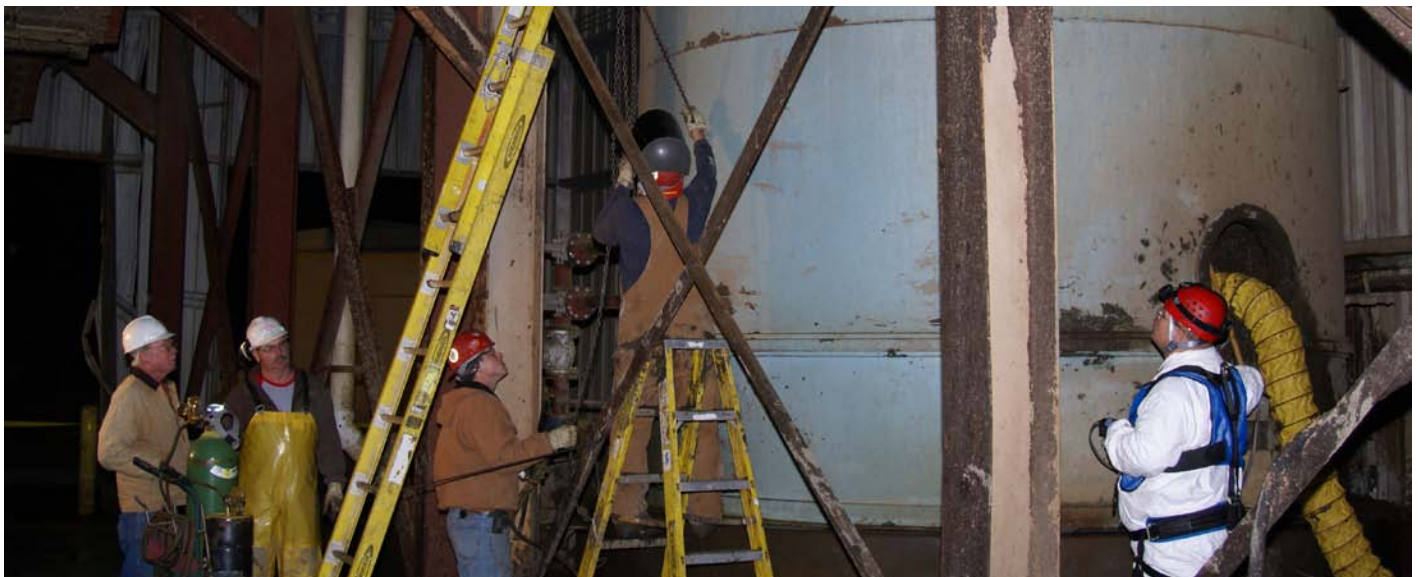
Rescue efforts following the February 16, 2009, hot work accident at ConAgra Foods in Boardman, Oregon.
