BETA LAB No.M10198- LS3 TOP	TESORO REFINING AND MARKETING COMPANY ANACORTES REFINERY 10200 W. MARCH POINT ROAD T91WA4428 ANACORTES, WA 98221	CUSTOMER P.O. No.: 4501667904
PART: 6600-E HEAT EXCHANGER LS 3 TOP PART 15		DATE: SEPTEMBER 20, 2010
PAGE 1 OF 53

**LABORATORY REPORT-LS3 TOP**

This report is the seventh of a series on the failed parts of the 6600E heat exchanger. The LS# and CS# refer to longitudinal and circumferential weld seams while the part number refers to the chain of custody number.

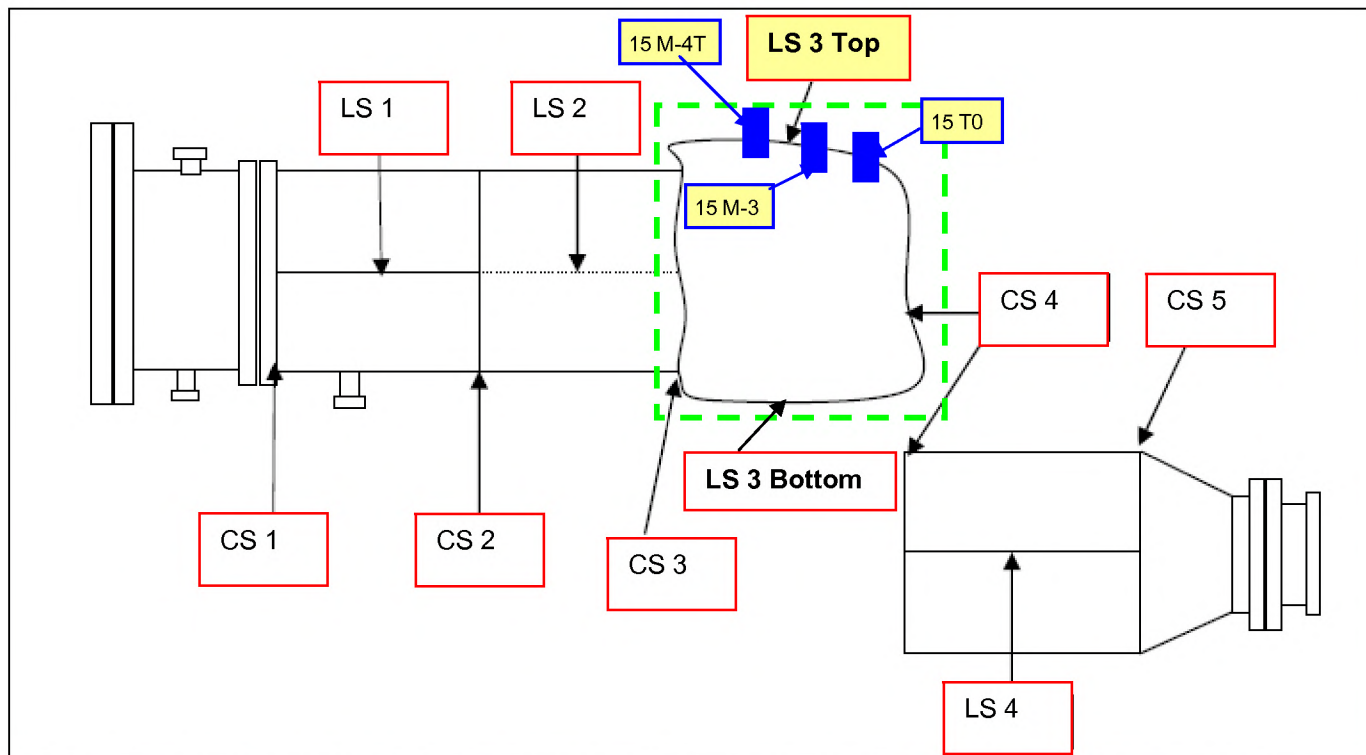
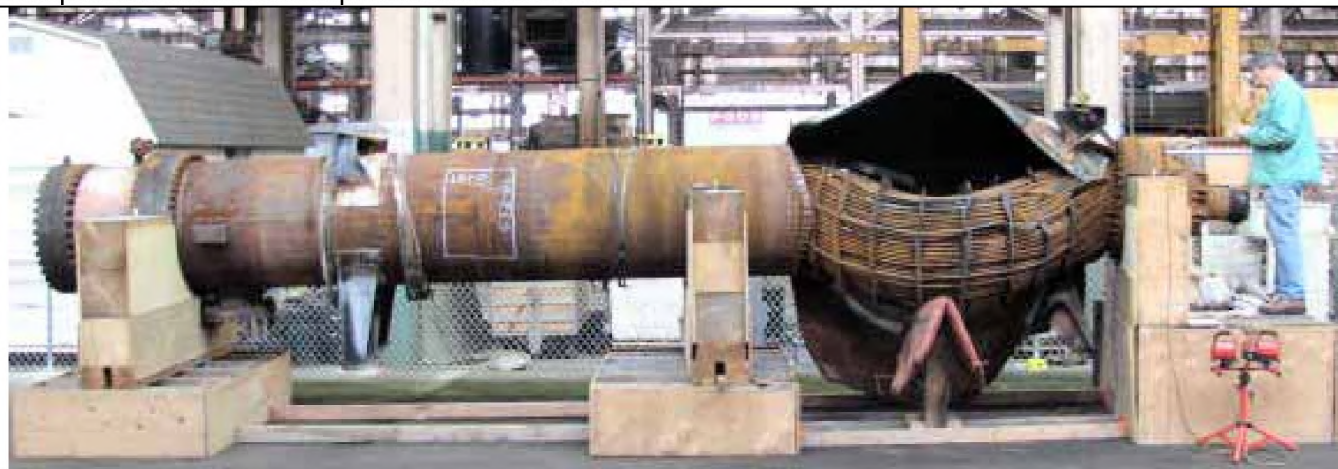
**Figure 1 Un-packed main heat exchanger**

Sketch of main heat exchanger Cans 1-3 and separated back head can 4. The approximate locations of the samples evaluated in this report are shown in blue.

Overall main heat exchanger with "fish mouth " rupture primarily along LS3 and CS4 as shown by green box above

**TEST RESULTS:** The heat exchanger weld seams had been previous labeled as shown in Figure 1 and the same labeling was used for this report.

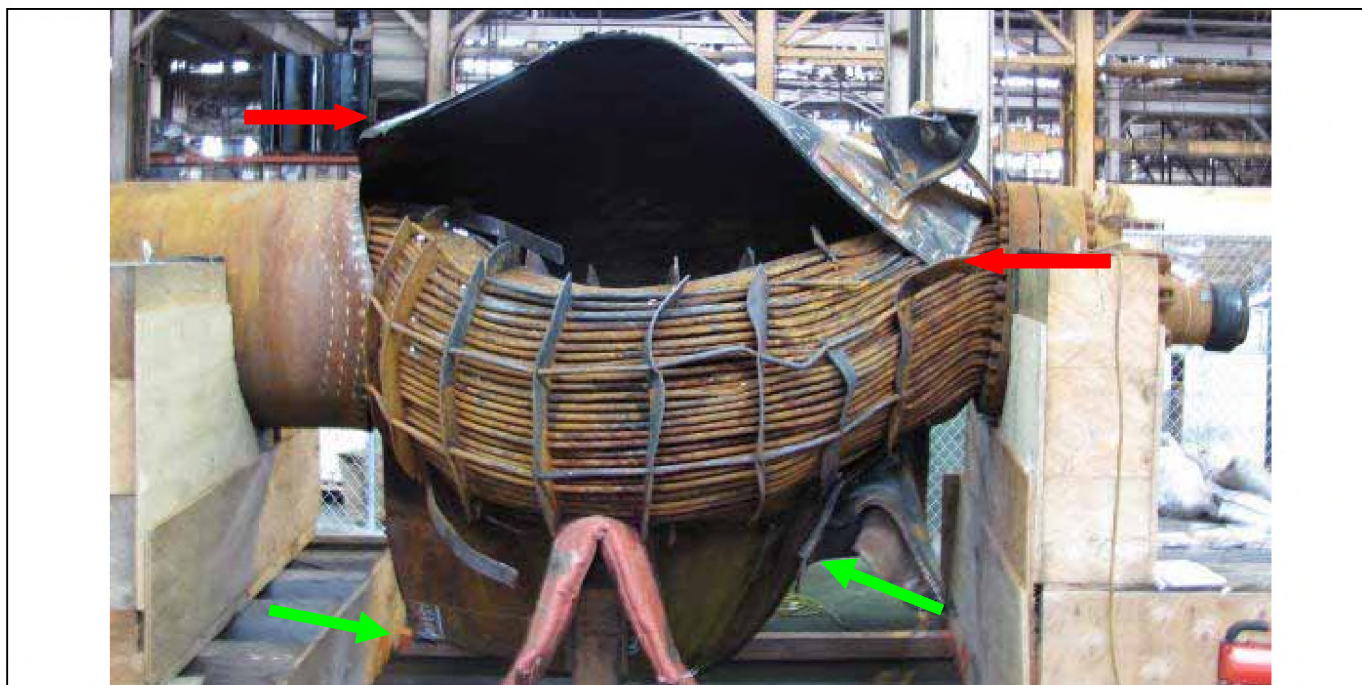
**Figure 2 Photo showing the fracture along LS3 where an approximate 6 inch wide portion was removed**

Fracture along LS3 seam between the green arrows for the bottom part of the fracture, and for the LS3 top – between the red arrows

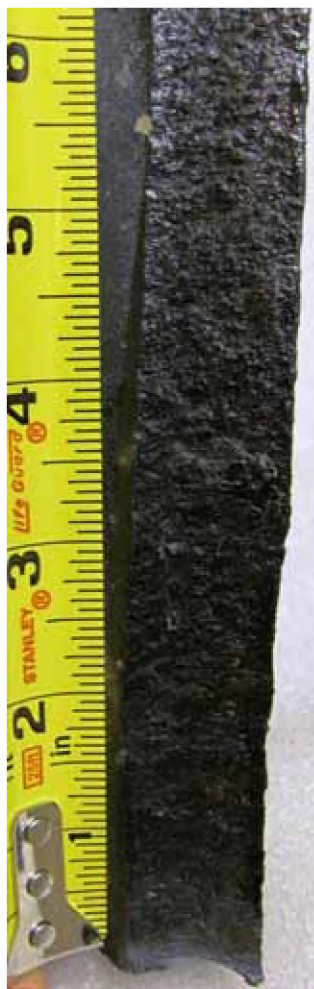
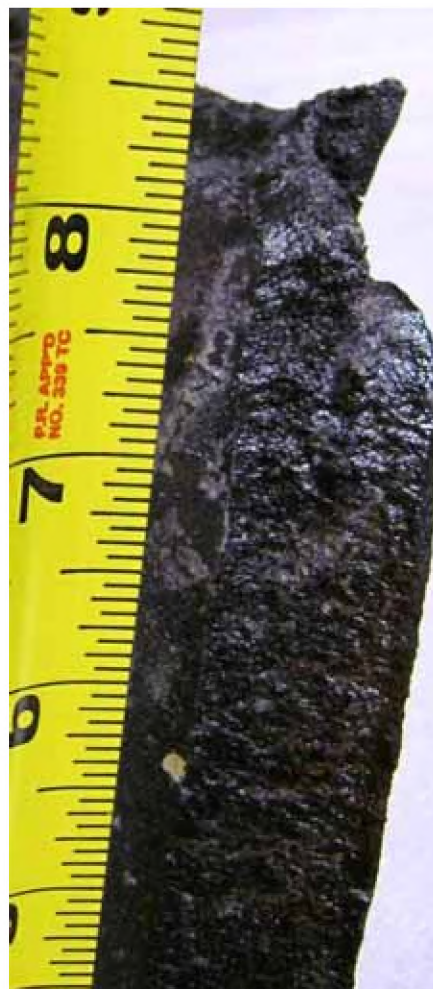
Figure 4. Fracture surfaces along the CS4 weld. ID is on the right.

Location V1

Location V2

The fracture surfaces were photographed and are shown on Figures 4 through 8. The thickness measurement results by micrometer are in Table 5. The magnetic particle test results (performed by others) are on Figures 9 through 13, the NDE Report is in Attachment 3.

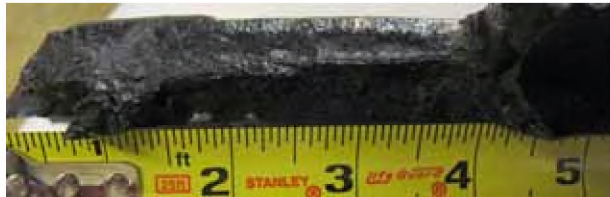
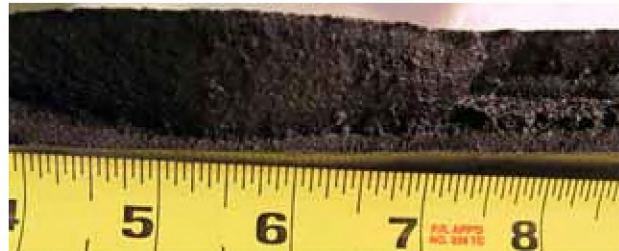
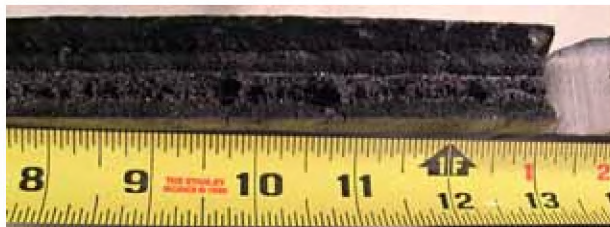
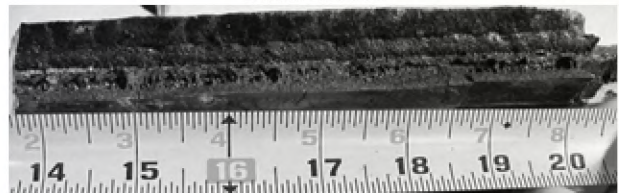
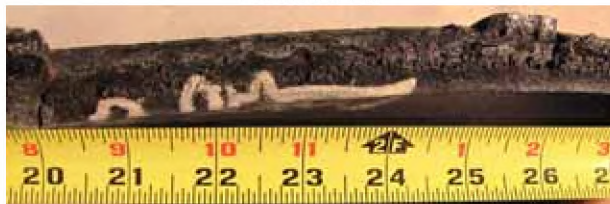
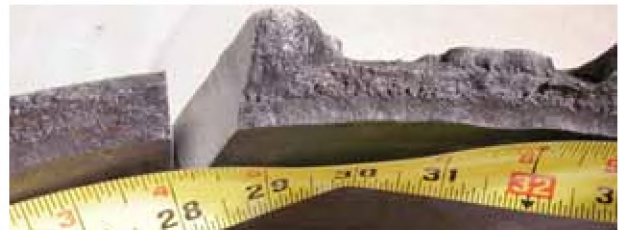
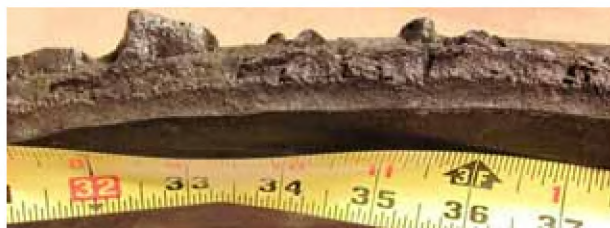
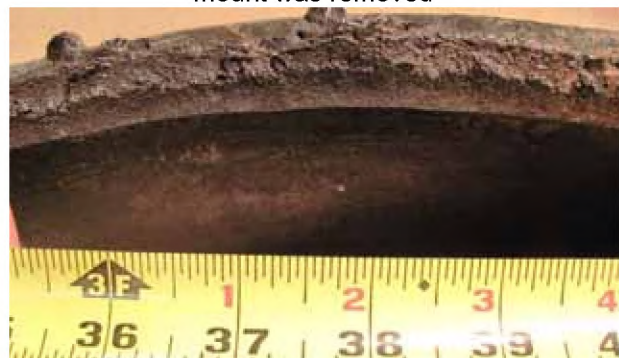
**Figure 5. Fracture surfaces along the LS3 weld. ID is on the bottom, where the measure tape is located.**

Location H6-cut is where the mate 14 M3 LS3 mount was removed

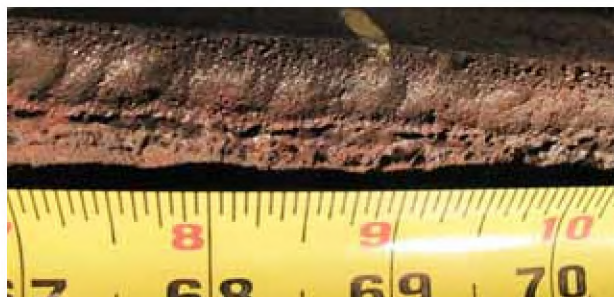
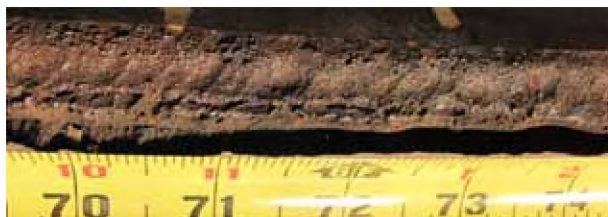
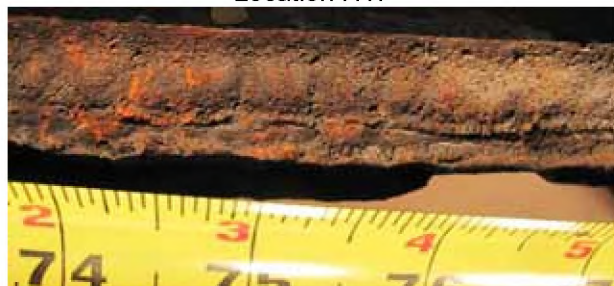
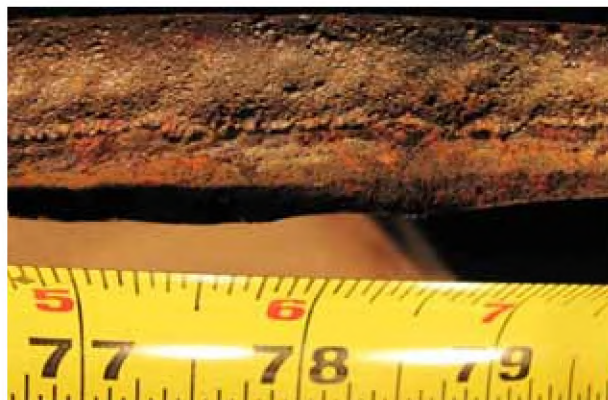
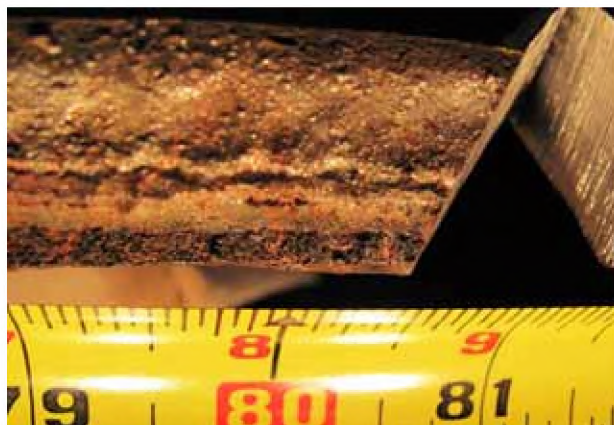
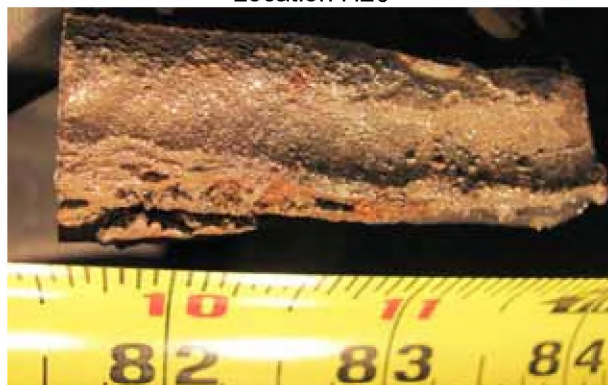
**Figure 7. Fracture surfaces along the LS3 weld. ID is on the bottom, where the measure tape is located.**

Location H21-cut is where the mate 14 M3 TO mount was removed
