Investigation Update

September 2024

This document provides an update on the CSB investigation of the May 30, 2024, incident at the TS USA Liquid Nitriding Facility in Chattanooga, Tennessee.

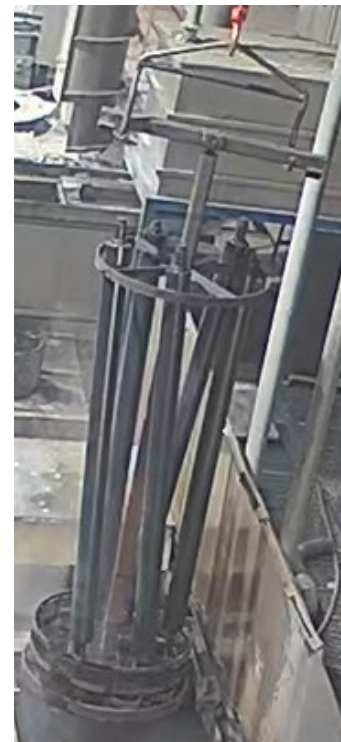
- On May 29, 2024, TS USA completed its liquid nitriding process to improve the wear resistance of five 316 stainless steel rollers (**Figure 1**) for a new customer.^b At the end of the work day, the rollers were left in the hot water rinse bath,^c which was a common practice at the facility.^d

Figure 1. Five rollers on a rack for treatment. (Credit: TS USA)

^b All five rollers were on one rack/figure during the nitriding process.

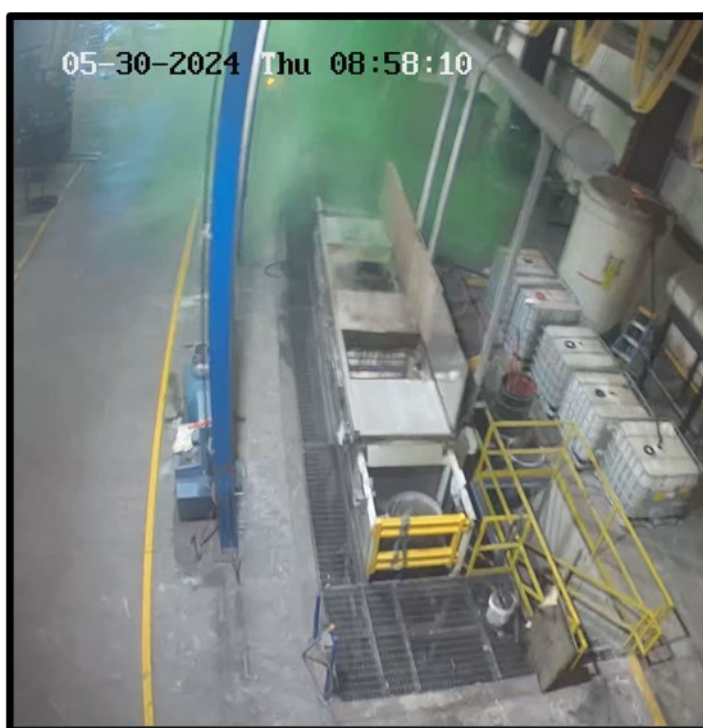
- Approximately 5 minutes later, at 8:46 a.m., the plant manager discussed the plan to rework the rollers with the line operator based on guidance from the process engineer. The operator was instructed to reintroduce the rollers back into the oxidizing bath without preheating.
- At 8:51 a.m., the operator lowered the rollers into the oxidizing bath. The rollers were submerged by 8:54 a.m.
- At 8:58 a.m., chemicals^a erupted from the oxidizing bath (**Figure 2**), releasing molten salt into the processing area.

Figure 2. Surveillance image showing the eruption of molten salt (Credit: TS USA)

- The released molten salt engulfed and fatally injured one employee.^b The ejected molten salt contacted various combustible materials, triggering multiple fires inside the building due to the molten salt exceeding the autoignition temperature^c of the ignited materials.

^a While sodium nitrate and sodium hydroxide are crystalline, white solids at room temperature, the molten mixture is bright green.
