Safety Bulletin

U.S. Chemical Safety and Hazard Investigation Board

No. 2005-05-B | June 2006

FIRE AT PRAXAIR ST. LOUIS

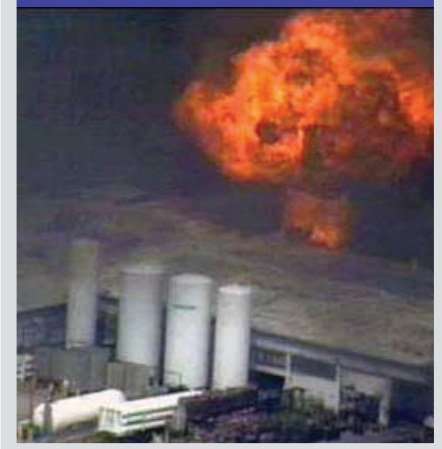
Figure 1. Fire at Praxair St. Louis

- ***A small fire from one propylene cylinder spread to others and then to propane and acetylene cylinders. Exploding cylinders flew up to 800 feet, damaged property, and started fires in the community.***

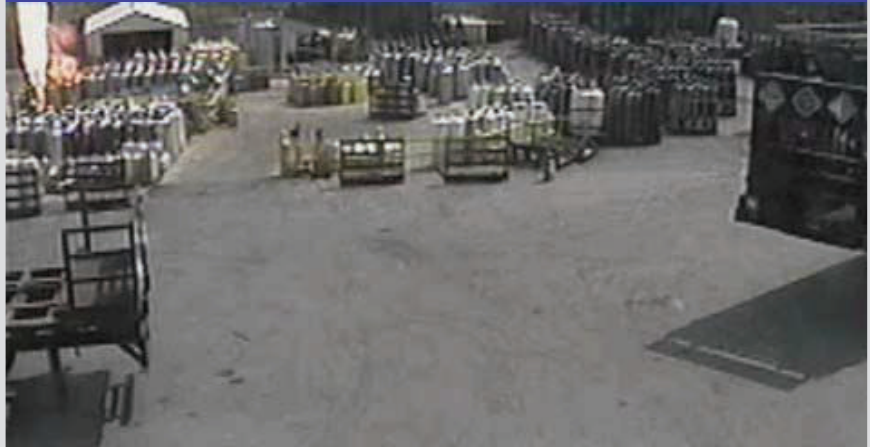
Figure 3. Initiating Event (from Praxair security camera)

afternoon; however, about 3:20 pm, a technician retrieving cylinders from an outside storage area saw a ten-foot high flame coming from a cylinder (Figure 3) and activated the fire alarm. Security camera video from the facility shows the release and ignition of gas from a cylinder in the propylene return area.

- Direct sunlight and radiant heat from asphalt paving heated returned propylene cylinders;
- High ambient temperature limited natural air-cooling of the cylinders;
- The returned cylinders, containing less gas than full cylinders, heated at a faster rate than full cylinders;
- As the cylinder wall temperatures rose, the internal pressures increased causing the relief device on a cylinder valve to open and vent propylene;
- The venting propylene ignited (most likely from a static discharge) at about 3:20 pm;
- An adjacent cylinder, further heated by the fire, released propylene, and caught fire;
- An employee saw the fire and activated the fire alarm;

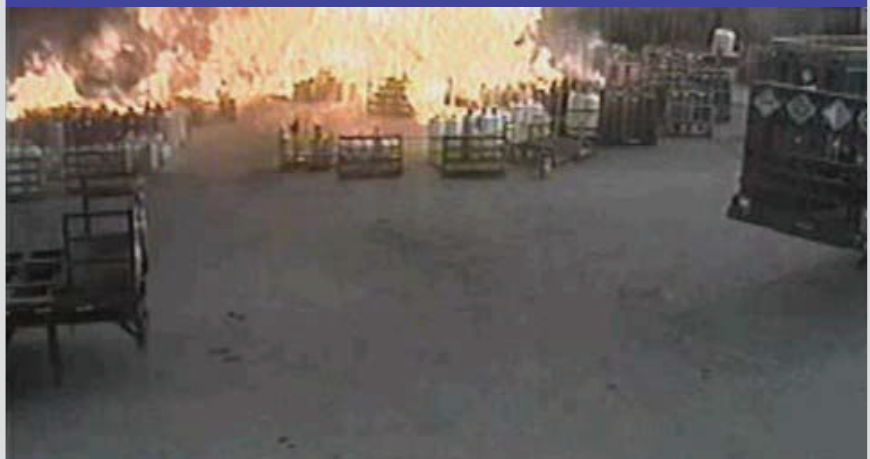
Figure 4. Spreading Fire (three minutes after ignition)

As workers and customers evacuated, the fire spread to adjacent cylinders. Security camera video shows nearby cylinders igniting in the first minute. At 2 minutes, cylinders begin exploding, flying into other areas of the facility, and spreading the fire (Figure 4). After 4 minutes, the fire covers most of the facility's flammable gas cylinder area and explosions are frequent.

- All 22 employees and two customers evacuated;
- The growing fire heated additional cylinders, which released more propylene into the fire;
- The fire's intensity continued to raise cylinder temperatures, softening the steel and rupturing the cylinders;

- The fire spread to a group of acetylene cylinders;
- The liquefied petroleum gas⁴ (LPG) area of the facility became fully involved in the fire;
- Ruptured cylinders (acetylene, propane, and propylene) rocketed into the community, damaging buildings and starting several vehicle fires;⁵

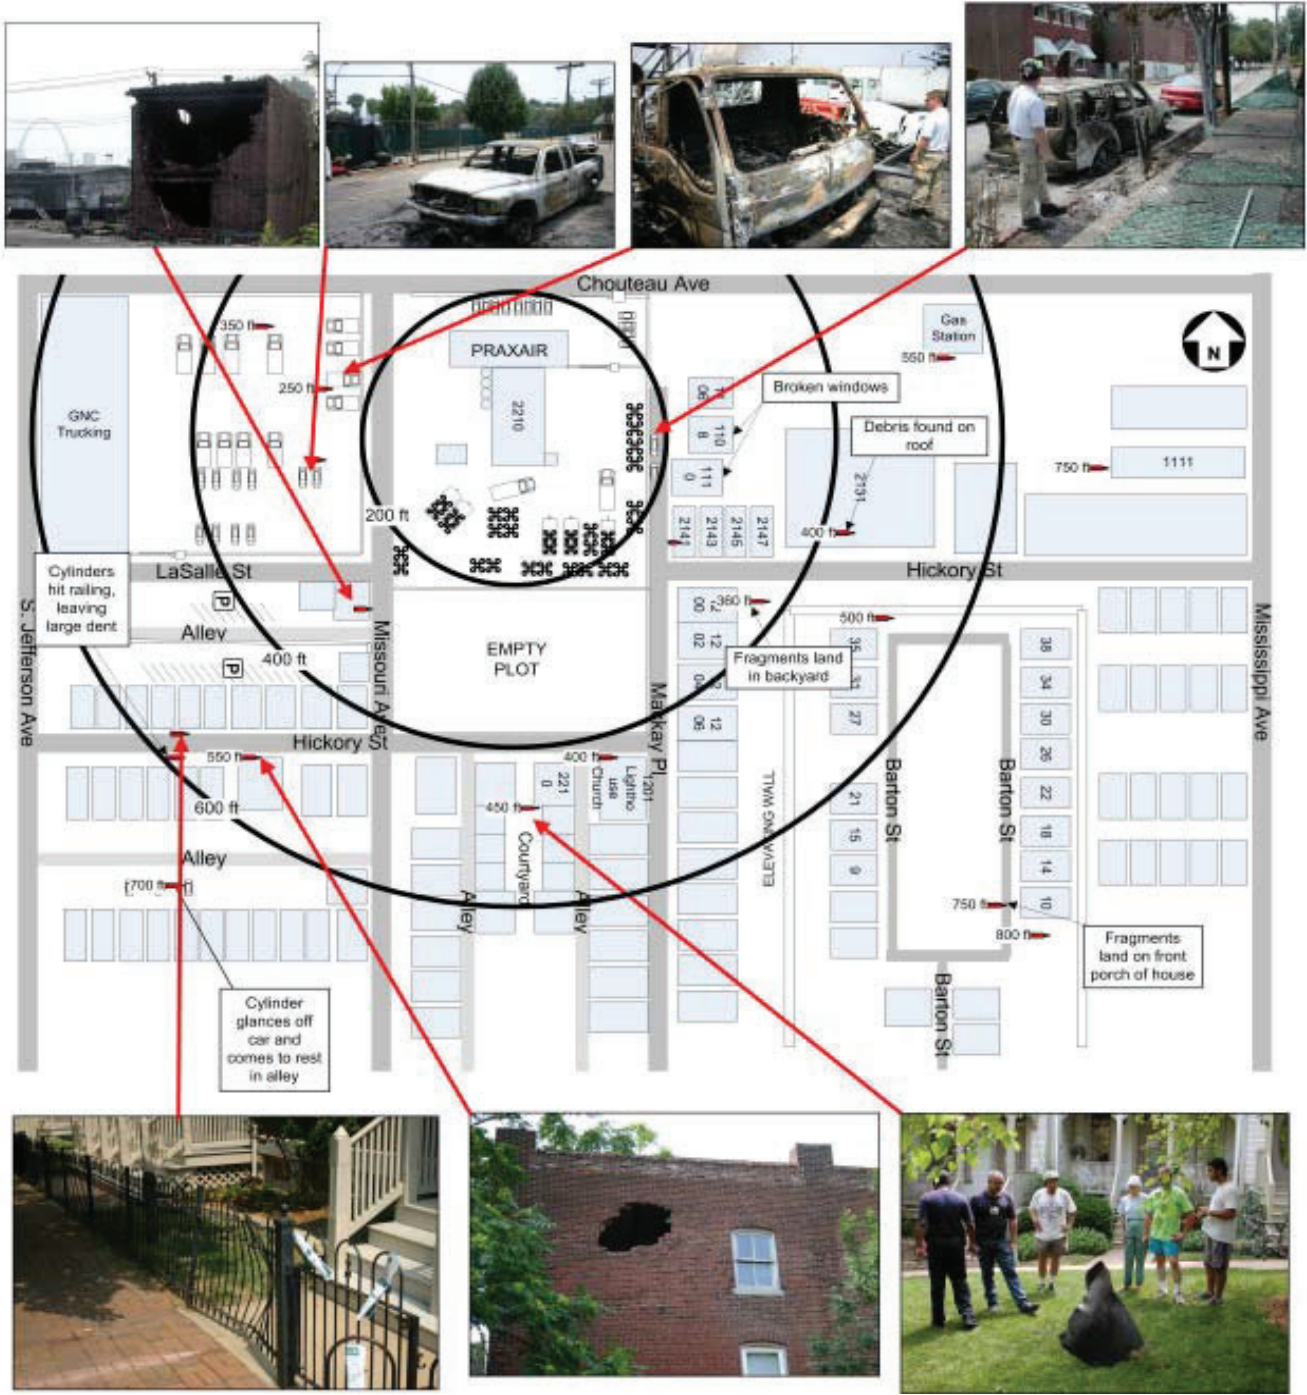
Figure 5. Community Impact

Dozens of cylinders and cylinder parts were propelled into the community and were found on sidewalks, front yards, backyards, courtyards, parking lots, and under cars. Damage included a burned-

out empty commercial building, fire-damaged cars, a three-foot hole in the wall of one residential building, broken windows, and other destruction to residential and commercial buildings. Cylinder parts traveled as far as 800 feet from the area of the explosions (Figure 5). The fire plume spread asbestos¹ from ruptured acetylene cylinders over a 1/3-mile wide and 1-mile long area.²

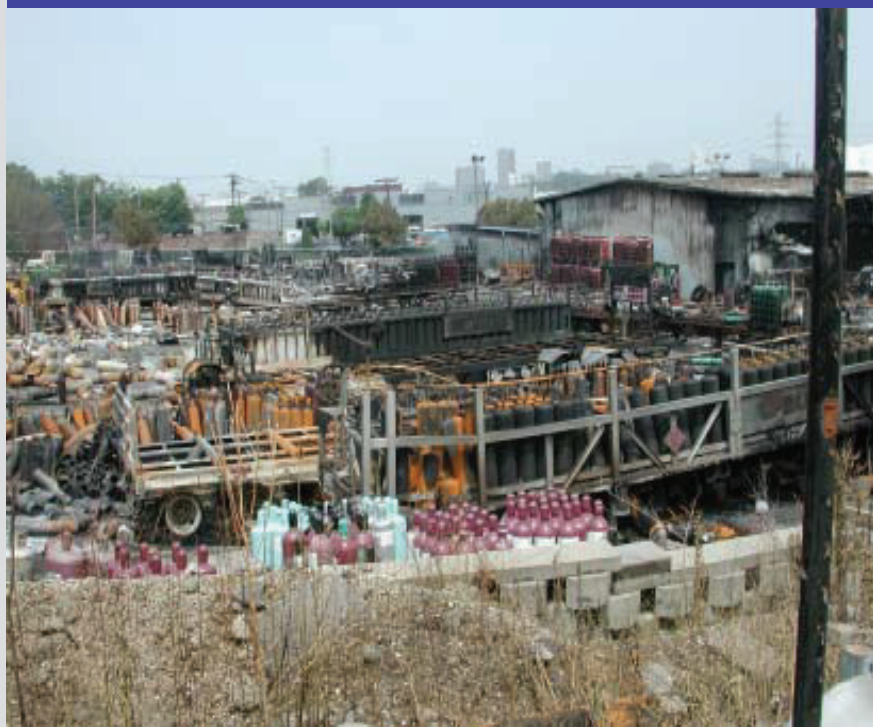
Figure 6. Facility Damage

While the facility was damaged extensively by fire and water, 22 employees and two customers evacuated safely in accordance with Praxair's procedures. A corner of the main production building and store area was heavily fire-damaged. Inside, the office and store areas were water- and smoke-damaged. In all, the fire consumed nearly the entire inventory of flammable gas, or about 8,000 cylinders (Figure 6).

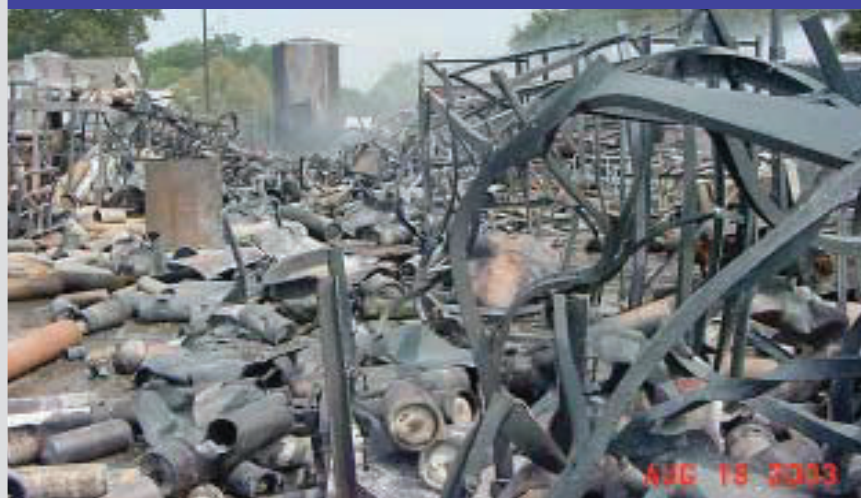
Figure 7. Tulsa Damage

On August 18, 2003 air temperatures reached 100°F (37°C) in Tulsa, Oklahoma. At about 4:30 pm, a vapor cloud of propylene that had formed around cylinders in the yard ignited, spreading fire around the Airgas gas distribution plant. As in the St Louis incident, cylinders exploded and flew into the community, damaging cars and homes (see Figure 7). Tulsa Fire Department investigators

concluded that although the official cause is undetermined, the most likely cause was “propylene venting due to the prolonged exposure to excessive heat.”

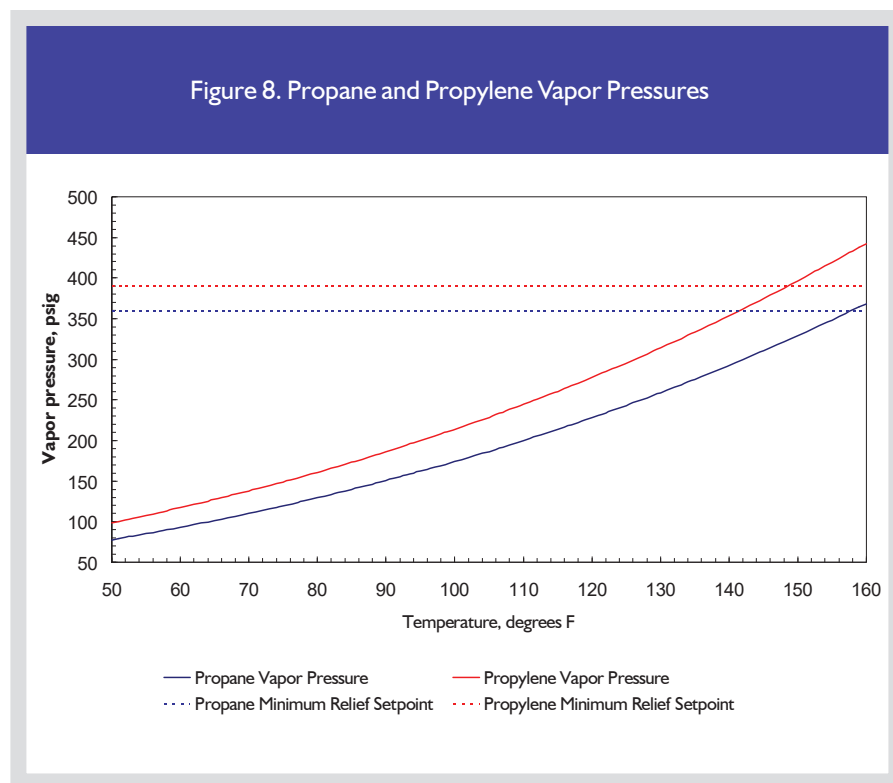
Figure 8. Propane and Propylene Vapor Pressures

Propylene and propane cylinders are manufactured to U. S. Department of Transportation (DOT) standards.¹⁰ The DOT standards require that each cylinder be equipped with a pressure relief device that meets the requirements of Compressed Gas Association, Inc. (CGA) Pamphlet S-1.1, “Pressure Relief Device Standards – Part 1 – Cylinders for Compressed Gases, 2001, Ninth Edition.”¹¹ CGA Pamphlet S-1.1 specifies a CG-7 type relief valve for both propylene and propane cylinders. Pamphlet S-1.1 also specifies the set point of the relief valve. Figure 8 shows the vapor

pressure curves and minimum relief valve setpoints for propylene and propane.

Although the performance of the CG-7 relief valves appears to be similar for propylene and propane, spontaneous releases leading to large facility fires have occurred primarily with propylene even though about 1,000 times more propane cylinders are in service than propylene cylinders. The propylene fires can be attributed to the greater margin provided in standard propane cylinders between the vapor pressure of propane and the minimum set pressure of the relief valve. Table 1 lists the temperature for various pressures in both propylene and propane cylinders.

As Table 1 shows, propylene relief valves may open at lower temperatures than propane.

Revise CGA standards for the CG-7 relief valves used in propylene service to require:

- 1) a greater margin between vapor pressure and relief valve setpoint (similar to propane); and
- 2) that valves be capable of multiple operations within the specified setpoint tolerance or be furnished with an indicator that alerts users that the valve has operated.
