Chemical Decomposition, Fire, and Toxic Gas Release at Bio-Lab, Inc.

CSB Public Business Meeting
January 23, 2025

U.S. Chemical Safety and
Hazard Investigation Board

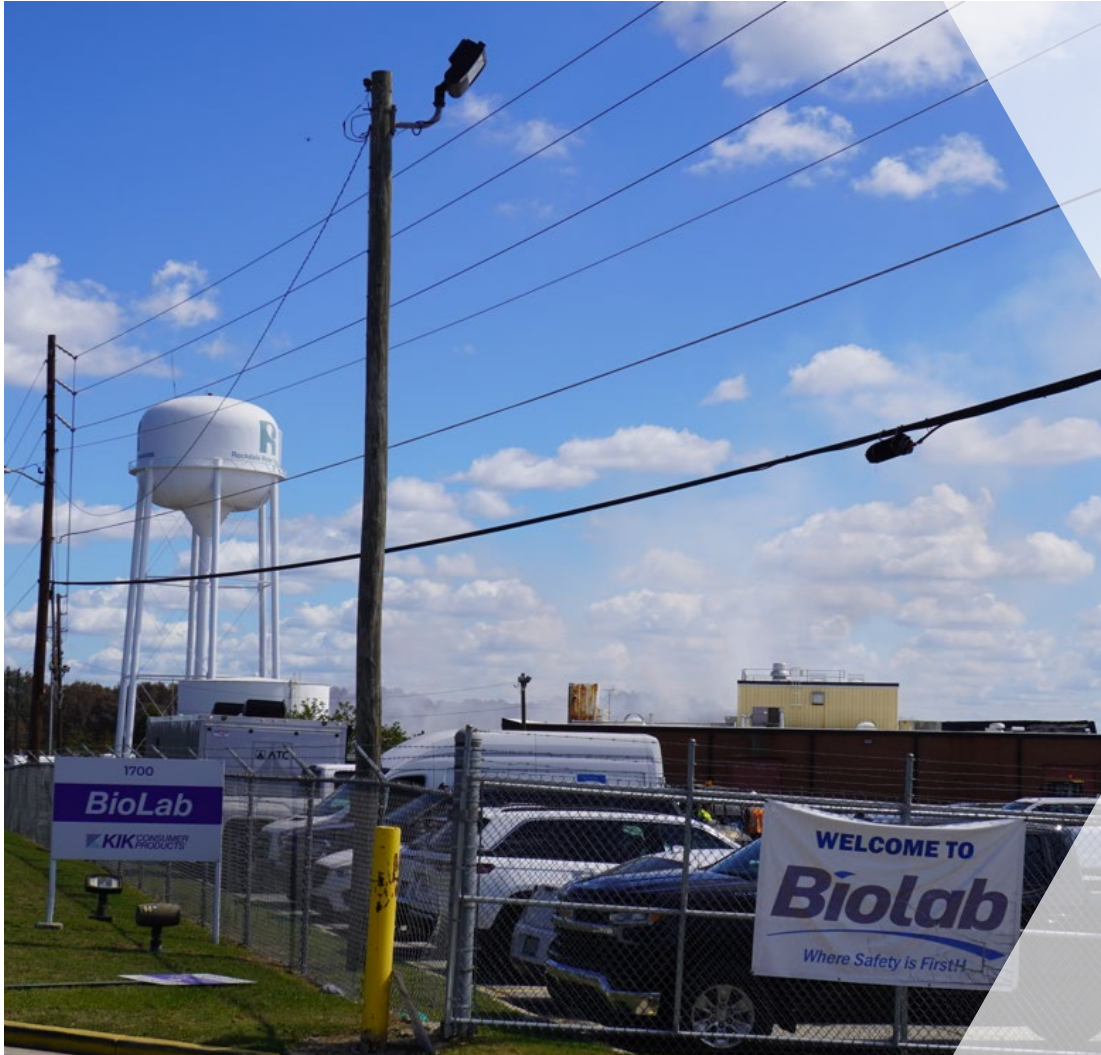
- Bio-Lab Conyers is in Conyers, Georgia (Rockdale County)
- Has been in operation since 1973 and employs ~241 full-time employees
- Converts raw materials and packages finished recreational water care consumer products for retail sale
- Operates several production facilities and storage warehouses
 - A bulk chemical storage warehouse (Plant 12) was involved in the incident on September 29, 2024. Raw and packaging materials were also stored in Plant 12.

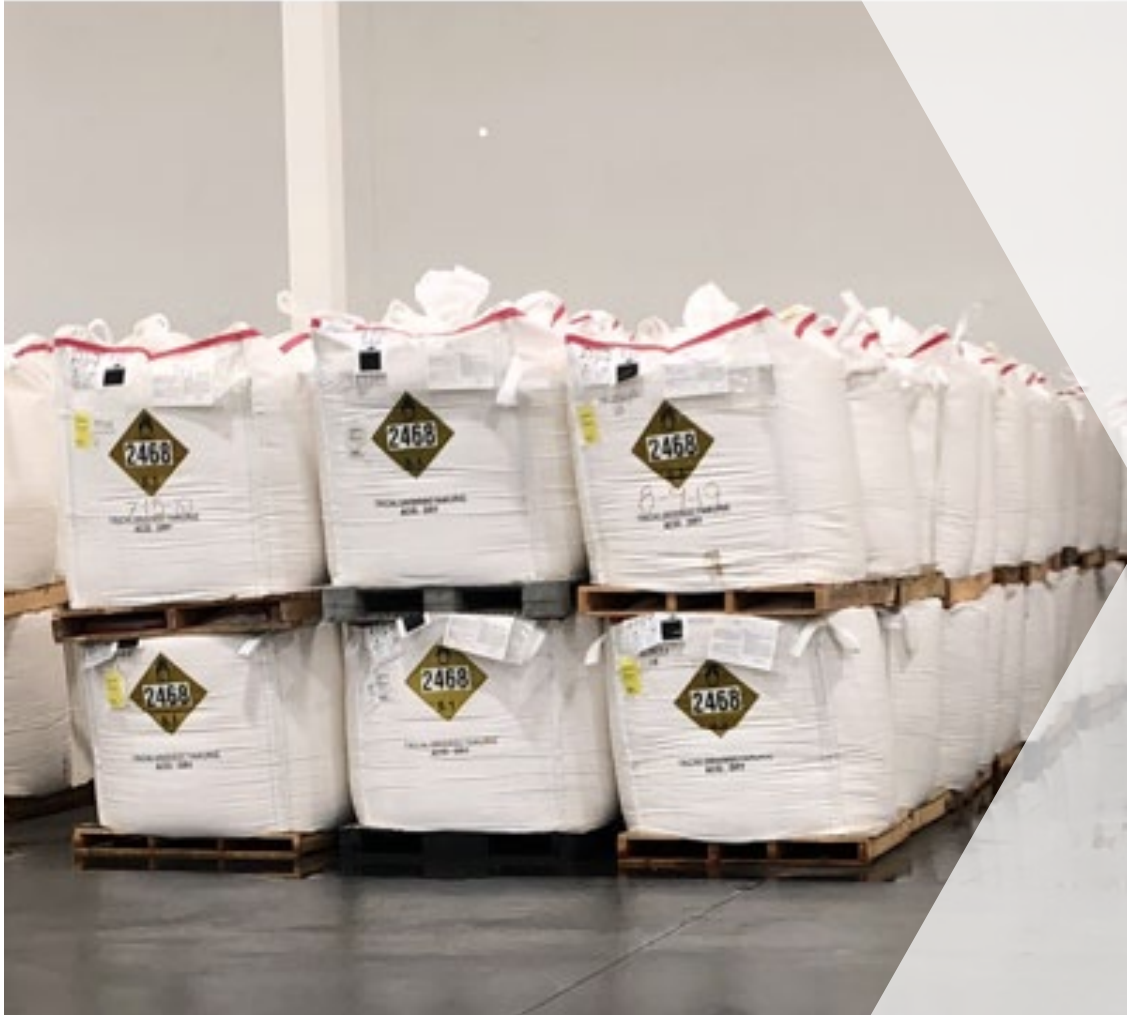
Bio-Lab, Inc. Conyers Background Cont.

- Per Bio-Lab, Plant 12 stored super sacks containing multiple solid oxidizers in granular form, that have a chlorine odor, including:
 - 99% trichloroisocyanuric acid,
 - 99% sodium dichloroisocyanurate, and
 - Bromochloro-5,5-dimethylimidazolidine-2,4-dione
- These bulk solid oxidizers can release toxic and corrosive products upon decomposition
- Bio-Lab had established a permanent fire watch a few months before the incident after detecting strong odors in storage buildings to mitigate any potential product decomposition events

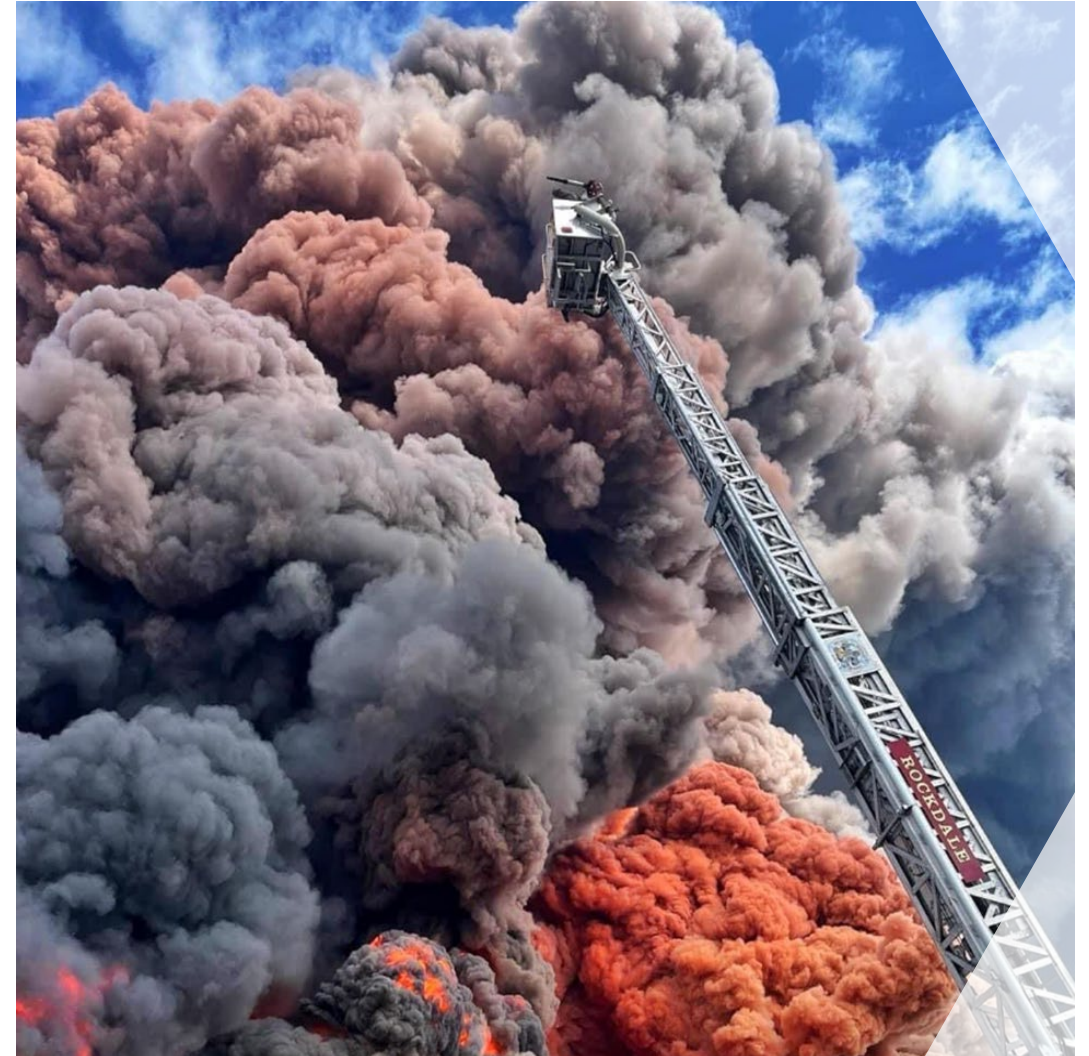
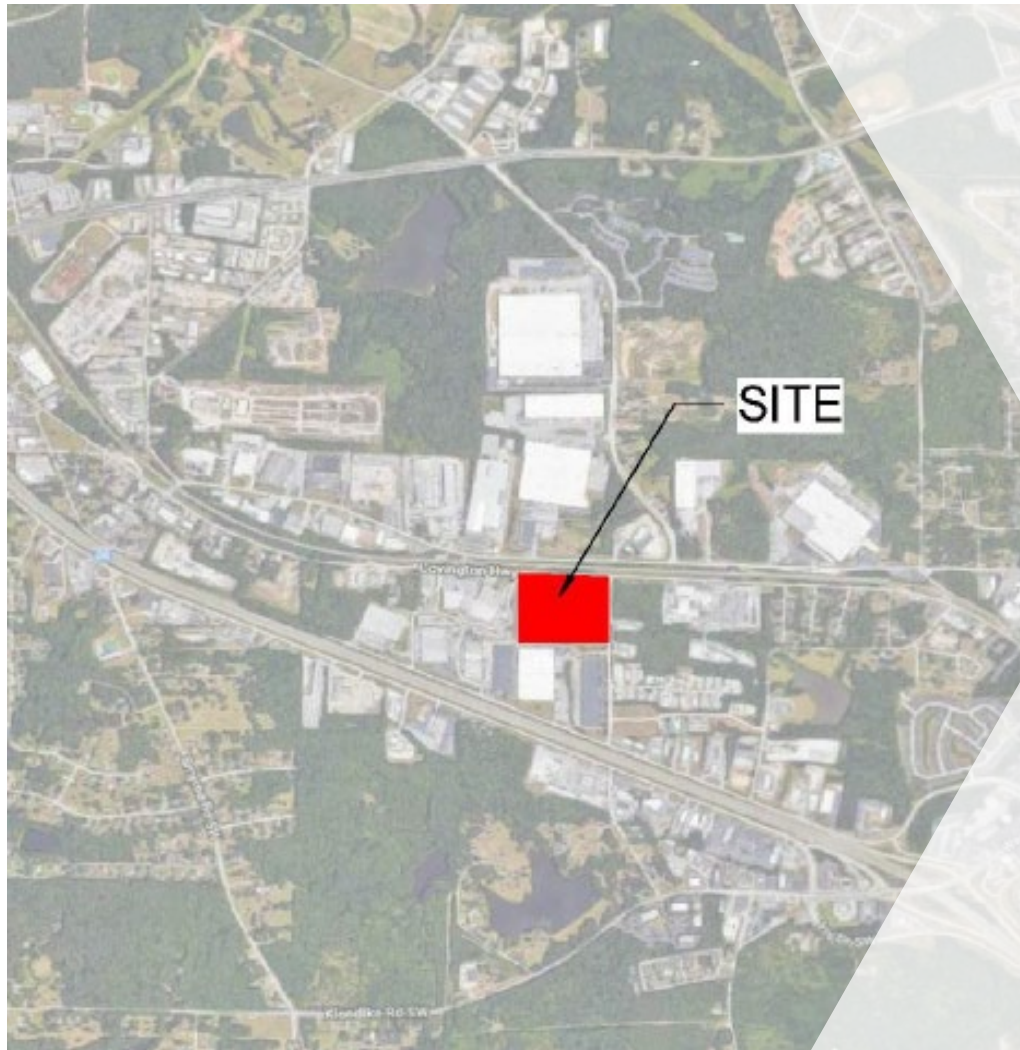
Bio-Lab, Inc. Conyers Incident Overview

- The morning of September 29, 2024, a chemical reaction occurred inside Plant 12 involving bulk materials stored inside, which resulted in product decomposition, the generation of excessive heat, multiple fires, extensive off-gassing, and a massive plume of potentially toxic smoke
 - Shelter-in-place orders issued
 - Final shelter-in-place warning expired several weeks after the incident on October 17
 - Mandatory evacuations
 - Interstate I-20 closed for ~19 hours; other smaller roads closed longer
 - Smog or haze with a chlorine smell drifted in parts of the metropolitan area
 - Plant 12 warehouse completely destroyed
 - No injuries were reported at the site during the incident or in the subsequent emergency response that followed
- Site remediation and clean-up activities continue
