# CASE STUDY

## Uncontrolled Oleum Release Petrolia, Pennsylvania (Three towns evacuated)

2009-01-I-PA  
September 2009

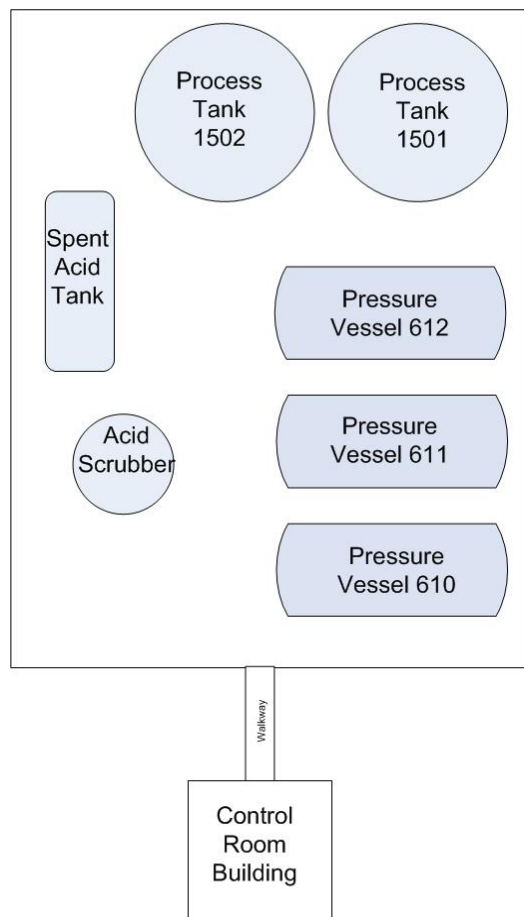
**Figure 2. Oleum storage and control room buildings**

The oleum storage building, containing three horizontal pressure vessels and two vertical process tanks (Figure 2), is located near the center of the facility. Operators use air pressure to transfer oleum from railcars into the pressure vessels, each of which can hold the contents of two full railcars. Operators

then pump oleum from the pressure vessels to either of the process tanks. While the manufacturing process operates, oleum flows continuously from the process tanks to the resorcinol production unit.

The operator began pumping oleum to a process tank from vessel 611 using the normal power supply and from vessel 610 simultaneously using the emergency power supply. When vessel 610 ran empty, the operator began pumping from vessel 612 (Figure 2) using the emergency power supply.

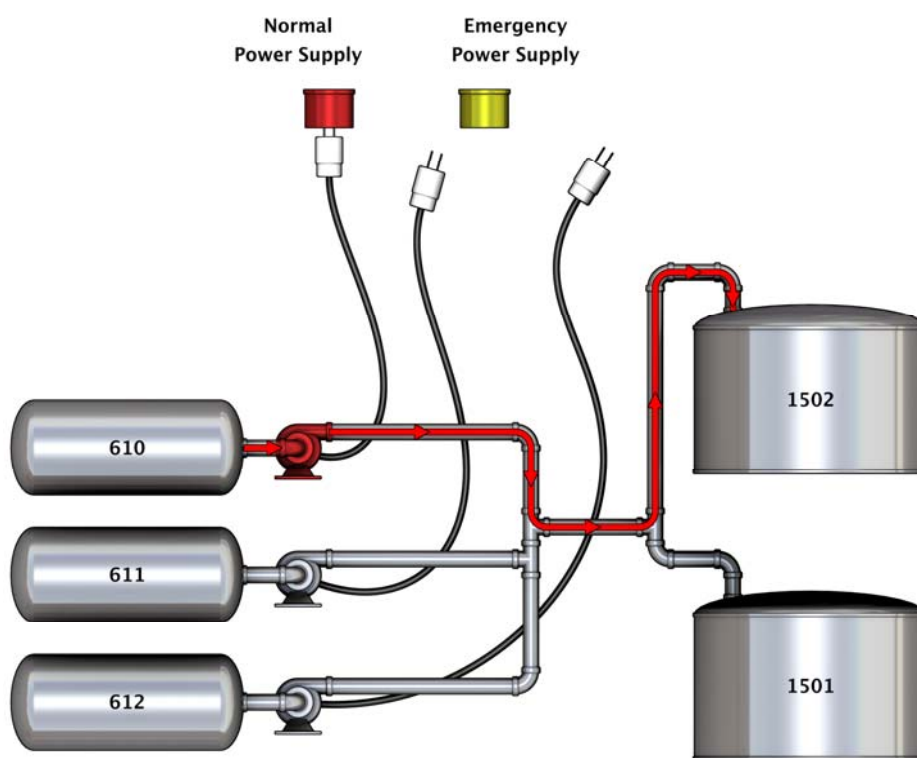
Figure 3. Normal power configuration

To pump oleum from a pressure vessel to a process tank, an operator plugs a pump power cord into a power supply (Figure 3). Each of the three pressure vessels has a dedicated transfer pump with a power cord and plug. While there are three power cords and plugs, there is only one (normal) power supply receptacle. The operator plugs the power cord into the normal receptacle in the oleum storage building and starts the pump using the DCS console in the adjacent control room. When transfer is complete, the operator stops the pump on the DCS console and returns to the oleum storage building to unplug the power cord.

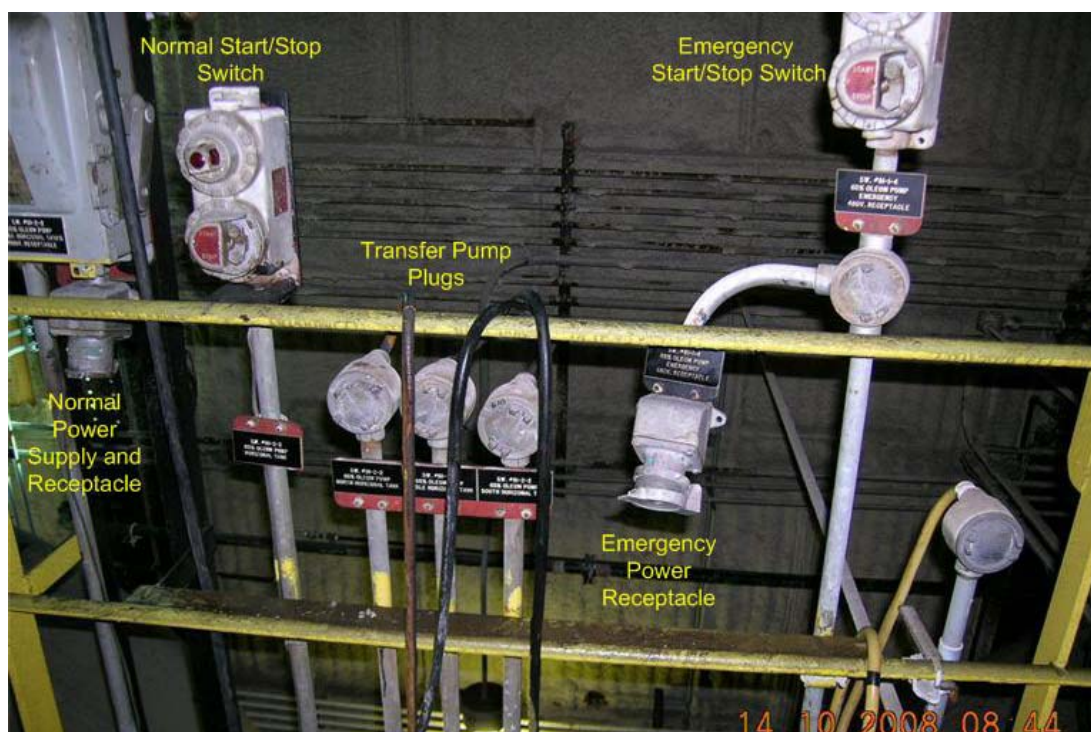
Figure 4. Power supply arrangement

Figure 4 shows the power supply arrangement on the day of the incident.

Prior to 1980, equipment failures in the oleum storage building affecting the normal power supply interrupted facility operations. Former and current employees stated that power-supply repair parts were difficult to obtain; thus, to minimize production interruptions, the facility<sup>10</sup> temporarily wired an emergency power supply with a separate switch and receptacle. A former operator told the CSB that at the time of this installation, a former supervisor verbally instructed operators to use the emergency power supply to transfer oleum from the pressure vessels to the process tanks. However, the emergency power supply did not incorporate the safety features of the normal power supply. The automatic shutoff that was tied to a high-high level switch<sup>11</sup> in the process tanks would not stop a pump powered by the emergency power supply. Therefore, the former supervisor cautioned operators to monitor these transfers closely to prevent overfilling.

Over the nearly 28 years since its installation, the emergency power supply arrangement remained functionally unchanged. The facility did not document the original intent of the emergency power supply in plant drawings<sup>12</sup> or procedures. Post-incident, the current managers, supervisors, and engineers told the CSB that they did not know of the original intent of the emergency power supply or its use in oleum transfer to the process tanks.<sup>13</sup> At the time of the incident, operators routinely used the emergency power supply on weekends—when supervisors, managers, and engineers were generally not in the facility—to transfer oleum from the pressure vessels to the process tanks.

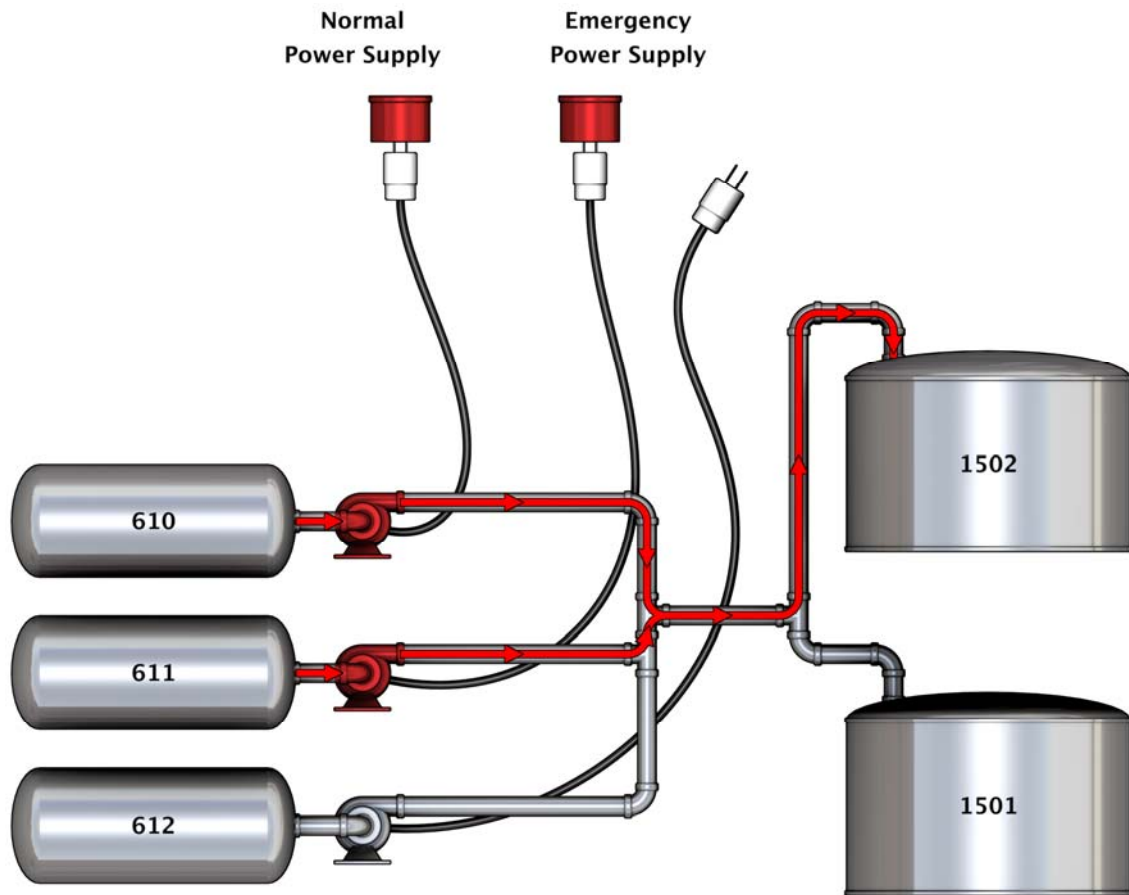
Figure 5. Weekend power configuration

they also transfer oleum from the pressure vessels to the process tanks. Up to and including the day of the incident, operators used two transfer pumps (one connected to the normal power supply and the second to the emergency power supply) on weekends to transfer as much oleum as possible during the 2.5 hours (Figure 5).

Operators transferred oleum on the weekends to improve the efficiency of oleum unloading operations on Monday. Operators stated that having at least one pressure vessel empty on Monday morning allowed the incoming oleum storage operator to begin immediately filling the pressure vessel from rail cars. Without room in the pressure vessels on Monday morning, the operator would first need to transfer oleum to the process tanks, delaying the railcar unloading. The emergency power supply eventually came to be used only on weekends, when additional oleum transfer could be accomplished in advance of the normal workweek. This proactive transfer and emptying of the pressure vessels maximized the efficiency of operators' weekend work. Operators used the emergency power supply for nearly 28 years; however, the practice was never identified as a potential hazard.
