CASE STUDY

Confined Space Entry - Worker and Would-be Rescuer Asphyxiated

No. 2006-02-I-DE

Valero Energy Corporation Refinery

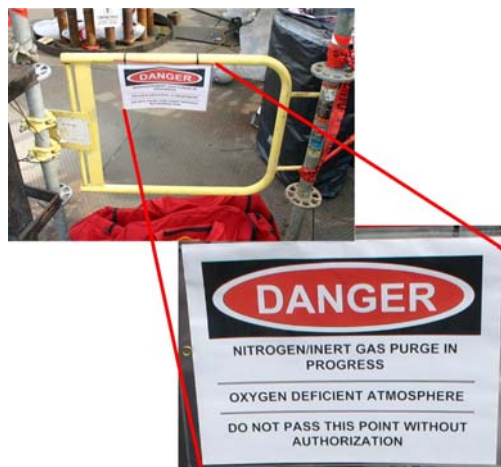
Figure 8. Nitrogen-purge controlled area barricade and warning installed on the R1 platform after the incident.

The Valero refinery has safe work procedures for using nitrogen, but they were inadequately implemented the night of the incident. The procedures required operators to install a barricade and post warning signs at all equipment access points (Figure 8) before the nitrogen purge was started, and to list all personnel working inside the barricaded area using a controlled area entry log. The barricade and control log were not used at the R1 manway the night of the incident, even though the reactor was on a nitrogen purge that vented directly onto the work platform area.
