September 2009

Dangers of Purging Gas Piping into Buildings

No. 2009-12-I-NC

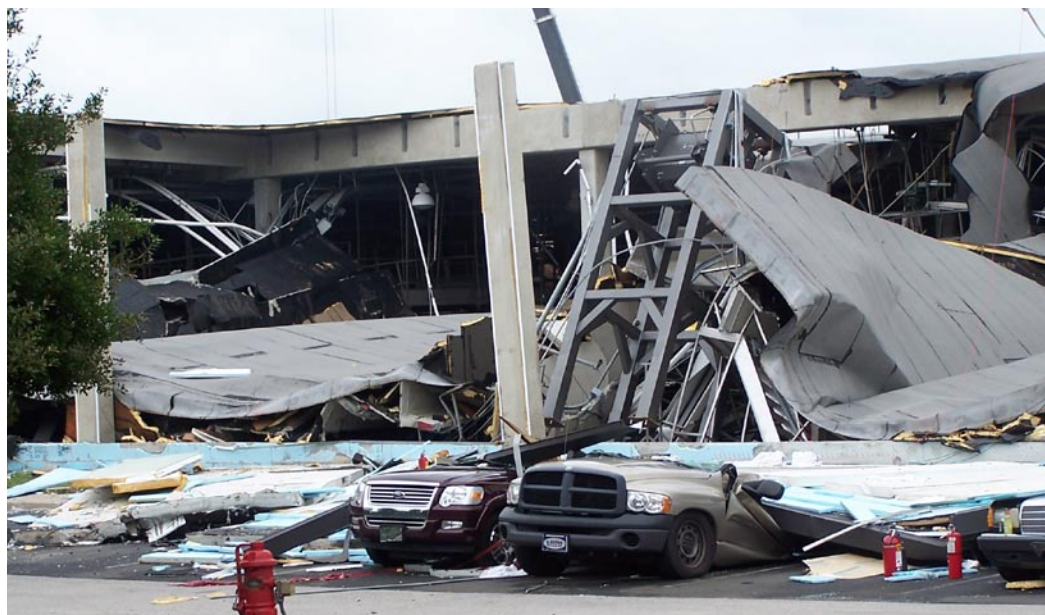
The ConAgra Slim Jim plant in Garner, North Carolina, where unsafe gas purging caused an explosion in June 2009 that killed three workers and sent 71 to the hospital.

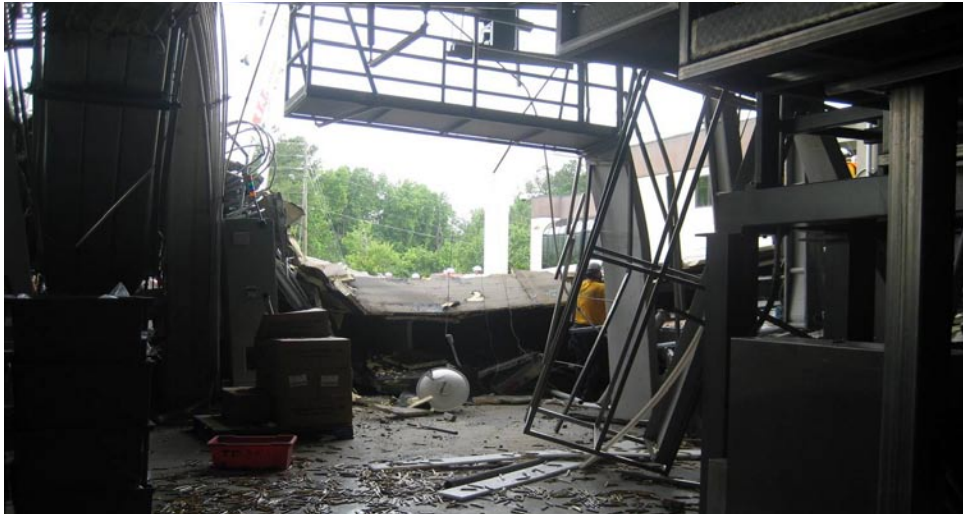
Interior of ConAgra facility following structural collapse.

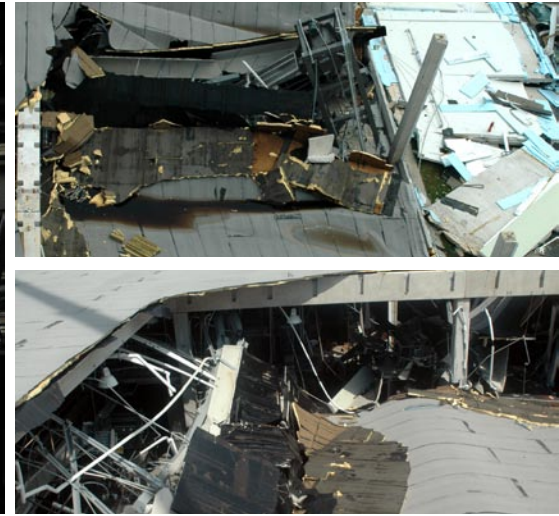
Aerial views of ConAgra facility after explosion.

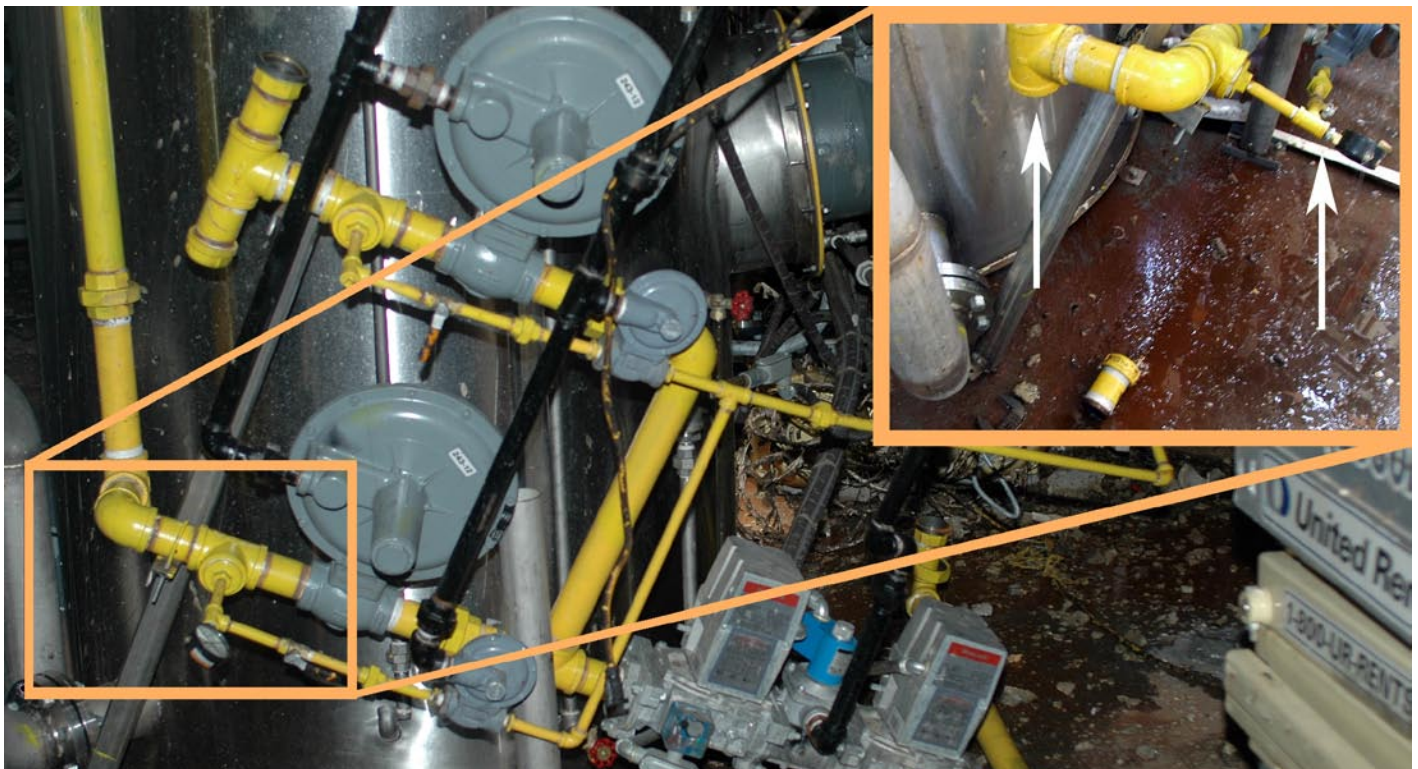
The accident occurred during the installation of a new fuel gas-fired industrial water heater in an interior utility room of the plant. Five days prior to the accident, a new section of three-inch steel piping – which would provide natural gas to the heater – was tied into a six-inch natural gas supply line located on the roof. The new natural gas piping ran horizontally over 120 feet along the roof and then descended into the utility room.

On the day of the accident, a worker from Energy Systems Analysts (ESA), the water heater manufacturer, was attempting to purge the new gas line by using natural gas to directly displace the air. This was done by removing threaded fittings, creating one or more pipe openings near the heater. The worker then opened a quarter-turn valve to control the release of purged gases. ESA reported that it was the company's normal practice to purge fuel gas piping directly into the room or area when installing gas-fired equipment. Code officials and other parties told the CSB that they believe this practice to be common.

The purged fuel gas was vented indoors into the utility room, which was ventilated by an exhaust fan. However, no assessment was made of the adequacy of the ventilation in comparison to the rate of the gas release; whether a dangerous accumulation of flammable gas had occurred could have been most accurately verified by taking direct measurements inside the utility room using a combustible gas detector. Because of the difficulties in lighting the water heater, personnel perceived that the gas line was not effectively purged of air. Therefore, purging was conducted intermittently over a period of up to two-and-a-half hours.

Gas-fired water heater and piping, indicating points where gas was likely released into the building.

Following the June 9 explosion, ConAgra established new procedures for gas purging. These procedures require direct venting of purged gases via a hose or piping to a safe location outdoors, exclusion of personnel and ignition sources from the vicinity of the vent, continuous air monitoring using combustible gas detectors, and evacuation of nonessential personnel from the facility.

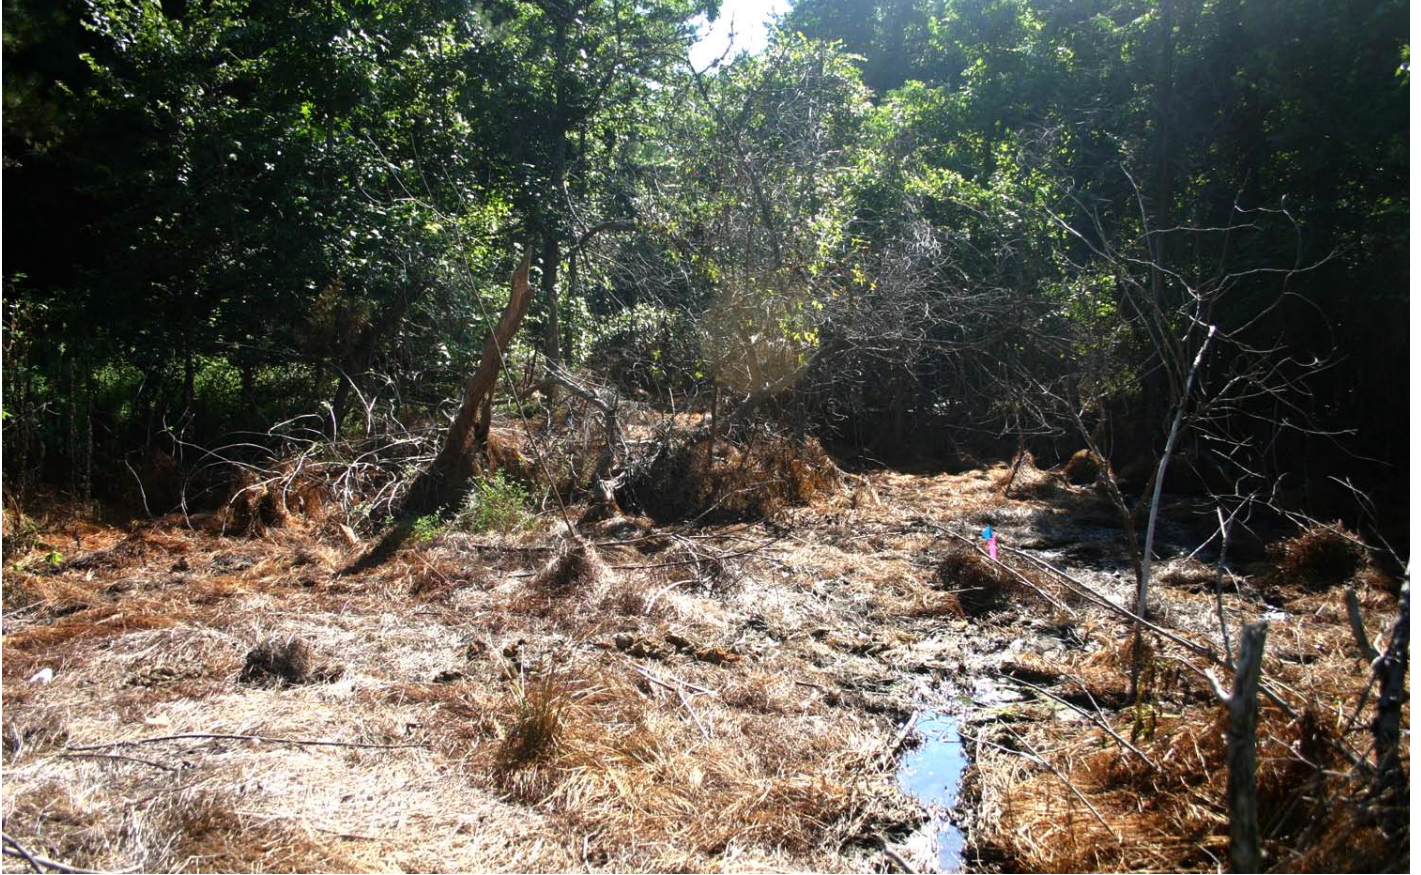
Damage to vegetation hundreds of feet away from the ConAgra plant due to the ammonia release that followed the explosion.

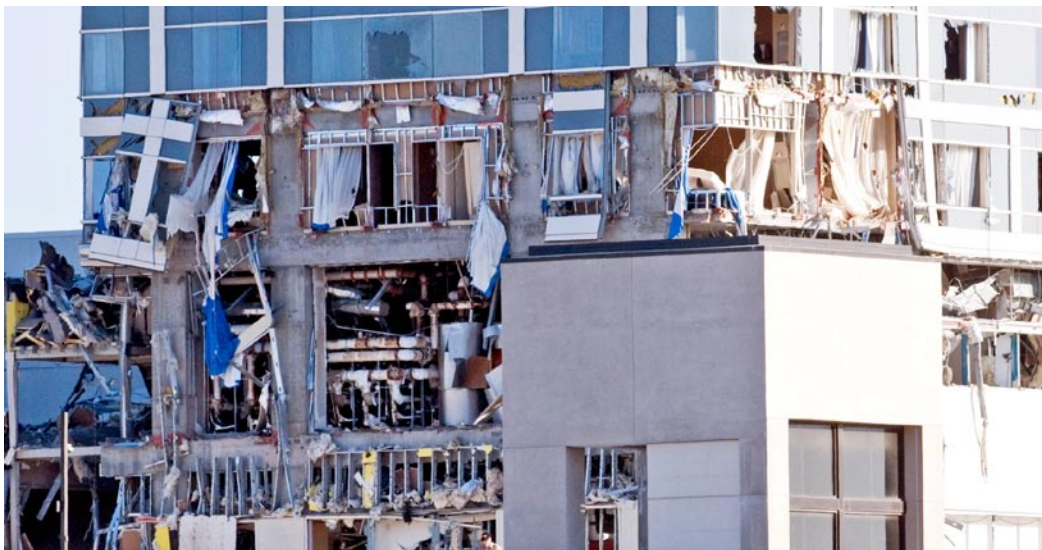
- An explosion at a 30-story hotel under construction in San Diego, California, on May 19, 2008, that injured 14 workers, including three who suffered severe burns;
- An explosion at a hotel in Cheyenne, Wyoming, on August 7, 2007, that severely burned two plumbers;

Explosion seriously damages three floors of a Hilton Hotel under construction in San Diego in May 2008, injuring 14.
