U.S. Chemical Safety and Hazard Investigation Board

Investigation Report

Non-Condensable Gas System Explosion at PCA DeRidder Paper Mill

Report Number: 2017-03-I-LA
April 2018

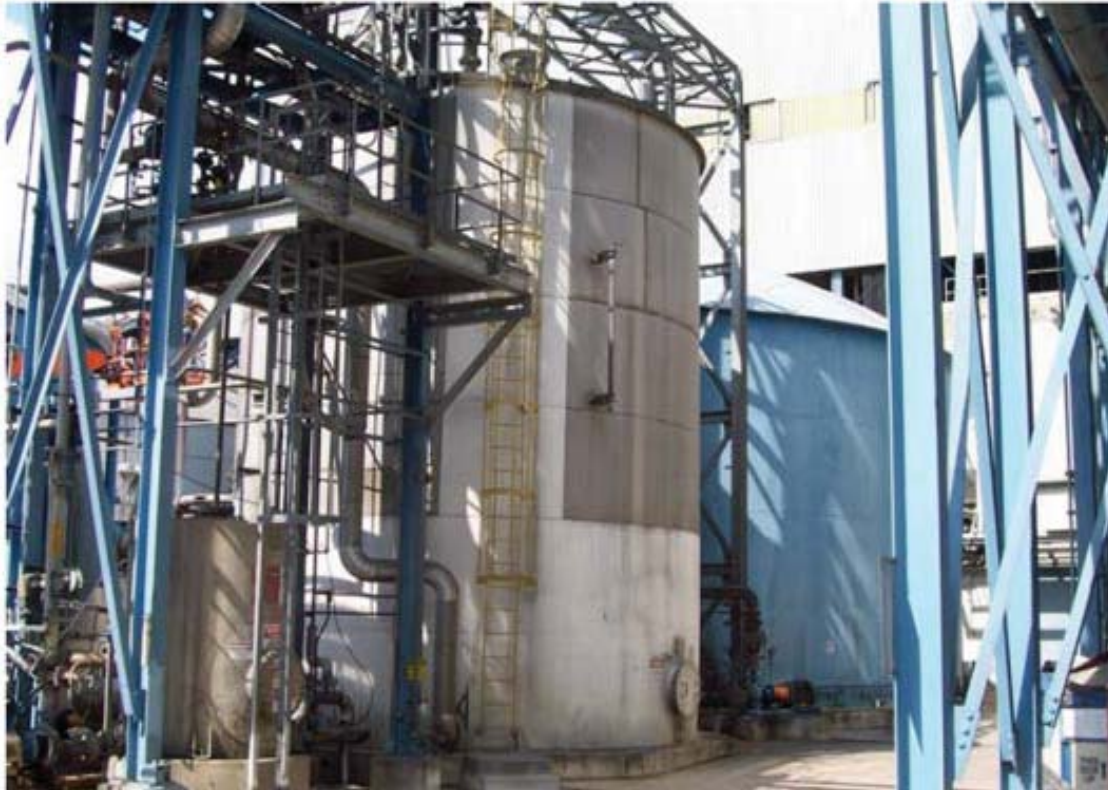
Figure 7. Pre-Incident Photograph of the DeRidder Mill Foul Condensate Tank. Welding work was being conducted above the tank on the pipe rack at the time of the incident. Photograph: PCA.

1. At approximately 11:05 am central daylight time (CDT) on February 8, 2017, a tank containing foul condensate (**Figure 7**) exploded at the PCA DeRidder mill in DeRidder, Louisiana.

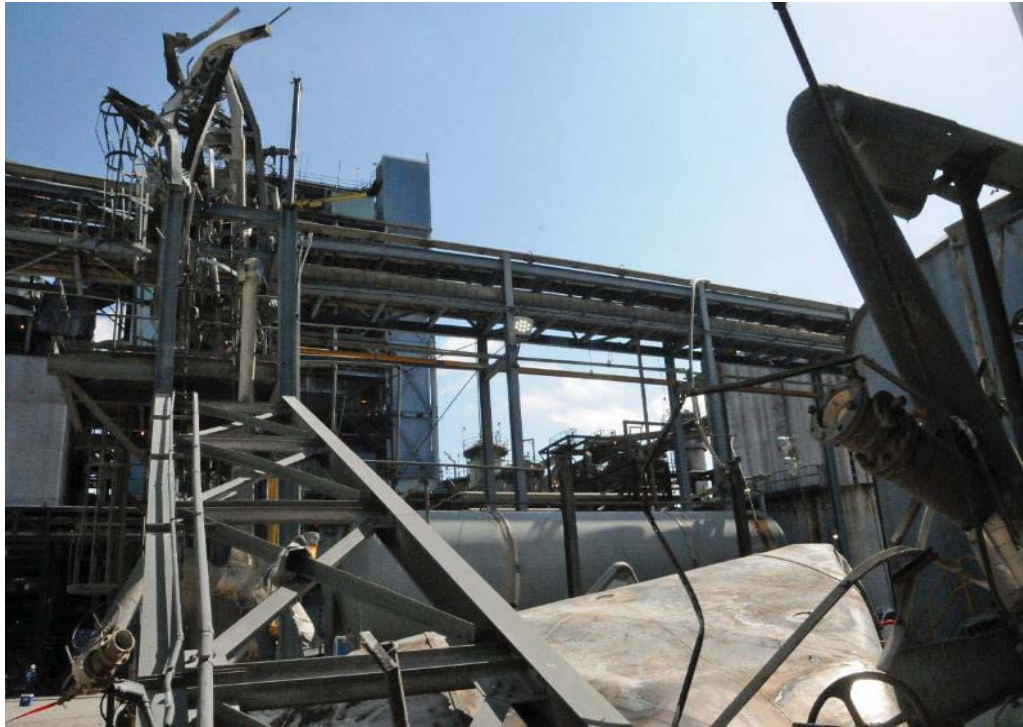
3. The explosion killed three people and injured seven others. All 10 workers were contractors working near the foul condensate tank. Their injuries included contusions and burns [10]. At least one contract worker had burns consistent with those caused by hot liquid.
4. The explosion damaged the pipe rack structure, its associated piping located above the tank (Figure 10), a work platform at the top of a powerhouse stack, and ductwork attached to the precipitator in the powerhouse area. Other areas of the mill also sustained damage.

Figure 10. Photograph Showing Explosion Damage at the PCA DeRidder Mill in DeRidder, Louisiana. The bottom right corner of the photograph shows the foul condensate tank's base upside-down. The explosion separated the tank from its base. Photograph: CSB.

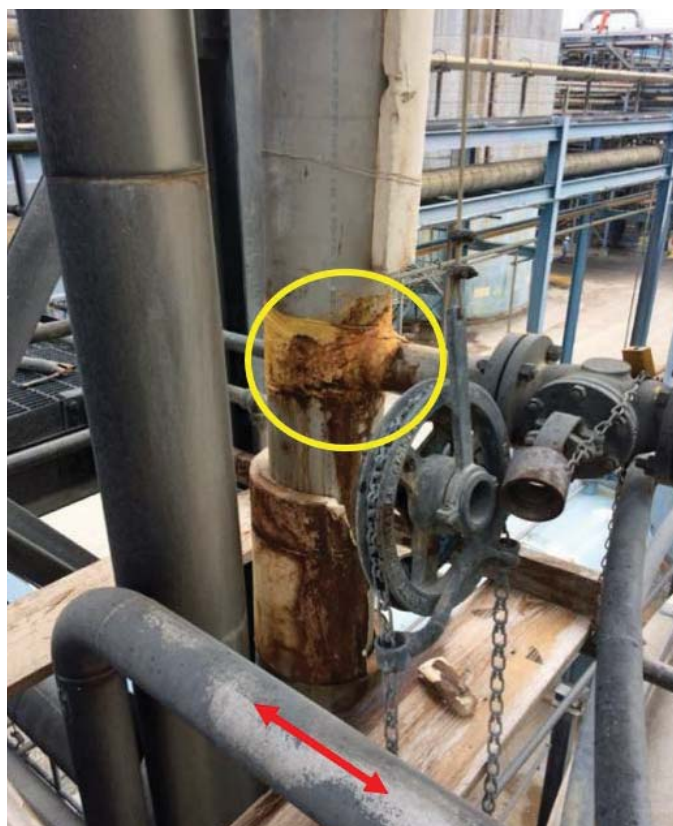
Figure 11. Pre-incident Photograph of the Cracked Three-inch Piping Connection on the Eight-inch Water Piping (yellow circle). This photograph shows a temporary repair to slow the leak, installed in October 2016. Witnesses stated that workers repaired this crack before the explosion. Workers disconnected the water piping from the valve (just to the right of the yellow circle) to create an air gap and to separate the repair area from the foul condensate tank. The red arrow shows the adjacent vent piping from the foul condensate tank to the CNGC system. The valve on the foul condensate side of the air gap, which was never located, was reportedly closed leading up to the incident. The vapor inside the foul condensate tank and the vent piping likely contained an explosive mixture of NCG and air when this repair work took place. Photograph: PCA.

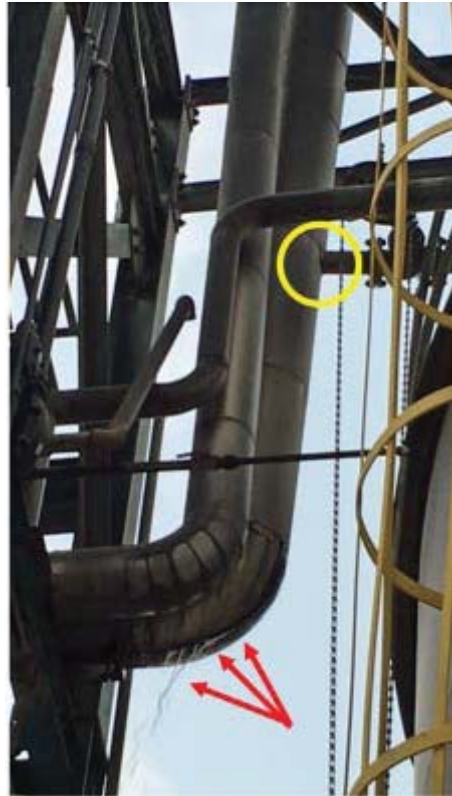
Figure 12. Pre-Incident Photograph of the Water Leak. The water piping (yellow circle) had cracked at the connection point between the eight-inch vertical water piping and the three-inch horizontal piping entering the foul condensate tank. Water was leaking from the crack (red arrows). Photograph: PCA.

- There were no known risks among mill personnel of leaving liquid in the tank.
 - The company did not have plans to work directly on the tank during the outage.
 - There were resource limitations as mill staff had numerous other tasks to complete during the annual outage.
8. During the outage, there was no planned or actual work directly on the foul condensate tank. However, work was planned on water piping located above the foul condensate tank. Months earlier, that piping shifted off its supports and cracked at the intersection of an eight-inch line and a three-inch line that was connected to the foul condensate tank (**Figure 11**), resulting in a significant leak that was visible in a pre-incident video taken by a mill employee who planned the repair work (**Figure 12**).

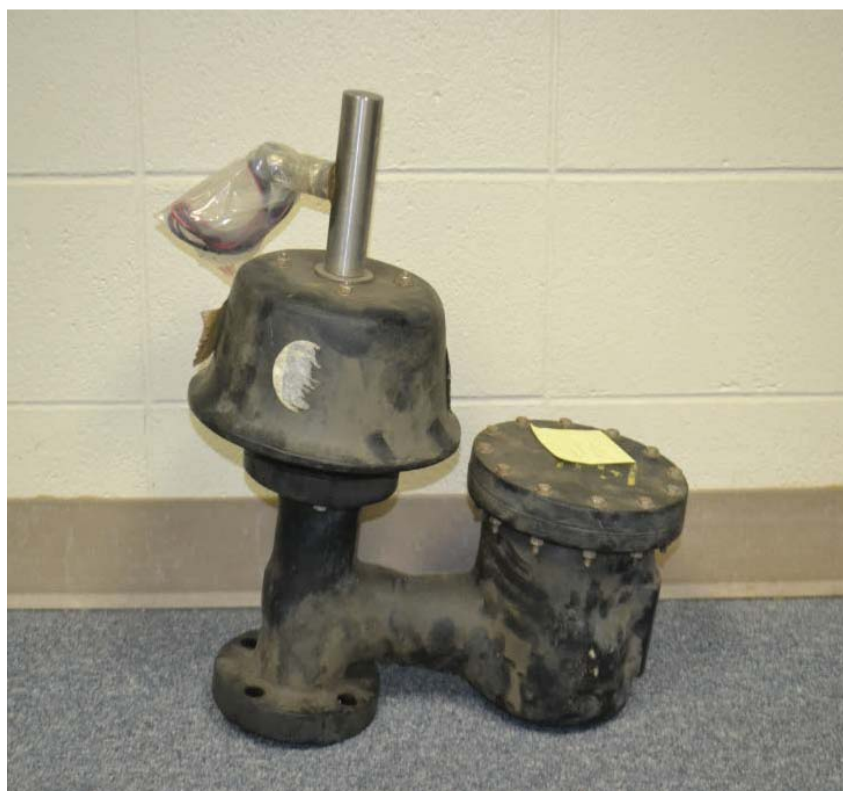
Figure 15. Photograph of a Spare Pressure Vacuum Breaker for the CNG System at the DeRidder Mill. If the foul condensate tank experiences high-pressure (six-inches of water), the left-hand portion of the pressure vacuum breaker opens and releases vapor to the atmosphere. If the tank experiences low-pressure (minus six-inches of water), the portion of the pressure vacuum breaker extending to the right will open and pull air into the tank.^b Photograph: CSB.

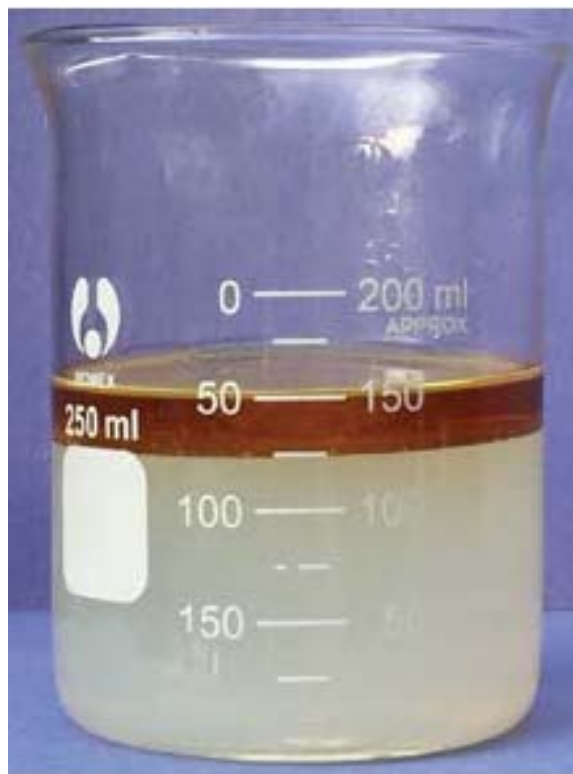
Figure 16. Photograph of Immiscible Oil Layer on Top of Water. This photograph shows how oil forms an immiscible liquid layer on top of water similar to how a turpentine layer might appear inside the foul condensate tank. Photograph: CSB.

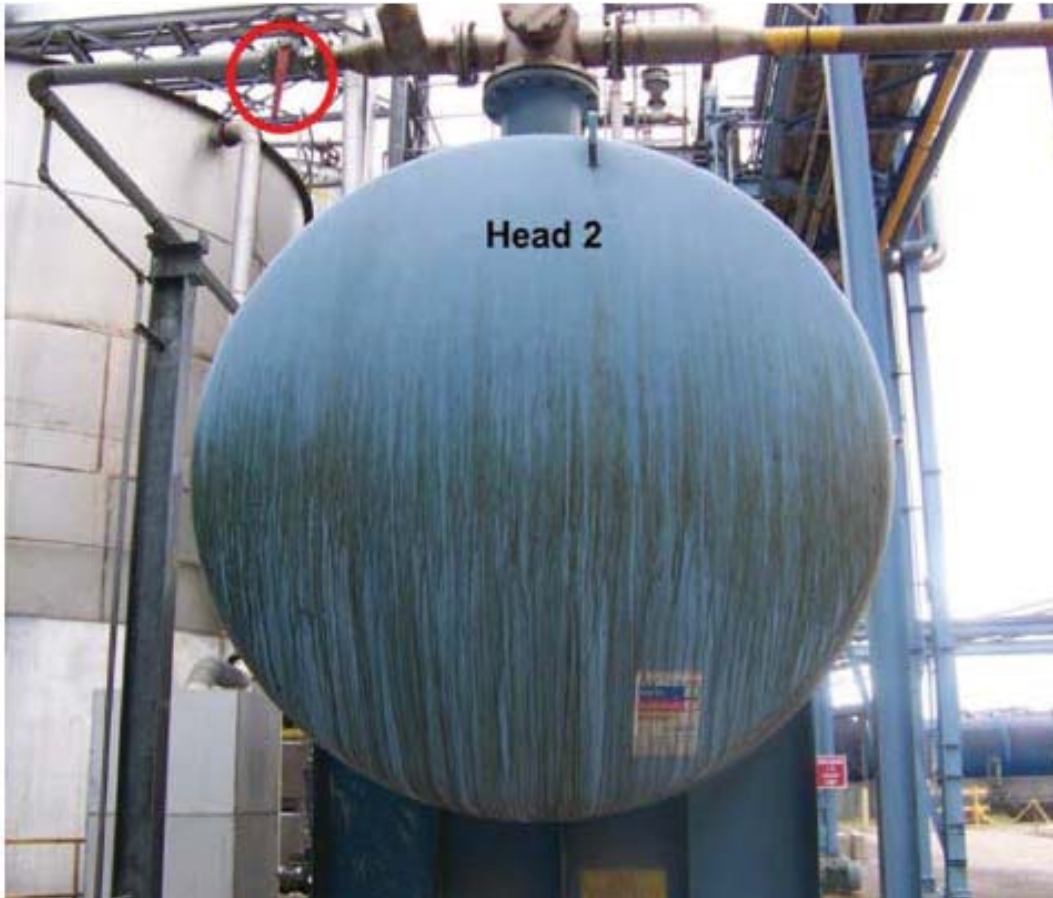
Figure 21. Closed Valve on the Piping from the Foul Condensate Weir to the Turpentine Recovery System. This photograph from the mill's 2010 inspection file shows that the valve is in the closed position. Post-incident, this valve also was found in the closed position. The CSB learned that the PCA DeRidder mill had not used the foul condensate tank's weir system to remove turpentine. Photograph: PCA.

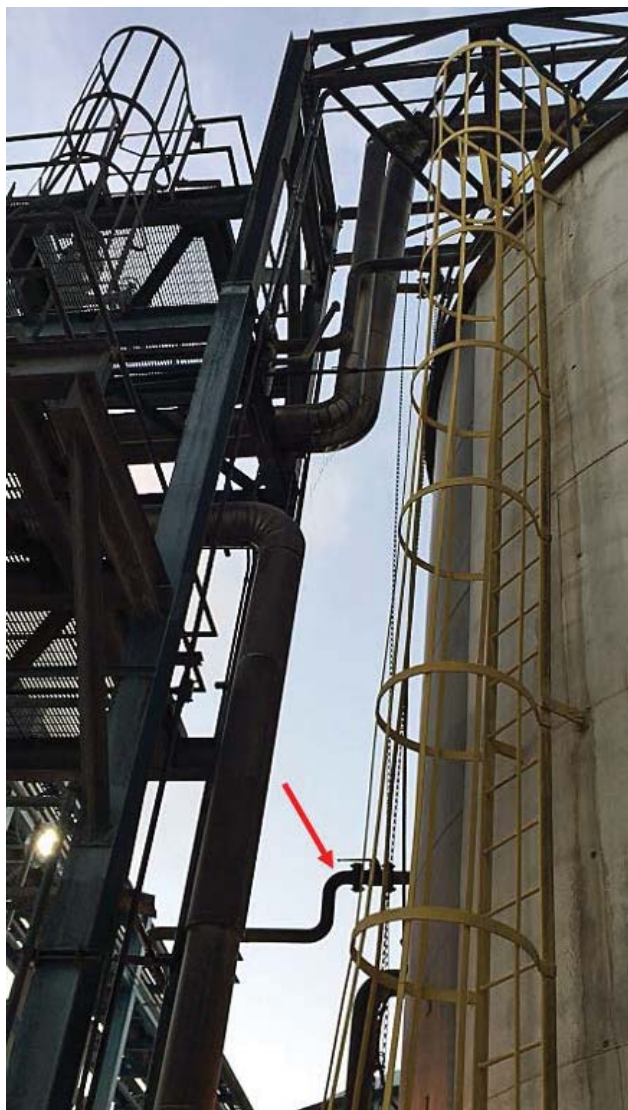
Figure 22. Pre-Incident Photograph of the Foul Condensate Tank. The line from the weir inside the tank to the turpentine recovery system is indicated by the red arrow. The valve at the foul condensate tank is kept open, but the valve at the turpentine recovery system (**Figure 21**) is kept closed. Photograph: PCA.

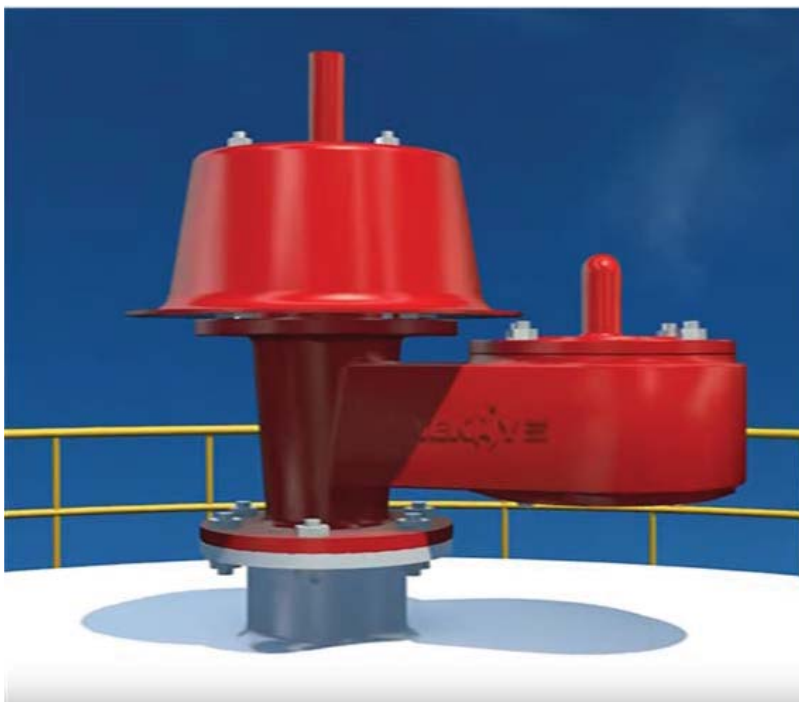
Figure 23. Image of a Pressure Vacuum Breaker. If the vessel experiences an over pressure event, the top portion of the pressure vacuum breaker releases to the atmosphere. If the vessel experiences an under pressure event, the portion of the pressure vacuum breaker extending to the right will pull air into the vessel. Photograph: Finekay [12].

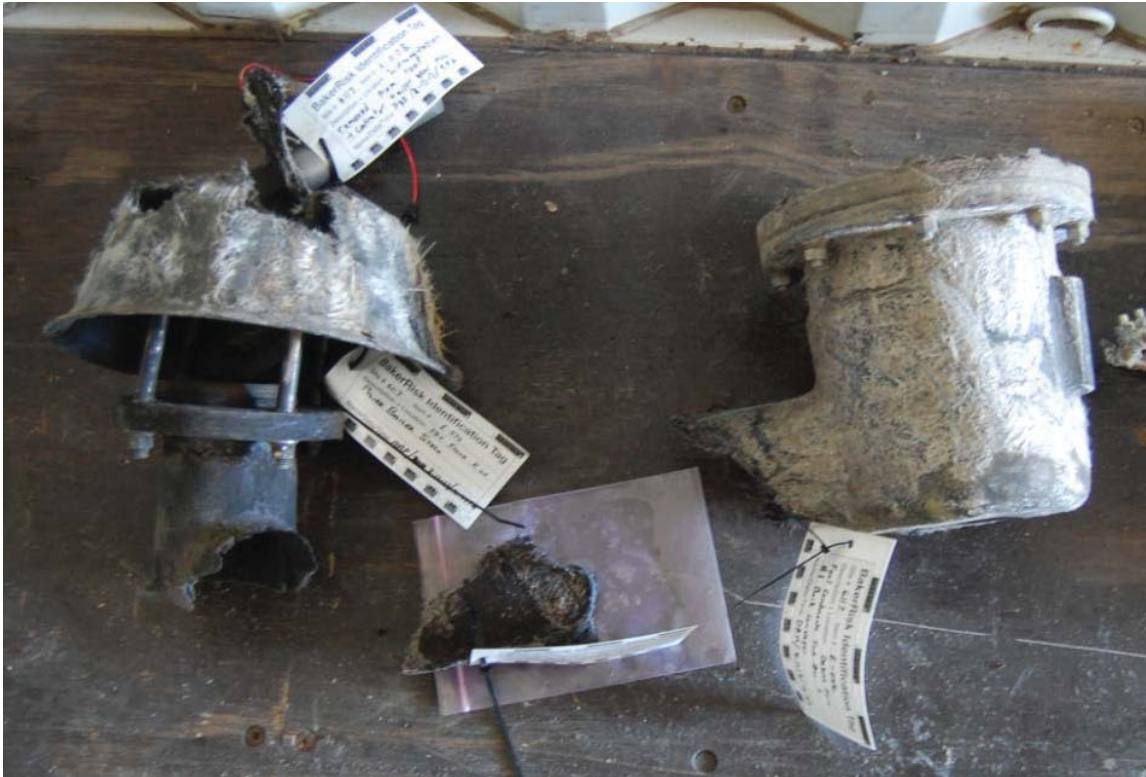
Figure 24. Post-Incident Pressure Vacuum Breaker. The foul condensate tank’s pressure vacuum breaker is shown post-incident. Photograph: PCA.

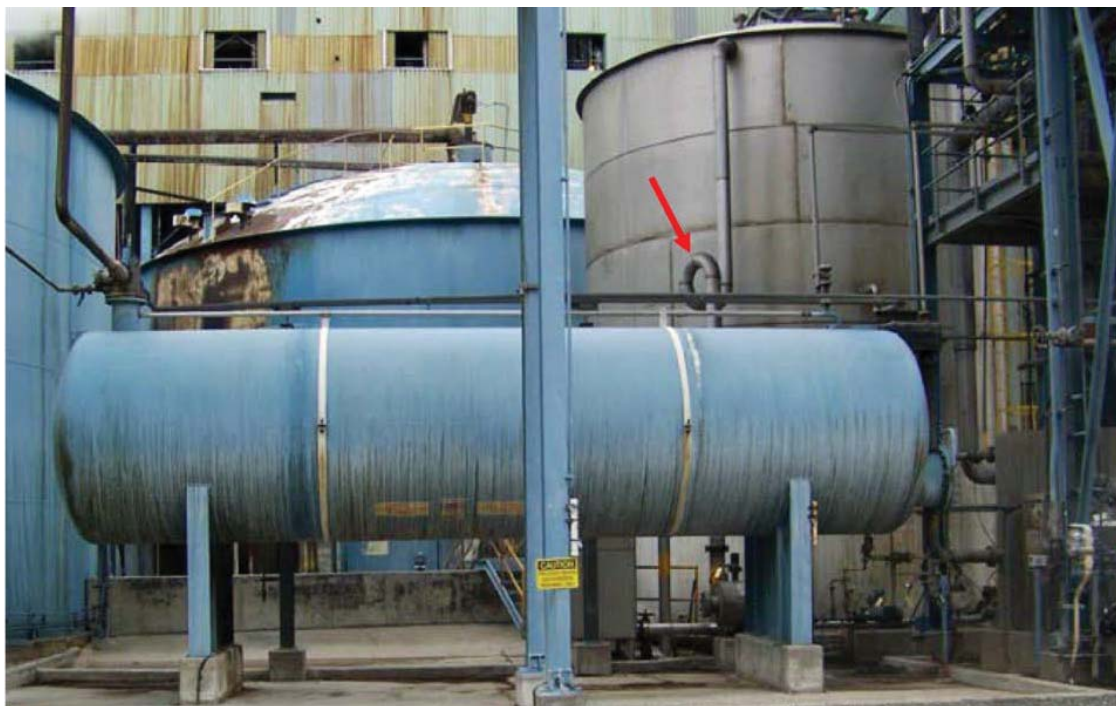
Figure 29. Pre-Incident Photograph Showing Overflow Seal Leg. This pre-incident photograph shows the overflow seal leg on the foul condensate tank (red arrow). Photograph: PCA.

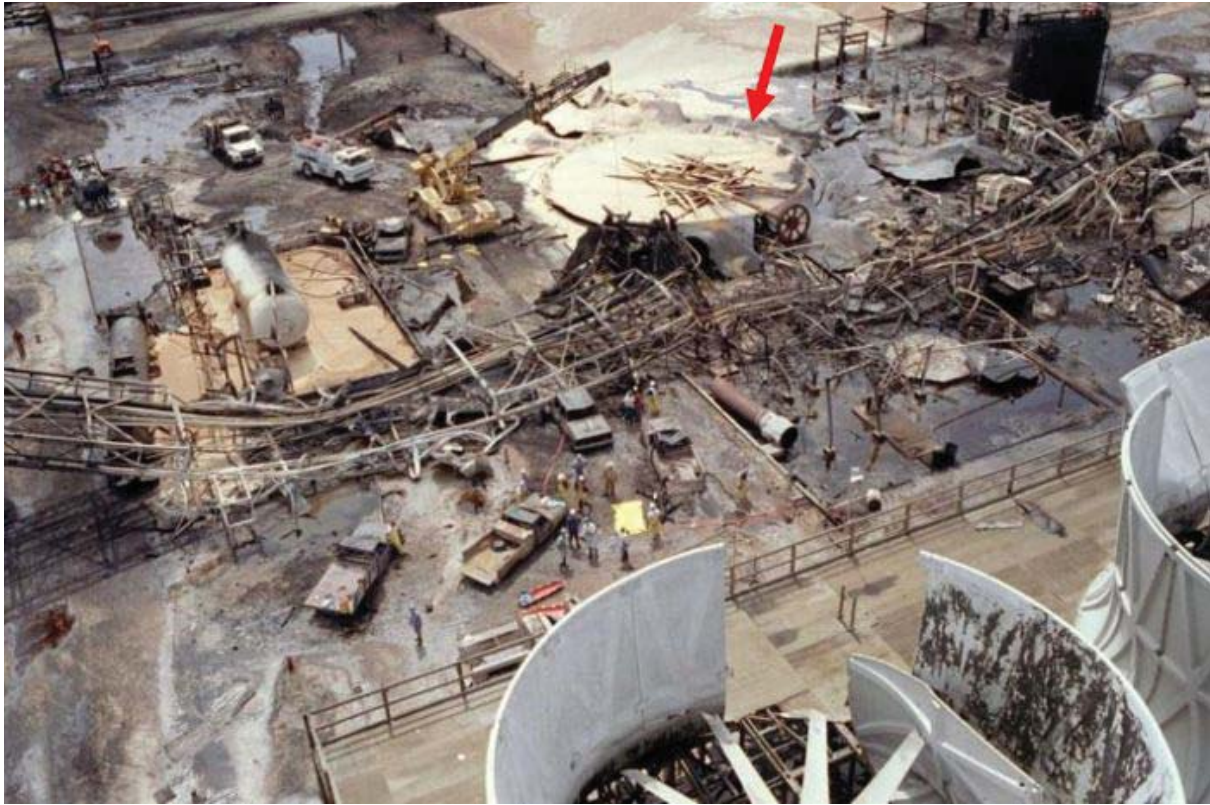
Figure 36. Post-Incident Photograph of the July 1990 Explosion at the ARCO Chemical Facility in Channelview, Texas. The location of the wastewater storage tank is indicated by the red arrow. Photograph credit: [41].

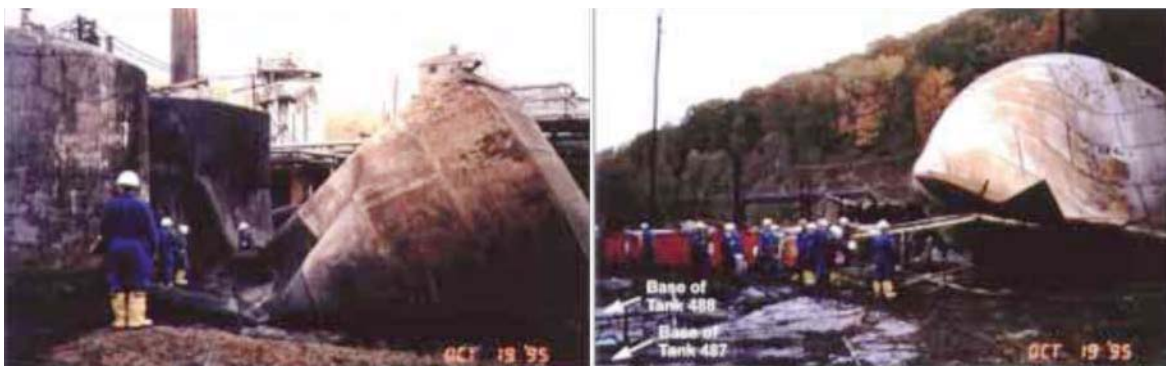
Figure 38. Photographs from the Pennzoil Refinery. These post-incident photographs show the October 1995 explosion at the Pennzoil refinery in Rouseville, Pennsylvania. Photograph credit: [43].

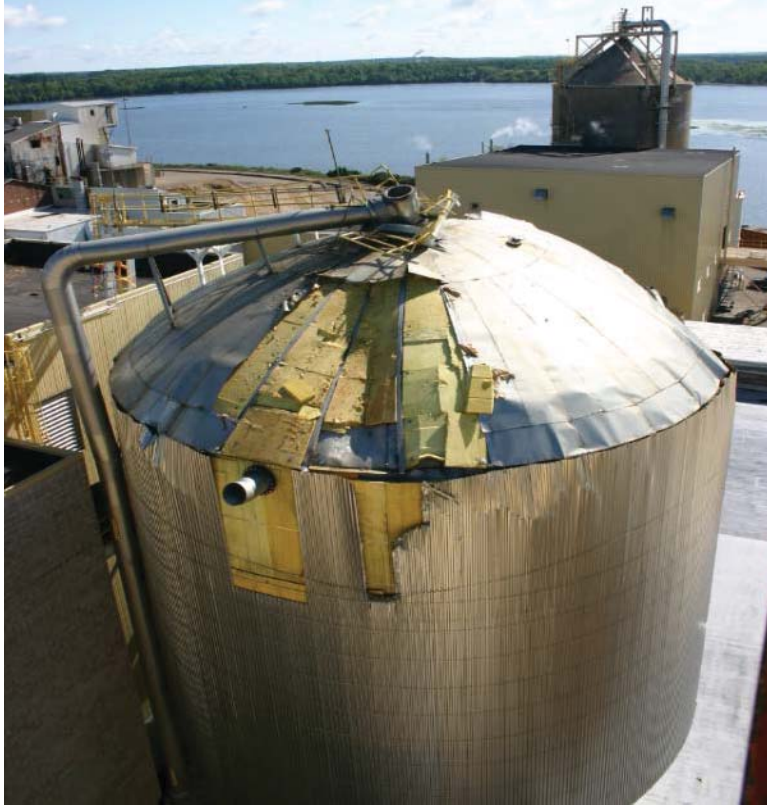
Figure 39. Post-Incident Photograph at the PCA Tomahawk Mill. This photograph shows the post-incident storage tank at the PCA Tomahawk mill in 2008. Photograph: CSB.

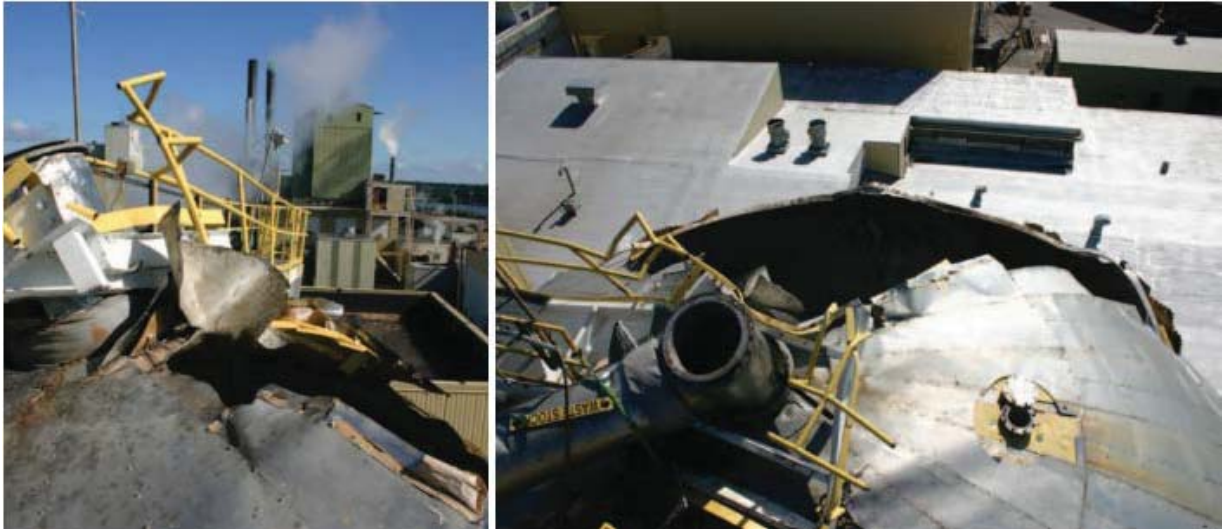
Figure 40. Post-Incident Photographs from the PCA Tomahawk Mill. These photographs show views of the top of the storage tank involved in the 2008 explosion at the PCA Tomahawk mill. Photograph: CSB.

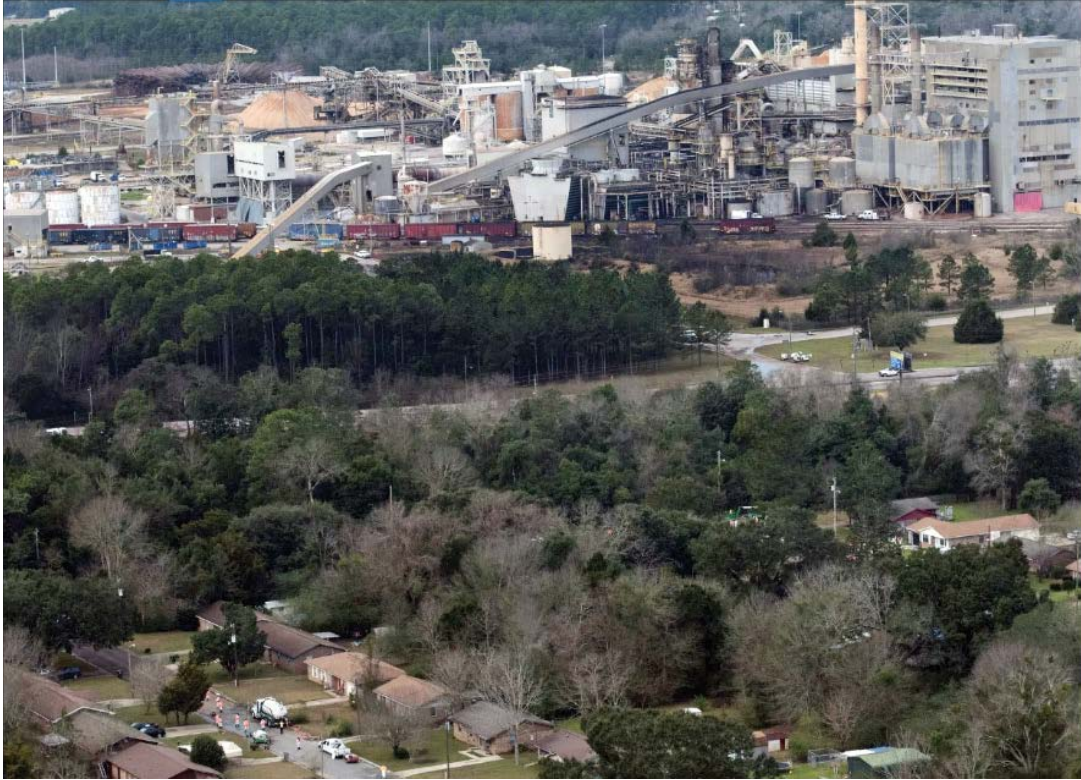
Figure 41. Post-Incident Photograph of the International Paper Pensacola Mill in Relation to Adjacent Neighborhoods. Clean-up crews can be seen in the neighborhood at the bottom left of the photograph. Photograph: Pensacola News Journal [48].

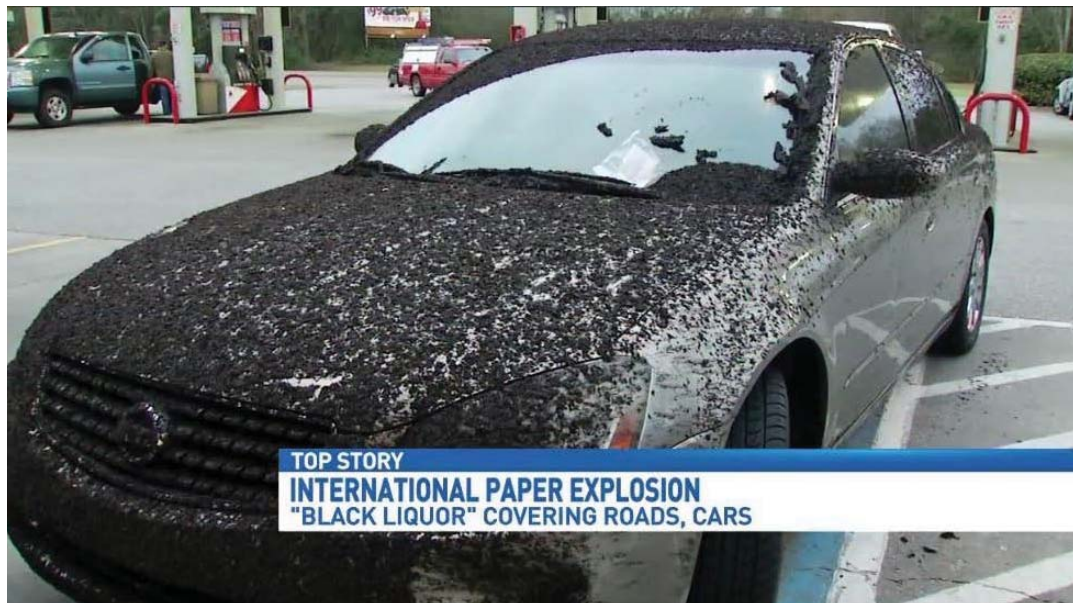
Figure 42. Post-Incident Photograph of Debris on a Car. This photograph shows a car covered with process chemicals that were released when a digester at the Pensacola mill exploded on January 22, 2017. Photograph: WEAR Television [51].

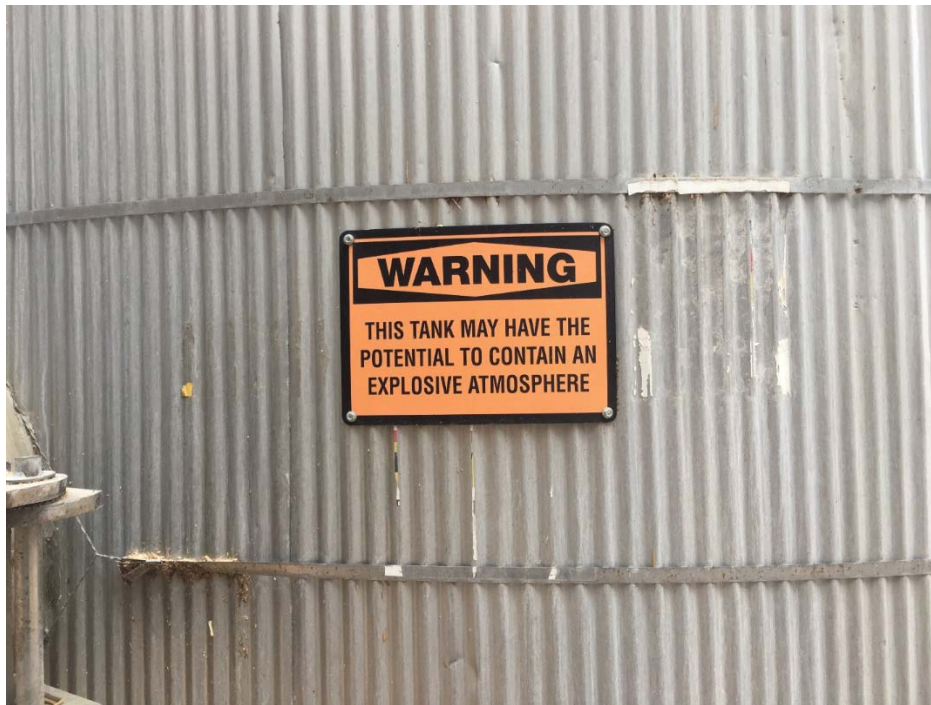
Figure 44. Post-Incident Warning Label. This warning label is intended to inform personnel of the potential hazards associated with a flammable atmosphere inside a vessel. Photograph: PCA.
