U.S. Chemical Safety and
Hazard Investigation Board

Explosion and Fire at AB Specialty Silicones Facility

Waukegan, IL | Incident Date: May 3, 2019 | No. 2019-03-I-IL

Factual Update

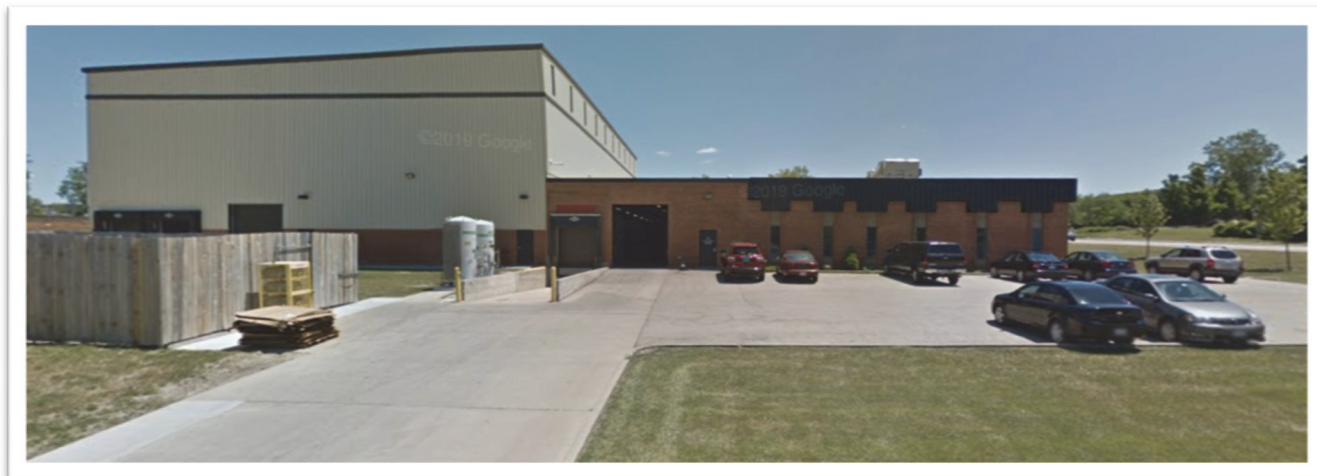
Figure 1. AB Specialty Silicones. Photo showing the AB Specialty Silicones production area (3790 Sunset Ave.) in Waukegan, IL, before the explosion. (Source: Google Maps).

On May 3, 2019, a silicone manufacturing process generated a flammable gas inside an enclosed production building at the AB Specialty Silicones (“AB Specialty”) facility in Waukegan, Illinois (**Figure 1**). At approximately 9:30 p.m., the flammable vapor cloud found an ignition source and ignited, causing an explosion and fire. The flammable vapor originated from the area where AB Specialty was making a silicon hydride emulsion. The explosion fatally injured four AB Specialty employees [1] and caused serious injury to another AB Specialty employee. At the time of the incident there were nine AB Specialty employees onsite. The explosion heavily damaged the AB Specialty’s production building. Additionally, the force from the explosion was felt up to 20 miles away in the surrounding communities [2], and some nearby businesses sustained damage from the blast [3]. Post-incident, AB Specialty has resumed some of its operations at another location [4].

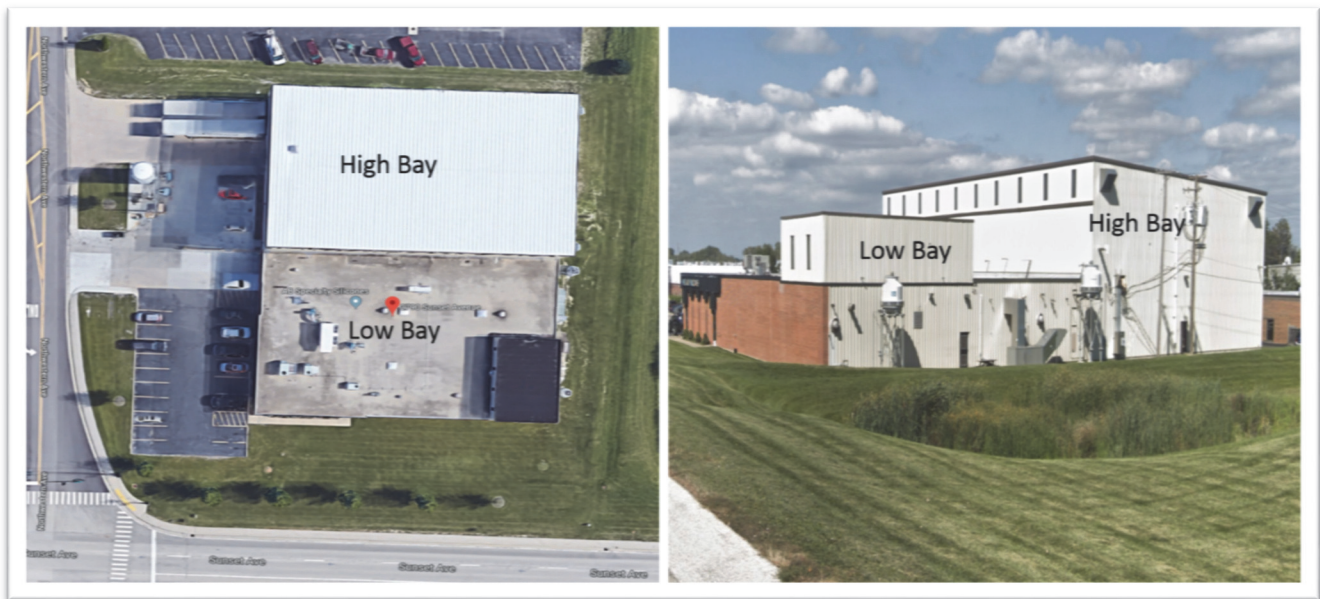
Figure 3. High Bay and Low bay. Photo showing the AB Specialty Silicones production area (3790 Sunset Ave.) in Waukegan, IL, before the explosion, with both the High Bay and Low Bay marked. Overhead view (Left) and back view (Right). (Source: Google Maps with annotations by CSB).

AB Specialty Silicones produces many silicone products at its Waukegan production facility. The production facility is separated into two portions—the “High Bay” and the “Low Bay”—named after the physical height of structure (**Figure 3**). These bays were further subdivided into areas depending on the chemicals being produced.

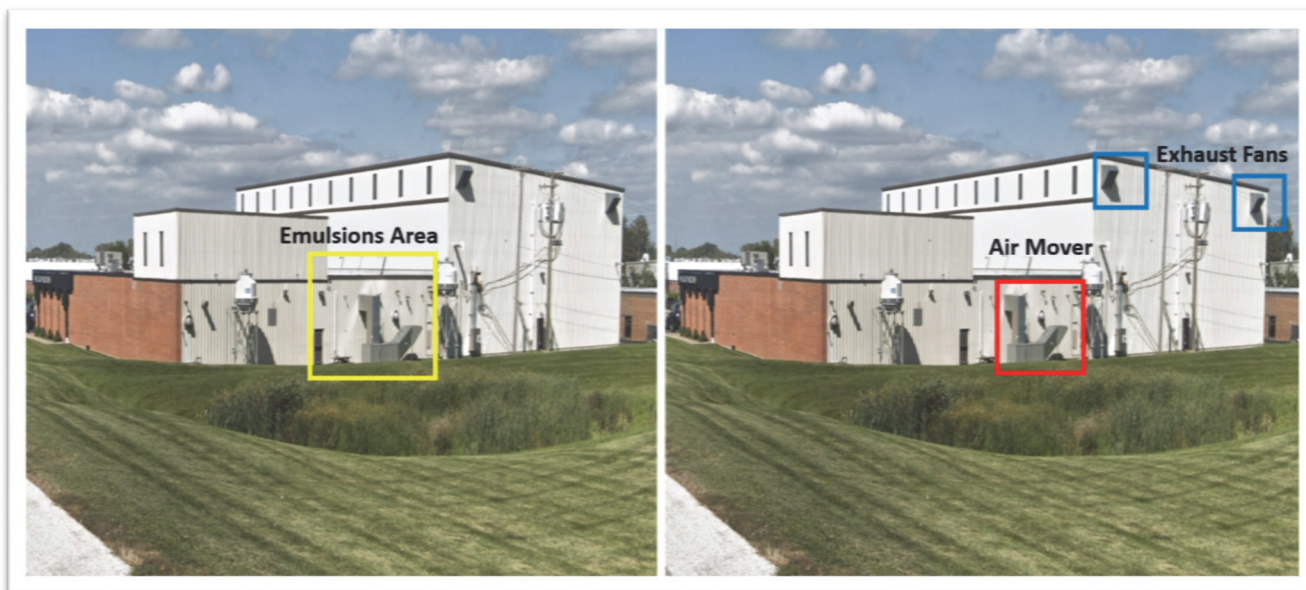
Figure 4. Location of the Emulsions Area and the Ventilation System on the East Side of the Building. Photo on the left shows where the Emulsions Area (yellow box) is located. Photo on the right shows the location of the Air Mover in the Emulsions Area (red box) and the Exhaust Fans in the High Bay (blue boxes). (Source: Google Maps with annotations by CSB).

The Low Bay and High Bay shared a mechanical ventilation system that consisted of air movers and exhaust fans throughout the building. On the east side of the production building in the emulsions area, there was one main air mover (12,000 cubic feet per minute (CFM)) and one smaller air mover (2,000 CFM) on the Low Bay roof that pulled in outdoor air and dispersed this air throughout the building (**Figure 4**). The main air mover was located in the emulsions area and provided approximately 86 percent of the total makeup air flow into the production building. The Low Bay area had four 1,500 CFM roof exhaust fans, two 1,500 CFM east wall exhaust fans, and one 5,000 CFM roof exhaust fan that ran continuously. In addition, on the east side on the High Bay end, there were two exhaust fans with a total capacity of about 44,000 CFM (**Figure 4**). These exhaust fans did not run continuously and had to be manually activated by a switch located in the maintenance area. The building was not equipped with functioning hydrogen gas^a or flammable gas detection systems.^b The production building was equipped with a fire alarm system that was to be activated in case of emergencies, including flammable gas releases, to notify workers^c to evacuate the production building.

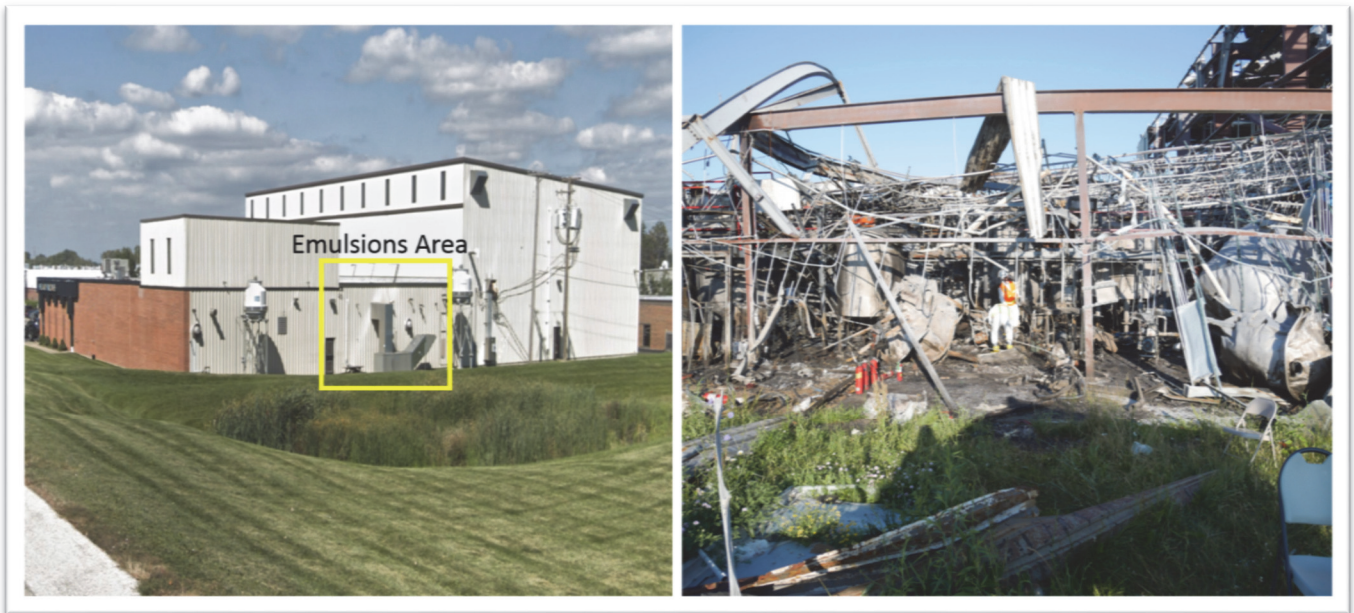
Figure 7. Emulsions Area. On the left, photo of location of the emulsions area prior to the incident. On the right, photo of the emulsions area post-incident. (Source: Google Maps (left); CSB (right)).

On May 3, 2019, operators in the emulsions area (**Figure 7**) were making back-to-back batches of EM 652. AB Specialty had started the first batch of EM 652 earlier in the week. The quality control analysis of the first batch of EM 652 began on May 2, during the second shift, and continued into the second shift on May 3. During the second shift on May 3, the first batch of EM 652 was packaged into totes, and Operator 1 began production of the second batch in the emulsions area. There were eight employees working on the second shift on May 3—the Shift Supervisor, a QA Chemist,^b and six operators.
